**EVALUATION OF INFRARED
TREATMENTS FOR MANAGING
ROADSIDE VEGETATION**

Final Report

SPR 376

Oregon Department of Transportation

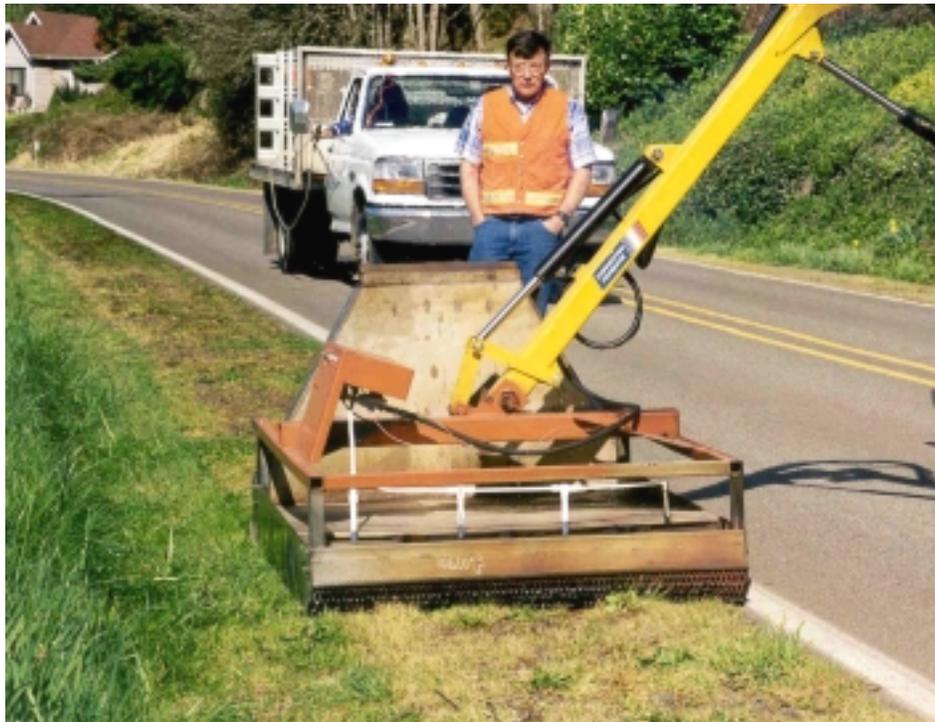
The radiating unit is a steel deck measuring 4 ft wide x 6 ft long (1.22 m x 1.83 m). The width of the treated area is the same as the deck width. The bottom of the deck travels 2 - 4 in. (50-100 mm) above the ground. The distance allows infrared heat to radiate down to the target vegetation with no equipment-to-vegetation contact. A hydraulic boom is used to maintain the proper deck elevation and is combined with a hydraulic pivot at the deck to match the slope of the road shoulder. The boom also provides some flexibility in moving the deck around obstacles such as sight posts, mailboxes and guardrail.

Figure 4.1: Infrared vegetation control unit

Infrared treatments were applied to the gravel shoulder of the road using a roadside infrared vegetation control unit (Figures 4.1). The prototype unit was manufactured by Sunburst, Inc. located in Eugene, Oregon. It applies an intense heat of about 1500° F (800° C), generated from a liquid propane fuel.

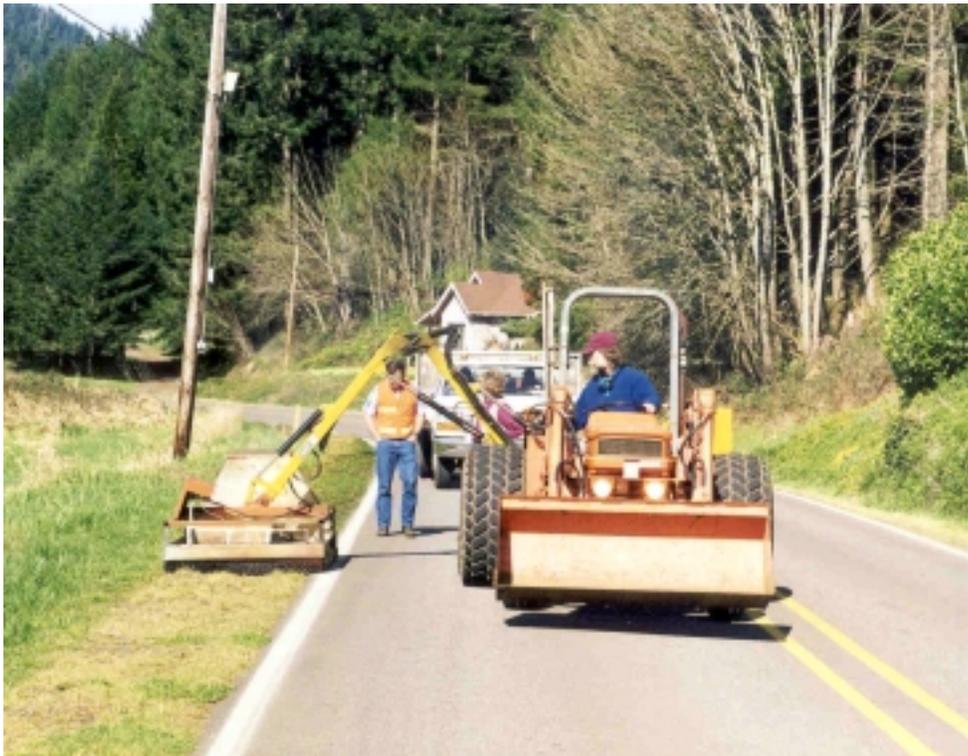
Figure 4.2: Tractor with infrared unit, followed by support truck

Fire control equipment accompanied the operation to extinguish ignited vegetation or debris. This consisted of a support truck with water tank, hose and spray nozzle (Figure 4.2). A laborer on foot with a shovel occasionally assisted in the fire suppression as needed.

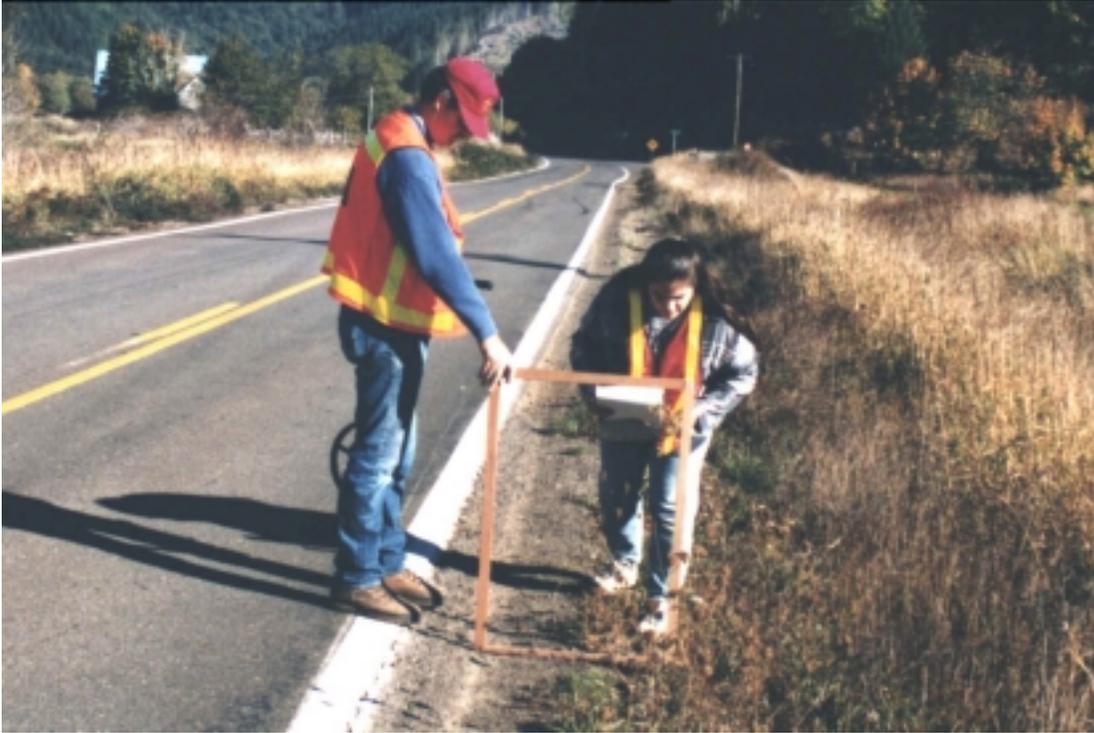
Figure 5.1: Measuring frame used in evaluation

All live vegetation that came in contact with one edge of the measuring frame between 15 and 60 cm was observed. The length of ground coverage was recorded and categorized as grass, broadleaf, or sedge. In addition, any vegetation that extended over the top of the measuring frame was measured by projecting downward over the tape. Dead vegetation was not counted.
