TICKET TAKER AUTOMATION

Final Report

Experimental Features Project OR 98-02

Oregon Department of Transportation

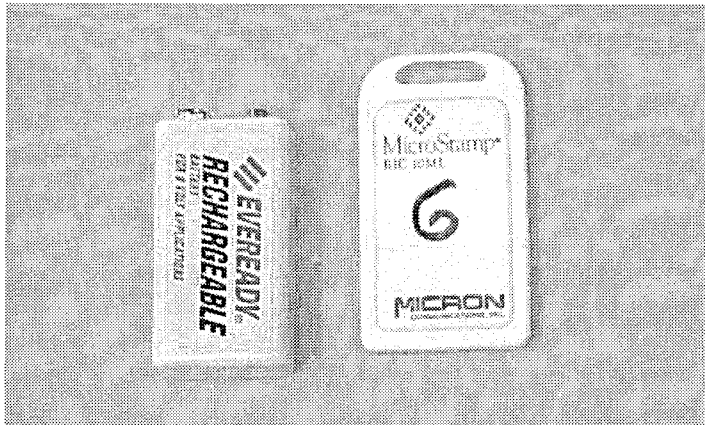
The current study tested the MicroStamp RIC system to replace ticket takers on ODOT construction projects. The RIC tag is shown in Figure 1.1. Note the small size of the device as compared to a nine-volt battery. This recently-developed system has not been used in construction environments. It has been successfully used in inventory control by reading tags on trucks going slowly through gates at storage facilities and garbage trucks being weighed at landfills.

Figure 1.1: The MicroStamp 10ML tag shown next to a nine-volt battery.

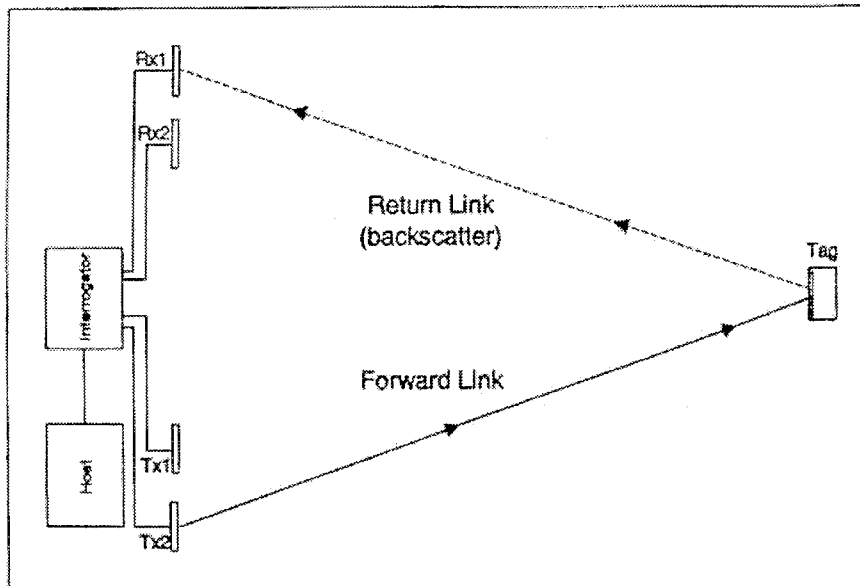
The MicroStamp 4000 system is composed of a host computer, an interrogator unit, and a RIC tag as shown in Figure 2.1. One complete system is needed at both the material plant and on the job site. The system sends a signal that includes batch time, truck number, job contract number, drivers name, mix weight, and material type to the tag mounted on the truck. At the construction site, another system reads the tag information and stores it in the host computer. In this test, only one system was used because of the experimental nature of the project.

Figure 2.1: MicroStamp 4000 System (courtesy of Micron Communications, Inc.)

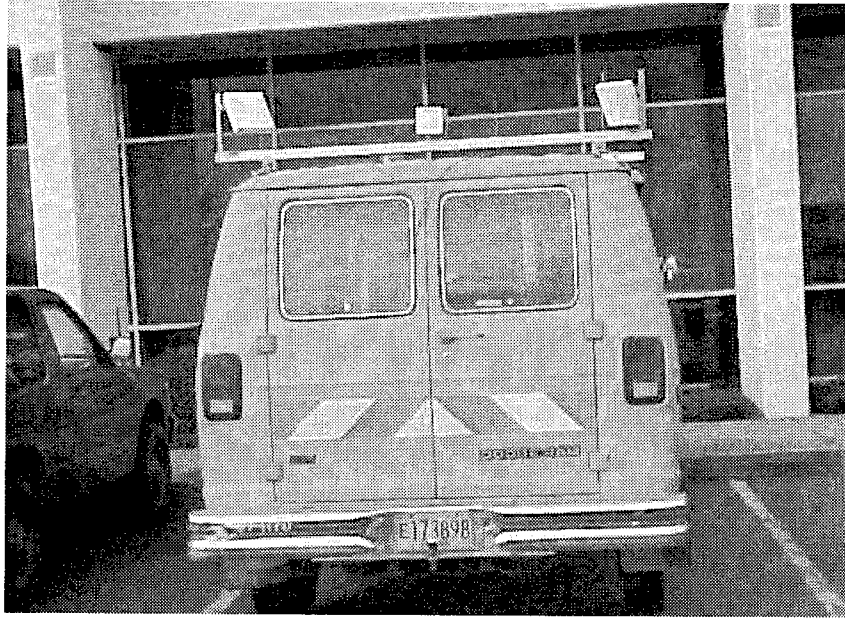
The host computer used was a Hewlett Packard OmniBook 5700CT operated by a Windows 95 system. The interrogator was a MicroStamp model 4000 and the RIC tags were the 10ML by Micron Communications Inc. Other equipment included four “patch” antennas, an inverter (DC to AC converter), a power strip, antenna mounting brackets and a Dodge Van (see Figure 2.2).

The laptop computer was setup on the front seat of the van. The interrogator was set up in the rear of the van on the shipping case in which it was delivered. A long serial cable connected the interrogator to the computer. An extension cord from the inverter supplied the operating power. Power for both the computer and the interrogator was taken from an inverter connected to the cigarette lighter. The patch antennas were mounted on an aluminum light bar on the rear of the van roof with the connecting cables routed through the rear door window to the interrogator. These antennas could be aimed in azimuth and elevation.

Figure 2.2: The patch antennas, mounted on the rear light bar of the van.

The antenna array was suggested by Micron. The Dodge van had three 2.5 m aluminum bars mounted on top, used for roto beams or for transporting objects on the van top. The rear-most bar was used to mount the antennas. Two receiving antennas were placed at opposite ends of the light bar with one transmitting antenna mounted between. The mounts made for the antennas consisted of two brackets bolted together so that they could be adjusted in the vertical plane as well as the horizontal plane.

After the first trial, the antenna array mounting system and the tags were modified to improve the reading range. The antennas were mounted on the roof of the van with a bracket that allowed them to be aimed in both azimuth and elevation, as shown in Figure 2.2. Also, the addition of a back plane doubled the reading range of the tags (see Figure 2.3).
