US Department
of Transportation

**National Highway
Traffic Safety
Administration**

DOT HS 809 297

An Evaluation of Existing Tire Pressure Monitoring Systems

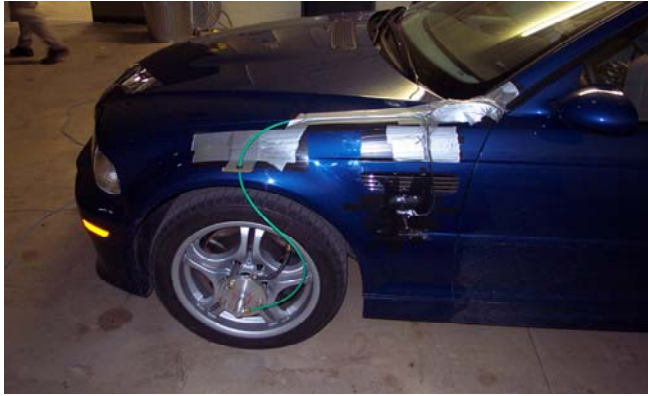
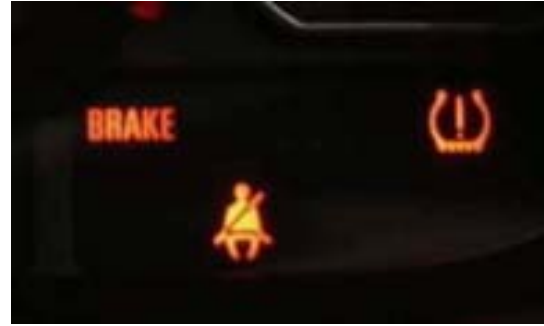
Figure 3.1 – System A Test Vehicle / Significant Underinflation Warning Light (Rightmost)

Method and Conditions of Warning Presentation: System A had a single stage underinflation warning to inform the driver when the inflation pressure in one of the tires dropped significantly [5] (amount of pressure loss until activation was not given in owner's manual). This warning only occurred while the vehicle was being driven. The system warned the driver by illuminating the ISO K.11 icon on the instrument cluster (the right-most icon Figure 3.1) and sounding an auditory warning tone. The icon (the right-most icon in Figure 3.1) illuminated with the color red to show underinflation and the color yellow to show a system malfunction condition. System A allowed the driver to deactivate the system for driving with snow chains by pushing the system button on the dashboard, which then illuminated yellow.

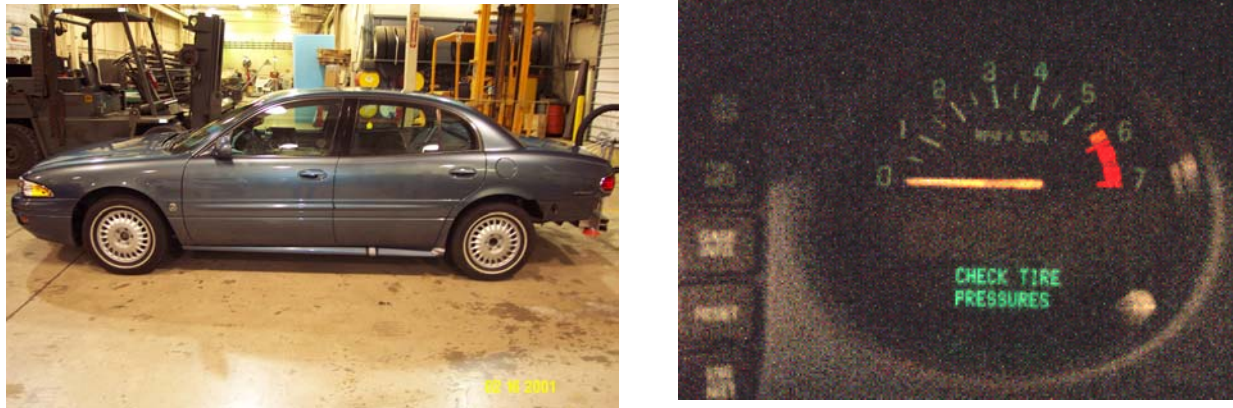
Figure 3.2 – System B Test Vehicle / TPMS Warning Message

warning that consisted of the text message “CHECK TIRE PRESSURES” (Figure 3.2) accompanied by an auditory warning tone.

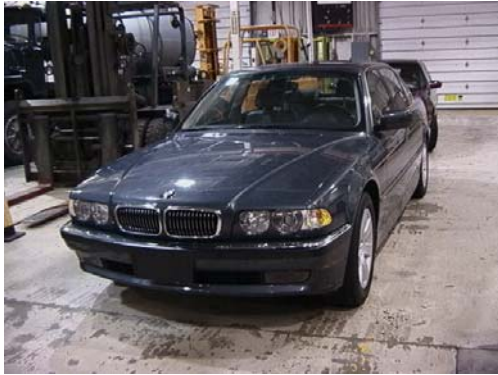
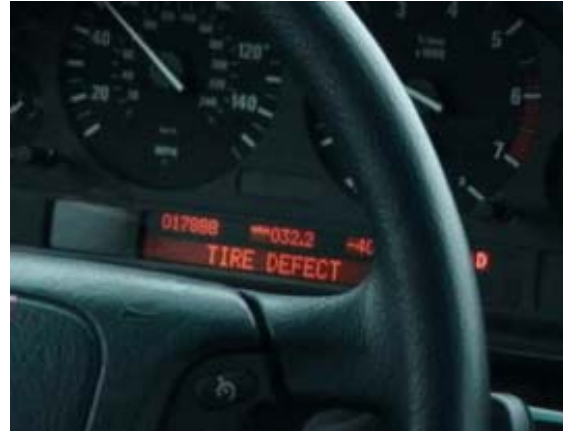
Figure 3.3 – System C Test Vehicle / TPMS Warning Message

Method and Conditions of Warning Presentation: System C had a one stage underinflation warning that alerted the driver of significant tire pressure loss by displaying the following message on the driver display: "TIRE DEFECT" (Figure 3.3) with an audible signal. The word "DEFECT" in the "TIRE DEFECT" message was a translation discrepancy that the vehicle manufacturer was reportedly addressing. The system could inform the driver of tire failure only while the vehicle was in motion.

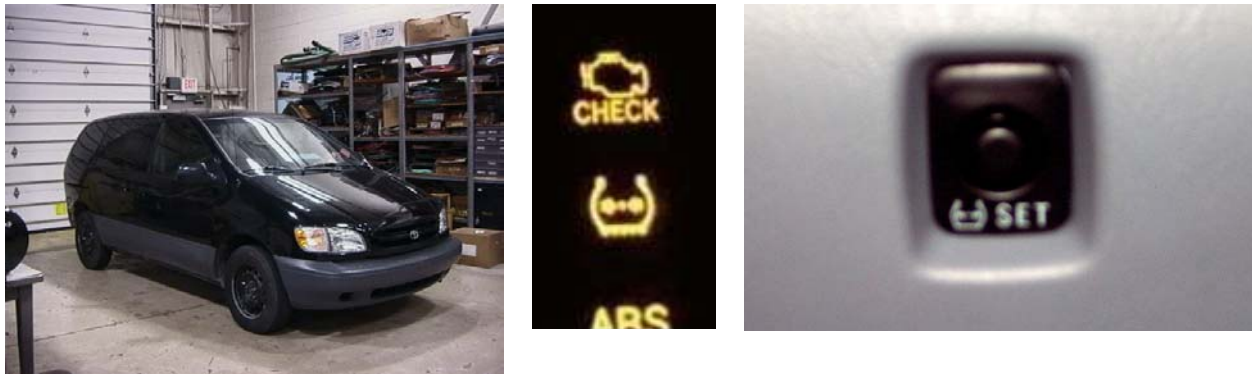
Figure 3.5 – System D Test Vehicle / Warning Light (Middle) / TPMS Reset Button

Method and Conditions of Warning Presentation: System D had a one stage underinflation warning that provided the driver with a warning when tire pressure in one of the tires was “critically reduced”. This alert only occurred while the vehicle was in motion. The system alerted the driver by illuminating the ISO icon K.11 on the instrument cluster (the middle icon in Figure 3.5).

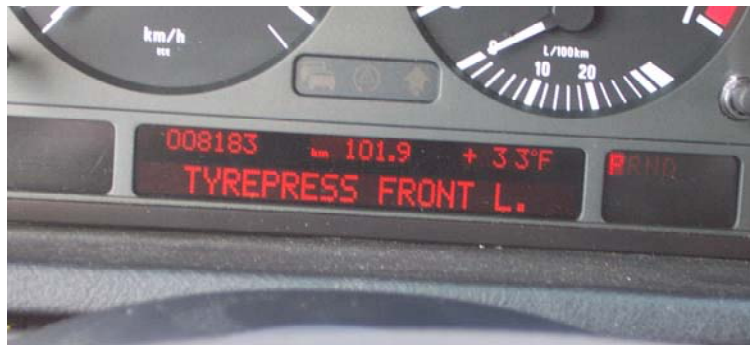
Figure 3.7 – System E TPMS Warning Message With Wheel Location

Method and Conditions of Warning Presentation: The driver interface for System E is shown in Figure 3.7. The system present on the European specification vehicle provided for testing had a single level of warning. This single warning level indicated the condition of significant tire underinflation and consisted of the text message "TYREPRESS" followed by either "FRONT" or "REAR" and then "L." or "R." to indicate the specific tire that the warning referred to. The system used pre-stored values to evaluate tire pressure, but could also accept values supplied by the driver.

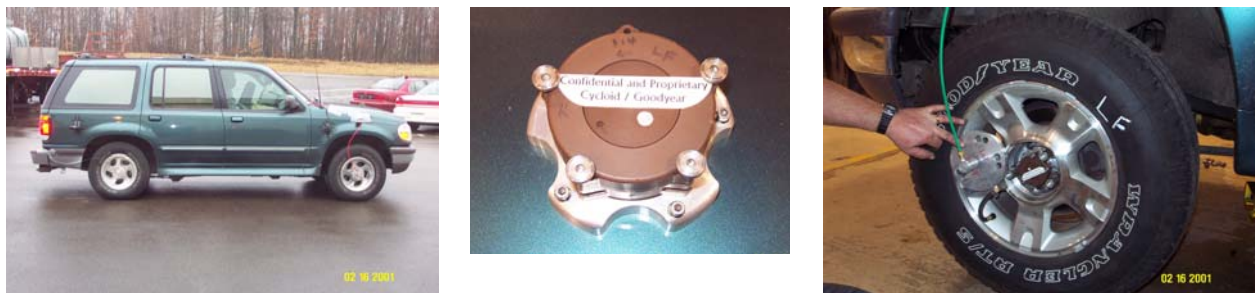
Figure 3.8 – System F Test Vehicle / System F Wheel Sensor-Transmitter-Pump Unit

Method and Conditions of Warning Presentation: System F was designed to give two warning levels. The first was a “low pressure warning” designed to activate at 18 psi. The second was a “severe underinflation alert”, which was designed to activate at 10 psi. However, since this version was a prototype of an original equipment system that was not commercially available, no driver interface was available for testing. Instead, a laptop computer was connected to the receiver to permit monitoring of the system.

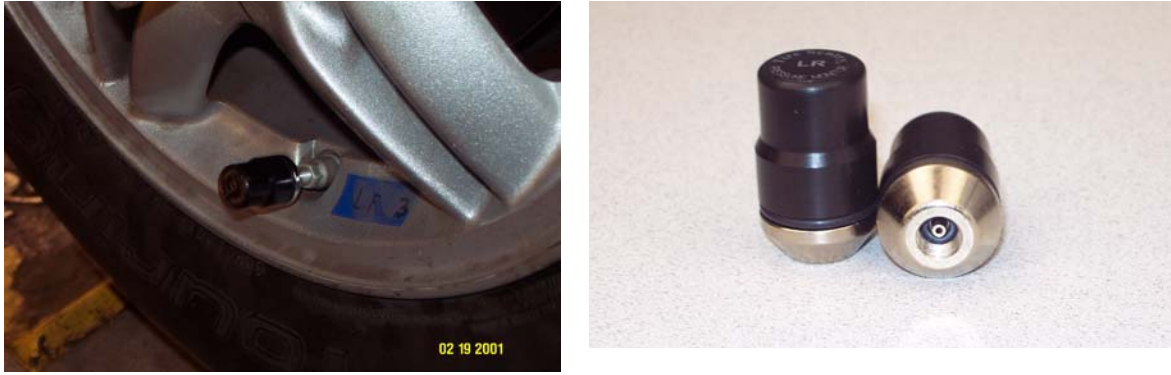
Figure 3.9 – System G Tire Sensor-Transmitter

Calibration: System G's sensors screwed onto the valve stem and were labeled for each wheel position. Thus, the position of the sensors was intended to be fixed even in the event of tire rotation. Once the sensors are screwed back on or the inflation pressure problem is rectified (or low battery is rectified), A "RESET" button was present on the receiver and was used to clear any low battery (sensor) or underinflation warnings and to reset the system after removal of the sensors or adjustment of tire pressure.

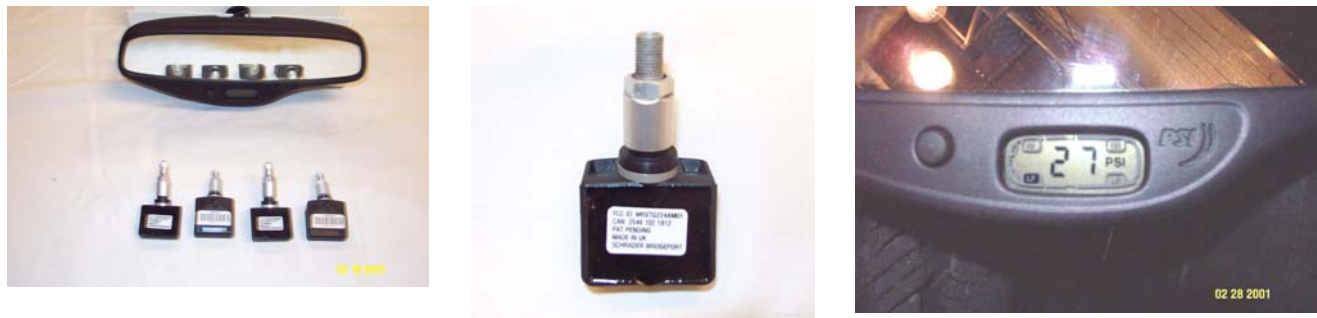
Figure 3.11 – System H Sensor-Transmitter / Rearview Mirror Display

code. One antenna was contained in the receiving unit, which was mounted in a battery powered replacement rear-view mirror. Provisions to provide 12V power to the mirror are available. System H was the simplest aftermarket system to install and the least obtrusive since it did not require antennas or a 12V power cable to the cigarette lighter. The stated accuracy of the system was 2 to 5 percent, depending on the operating temperature.

Method and Conditions of Warning Presentation: Tire pressure warning information was provided to drivers through a display that was integrated into the center rear-view mirror, as pictured in Figure 3.11. System H was designed to give two different levels of warning. The first was a “low pressure” warning, which occurred at 19.9 psi and consisted of a single auditory tone, or beep. The second was a “critically low pressure” warning, which occurred at 15.0 psi and consisted of a double beep. In both cases, the display alternated between the word “LO” and the measured pressure of the lowest tire. The tire indicator light for each low tire was also illuminated.

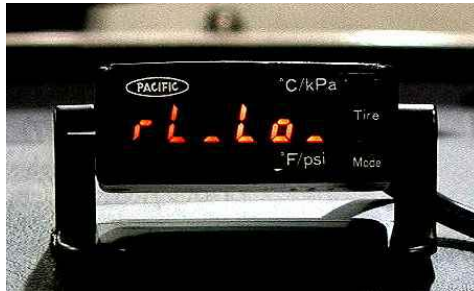
Figure 3.13 – System I TPMS Display

Method and Conditions of Warning Presentation: The driver interface for System I is shown in Figure 3.13. System I monitored both pressure and temperature and could provide warnings for these conditions for each of the four tires individually. The system was designed to give four different levels of warnings. The first was a “below user target pressure” warning and auditory tone, which occurred when the pressure dropped below the level set by the user. The pressure was sampled every 15 seconds. Normally, data was transmitted every 10 minutes; but, in the case of a warning condition, it was transmitted every 15 seconds. The second warning was a “below warning pressure” alert and audible signal, which occurred at 20.3 psi. The third warning was a “decreasing tire pressure” warning that occurred when there was a loss of 2.9 psi in 15 seconds or a loss of 23.5 psi in 45 seconds. The fourth warning was the “temperature alarm” which activated when one of the tires’ contained air reached 230 degrees F. The temperature or pressure could be checked at any time by the driver.

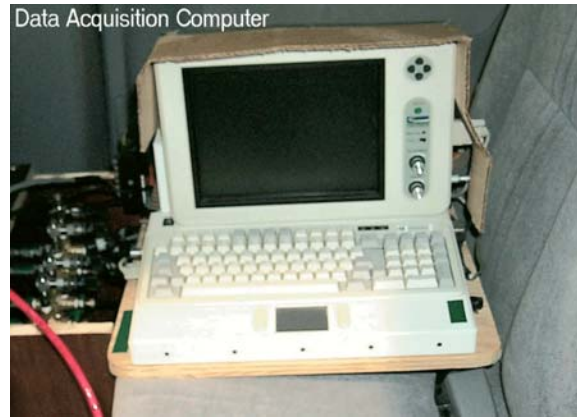
Figure 4.1 – Data Acquisition Computer

Test sensors were attached to a PC-based in-vehicle data acquisition system (Figure 4.1) that recorded up to 10 channels at a rate of 20 Hz.

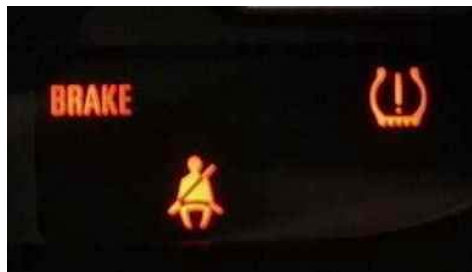
Figure 7.1 – Visual Warning of System A (top right corner)

System A provided indication of significant tire underinflation using the ISO icon for “tire failure” (K.10). This symbol was located near the gauge cluster amongst other similar icons, as shown in Figure 7.1. An auditory warning coincided with presentation of this message as described in Table 7.1.

Later comprehension tests show that drivers do not recognize this symbol as referring to a failure condition. The use of this symbol (tire cross-section with exclamation point) to alert the driver to the non-failure condition of tire underinflation is somewhat inappropriate based on the ISO standard.

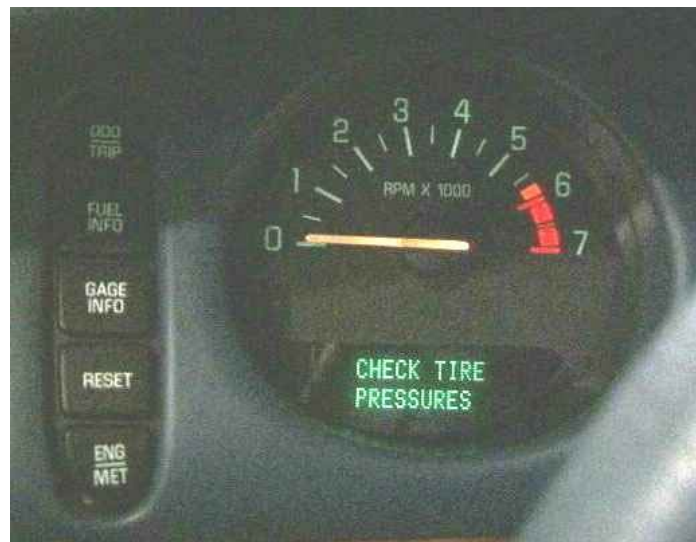
Figure 7.2 – Visual Warning of System B

The System B provided a visual warning when a tire became significantly underinflated. This visual warning consisted of a green text message reading “CHECK TIRE PRESSURES,” as pictured in Figure 7.2. When this message was presented, the “GAGE INFO” button could be pressed to see an additional message, “TIRE PRESSURE LOW: CHECK TIRES.” An auditory warning coincided with presentation of the initial message as described in Table 7.1. This system required the use of a reset button to prompt calibration of the system after a change (such as tire rotation).

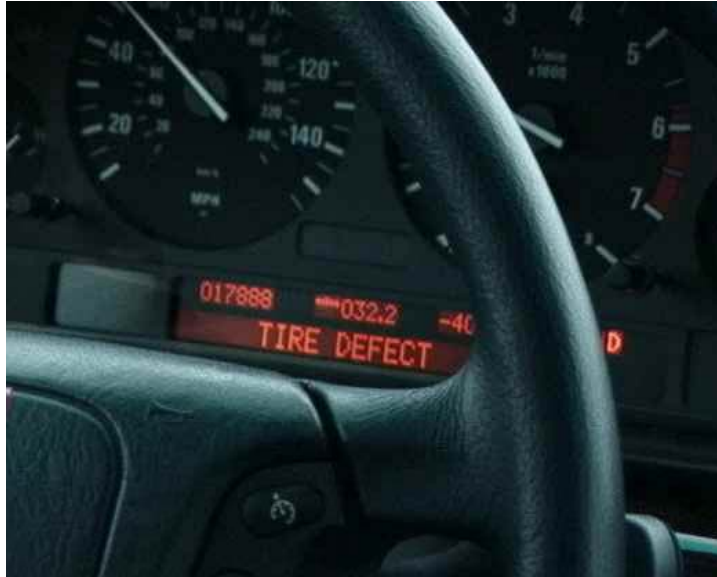
Figure 7.3 – Visual Warning of System C

System C provided visual indication of low tire pressure using red LED text stating “TIRE DEFECT” as shown in Figure 7.3. An auditory warning coincided with presentation of this message as described in Table 7.1.

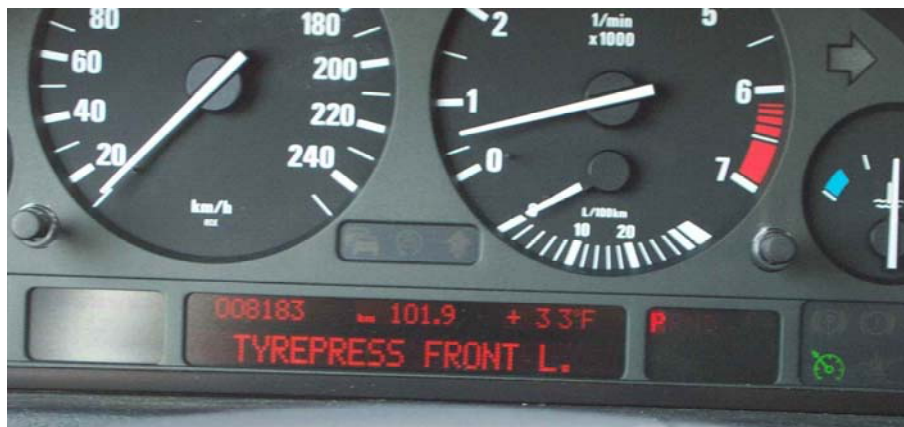
Figure 7.6 – Visual Warning of System E

System E provided visual indication of low tire pressure using red LED text stating “TYREPRESS (FRONT/REAR) (L. / R.)”. Figure 7.6 illustrates the system indicating that the pressure in the left front tire is low. The European spelling of tire (“tyre”) was appropriate for this European version of this particular make/model. We assume that the version intended for use in the American market would use spellings appropriate for that market.

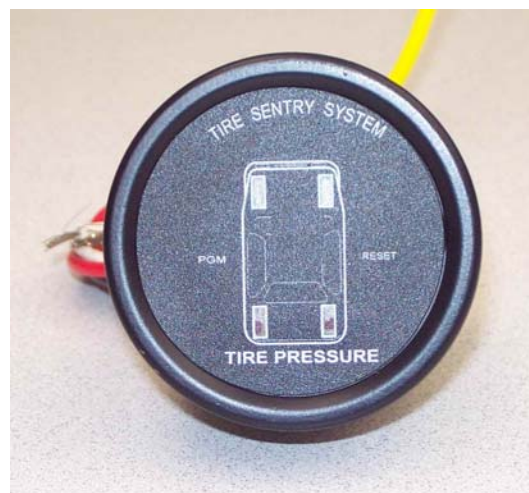
Figure 7.7 – Driver Interface of System G - Un-powered

Figure 7.7 shows System G driver interface un-powered. Figure 7.8 shows this system’s method of providing a visual warning for the left rear tire. As can be seen, that although only the left tire had low pressure, light leaking around the low-tire indicator made it appear that both front tires were also illuminated. This method of presenting a low tire pressure warning is likely to confuse drivers by making them unsure which tire is low and frustrate them by making them have to check the pressure of multiple tires to determine which one is low.

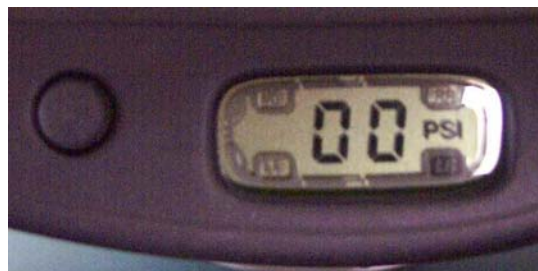
Figure 7.9 – Driver Interface of System H

System H provided indication of low tire pressure using an LCD display that was integrated into the rearview mirror. Figure 7.9 shows only the bottom portion of the mirror housing which contained the visual display and selector button. This display provided visual warning of tire underinflation in terms of the specific tire, or tires, that were underinflated as well as the current pressure value(s). An auditory warning coincided with presentation of the visual warning message as described in Table 7.1.

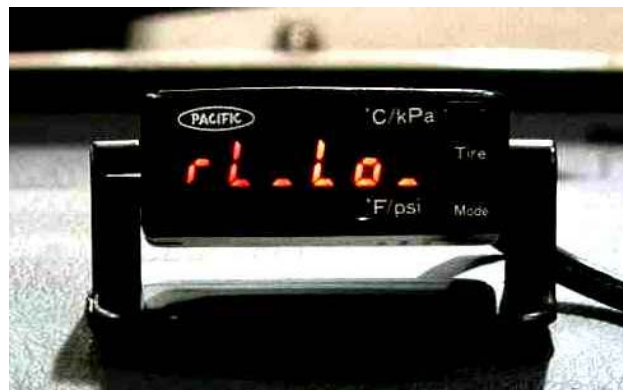
Figure 7.10 – Driver Interface of System I

The text codes presented by this display were frequently difficult to decipher and confusing. One error message was seen during testing that was not defined in the user manual.

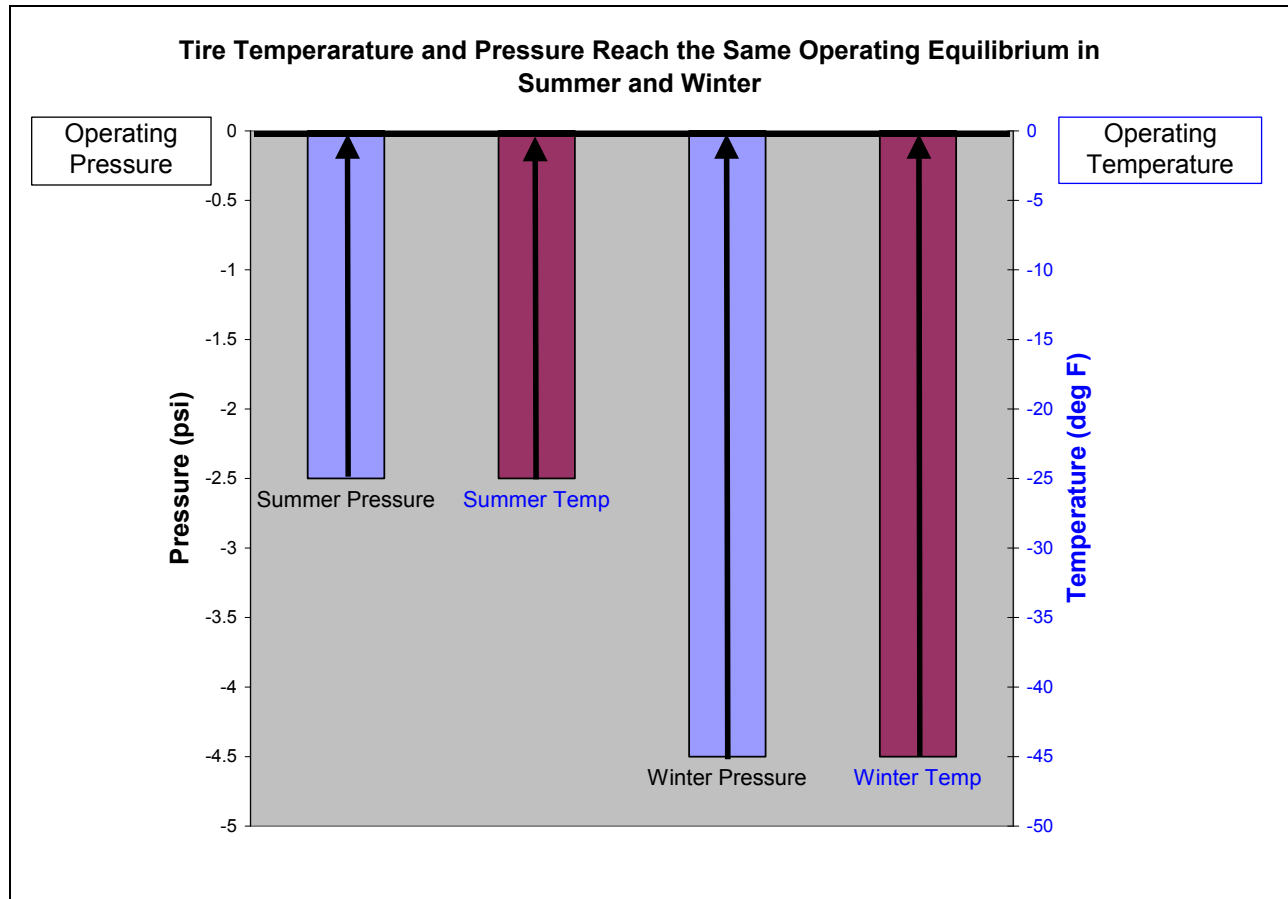
Figure 9.2 – Rise in Tire Pressure and Temperature During Different Ambient Conditions

A major issue encountered when designing tire pressure monitoring systems is determining when to warn for underinflation. Monitoring systems that give false warnings or overly frequent warnings can quickly erode consumer confidence and lead to unnecessary repair trips to the dealer. Systems that do not warn quickly enough can allow tire damage to occur while in the underinflated condition. The most significant challenge encountered when setting a warning threshold is the fact that the tires heat up and increase their contained air pressure during operation. Based on the Ideal Gas Law, the contained air of a tire will rise 0.5 to 1.0 psi per 10°F increase in tire air temperature. During typical operation, VRTC’s measurements show a typical passenger vehicle tire will rise 2 to 5 psi during normal operation. Since tires are excellent thermal insulators, the tire air will in general reach a steady state operating temperature regardless of ambient conditions. The implication of this is that tire air temperature and pressure will rise more on a cold winter day than on a hot summer day. An illustration of this can be seen in Figure 9.2.

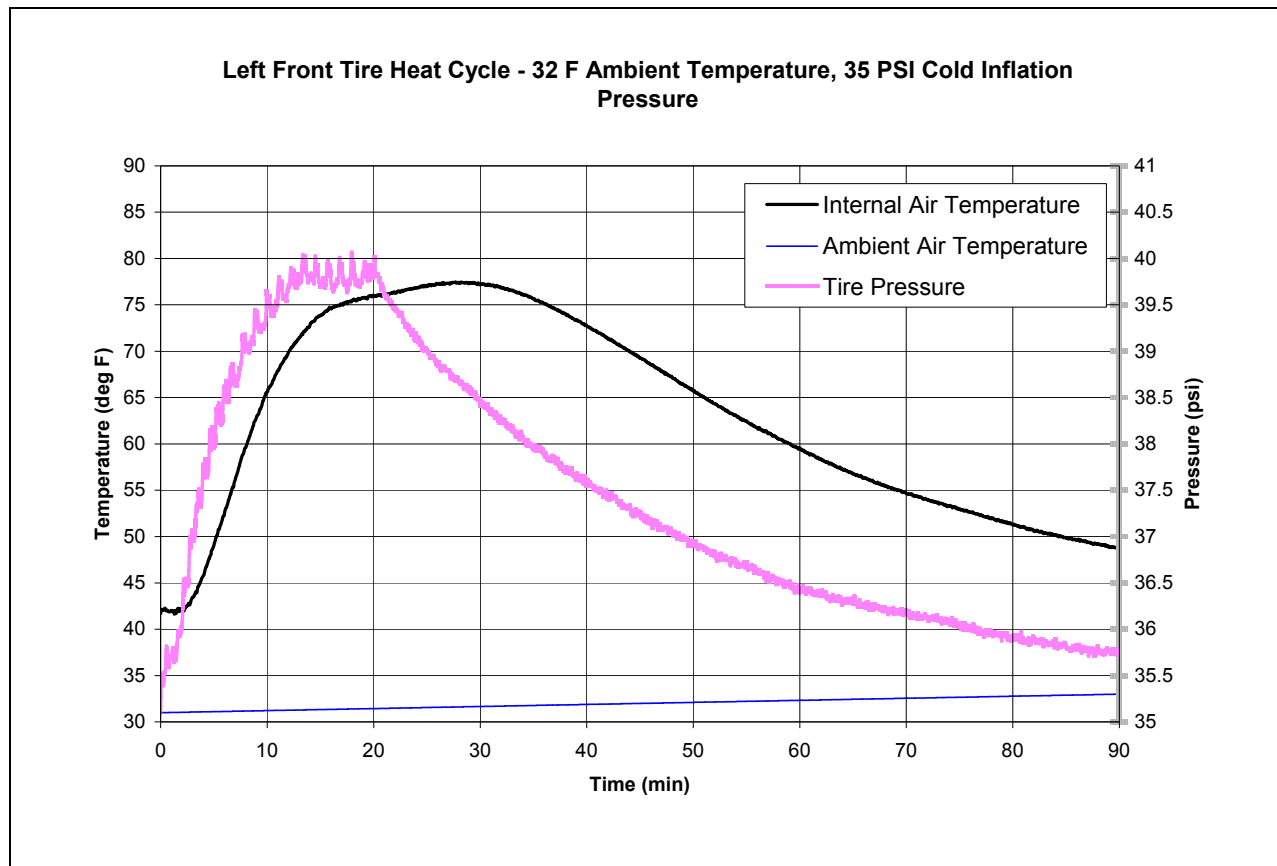
Figure 9.3 – Left Front Tire of Minivan during Brake Snubs with Underinflation

Another implication of thermal insulation properties of tires is that they take about an hour to cool down to ambient conditions from steady-state temperatures. For example, Figure 9.3 documents the rise in internal tire pressure and contained air temperature for an underinflated tire on a minivan that is doing brake snubs (60 to 20 mph brake applications at 10 ft/s^2 deceleration during each mile of driving). After 20 minutes of driving the vehicle was stopped and the tires allowed to cool in 32°F ambient temperature. Only after 70 plus minutes of cooling does the tire pressure return to the original cold placard pressure.

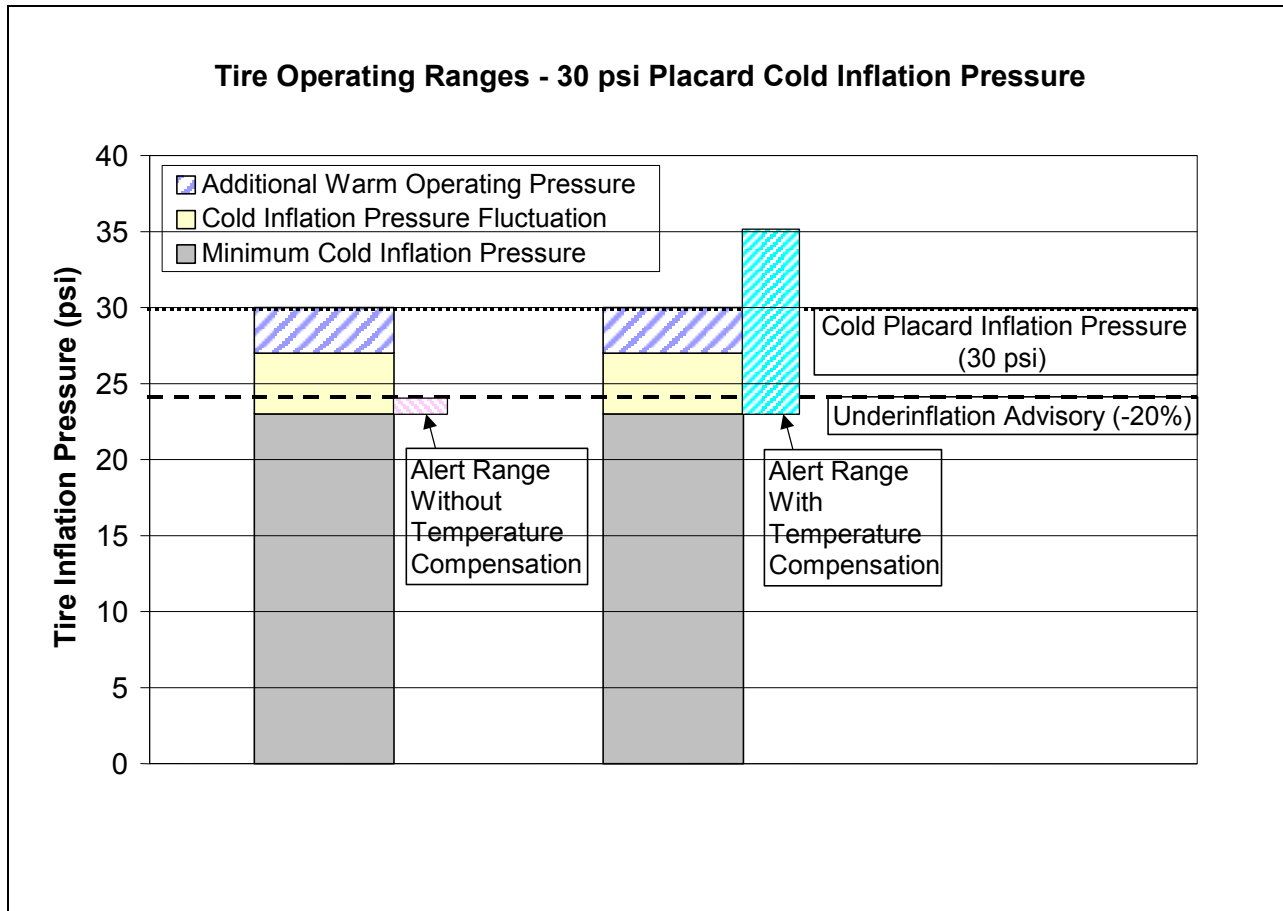
Figure 9.5 – Increase in Advisory Range for Scenario #2 with Temperature Compensation

the current tire air temperature, and then compare the current tire pressure to that number. If the current inflation pressure deviates more than a set amount from the “temperature-compensated cold inflation pressure”, the advisory activates (even if the tire pressure well above the normal advisory threshold). Figure 9.5 displays the increase in size of the possible advisory range with temperature compensation.

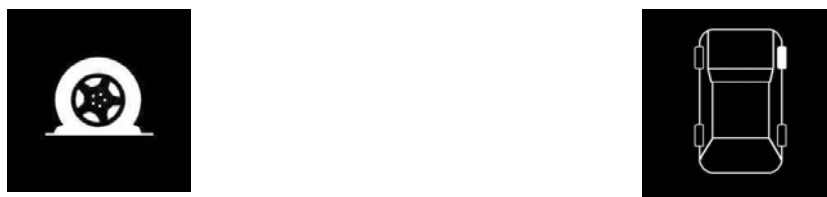
Figure 10.1 – Suggested icon for indication of significant tire underinflation and alternative vehicle-based display.

Use of a top-view vehicle display showing individual tires (as shown in Figure 10.1) could also be implemented in vehicles for the presentation of low tire information. Use of this display would allow the presentation of tire specific information to the driver, i.e., tell which tire is underinflated. This type of display could be permitted as an alternative to, or in lieu of, a telltale. Of course a WSB system cannot detect which tire is low, only that one or more tires are low. Therefore, WSB systems would be limited to the use of a telltale.

Results of the comprehension tests showed that recognition was poor for the ISO tire pressure icons (K.10 and K.11). All of the icons proposed as alternatives to the ISO tire pressure icon were found to communicate at least some degree of tire inflation condition much better than the ISO icons. Based on these results, it is suggested that an alternative to the existing ISO icons be considered for use in warning drivers of low tire pressure. Considering the best recognized “wheel type” and best recognized “icon version”, a single icon was identified as that which is most likely to be recognized by the general population. This icon is suggested for consideration as a visual indicator of significant tire underinflation and is pictured in the following figure.

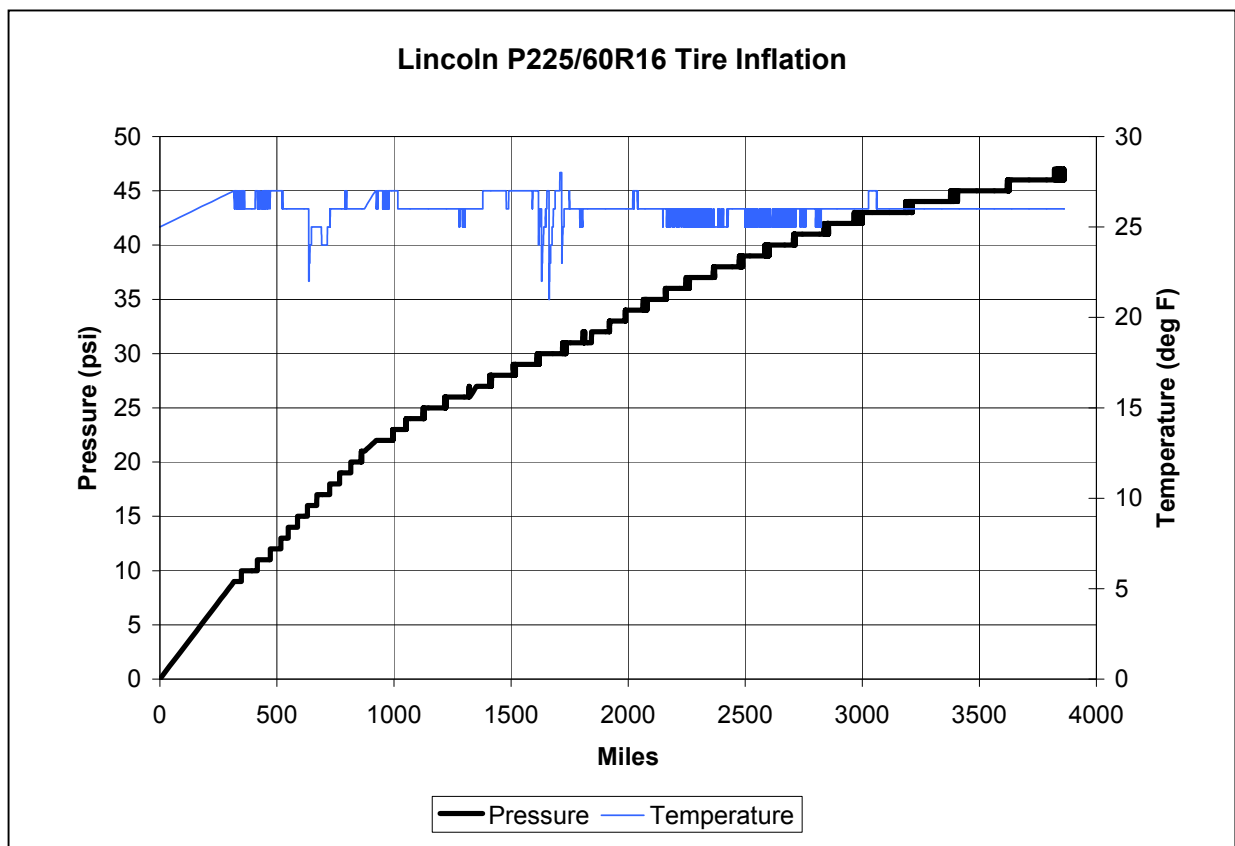
For normally inflated tires, the Cycloid AutoPump's inertial driven compressor adds a maximum of 2 psi per hour of driving. The inflation rate of the pump is high at low pressures and drops off as tire pressure increases. The pump will eventually reach its preset equilibrium level with the tires and will not be able to add more pressure. The inflation system is currently configured to handle cold inflation pressures up to 45 psi; though the pump has the theoretical capacity of 65 psi.
