**TRUCK MONITORING AND WARNING SYSTEMS FOR  
FREEWAY-TO-FREEWAY CONNECTIONS**

Research Report Number 7-2915-1

Research Project 7-2915  
Truck Monitoring and Warning Systems for Freeway-to-Freeway Connections

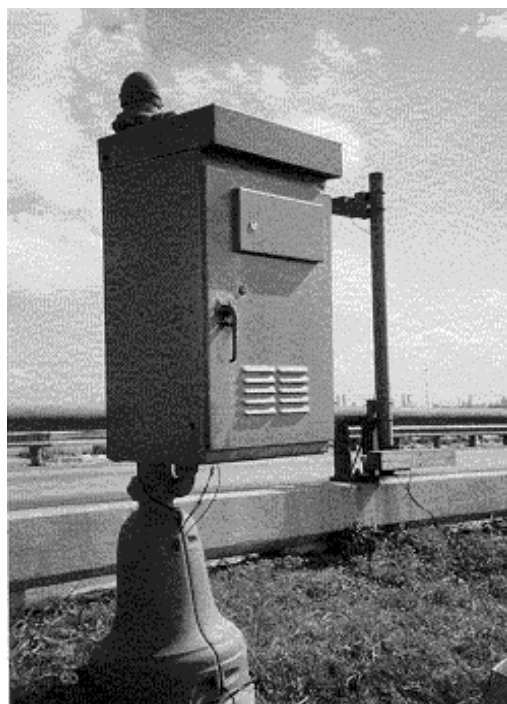
Photo 2.5 Outside of the Cabinet

far side of the ramp were buried in conduit, routed across the roadway in an existing pavement joint, and run into a roadside cabinet (see Photo 2.5). All source cables were connected to their respective control unit, along with the matching sensor receiver cables.

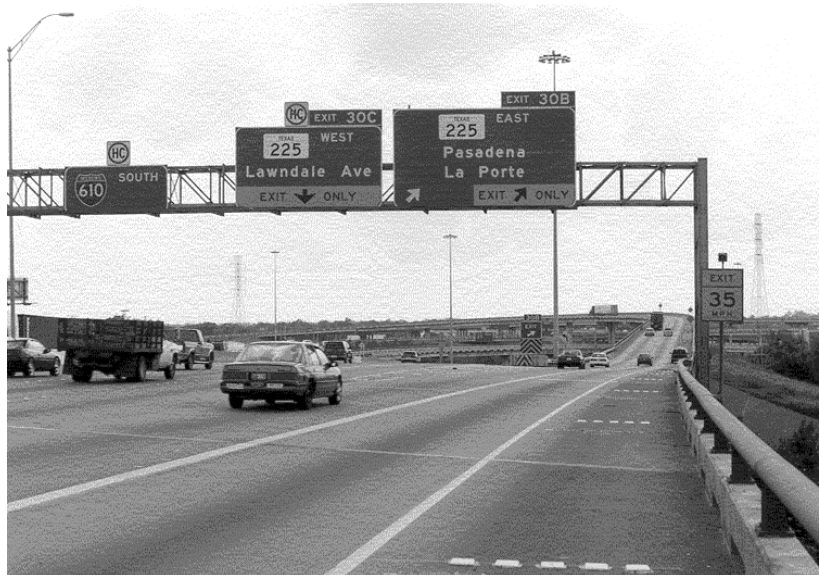
Photo 2.6 Gore of Exit Ramp

Warning signs are used when it is deemed necessary to warn traffic of an existing or potentially hazardous condition. They may sometimes be supplemented by a Hazard Identification Beacon — a flashing circular yellow signal indication — called herein a flasher (Ref 12). At the study site, the first such sign is an advisory exit speed sign, EXIT 35 mph, with an 8 in. (0.2 m) flasher on top, located at the exit ramp gore (see Photo 2.6). This flasher operates continually and apparently has little effect on the speed of exiting vehicles. The second warning display consists of two 8 in. flashers (one above and one below the warning sign), a truck overturn sign, and a 35 mph advisory speed plate; it is located 550 ft (168 m) from the beginning of the exit ramp terminal (see Photo 2.8). The third warning sign group includes a curve sign with a 35 mph advisory speed plate below and an 8 in. flasher above the warning sign (see foreground in Photo 2.7). This array is 1,056 ft (320 m) from the beginning of the ramp and 64 ft (19 m) in advance of the first horizontal curve. The fourth sign array is the same as the second. It is located 1,256 ft (380 m) from the beginning of the ramp on the horizontal curve. All sign assemblies are post-mounted on the right-hand side of the ramp (see Photos 2.9 and 2.10).

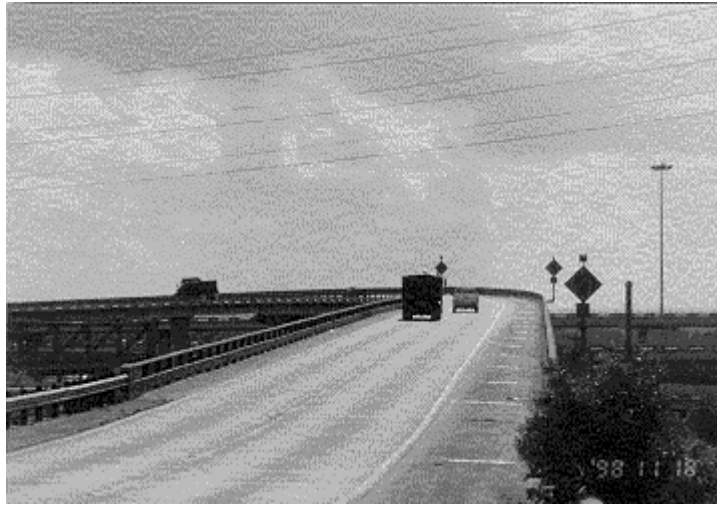
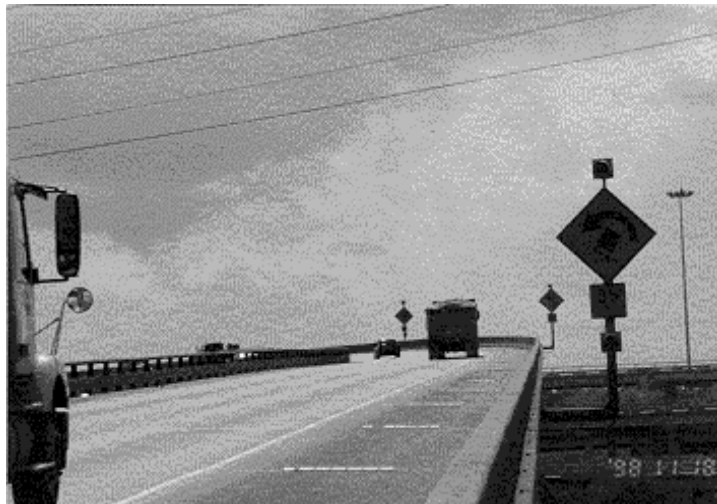
Photo 2.9 View of Ramp from TDA3 Location

Photo 2.10 Flashers That Are Activated by TDA3

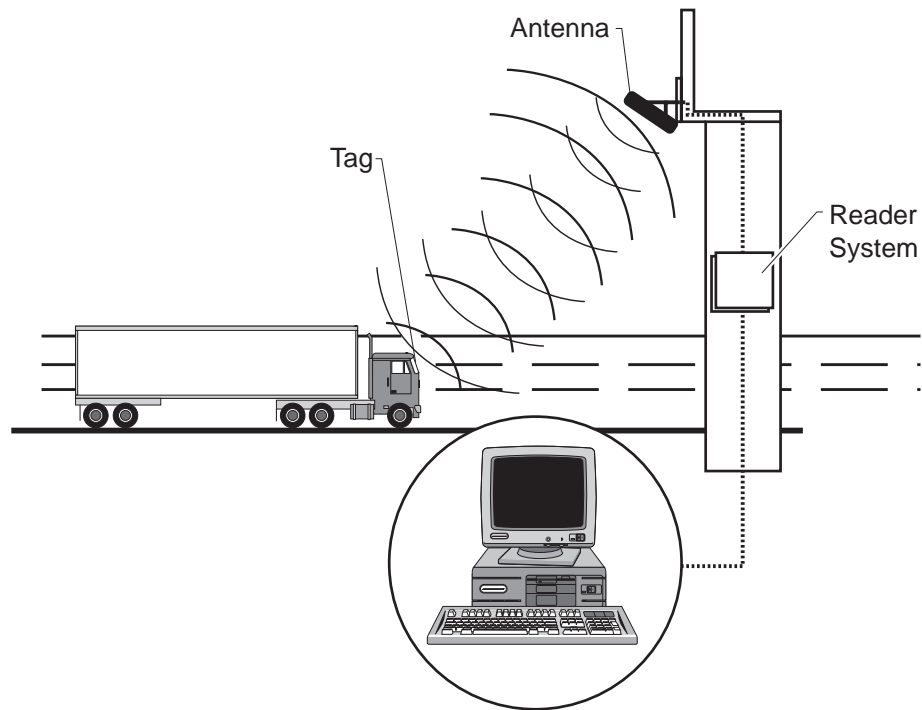
Figure 2.6 Amtech System

A basic Amtech Intelligent-Tag-On-Vehicle system (Ref 15) consists of tags, antennas, and readers. The reader's radio frequency source is either integrated or a separate component. The reader broadcasts radio frequency energy over an adjustable area called the read zone or reader footprint. The tag on the vehicle reflects a small part of this radio frequency energy back to the antenna and can also send a sound and flashing visual message to the driver. The reflected radio waves incorporate the tag's unique identification code and other stored data. The antenna relays the signal to the reader, which can add such information as date/time to the tag's identification code, and stores it in a buffer. The reader can transmit the tag's identification code to the customer's information management system; the entire process takes only milliseconds. Figure 2.6 shows the system components.

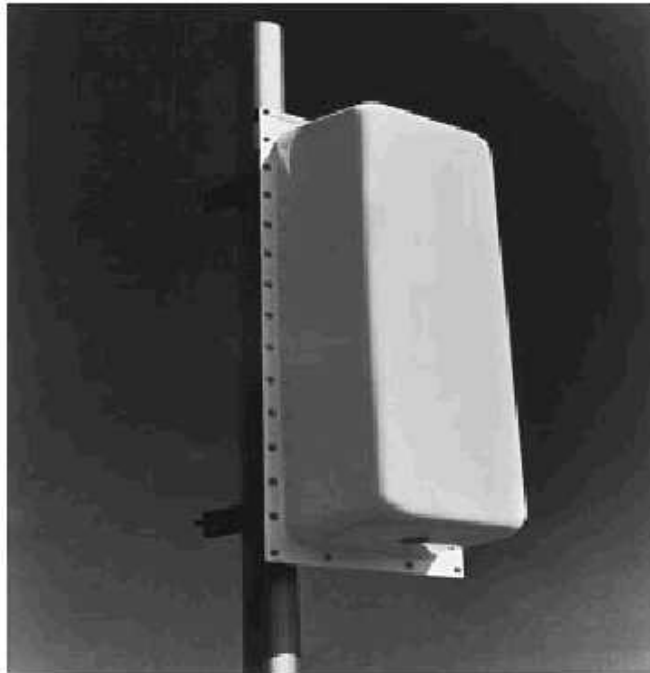
Photo 2.12 shows an antenna mounted on a post. This research used two AA3110 Parapanel antennas arranged together.

The AA3110 Parapanel antenna is a precision dipole array designed for directional transmission and reception of radio frequency (RF) signals in the 902- to 928-MHz RF band.

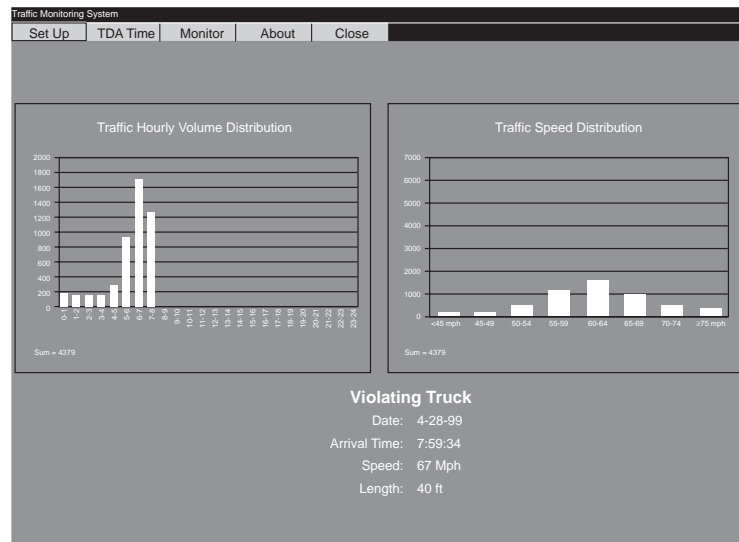
Figure 3.1 Real-Time Display on Monitor Screen

The real-time display on the computer's monitor screen of the above information is shown in Figure 3.1.

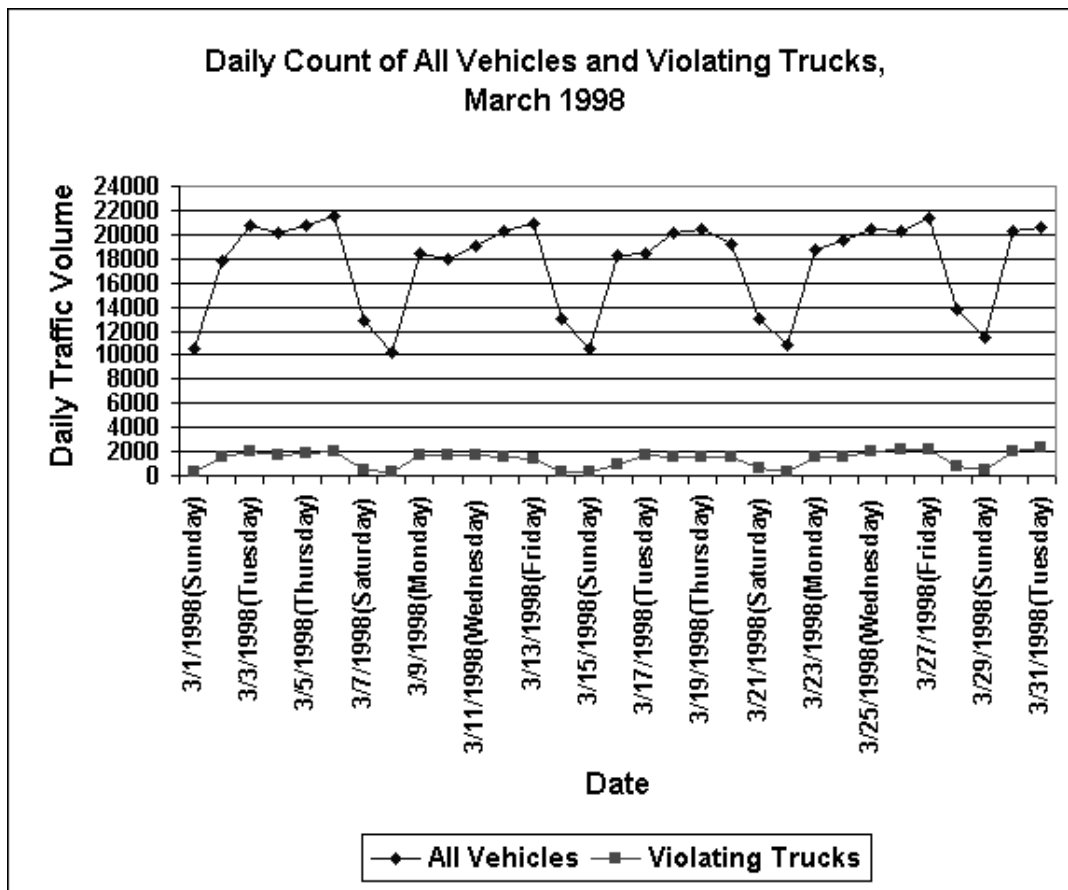
Figure 3.2 Daily Count of All Vehicles and Violating Trucks in March 1998

All real-time data were saved into the daily files (text format) and downloaded to a remote server. It should be noted that the TDA3's infrared light beams extend across both lanes on the two-lane ramp; therefore, two vehicles running side-by-side will interrupt the counting beam simultaneously and register as only one vehicle. The volume count value will be somewhat lower than actual owing to this phenomenon. Figure 3.2 depicts a plot of daily traffic volume data collected by the system continuously for 1 month.

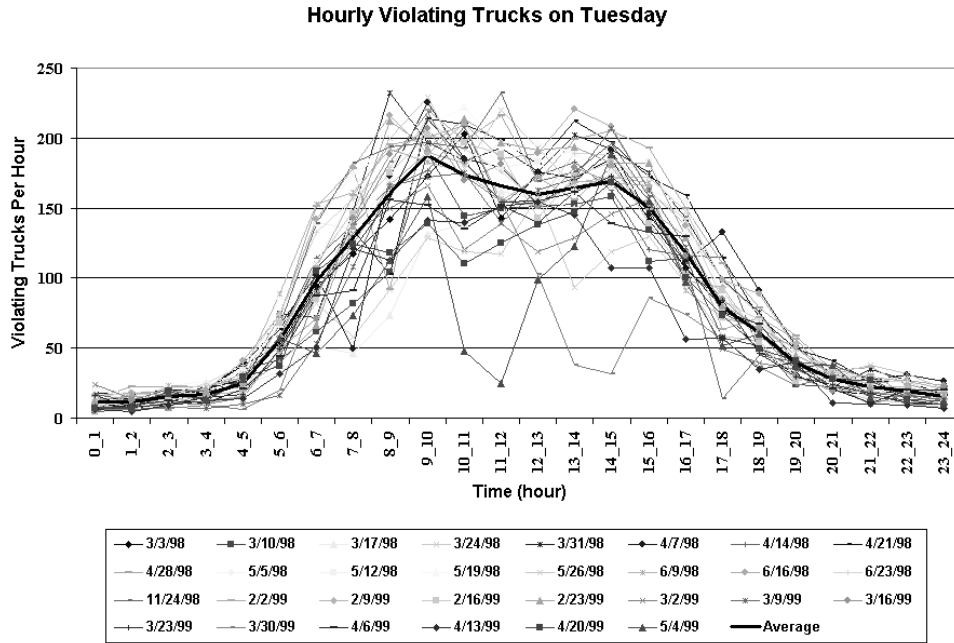
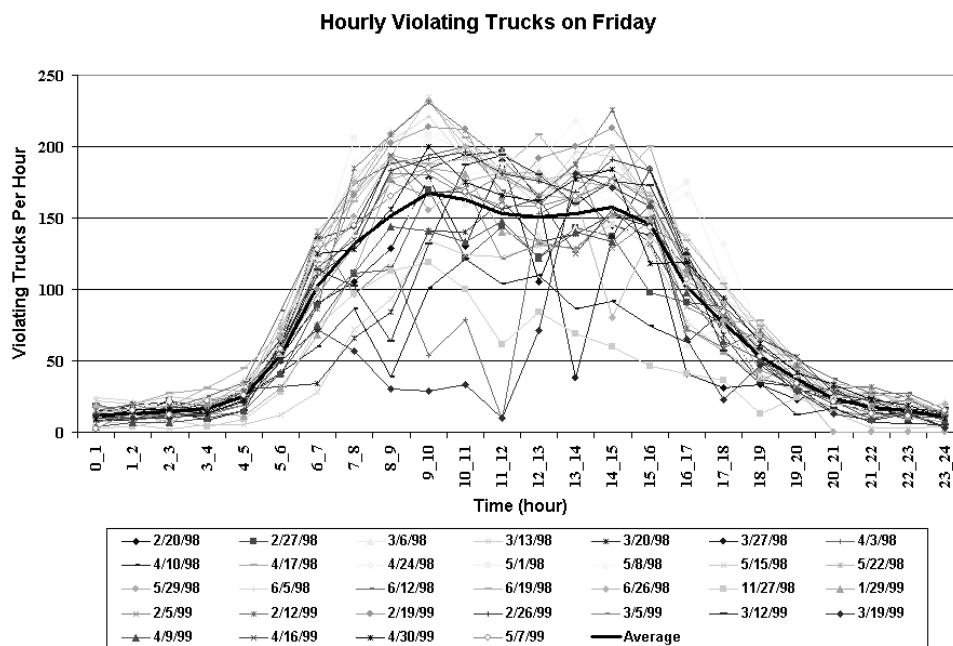
Any truck that is longer than 16 ft (4.9 m) at a height of 7 ft (2.1 m) and traveling faster than the preset speed of 56 mi/h (90 km/h) is designated as a violating truck. The number of violating trucks each hour from Monday to Friday is plotted in Figures 3.8 to 3.12. There is some variation in the counts on Tuesdays and Wednesdays, and the number of violating trucks is usually greater from 9:00 to 17:00. Interestingly, there is a reversal of the pattern, in which the number of violating trucks is greater in off-peak hours than in peak hours. The reason might be that during the peak hours, the traffic volume is very high and, therefore, there is more constraint in traffic flow and speed. During off-peak hours, on the contrary, drivers have more freedom to choose a speed, which may result in higher traveling speed and, unfortunately, hazardous situations at the curve.

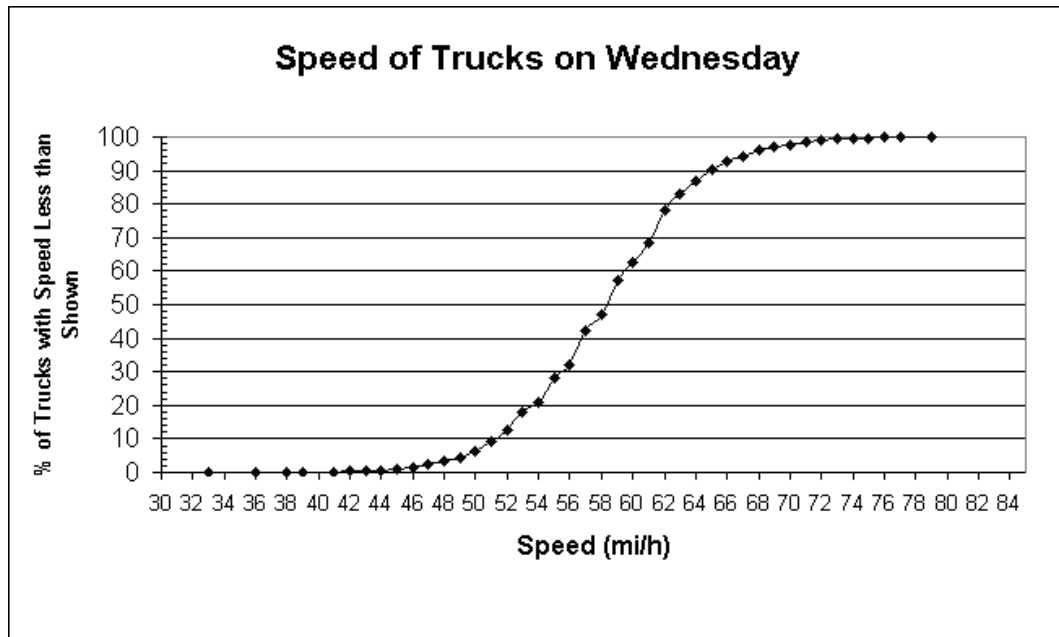
The speeds of all trucks going faster than 30 mi/h (48km/h) that were observed from Monday to Sunday are shown in Figures 3.13 to 3.19. The cumulative frequency distribution of the truck speed is the familiar S-shaped curve. Most trucks were running within a speed range from 54 mi/h (86 km/h) to 64 mi/h (102 km/h); this is called the 10-mi/h pace. The ratio of the violating trucks (at speeds exceeding 56 mi/h) to the total number of trucks is summarized in Table 3.3. This ratio is higher on Mondays, Tuesdays, and Wednesdays, excluding weekends. When traffic was light, the ratio of violating trucks to total trucks increased.

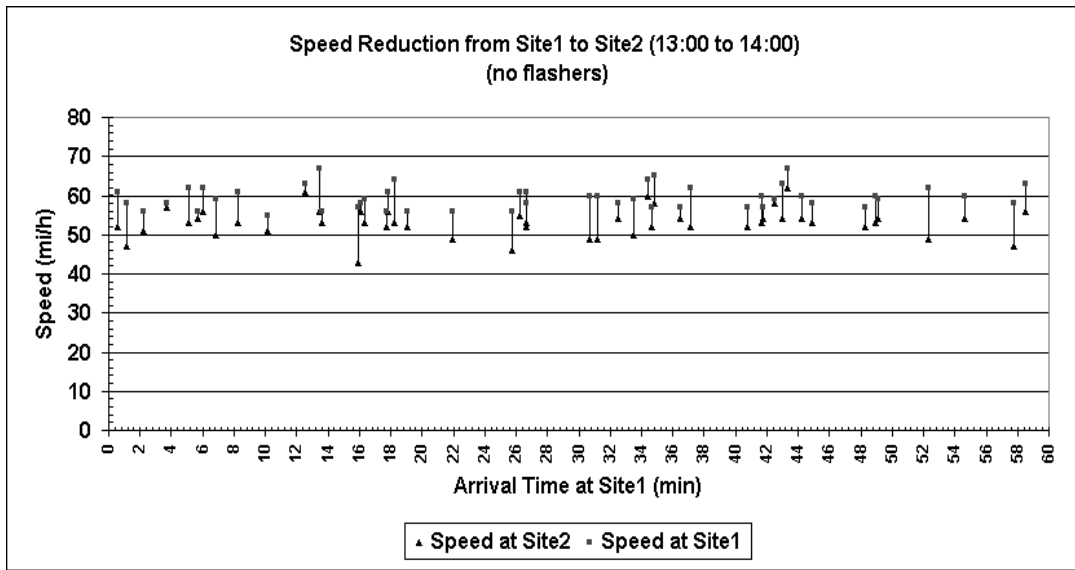
The normal speed reduction of 141 violating trucks from Site 1 to Site 2, with no flasher warning system, is shown graphically in Figures 3.24 to 3.28. This speed reduction was due to the driver’s normal response to the road geometry, traffic control devices, and other vehicles. The time headway between successive violating trucks can also be determined from the plotted data.

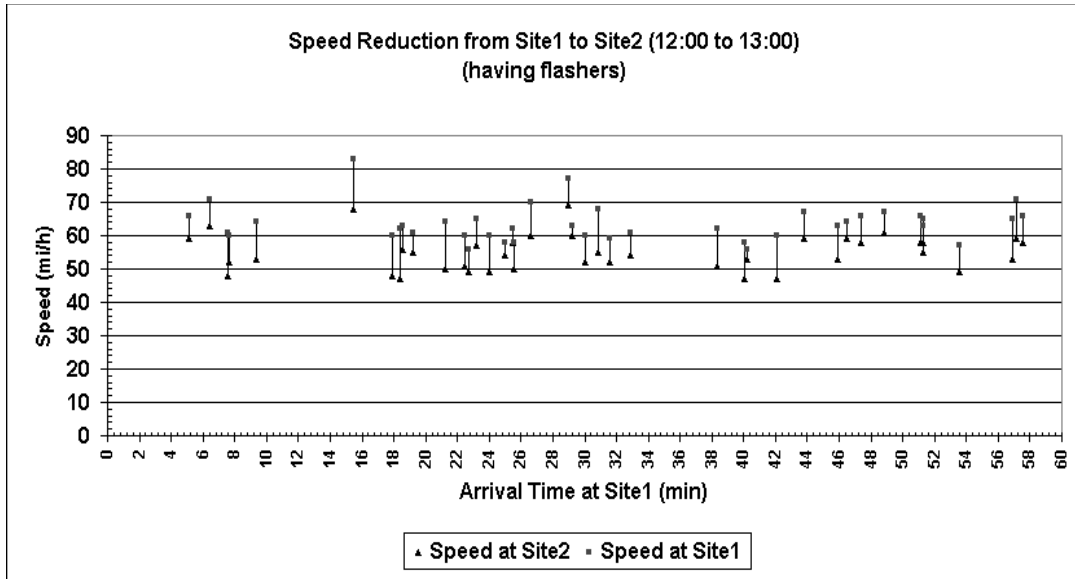
The calculated speed reduction for each of these 280 violating trucks, with the flasher warning system activated, is plotted in Figures 3.29 to 3.36.

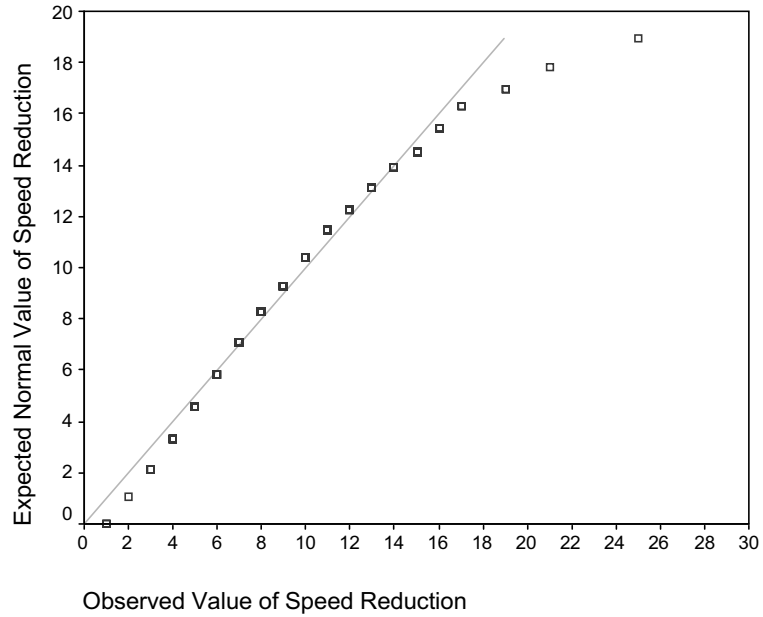
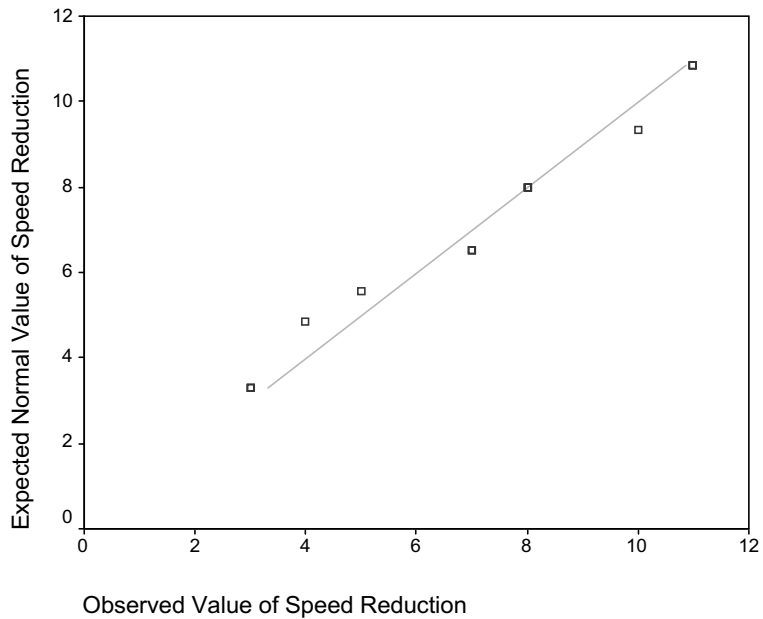
Data values plotted in Figures 3.41 through 3.44 suggest that the frequency of observed speed measurements (speed reduction values) is approximately normally distributed. Thus, it is appropriate to use the same statistical testing technique as was employed in the previous section to test the hypothesis that there was a statistically significant effect on speed reduction caused by actuating the flashers to warn high, long, fast trucks of impending hazard.

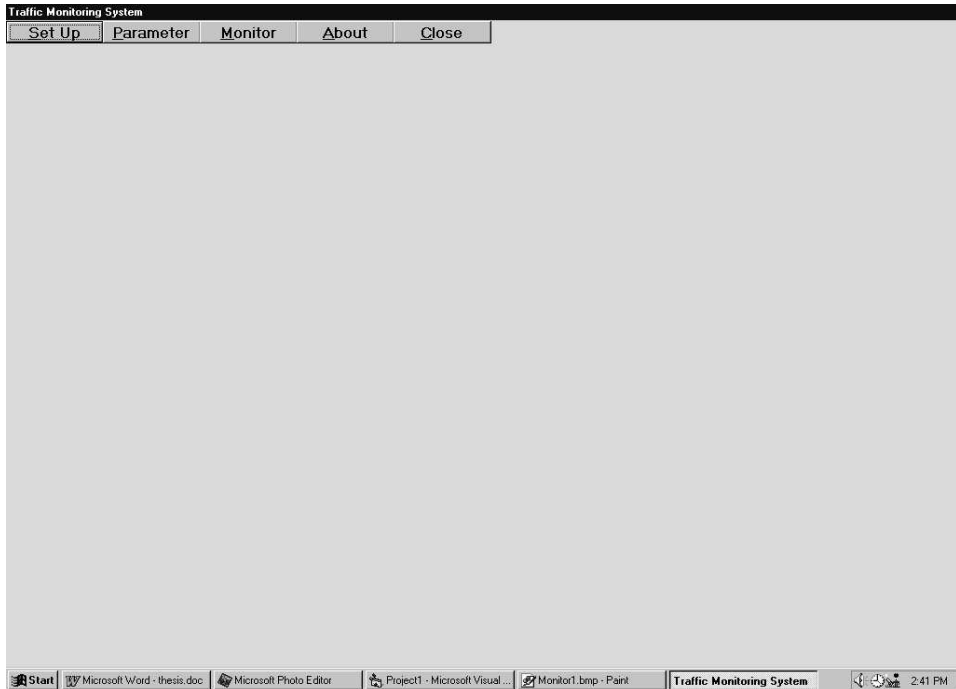
Figure A.6 Monitor Form of TDA3 Before Click Monitor Button

The user can reset the critical parameters of the TDA system through clicking the Setup button, monitor the violating truck, the distribution of hourly traffic volume, and the traffic speed through clicking the Monitor button and closing the form through clicking the Close button (see Figures A.6 and A.7).

**Notice:** If the user clicks the Setup button to reset the system, all data in the system memory will be lost. The About button is used to check the information about the program designer. The Parameter button is used to set the timer parameter that is a constant, 3,599. The user clicks TDA Time button to determine whether the system time is equal to real time. If not, the user may need to click the Parameter button to check to see if the timer parameter is 3,599.
