RESEARCH REPORT 2945-1

EVALUATION OF CATHODIC PROTECTION  
SYSTEMS FOR MARINE BRIDGE  
SUBSTRUCTURES

Project title: *A Performance Evaluation of Cathodic Protection Systems for Queen Isabella*

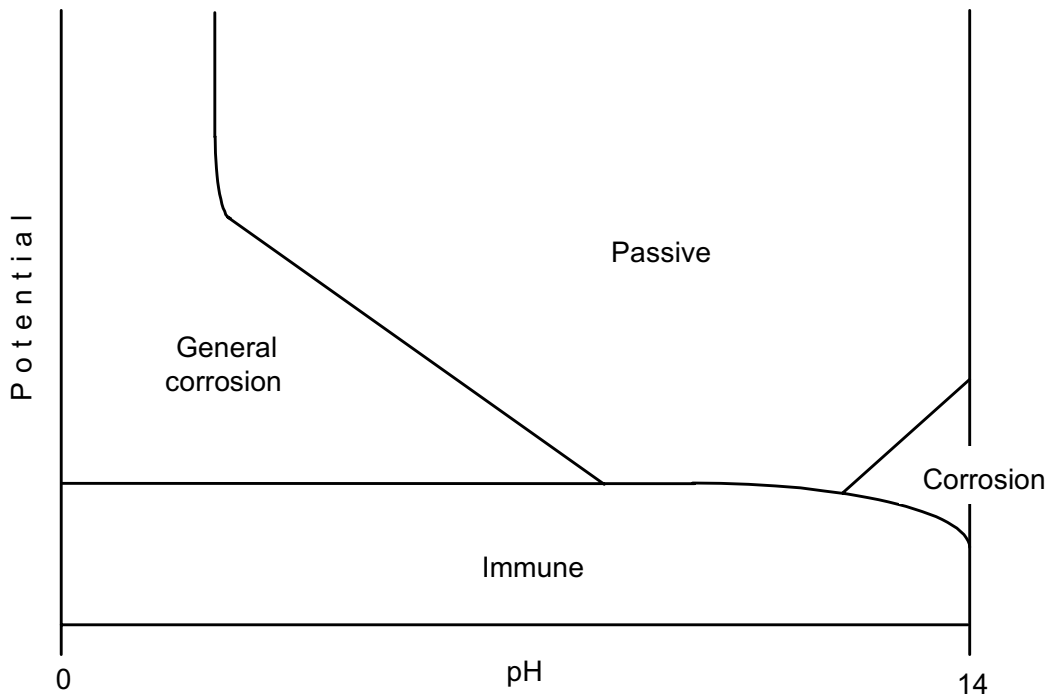
Figure 2.1: Schematic Pourbaix diagram for iron

The Pourbaix diagram, which is an electrical potential versus pH diagram, describes the electrochemical behavior of iron in an aqueous environment (Figure 2.1). Iron will not corrode in the pH range from 8 to 13.5 (Ref 6). The alkalinity of concrete helps to prevent the corrosion of steel in concrete.

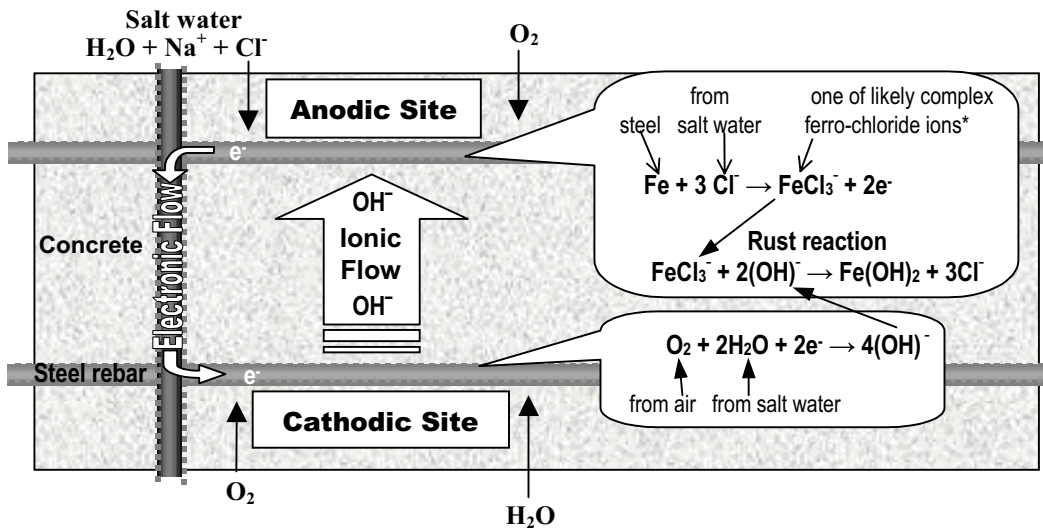
Figure 2.3: Macrocell activity with chloride ions in steel reinforced concrete (\*Note: Several possible complex ferro-chlorides can form and compete for available reactive ions. Their instability in the presence of oxygen results in various expansive oxidation products of iron, as shown in Figure 2.4).

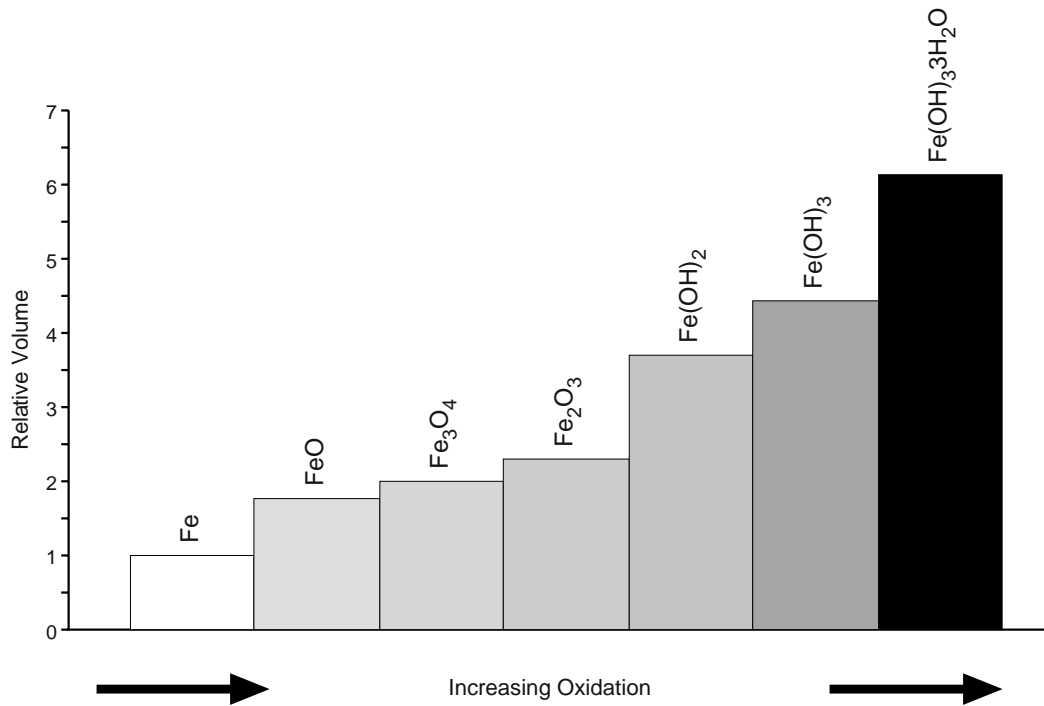
Figure 2.4: Relative volumes of iron oxidation products

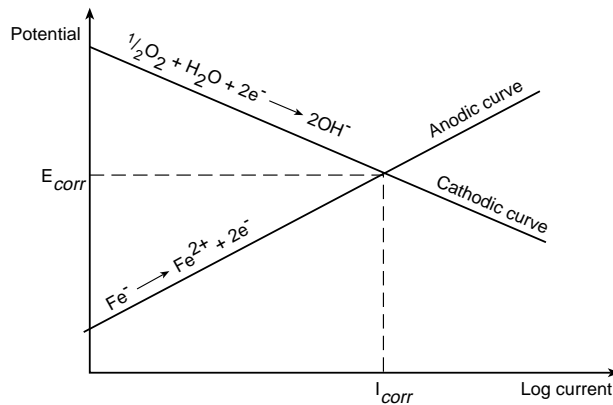
Figure 2.5: Simplified representation of a corrosion cell of steel in concrete

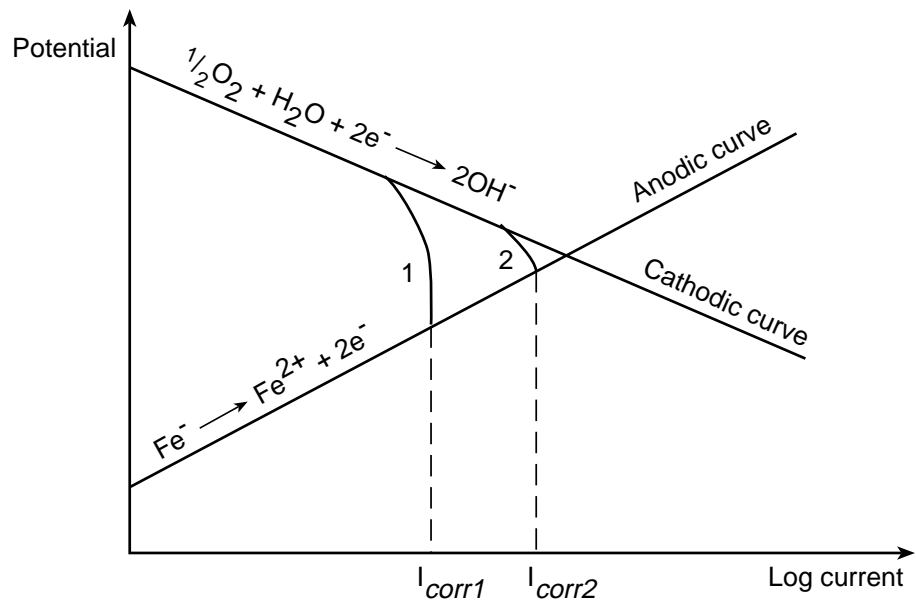
Figure 2.6: Effect of cathodic diffusion on polarization

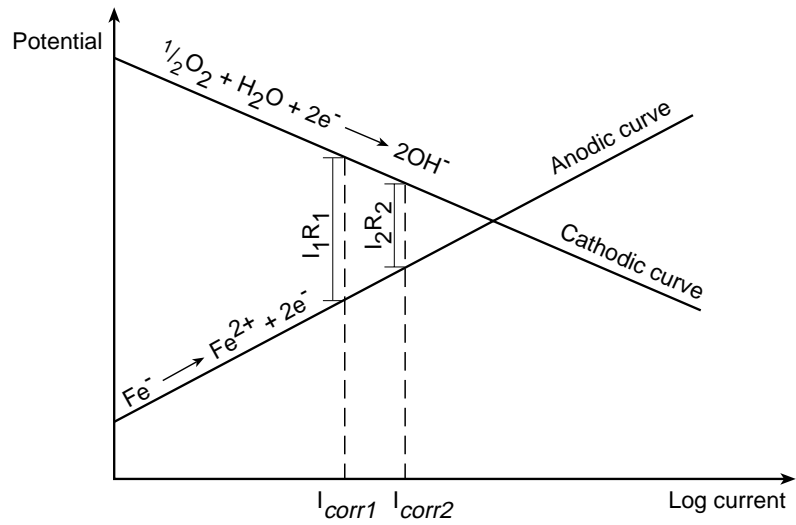
Figure 2.7: Effect of concrete resistance on polarization

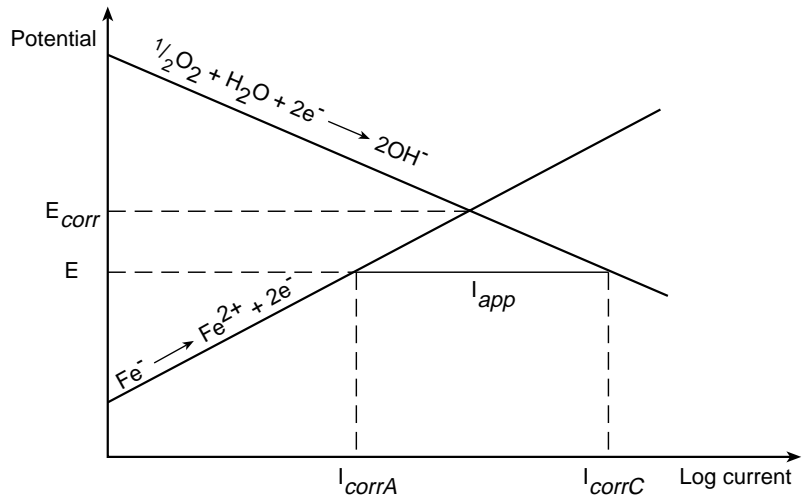
Figure 2.9: Electrochemical principle of impressed current systems

The electrochemical principle of impressed current cathodic protection can be explained by the polarization curves of the reactions involved. Figure 2.9 shows the polarization of the two reactions involved.

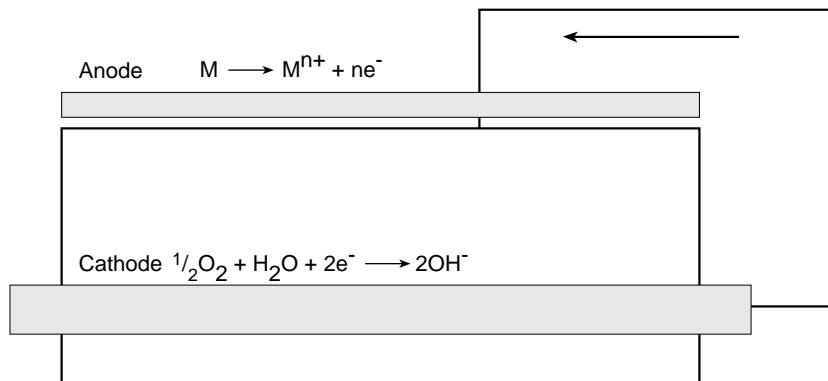
Figure 2.10: Sacrificial system

Another method of providing cathodic protection to a structure is by introducing a sacrificial anode, also called galvanic anode. The sacrificial anode corrodes preferentially producing electrons. Sacrificial anodes need to be more active than iron to protect the reinforcing steel. Typical anodes are zinc, aluminum, magnesium, and their alloys. Figure 2.10 shows a sacrificial system schematically and the reactions involved.

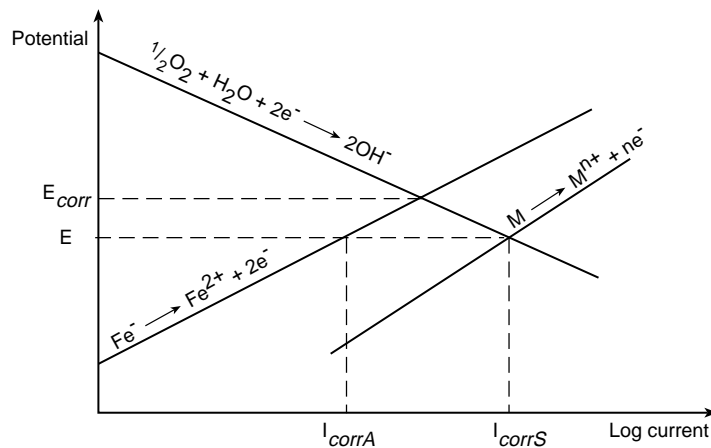
Figure 2.11: Electrochemical principle of sacrificial systems

The electrochemical principle of sacrificial anode protection can be explained by the polarization curves of the reactions involved. Figure 2.11 shows the polarization of the two reactions involved.

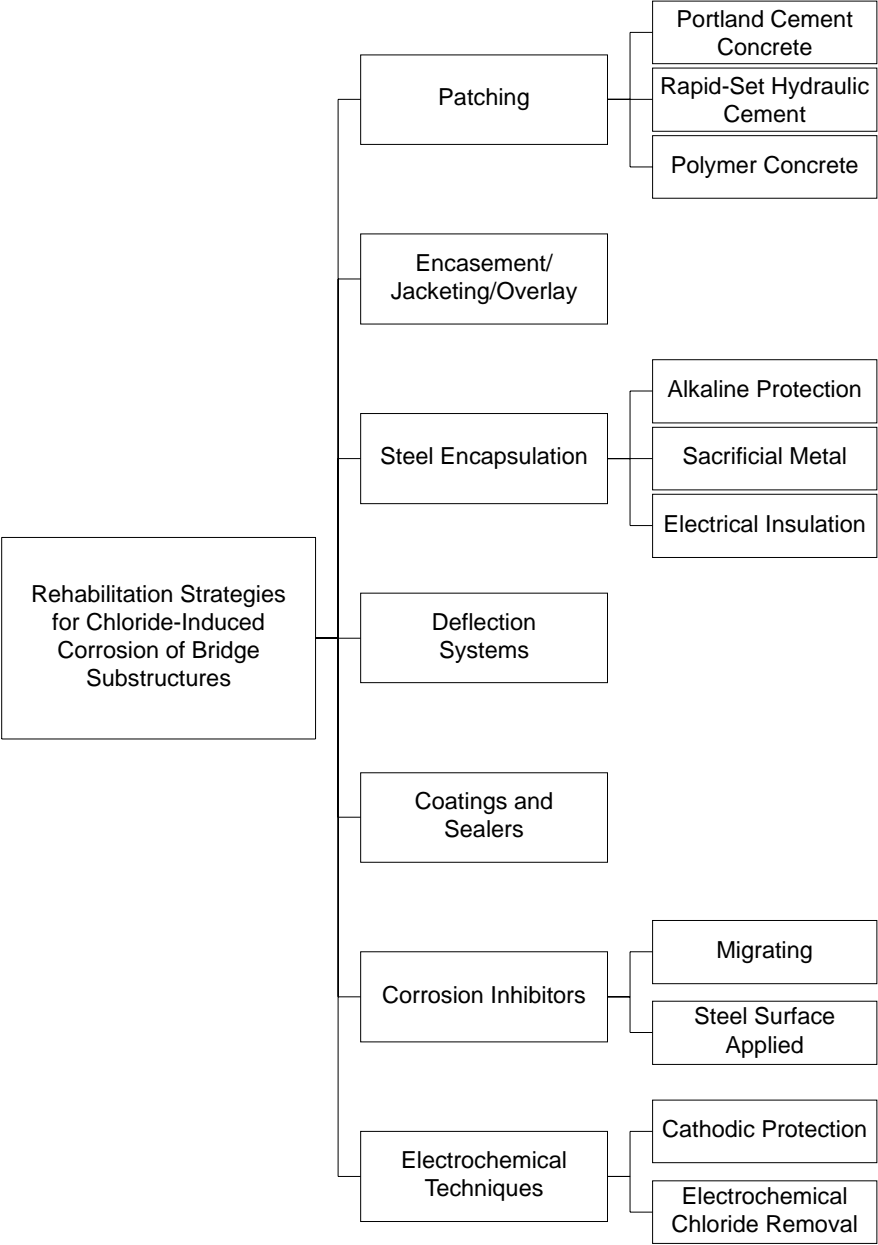
Figure 3.1: Rehabilitation strategies for chloride-induced corrosion of bridge substructures

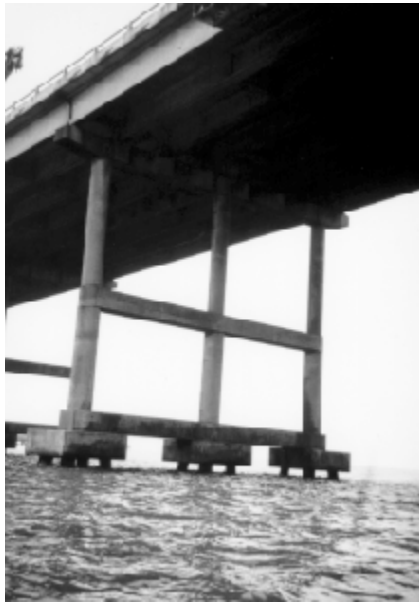
Figure 4.3: Typical bent

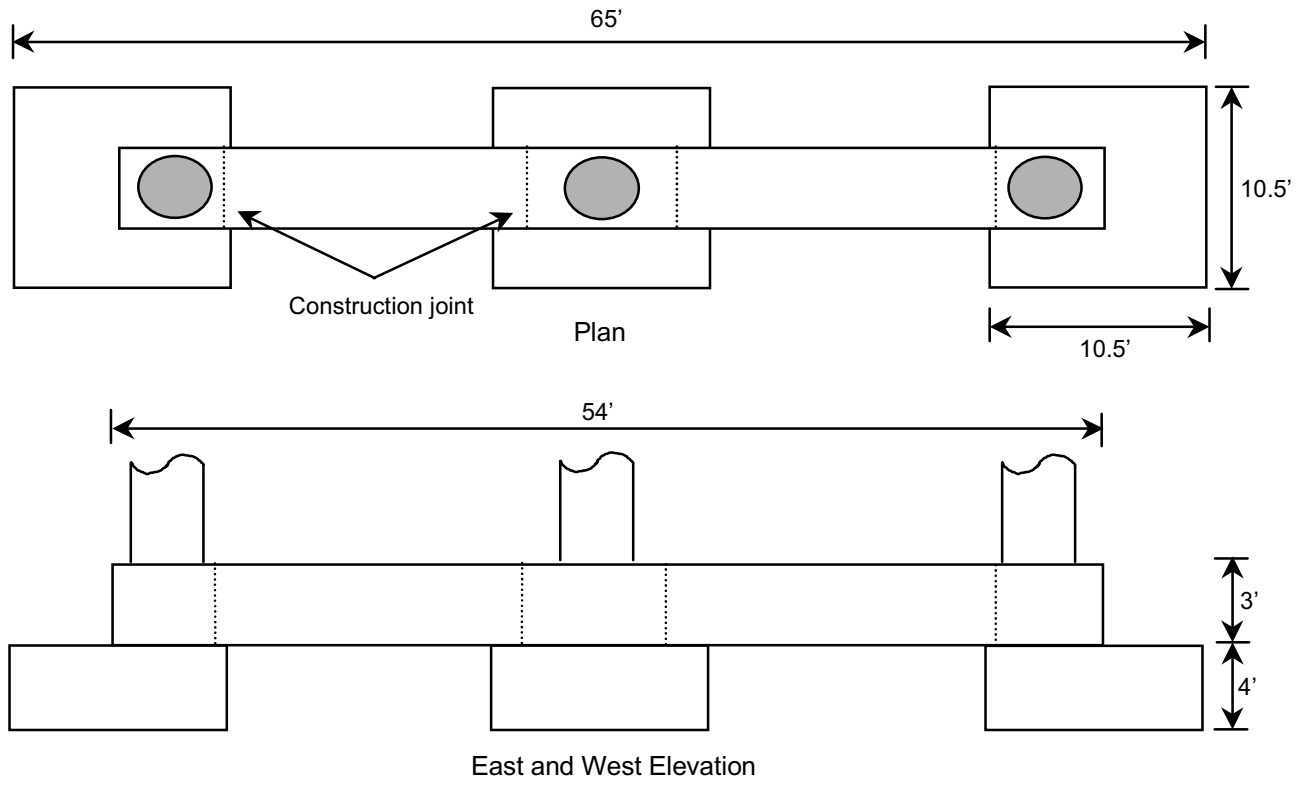
Figure 4.4: Geometry of footings and tie beams

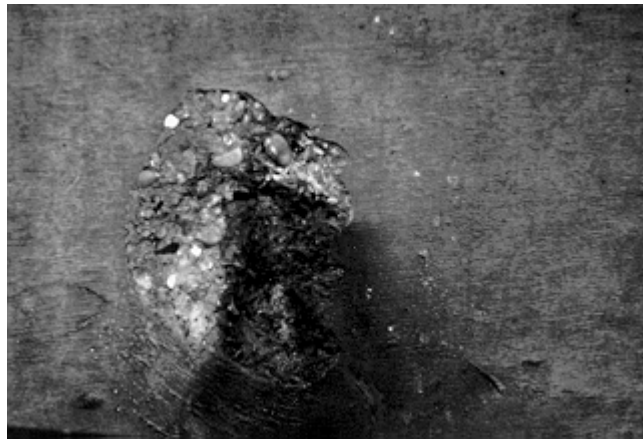
Figure 4.5: Typical spall in a footing

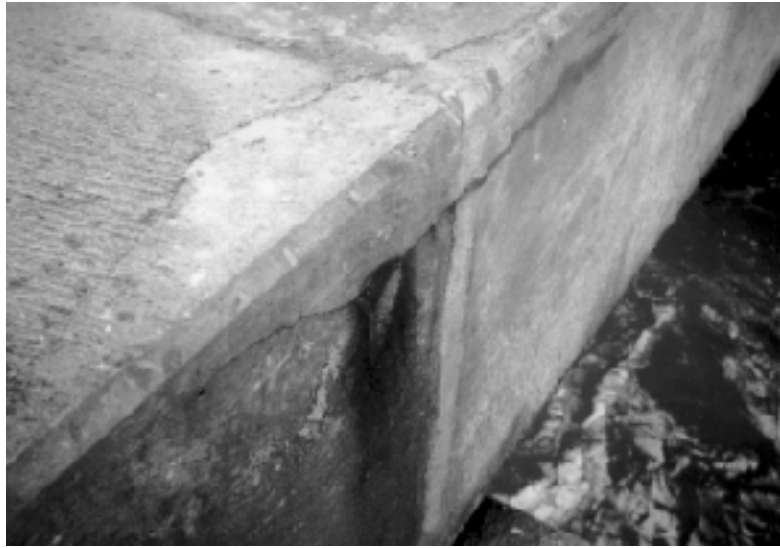
Figure 4.6: Crack in the proximity of tie beam construction joint

The tie beams exhibited mostly cracks, which were predominant in areas in the proximity of the construction joint. Crack widths recorded ranged from 0.030 in. (0.8 mm) to 0.125 in. (3.2 mm). Cracks in the proximity of a construction joint are shown in Figure 4.6. The crack lengths were greater in Bents 23 and 24, as shown in Table 4.2, reaching a density of up to 3 ft/100 ft<sup>2</sup> (10 m/100 m<sup>2</sup>). No major spalled areas were found in the tie beams.

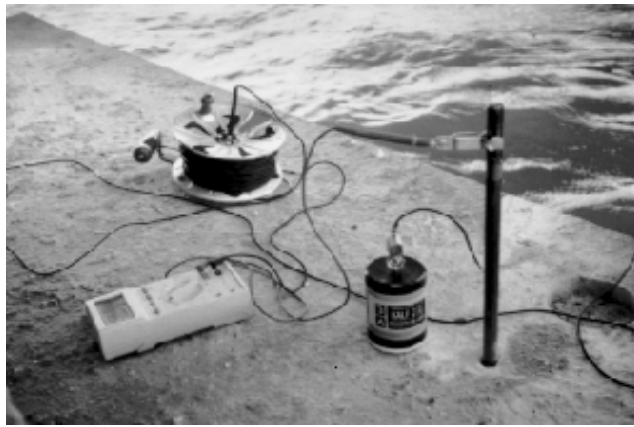
Figure 4.7: Setup for half-cell potential measurements

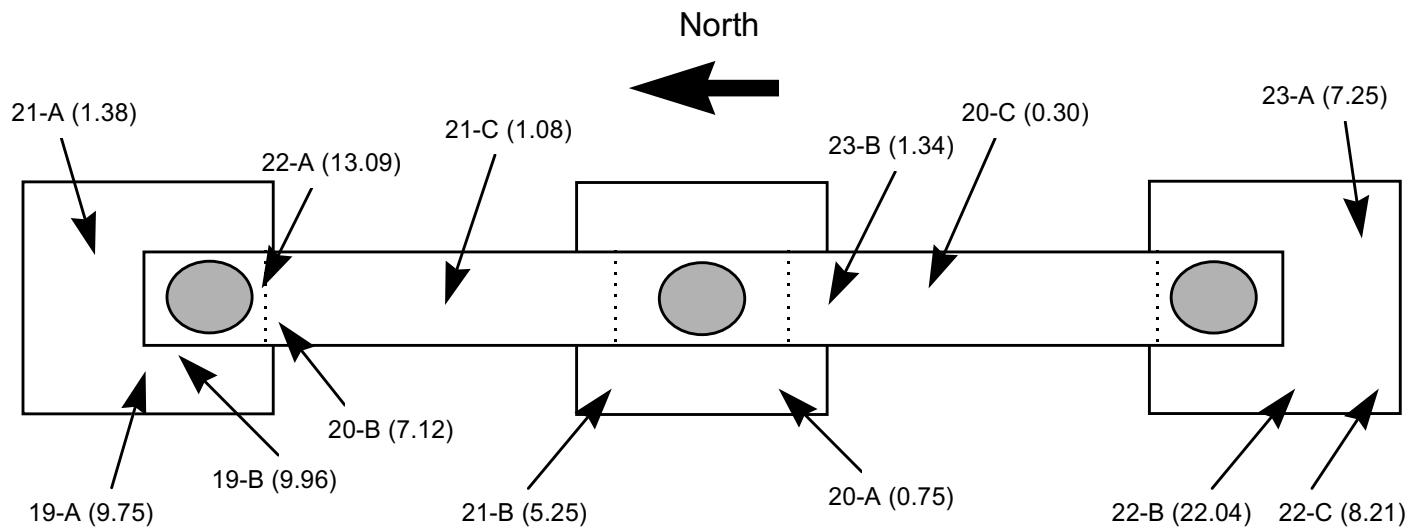
Figure 4.8: Total chloride contents at the level of the reinforcing steel

Number in parentheses are the chloride contents at the level of the reinforcing steel expressed in lb/yd<sup>3</sup>

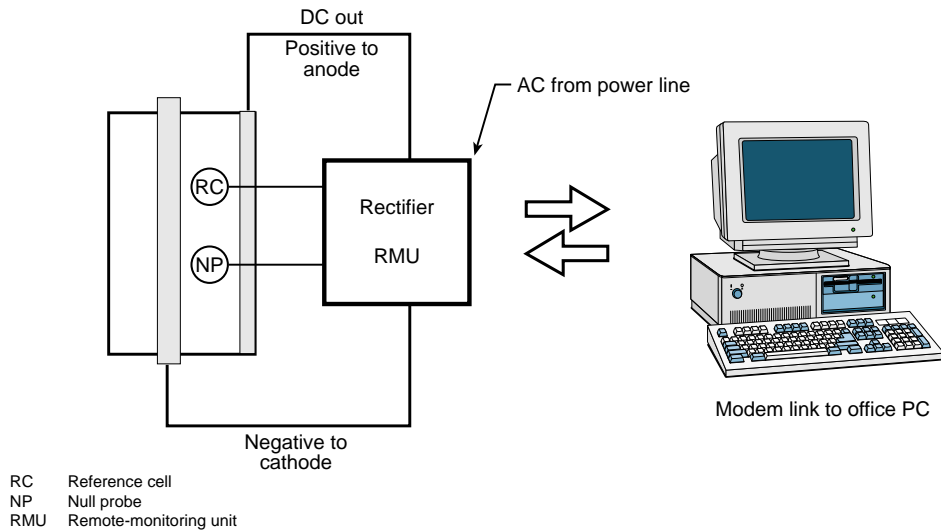
Figure 4.9: Components of the cathodic protection systems for the Queen Isabella Causeway

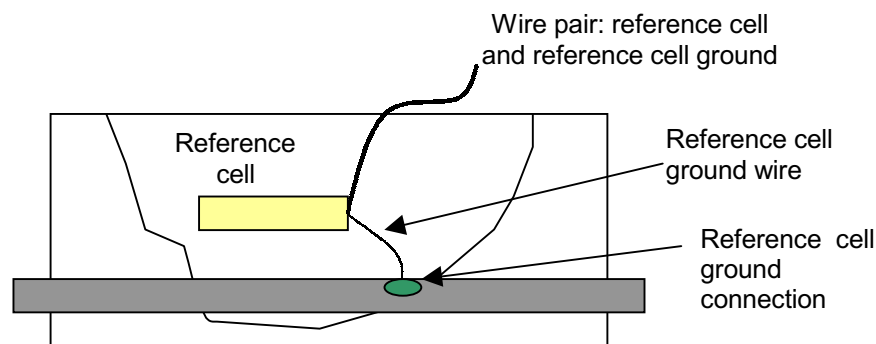
Figure 4.10: Reference cell and its wire connections

Figure 4.10 shows a diagram of the reference cell and its connections. Each reference cell had a ground wire that was connected to the reinforcing steel. A pair of wires, one corresponding to the reference cell and one corresponding to the reference cell ground were spliced to a pair of wires in a junction box at the location of each reference cell and routed to the rectifier through the conduit.

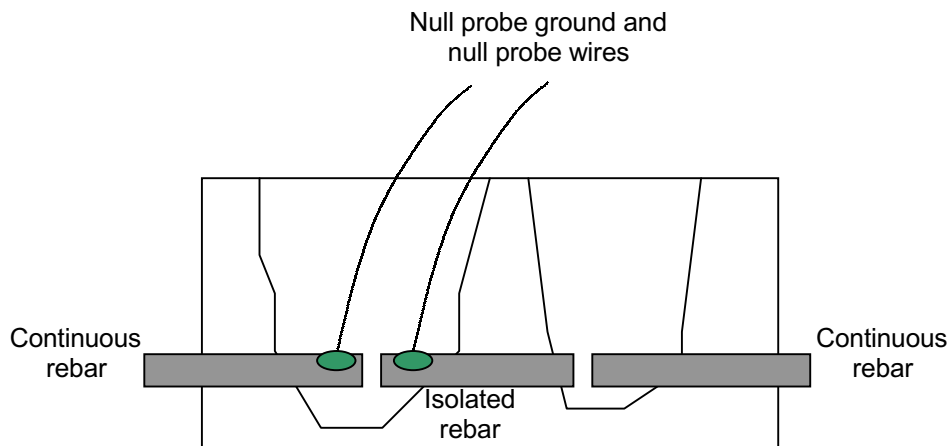
Figure 4.11: Null probe and its wire connections

Figure 4.11 shows a diagram of the null probe and its connections. The null probe ground wire was connected to the continuous reinforcing steel and the null probe wire is connected to the isolated piece of reinforcing steel. These wires were spliced to a pair of wires in each null-probe junction box and were routed to the rectifier through the conduit.

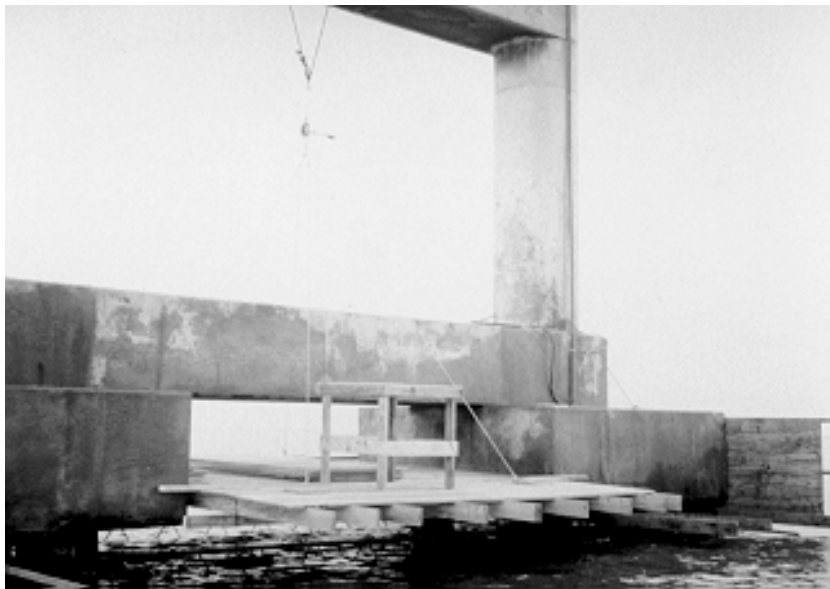
Figure 5.1: Modified scaffold design in raised position

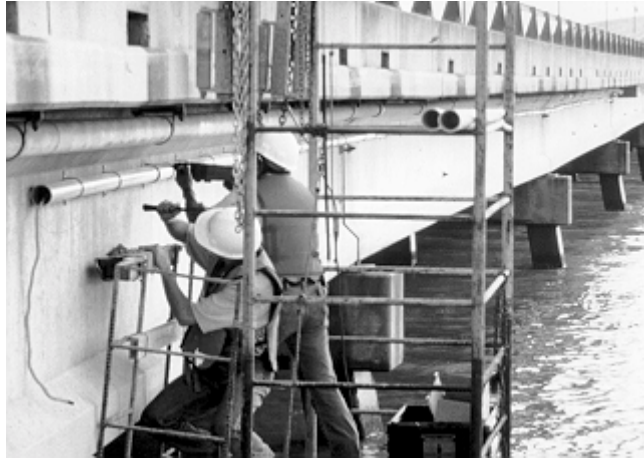
Figure 5.2: Conduit installation

The main conduit was secured along the south side of the bridge at the face of the outermost beam supporting the concrete deck. A rolling scaffold hanging to the side of the bridge deck was used to install the conduit (Figure 5.2). One traffic lane was blocked off during the installation of the conduit and wiring.

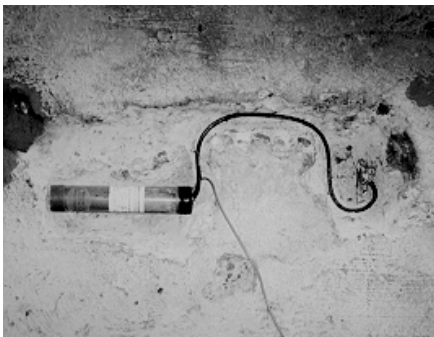
Figure 5.3: Reference cell

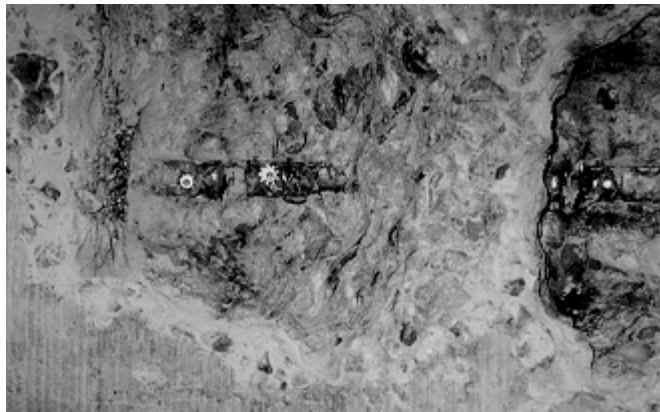
Figure 5.4: Null probe

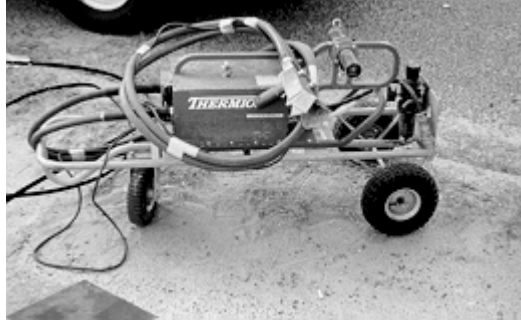
Figure 5.5: Arc spraying equipment

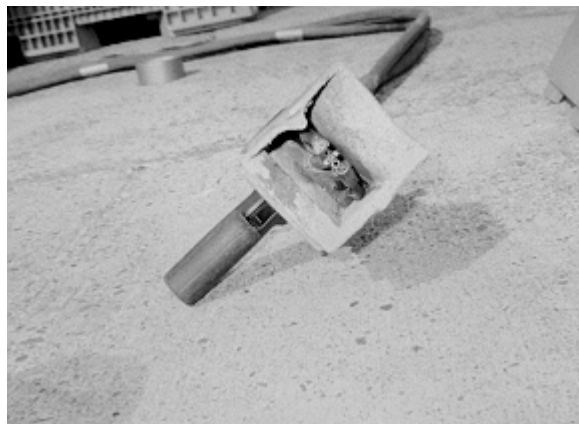
Figure 5.6: Arc spraying gun

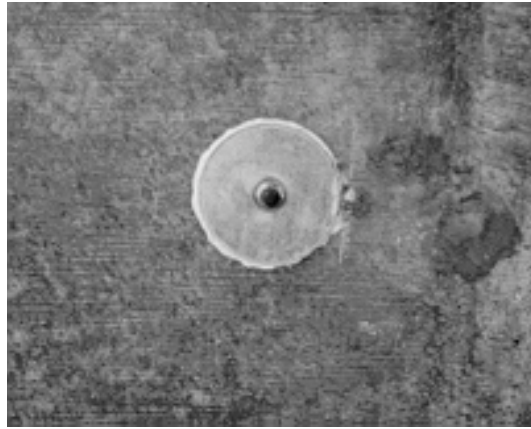
Figure 5.7: Excessive epoxy under a current distributor plate

*Application.* The primary anodes for the zinc systems consisted of 3.5-in. (89-mm) diameter circular plates, which served as current distributors. Each current distributor plate was secured to the concrete surface by means of a galvanized stud. The galvanized stud was inserted in a drilled hole with epoxy. In two instances, an excess of epoxy was placed in the drilled hole. The excess epoxy deposited between the current distributor plate and the concrete surface nullified the current distribution. Figure 5.7 shows one of the current distribution plates where excessive epoxy was placed. The plate had to be removed, and the area under the plate was sandblasted to remove the excess epoxy.

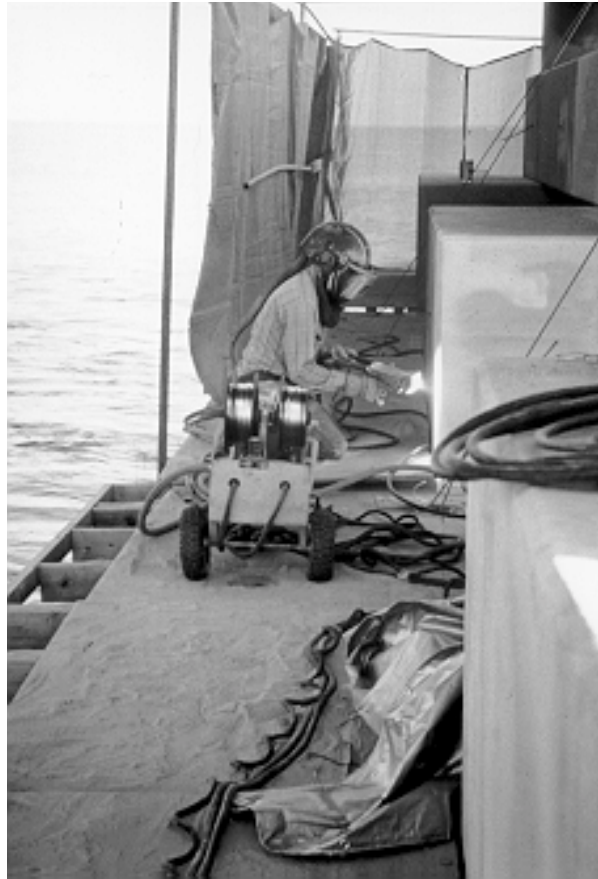
Figure 5.8: Zinc arc spraying

The method selected for spraying zinc was arc spray (Figure 5.8). The zinc consumption rate when using arc spray was 0.90 lb/ft<sup>2</sup> (4.39 kg/m<sup>2</sup>), which is equivalent to a theoretical zinc thickness of 0.024 in. (0.61 mm). The actual thickness was less as a result of metal and wind action losses. The American Welding Society has published a *Guide for the Protection of Steel with Thermal Sprayed Coatings of Aluminum and Zinc and their Alloys and Composites* (Ref 30). In this document, the nominal feedstock required when using arc spray to apply a 0.02-in. (0.51-mm) coating (assuming a deposit efficiency of 60 percent to 65 percent) is estimated at 1.08 lb/ft<sup>2</sup> (5.27 kg/m<sup>2</sup>). The lower consumption rate for this job indicates higher than average productivity or deposit efficiency.

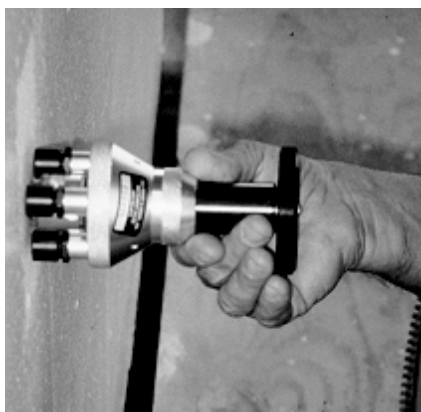
Figure 5.9: Adhesion tester

The average adhesion strength was 156 psi (109,700 kg/m<sup>2</sup>) and 151 psi (106,200 kg/m<sup>2</sup>) for Bents 19 and 22, respectively. The standard deviation for the adhesion strength measurements was 34 psi (23,900 kg/m<sup>2</sup>) and 84 psi (59,000 kg/m<sup>2</sup>) for Bents 19 and 22, respectively. The target adhesion strength was 150 psi (105,500 kg/m<sup>2</sup>). The adhesion strength tests were performed with an Elchometer 106 Adhesion Tester (Figure 5.9).

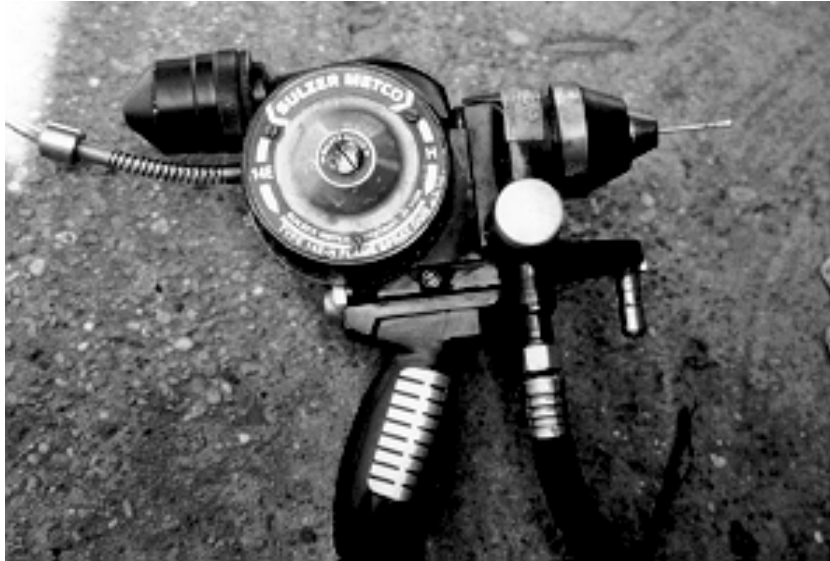
Figure 5.10: Flame-spray gun

concentrates the flame over the tip of the titanium wire. The molten metal is wiped away by the air, producing the resulting metal spray.

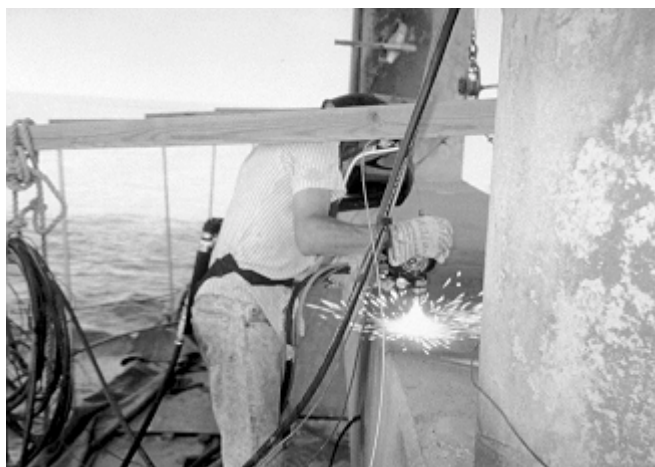
Figure 5.11: Titanium flame spraying

The method selected for spraying the titanium was flame spray (Figure 5.11). The machine productivity for the titanium was 45 ft<sup>2</sup>/hr (4.2 m<sup>2</sup>/hr). The actual production rate was 33 ft<sup>2</sup>/hr (3.1 m<sup>2</sup>/hr), a rate equivalent to 9.1 mhr/100ft<sup>2</sup> (0.98 mhr/m<sup>2</sup>), given that there were three workers per set of flame-spray equipment.

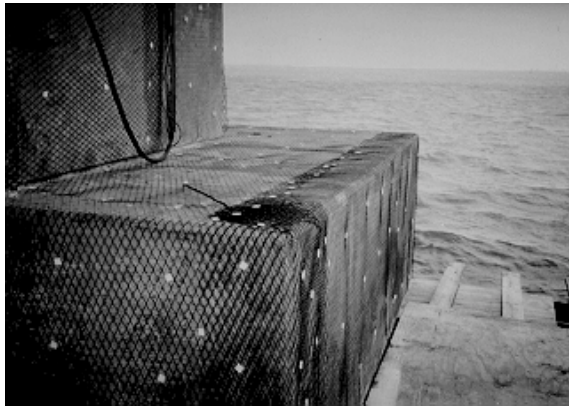
Figure 5.12: Titanium mesh secured with plastic fasteners

*Application.* The first step in the application of the titanium mesh with overlay was the installation of the titanium mesh. The titanium mesh was shaped to the geometry of the members and was secured to the concrete surface by means of plastic fasteners (Figure 5.12). The holes for the plastic fasteners were drilled, and the plastic fasteners were hammered in place. In several instances, the mesh caught in the grooves of the fasteners while we were securing the fasteners. This could have forced the mesh into contact with the reinforcing steel, creating a short. While the titanium mesh was being installed, the continuity of the titanium mesh with the reinforcing steel was checked at all times. One fastener was installed every 1 ft<sup>2</sup> (0.09 m<sup>2</sup>). At locations where there were bends in the mesh or where the mesh was installed in vertical or overhead orientation, the density of the fasteners was increased. Adjacent segments of titanium mesh were superimposed approximately 5 in. (127 mm) to achieve continuity.

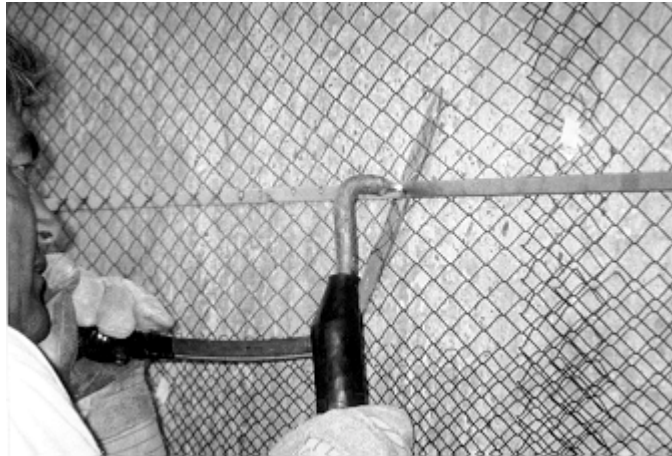
Figure 5.13: Spot welding of titanium strip to titanium mesh

Once the titanium mesh was secured in place, the titanium strip was installed. The titanium strip serves as the conductor, and the titanium mesh distributes the current. The titanium strip was wrapped around the sides of the footings and tie beams. The titanium strip was then spot-welded to the titanium mesh every 1 in. (25.4 mm). A spot welder capable of delivering 5,000 A over a 1-ft (0.30-m) segment was used (Figure 5.13). The productivity rate of the four workers involved in the installation of the titanium mesh and the titanium strip was 15.3 m<sup>2</sup>/hr (165 ft<sup>2</sup>/hr), which is equivalent to 0.6 mhr/100 ft<sup>2</sup> (0.06 mhr/m<sup>2</sup>).

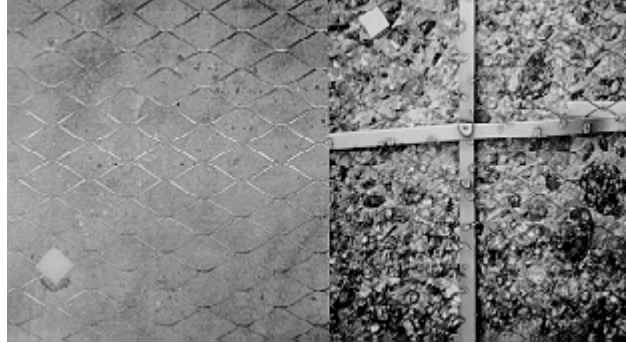
Figure 5.14: Concrete surface preparation comparison. Figure on left represents the lightly sandblasted surface used in the first two trials. The right figure shows exposed aggregates from heavier sandblasting used in the third trial.

guideline *Selecting and Specifying Concrete Surface Preparation for Sealers, Coatings and Polymer Overlays* (Ref 29). Figure 5.14 shows a graphic comparison of the surface preparation for the first two trials and the last trial.

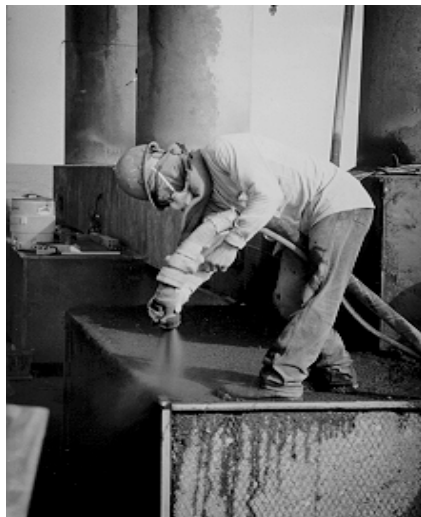
Figure 5.15: Shotcrete application of titanium overlay

The concrete overlay was dry-mix shotcrete applied for the third trial (Figure 5.15). The equipment consisted of an Allentown N2 shotcrete machine and a model 900 rig. The equipment was mounted on the bridge deck, and traffic on one lane was blocked for this purpose. The crew consisted of six workers: one applicator and a helper, two concrete finishers, and two laborers who loaded the shotcrete machine. The productivity for the shotcrete operation was 63 ft<sup>2</sup>/hr (5.8 m<sup>2</sup>/hr), which is equivalent to 9.5 mhr/100 ft<sup>2</sup> (1.02 mhr/m<sup>2</sup>).

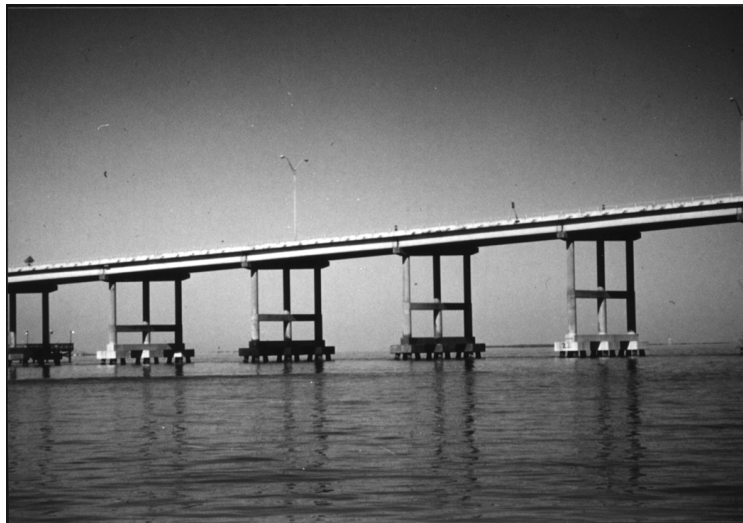
Figure 6.1: Completed installation of cathodic protection systems

Upon installation of the cathodic protection systems (Figure 6.1) in September 1997, the impressed current systems were energized, and the performance of the different cathodic protection systems was evaluated by field and remote monitoring. Energization and part of the field evaluation were conducted from the rectifier and the remote-monitoring unit shown in Figures 6.2 and 6.3, respectively.

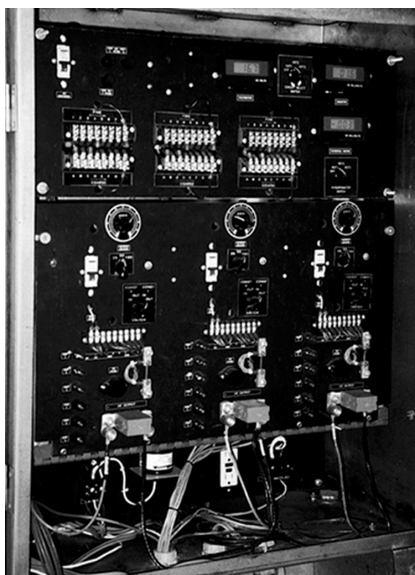
Figure 6.2: Rectifier unit

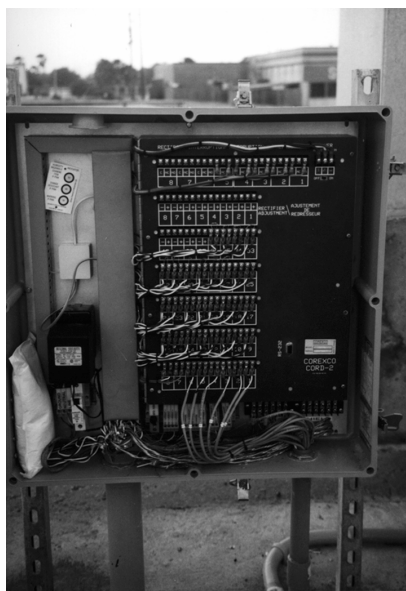
Figure 6.3: Remote-monitoring unit

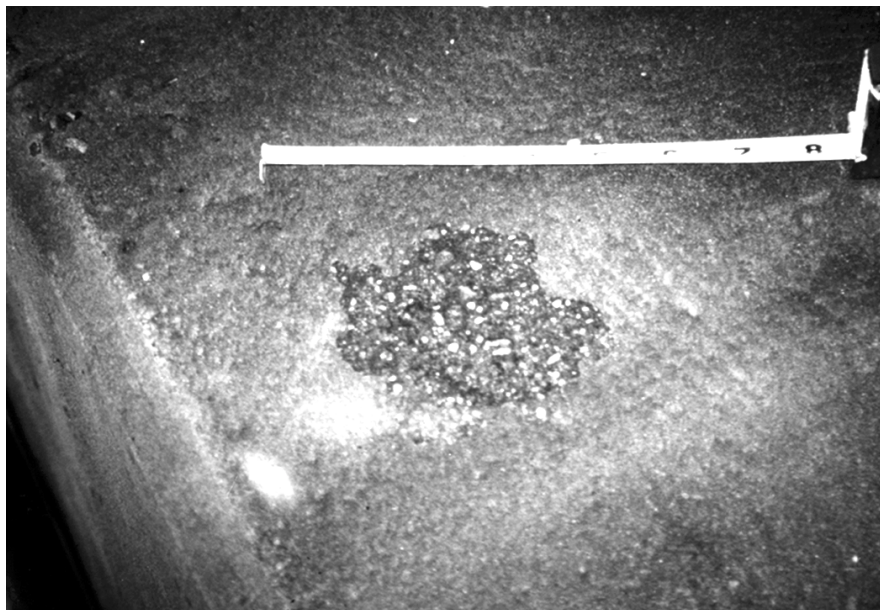
Figure 6.4: Sprayed titanium debonded

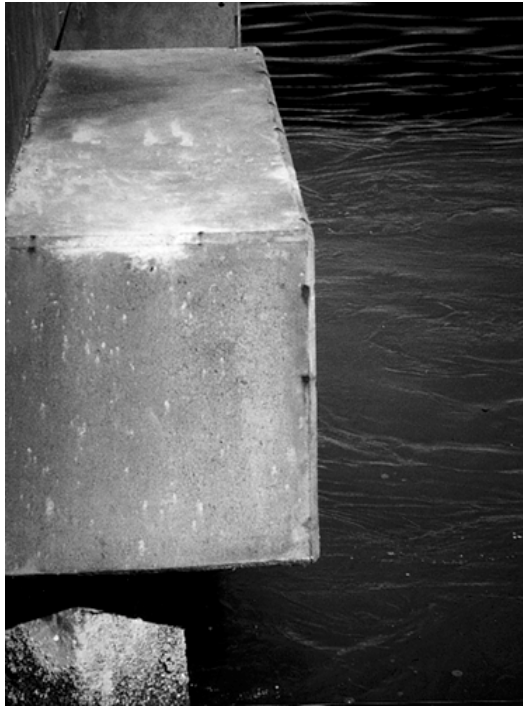
Figure 6.5: Corrosion of wire ties for Bent 21

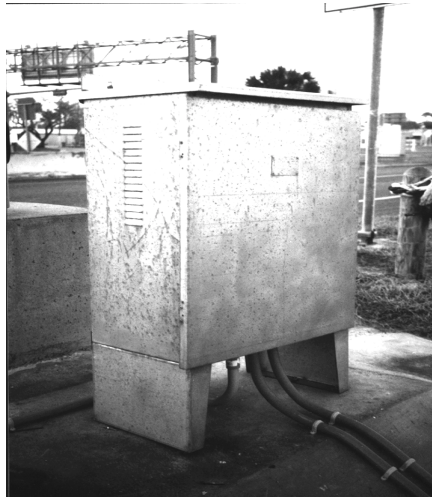
Figure 6.6: Corrosion of the rectifier box

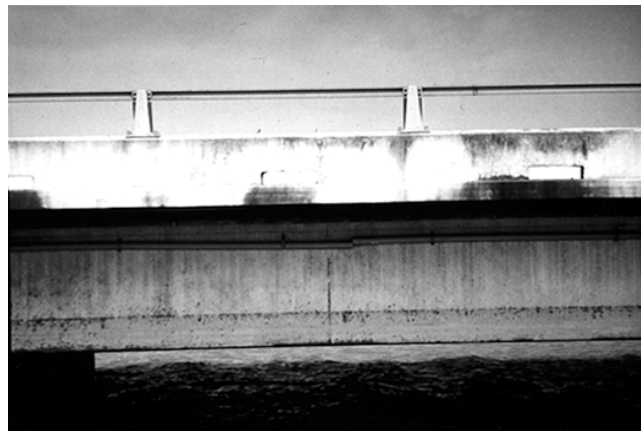
Figure 6.7: Disjointed conduit segments

6.7). This was probably due to a lack of a sufficient number of expansion joints at that location. The remaining cathodic protection system components were in good condition.

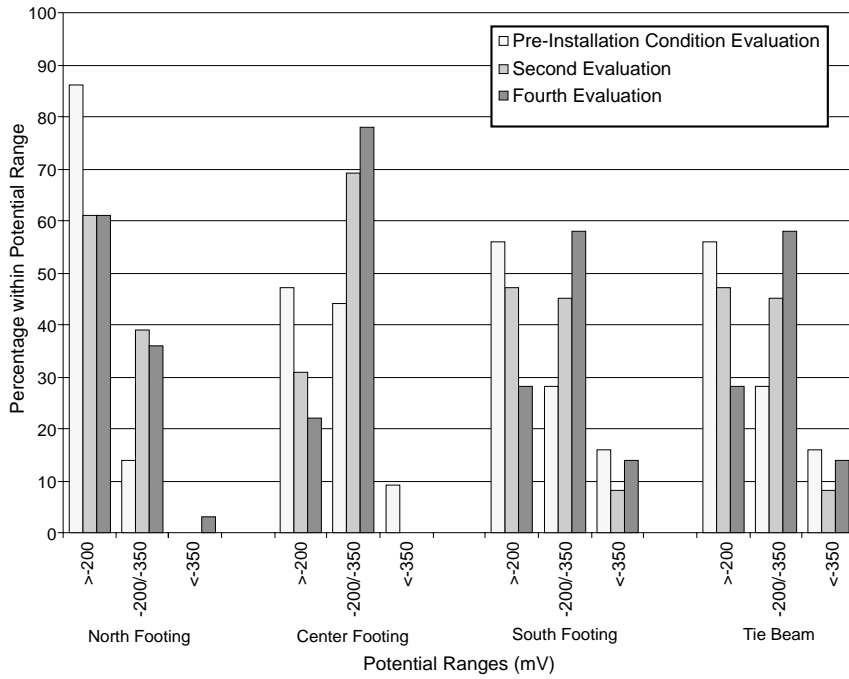
Figure 6.8: Corrosion potential ranges in different evaluations for Bent 23

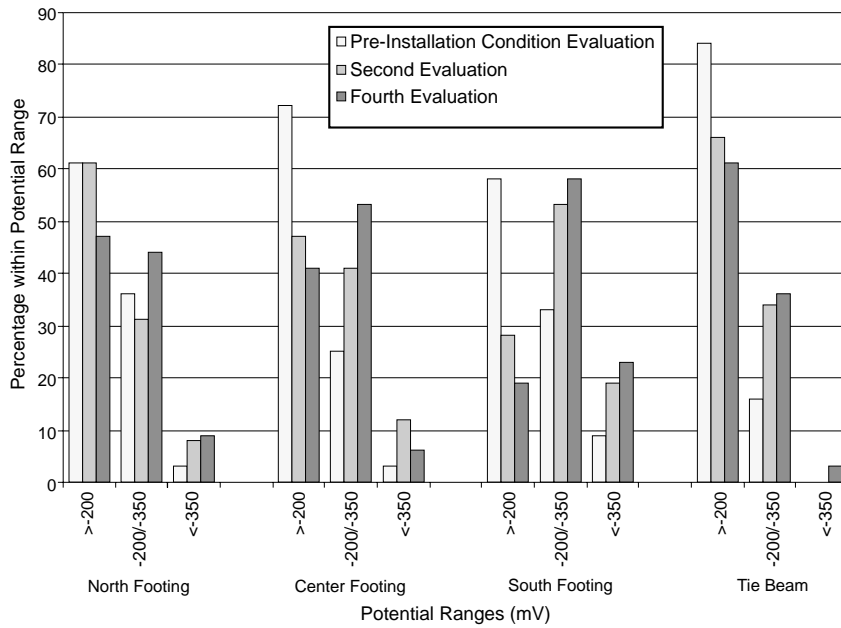
Figure 6.9: Corrosion potential ranges in different evaluations for Bent 24

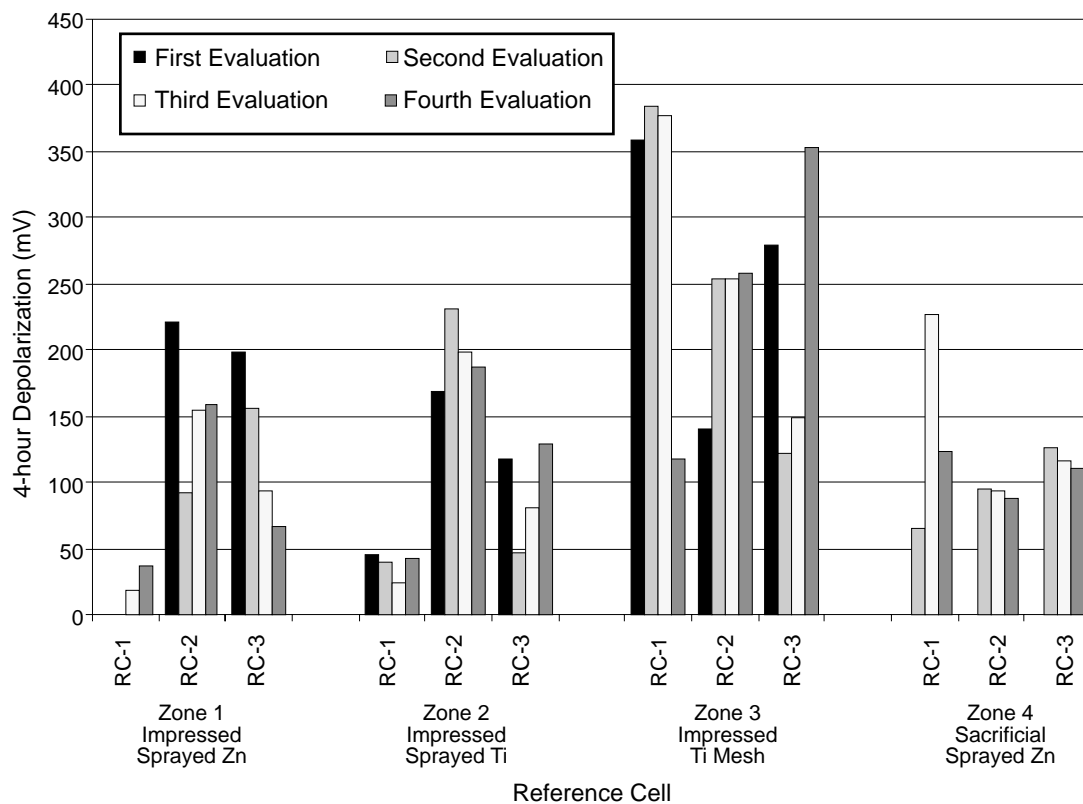
Figure 6.10: Four-hour depolarization for all reference cells

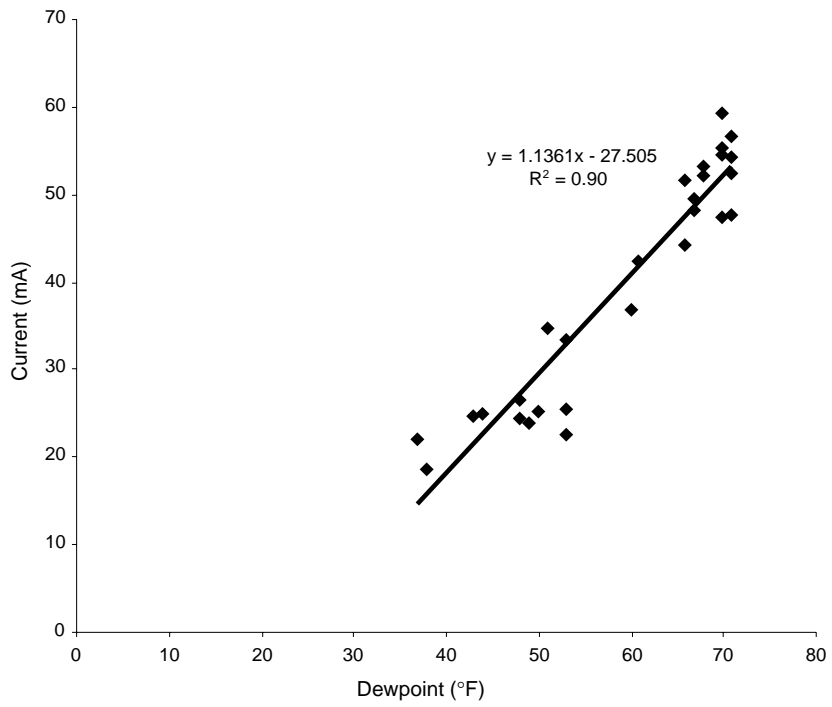
Figure 6.11: Dew point versus current between February and mid-April

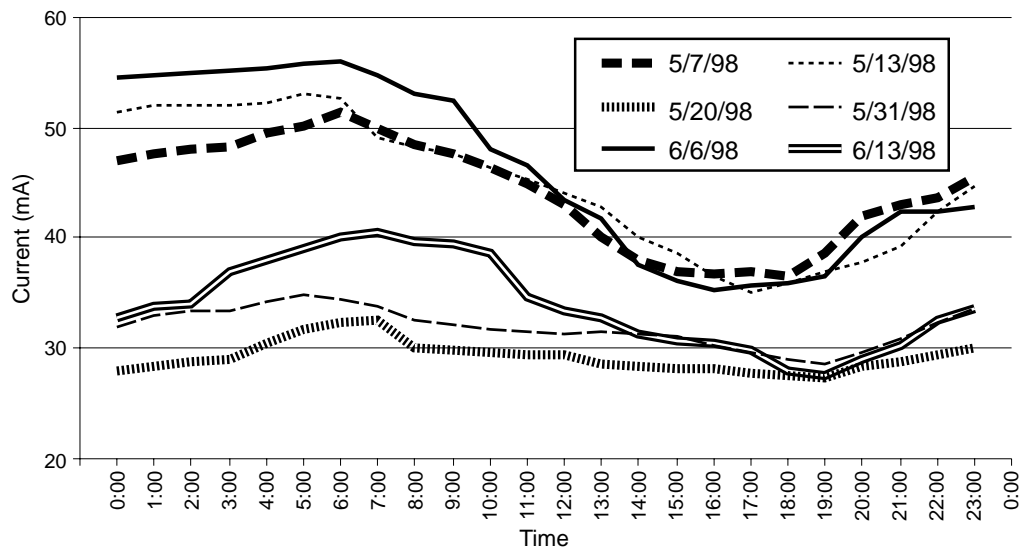
Figure 6.12: Cyclic current behavior
