RESEARCH REPORT 2945-1

EVALUATION OF CATHODIC PROTECTION  
SYSTEMS FOR MARINE BRIDGE  
SUBSTRUCTURES

Project title: *A Performance Evaluation of Cathodic Protection Systems for Queen Isabella*

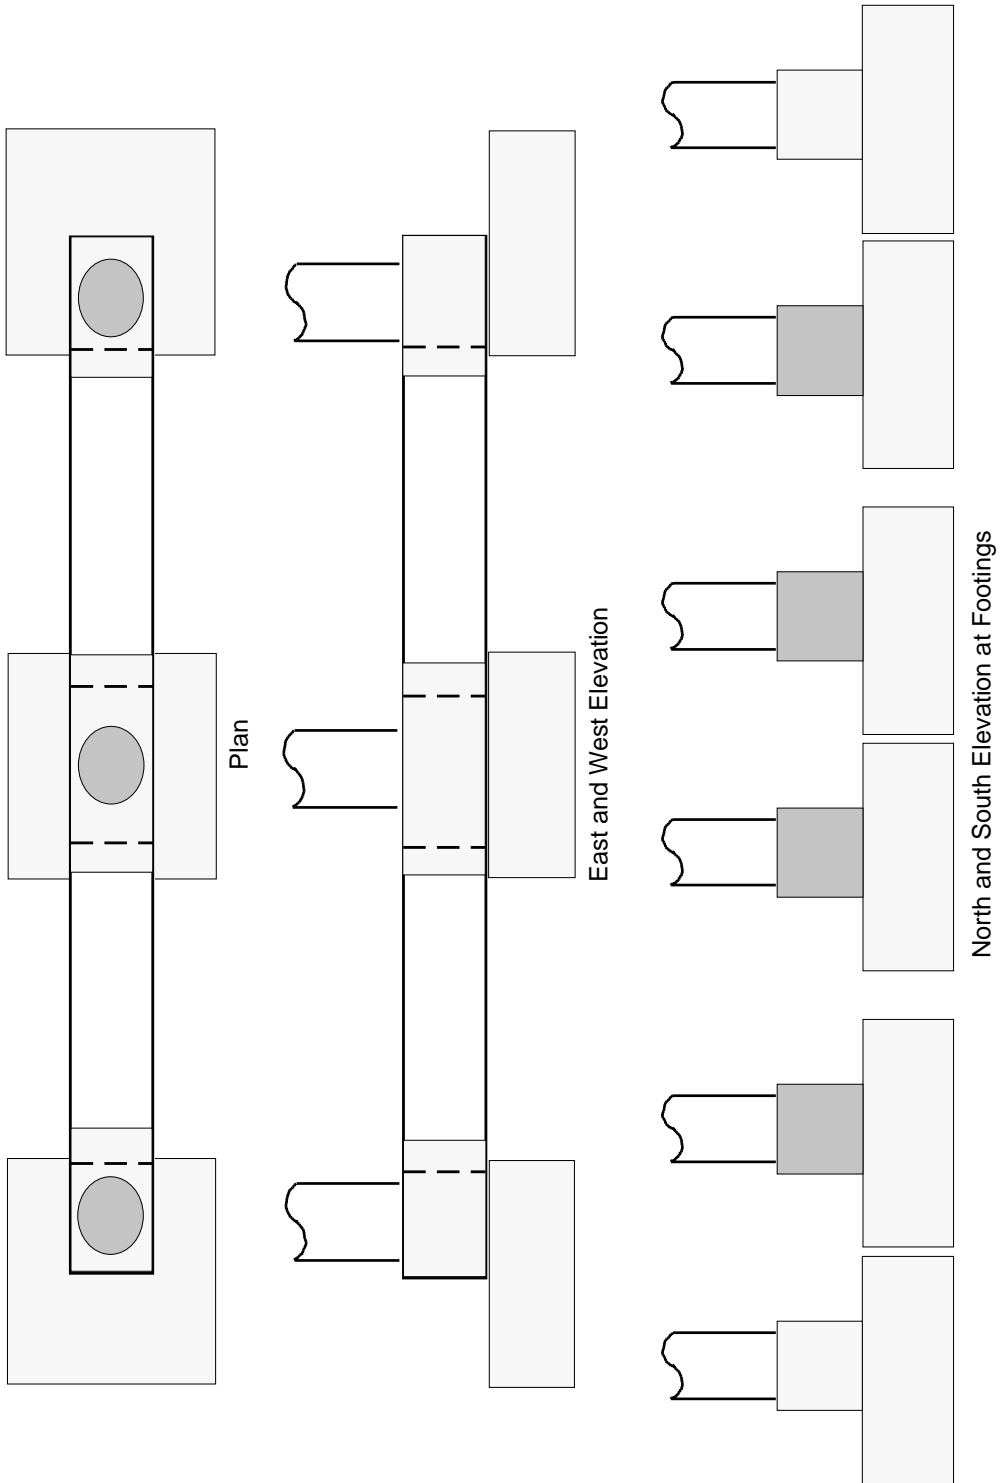
Figure 8.1: Recommended surface areas for sacrificial sprayed zinc installation
