**RETROFIT OF EXISTING REINFORCED CONCRETE
BRIDGES WITH FIBER REINFORCED
POLYMER COMPOSITES**

Report No. UC-CII 01/01

A Report to Sponsor:
Federal Highway Administration
And
Ohio Department of Transportation

Retrofit of a Three-Span Slab Bridge with FRP Systems – Testing and Rating

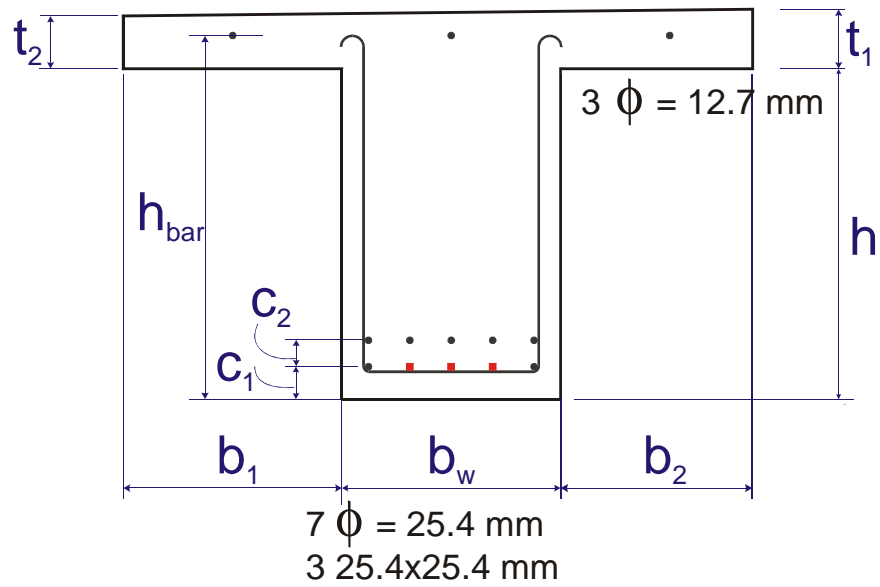
Beam	b_1	b_w	b_2	h	t_1	t_2	h_{bar}	C_1	C_2
1	419	419	375	591	152	146	654	63.5	50.8
2	422	410	378	587	152	152	654	63.5	50.8
3	362	616	381	616	140	102	654	114	50.8
4	397	408	454	565	152	140	622	63.5	50.8

Figure 1 Dimensions and Reinforcement of T Beams

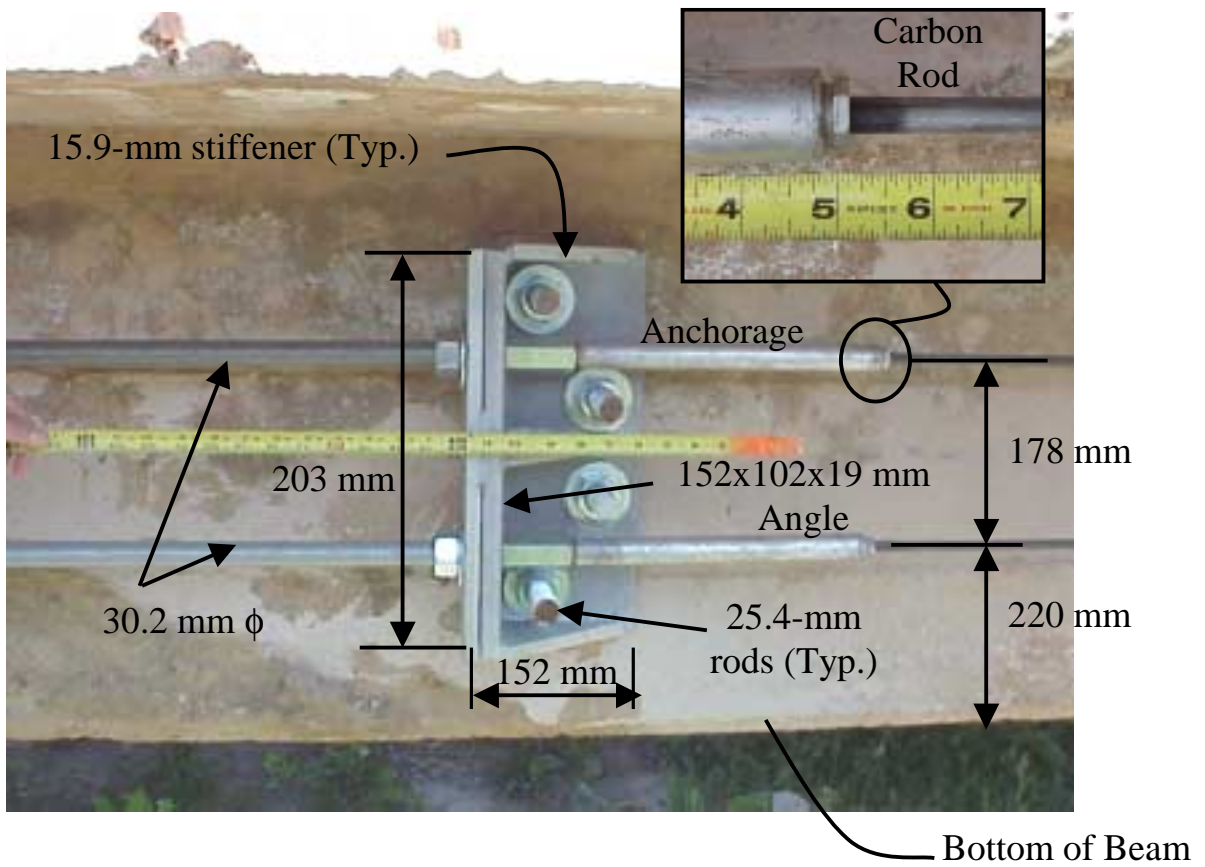
Figure 2 Elevation Views of Anchor System in Web of Beam 1

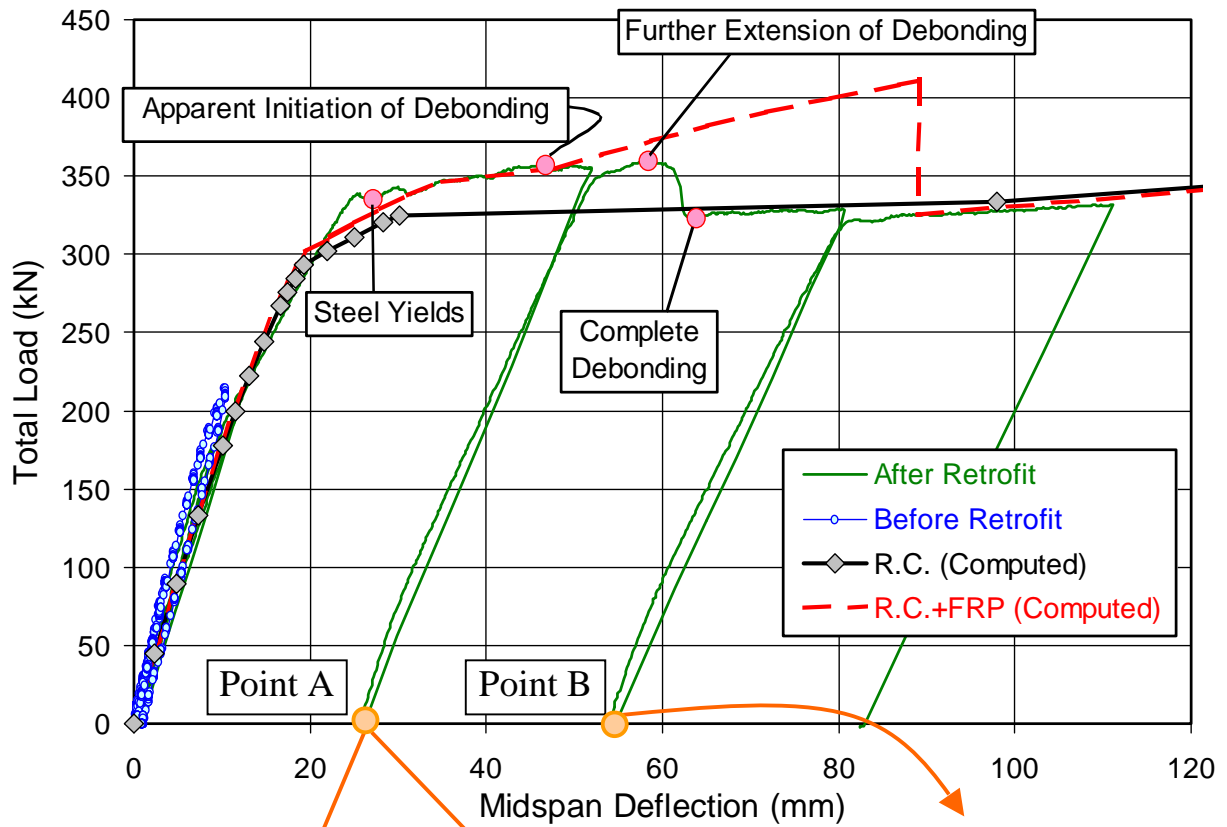
Figure 6 Load-Midspan Deflection Curve and Observed Damage in Beam 2

The stiffness of the beam before and after retrofitting was computed from the initial slope of the load-midspan deflection curves (Fig. 6), and by transformed section analysis in which standard techniques were used to transform the CFRP plates and reinforcing bars. Considering the condition of the beam, only the cracked section was considered. The change in stiffness is summarized in Table 3. Transformed section analysis indicates an increase of 4.2% in the stiffness in comparison to a 9% increase that was inferred from the measured load-midspan deflection curves. This difference is attributed to the slight variations in the test setup before and after retrofit, which would affect the inferred value of EI.

The crack pattern, condition of bond between the FRP plates and concrete, and mode of failure are illustrated in a number of insets in Fig. 6. At 335 kN ($\delta = 27.2$ mm where $\delta =$ midspan deflection), yielding of the instrumented longitudinal steel reinforcing bar at the midspan was detected. The FRP plates were bonded up to this point. However, at 357 kN ($\delta = 46.8$ mm), the FRP plates were apparently debonded as evident from the strain profile shown in Fig. 7a. Up to this load, the strain in the FRP plates was larger than the reinforcing bar strain, which suggests satisfactory bond transfer between the FRP plates and beam. Upon unloading (Point “A” in Fig.6), evidence of local debonding was visible. The north plate was found debonded 711 and 1345 mm to the east and

west of the beam centerline, respectively; and the south plate debonded 660 and 1041 mm to the east and west of the beam centerline, respectively. Local debonding extended further upon reloading, and at 360 kN ($\delta = 58.5$ mm) both of the plates debonded completely on the west side and fell (inset “b” in Fig. 6). The failure was apparently due to bond failure. The bond failure occurred at displacement ductility (defined as displacement at failure divided by the displacement at which the longitudinal bars yielded) was 2.15. Despite the age of the beam and its condition, the repair method was apparently successful in view of the displacement ductility, and the fact that debonding occurred after yielding of the bars. Loss of bond between the FRP plates and beam led to a sudden drop of 11% in the load carrying capacity. At point “B” (Fig. 6), local debonding of the plates that were still bonded to the beam was observed to have extended to 965 and 1143 mm to the east of the beam centerline for the south and north plates, respectively.

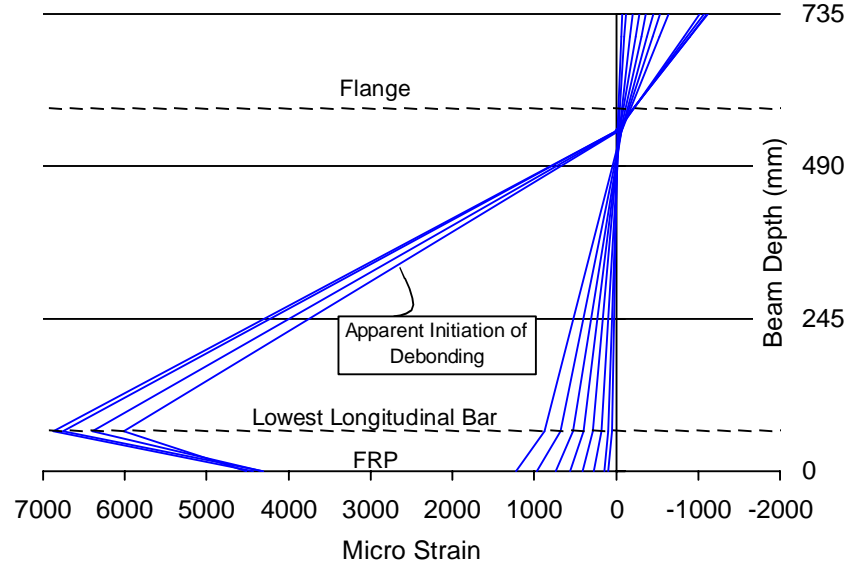
(a) Strain Profile at Midspan

Figure 7 Distribution of Strains in Beam 2

In spite of local debonding on either side of the midspan, the plates were still actively participating towards enhancing the capacity. Figs. 7b and 7c show the average strain in the FRP plates and concrete surface strain at the east and west quarter points, respectively. Up to complete debonding of the plates on the west side, the strains in the FRP plates continued to be larger than the concrete strain, which suggests adequate bond transfer. The strain in the FRP plates at the west quarter point reached a maximum of 3030 microstrains immediately before debonding. At this strain, the plates had developed 22% of their ultimate strength. After debonding on the west half of the beam, the plates at the east quarter point continued to work with the substrate as evident from the concrete strain and strain in the FRP plates (Fig. 7b). Bond transfer was apparently not uniform along the length. Throughout the test, up to complete debonding on the west half of the beam, the strains in the FRP plates on the west quarter point were between 1.5 to 2 times larger than their counterparts on the east quarter point. Immediately before complete debonding, the strain at the west quarter point became 6.5 times larger than the corresponding strain at the east quarter point.

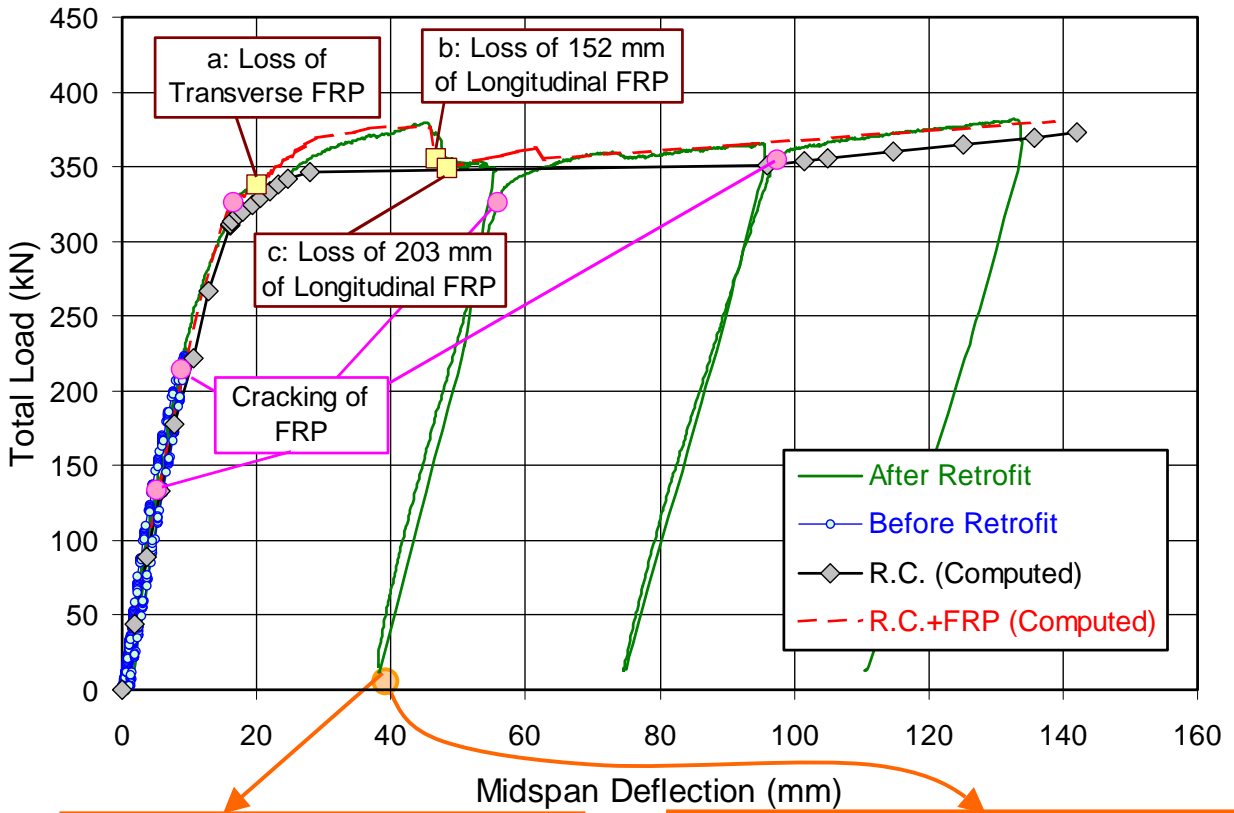
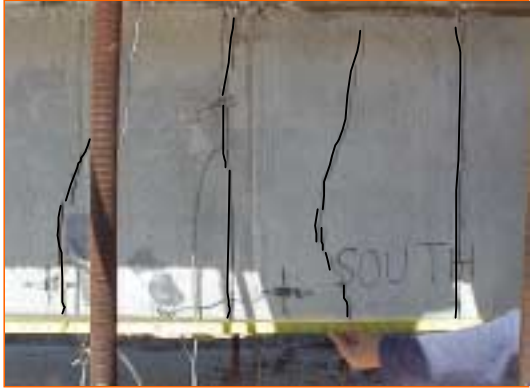
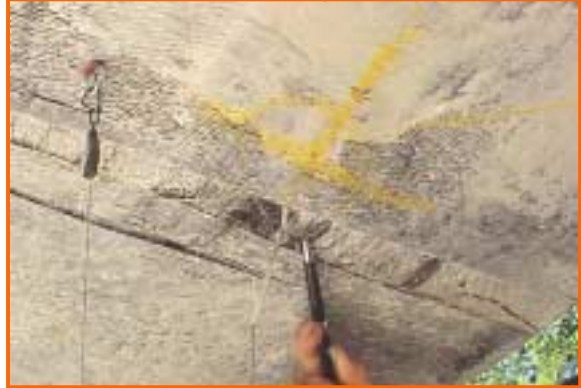
Figure 8 Load-Deflection and Damage Pattern in Beam 3

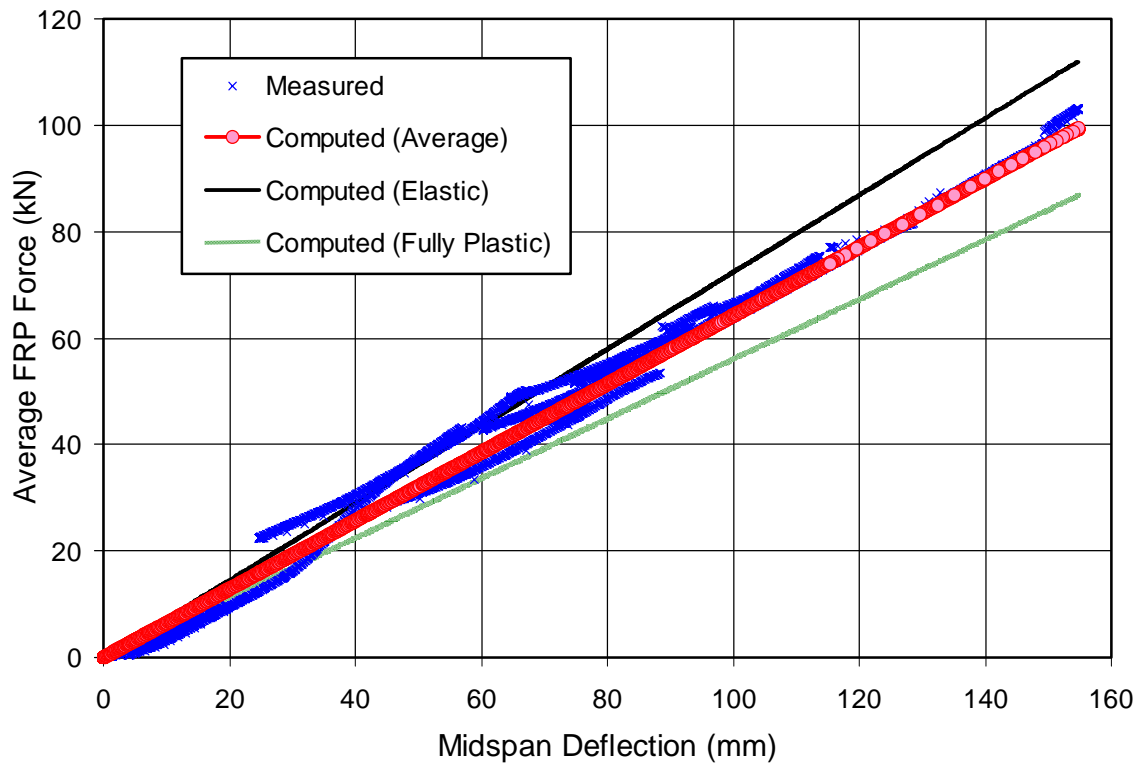
Figure 12. Measured v.s. Computed Tension Force in CFRP Plates

As seen from Figure 5, the measured force in the CFRP plates is bracketed by the computed values. Since the beam is neither completely elastic nor fully plastic, the average value of the coefficients for the elastic case and fully plastic case may be used, i.e., $F = 0.642\delta$. The resulting computed force in the CFRP plates matches the measured force (Figure 5) remarkably well. The aforementioned model provides a simple, yet effective method, to compute the expected force in the CFRP plates as a function of the midspan deflection.

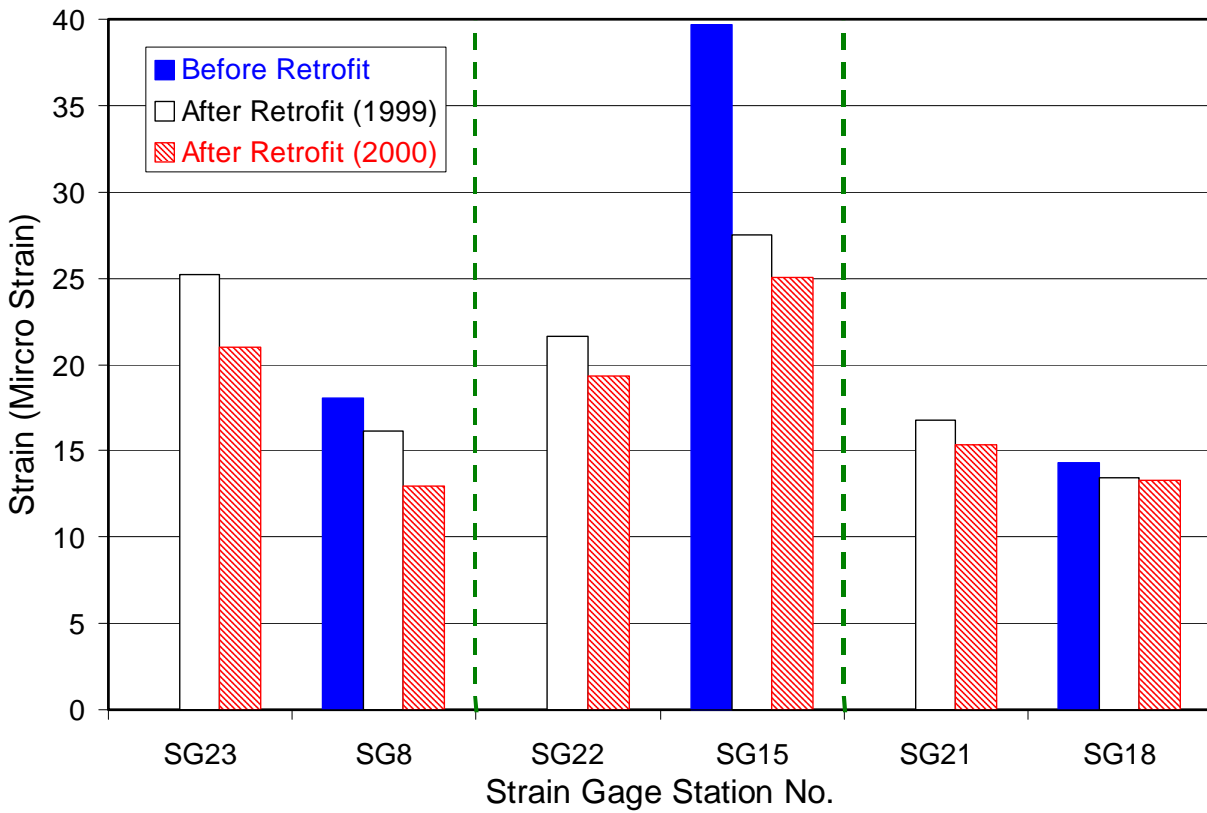
FRP Systems are shown partially.
 SG21, SG22, & SG23: on FRP systems
 SG21 on the 15th 76.2-mm plate from the south edge
 SG22 on the 6th 127-mm plate from the south edge
 SG23 on the 7th 102-mm bolted plate from the south edge

Figure 6. Maximum Strains in Slab and FRP Systems Measured During Various Tests

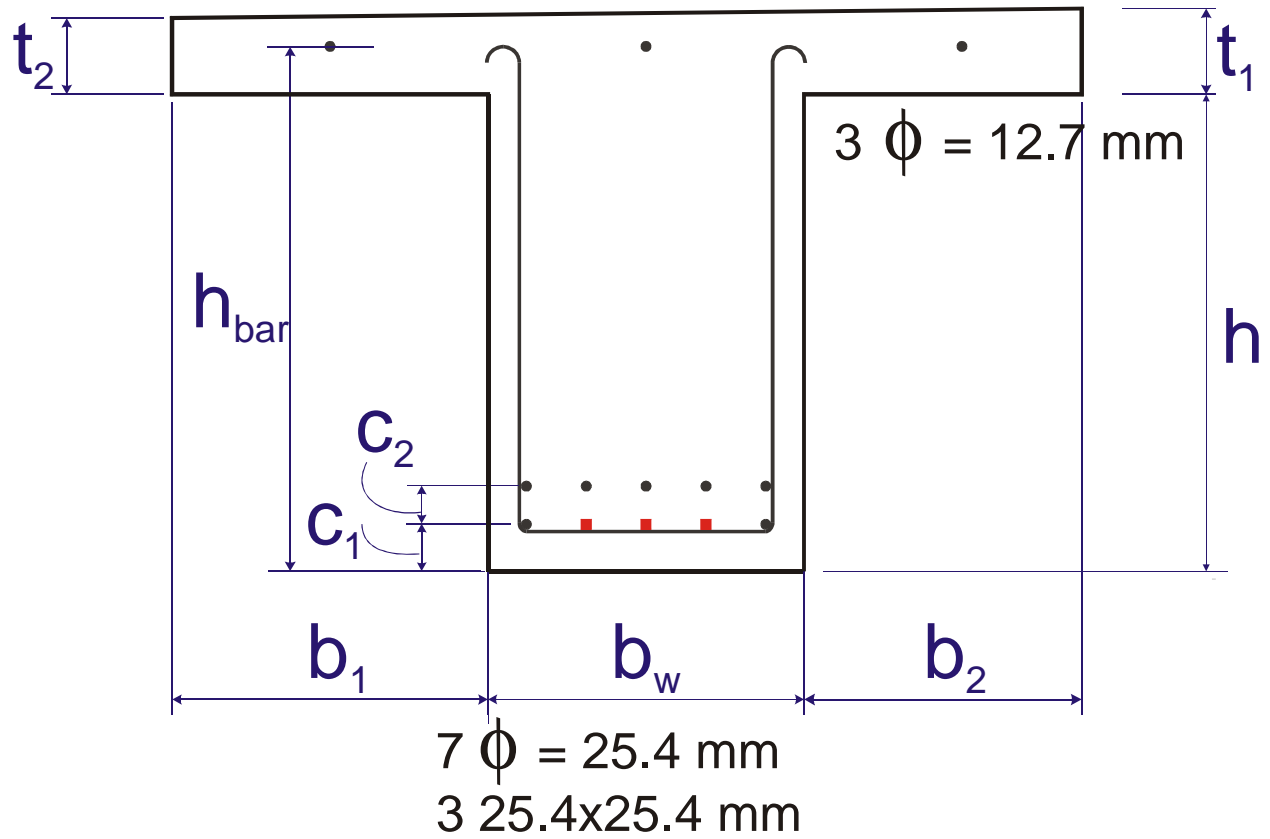
Beam	b_1	b_w	b_2	H	t_1	t_2	h_{bar}	C_1	C_2
1	419	419	375	591	152	146	654	63.5	50.8
2	422	410	378	587	152	152	654	63.5	50.8
3	362	616	381	616	140	102	654	114	50.8
4	397	408	454	565	152	140	622	63.5	50.8

Figure A.1 Cross Section of T Beams

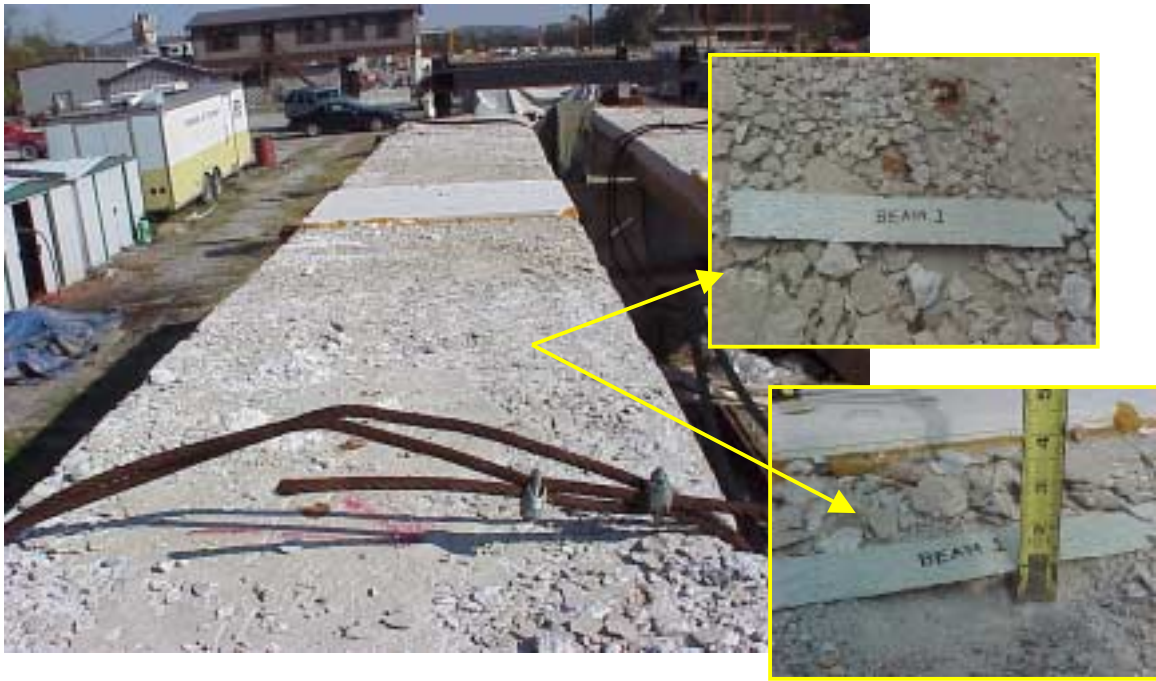
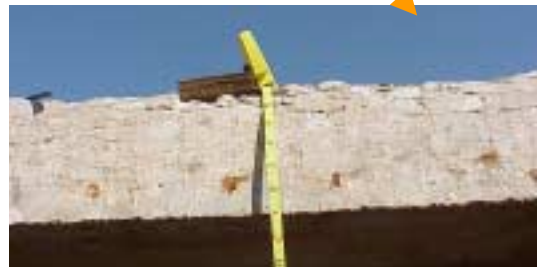
Figure A.2 Existing Damage and Crack – Beam 1

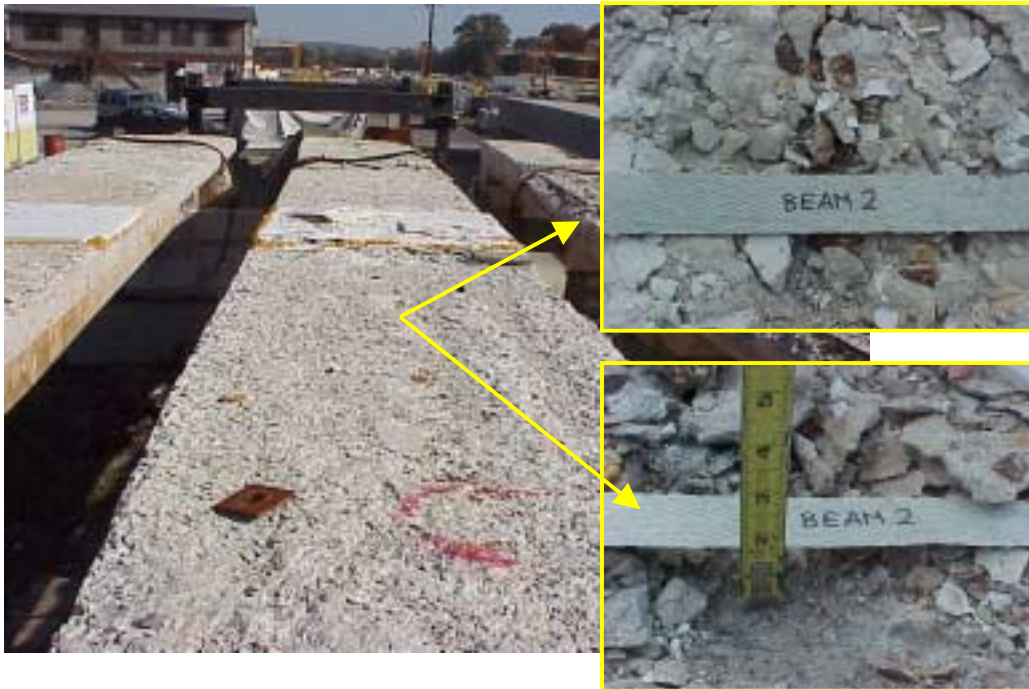
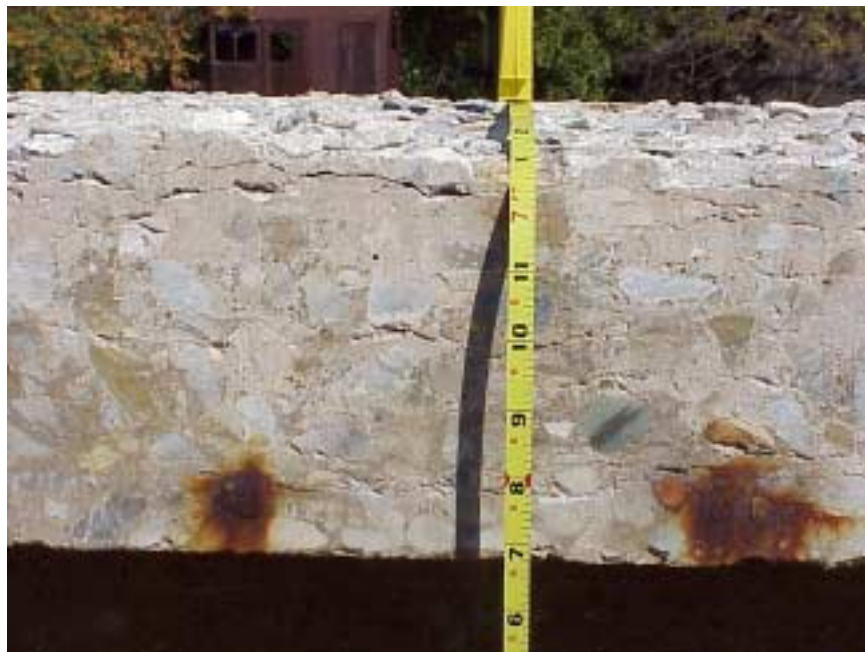
Figure A.2 (Cont.) Existing Damage and Crack Pattern – Beam 2

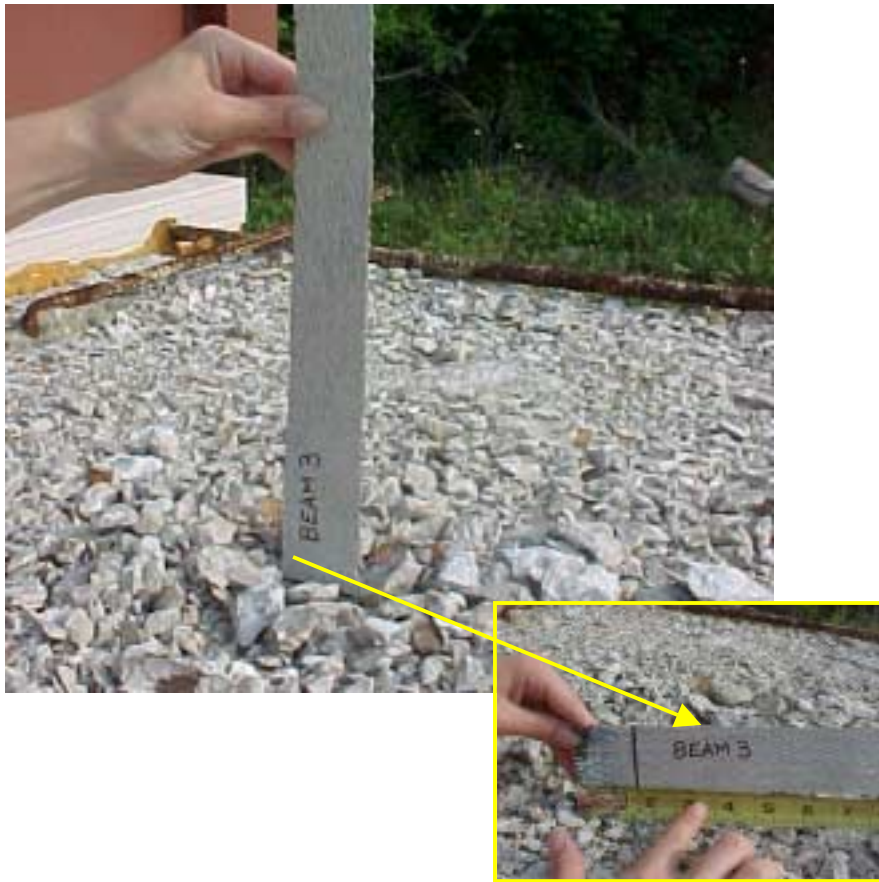
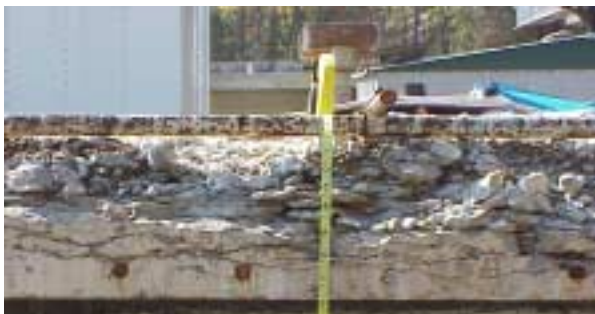
Figure A. 2 (Cont.) Existing Damage and Crack Pattern – Beam 3

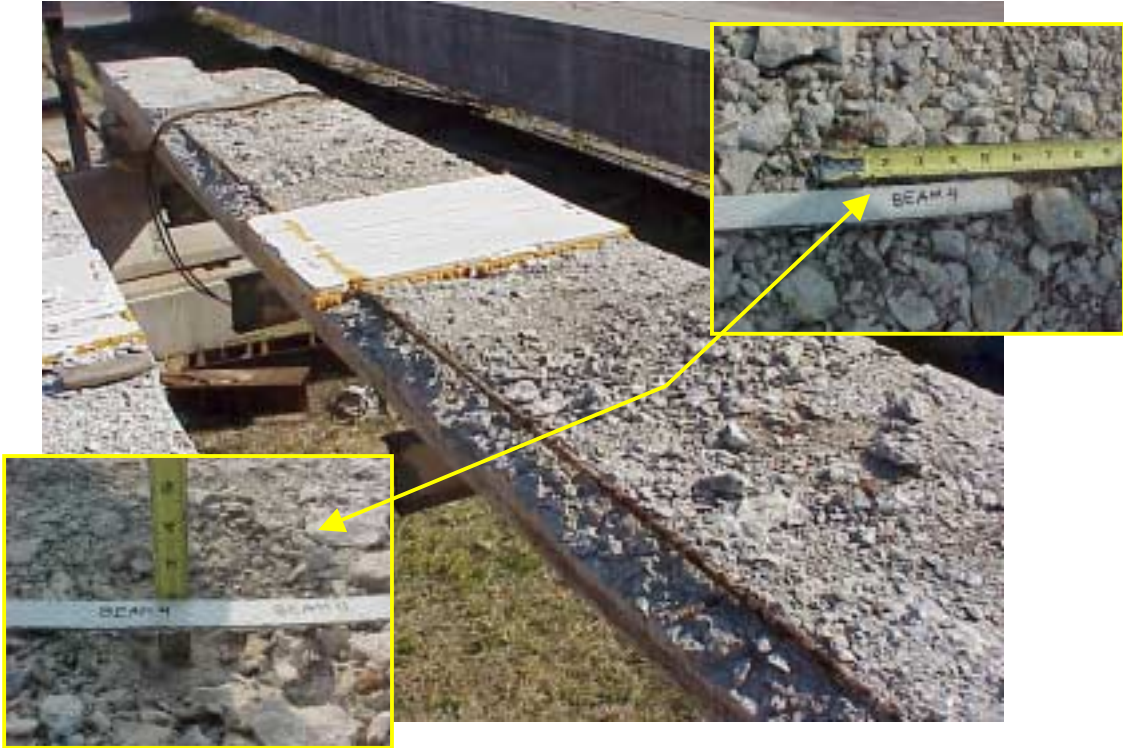
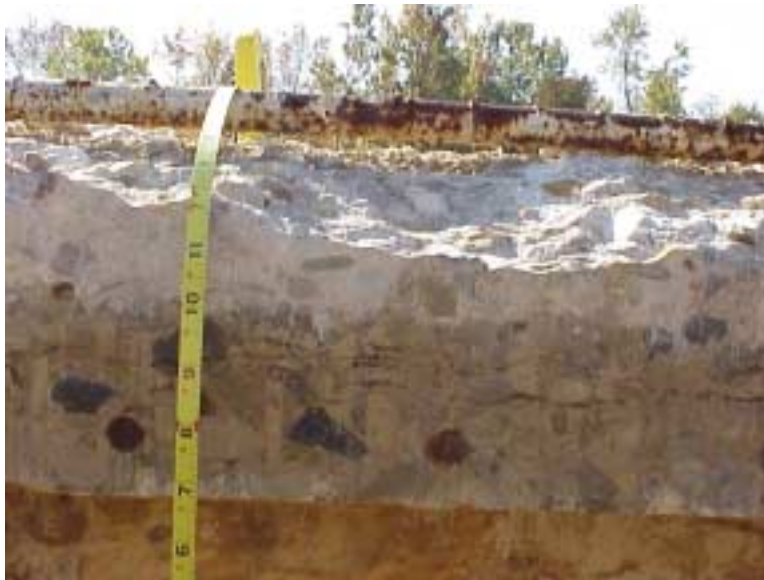
Figure A. 2 (Cont.) Existing Damage and Crack Pattern – Beam 4

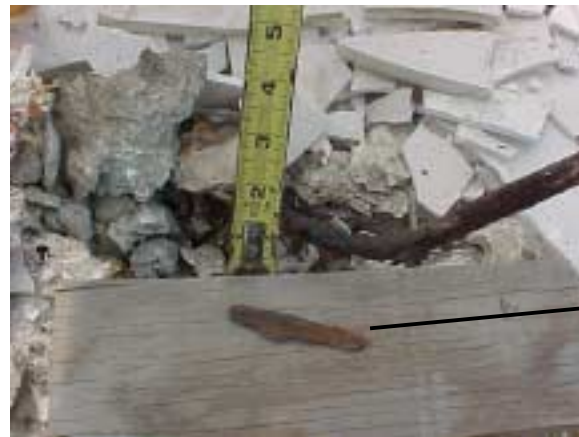
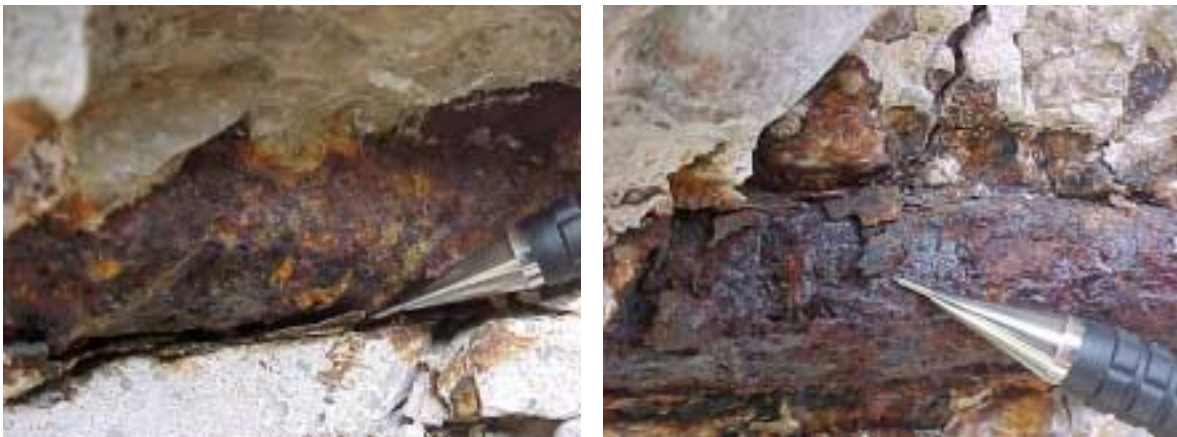
Piece of rusted
bar that came off

Figure A.3 Typical Corrosion in Reinforcing Bars

MPa, 426 MPa, 166,600 MPa, and 31%, respectively. The longitudinal bars in the test beams had evidently corroded as suggested by rust stains on the concrete surface. At the conclusion of testing, corrosion of the bars was verified visually by exposing the bars. The concrete was a standard 1:2:4 mix that was typical for bridges built in the 1920's. Attempts to core the slab in all the beams failed because of the significant level of deterioration in the slab. A standard rebound hammer in conjunction with ASTM C805 was alternatively used to establish the concrete strength. The equivalent cylinder strength of each beam is summarized in Table 1.

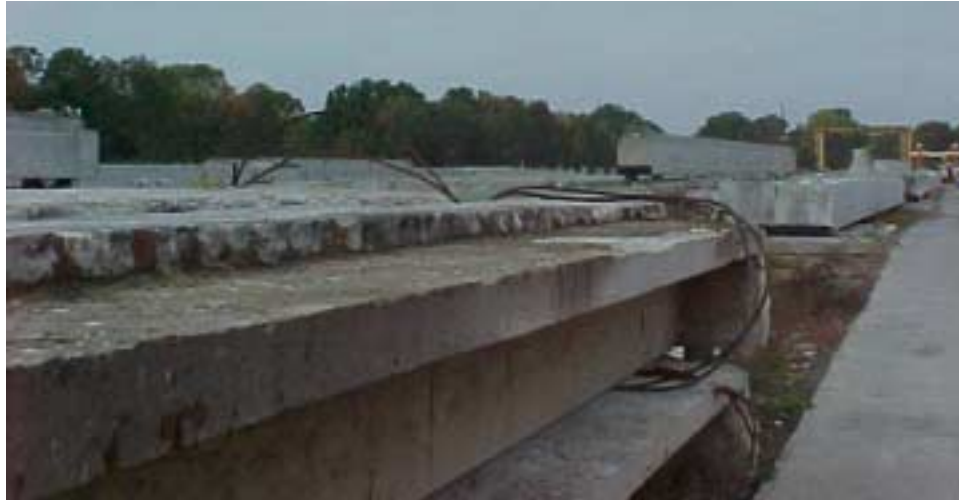
(b) Top View of Beam Showing Flange Thickness After Chipping

Figure A. 4 Flange in Beam 3

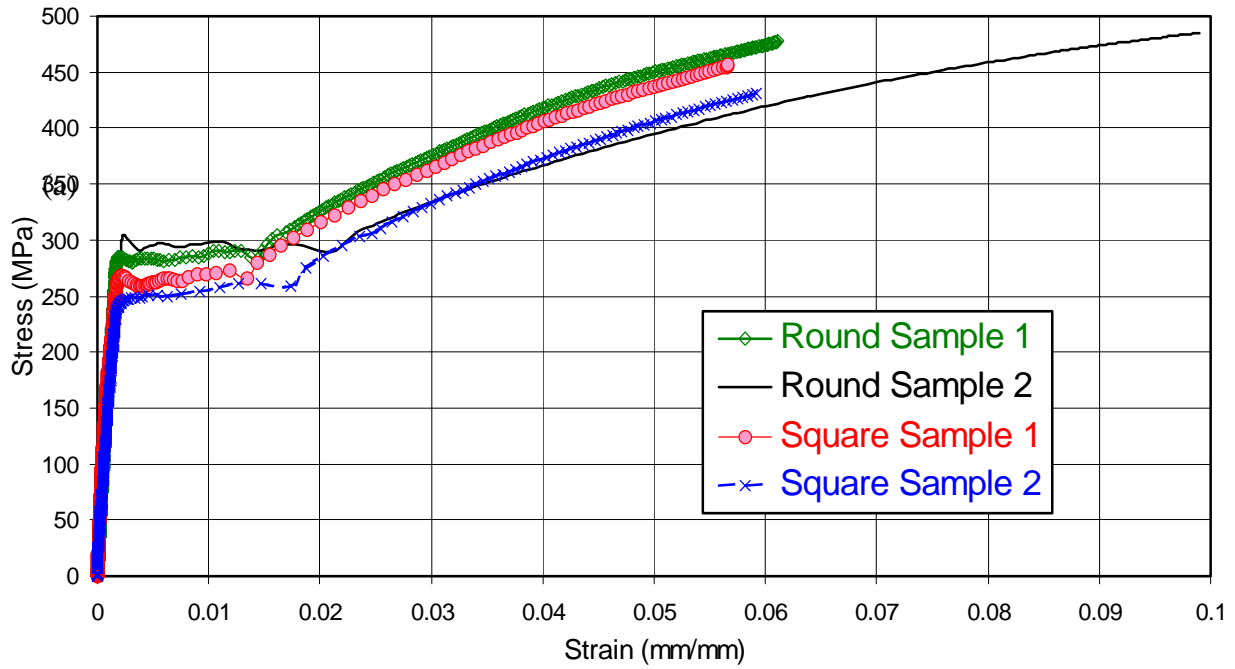
(a) Stress-Strain Curves

Specimen	F_y (MPa)	F_u (MPa)	F_f (MPa)	E_s (MPa)	ϵ_f (%)
Round # 1	288	554	479	181375	32.3
Round # 2	293	504	421	136742	31.9
Square # 1	269	502	408	209506	28.0
Square # 2	261	487	395	138775	31.5

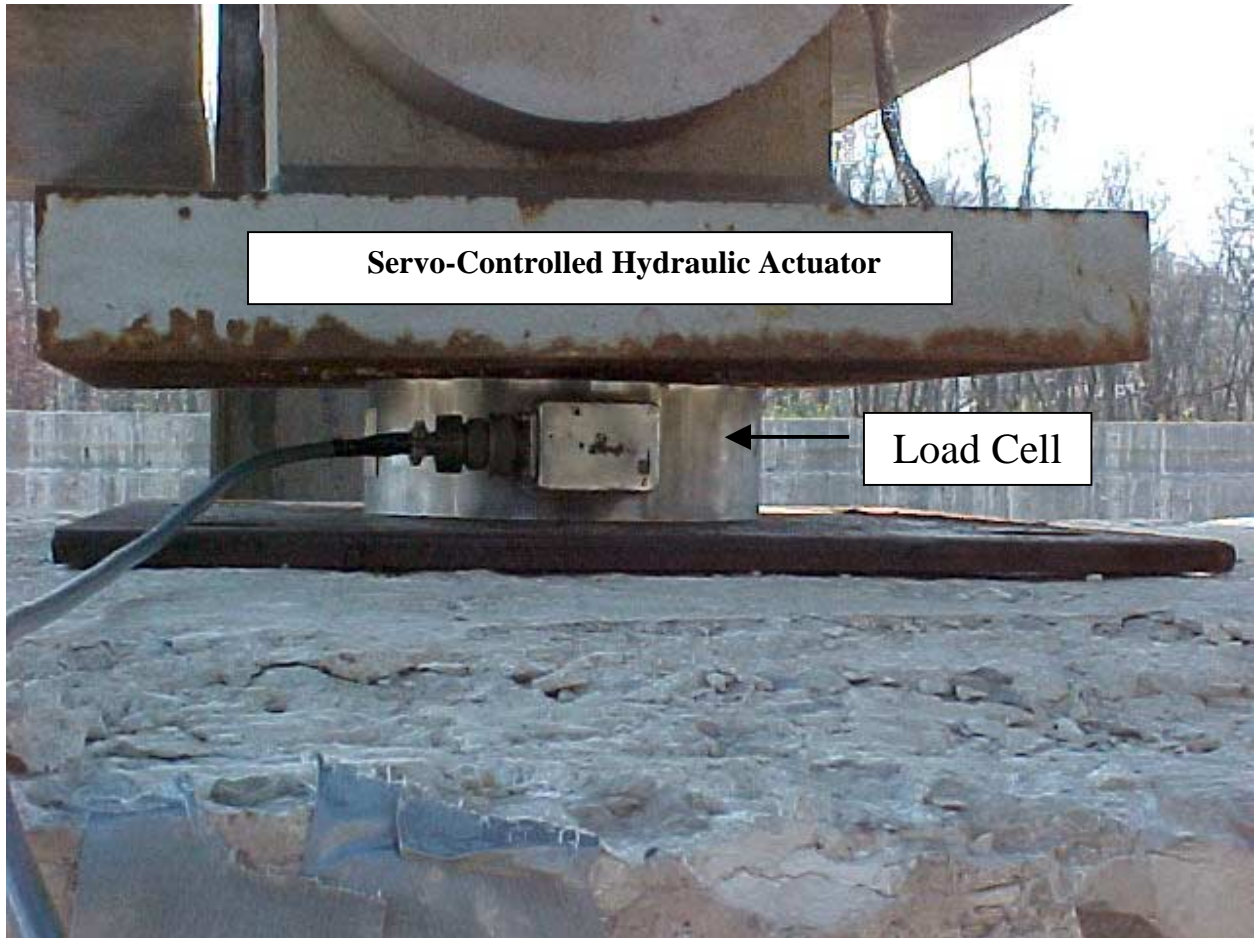
Figure A.9 Picture of Load Cell in Test Setup Before Installation of FRP

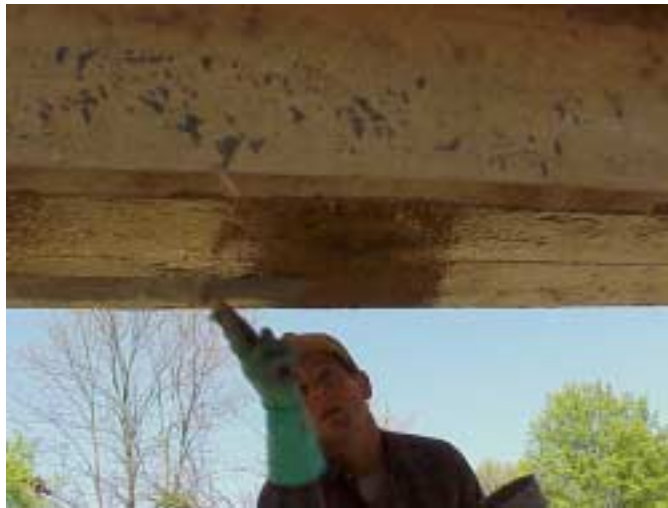
Application of Structural Epoxy on Primed Surface

1. Clean the concrete surface with high-pressure steam. Repair any deteriorated or spalled areas of the concrete to ensure that concrete surface is of good sound condition. The surface must be roughened to a coarse sandpaper texture either by sandblasting, shotblasting, or scarifying with a toothed grinder. The surface must be cleaned of all dirt and debris, and be free of all apparent moisture.
2. Mark the locations of the plates.
3. Apply FRS Epoxy Primer to the prepared surface by using a paint roller. Allow primer to dry for a minimum of thirty minutes. Mix the FRS Structural Epoxy in accordance with the manufacturer's directions, and apply a layer of FRS Structural Epoxy to the prepared concrete surface using a 3.175-mm v-notched trowel. The epoxy must fill any voids and uneven areas.

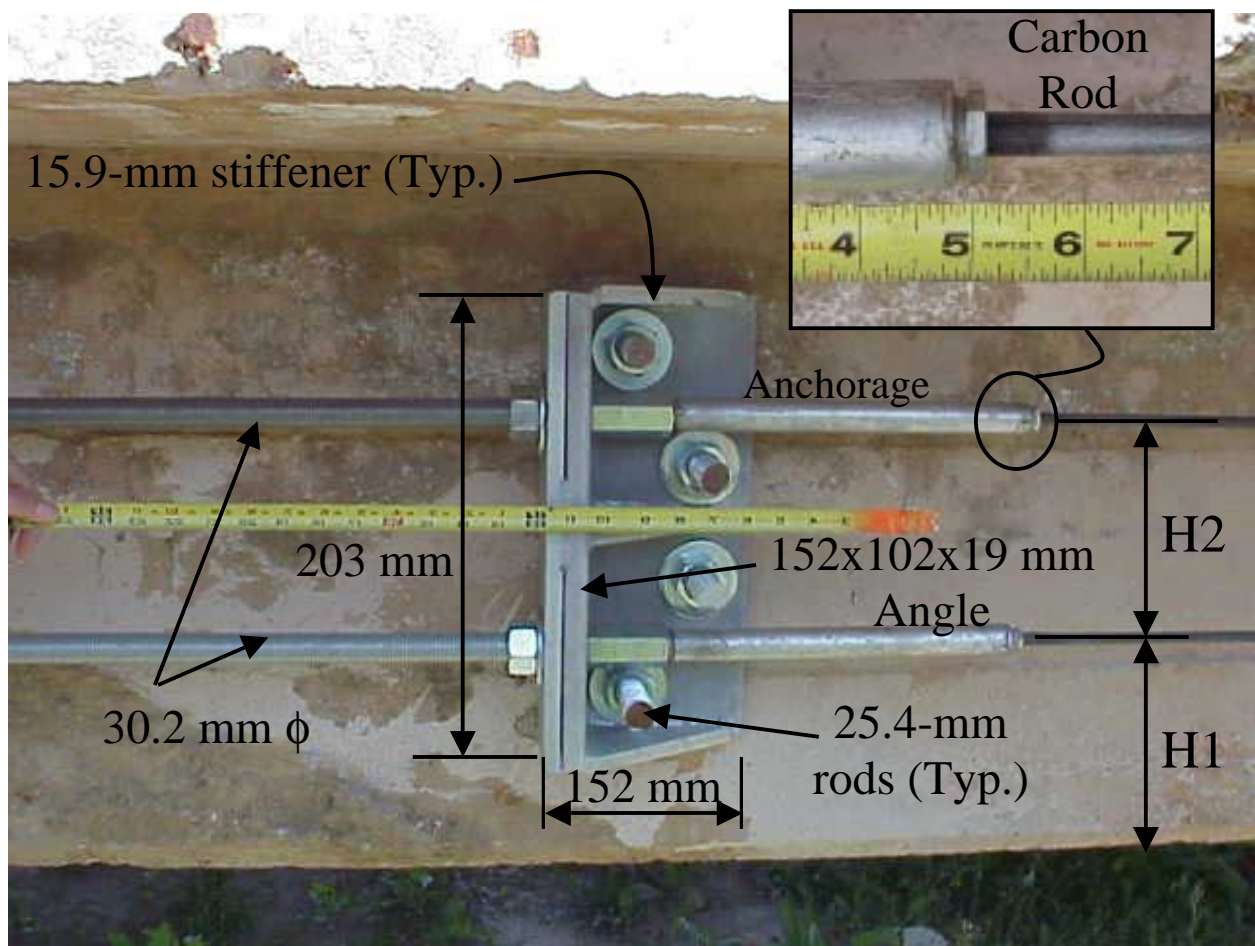
Location	H1 (mm)	H2 (mm)
North Face – East Anchor	216	178
North Face – Middle	229	178
North Face – West Anchor	216	178
South Face – East Anchor	219	178
South Face – Middle	222	178
South Face – West Anchor	216	178

East anchors were 4,560 mm from the center line.
 West anchors were 4,064 mm from the center line.

Figure A.10 Anchor System in Beam 1

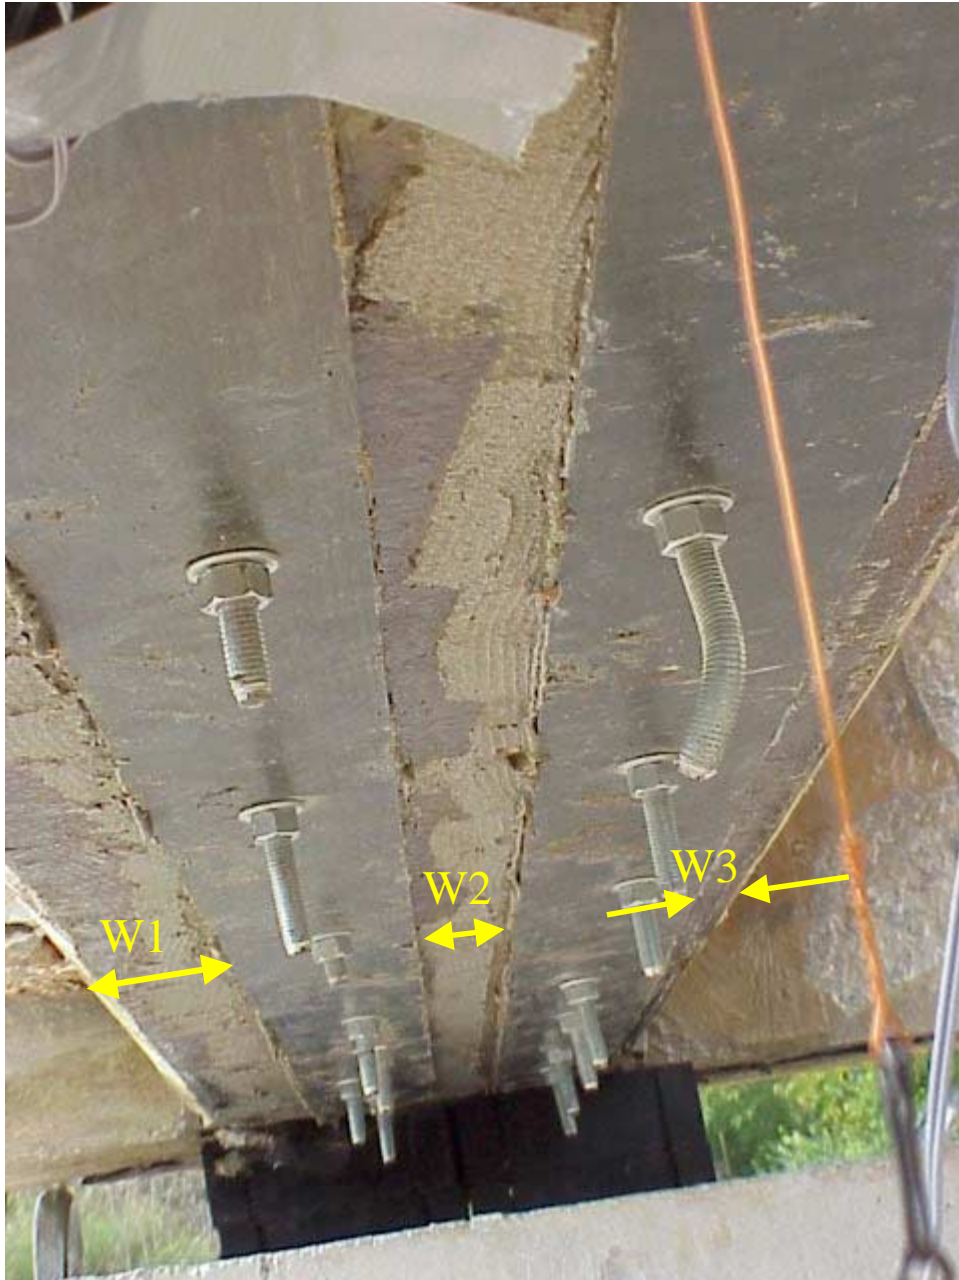
W1 = 25.4 to 76.2 mm
W2 = 50.8 to 76.2 mm
W3 = 19.1 to 44.5 mm

Figure A. 15 Locations of Bolted Plates in Beam 4

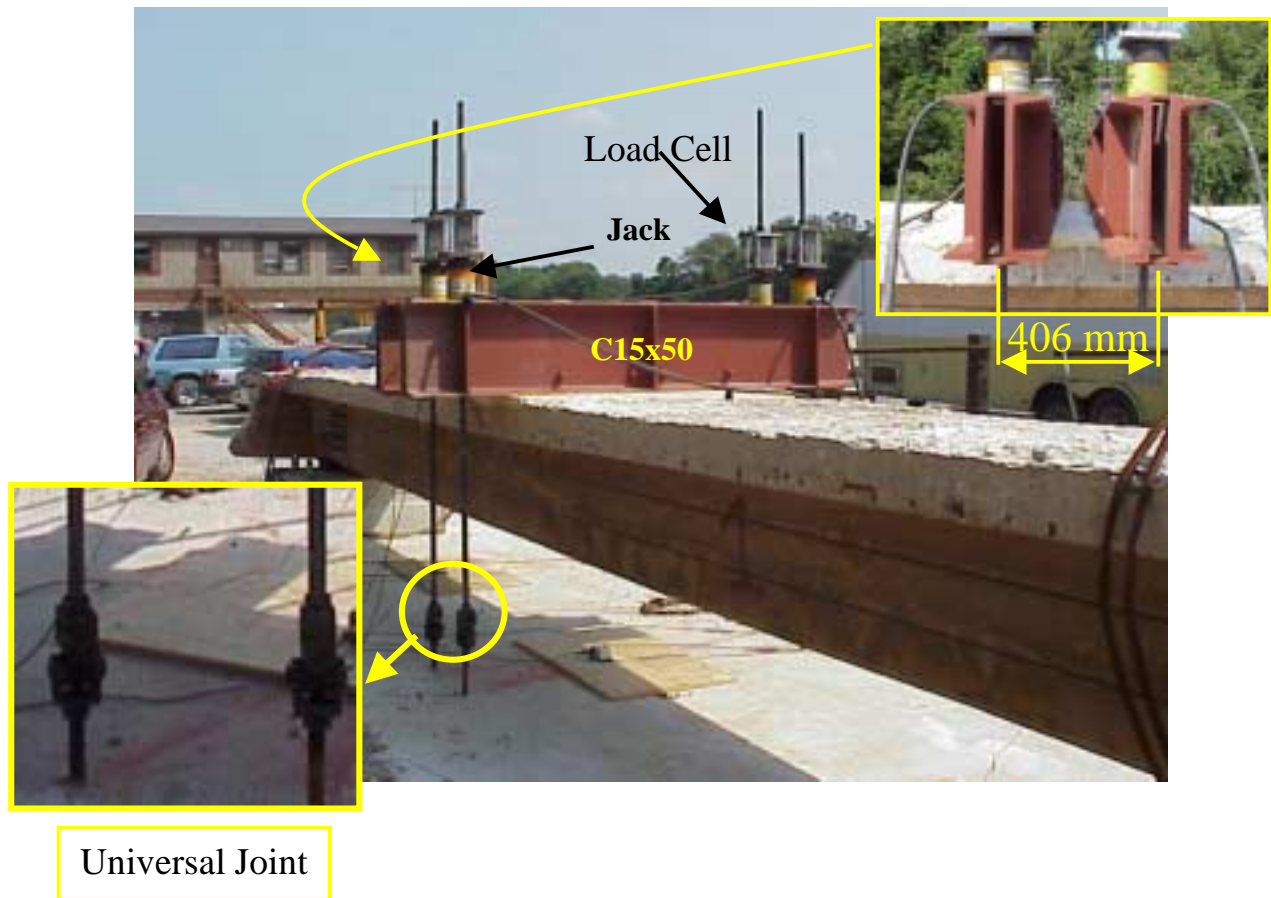
Figure A.16 Test Setup After Installation of FRP Systems

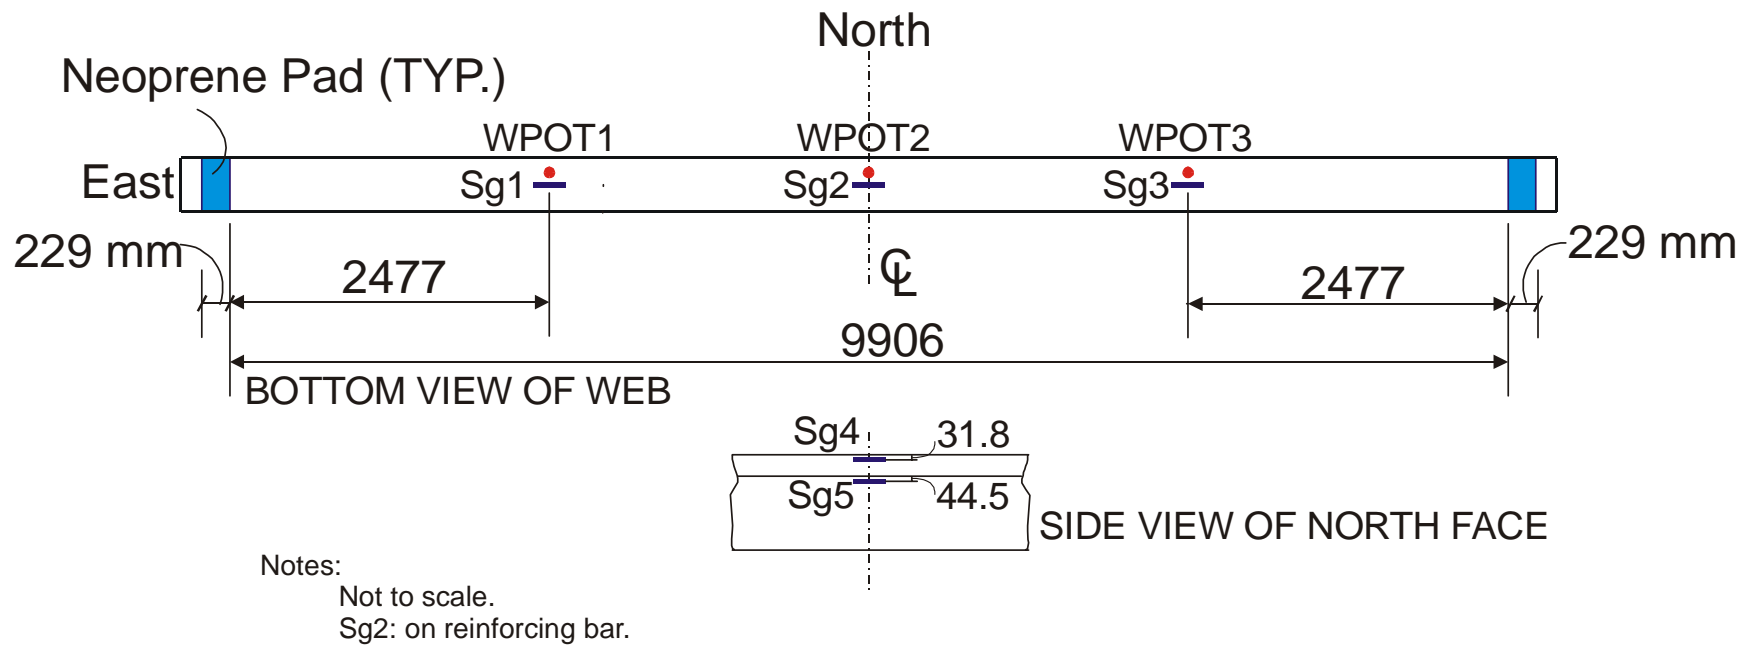
Figure A.17 Instrumentation for Beam 1 After Installation of FRP Systems
