**RETROFIT OF EXISTING REINFORCED CONCRETE
BRIDGES WITH FIBER REINFORCED
POLYMER COMPOSITES**

Report No. UC-CII 01/01

A Report to Sponsor:
Federal Highway Administration
And
Ohio Department of Transportation

Retrofit of a Three-Span Slab Bridge with FRP Systems – Testing and Rating

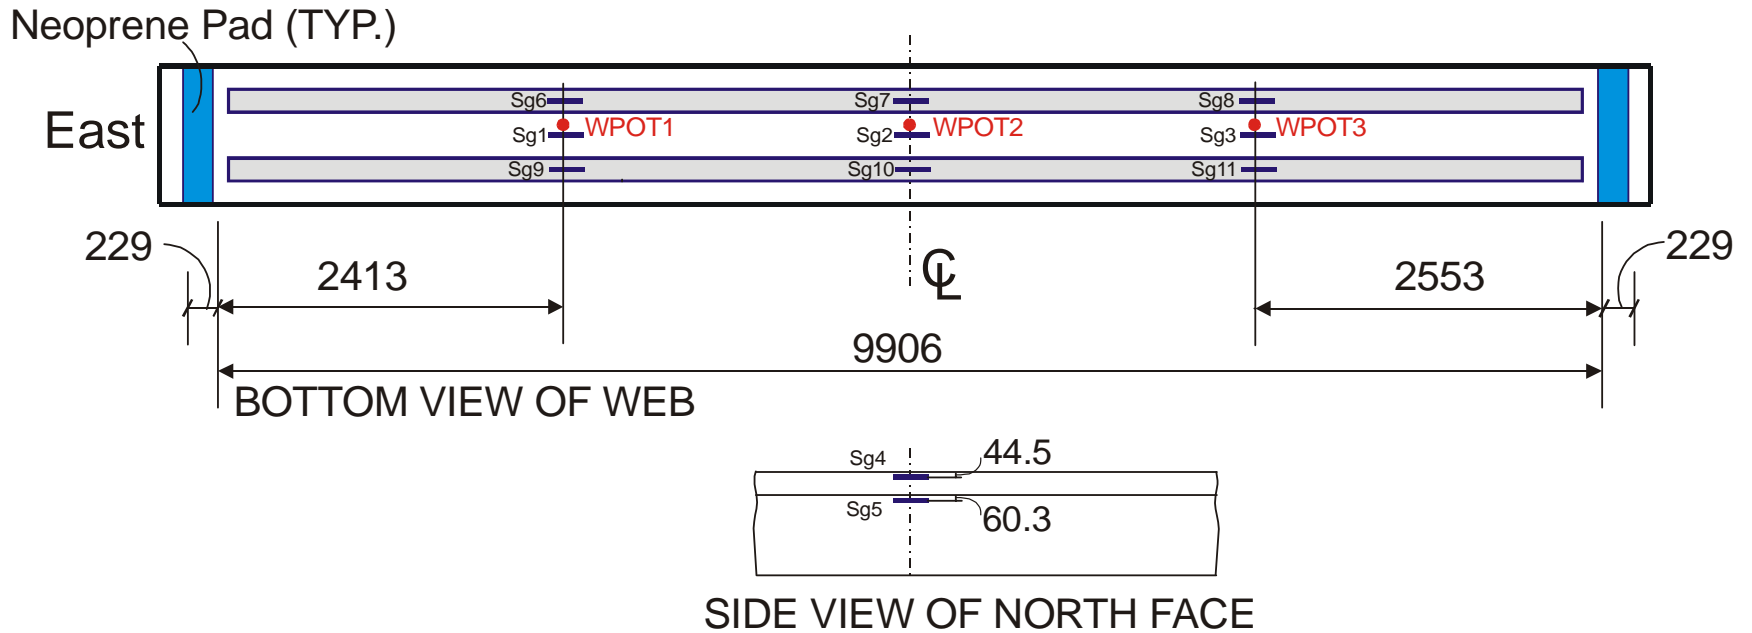
Sg2: on reinforcing bar.

Figure A.18 Instrumentation for Beam 2 After Installation of FRP Systems

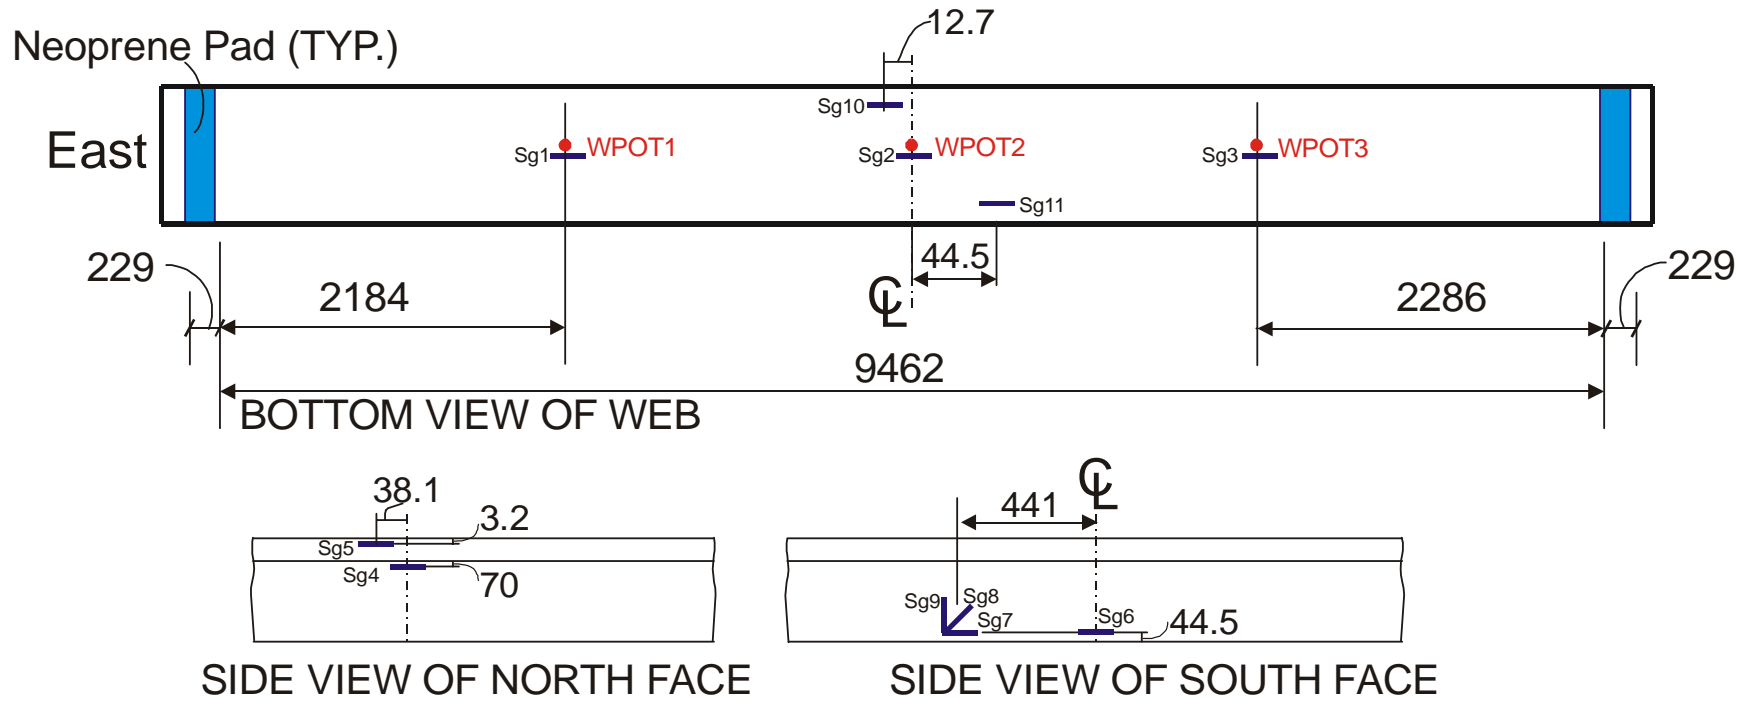
- Not to scale.
- Sg2: on reinforcing bar.
- Sg1 and Sg3: on concrete surface under longitudinal fabric.
- Sg10: on transverse fabric on the bottom.
- Sg11: on longitudinal fabric on the bottom.

Figure A.19 Instrumentation for Beam 3 After Installation of FRP Systems

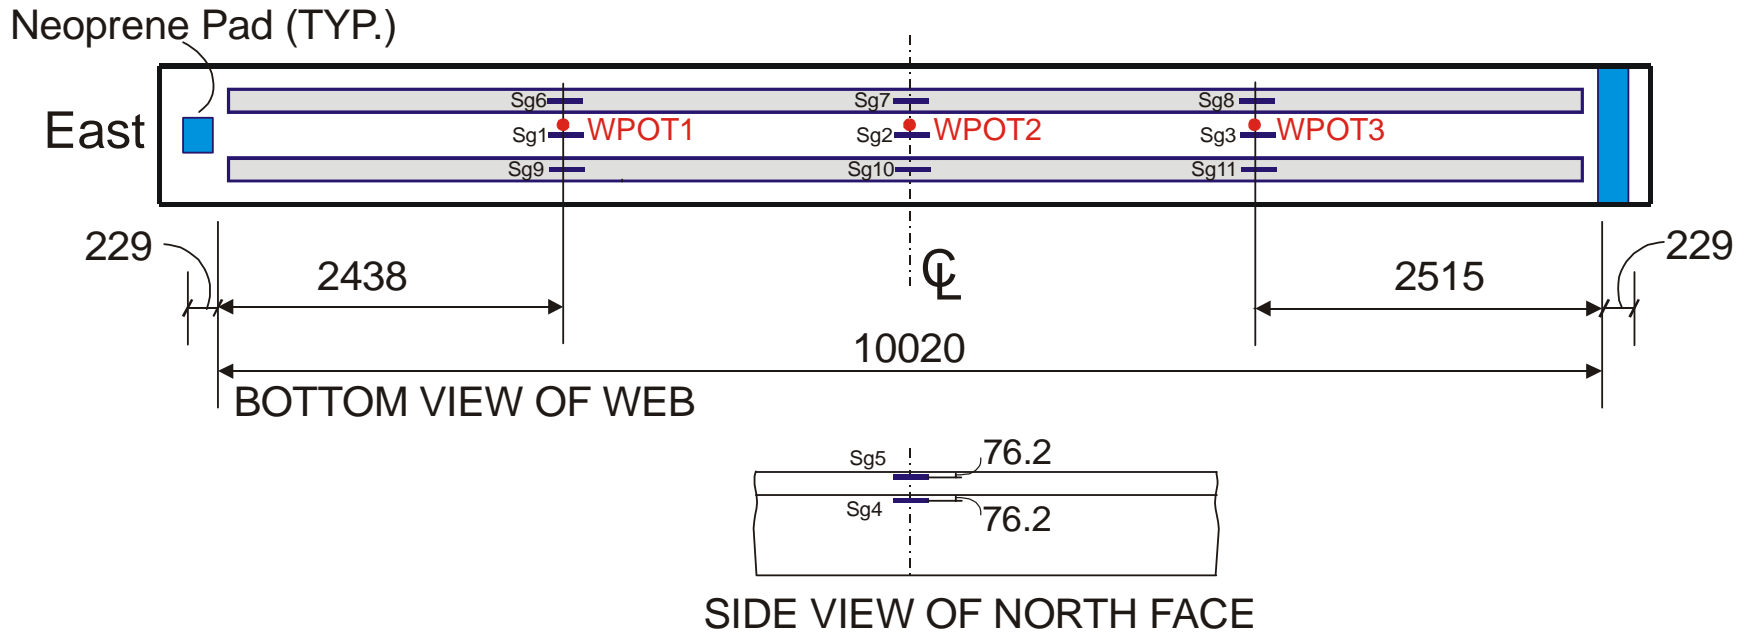
Sg2: on reinforcing bar.

Figure A.20 Instrumentation for Beam 4 After Installation of FRP Systems

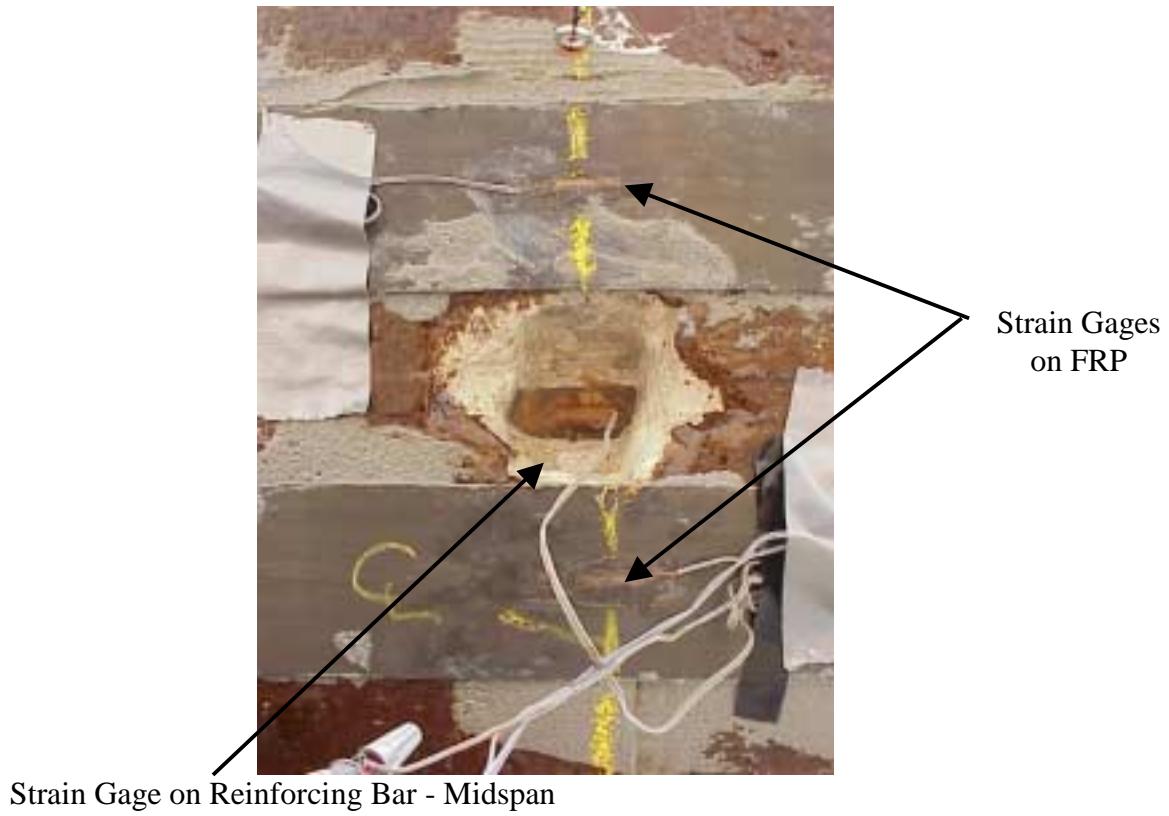
(a) Strain Gages on Steel and FRP

(b) Load Cell for Monitoring of Loss of Pre-Stressing Force in Beam 1

Figure A.21 Pictures of Additional Instruments After Installation of FRP Systems

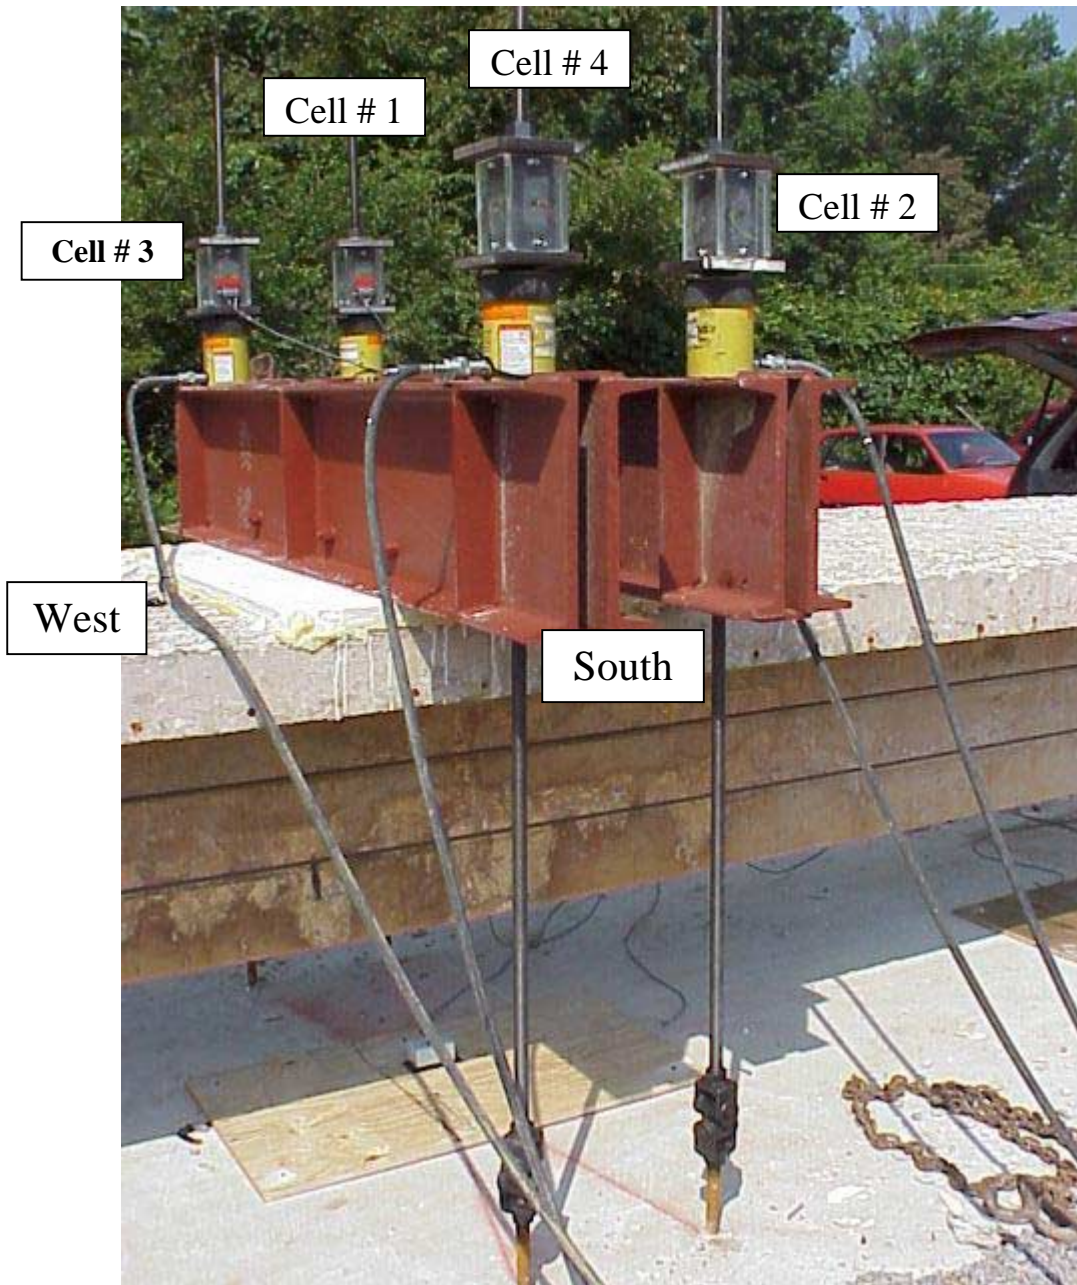
(c) Location of Load Cells

Figure A.21 (Cont.) Pictures of Additional Instruments After Installation of FRP Systems

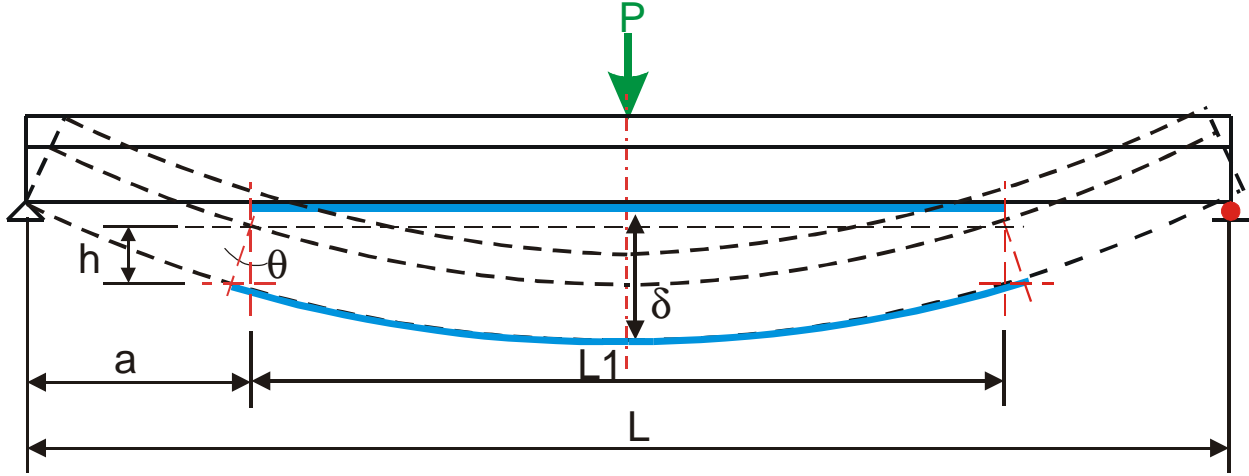
Figure 1

Refer to the figure shown below. In this figure, the deflections are magnified for illustration purposes.

Assume that a second-degree parabola represents the equation of the elastic curve, i.e., $y=ax^2+bx+c$. By imposing the boundary conditions of @ $x=0: y=0$, @ $x=0.5L: y=\delta$, and @ $x=0.5L: dy/dx=0$, this equation is simplified to $y = -\frac{4\delta}{L^2}x^2 + \frac{4\delta}{L}x$. After the beam deforms, the

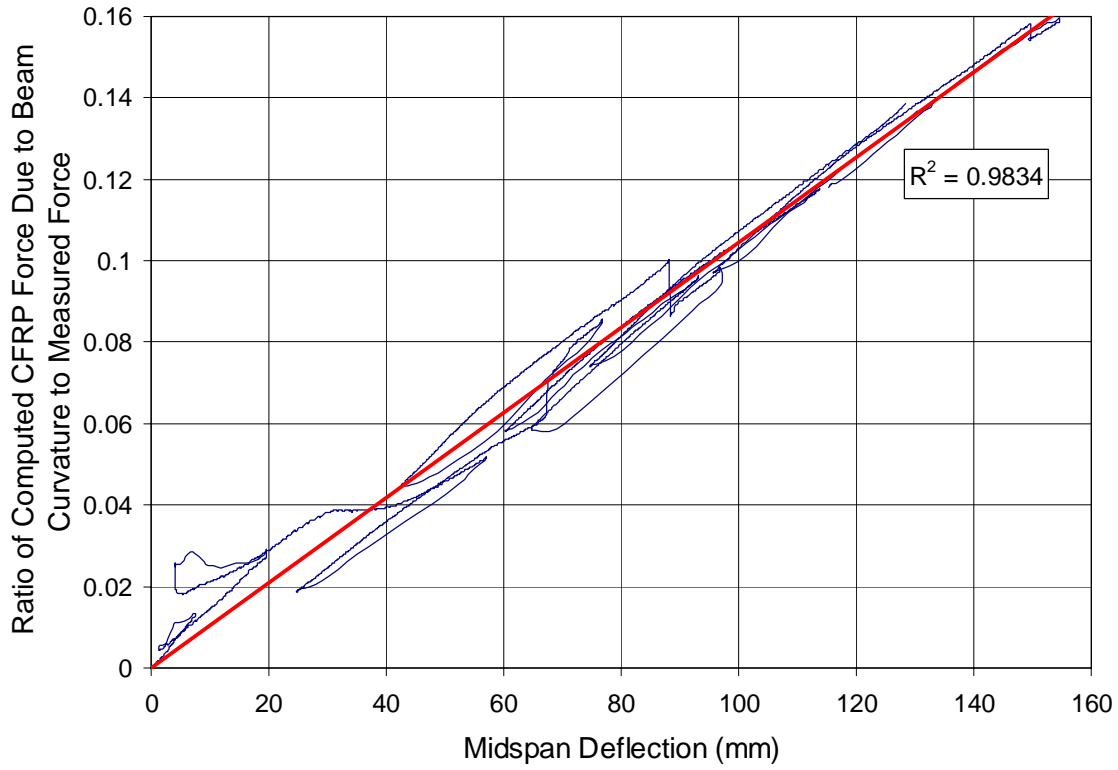
Figure 2 Contribution of Beam Curvature to Force in CFRP Plates

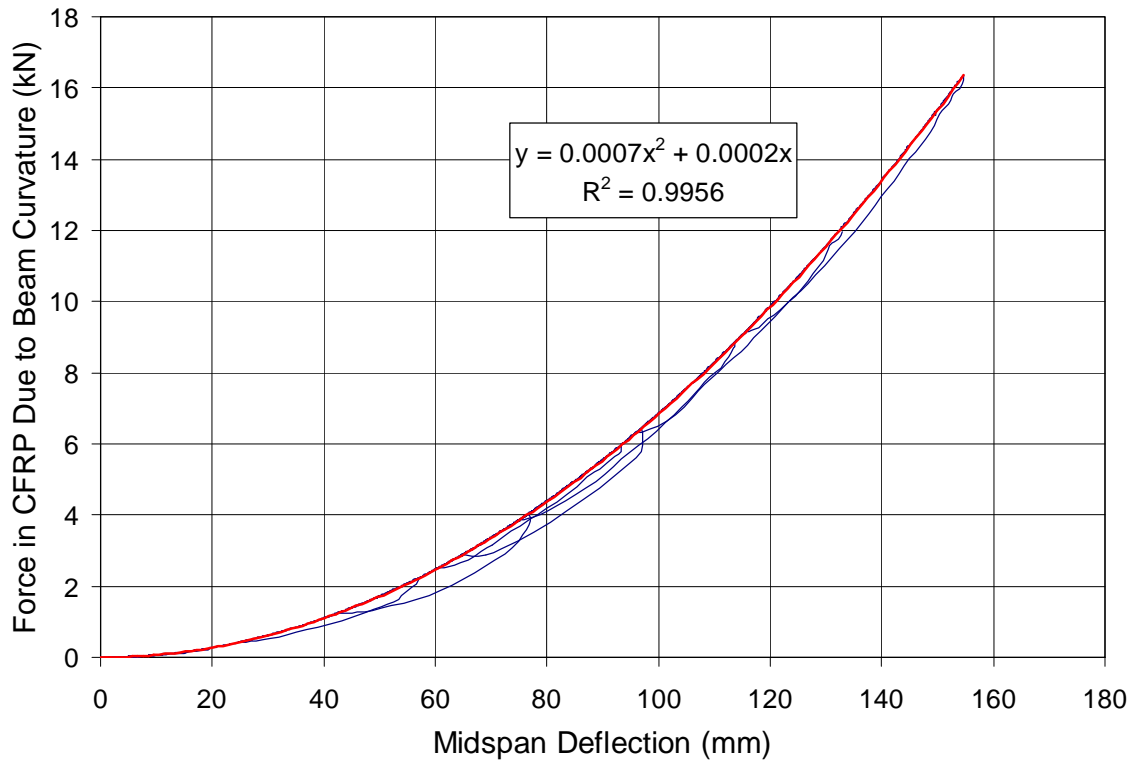
Figure 3 Simplification of Force in CFRP Plates due to Beam Curvature

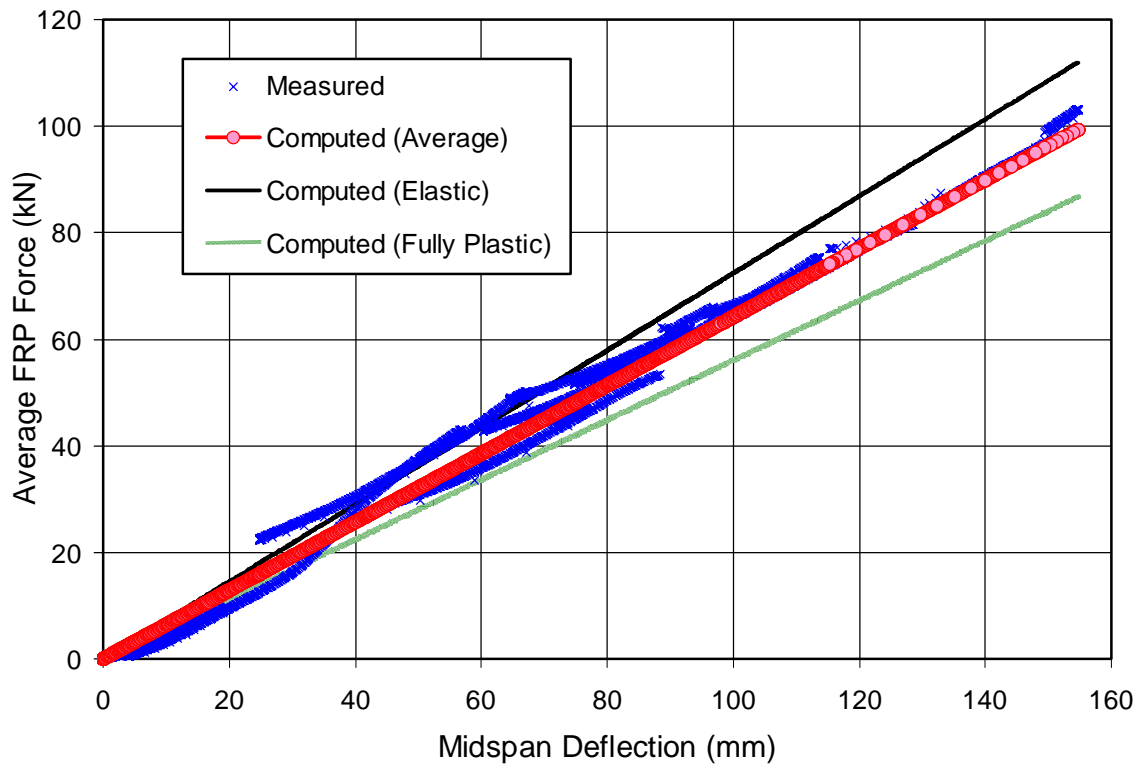
Figure 4 Verification of Analytical Model for Computing Force in CFRP Plates

As seen from Figure 5, the measured force in the CFRP plates is bracketed by the computed values. Since the beam is neither completely elastic nor fully plastic, the average value of the coefficients for the elastic case and fully plastic case may be used, i.e., $F = 0.642\delta$. The resulting computed force in the CFRP plates matches the measured force (Figure 5) remarkably well. The aforementioned model provides a simple, yet effective method, to compute the expected force in the CFRP plates as a function of the midspan deflection.

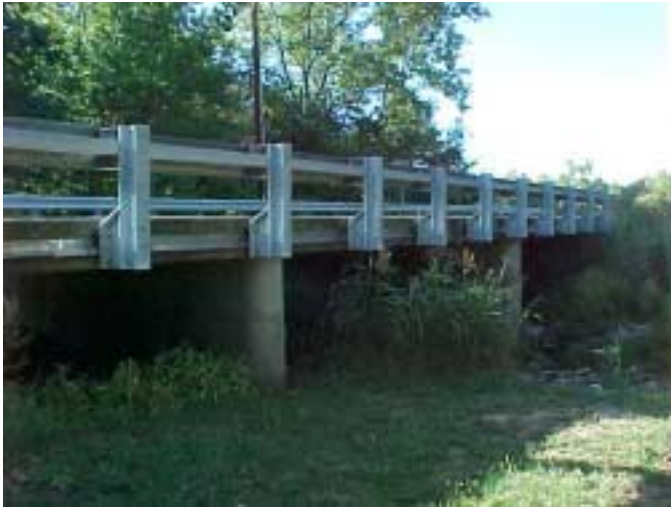
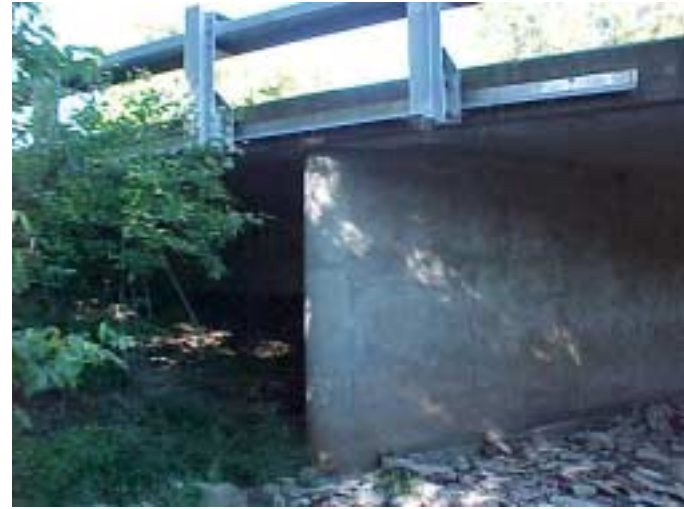
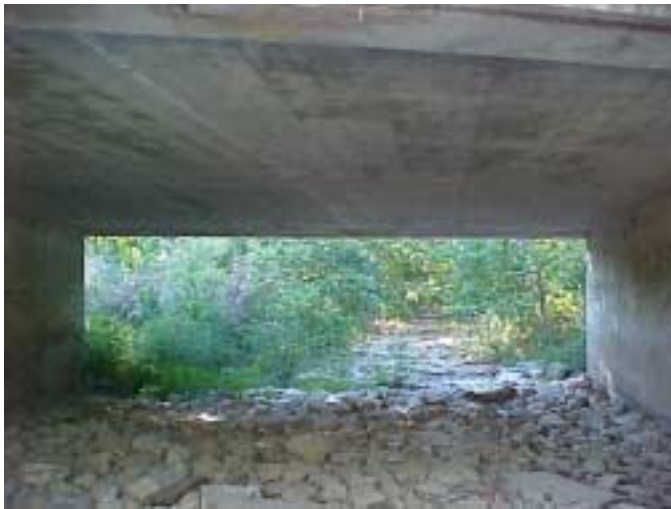
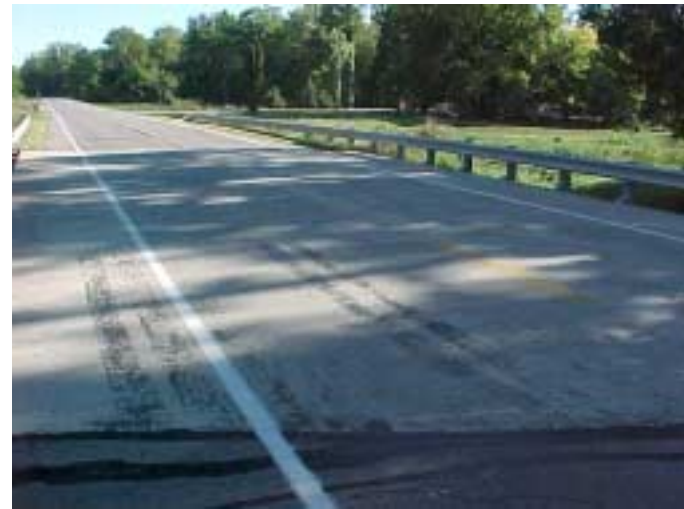
Figure B.1 Photographs of Test Bridge Before Repair

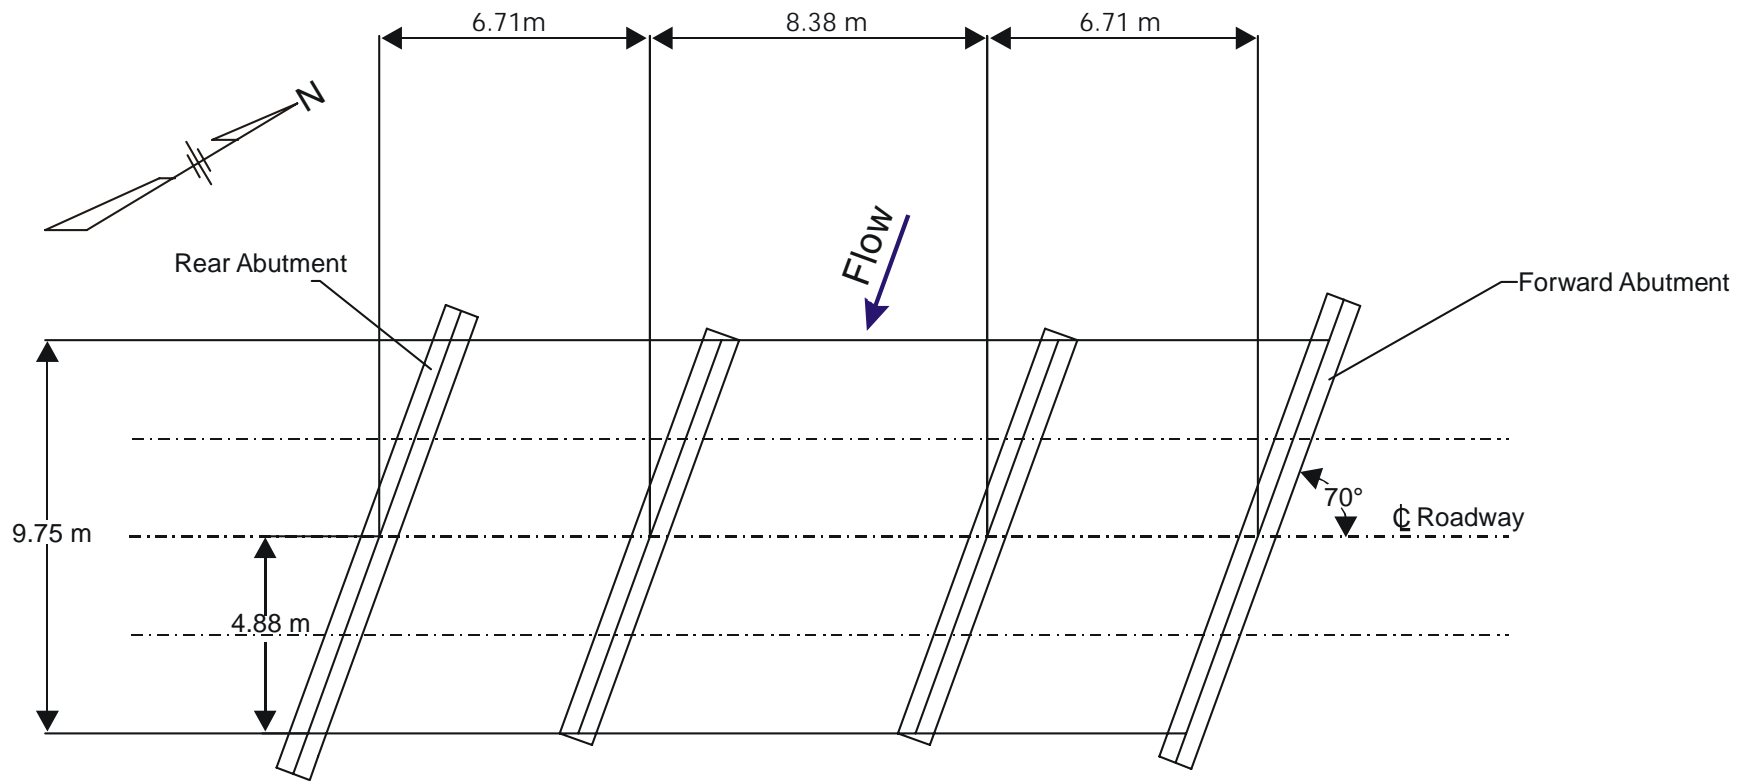
Figure B.2 Plan View of Test Bridge

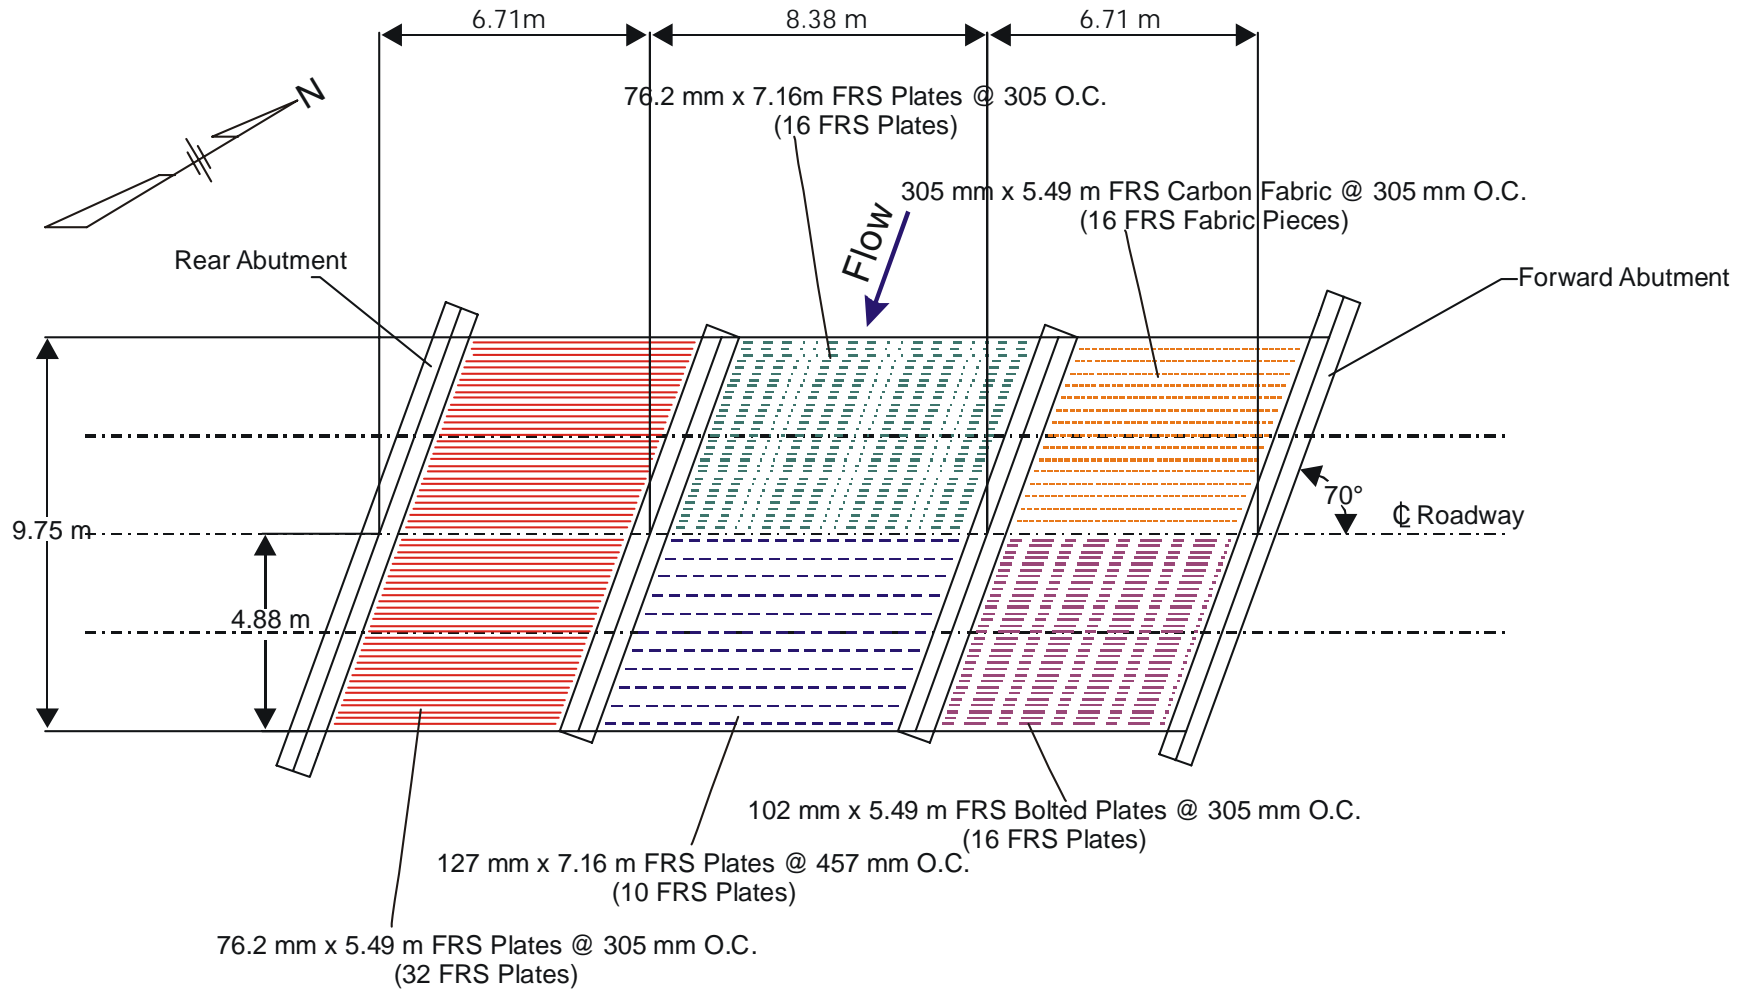
Figure B.4 Locations of Various FRP Systems

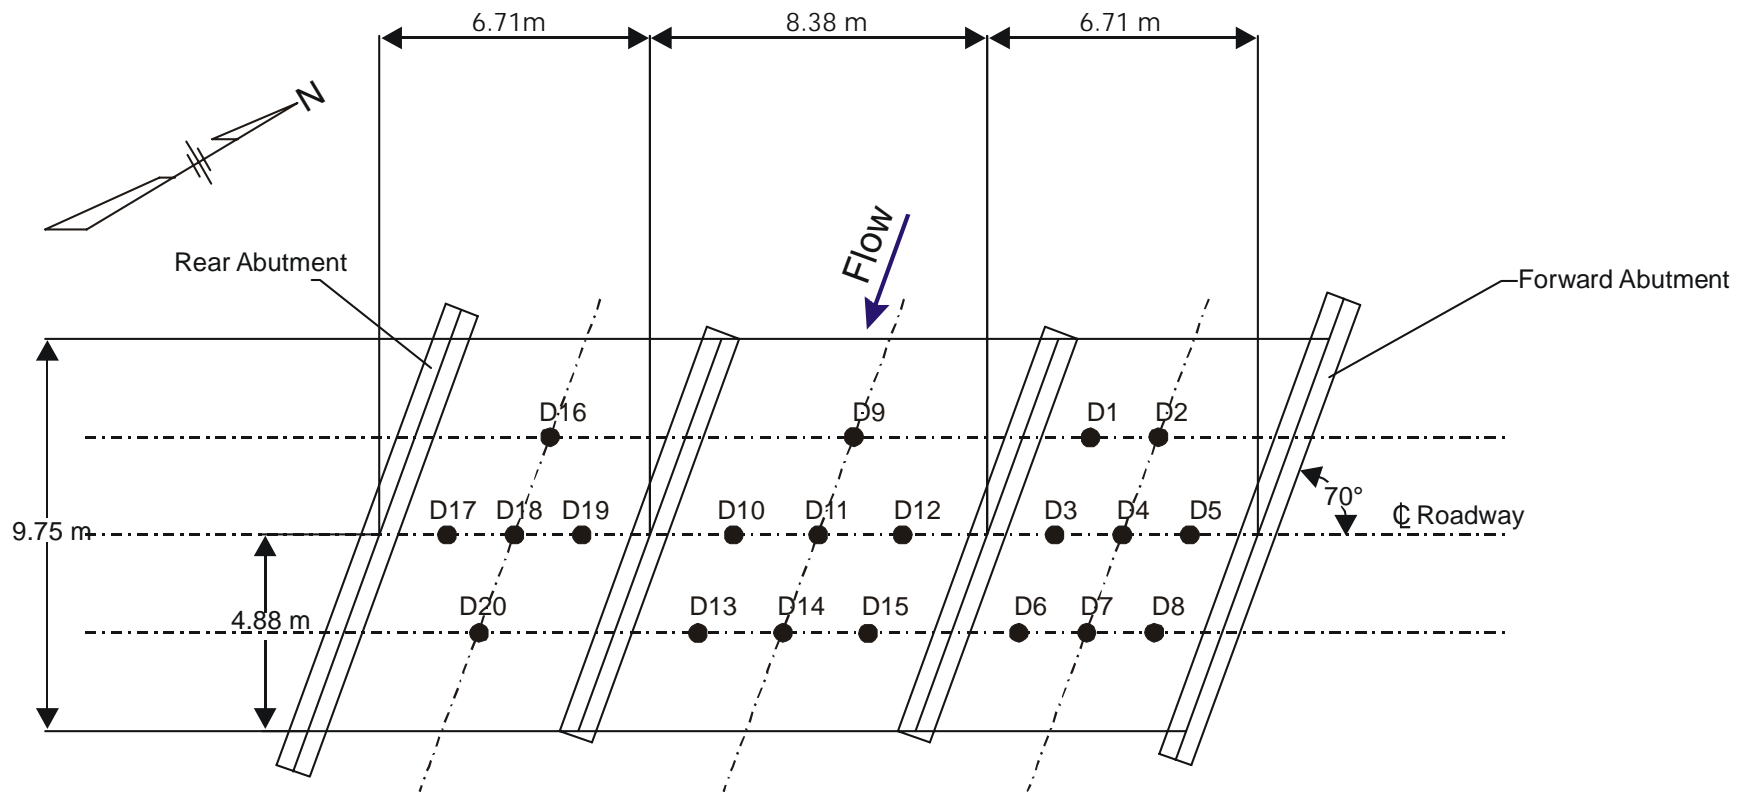
Figure B.7 Location of Displacement Transducers to Measured Slab Vertical Deflections

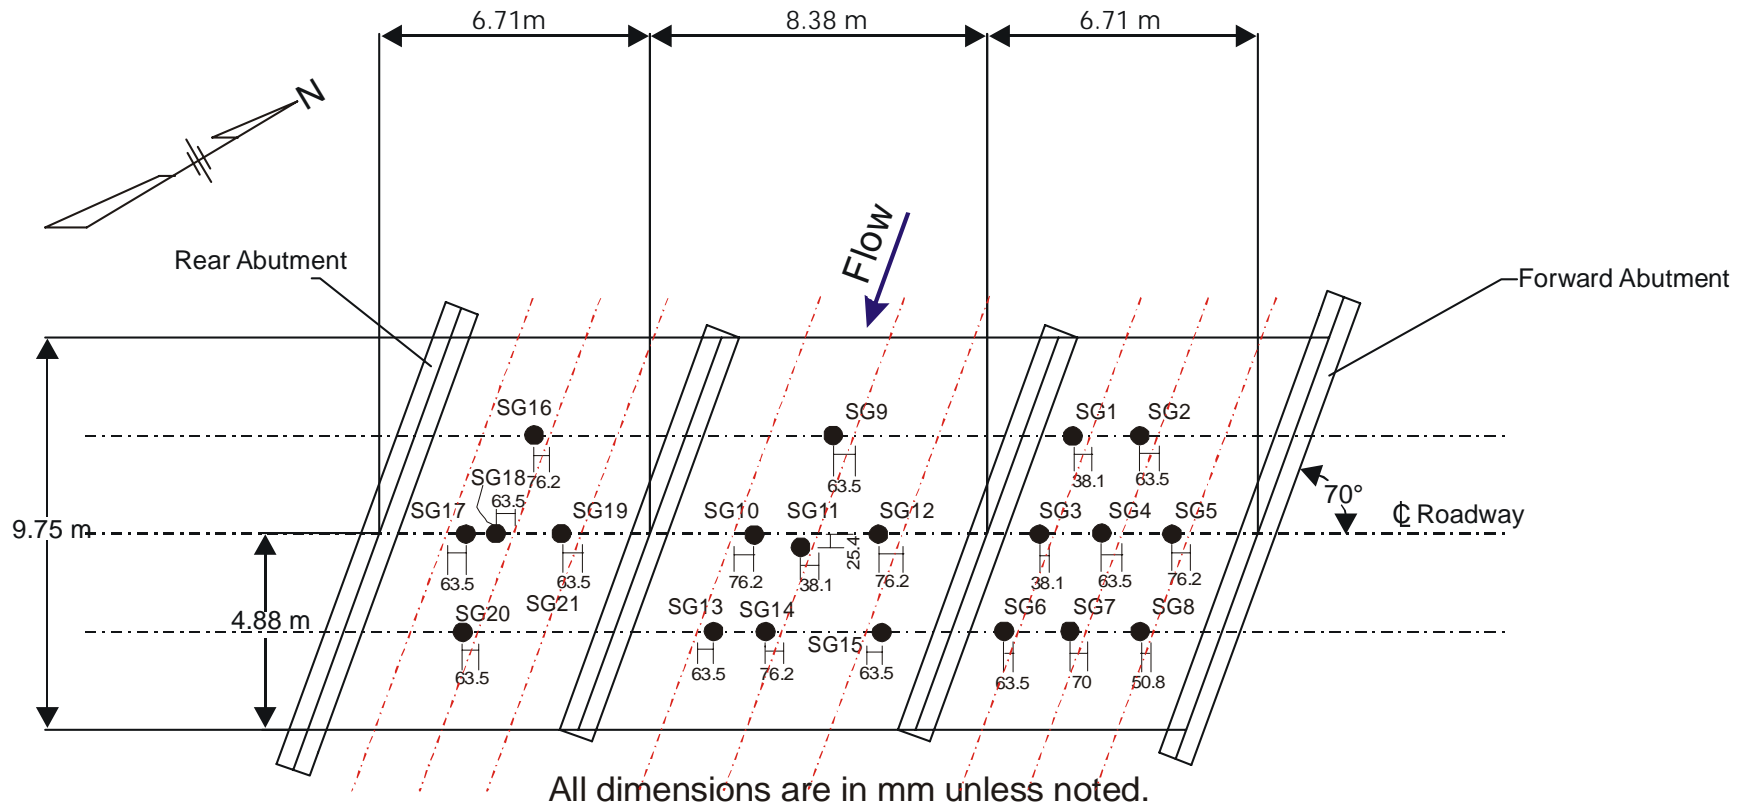
Figure B.8 Locations of Strain Gages Mounted on Bottom Surface of Slab – Before Retrofit

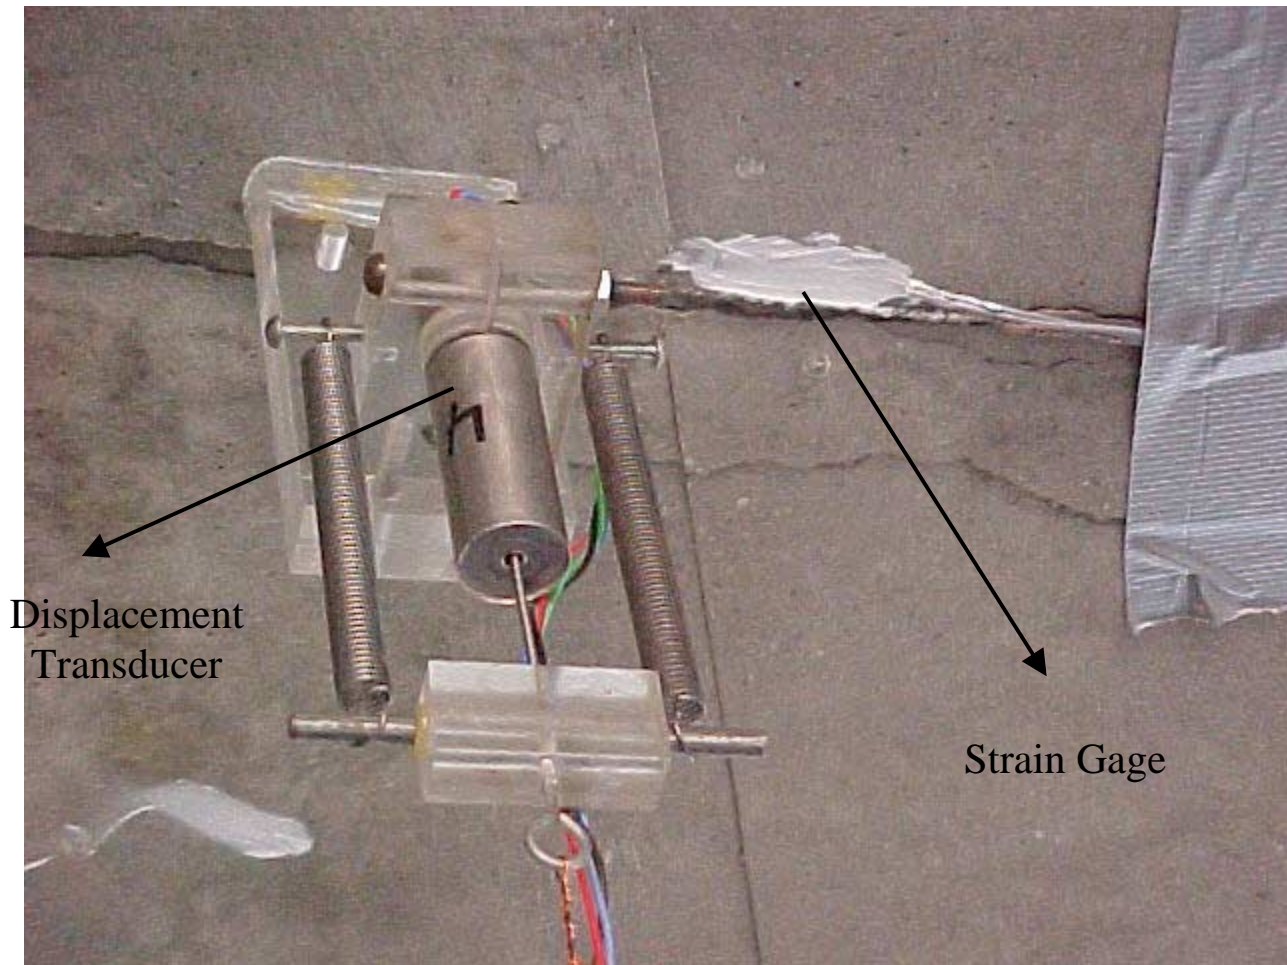
Figure B.10 Photographs of Representative Displacement Transducer and Strain Gage

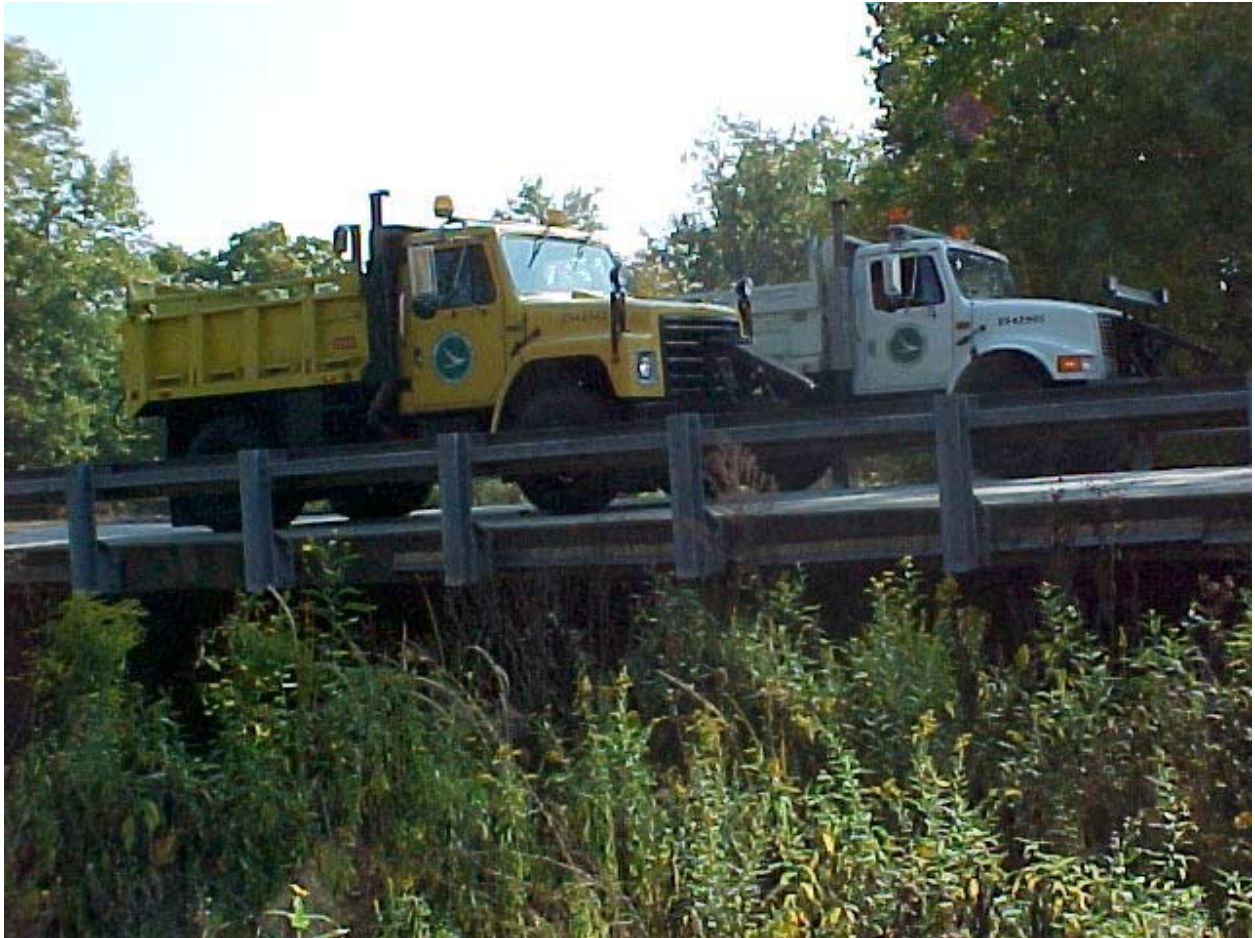
Figure B.12 Photograph of Trucks During Truck Load Tests

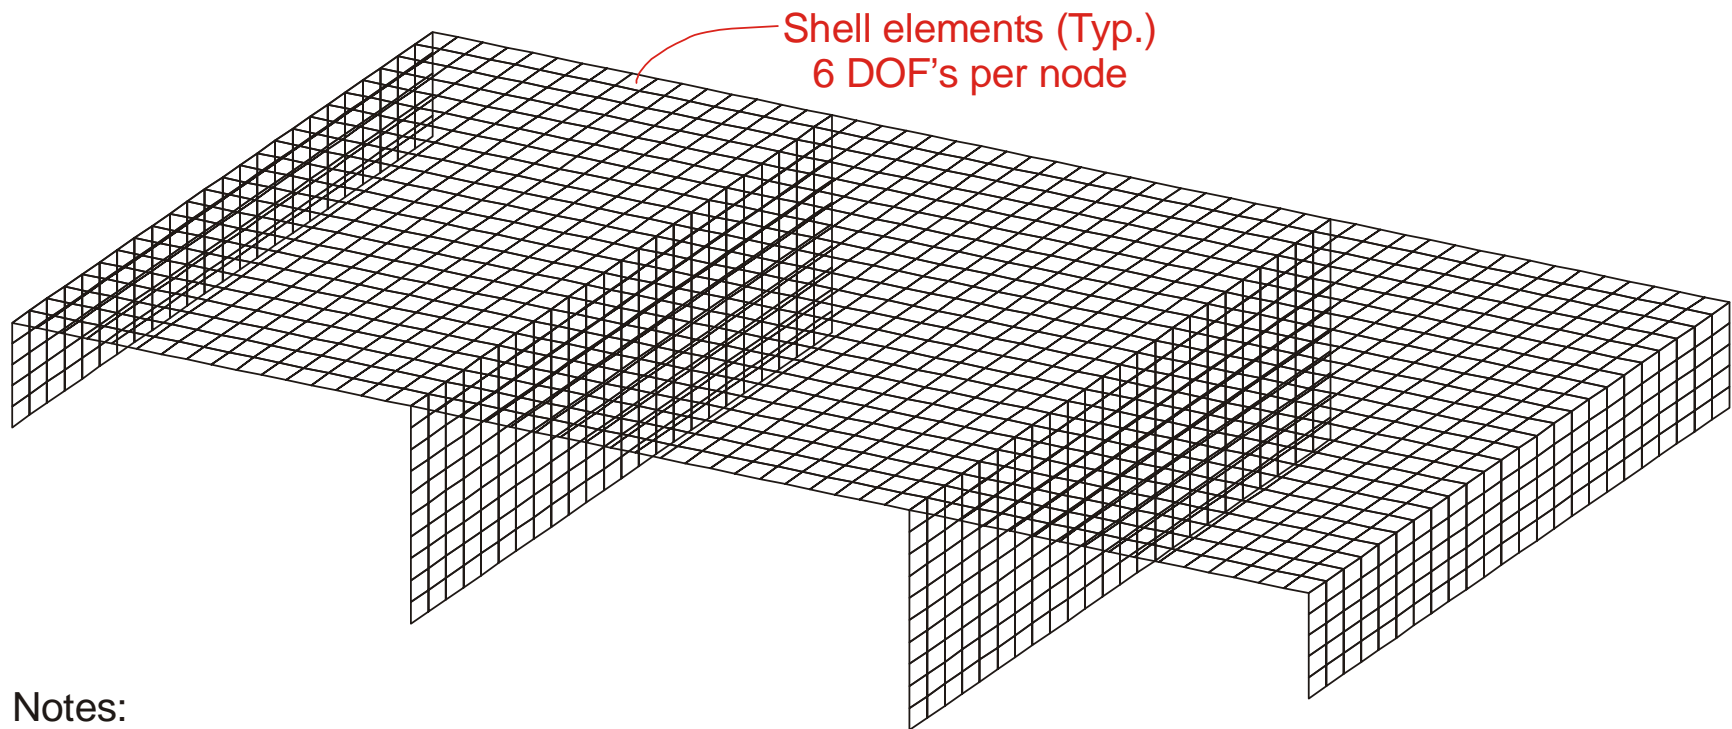
1. All DOF's are fixed at the base of abutment and pier elements.
2. Rotational springs in x, y, and z with $K_{\theta} = 16,948 \text{ kN-m/rad}$. were used at all adjacent nodes in the slab shell elements and in the abutment/pier shell elements.
3. Translations in x, y, and z directions are the same at all adjacent nodes in the slab shell elements and in the abutment/pier shell elements.

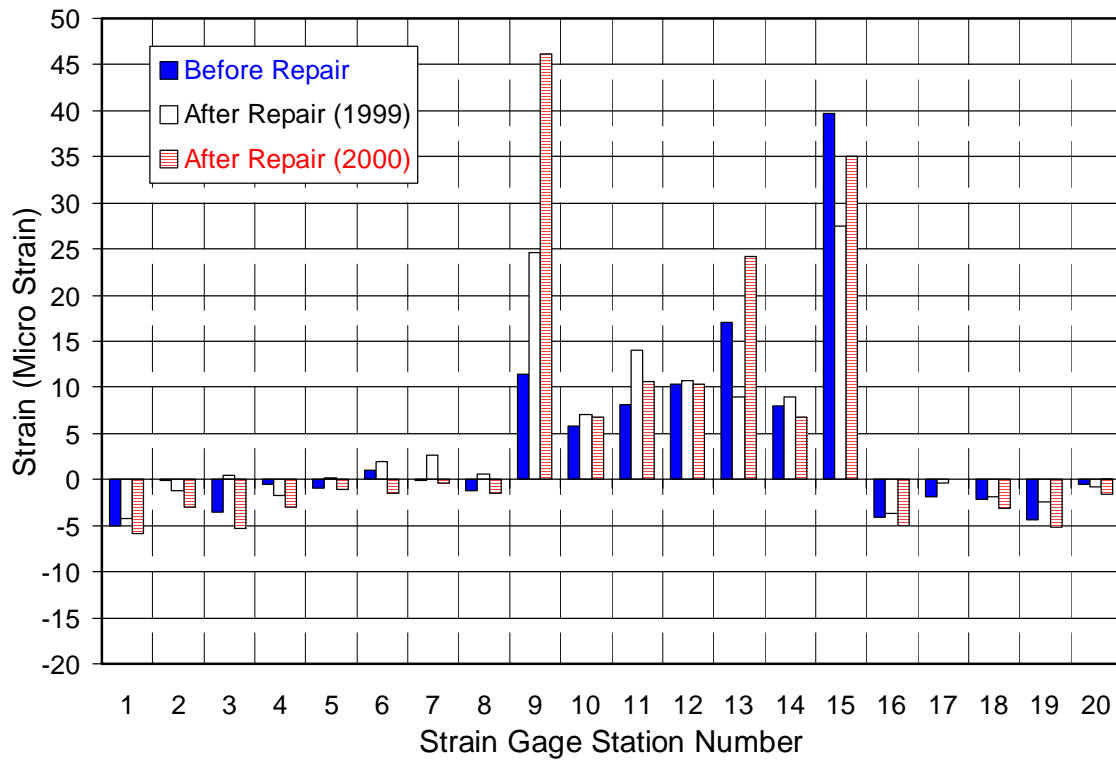
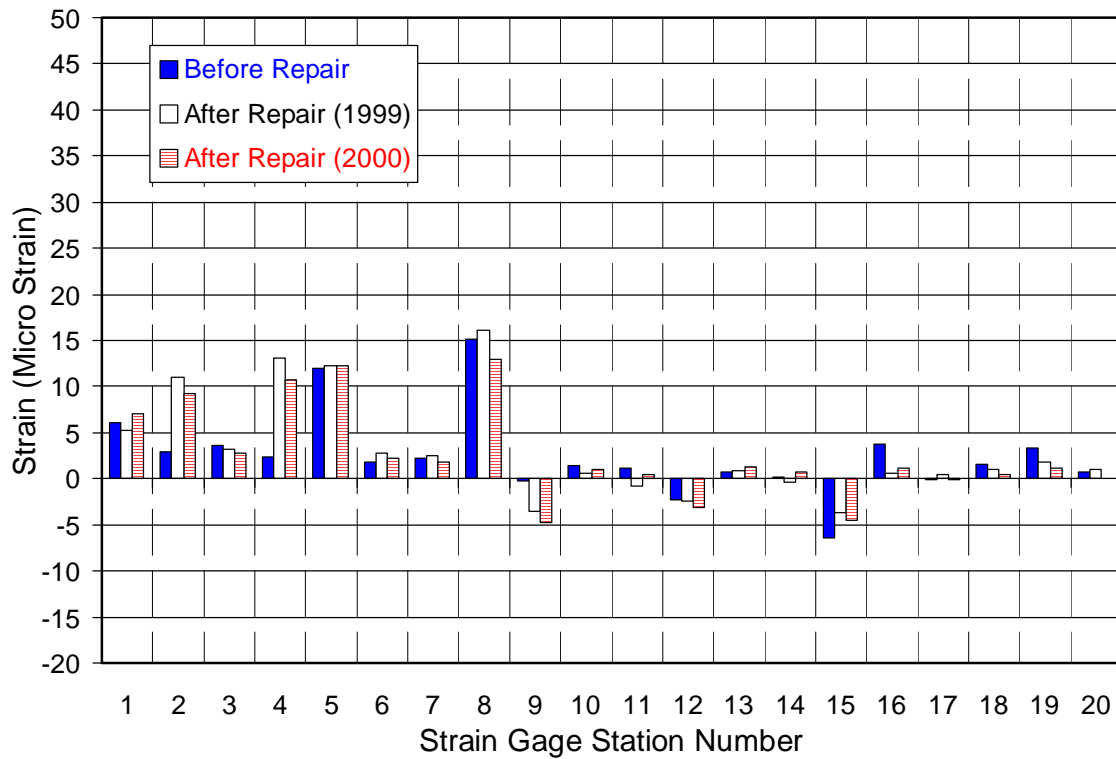
(a) Truck Load Test No. 1

(b) Truck Load Test No. 2

Figure B.17 Concrete Surface Strains at Various Locations
