**RETROFIT OF EXISTING REINFORCED CONCRETE
BRIDGES WITH FIBER REINFORCED
POLYMER COMPOSITES**

Report No. UC-CII 01/01

A Report to Sponsor:
Federal Highway Administration
And
Ohio Department of Transportation

Retrofit of a Three-Span Slab Bridge with FRP Systems – Testing and Rating

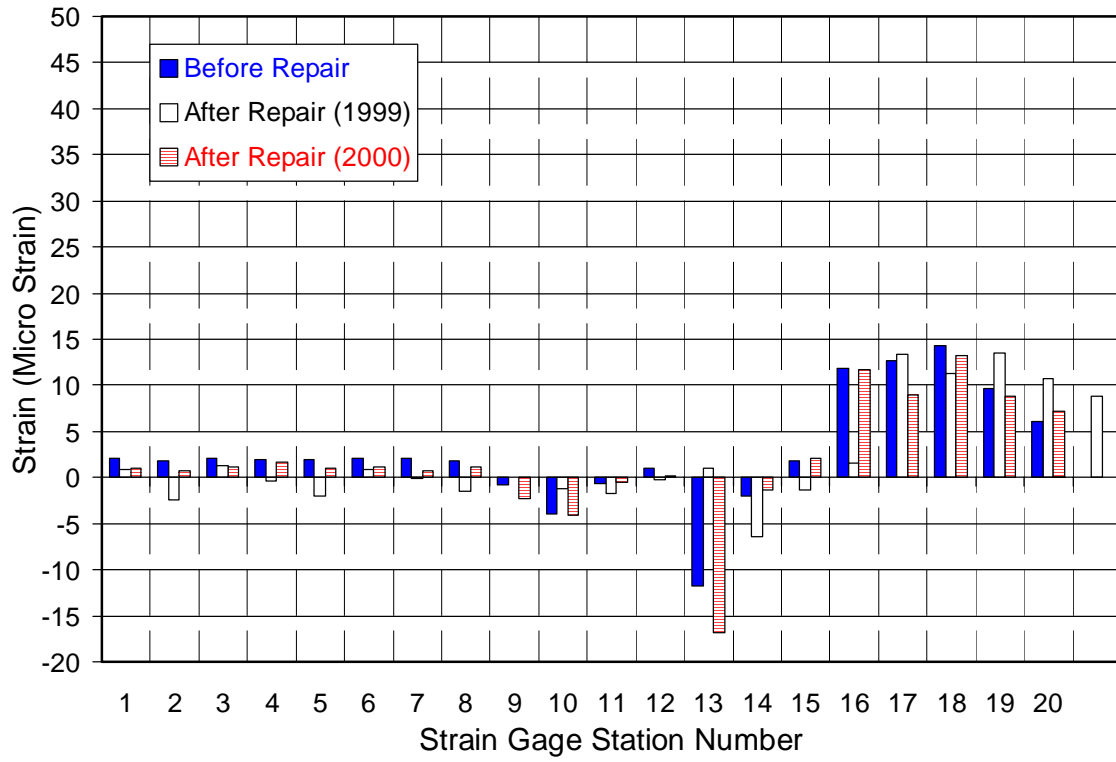
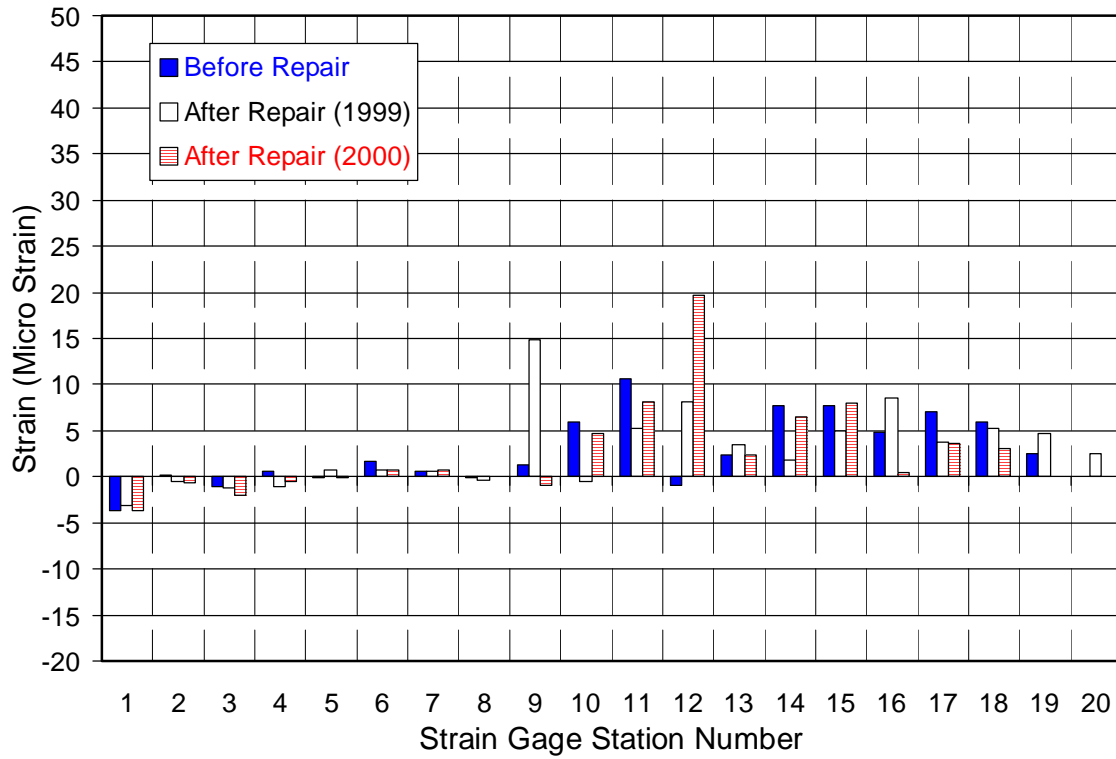
(c) Truck Load Test No. 3

(d) Truck Load Test No. 4

Figure B.17 (Cont.) Concrete Surface Strains at Various Locations

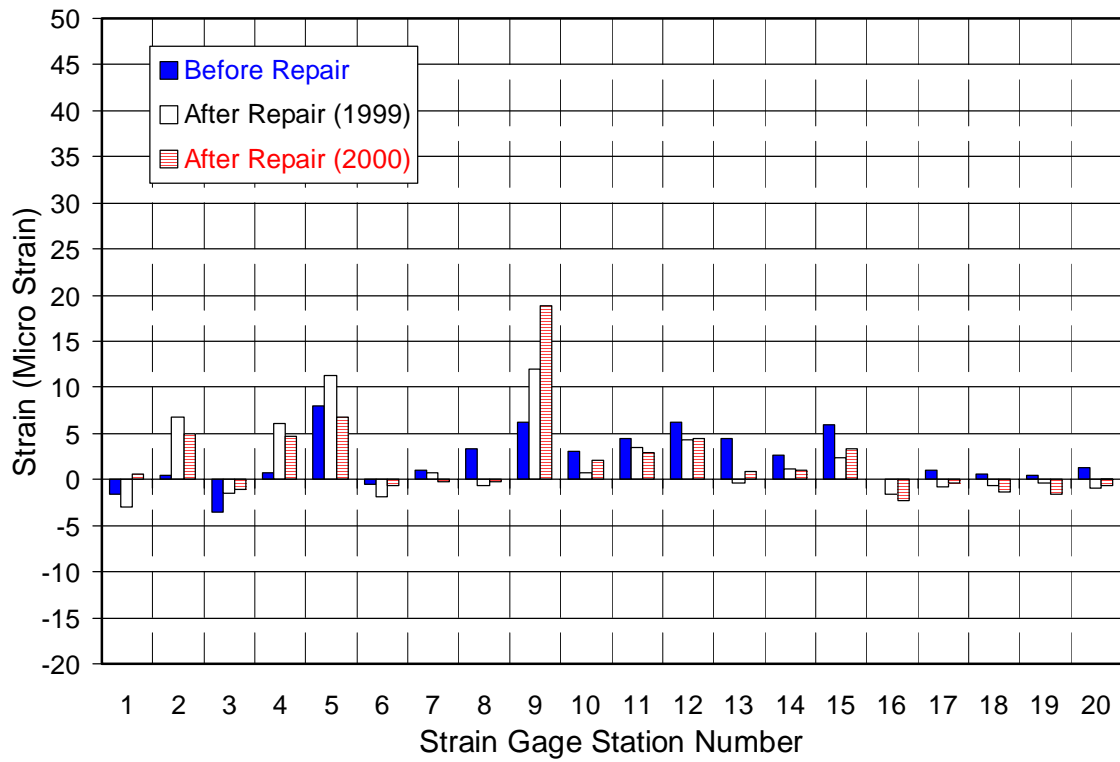
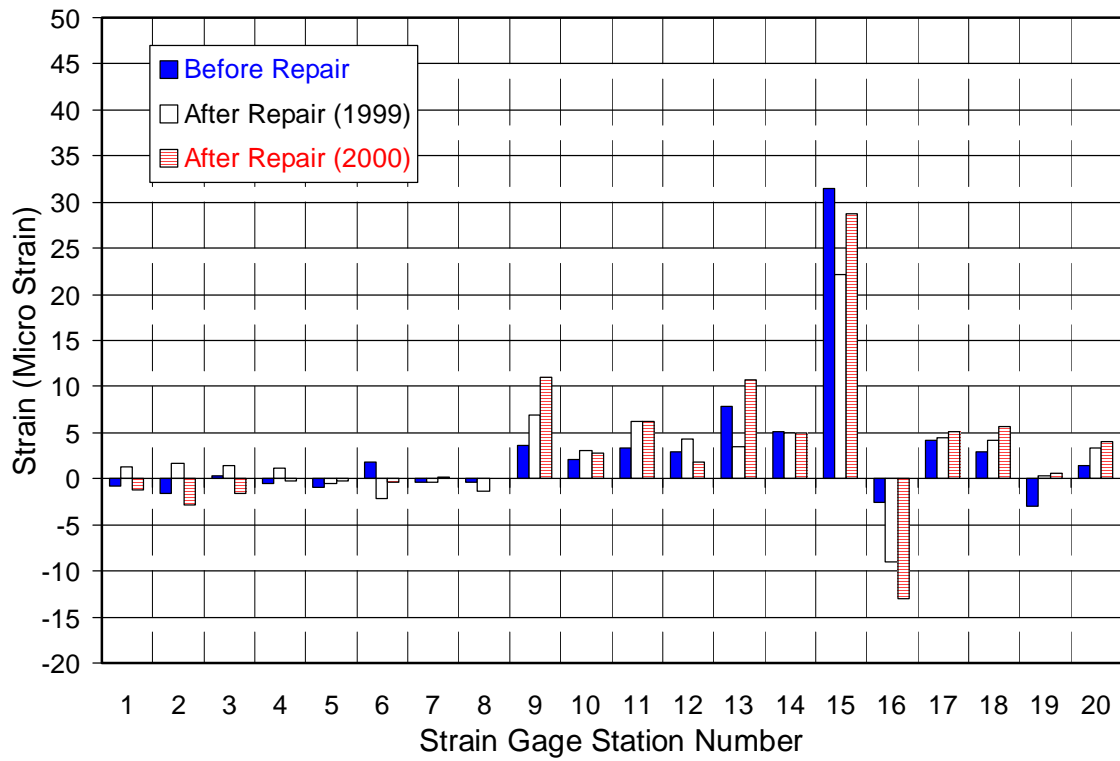
(e) Truck Load Test No. 5

(f) Truck Load Test No. 6

Figure B.17 (Cont.) Concrete Surface Strains at Various Locations

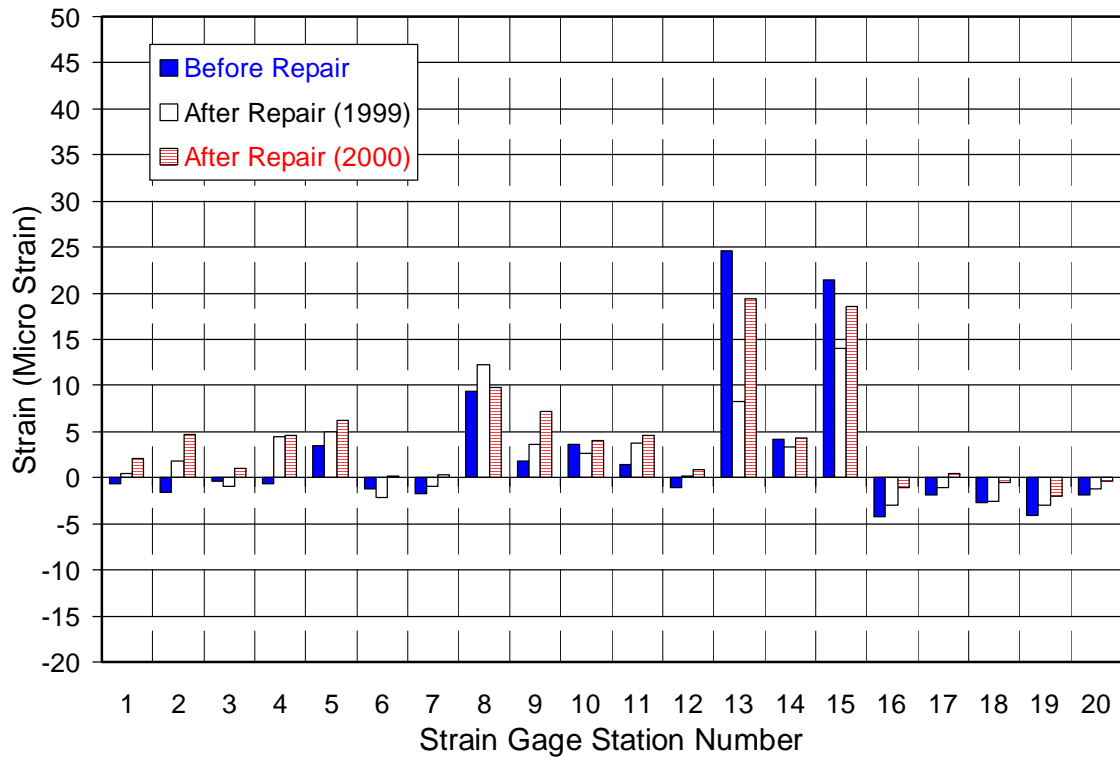
(g) Truck Load Test No. 6

Figure B.17 (Cont.) Concrete Surface Strains at Various Locations

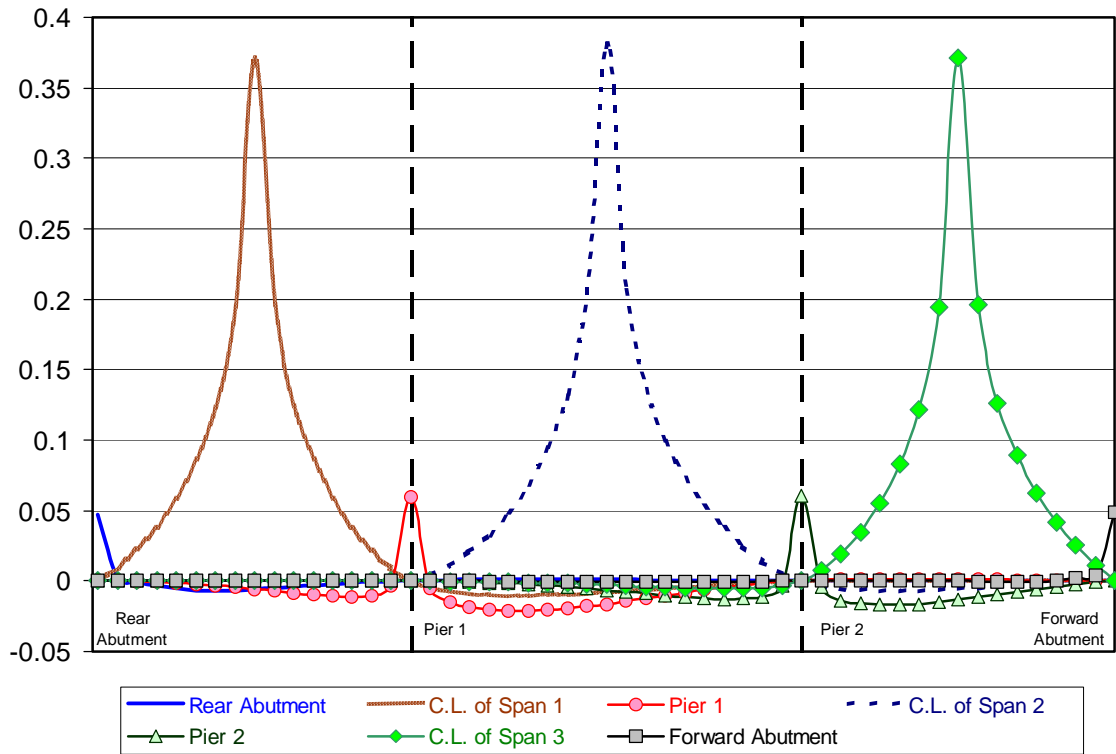
Figure B.18 Moment Influence Line Diagram – Unit Load in Lane 1

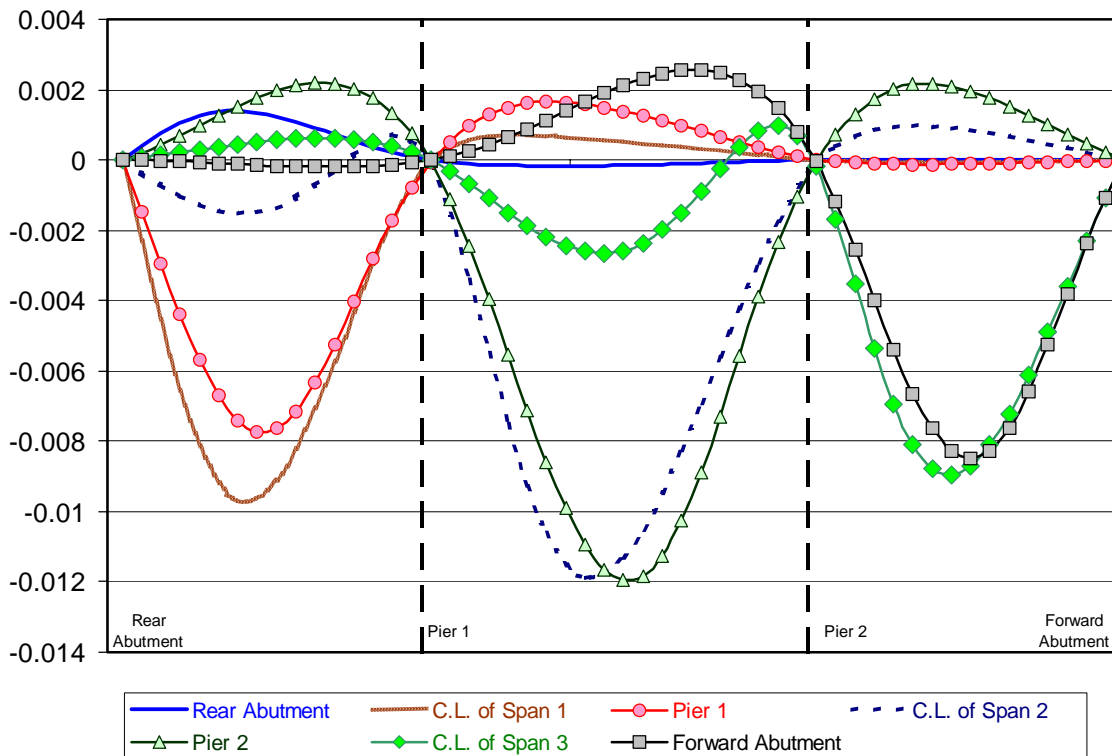
Figure B.19 Moment Influence Line Diagram – Unit Load in Lane 1

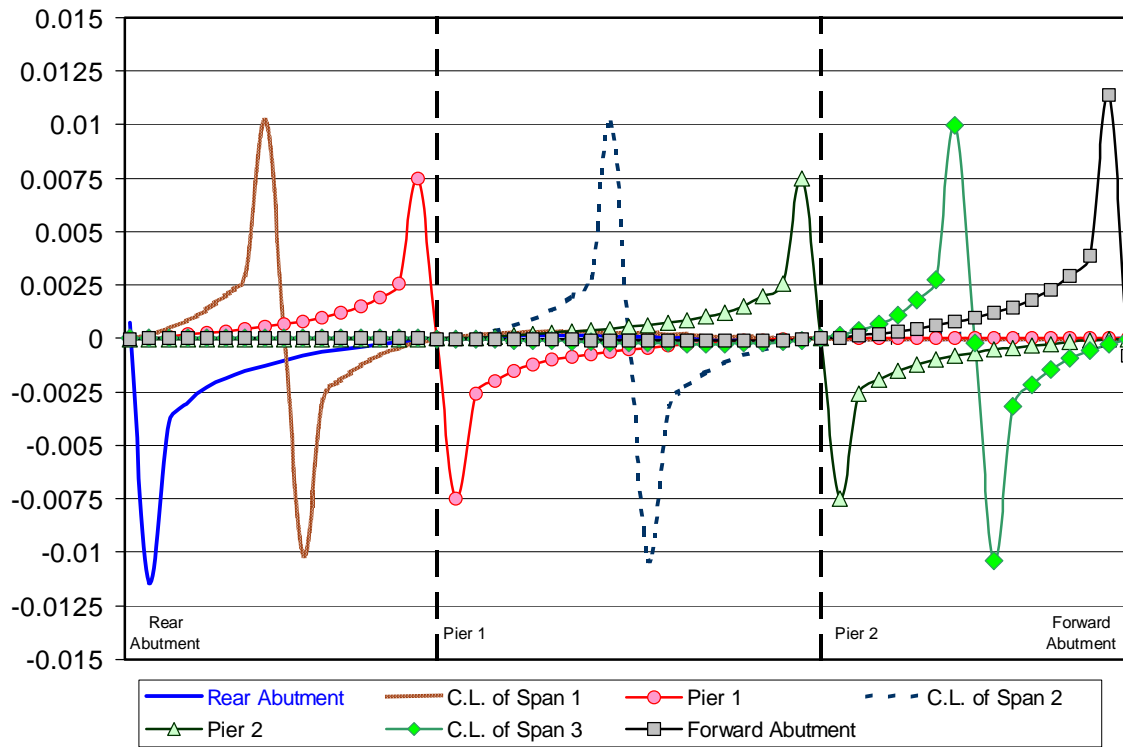
Figure B.20 Shear Influence Line Diagram – Unit Load in Lane 1

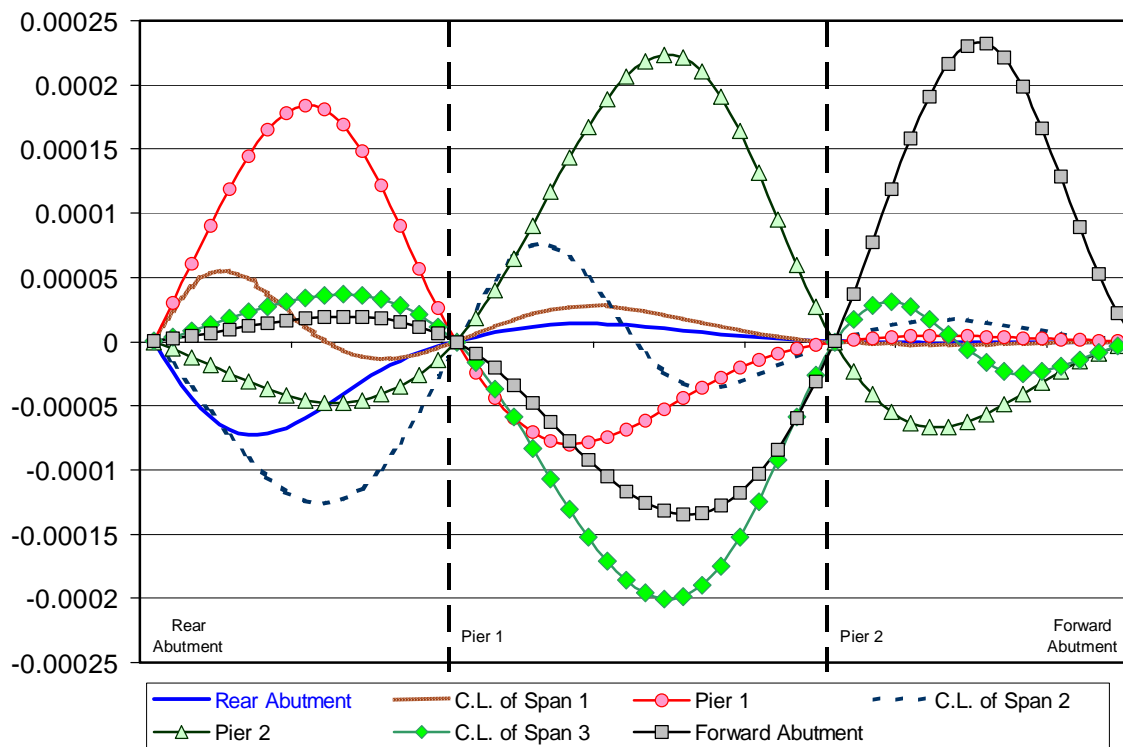
Figure B.21 Shear Influence Line Diagram – Unit Load in Lane 2

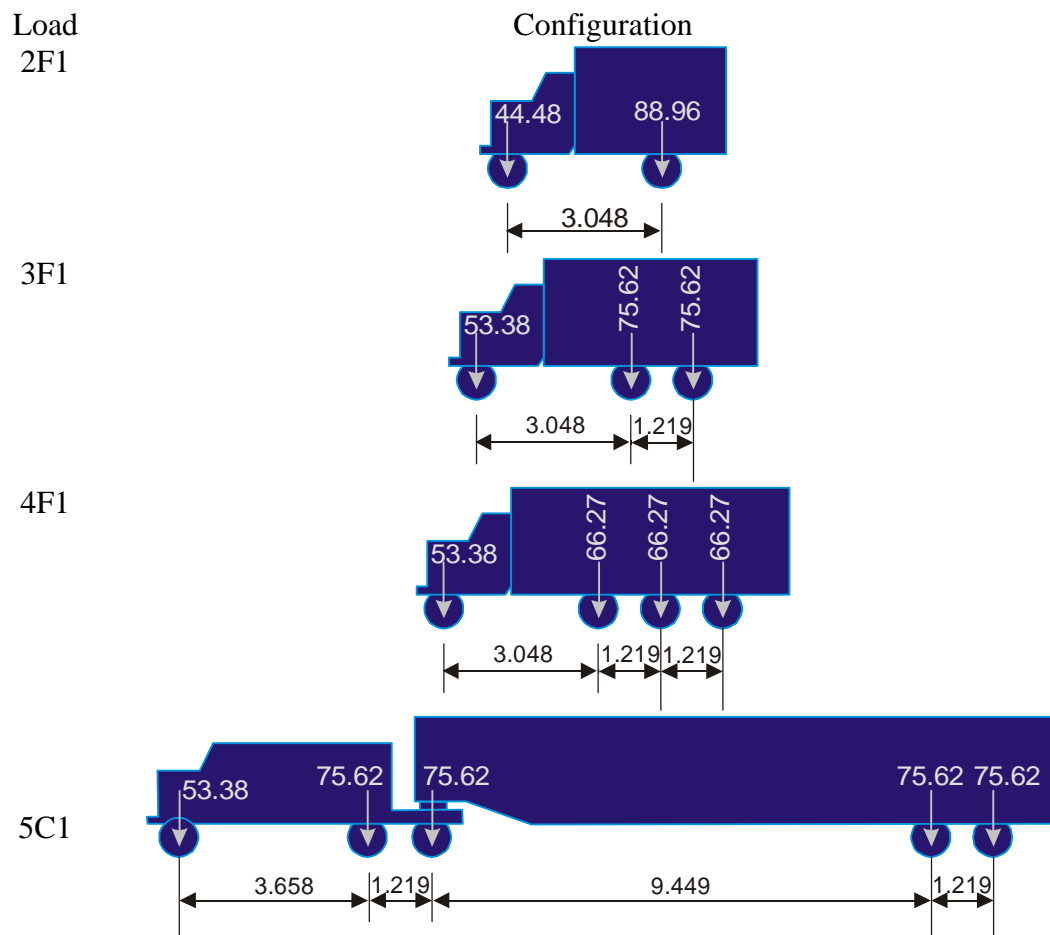
All dimensions are in m and loads are in kN.

Figure B.22 Configuration of Various Ohio Legal Loads
