# EFFECT OF CONCRETE REMOVAL EQUIPMENT AND METHODS ON THE CONDITION OF DECK CONCRETE LEFT IN PLACE

| Report No.<br>VTRC 01-TAR1 | Report Date<br>August 2000 | No. Pages<br>11 | Type Report:<br>Technical Assistance<br>Period Covered:<br>8/99-4/00 | Project No.:<br>00015633 |

August 2000  
VTRC 01-TAR1

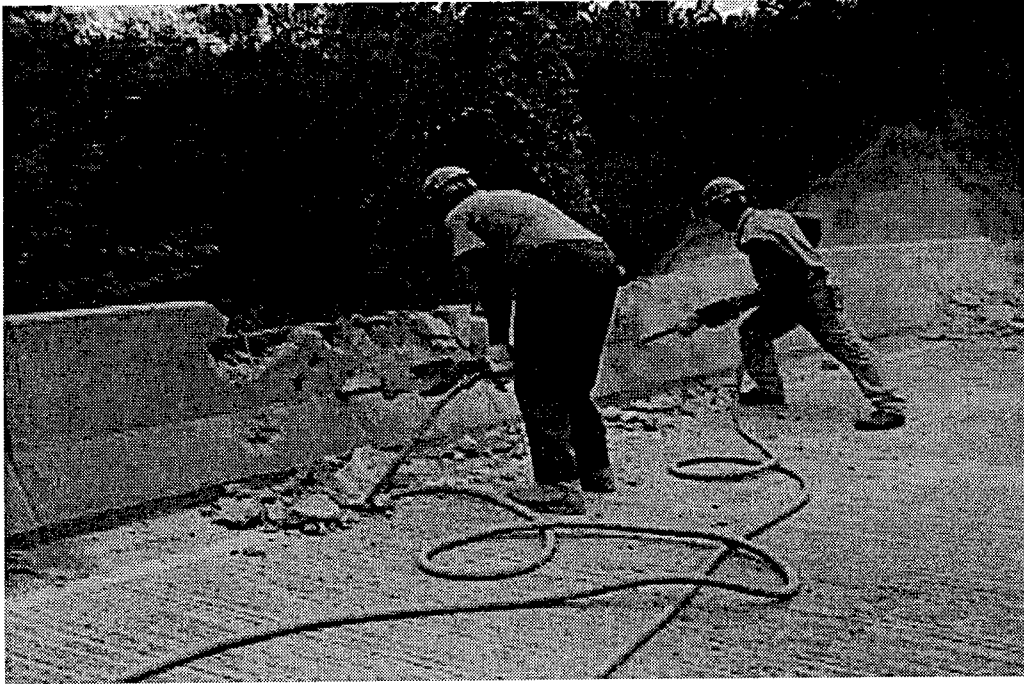
**Figure 4. Concrete Removed From Parapet Using 90-lb Hammers**

Figures 4, 5, and 6 show concrete being removed using 90-lb (41-kg) hammers, a hoe ram, and a concrete crusher. Each piece of equipment was used to remove a 10-ft-long (3.1 m) section of the parapet and exterior edge of the deck or just the parapet. The contractor's estimates for the time required and total cost for the removal are given in Table 1. Use of the hoe ram and crusher provided considerable savings in both time and cost. Compared to the use of the 30-lb (14-kg) hammer, the time required to remove the deck and parapet with the hoe ram or crusher was 94 percent less. The use of the hoe ram and crusher provided a reduction in cost of 59 and 58 percent, respectively, compared to the use of the 30-lb hammer. The crusher was more effective than the hoe ram in removing the parapet.
