The Effects of Higher Strength and Associated Concrete Properties on Pavement Performance

PUBLICATION NO. FHWA-RD-00-161

JUNE 2001

U.S. Department of Transportation
Federal Highway Administration

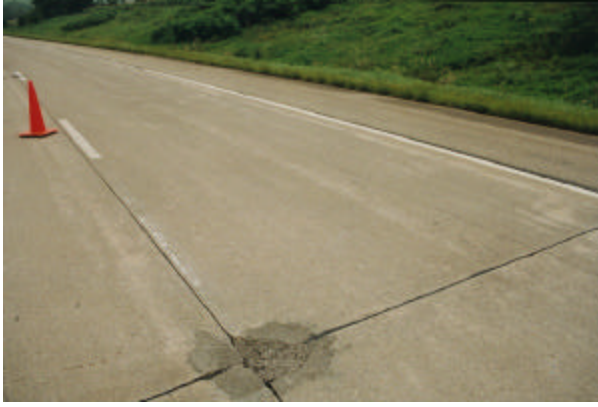
The test section was in a relatively good condition except for the faulting, which ranged from 0.8 to 7.5 mm, two small high severity corner breaks, and low severity transverse joint spalling due in part to snow plowing.

Figure 3.1.23 Corner break and repair at 27-4054.

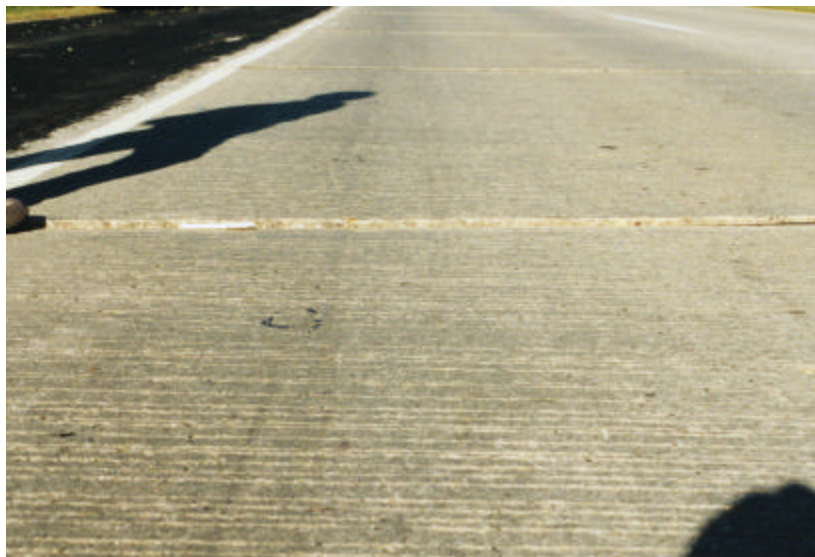
Figure 4.2.1 Faulted transverse joint in test section 55-3008.

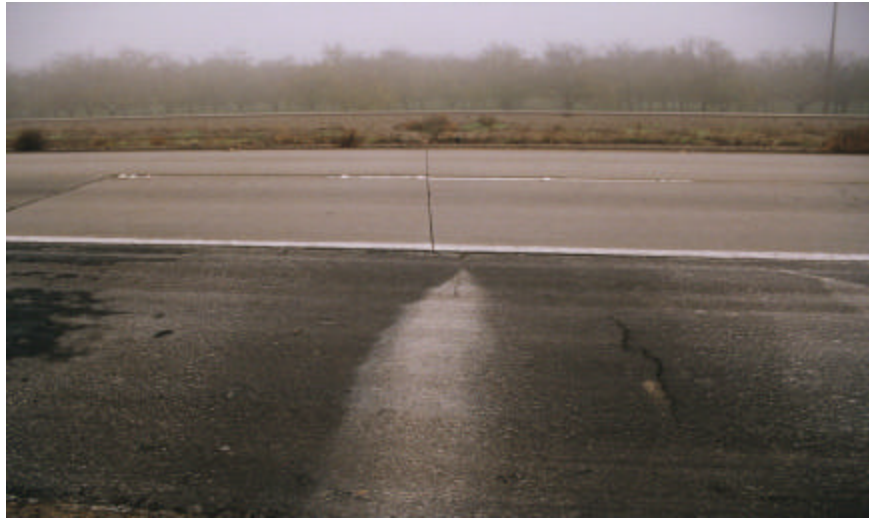
Figure 4.2.3 Surface staining on the shoulder close to joints from Tracy Test Road (06-CS1).

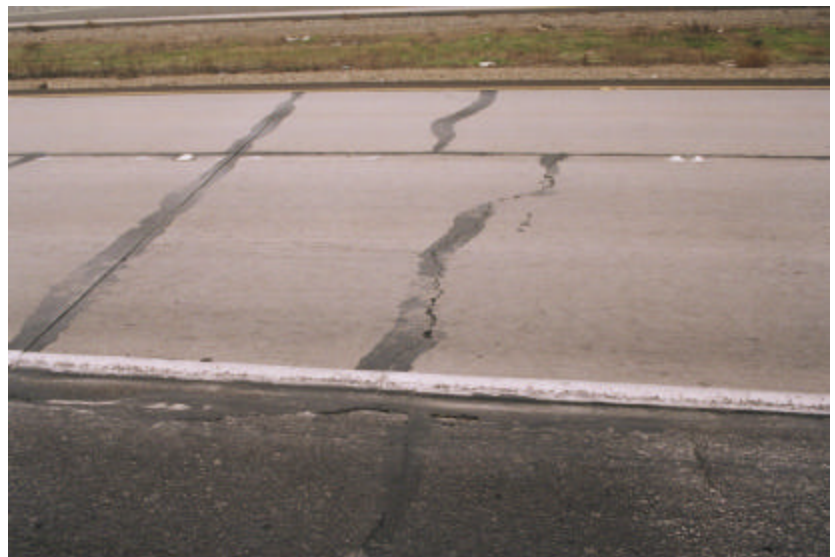
Figure 4.2.5 Depressed shoulder in test section 06-CS3 from pumping of fines. Transverse cracking in outer and inner lane.

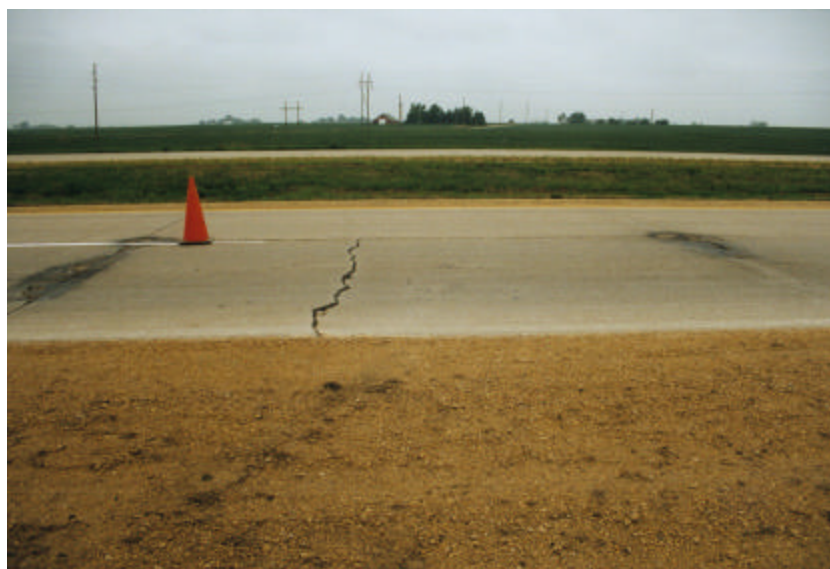
Figure 4.3.5 Transverse cracking closer to the leave joint for the Iowa section 19-3006.

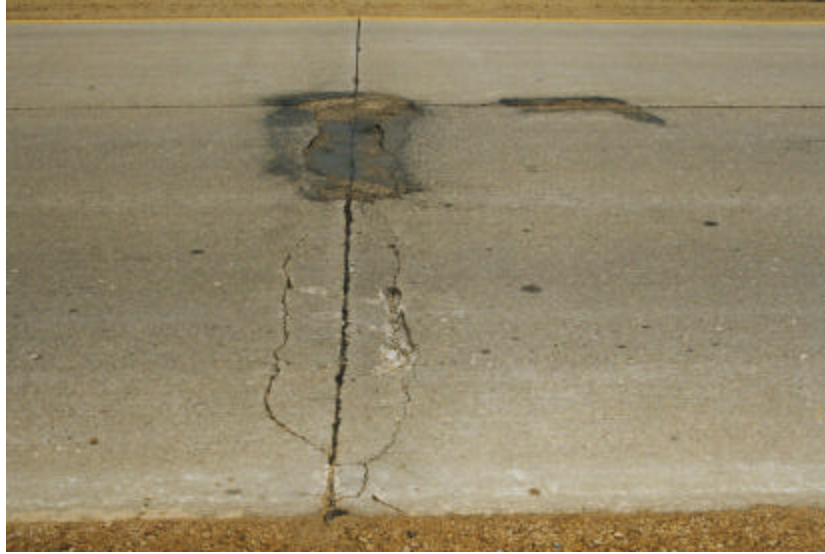
Figure 4.4.2 Spalling crack running parallel with the joint in a distance of about 0.3 m.

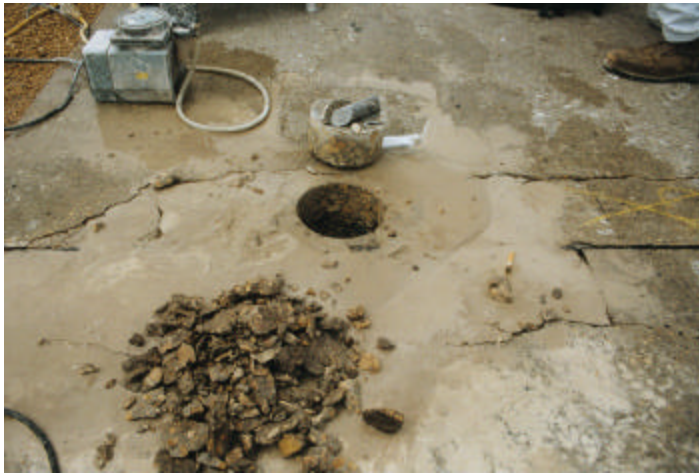
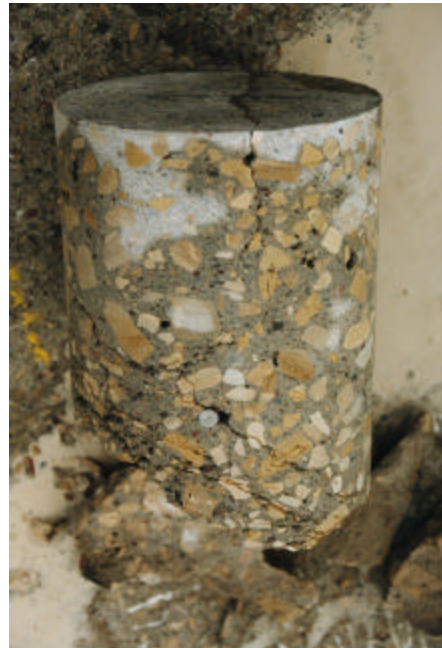
Figures 4.4.3 Close-up photos of joint deterioration from test section 19-3006.

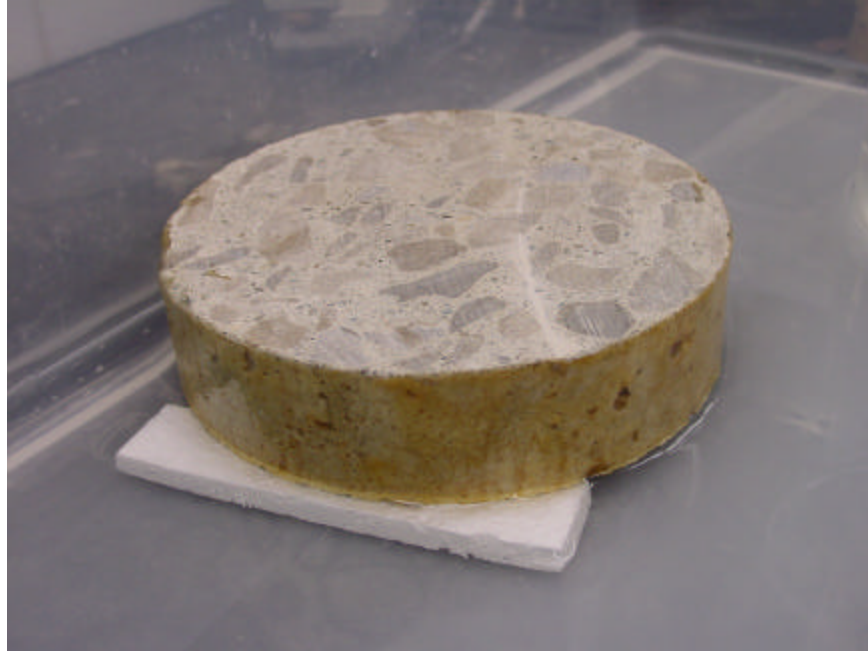
Figure 5.6.6 *Close-up of water absorptivity test.*

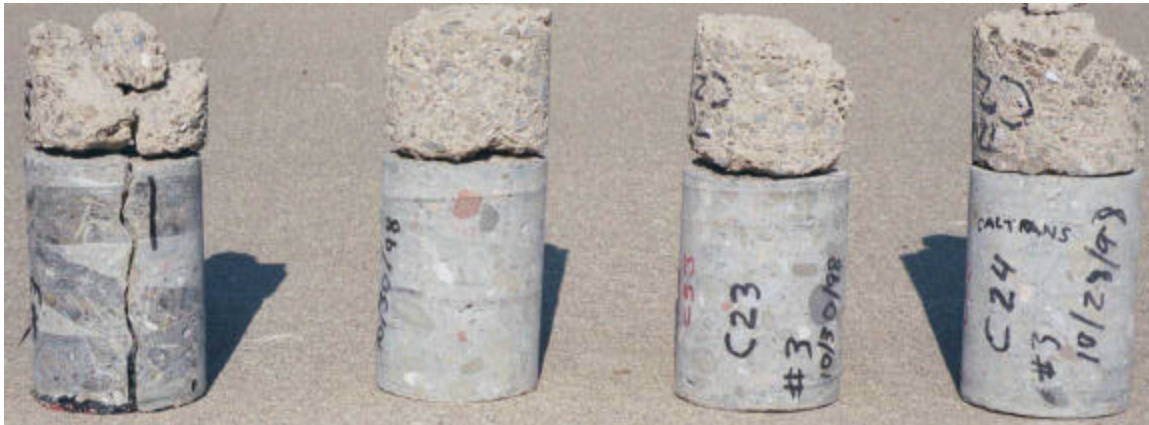
Figure 7.1.2 Eroded CTB at joint. Decreasing erosion moving away from joint (left to right). Experimental test road at Tracy, California, with higher cement content.
