# Application of High Performance Concrete in the Pavement System

## Structural Response of High Performance Concrete Pavements

Final Report  
March 2002

15. Supplementary Notes  Prepared in cooperation with the U.S. Department of Transportation, Federal Highway Administration	
16. Abstract <p>A concrete pavement was constructed on US 50 east of Athens Ohio to determine the influence of ground granulated blast furnace slag on the curing of a high performance concrete pavement, and on the performance of that pavement as it was subjected to environmental cycling and nondestructive testing with a Falling Weight Deflectometer (FWD). Three test sections of high performance concrete and one control section constructed with ODOT Class C concrete were instrumented and monitored closely to determine any differences in response and performance. The high performance sections contained 25% ground granulated blast furnace slag. Several joints were not sealed to evaluate their performance when compared to joints sealed in accordance with ODOT specifications.</p> <p>Based upon laboratory tests and field data obtained during this study, the following conclusions were derived from this pavement.

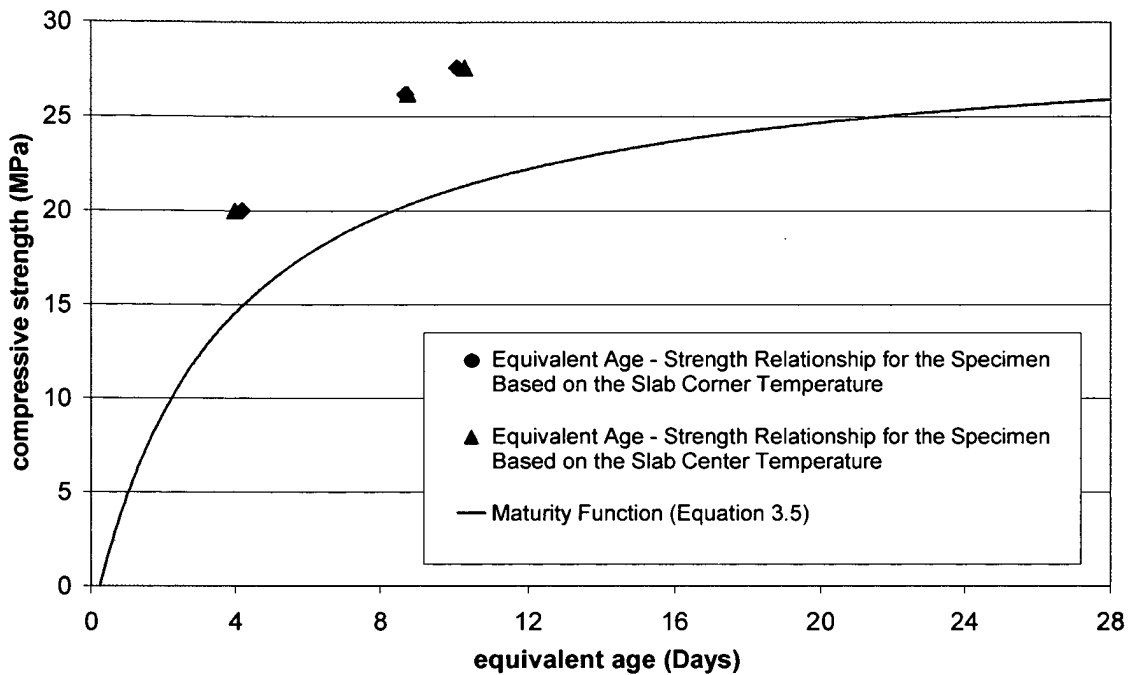
**Figure 3.5** Strength vs. Equivalent Age Relationship of Test Specimen and Estimated with Equation 3.5

It should be noted that the temperature at the bottom of the slab was measured at two different points, the center and the corner. Thus, each compressive strength coincides with two slightly varying equivalent ages. Figure 3.5 shows the strength versus equivalent age relationship of the specimens, as well as the same relationship estimated from Equation 3.5.

As can be seen in the figure 3.5, the fit between the strength data of the specimen to the estimated strength from Equation 3.5 is poor. The strength values of the specimen are between 30 and 40 percent higher than the values estimated with Equation 3.5. All test results exceed 50 percent of the compressive strength at an equivalent age of 28 days. Although every effort was made in the laboratory to duplicate the mix that was used in the field, discrepancies between the field and laboratory test results indicate that the mixes were slightly different.

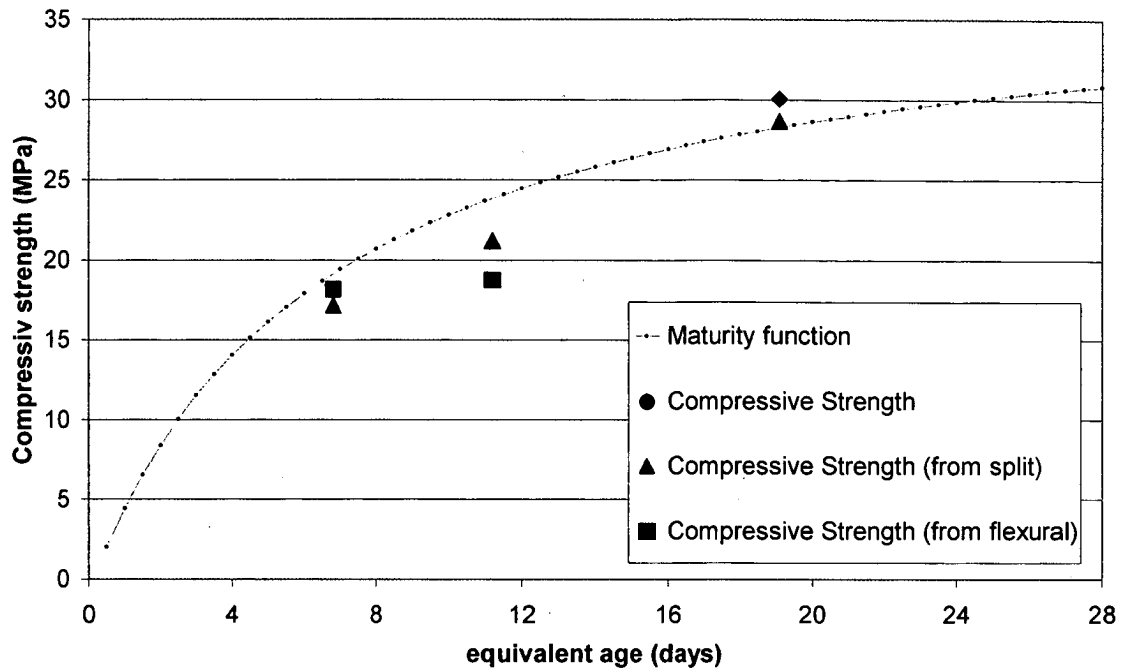
**Figure 3.13** Strength vs. Equivalent Age Relationship of the Specimen and of the Maturity Function

Figure 3.13 shows the strength data at different equivalent ages deduced from the compressive strength values in Table 3.4 and the maturity function determined from the above equation for the SP concrete.
