Performance of Continuously Reinforced Concrete Pavements

Volume V: Maintenance and Repair of CRC Pavements

PUBLICATION NO. FHWA-RD-98-101

OCTOBER 1998

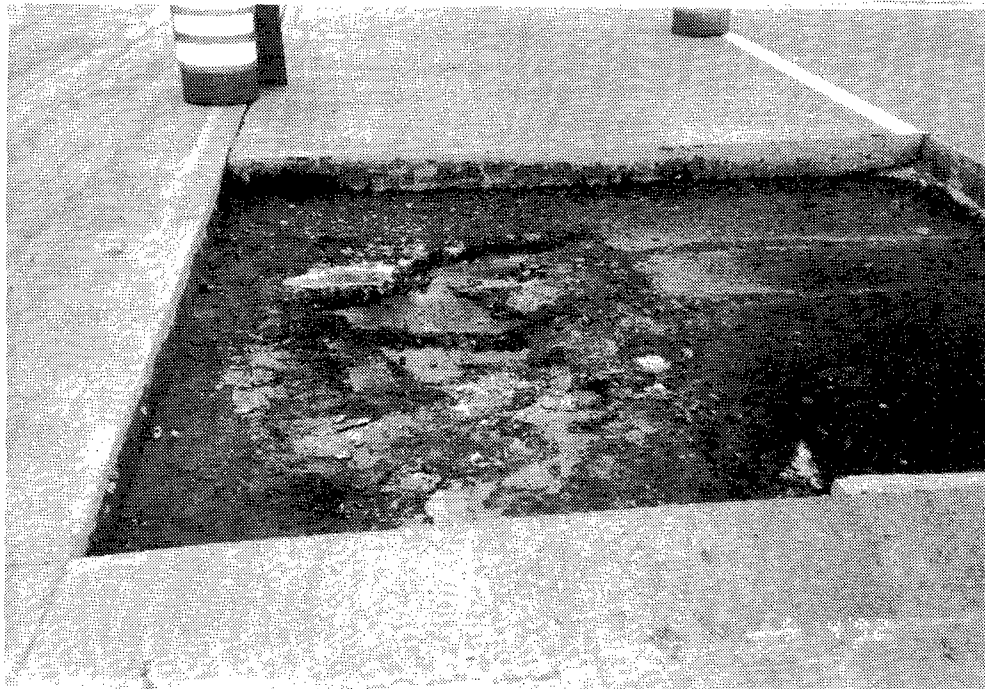
Figure 10. Erosion of subbase under punchout distress.

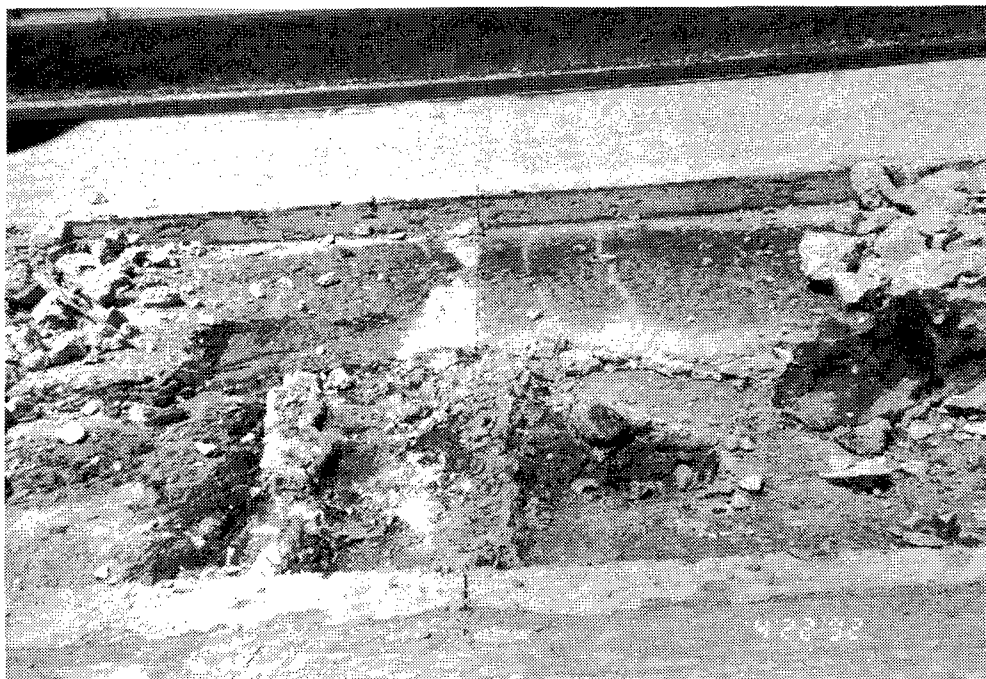
Figure 11. Movement of material caused by pumping.

Because slabs naturally tend to lift up at the edges from warping and curling, there is usually some gap beneath the edges of the slab for water to accumulate either temporarily or permanently. When heavy loads deflect the pavement, the water is squeezed out from under the pavement under extremely high pressures. If the water is trapped at the interface between the pavement and subbase because of poor drainage conditions, the water may be forced from the interface through the longitudinal joint under the weight of an axle load. Under repeated axle loading, this process will tend to erode away the subbase material when enough moisture is trapped at the interface. The material and water are forced laterally and vertically along the pavement edge. The material is then either deposited under or on top of the shoulder. Pumping can be easily recognized by the presence of subbase material along the adjacent shoulder. The result is a void condition beneath the pavement. The voids change the slab support system from a uniformly supported condition to an unsupported condition at some points. Figure 11 demonstrates the results of pumping at a subsequent punchout failure. The use of widened truck lanes will substantially reduce edge pumping with or without the use of tied concrete shoulders. Also strong base/subbase/subgrade support is critical to prevent excessive deflection of CRC pavements which is relatively flexible.

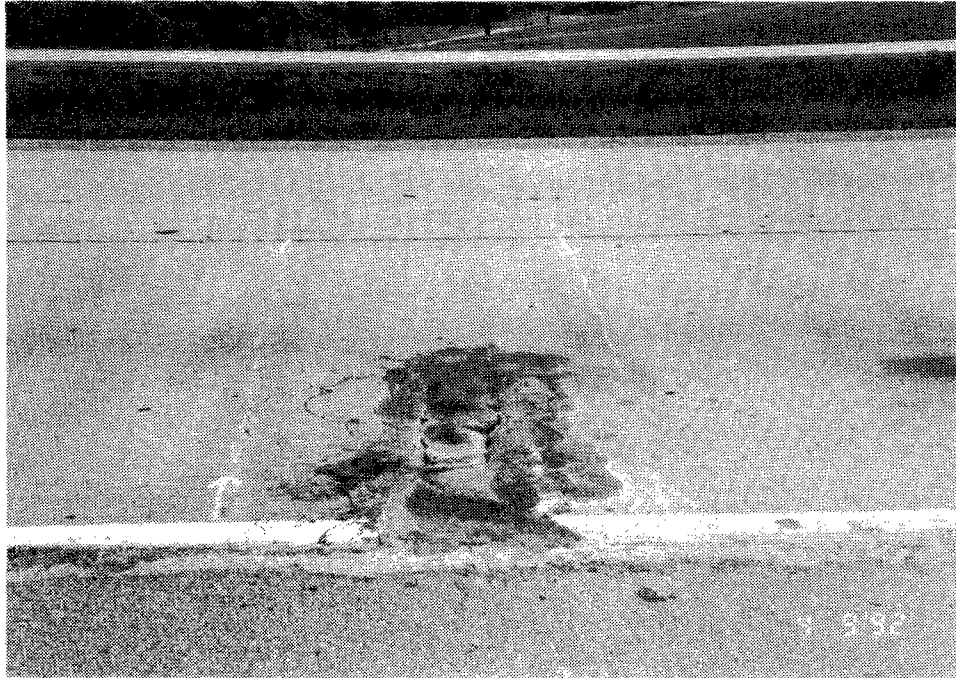
Figure 20. Marked out distress area.

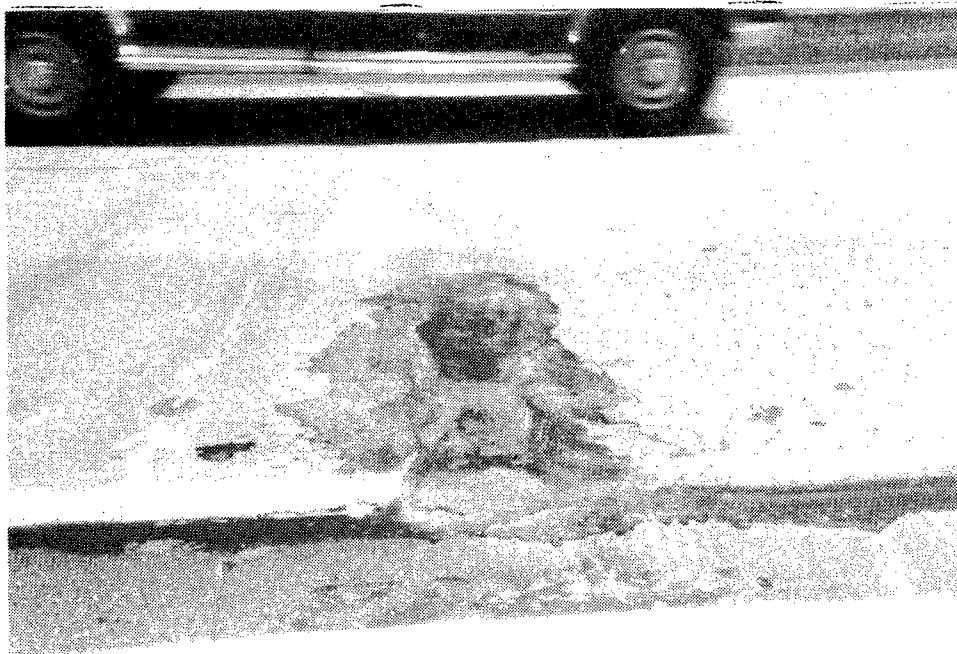
Figure 21. Punchout marked out for removal.

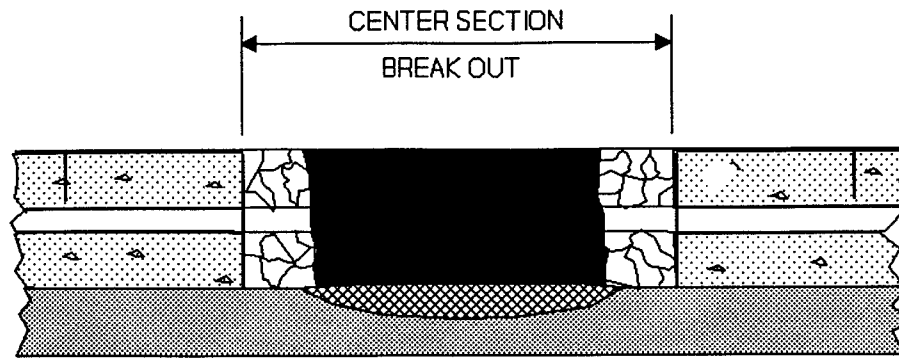
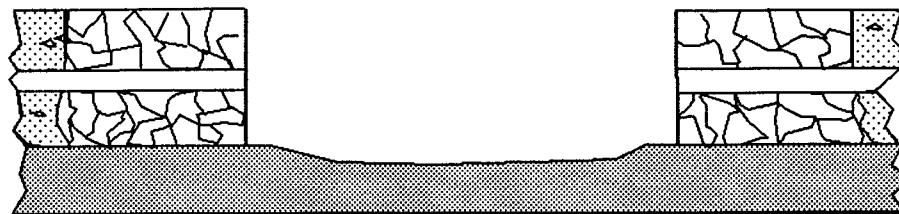
A.) Partial and Full-Depth Saw Cut

B.) Center Section Breakout

C.) End Section Breakout

Figure 23. Break up and clean out method.

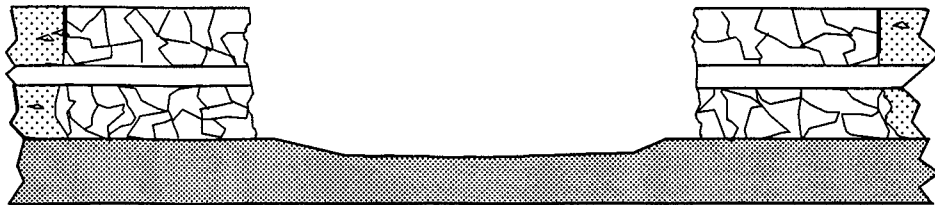
A.) Partial and Full-Depth Saw Cut

B.) Center Section Removal

C.) End Section Removal

Figure 26. Lift out method.

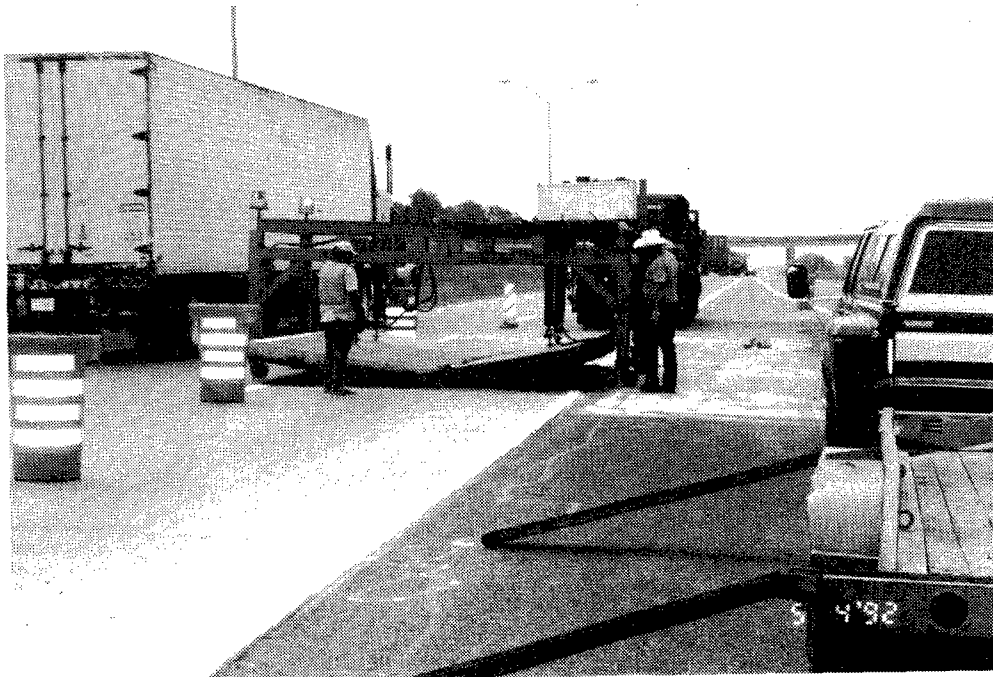
Figure 27. Slab lifting device.

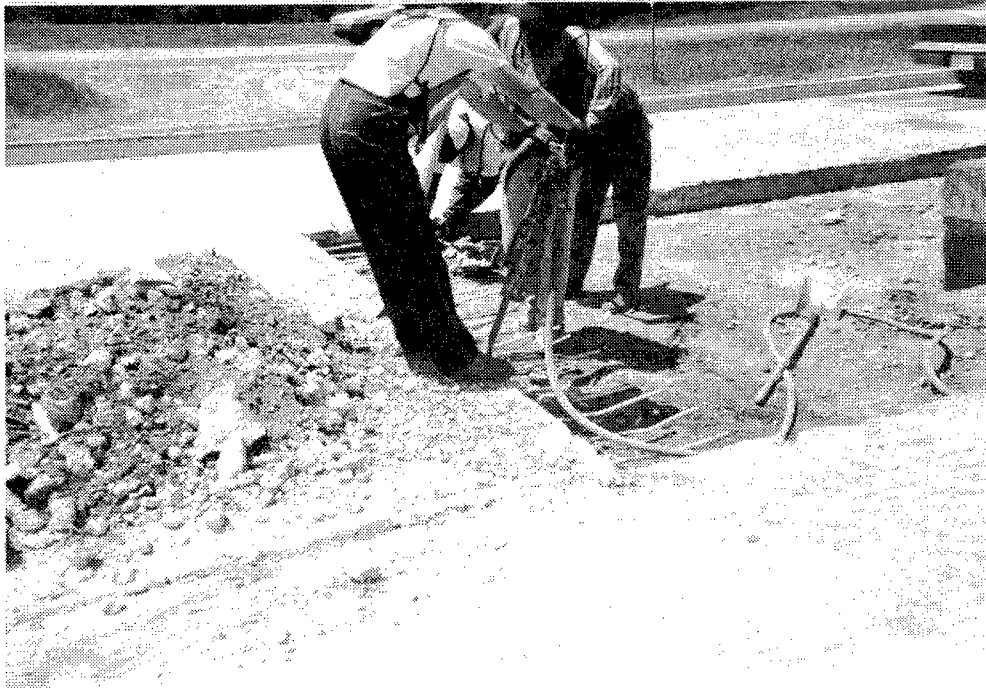
Figure 29. End section removal – using a jackhammer.

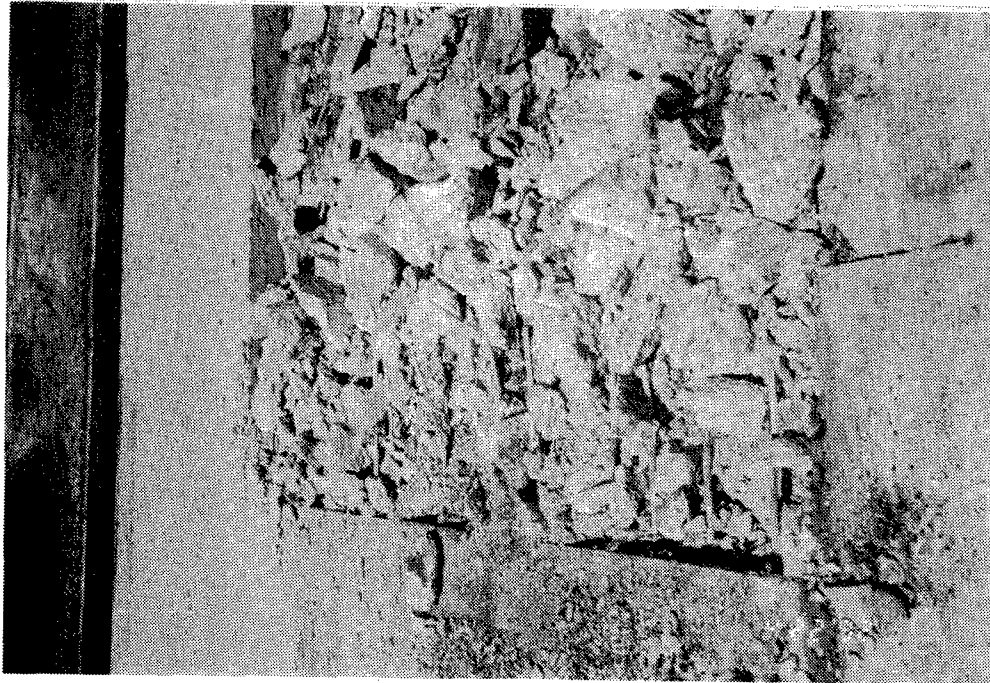
Figure 31. End section removal - close-up view.

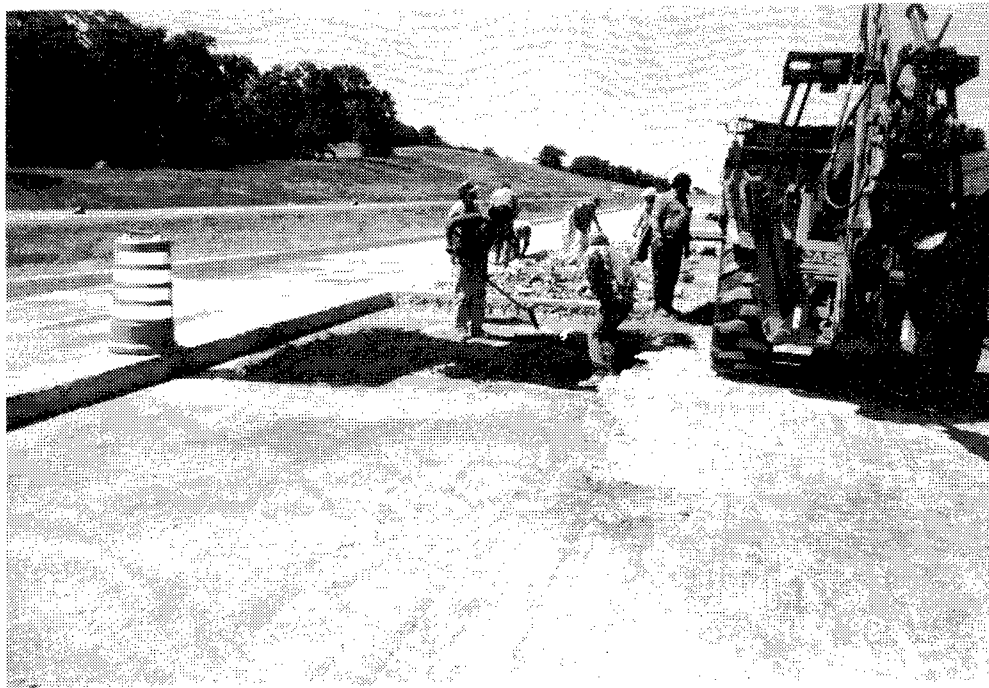
Figure 33. Replacing disturbed subbase with asphaltic concrete.
