EVALUATION OF AUTOMATED BRIDGE DECK ANTI-ICING SYSTEM

Research Report
KTC-01-26 / KH36-97-1F

KENTUCKY HIGHWAY INVESTIGATIVE TASK NO. 36

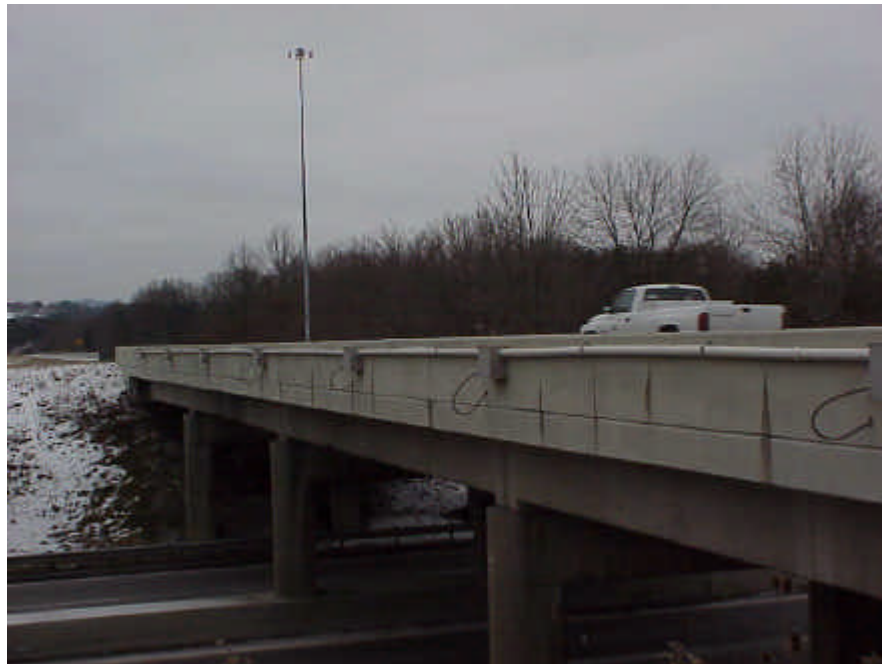
Odin Systems was chosen as the company to supply the anti-icing bridge deck system. This system includes a nozzle and spray system mounted on the bridge rail and bridge walls (Figures 1-3).

Figure 1. Spray System Mounted on Bridge

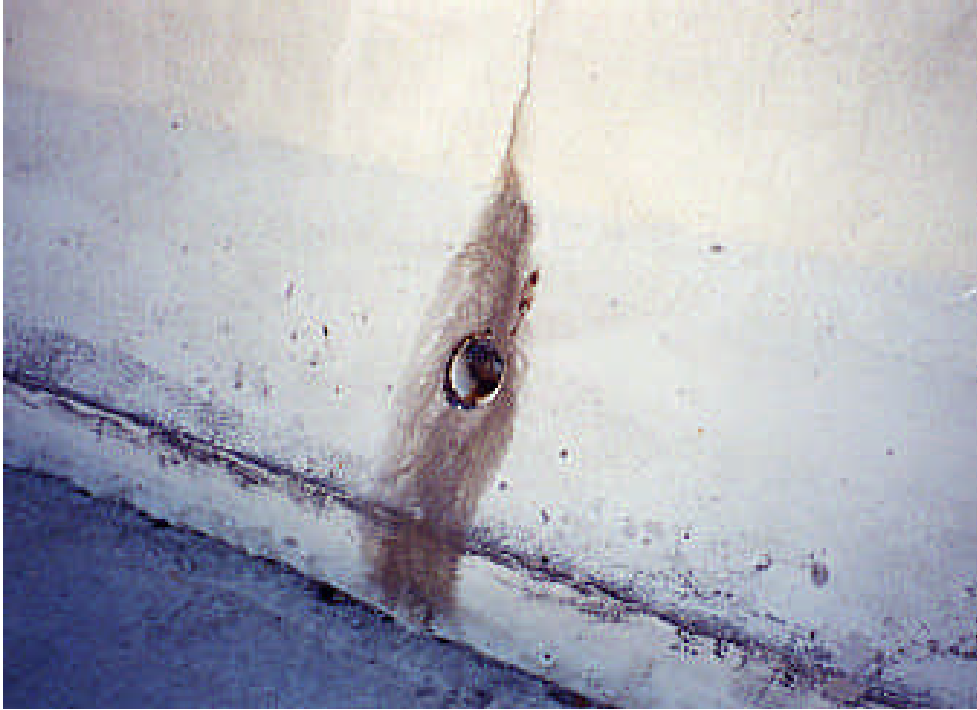
Figure 2. Spray Nozzle in Bridge Wall

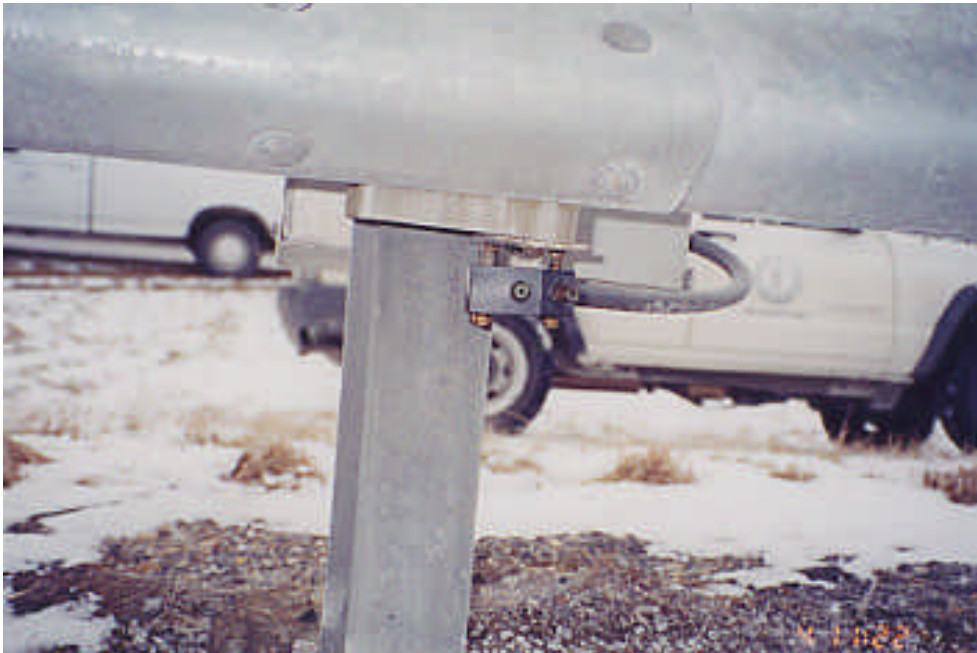
Figure 3. Spray Nozzle under Bridge Rail

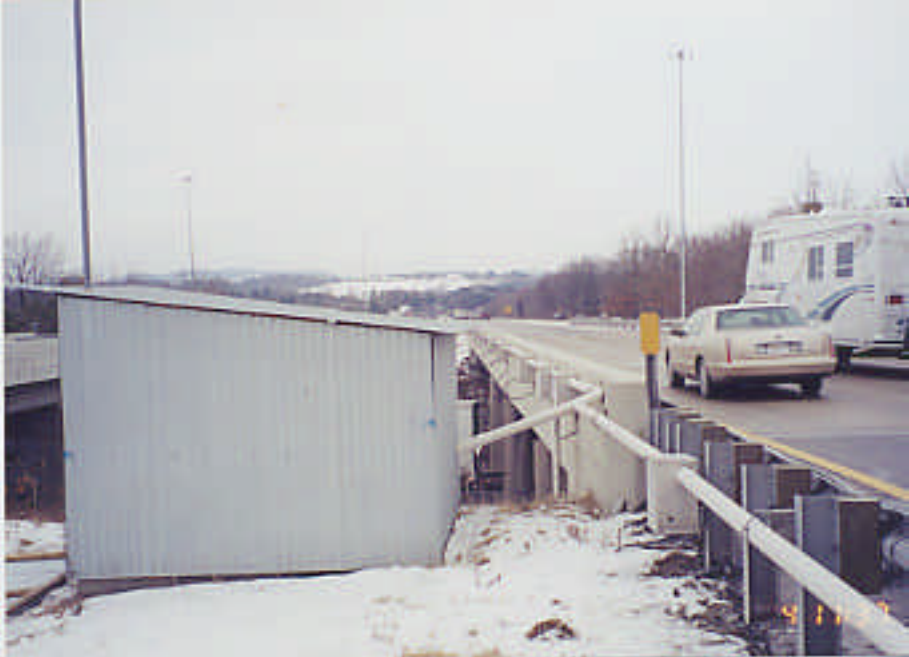
A fluid storage tank, pump, and delivery system installed at one end of the bridge deck will deliver the anti-icing fluid to the nozzles (Figures 4, 5).

Figure 4. Storage Building that Houses System

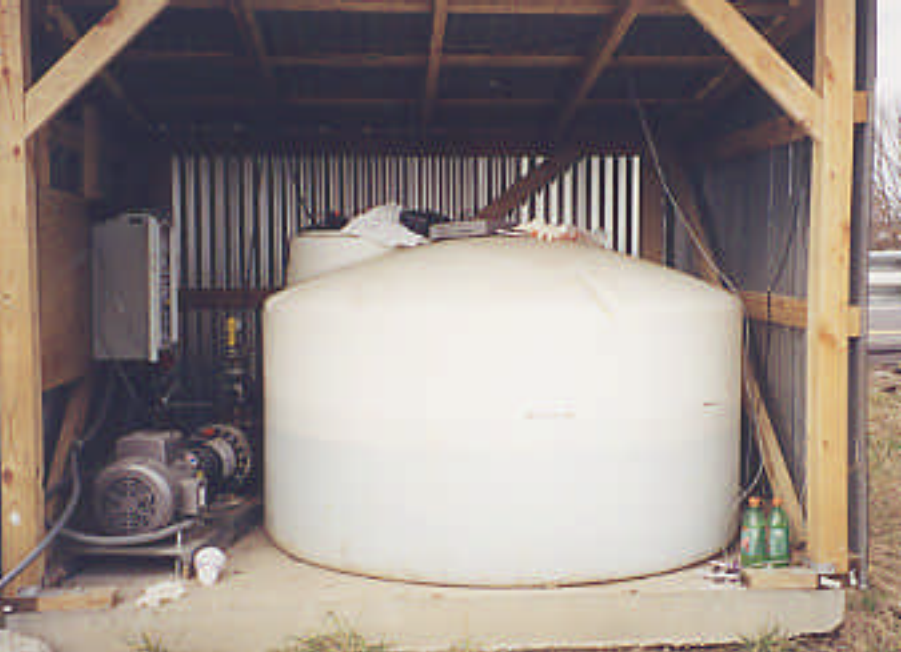
Figure 5. Inside Storage Building

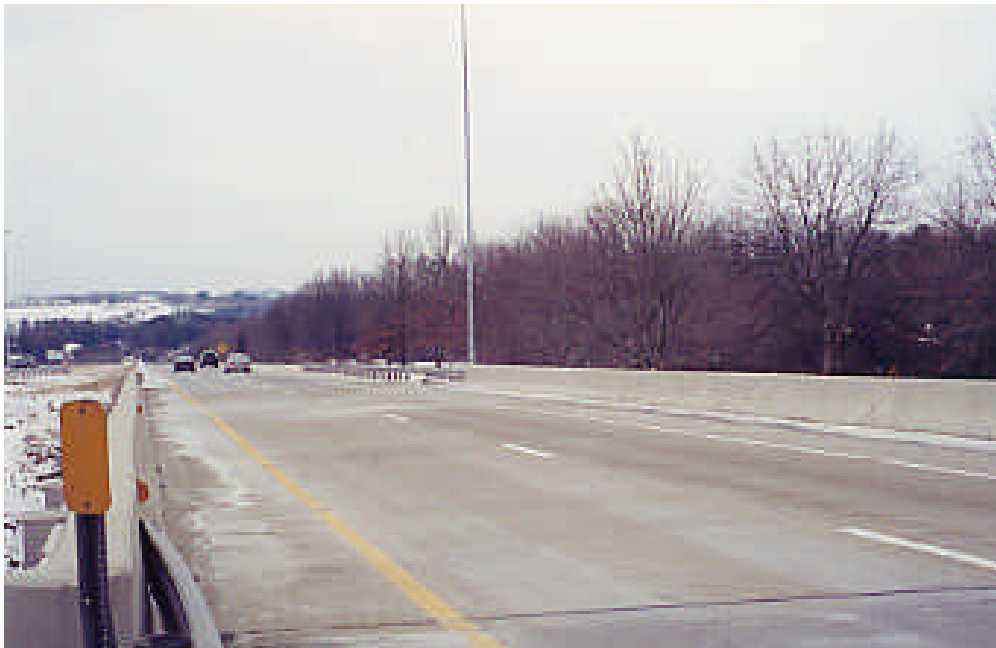
The anti-icing agent is pumped to the deck surface through a system of pipes and nozzles placed along the structure. Once activated, the system builds up pressure and starts spraying the farthest nozzle from the tank first (Figure 6). As pressure builds up, the sprayers continue spraying while moving upstream towards traffic until all the nozzles have sprayed (Figure 7). Each nozzle sprays two streams of the deicing chemical at a time. The entire activation cycle takes approximately four minutes and uses a total of eight gallons of deicing chemical for the entire bridge.

Figure 6. First Nozzles Spraying

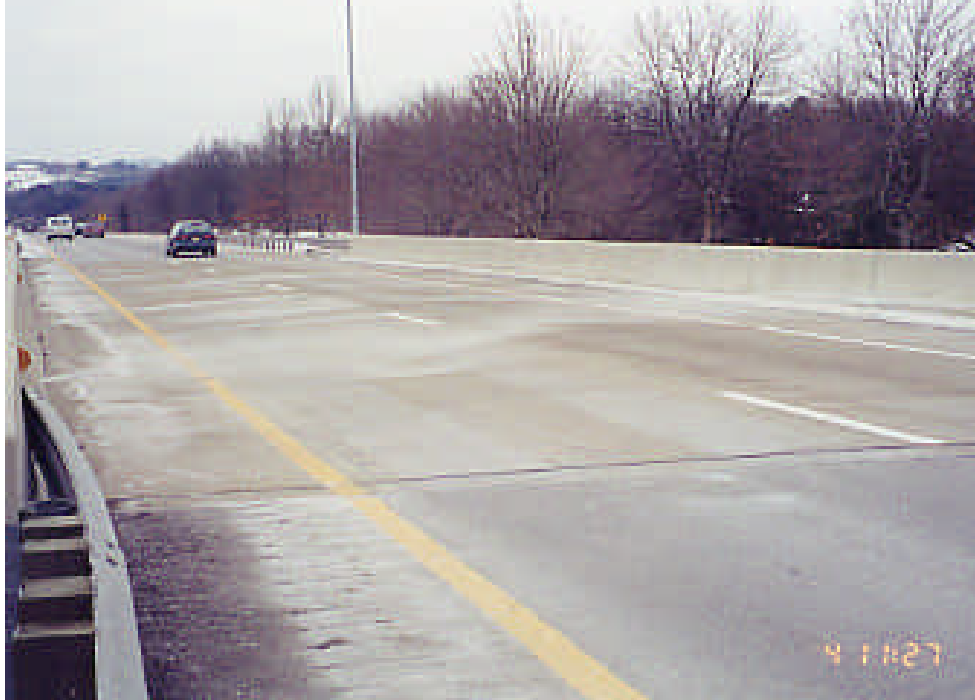
Figure 7. Nozzles Spraying Upstream

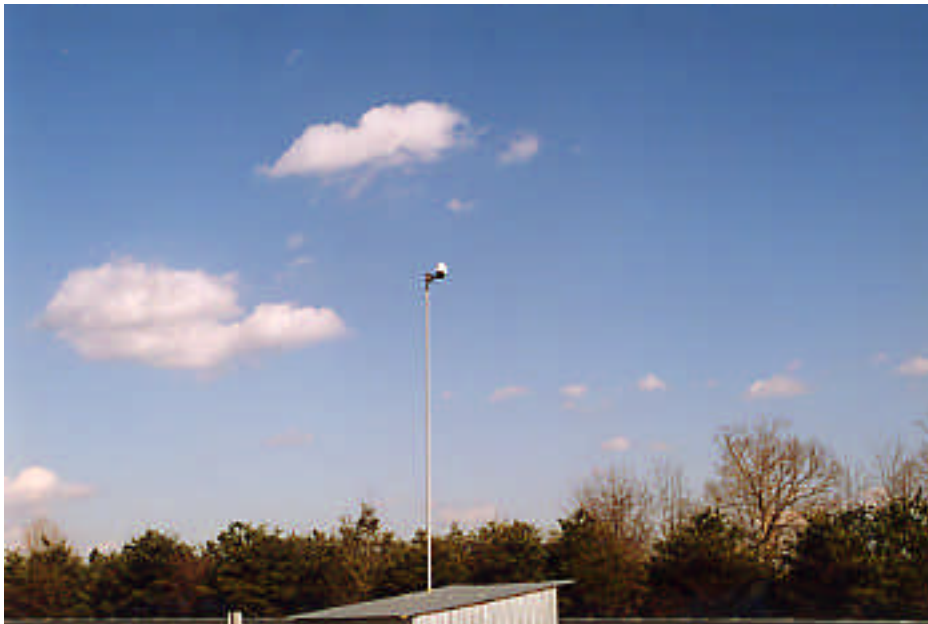
The camera system was replaced in 2001 with a higher resolution black/white camera system. The new camera gives a clearer picture of the bridge surface area than the original camera system. Because of the new camera, a maintenance worker does not have to visually inspect the bridge surface before activation is initiated. Figure 8 shows the location of the mounted camera.

Figure 8. Camera System

The original video camera system installed at the bridge was a fixed black/white system. The camera image was not sufficiently clear to accurately monitor the bridge surface. Therefore, a maintenance worker was dispatched to visually inspect the bridge before the anti-icing activation took place. This method was inefficient from the standpoint that remote activation capabilities were not used.

The original video camera did not provide adequate picture quality and the bridge surface was not clearly visible through the camera system. The transmission rate for the camera was too slow and the images were stored on a computer at the site and then later accessed remotely. These camera problems led to the need of dispatching a maintenance worker to visit the bridge before activation was initiated. This proved to be an inefficient operation with no practical value. The camera was replaced in 2001 with a higher resolution black/white camera system that provides a clearer picture than the original camera system.

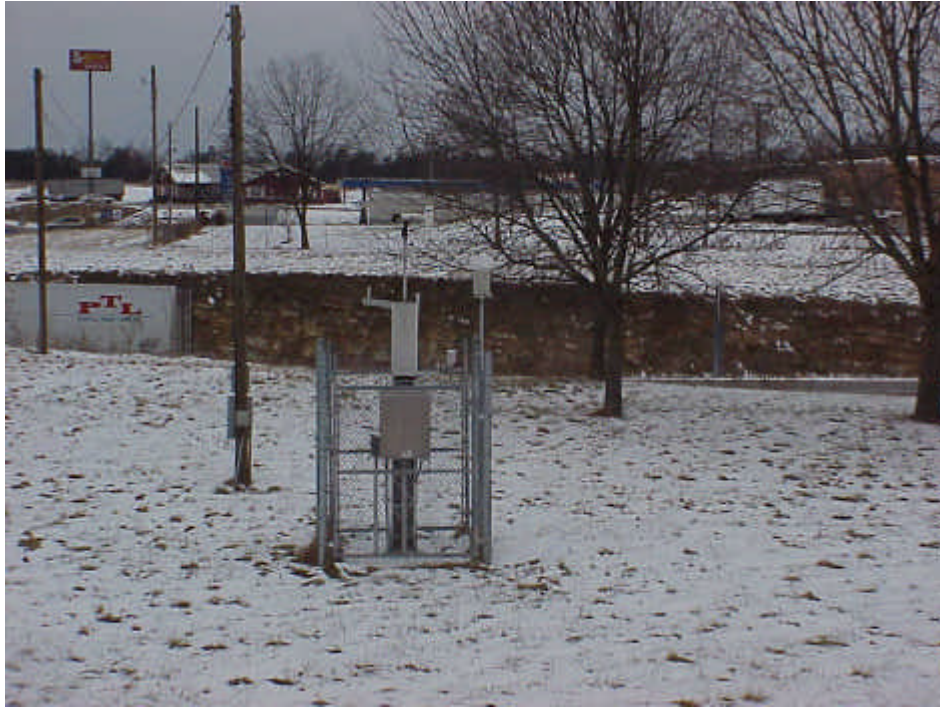
A Roadway Weather Information System (RWIS) is located adjacent to the bridge (Figure 9). The RWIS collects such information as air temperature, precipitation, wind velocity, and pavement temperature. The RWIS is not automatically linked to the activation of the anti-icing system; however, the information collected, is used to determine whether the bridge system is activated.

Figure 9. RWIS

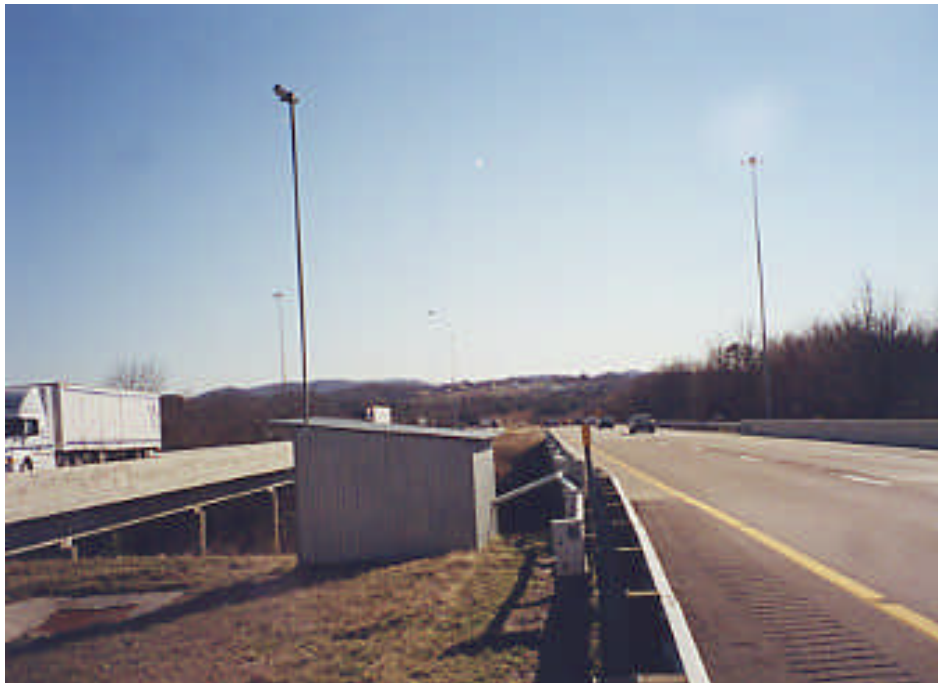
The existence of twin bridge structures allowed for test and control bridge deck conditions. There was no noticeable difference recorded between the deterioration of the anti-icing test bridge over the control bridge. This may have been related to the limited use of the anti-icing system. Also, both bridges were salted by the maintenance trucks during snow/ice conditions so no observations could be made as to the effectiveness of the system.

Figure 10. Twin Bridge Structures
