FIELD INVESTIGATION OF  
A STRENGTHENED  
TIMBER TRESTLE RAILROAD BRIDGE

Richard M. Gutkowski, Ph.D., P.E.  
Abdalla M.T. Shigidi, Ph.D.  
An Vihn Tran, Ph.D.

Department of Civil Engineering  
Colorado State University  
Fort Collins, Colorado 80523

June 2003

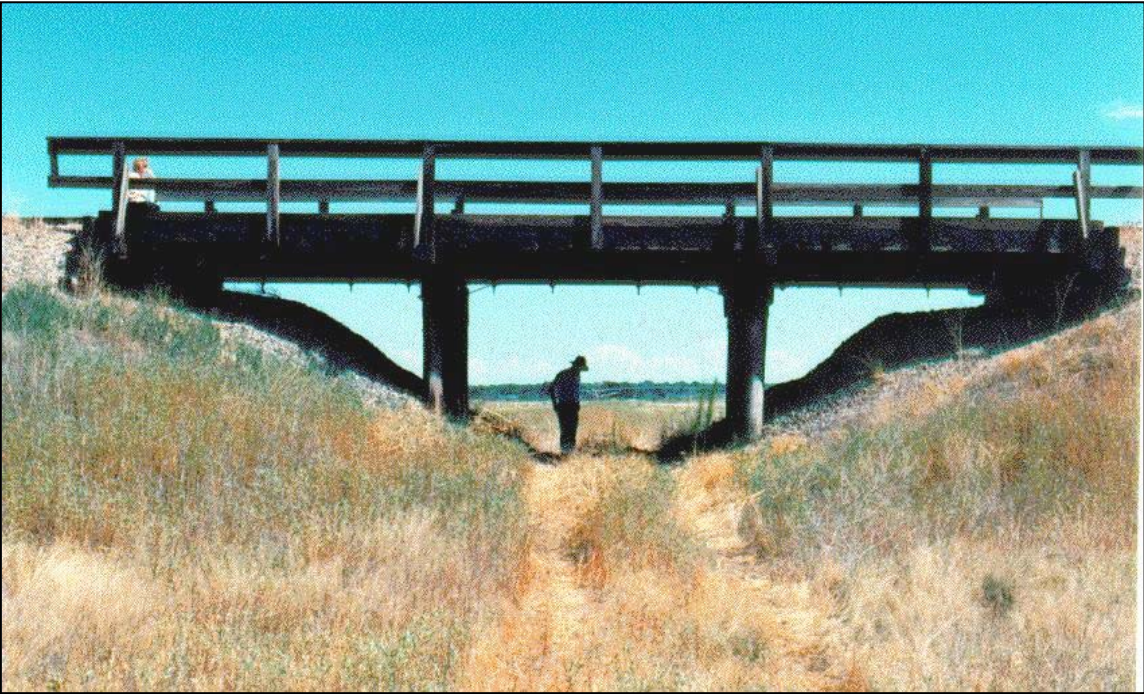
**FIGURE 1.** Bridge No. 101, View from West Side of Bridge

Bridge No. 101 is shown in Figures 1 and 2. It is a three-span, open-deck timber railway bridge with a total length of 40.25 feet of typical construction [13]. The individual spans are approximately 13 feet, 14 feet and 13 feet (157.5 inches, 168 inches and 157.5 inches). A walkway was attached on each side of the bridge at tie level. The bridge spans a gap in an embankment.

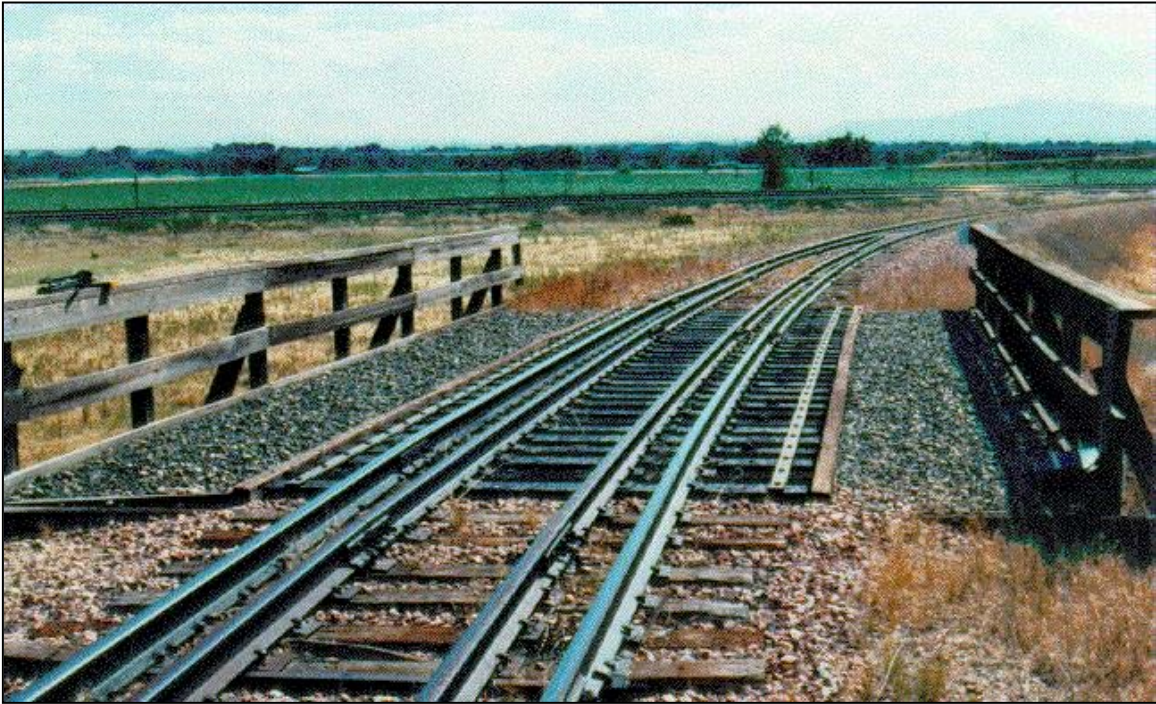
**FIGURE 2.** Bridge No. 101, View from North End of Bridge

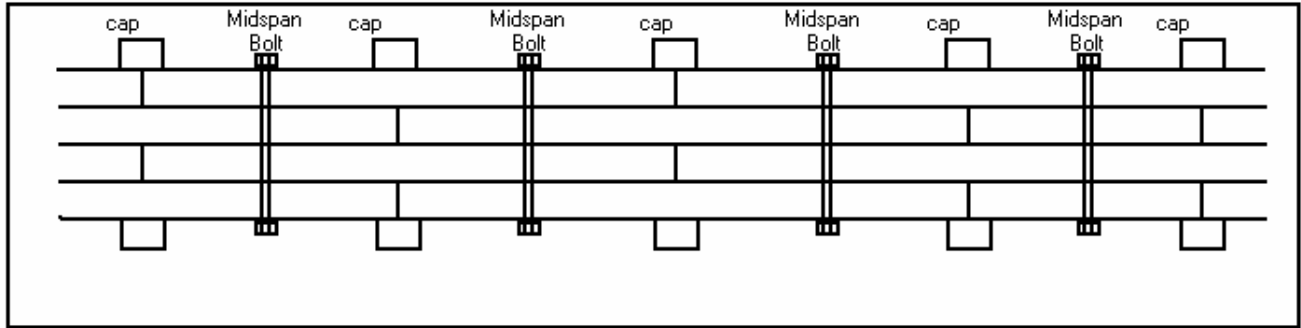
**FIGURE 3.** Typical placement of Members of Staggered Stringer Construction

After the initial test of Bridge No. 101, an additional line of exterior stringers was added to each chord. To do this required temporary removal of the two walkways. Lateral bolts connecting the existing stringers were removed and the new helper stringer was inserted between the cap and the wood ties. Two treated stringers were added to each chord, one a two-span member and the other a one-span member. Placement was consistent with the existing pattern of one- and two-span staggered stringers. Stringer sizes and species were the same as the existing stringers. The helper stringers were placed without centering the chord under the steel rail, the easiest and most economical replacement method. Centering would have necessitated removing the rail and disassembly and reassembly of the existing stringers. Longer tie connectors were installed to allow for the added stringer.

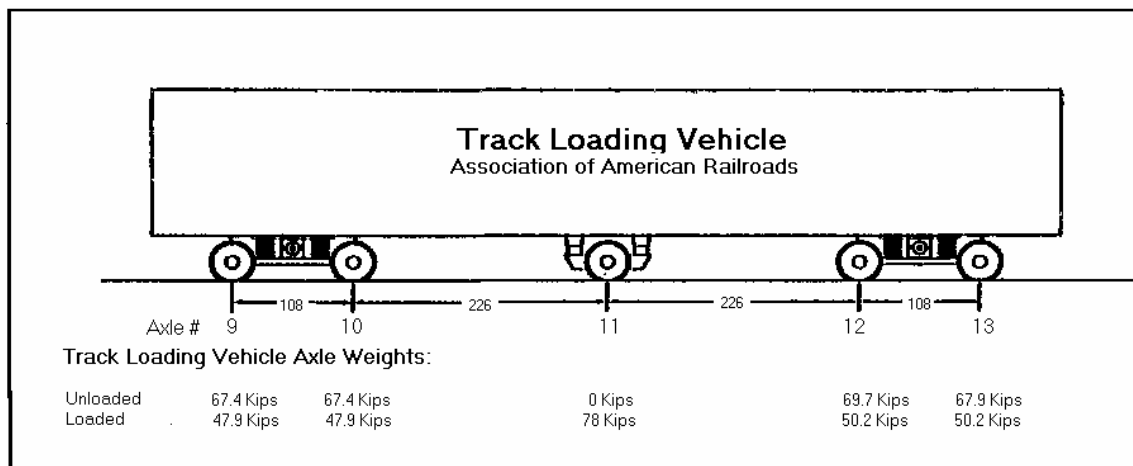
**FIGURE 4.** Track Loading Vehicle Schematic

For the first phase of load tests, the TTCI utilized the TLV for loading. The TLV (depicted in Figure 4) is a specialized rail car which provides hydraulic actuator capability by which controlled concentrated loading can be applied to railroad track. Although the TLV is capable of applying load simultaneously in three orthogonal directions, only vertical loading was used in the tests of Bridge No. 101. A pair of side-by-side actuators (one actuator per track line) lift the TLV at its mid-span so as to transfer either part or all of its weight to the track, thus loading the bridge at that location.

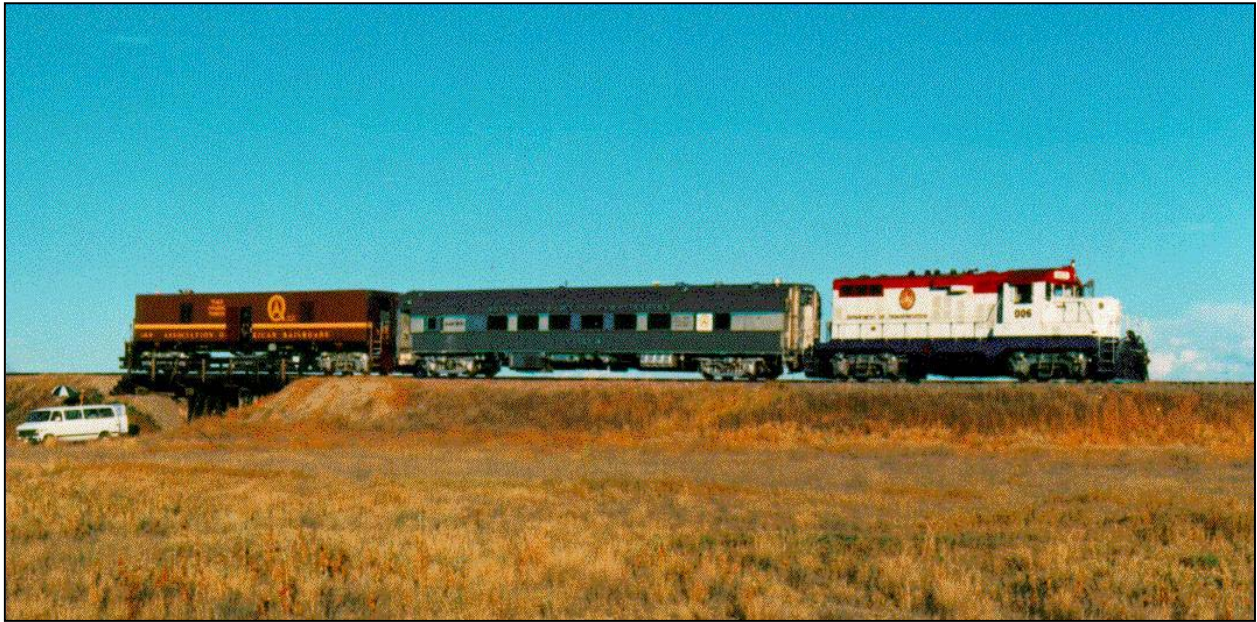
**FIGURE 5.** Test Train Composed of Locomotive, Instrumentation Car and Track Loading Vehicle at Bridge 101.

In the test configuration, an instrumentation car (IC) and a locomotive are included in tandem with the TLV. A four-axle locomotive was used for the pre-strengthening tests of Bridge No. 101. A photo of the test train is shown in Figure 5 and its configuration is shown in Figure 6. The axle weights are listed in Table 1. Static loading cases were achieved by positioning the three-car test train (12 axles) at specific locations with reference to the bridge being tested. For a given loading sequence, the train was positioned just off the bridge and instrumentation measurements were taken (instrumentation was “zeroed”). Then the train was slowly moved and stopped at the first predetermined position and measurements (electronic data and optical back-up data) were taken again. After that, the train was moved to the next position and the measurement process was repeated, then moved again to next position of interest, etc. A total of 108 positions were used and are described in the previous reports [1, 2, 3].

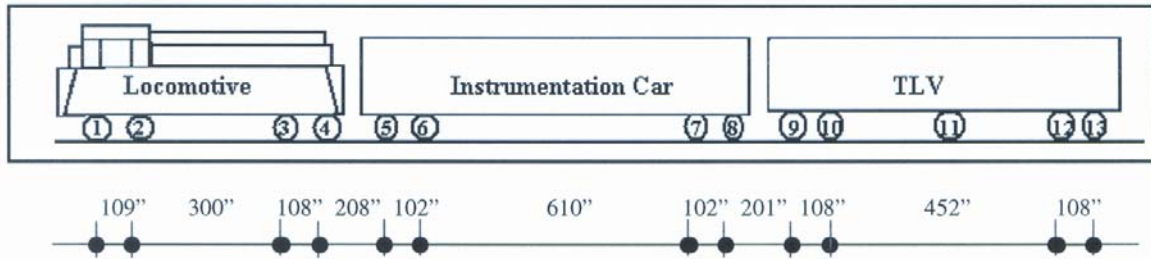
**Figure 6.** Test train axle spacing pre-strengthening tests

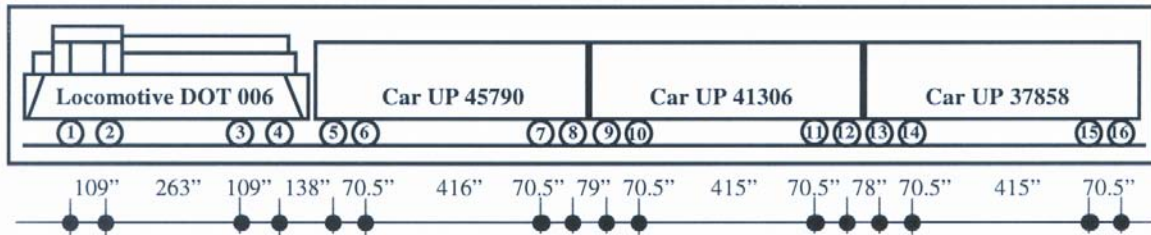
Figure 7. Test train axle spacing post-strengthening tests

After the retrofit, Bridge No. 101 was tested in March 1997 using a locomotive and three boxcars. The configuration of the train is shown in Figure 7. Table 2 lists the axle weights. Only rolling train loadings were used. The train made six passes across the bridge for each of the five speeds — 2, 5, 10, 15, and 20 mph.

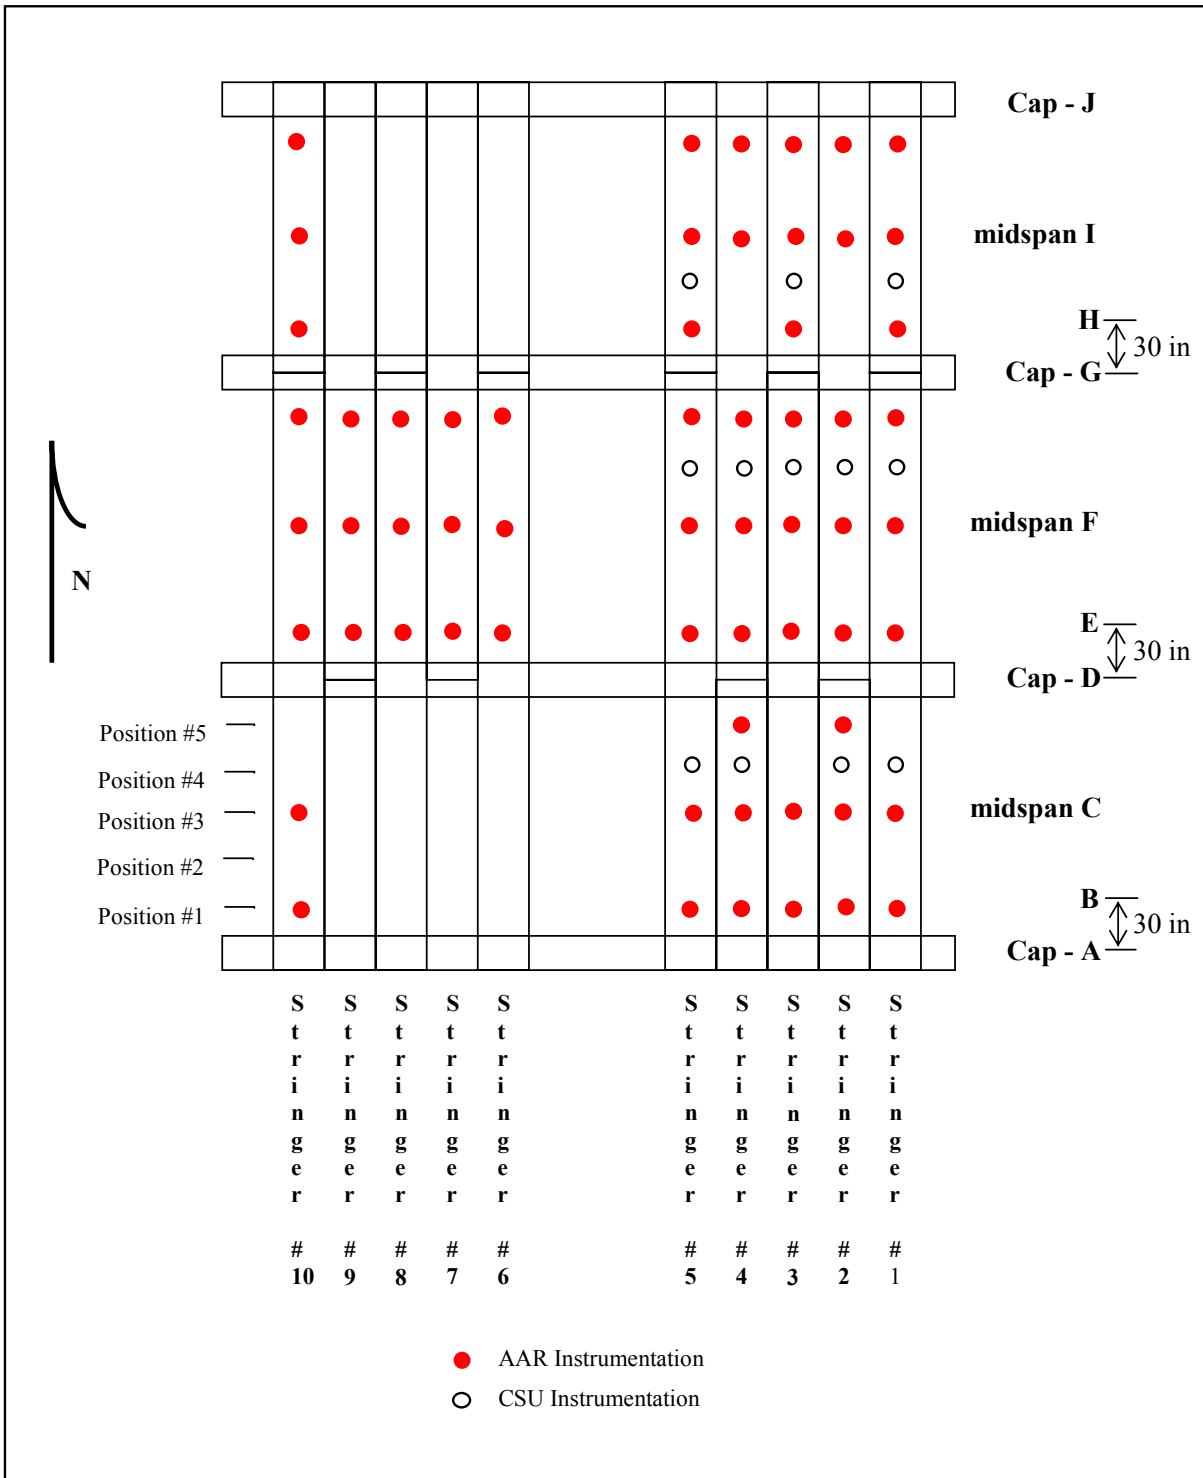
FIGURE 8. Bridge No. 101 - Plan View

The instrumentation locations and data referencing nomenclature are shown in Figure 8. Within any span, five instrumentation positions (Positions #1 to #5) representing the sixth points of a span are referenced, but not every stringer was monitored at each point. The longitudinal stringers are assigned numbers 1 through 10. The letters A, D, G, and J, going from south to north, reference the four cap beams. Points B, C, E, F, etc. are intermediate locations along the spans. The letter references are the same as were assigned during the pre-strengthening load test.

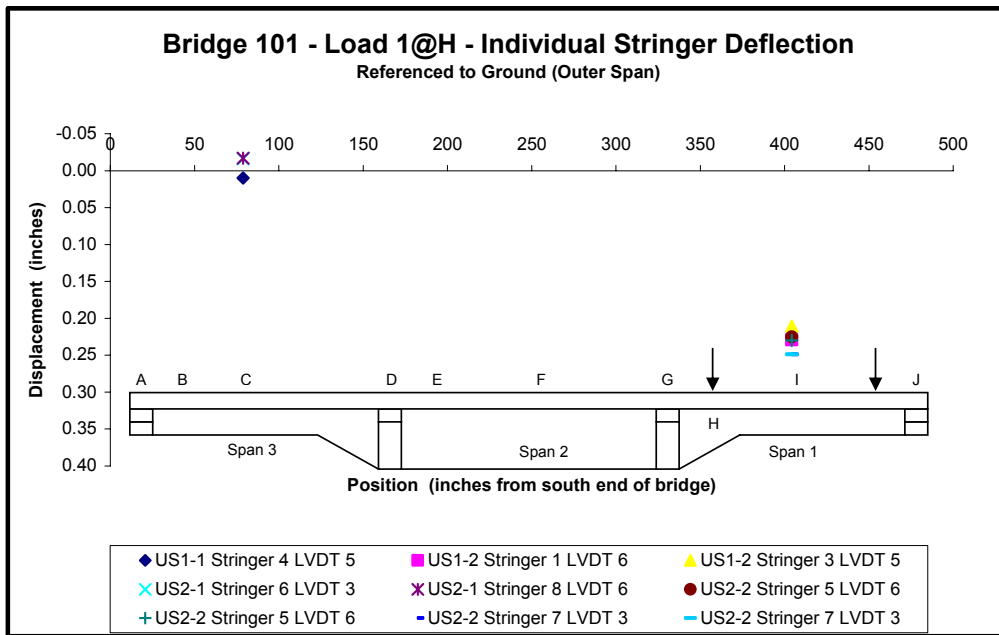
Figure 9. Transducer deflection measurements referenced to ground of Bridge 101 for load 1@H.

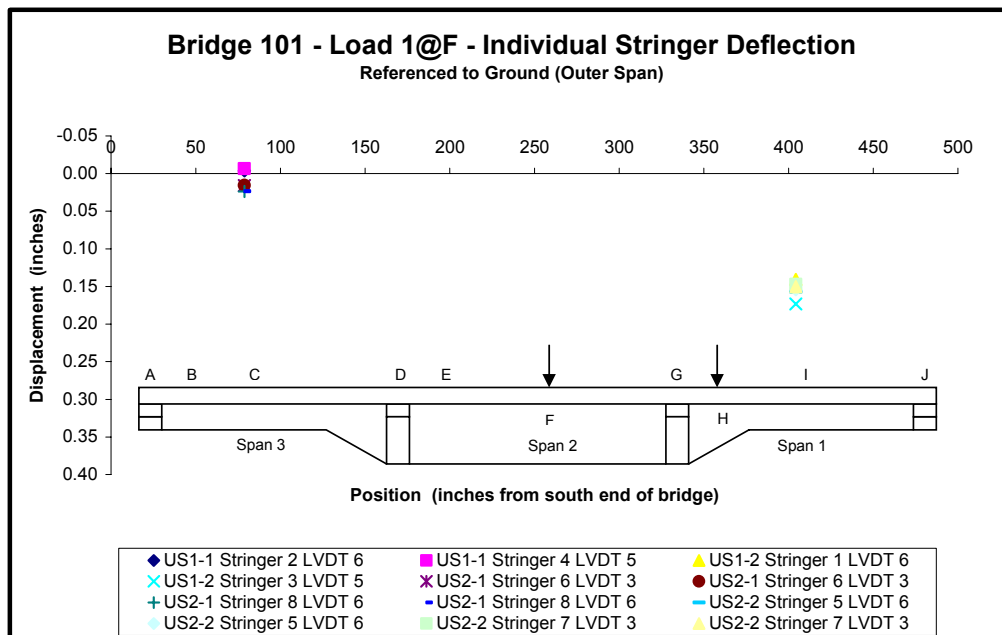
Figure 10. Transducer deflection measurements referenced to ground of Bridge 101 for load 1@F.

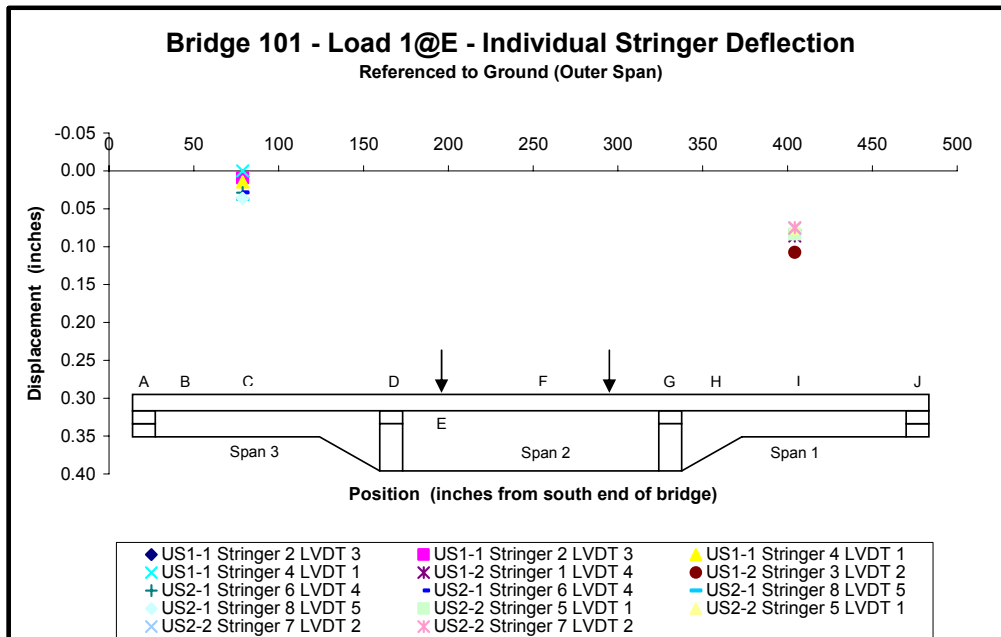
Figure 11. Transducer deflection measurements referenced to ground of Bridge 101 for load 1@E.

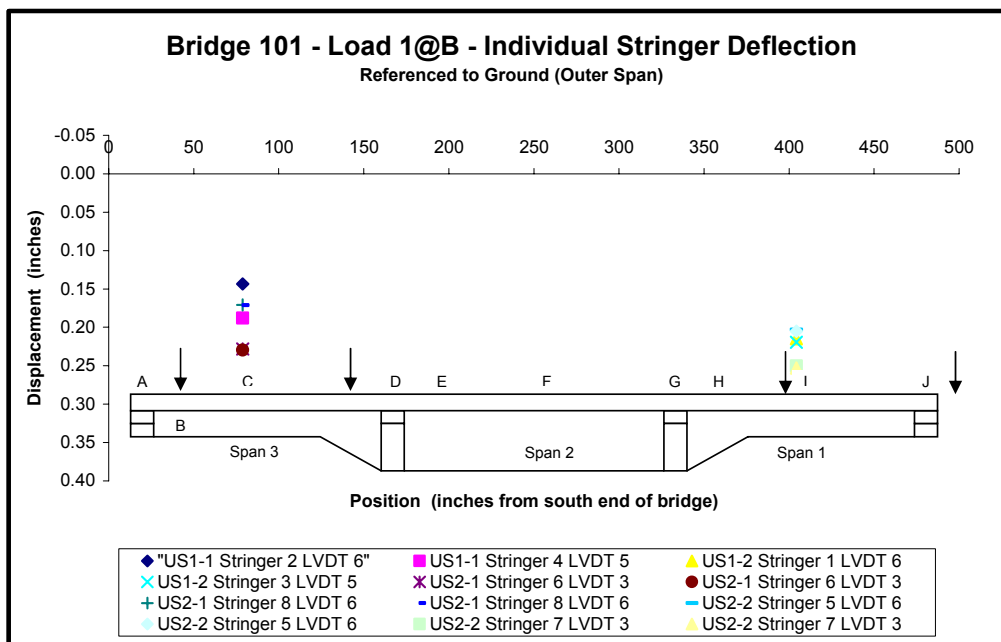
Figure 12. Transducer deflection measurements referenced to ground of Bridge 101 for load 1@B.

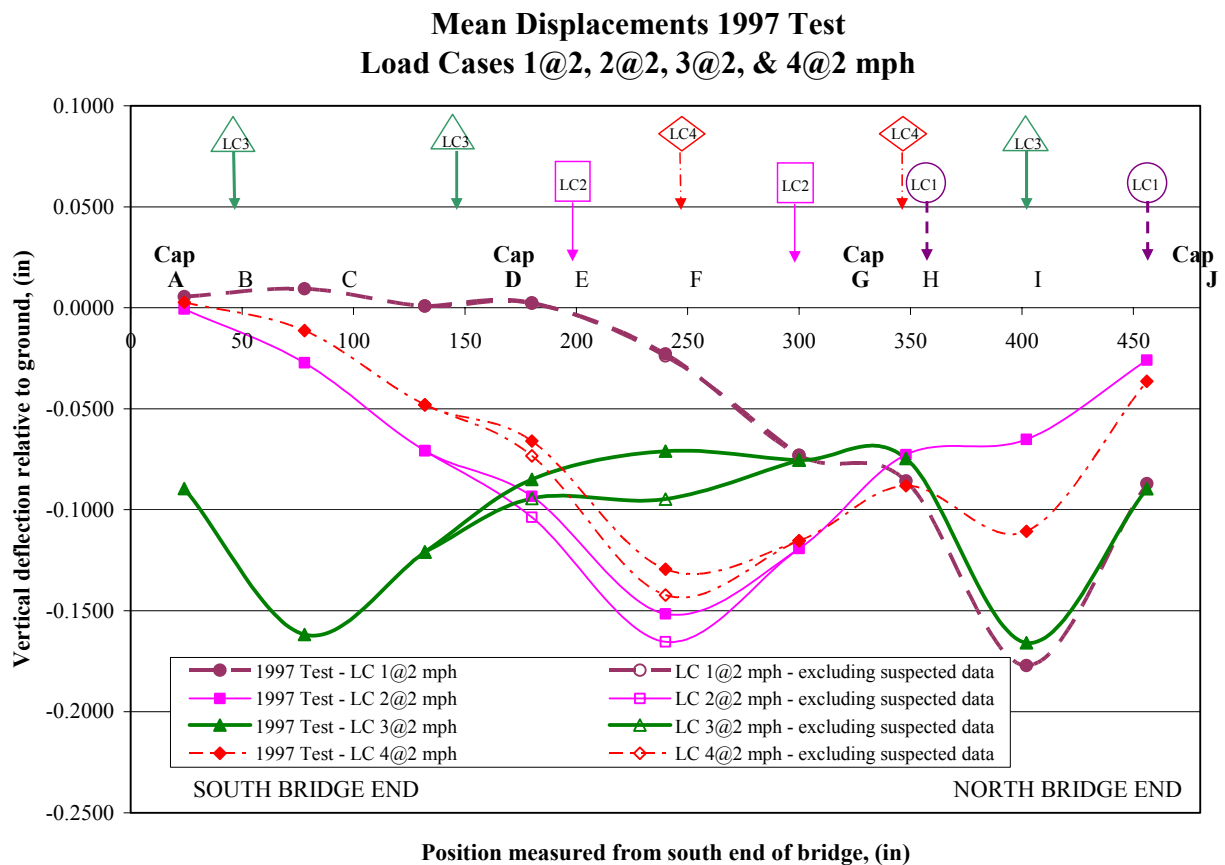
**FIGURE 13.** Mean Displacements Post-Strengthening Load Cases 1@2, 2@2, 3@2, and 4@2 mph.

Figure 13 shows some collective results for the quasi-static loadings. The mean mid-span displacements values for the stringers (average of the individual stringer mid-span displacement values within a span for all passes

combined) along the bridge are plotted for each of Load Cases 1@2 mph, 2@2 mph, 3@2 mph, and 4@2 mph. The displaced various shaped curves are qualitatively consistent with the corresponding loadings but also give evidence of small support settlements at two intermediate bents, i.e. at cap D and cap G.

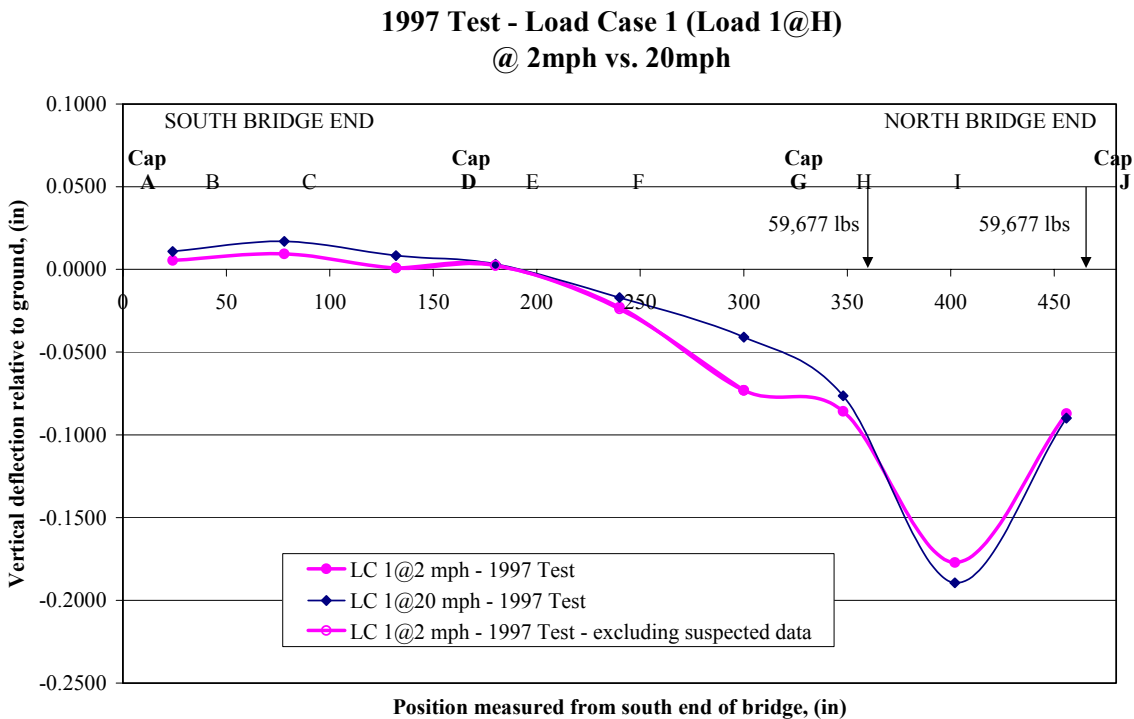
FIGURE 14. Load Case 1- Post-Strengthening Test @ 2 mph and 20 mph

Figures 14-17 graphically compare the post strengthening displacement responses for the 2 mph vs. 20 mph train speeds. (Figure 14 (15, 16, 17) is for Load Cases 1@2 mph vs. 1@20 mph (2@2 mph vs. 2@20 mph, 3@2 mph vs. 3@20 mph, 4@2 mph vs. 4@20 mph). The responses of the bridge to the moving train at the nominal 2 mph and 20 mph speeds are very close to each other. Note that the displacement response at 20 mph was predominantly less than that at 2 mph. The inference is that the dynamic impact effect was essentially non-existent.

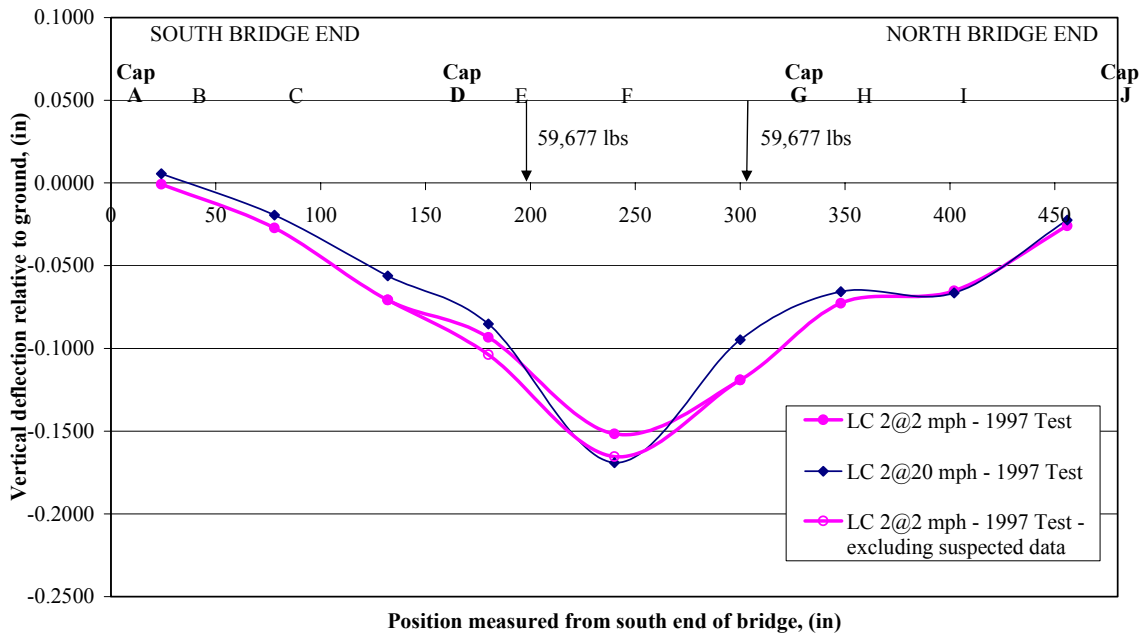
**1997 Test - Load Case 2 (Load 1@E)  
@ 2mph vs. 20mph**

**FIGURE 15.** Load Case 2- Post-Strengthening Ttest @ 2 mph and 20 mph

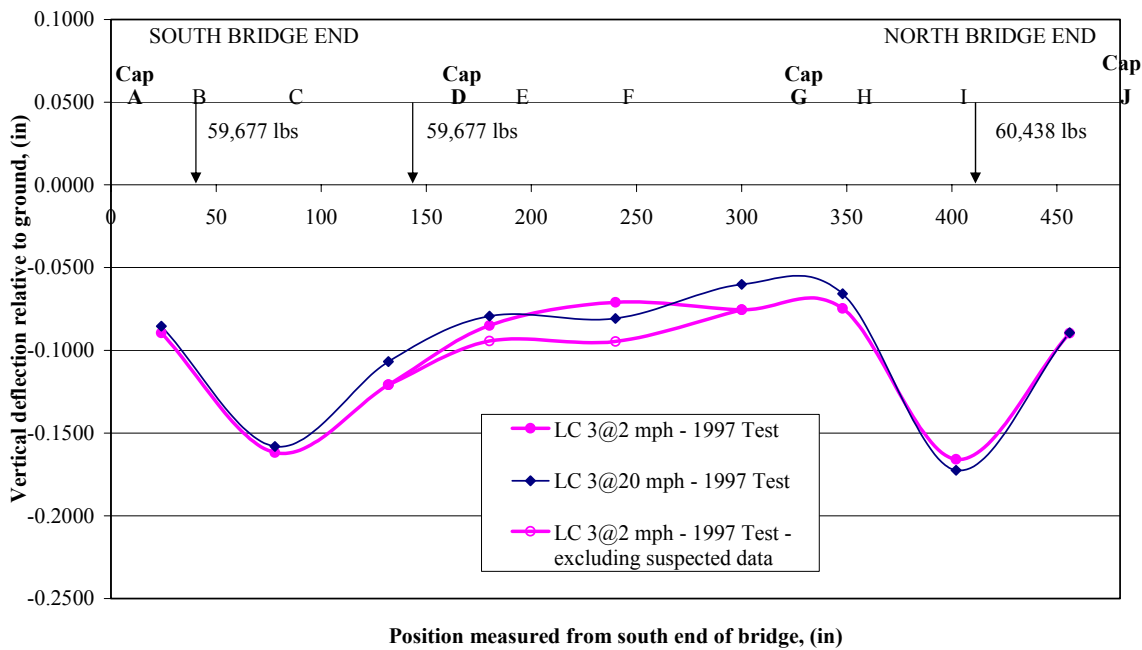
**1997 Test - Load Case 3 (Load 1@B)  
@ 2mph vs. 20mph**

**FIGURE 16.** Load Case 3 - Post-Strengthening Test @ 2 mph and 20 mph

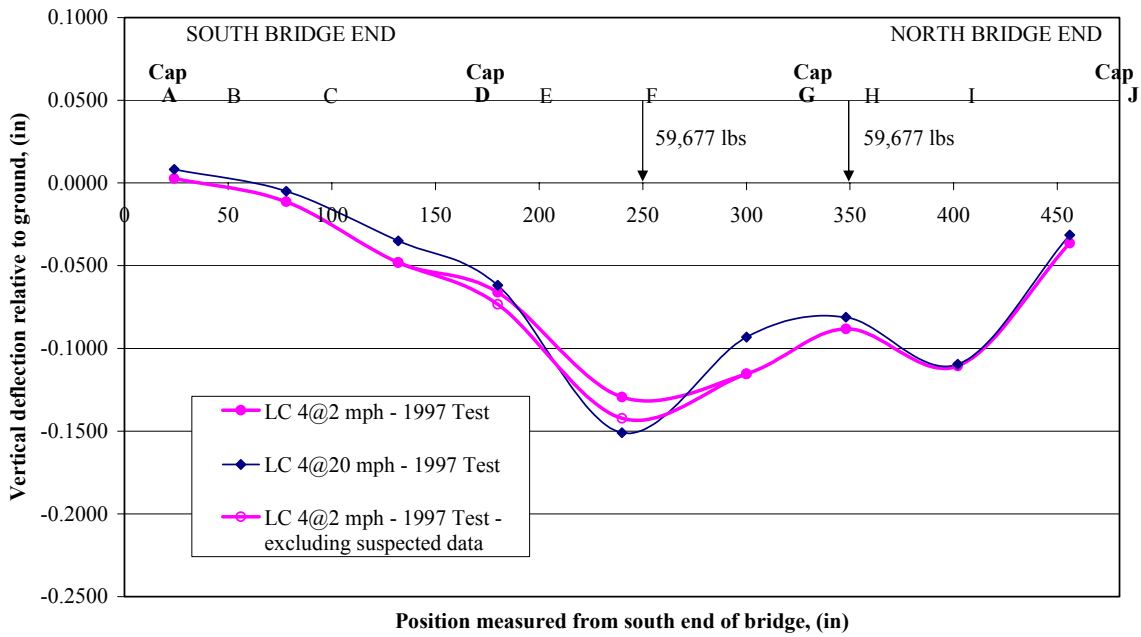
**1997 Test - Load Case 4 (Load 1@F)  
@ 2mph vs. 20mph**

FIGURE 17. Load Case 4 Post-Strengthening Test @ 2 mph and 20 mph

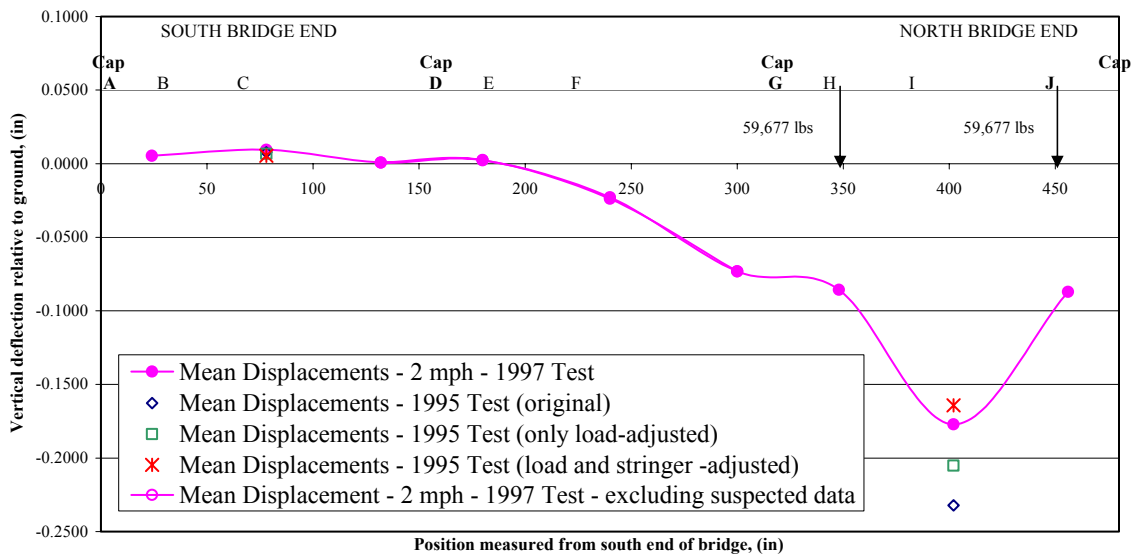
**1997 Test vs. 1995 Test  
Load Case 1 (Load 1@H)**

FIGURE 18. Load Case 1 (Load 1 @ H) Post-Strengthening Test vs. Pre-Strengthening Test

The results listed in Table 5 are displayed graphically in Figures 18 and 19. The mean displaced shape for Load Case 1@2 mph is illustrated in Figure 18. The plot is done both including and excluding the suspect data for stringer 4 in Span 2, with no noticeable difference. At two locations (C and I) the actual (measured) mean pre-strengthening displacements for Load Case 1@0 mph (Load 1@H) are plotted. These values are also plotted after: a) adjusting for the difference in load level for the two test trains and then b) adjusting for the additional stringer. The resulting value is close to the plot for the post-strengthening displaced shape. Companion information for Load Case 3@2 mph vs. Load Case 3@0 mph (Load 1@B) is shown in Figure 19. Excluding the suspect stringer 4 data in Span 2 makes a noticeable difference within Span 2 only. The result underscores that stringer 4 data is suspect as the adjusted shape has curvature that better matches the sense of the loads. In particular, Span 2, which has no loads on it, should likely have concave downward curvature.

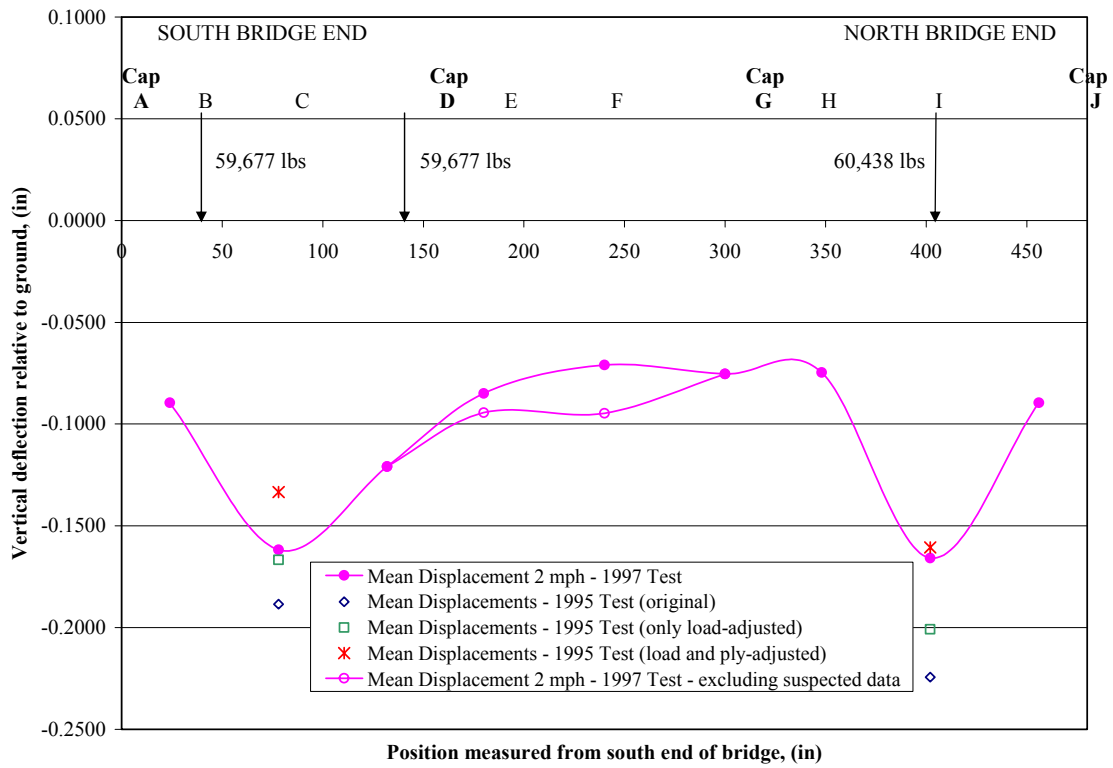
**1997 Test vs. 1995 Test  
Load Case 3 (Load 1@B)**

**FIGURE 19.** Load Case 3 (Load 1 @ B) Post-Strengthening Test vs. Pre-Strengthening Test

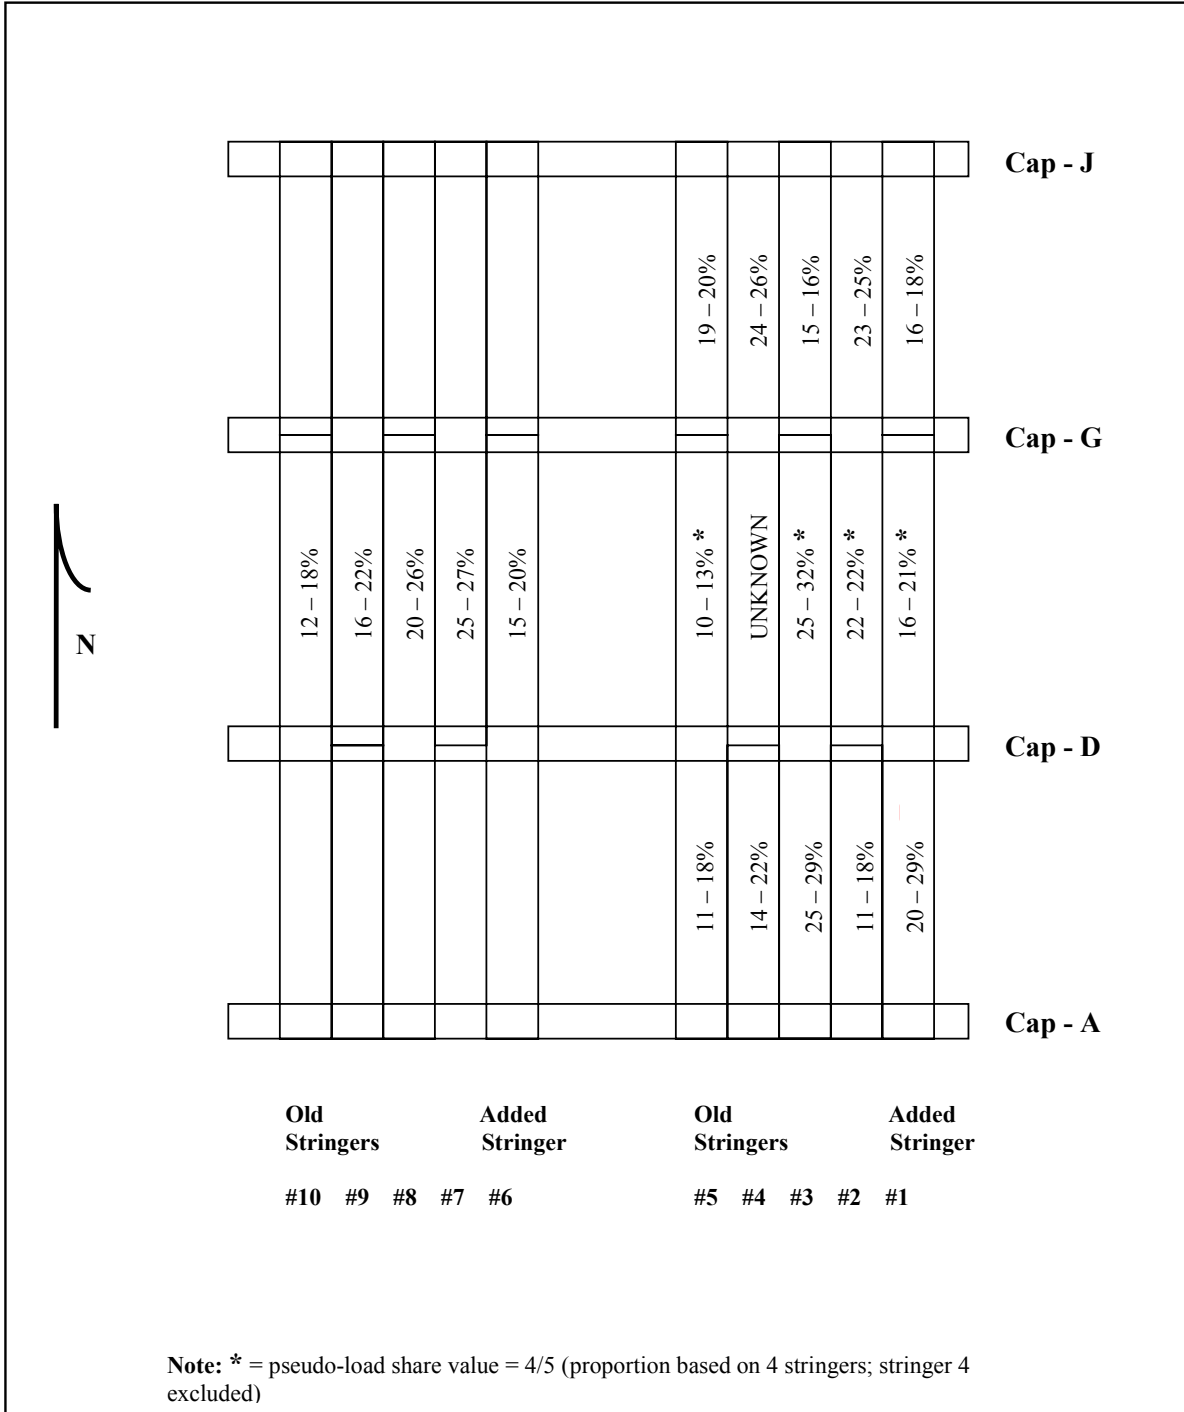
**FIGURE 20.** Bridge No. 101 - Load Share Ranges Based on the Post-Strengthening Measurements

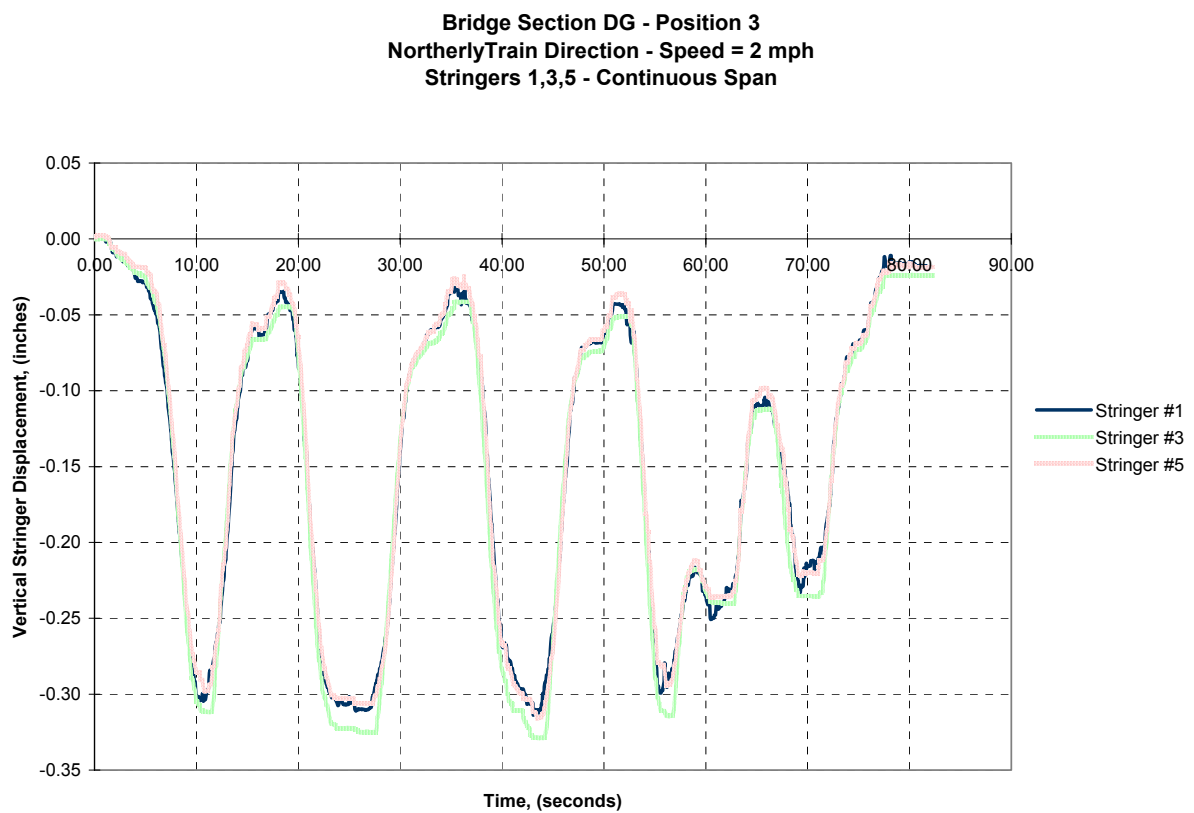
**FIGURE 21-A. Transverse Response @ 2 mph**

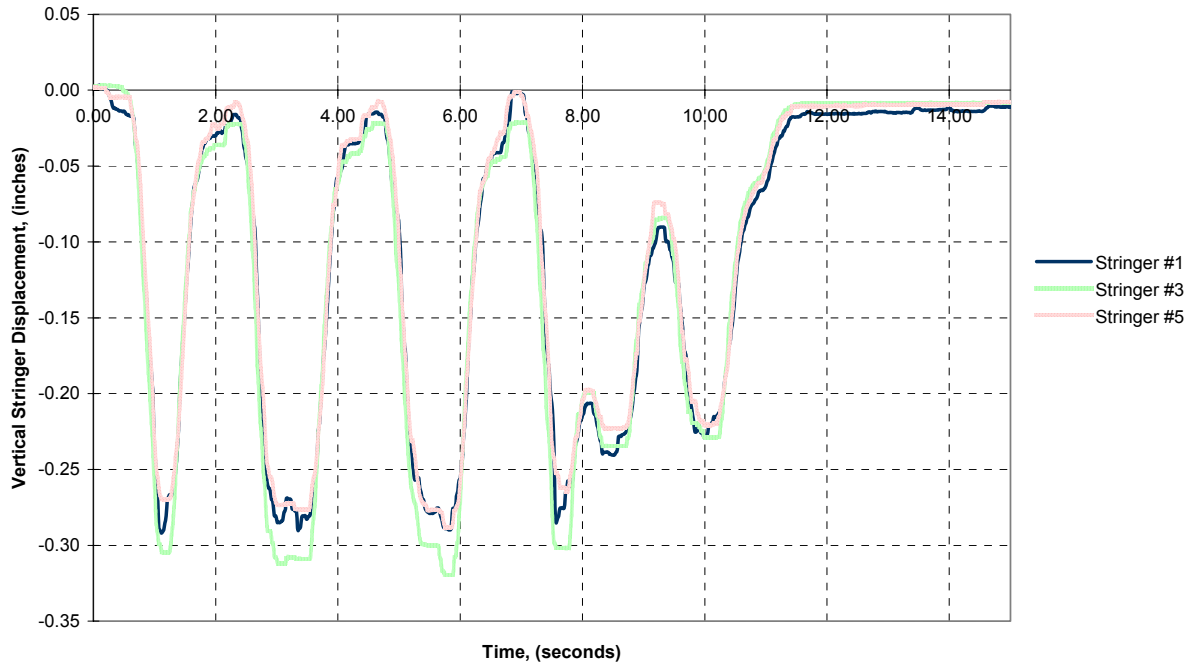
Bridge Section DG - Position 3  
Northerly Train Direction - Speed = 20 mph  
Stringers 1,3,5 - Continuous Span

FIGURE 21-B. Transverse Response @ 20 mph

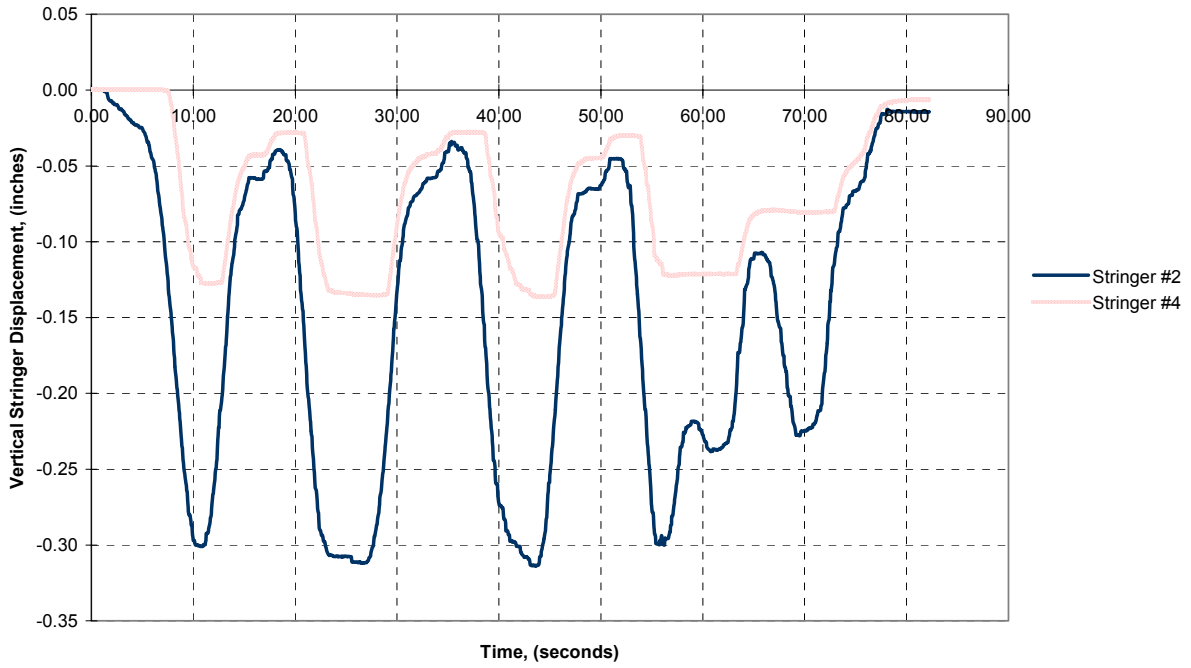
Bridge Section DG - Position 3  
Northerly Train Direction - Speed= 2 mph  
Stringers 2,4 - Continuous Span

FIGURE 22-A. Transient Response @ 2 mph

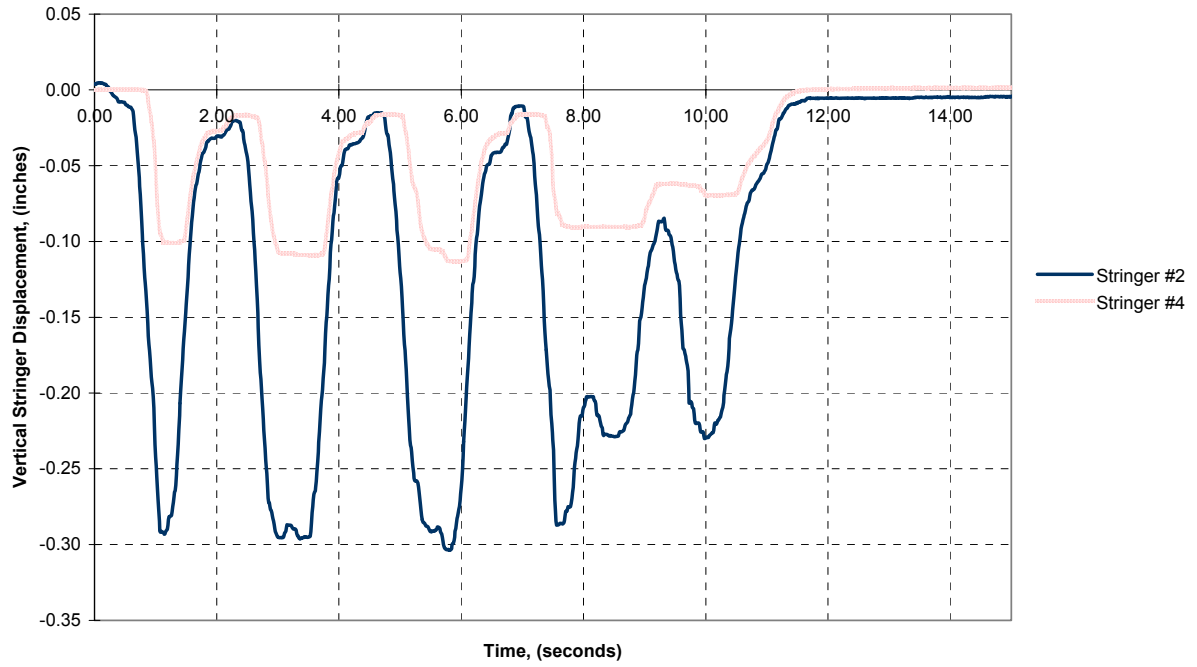
Bridge Section DG - Position 3  
Northerly Train Direction - Speed = 20 mph  
Stringers 2,4 - Continuous Span

FIGURE 22-B. Transient Response @ 20 mph

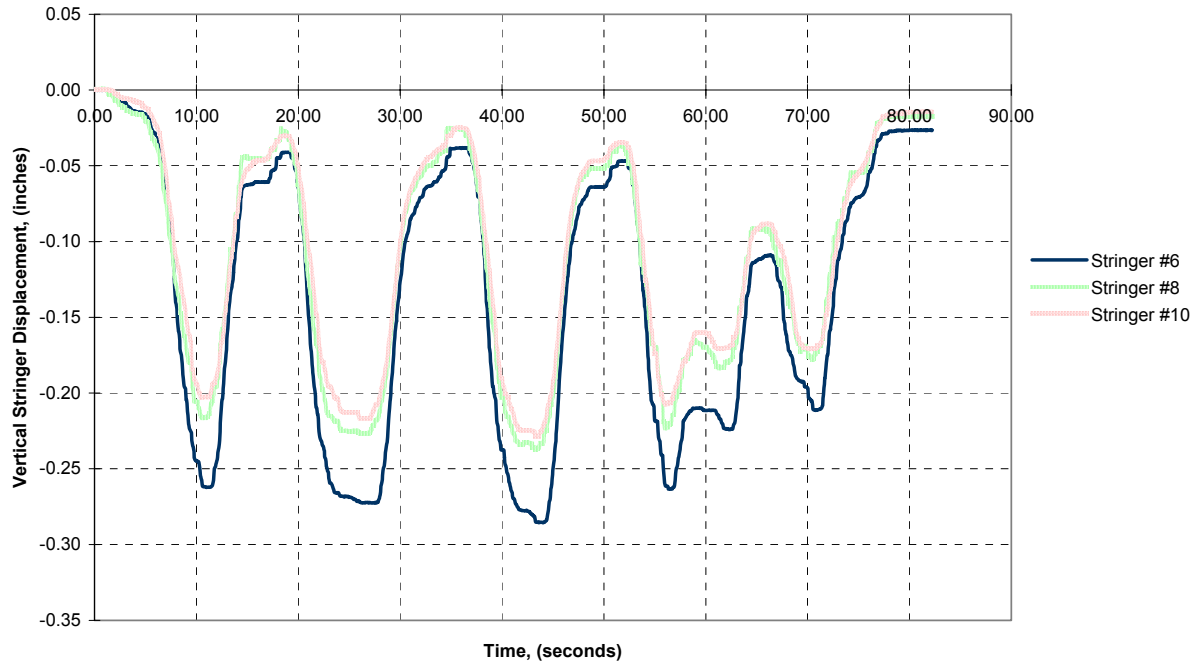
Bridge Section DG - Position 3  
Northerly Train Direction - Speed = 2 mph  
Stringers 6,8,10 - Continuous Span

FIGURE 23-A. Transient Response @ 2 mph

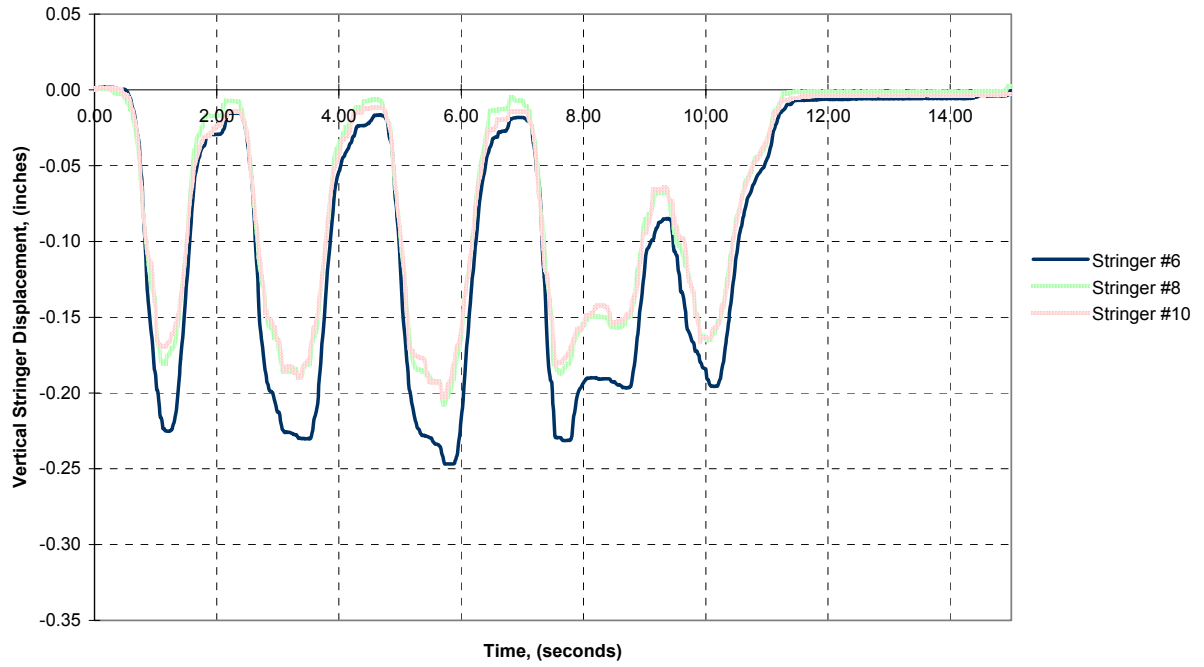
Bridge Section DG - Position 3  
Northerly Train Direction - Speed = 20 mph  
Stringers 6,8,10 - Continuous Span

FIGURE 23-B. Transient Response @ 20 mph
