FIELD INVESTIGATION OF  
A STRENGTHENED  
TIMBER TRESTLE RAILROAD BRIDGE

Richard M. Gutkowski, Ph.D., P.E.  
Abdalla M.T. Shigidi, Ph.D.  
An Vihn Tran, Ph.D.

Department of Civil Engineering  
Colorado State University  
Fort Collins, Colorado 80523

June 2003

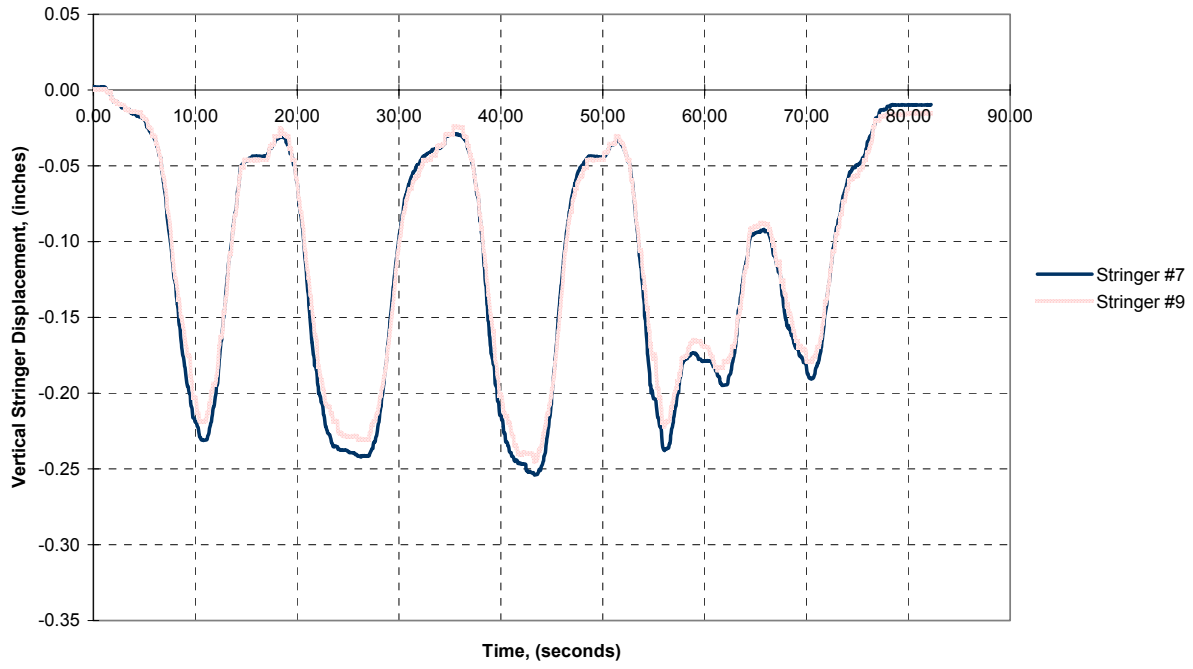
**Bridge Section DG - Position 3**  
**Northerly Train Direction - Speed = 2 mph**  
**Stringers 6,7,8,9,10 - Continuous Span**

**FIGURE 24-A.** Transient Response @ 2 mph

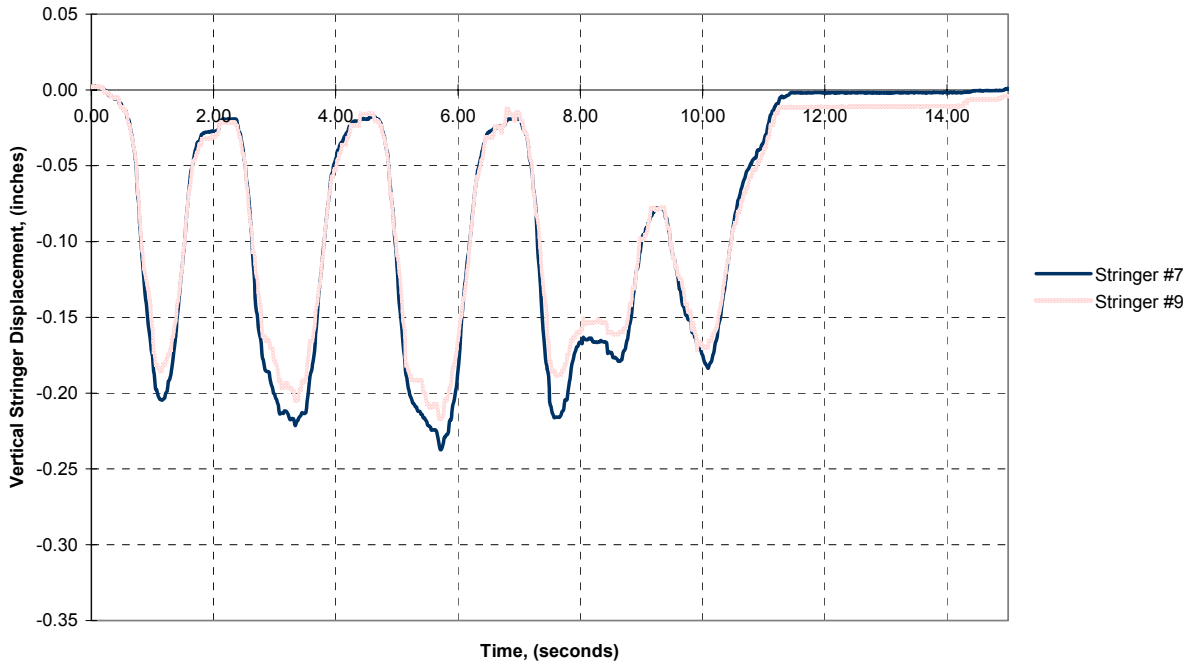
**Bridge Section DG - Position 3**  
**Northerly Train Direction - Speed = 20 mph**  
**Stringers 6,7,8,9,10 - Continuous Span**

**FIGURE 24-B.** Transient Responses @ 20 mph

Figure 24b, the corresponding amplitudes are visually scaled as .18" (.17"). The calculated impact dynamic impact effect is -5.3 percent (-5.5 percent).
