NYSDOT Bridge Deck Task Force Evaluation of Bridge Deck Cracking on NYSDOT Bridges

**Written by: Robert H. Curtis, PE
Edited by: Harry White 2nd, PE**

February 2007

**New York State Department of Transportation
50 Wolf Road, Albany, New York, 12232**

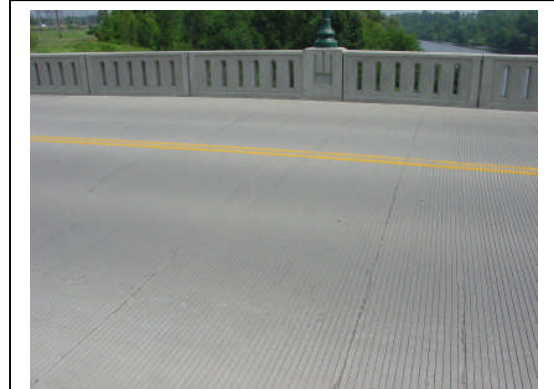
Figure 5 - Cracking in BIN 3221420, Alcoa Road over Grasse River constructed in 2002.

Several newly constructed bridges in northern NY were identified as having serious cracking. This prompted inspections and documentation of the extent of the bridge deck cracking. Figures 4 and 5 show the seriousness of the problem.

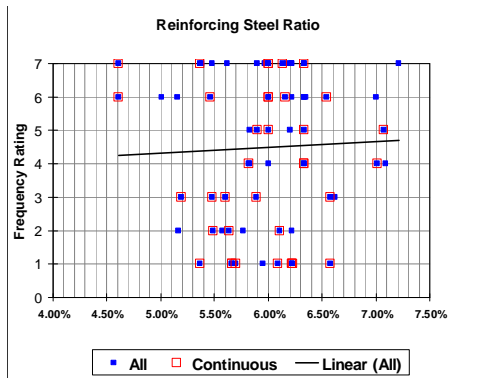
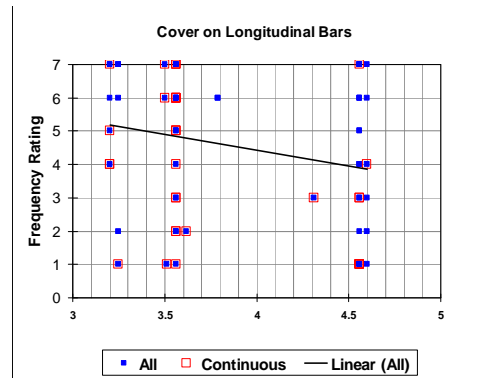
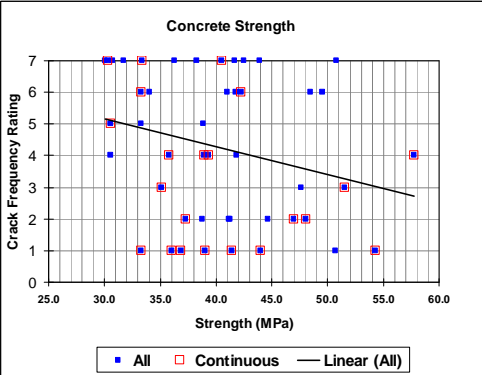
Figure 6 – Correlation of Various Parameters on Cracking Frequency

In addition to field rating the structures, construction records, as-built plans, and materials records were researched to create a database with all known parameters that affect the likelihood of cracking the bridge deck. Plots were created with the crack frequency rating as a function of each of several parameters as shown in Figure 6. A trend line was created using linear fit of the data. It should be noted that there is

Based on experience and information obtained from the plots presented in Figure 6, the following parameters have been determined to be the most influential factors that determine whether a concrete bridge deck cracks.

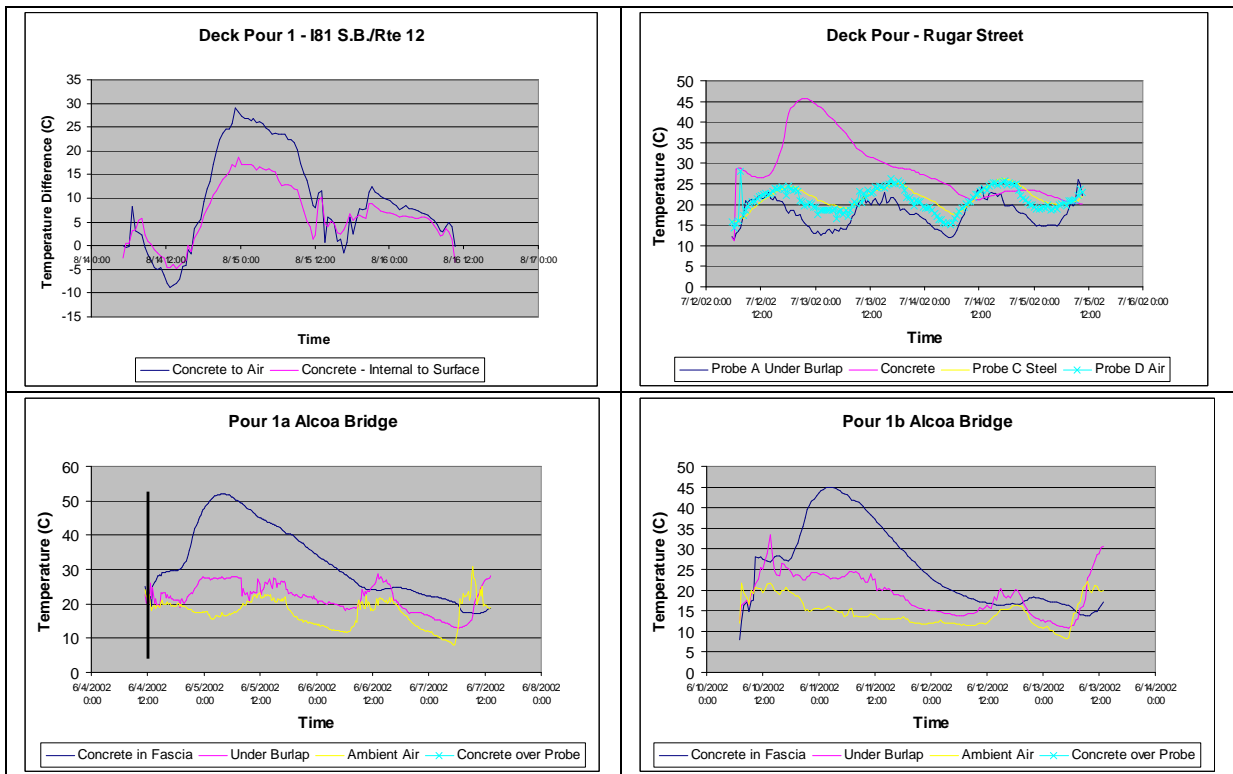
The time at which the deck concrete gains its initial strength coincides with an increase in concrete temperature from the chemical reaction of hydration. Thus, the concrete sets at a temperature well above the temperature of the steel. As the concrete cools, the steel, which does not appreciably change in temperature, restrains the deck. Although this effect is difficult to quantify, it is clear that in decks where temperatures were measured in the hours after the deck pour, the temperature rise starts before the initial set of the concrete and the deck returns to ambient temperature occurs well after concrete set and at a point where the strength of the concrete has reached a value of more than half of the 28-day strength. Figure 7 shows the temperature rise relative to time for several bridge decks that were instrumented by NYSDOT.

Figure7 - Initial Temperature Rise in Bridge Decks

Peak temperature differences of up to 54° F (30° C) are not uncommon. If the deck sets at a temperature of 120° F (50° C) and the superstructure steel top flange temperature is 85° F (30° C) at the time of set, there will be a built-in thermal stress corresponding to a 35° F (20° C) temperature difference.

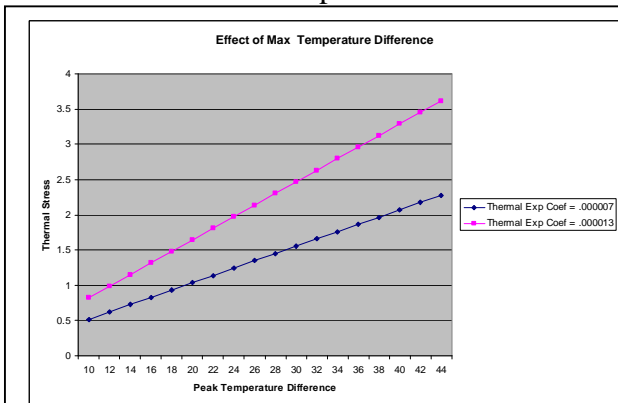
There is a linear relationship between the temperature difference at concrete set and the final concrete thermal stress. Likewise, there is a linear relationship between the coefficient of thermal expansion and the final thermal stress as shown in Figure 9.

Figure 9 - Relationship of Concrete Thermal Stress and Peak Temperature Differences for range of thermal expansion coefficients reported by Emerson (1979).

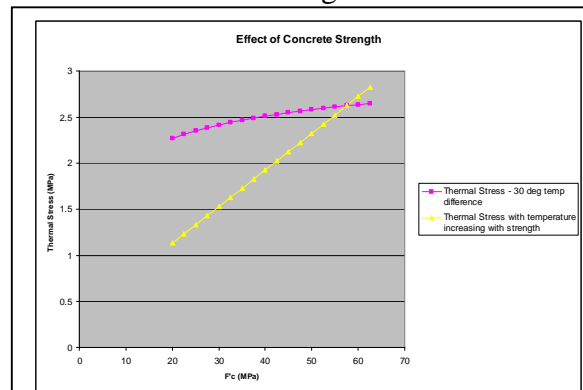
Figure 10 - Effect of Modulus of Elasticity as determined by Concrete Strength (f'_c) on the thermal stress for a 54° F (30° C) temperature rise due to the heat of hydration.

The modulus of elasticity is generally computed as a function of the strength of concrete. Therefore, the thermal stress can be computed as a function of the strength. In addition, higher strength concretes tend to have a higher heat of hydration. Figure 10 shows the relationship of strength to thermal stress for both a constant temperature difference and an increasing temperature difference.

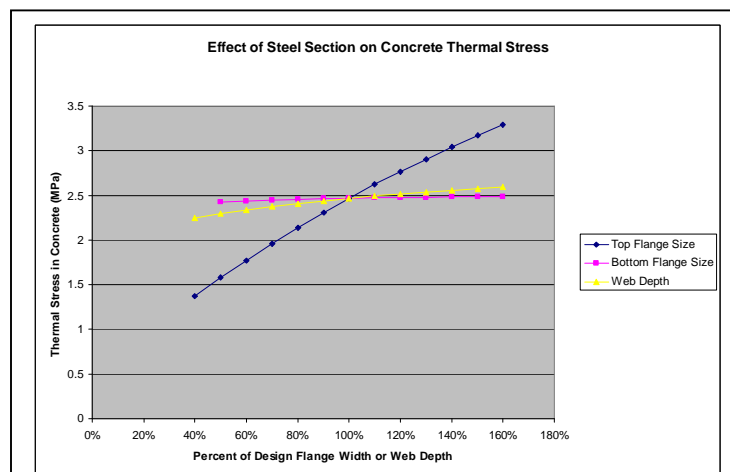
Figure 8 - Effect of Steel Section Properties on Thermal Stress.

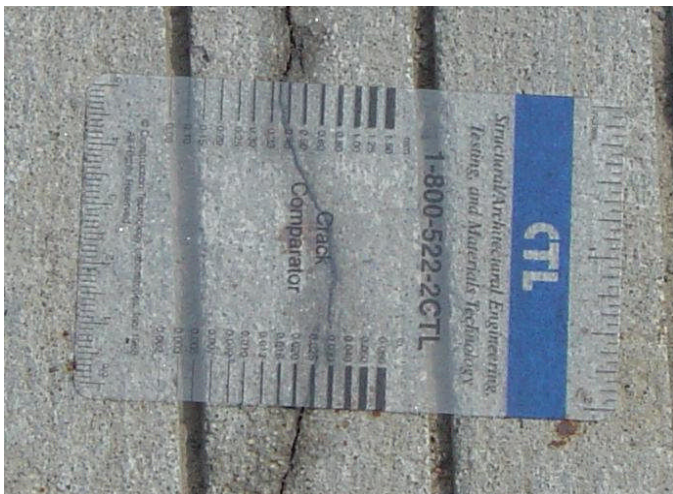
Figure 15 - Close up of one of many cracks in BIN 3221420 - Alcoa Road over Grasse River

crack size rating scale. Of the decks that were cracked in the study sample, most had cracks larger than this threshold. Cracks of 0.013 in. (0.33 mm) were not uncommon and cracks as large as 0.030 in. (0.75 mm) were observed. Cracks of this size easily permit chlorides to reach the reinforcing steel (see Figure 15).

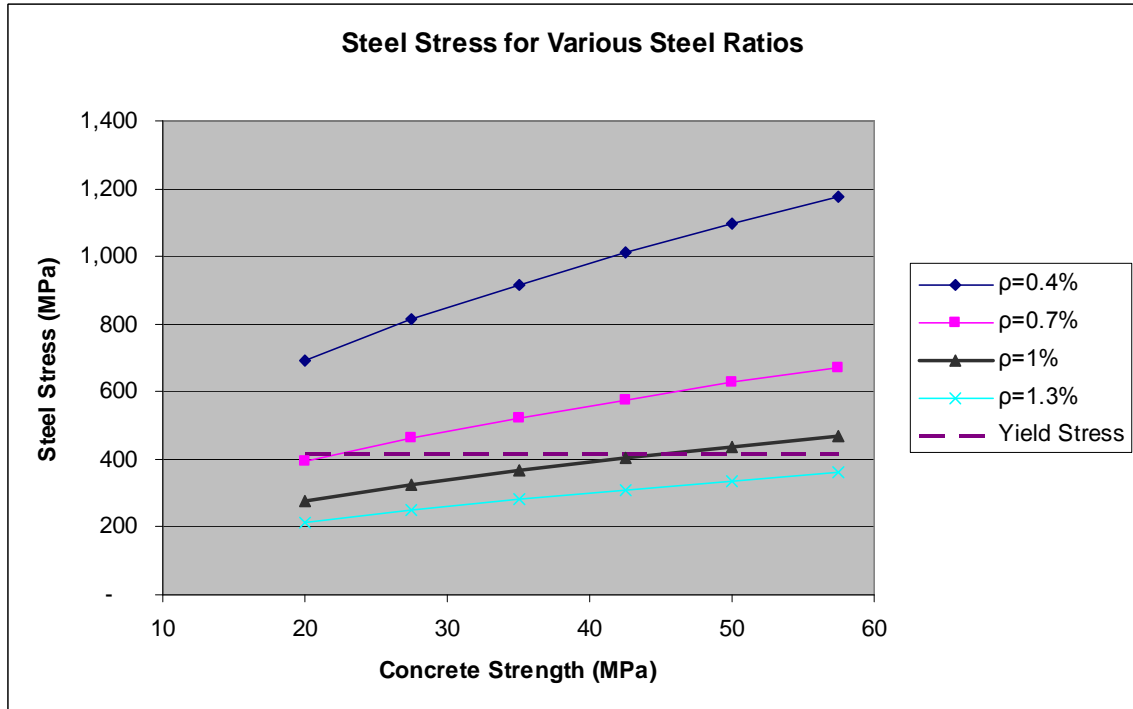
The following shows the stress in the reinforcing steel at the instant of concrete cracking for various concrete to steel ratios and concrete strengths.

For concrete strengths up to approximately 6.5 ksi (44 MPa), the 1% value of the steel ratio will ensure that the steel does not yield. Obviously, stresses higher than yield cannot occur. However, when yield is reached the crack size could be expected to increase dramatically as plastic deformations occur. Typically, NYSDOT bridge decks have steel reinforcing ratios of 0.35% to 0.45% at midspan.
