USE OF TRIBUTARIES OF THE LOWER JAMES RIVER
BY ANADROMOUS FISHES

Final Report for Phase Two of an Analysis of the Impediments
to Spawning Migrations of Anadromous Fish in Virginia Rivers

August, 1986

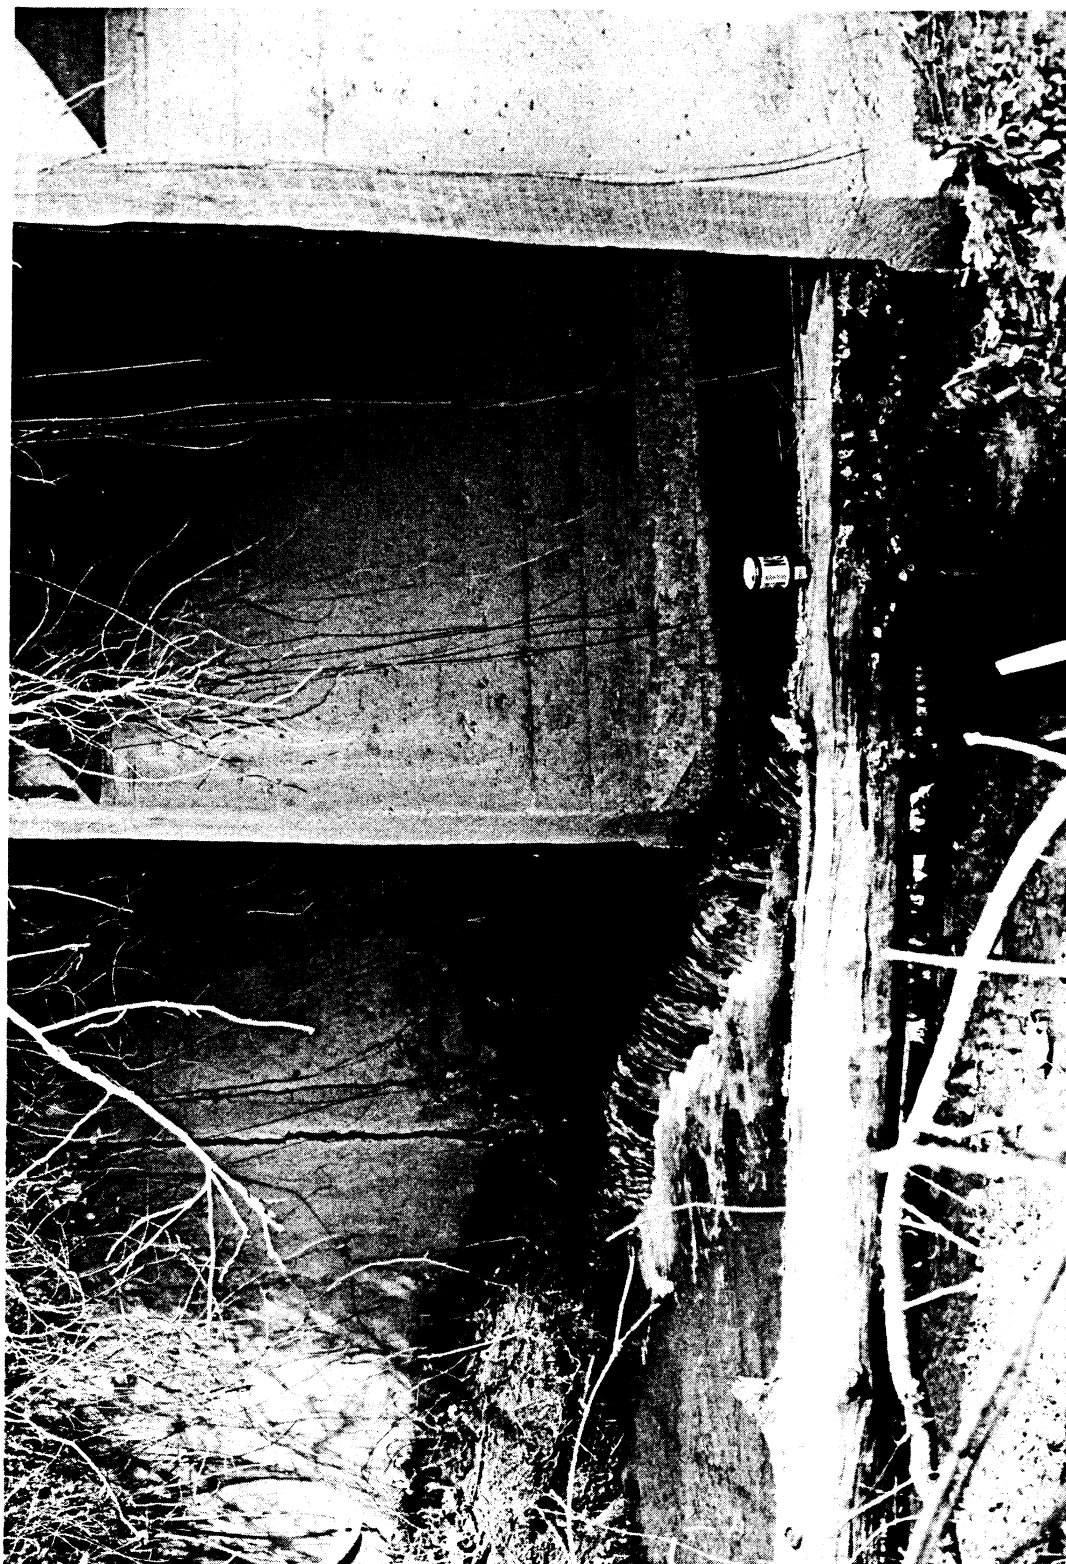
Figure 6. Poor Creek flowing out of the culvert parallel and adjacent to Route 36, as it passes under an elevated railroad. Note the vertical drop at the mouth of the culvert, and lack of depth in the cells.

Street, Poor Creek passes through a culvert that is adjacent and parallel to Route 36 as it passes under an elevated Norfolk and Western railroad line. This culvert has a vertical drop of about 15 cm at its outlet (Fig. 6), which would be impassable for river herring except during high discharge. This culvert is probably the upstream limit for river herring runs, if the riffles below do not stop them. Further research is needed to make a final determination. If this culvert was modified, river herring could possibly run up this stream an additional 0.1 mile to the Route 36 culvert during years with above-average discharge. The water depth in the Route 36 culvert is too shallow (~ 3 cm deep on March 11, 1986) for river herring to negotiate during average spring flows (Fig. 7), but at above-average flows, there may be adequate depth for them to ascend through this structure. Consequently, the Route 36 culvert was labeled "questionably passable"; an evaluation during high discharge would be required to make a final determination. Approximately 80 m above Route 36, the stream cascades down a section of steep gradient through numerous cobbles and small boulders; this would stop river herring at all flow conditions. Locals indicated that the river herring runs on this stream are small and are not observed every year.

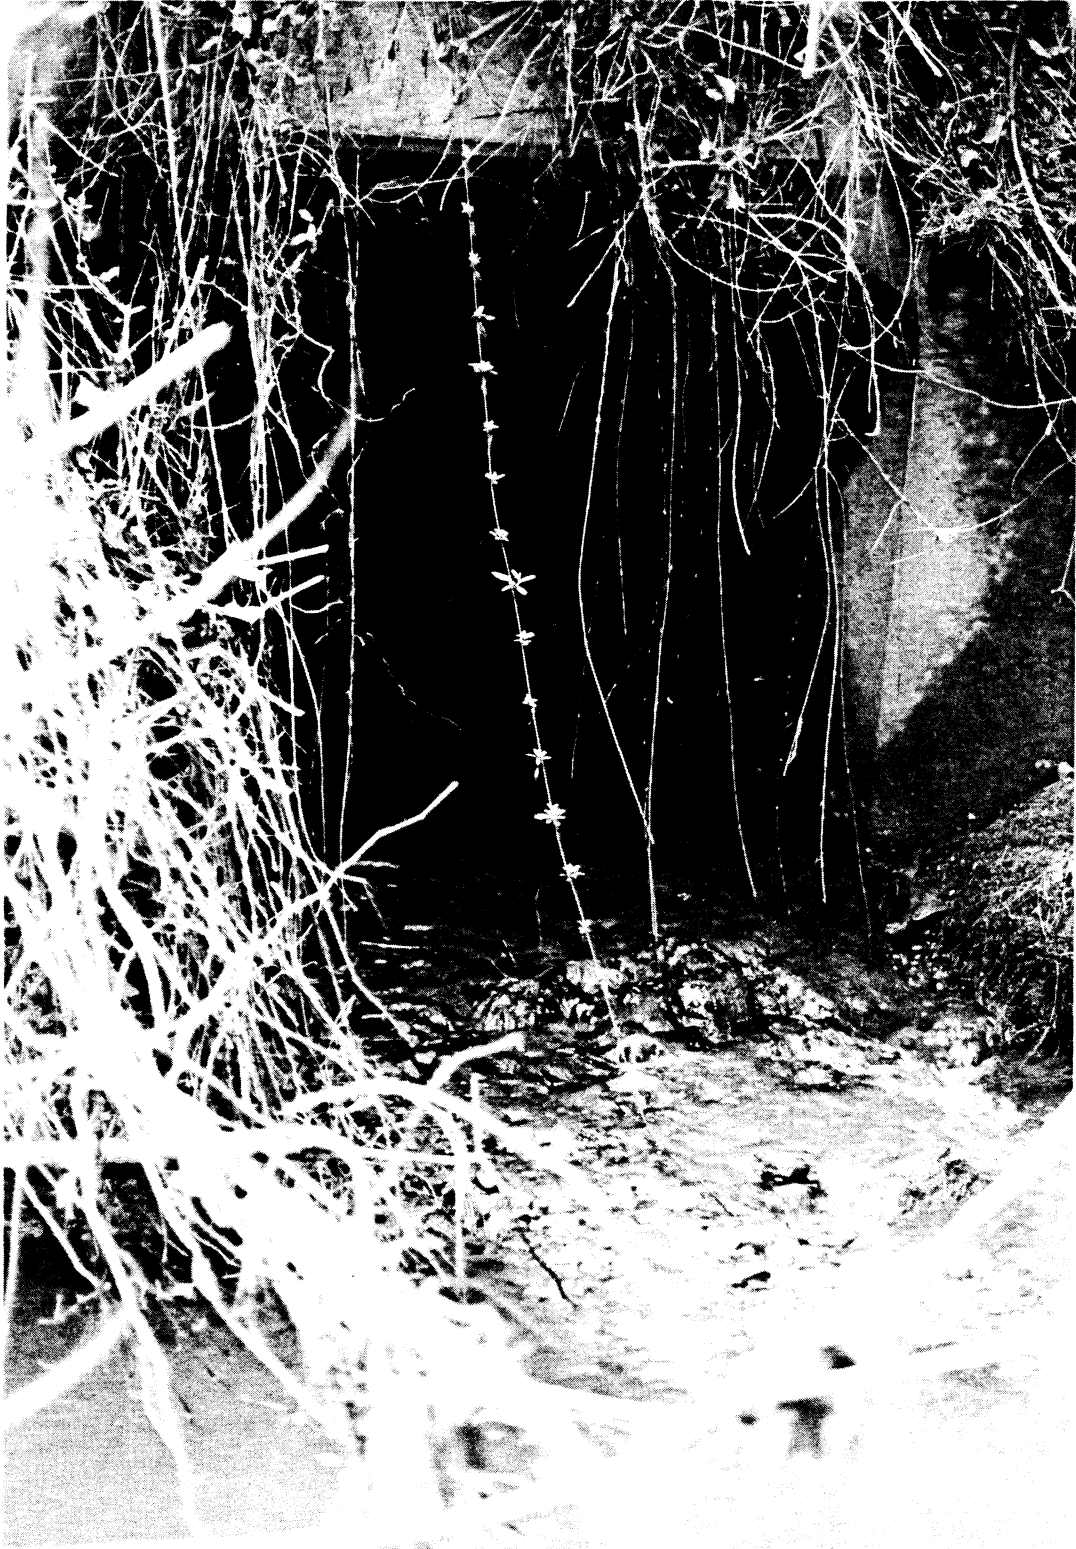
Figure 7. Outlet of the Route 36 culvert on Poor Creek.
Note the shallow water in the visible cell.
