COST-EFFECTIVENESS AND PERFORMANCE OF OVERLAY SYSTEMS IN ILLINOIS VOLUME 1: EFFECTIVENESS ASSESSMENT OF HMA OVERLAY INTERLAYER SYSTEMS USED TO RETARD REFLECTIVE CRACKING

Prepared By
Imad L. Al-Qadi
William G. Buttlar
Jongeun Baek
Minkyum Kim
University of Illinois at Urbana-Champaign

Research Report ICT-09-044

A report of the findings of
ICT-R58
Cost-Effectiveness and Performance of Overlay Systems in Illinois
Illinois Center for Transportation

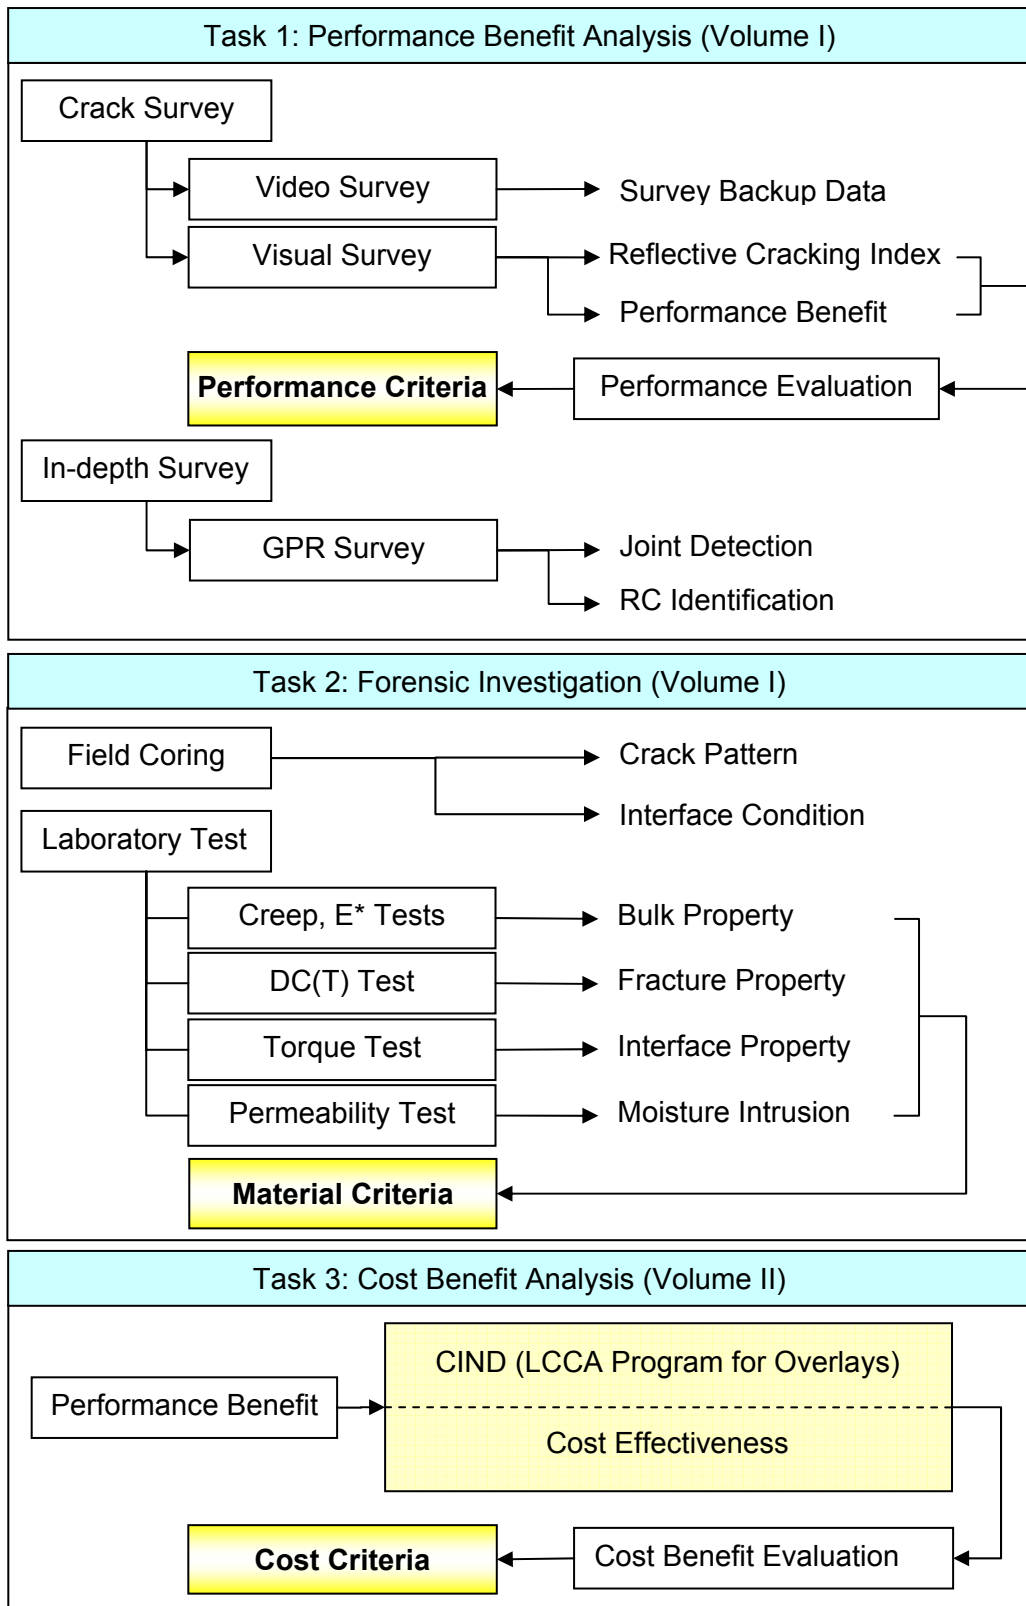
Figure 1. Framework for evaluating interlayer systems' effectiveness in retarding reflective cracking.

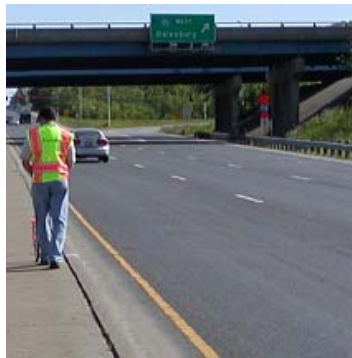
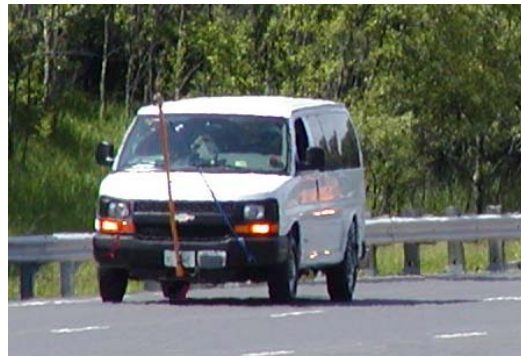
Figure 3. Field crack survey: (a) visual (walk-on) survey and (b) video surveying van.

Field crack surveys were conducted to collect pavement distresses, mainly transverse cracks, for all sections in 2006 and for selected sections in 2007. A visual crack survey was primarily used but supplemented with a video crack survey in several sections. Figure 3 demonstrates the visual and video crack surveys conducted. In addition, a large amount of historical crack survey data was obtained from IDOT

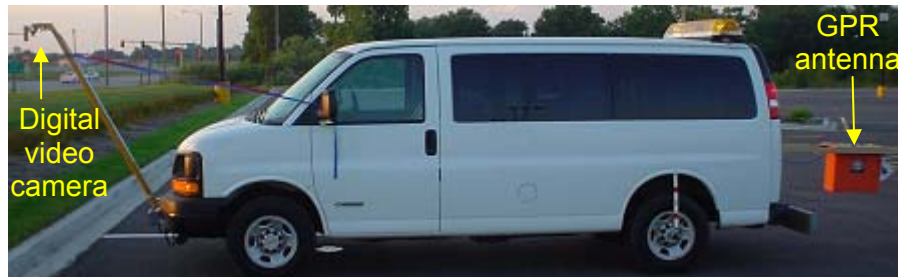
Figure 5. The video integration system (GaVIS) setup.

To create a more efficient and safer crack surveying environment, video crack surveys were performed at several locations. Video crack survey equipment was mounted on a van with ground penetrating radar (GPR) and a video integration system. The system, GaVIS, Figure 5, developed by Al-Qadi and co-workers consists of four measurement systems: GPR antennae, a digital video camera, a distance measurement instrument (DMI), and a data acquisition system (Baek et al. 2008). A 640 by 480 pixel digital video camera was mounted at the end of an extension bar, which can capture 10-ft-long by 12-ft-wide video images at highway speeds. The video image covers a whole lane and one pixel of the image spans across a 0.25 in. by 0.25 in. area, which is enough to distinguish a low-severity level crack. Because sunlight greatly affects the determination of a crack's severity level, care is required to adjust image brightness, which can be accomplished using the iris diaphragm on the video camera and through software-level image processing. In-house video image acquisition software, Camera Grabber, was used to collect video image data. By changing exposure time, brightness, and gain, high quality video images could be achieved. Due to differences in lighting conditions, different settings were required for the various pavements investigated.

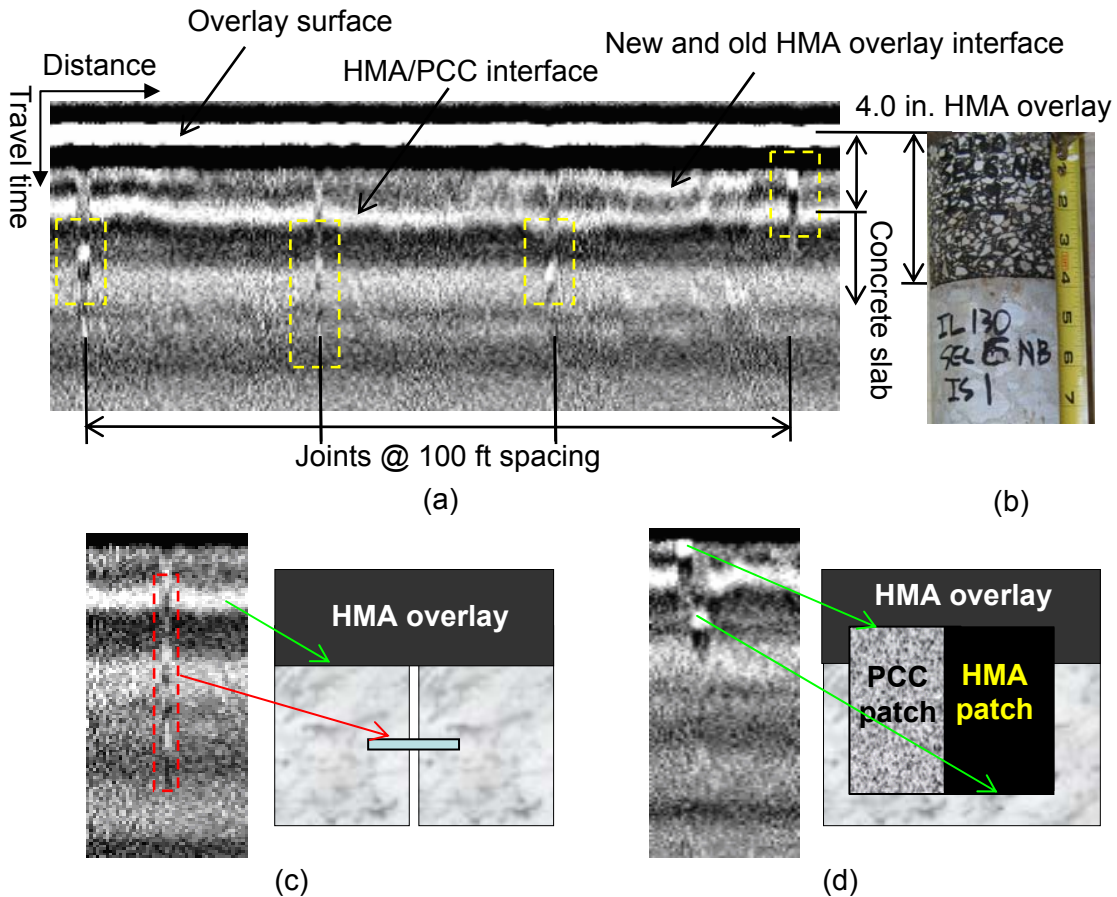
Figure 7. 1.0 GHz air-coupled GPR data (IL 130, Philo): (a) joint and patch detection; (b) field core; typical GPR data and corresponding pavement profiles for (c) a dowel bar and (d) patches.

Four discontinuities are found in the second line at a uniform spacing of 100 ft, which coincide with pavement joint spacing. In addition, two distinct patterns are found at discontinuities. Multiple reflections with a finite width are found through the concrete pavement. These reflections result from a scattering effect when an EM wave encountered an object having a different dielectric property such as steel, water, or air. In this case, the scattering is caused by a dowel bar in the middle of the concrete pavement as shown in Figure 7(c). The data was further confirmed using a ground-coupled antenna. Hence, the location is identified as a joint location. The second pattern type has a small width in the middle of the concrete pavement or within the HMA overlay. This represents patches used to repair existing pavement. An example of a section with PCC and HMA patches is demonstrated in Figure 7(d). In the first, a strip is located within the HMA overlay. This suggests a reflection from the top of a PCC patch that was used to repair the old HMA overlay and PCC pavement. The second strip's reflection occurs within the PCC slab without any reflection through the whole HMA overlay. In this case, the existing PCC pavement was repaired with a HMA patch. Such conclusions are made because the dielectric constant of concrete is significantly greater than that of HMA.

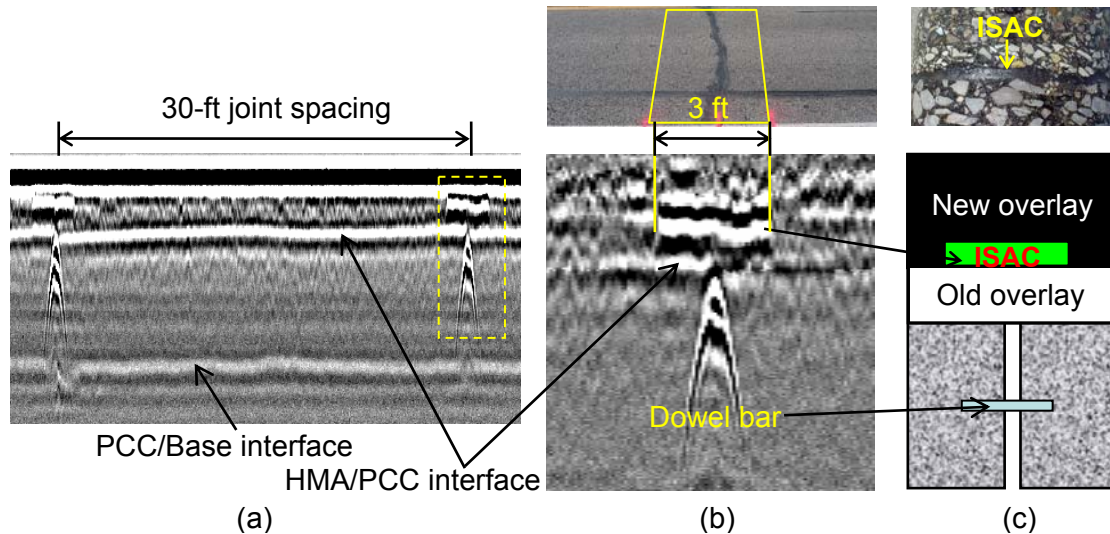
Figure 8. 1.5 GHz ground-coupled GPR data (IL 136, East of San Jose): (a) ISAC and dowel bar detection; (b) detail in vicinity of PCC joint, and; (c) pavement profile.

Figure 8(b) provides a detailed view of two strong parabolic-shaped reflections located at 30-ft-long uniform intervals. The parabolic scattering of the EM waves indicates the presence of dowel bars. Directly above the dowel bar, a 3-ft-long strip-shaped reflection was detected, which is characteristically different than a reflection associated with a pavement patch. According to the construction report, this section contains ISAC strips along transverse joints, which were installed on an old HMA overlay. The GPR data and ability to identify ISAC locations was confirmed by field coring.

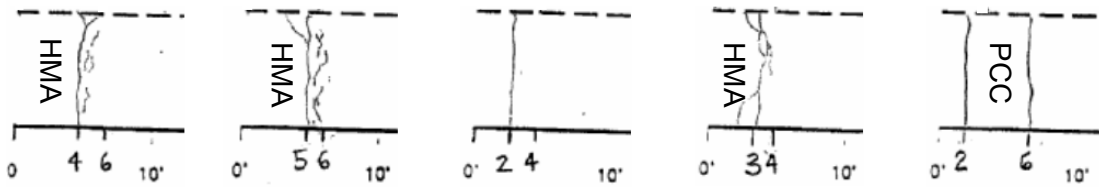
(b)

2006 (3-year-old overlay)

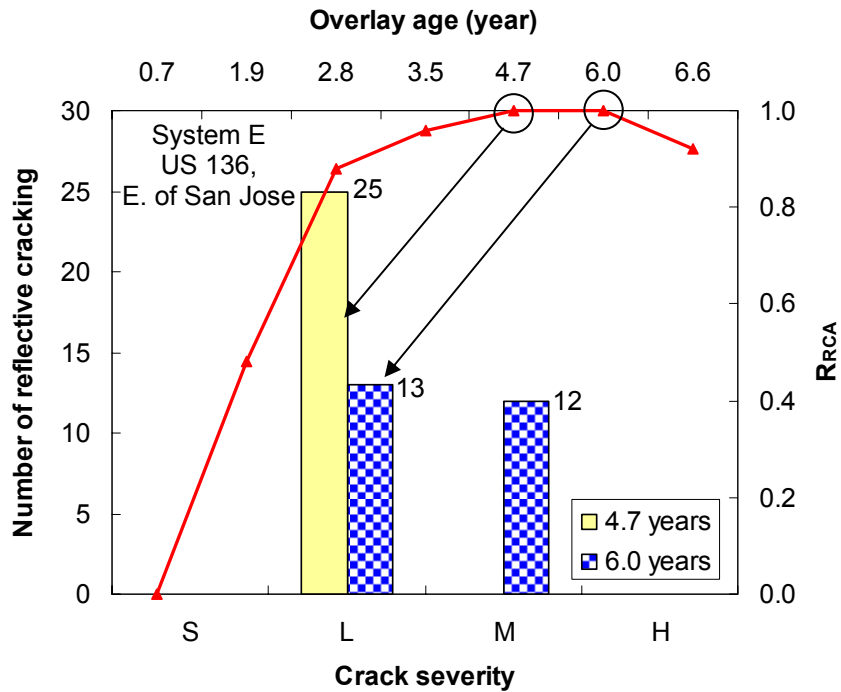
Figure 10. Number of reflective cracking at 4.7 and 6.0 years old and R_{RCA} variations over overlay age (US 136, E. of San Jose)

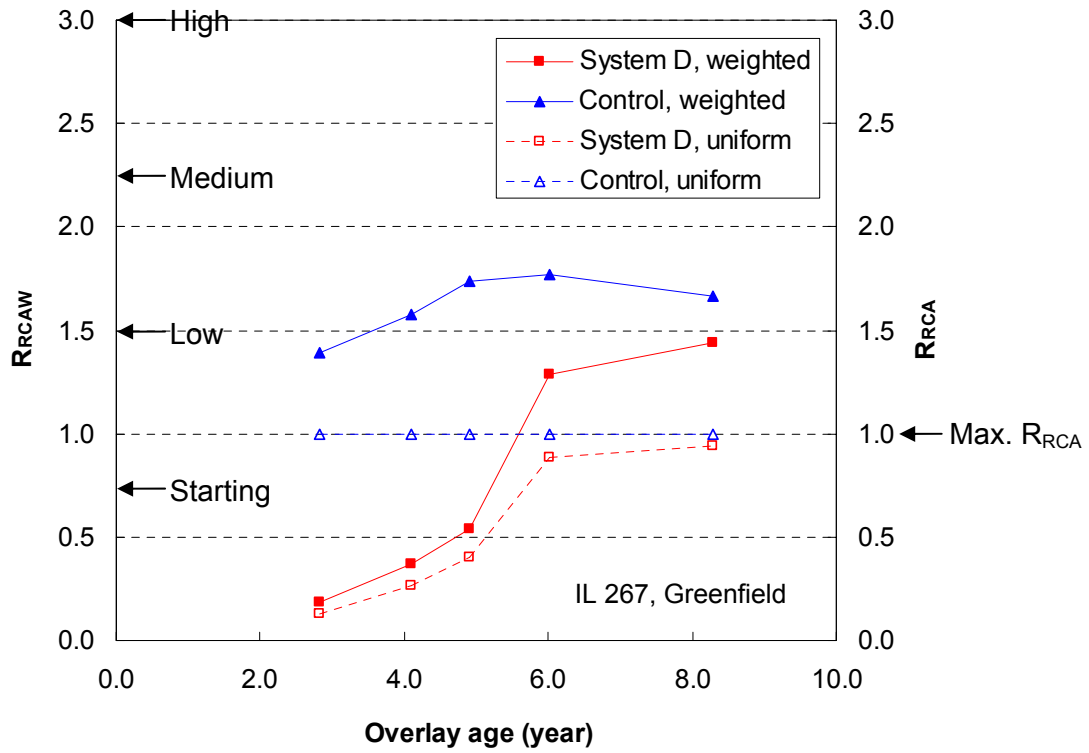
Figure 11. Comparisons of uniform and weighted R_{RCA} for System D and control section (IL 267 at Greenfield).

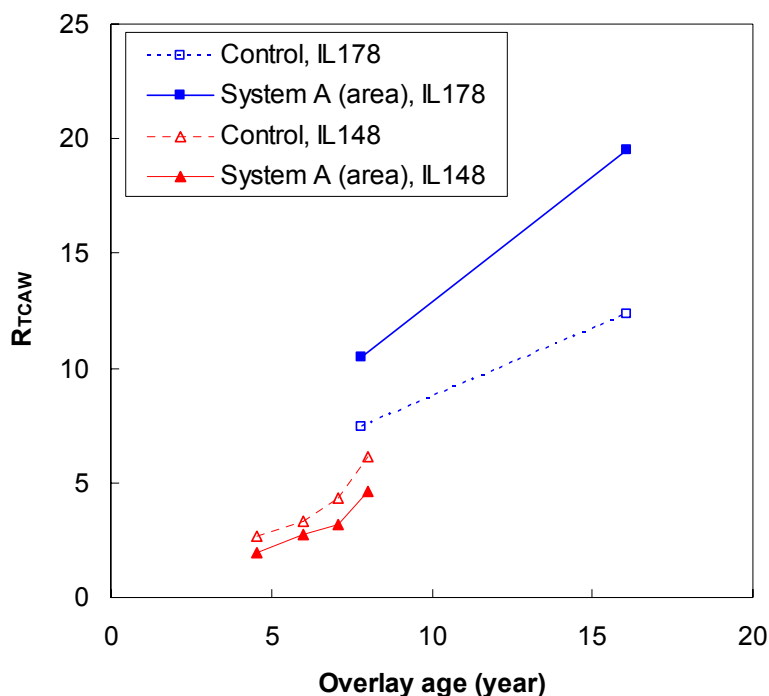
Figure 13. R_{TCAW} variations over overlay age at different locations (IL 178 at Oglesby and IL 148 at Christopher).

The applicability of the R_{TCAW} was evaluated at various locations (IL 178 at Oglesby and IL 148 at Christopher) where area-type system A is installed. Oglesby is located in District 3 (climate zone 2) and two-way average annual daily traffic (AADT) is 2650 in 2008; Christopher is located in District 9 (climate zone 3) and has 5800 two-way AADT in 2008. The two sections have different characteristics regarding traffic volume and climate zone. As shown in Figure 13, the R_{TCAW} varies from 2.7 to 6.1 for the control section at Christopher; while it varies from 7.4 to 12.3 at Oglesby. Although it is difficult to compare the behavior of the two sections directly because of the aforementioned variations as well as the overlay age, it can be simply concluded from the R_{TCAW} values that System A at IL 148 has performed better than the control section as well as the interlayer system A at IL 178. This clearly suggests that the performance of interlayer systems at various locations can be appropriately quantified.

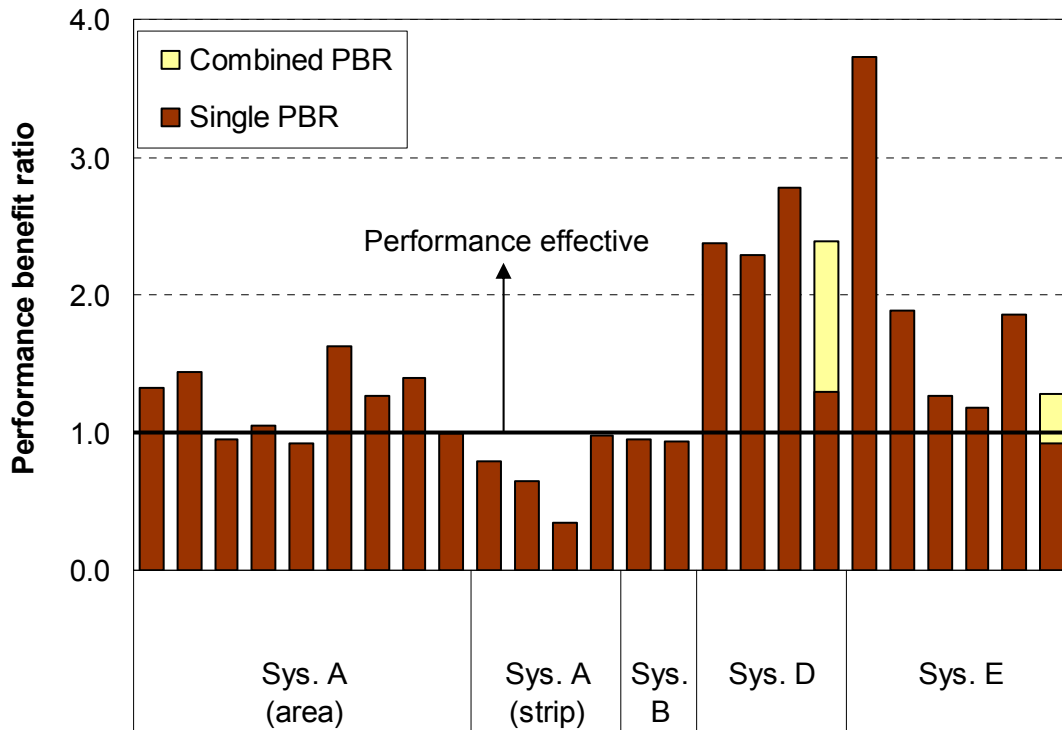
Figure 17. Performance benefit ratios for all sections (25 interlayer systems).

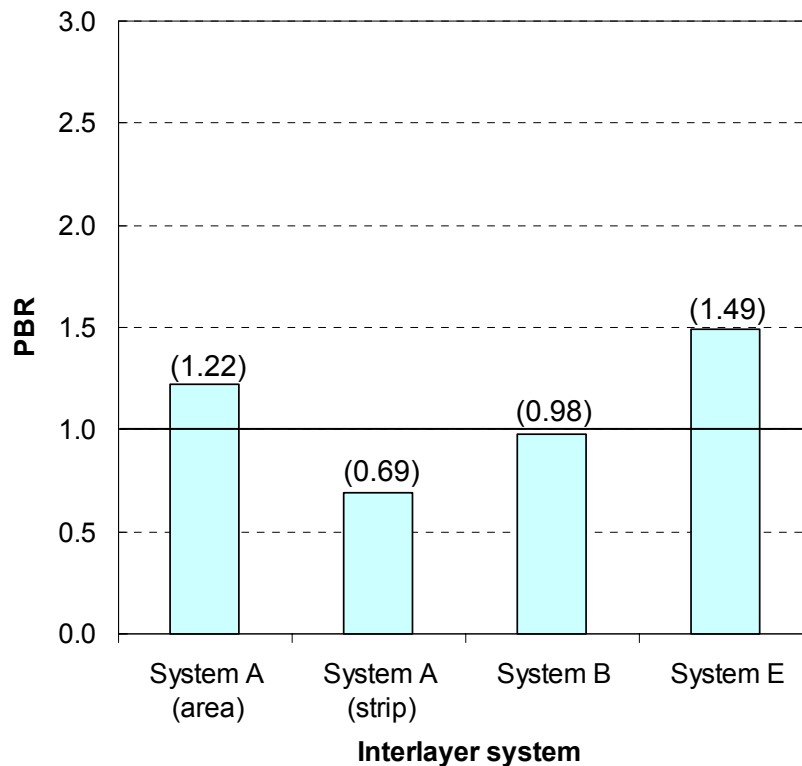
Figure 23. Average performance benefit ratio for System A (area), System A (strip), System B, and System E.

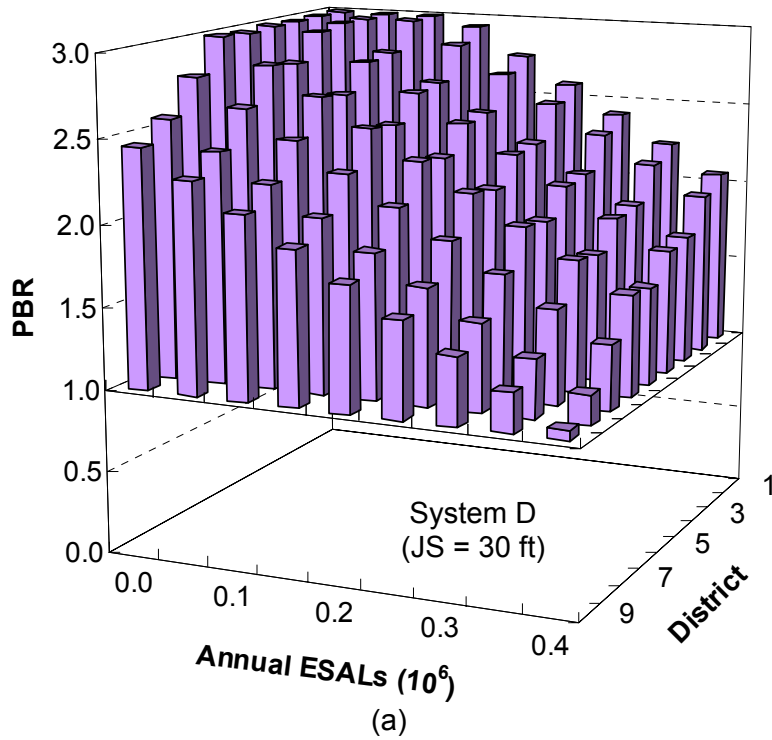
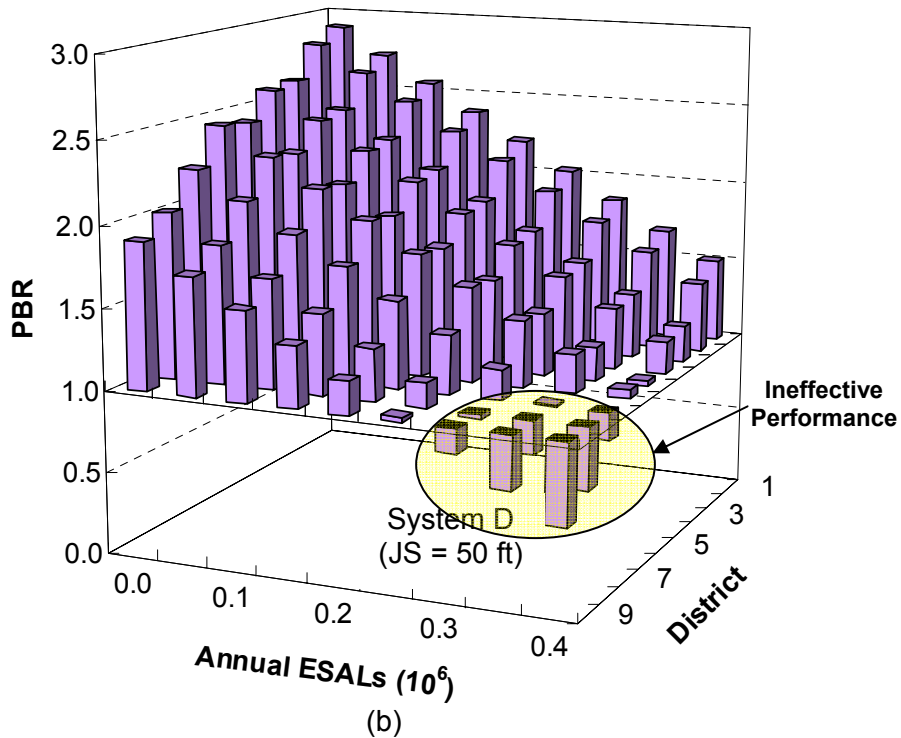
Figure 24. Performance benefit ratio versus ESALs and districts for various interlayer systems: (a) System D with JS of 30 ft, and (b) System D with JS of 50 ft.

For System D, the PBR values were estimated from the Equation 8. Figure 24 demonstrates the PBR variations for System D with respect to traffic loading, districts, and joint spacing. If the PBR is above 1.0, System D is considered effective in controlling reflective cracking in that district. In most districts, System D shows positive performance. However, System D was ineffective for high-volume roads (greater than 0.3 million ESALs) in the southern districts, climate zone III when joint spacing is 50 ft.

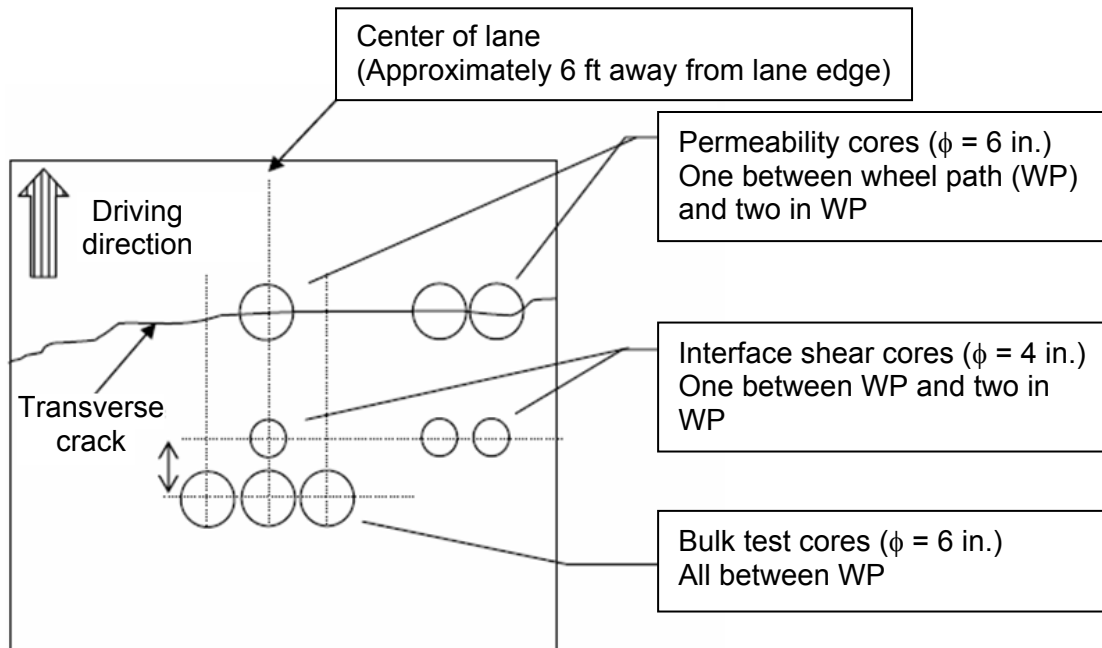
Figure 27. Types of cores and locations.

Figure 27 schematically illustrates three different types of field cores taken and their corresponding locations across the pavement lane. A set of 6-inch diameter bulk testing cores were taken between the wheel path to produce laboratory specimens for bulk material property testing (creep, fracture). Another set of 6-inch cores were taken over transverse cracks. These cores were expected to provide information on interlayer system condition, crack propagation pattern, condition of underlying structure, etc. Also, cores with intact interlayers were used for permeability testing. To assess the interface condition of interlayer/AC overlay and the existing PCC surface, a set of 4-inch cores were taken in crack-free areas as indicated in Figure 27. Precise coring locations were field selected to ensure that cores were taken over the interlayer fabric installed underneath. Interface shearing cores were full depth (HMA overlay/interlayer/PCC slab), while other cores were taken only down to the PCC layer.

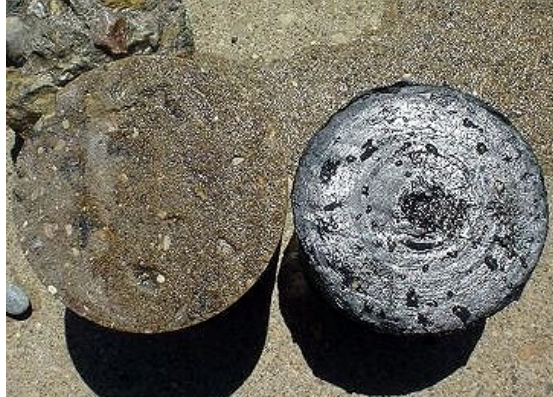
Figure 28. Debonded surface of interlayer fabric (IL 29 Creve Coeur).

Three-foot wide, System B and System D strips were placed directly onto bare PCC, as a means to retard reflective cracking over transverse joints. All five 4-inch IS cores appeared to be debonded from the underlying PCC layer. This may be an indication of either poor bonding of the fabrics to the relatively smooth existing PCC surface; possibly an insufficient amount of tack coat; or excessive stress transmitted from a core barrel during coring. Figure 28 shows an example of debonded surfaces, where the PCC surface appears to be free of tack coat material and the interlayer fabric surface shows evidence of complete separation and free rotation during the coring operation.

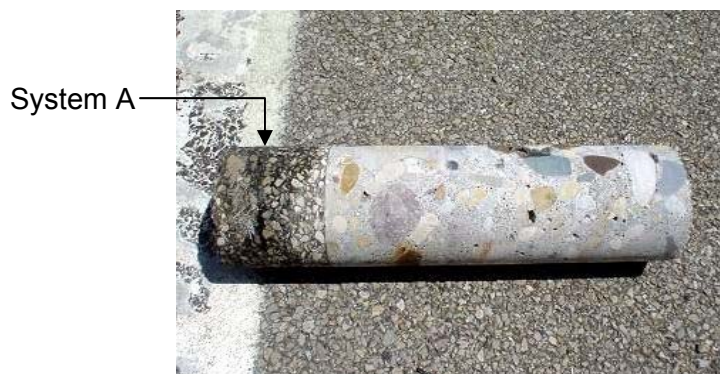
Figure 29. Intact interface shear core from IL 29 Mossville.

Area-wide System A fabric was placed in between 0.75 in. of LBC and 1.5 in. of HMA overlay lift, which was all placed over a lift of existing HMA overlay. The fabric layer appeared to be intact and showed no debonding even in the case of cracked permeability cores. Figure 29 shows a 4-inch IS core with full bonding between all layers.

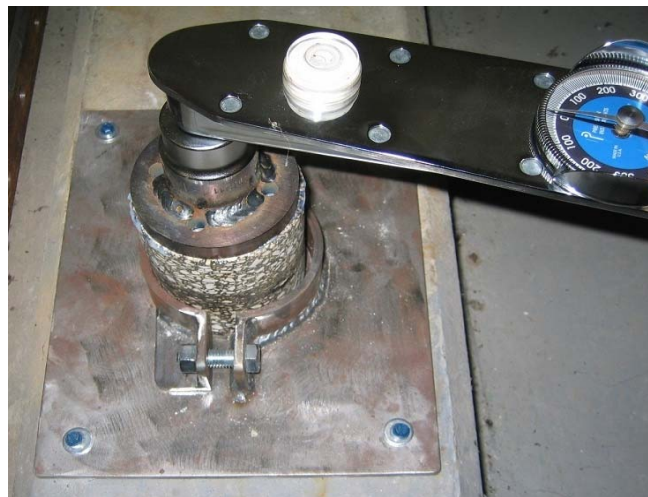
Figure 34. Torque bond test apparatus.

To determine bond (shear) strength at the interface between an interlayer and adjacent layers, a laboratory torque bond test was conducted with field cores although it is also directly applicable in the field. The test apparatus and procedures were followed in accordance with an UK guideline (Wheat 2007) as shown in Figure 34. A 4-in.-diameter field core is trimmed such that the interface is located 0.8 ± 0.4 in. above the mounting rim. In the original test procedure, a target temperature of 68°F is used. However, for the purposes of the reflective cracking study at low temperature, a target temperature was 14°F which is the same temperature of the fracture test. A torque is applied and the maximum torque is recorded and used in the calculation of bond strength.

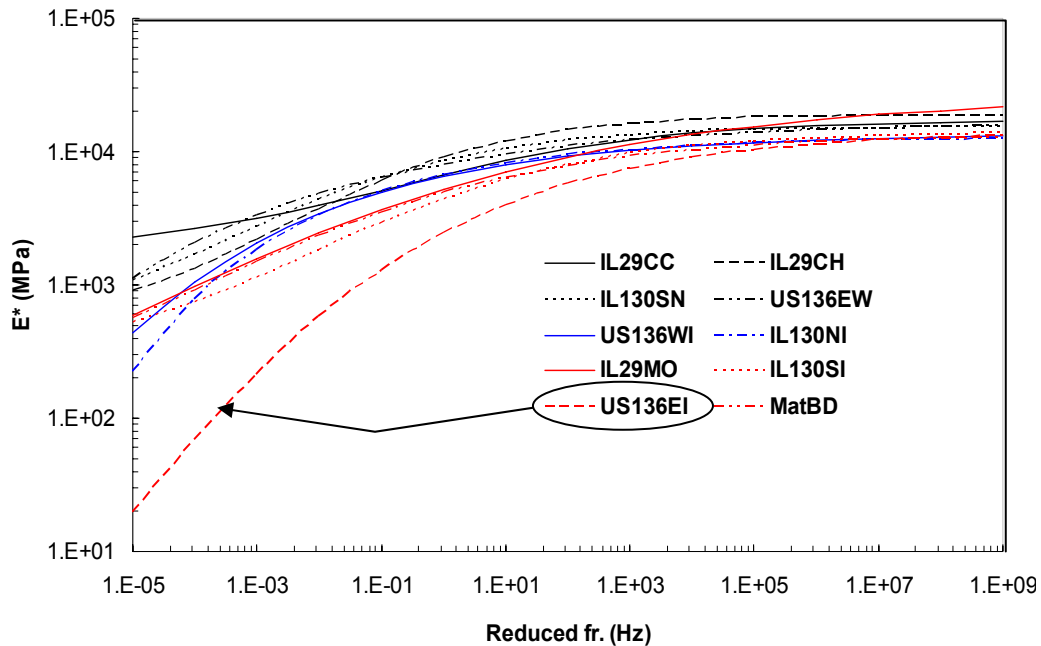
Figure 36. Sigmoid E^* master curves of all mixtures.

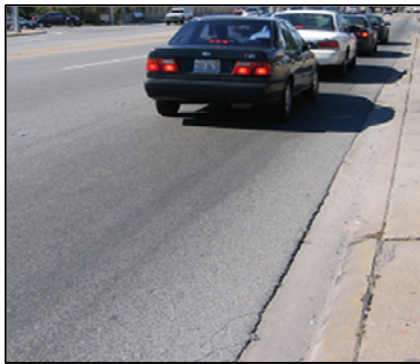
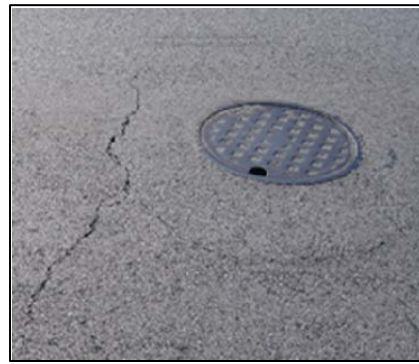
Figure A.1.3. (a) Longitudinal reflective cracking and (b) cracks around a manhole.

The UIUC research team conducted only visual survey on Oct. 7, 2006 to quantify surface cracking in transverse direction. A 4400-ft-long section was surveyed (1100-ft-long in each lane). The crack severity of this section had been monitored since 2004 by IDOT. The same surveying criteria were used in this reflective cracking evaluation. The severity and extent of transverse cracks were reported. Figure A.1.3 shows typical cracks and unique distress found in this section. Longitudinal reflective cracking was developed along shoulder joints (Figure A.1.3(a)). As a unique type, a crack was developed around a manhole or initiated from an edge of a manhole (Figure A.1.3(b)).

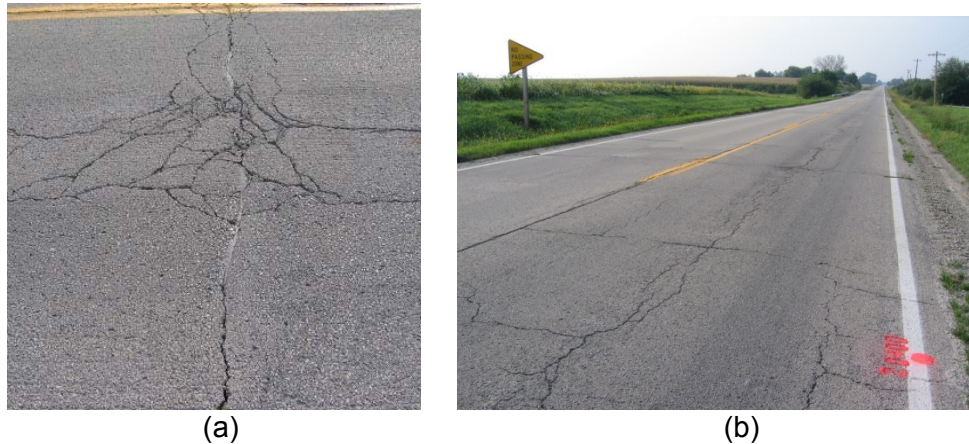
Figure A.6.3. (a) High-severity-level cracking and (b) block cracking.

The UIUC research team conducted visual and video survey to quantify surface cracking on Sep. 16, 2006. An 1850-ft-long section was surveyed (2 x 500 ft for the treated section and 2 x 425 ft for the control section). The crack severity of this section was measured in 1998. The same surveying criteria were used in this evaluation. The severity and extent of transverse cracks were reported. Majority of transverse cracks belongs to the medium-severity level. Highly deteriorated cracks were also observed in transverse direction and they were channelized to longitudinal cracks (Figure A.6.3.3 (a)). However, most of cracks observed were unsealed. Block cracking was often observed in the treated section (Figure A.6.3.3 (b)).

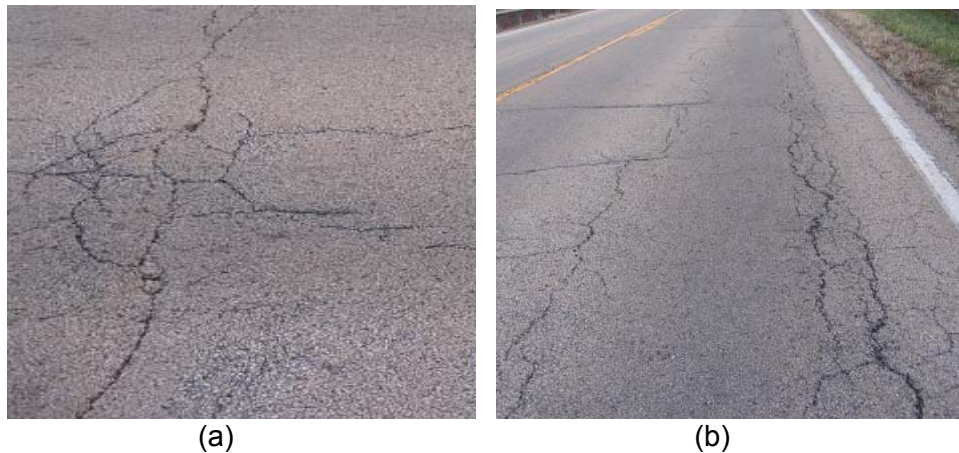
Figure A.7.3. (a) Unsealed high-severity-level transverse cracking and (b) unsealed middle and edge longitudinal cracks.

The UIUC research team conducted visual survey to quantify surface cracking on Nov. 26, 2006. A 1000-ft-long section was surveyed (2 x 500 ft in both lanes). The crack severity of this section was monitored in 1998. The same surveying criteria were used in this evaluation. The severity and extent of transverse cracks were reported. Most of transverse cracks belonged to medium- and high-severity levels. All cracks did not receive crack sealing though highly deteriorated reflective cracking was observed (Figure A.7.3.3 (a)). Those highly deteriorate transverse and longitudinal cracks were linked and so looked like block cracking. Since too many cracks were observed in this section, it was hard to distinguish reflective cracking from those transverse cracks.

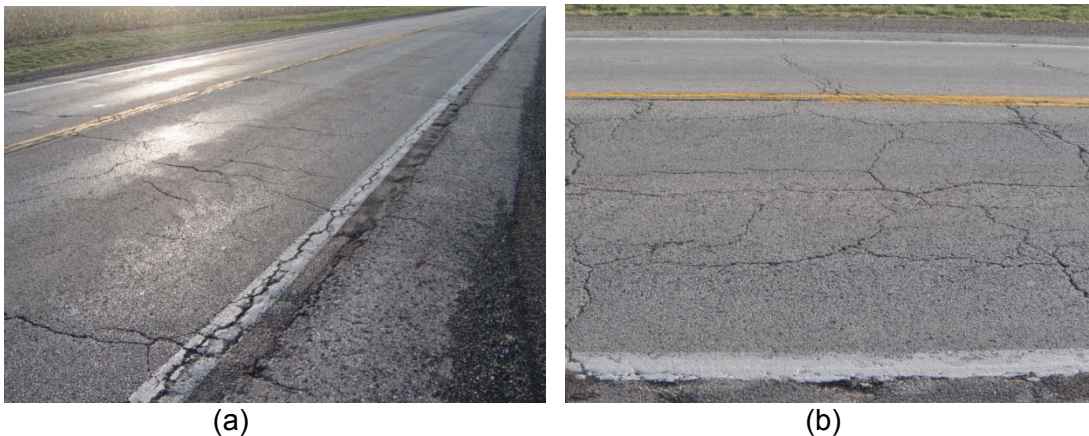
Figure A.8.3. (a) Unsealed longitudinal and transverse cracking and (b) block cracking.

The UIUC research team conducted visual survey to quantify surface cracking on Oct. 29, 2006. A 1000-ft-long section was surveyed (2 x 500 ft in both lanes). The crack severity of this section was monitored in 1998. The same surveying criteria were used in this evaluation. The severity and extent of transverse cracks were reported. Most of transverse cracks belonged to low- and medium- -severity levels. All cracks did not receive crack sealing though intermediately deteriorated cracks were observed (Figure A.8.3.3 (a)). Transverse and longitudinal cracks were linked and so looked like block cracking. Since too many cracks were observed in this section, it was hard to distinguish reflective cracking from those transverse cracks. Moreover, it was not able to account for those linked cracks correctly in the crack index in that only transverse cracks are included but block cracks are excluded.

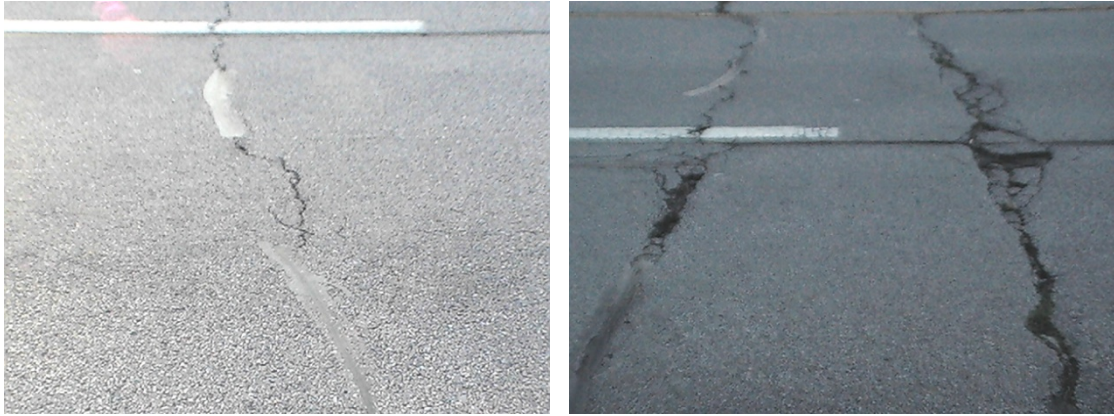
(a) (b)
Figure A.9.3 Transverse cracking: (a) Medium and (b) High severity

A 2500-ft-long section was surveyed (3 x 500 ft and 1 x 1000 ft in two northbound lanes). The crack severity of this section has been monitored since 2003 by IDOT. The same surveying criteria were used in this evaluation. The severity and extent of transverse cracks were reported. Figure A.9.3 shows typical reflective cracks found in this section. Joint-associated (Figure A.9.3 (a)) and patch-associated (Figure A.9.3 (b)) reflective cracking were observed. As Figure A.9.3 (a) shows, first, the sealed crack occurred under a wheel path and then the unsealed crack out of the wheel path was developed later. Other distress types were also reported.

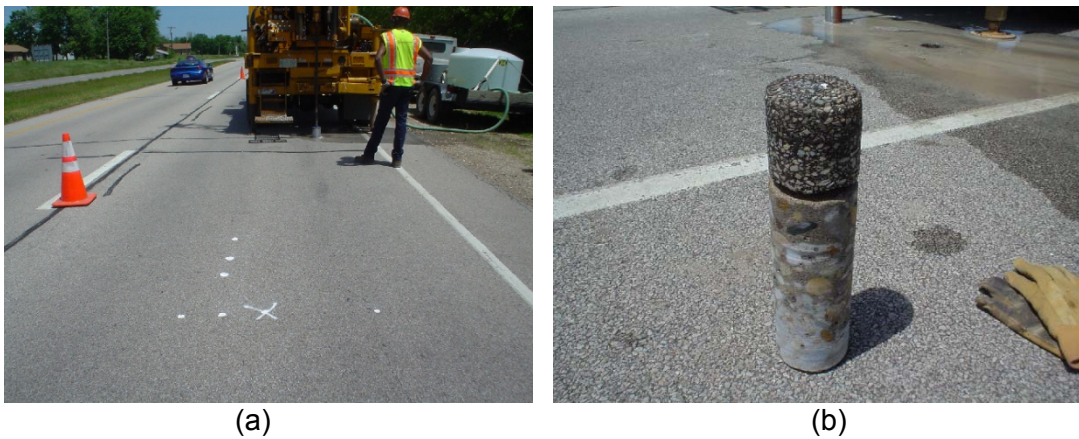
(a) (b)
Figure 4 Field coring work: (a) Coring locations (b) Coring samples.

Cores with 4-in and 6-in diameter were obtained from the evaluated sections (Figure A.9.4). Construction information, crack mapping, and GPR survey results were used to locate pavement joints and treatment locations. Table A.9.1 presents the number of cores and locations. Cores on top of reflective crack, in both wheel-path (WP) and between wheel-paths (BWP) were obtained. Cores for bulk testing were obtained from WP intact surface; while cores for interface shear testing were obtained from both WP and BWP over treated locations.

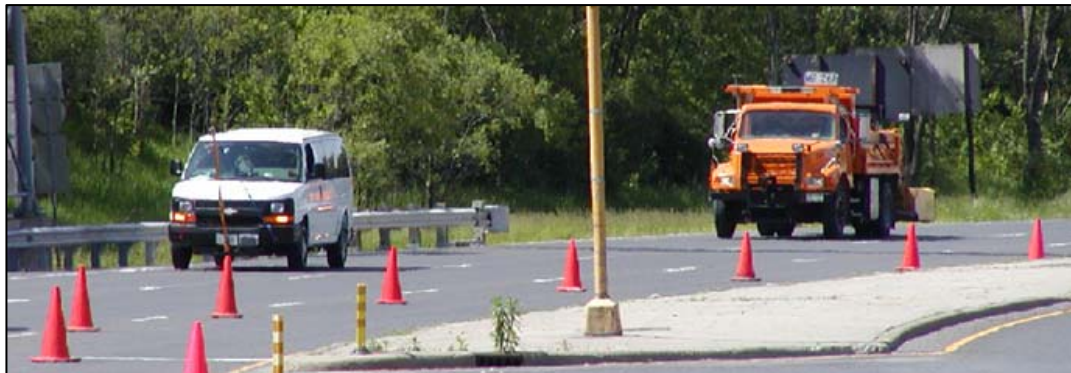
Figure A.13.4. Video and GPR surveys with a moving traffic control.

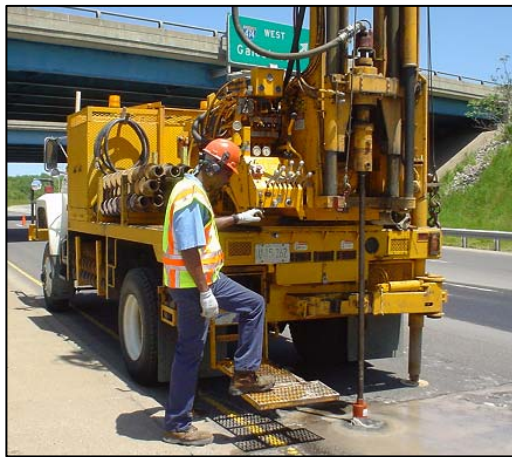
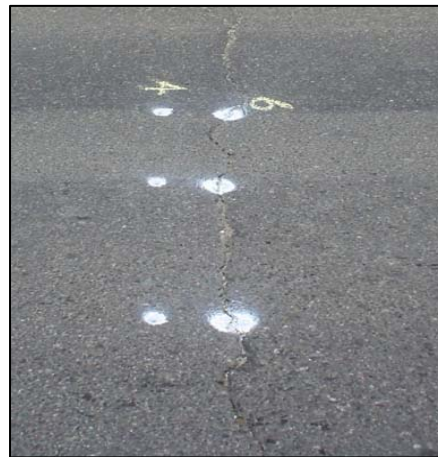
Figure A.13.5. Field coring work: (a) coring truck (b) coring locations on a transverse crack.

Cores with 4-in and 6-in diameter were obtained from the evaluated sections (Figure A.13.5). Construction information, crack mapping, and GPR survey results were used to locate pavement joints and treatment locations. Table A.13.1 presents the number of cores and locations. Cores on top of reflective crack, in both wheel-path (WP) and between wheel-paths (BWP) were obtained. Cores for bulk testing were obtained from WP intact surface; while cores for interface shear testing were obtained from both WP and BWP over treated locations.

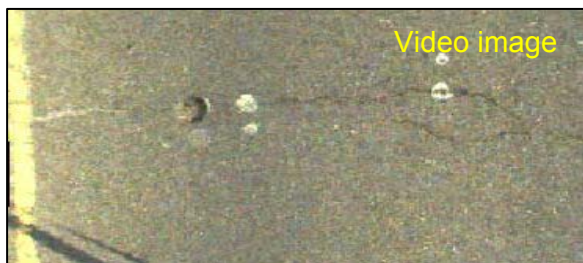
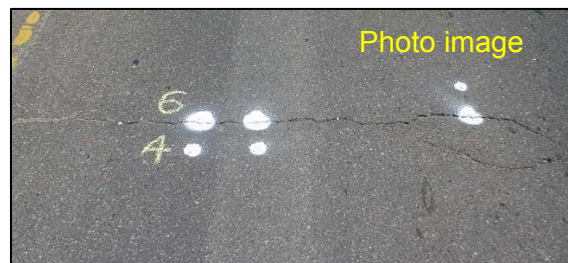
Figure A.13.6. Comparison of video-captured and photo images at STA. 7+638.

The quality of the video image recorded on May 22, 2006, was not good enough to use for data analysis because the video recorder was not set correctly to receive fast images at highway speed. Therefore, another trial was performed on August 6, 2006, after fine-tuning. The second video data were good enough to count the number of transverse cracks and distinguish crack severity as shown in Figure A.13.6. The captured video image is clear enough to differentiate crack extent and severity compared to the photo image. The severity is a low to medium level and coincides with the field visual survey classification.

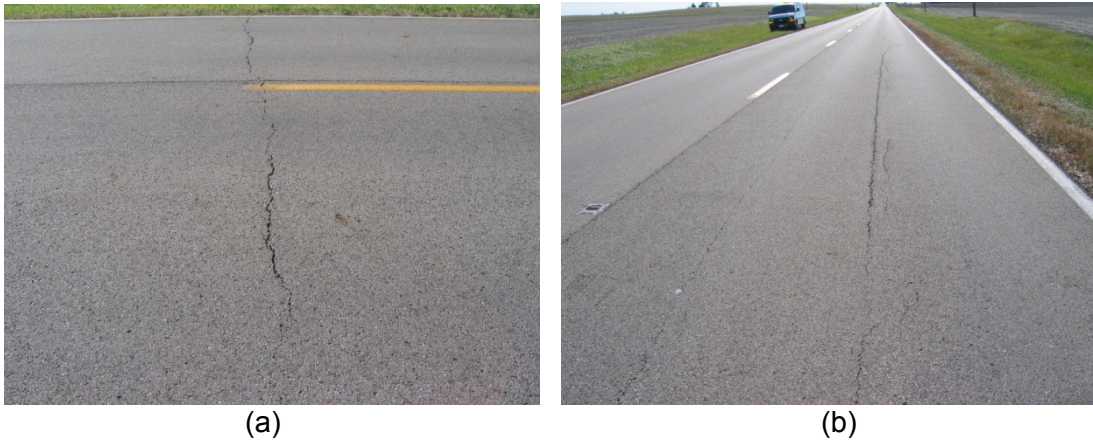
Figure A.15.3. (a) Unsealed transverse cracks and (b) unsealed longitudinal cracks.

The UIUC research team conducted visual survey to quantify surface cracking on October 29, 2006. A 12000-ft-long section was surveyed (12 x 500ft in both lanes). The crack severity of this section has been monitored since 2003 by IDOT. The same surveying criteria were used in this evaluation. The severity and extent of transverse cracks were reported. Figure A.15.3 shows typical reflective cracks found in this section. Most of transverse cracks were single cracks, not double cracks. Some locations, longitudinal cracks were observed in the middle of a lane. No sealed crack was found.

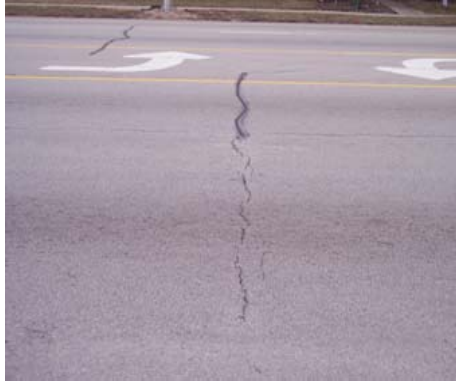
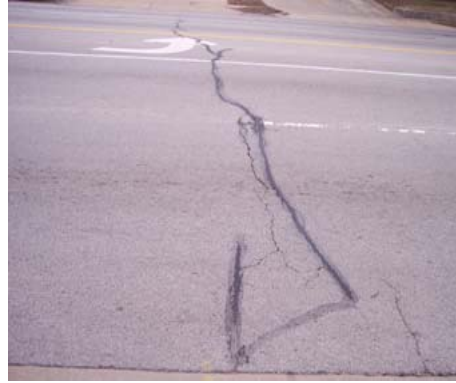
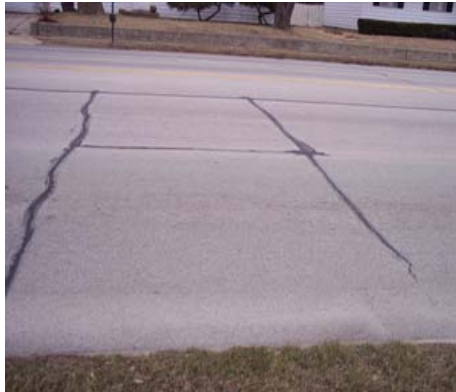
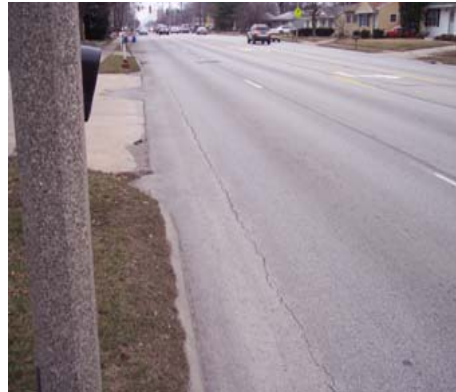
Figure A.17.3. Typical reflective cracks in this section: (a) sealed and unsealed low-severity-level crack; (b) medium- (upper) and high- (lower) severity-level crack; (c) patch-associated crack; and (d) longitudinal crack.

A 19200-ft-long section was surveyed (4800-ft-long in four lanes). The crack severity of this section had been monitored since 2000 by IDOT. The same surveying criteria were used in this reflective cracking evaluation. The severity and extent of transverse cracks were reported. Figure A.17.3 shows typical reflective cracks found in this section. Sealed and unsealed crack have the same low severity level (Figure A.17.3(a)). Sealed medium-severity-level crack with medium-severity-level cracks becomes high level (Figure A.17.3(b)). Two parallel reflective cracks were developed at the edge of an underlying patch (Figure A.17.3(c)). Also, longitudinal cracks were observed at outer lane shoulder. Besides, other distress types, such as block cracking, were also reported.

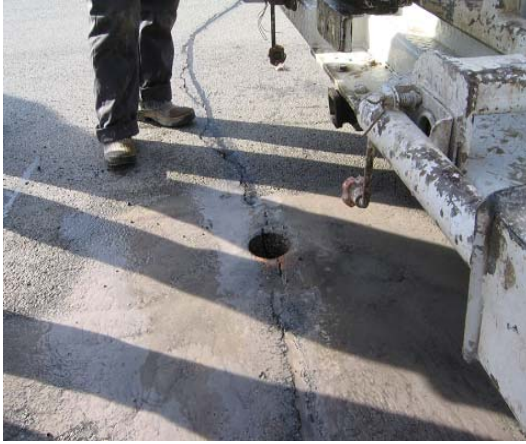
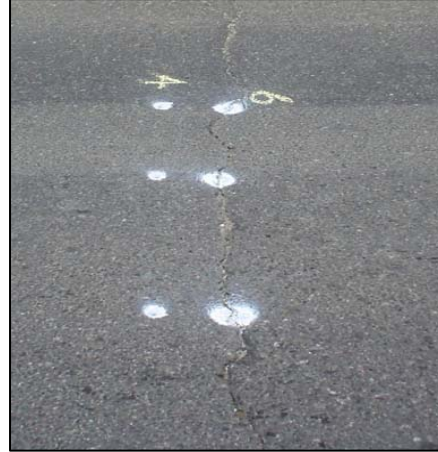
Cores with 4-in and 6-in diameter were obtained from the evaluated sections (Figure A.17.4). Construction information, crack mapping, and GPR survey results were used to locate pavement joints and treatment locations. Table A.17.1 presents the number of cores and locations. Cores on top of reflective crack, in both wheel-path (WP) and between wheel-paths (BWP) were obtained. Cores for bulk testing were obtained from WP intact surface; while cores for interface shear testing were obtained from both WP and BWP over treated locations. Since interface between PCC and HMA with interlayer systems was debonded during coring, samples could not be obtained for interface bond strength tests.

Figure A.17.4. Field coring work: (a) coring truck (b) coring locations on a transverse crack.

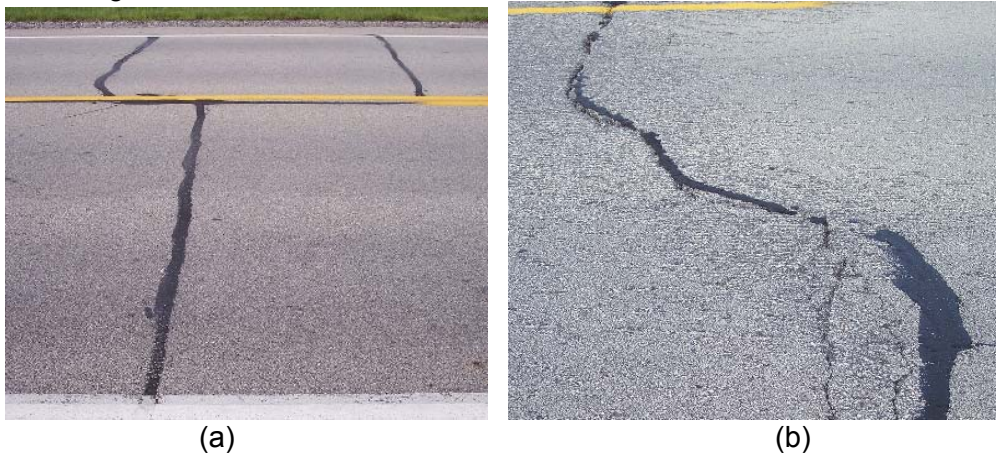
Two lanes of 6000-ft-long section were surveyed. The crack severity of this section has been monitored since 2003 by IDOT. The same surveying criteria were used in this evaluation. The severity and extent of transverse cracks were reported. Figure A.18.3 shows typical reflective cracks found in this section. When a crack is sealed, the severity of the crack is evaluated differently, i.e., when no additional crack is developed around the sealed crack, its level goes down to low level in most cases regardless of previous crack severity. For example, two sealed cracks have different severity: low severity (Figure A.18.3(a)) and medium to high severity (Figure A.18.3(b)). Other distress types were also reported. The video and GPR survey was conducted at highway speed without moving traffic control.

Figure A.18.3 Severity of sealed crack: (a) low and (b) medium (up) to high (down) level.

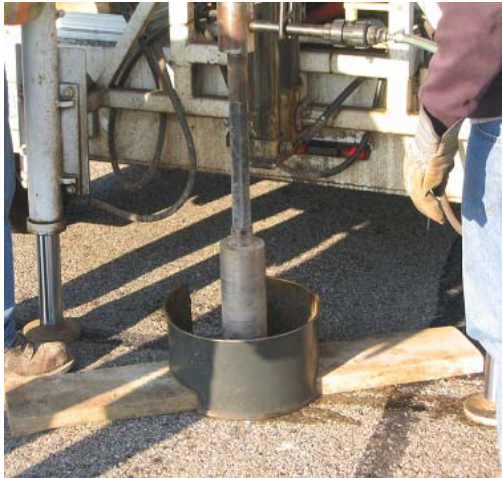
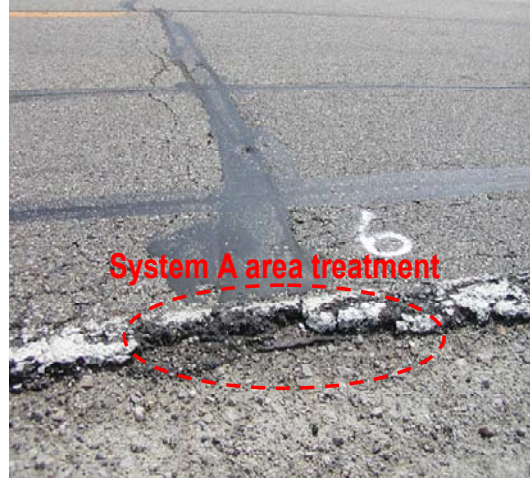
Seven 4-in diameter cores and 18 6-in. diameter cores were obtained from the evaluated sections (Figure A.19.4). Construction information, crack mapping, and GPR survey results were used to locate pavement joints and treatment locations. Cores on top of reflective crack, in both wheel-path (WP) and between wheel-paths (BWP) were obtained. Cores for bulk testing were obtained from WP intact surface; while cores for interface shear testing were obtained from both WP and BWP over treated locations. Based on several cores at the System A section, no fabric was found while a part of fabric was discovered at STA. 11+639 (Figure A.19.4 (b)).

Figure A.19.4 Field coring work: (a) coring truck and (b) System A treatment on the edge of overlay
