COST-EFFECTIVENESS AND PERFORMANCE OF OVERLAY SYSTEMS IN ILLINOIS VOLUME 1: EFFECTIVENESS ASSESSMENT OF HMA OVERLAY INTERLAYER SYSTEMS USED TO RETARD REFLECTIVE CRACKING

Prepared By
Imad L. Al-Qadi
William G. Buttlar
Jongeun Baek
Minkyum Kim
University of Illinois at Urbana-Champaign

Research Report ICT-09-044

A report of the findings of
ICT-R58
Cost-Effectiveness and Performance of Overlay Systems in Illinois
Illinois Center for Transportation

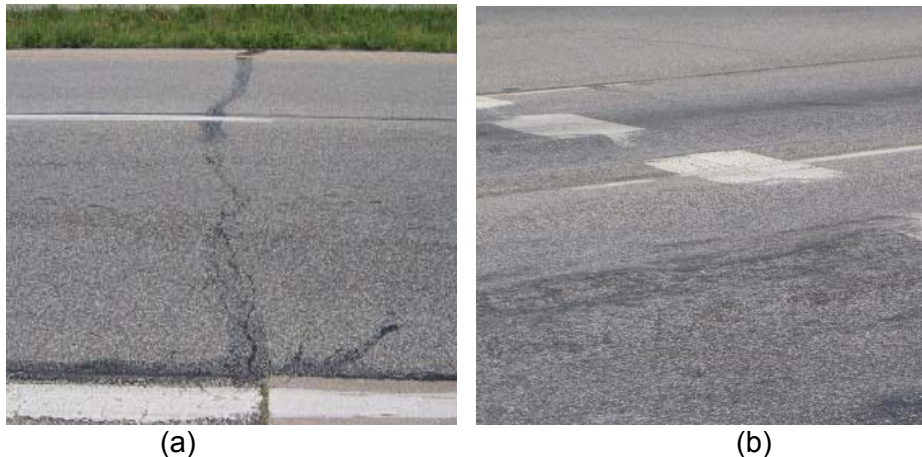
The UIUC research team conducted visual and video survey to quantify surface cracking on, 2006. A 3000-ft-long section was surveyed (500 ft + 1000 ft southbound two lanes). The crack severity of this section was conducted in 1998. The same surveying criteria were used in this evaluation. The severity and extent of transverse cracks were reported. Figure A.22.3 demonstrates distresses found in this section.

Figure A.22.3. (a) Medium-severity-level transverse crack and (b) bleeding and rutting.

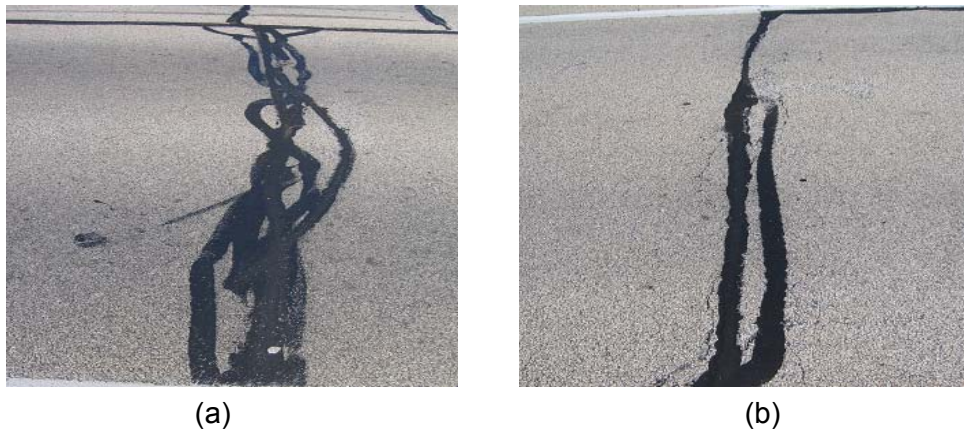
The UIUC research team conducted visual and video surveys to quantify surface cracking. This task was conducted on Sep. 12, 2006. A 3.2-mi-long section was surveyed (1.6-mi-long in each direction). The crack severity of this section had been monitored since 2000 by IDOT. The same surveying criteria were used in this reflective cracking evaluation. The severity and extent of transverse cracks were reported. Figure A.23.2 shows typical reflective cracks found in this section. Both cracks are double reflective cracking with crack sealing; the left one is low-severity level and the right one is medium-severity level. The severity of sealed crack is mainly dependent on current crack condition such as how many associated cracks exist, not how much a crack was sealed. Thus, while the left crack received lots of crack sealing, current crack condition is sound. On the other hand, the right one got additional adjacent cracks after sealed so that current crack condition is worse than the left one. Thus, a certain level of maintenance was already applied in this section after the overlay.

Figure A.23.2. Sealed transverse reflective cracking: (a) low-level and (b) medium-level.

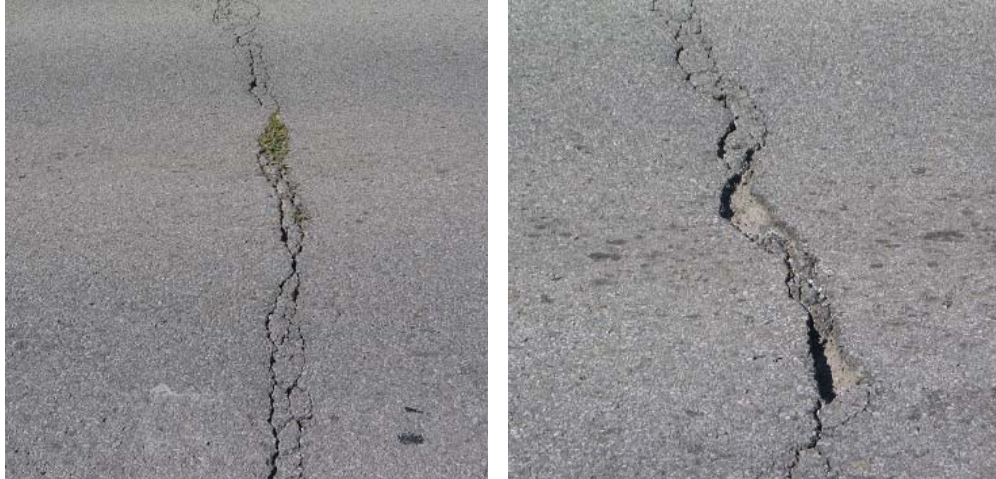
The UIUC research team conducted visual survey to quantify surface cracking on Oct. 1, 2006. A 3300-ft-long section was surveyed (663 ft for the control section and 991 ft for the treated section in both lanes). The crack severity of this section has been monitored since 2003. The same surveying criteria were used in this evaluation. The severity and extent of transverse cracks were reported. Figure A.24.3 shows double reflective cracking found in this section. The left one belongs to medium to high severity level and the right one belongs to high severity. However, those cracks were not sealed.

Figure A.24.3. Highly deteriorated double reflective cracks
