1. Report No. FHWA/TX-09/0-5598-2		2. Government Accession No.		3. Recipient's Catalog No.	
4. Title and Subtitle DESIGN AND PERFORMANCE EVALUATION OF VERY THIN OVERLAYS IN TEXAS				5. Report Date January 2009 Published: June 2009

DESIGN AND PERFORMANCE EVALUATION OF VERY THIN OVERLAYS IN TEXAS

Project 0-5598

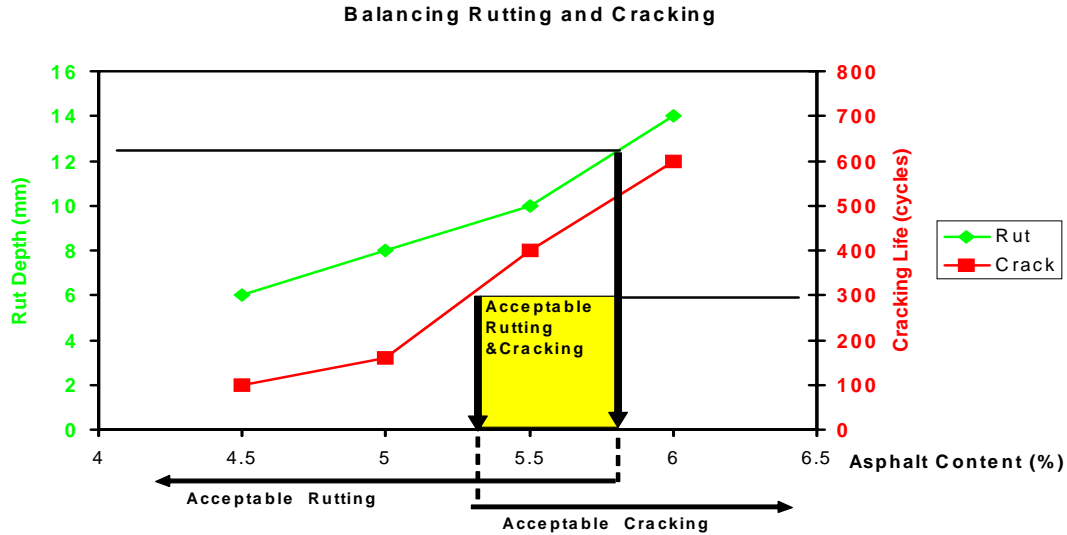
Figure 3. Determining the Binder Content to Meet Rutting and Cracking Requirements.

The concept of a balanced mix design is shown in Figure 3. The green line represents the Hamburg rut depth for different binder contents; rut depths below 12.5 mm (0.5 inches) are acceptable. The red line shows the performance in the overlay tester; in this case samples that last over 300 cycles to failure are judged as acceptable. This figure clearly shows the concept of a balanced design. As the percent asphalt increases the rutting resistance decreases, but the cracking resistance increases. The balanced design is the zone of asphalt contents that passes both rutting and cracking requirements. Studies at TTI (Zhou 2006) have shown that the window of acceptable asphalt contents is narrow for the lower PG grades. For PG 64-22 binders adding additional binder often get the mixes to rut excessively. The window for PG 76-22 has been found to be substantially wider as these binders are not highly rut susceptible. Zhou's studies also showed that for some combinations of aggregate and binder, it is impossible to meet both requirements.

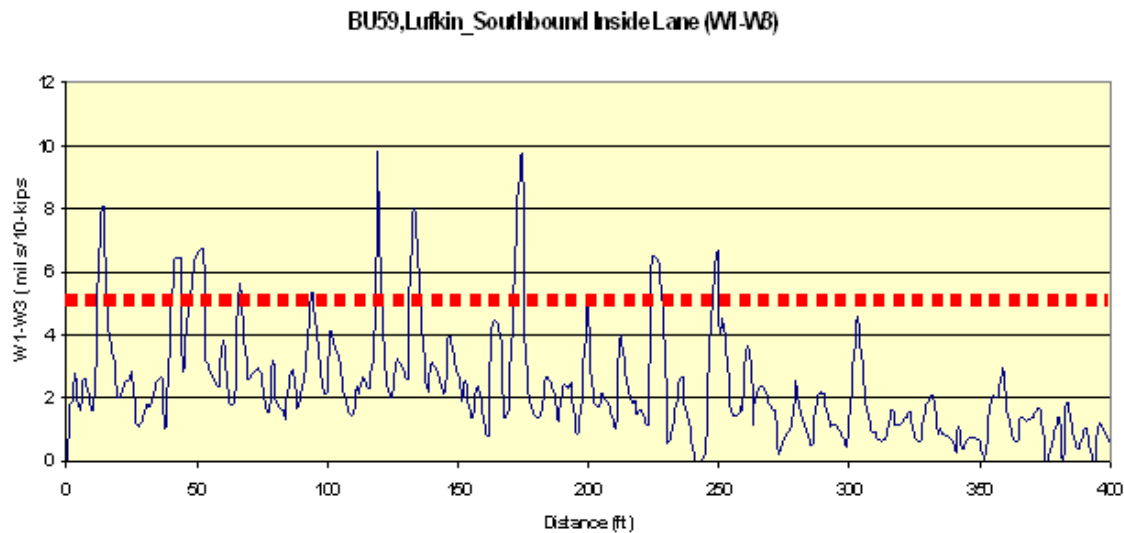
Figure 6. Problem Area Identified by the RDD on US 59.

The problem area at the start of this project is expanded below in Figure 6. The large peaks in this data are recorded when the RDD runs over joints with poor load transfer. This plot shows that the eight problem joints are located in the first 250 feet of the project. It is anticipated that overlays placed over these joints would be prone to reflection cracking because of the high vertical movement occurring at these joints.

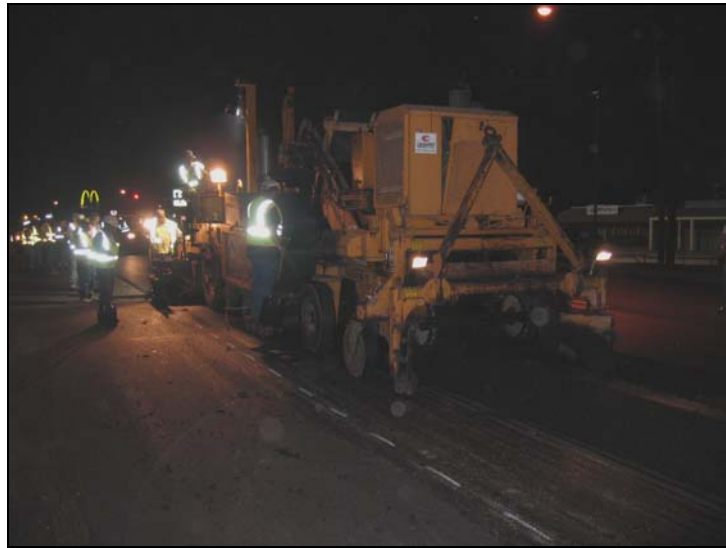
Figure 9. CAM Paving Operation on Business 59.

The contractor used belly-dump trucks to place the mix in windrows. A Lincoln 660 windrow elevator and a Blaw Knox PF-3200 paving machine then placed the CAM. Figure 9 shows the paving operation. Figure 10 shows the contractor's primary compaction roller was a CAT CB-634D. The contractor used an Ingersoll Rand DD130 for the finish roller.

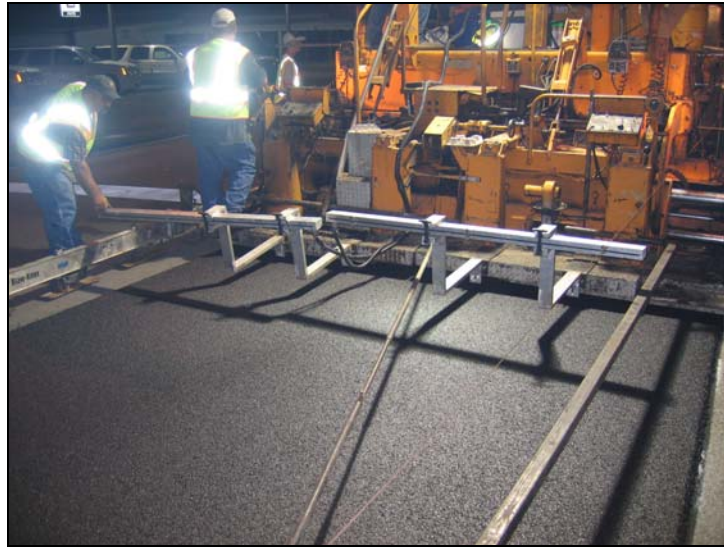
Figure 11. Pave-IR Collecting Thermal Profile on Business 59.

inches apart to profile the HMA placement temperatures. TTI used a sampling rate of 2 inches, i.e., a temperature scan was collected for every 2 inches of forward travel.

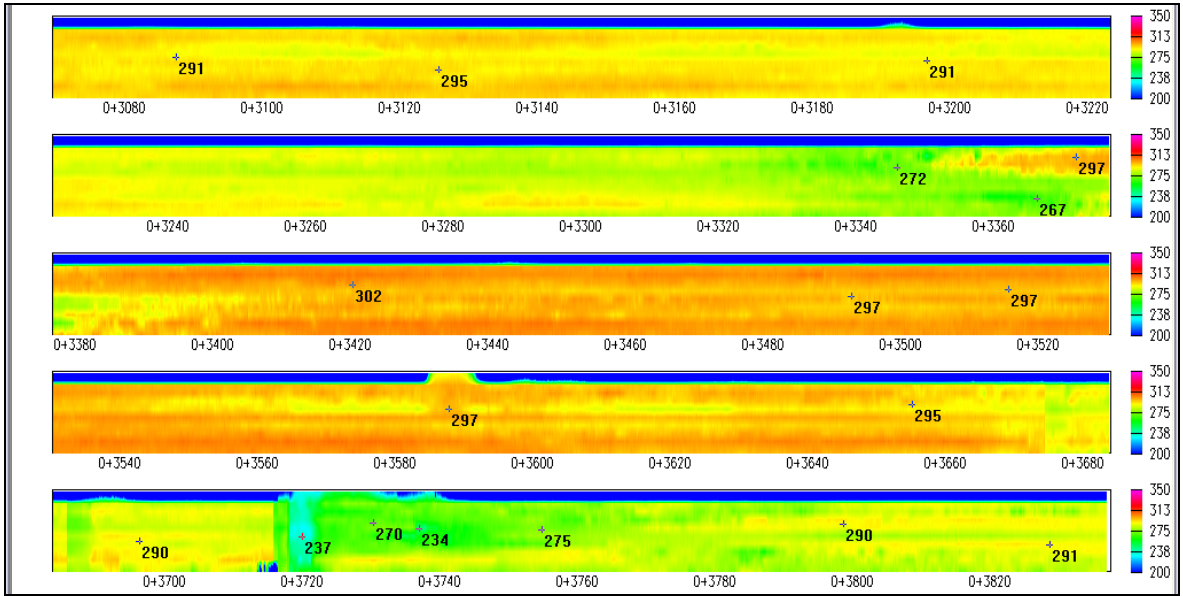
Figure 14. Thermal Profile of CAM Southbound Inside Lane.

Figure 14 shows excerpts from the thermal profile of the southbound inside lane. As before, the profile shows good uniformity within truckloads, some variations in the mean placement temperature from individual trucks, and some truck-end thermal differentials. The histogram from the temperatures recorded in the thermal profile, shown in Figure 15, reveals that approximately 95 percent of the placement temperatures fell within the 50 °F range from 260 to 310 °F.

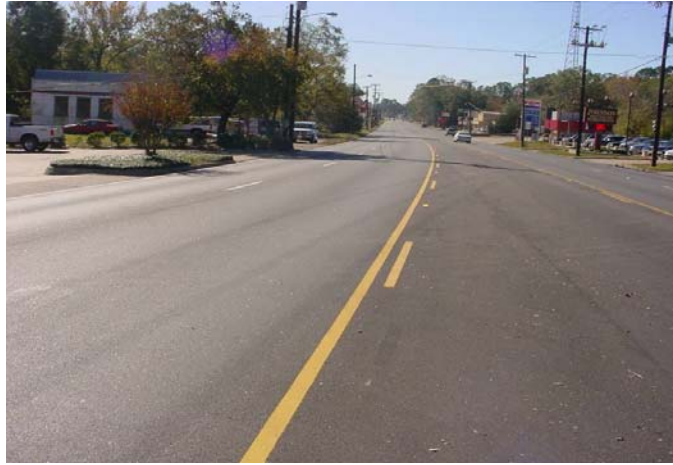
Figure 17. CAM Mix on US 59 Three Months after Placement.

After three months in service, a visual inspection and skid data were collected on this project. A photo of the CAM mix is shown in Figure 17.

No performance problems were reported, and no reflection cracks were found. This inspection will be repeated in the spring of 2009. TxDOT also performed skid testing on this section, and the results are shown in Figure 18. This is with a bald tire locked wheel trailer traveling at 40 mph. The average value is reasonable at 23.5, but this section does have some low values with three values below 20. There are no standards for acceptable skid numbers, but values for new pavements are normally above 20. The cause for these low numbers is not known at this time. These measurements will be repeated on a semi-annual basis. The CAM mix has a high asphalt content, and the surface rocks are coated in asphalt. With trafficking perhaps the surface aggregates will become exposed and the skid numbers increase.

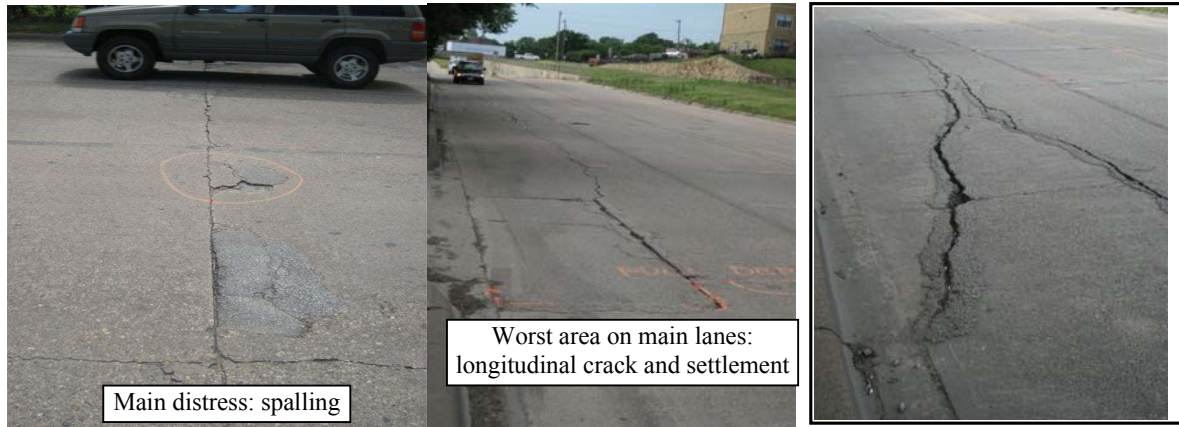
Figure 21. Observed Distresses on the Main Traffic Lanes, Pumphrey Drive, FTW.

Both Richard Williammee, P.E., Fort Worth District Materials Engineer and the TTI researchers evaluated the existing PCC pavement conditions on June 14, 2007, and made recommendations on the areas that needed to be repaired before placement of the thin HMA overlay. The main distress observed was spalling at the joints. The overall conditions of the main traffic lanes were acceptable except in two large areas with longitudinal cracks, settlements, and block cracking. Figure 21 shows examples of the existing conditions of the main traffic lanes before the HMA overlay. The general conditions of the PCC pavement on the ramps were substantially worse than those of the main traffic lanes as shown in Figure 22. Figure 23 presents some areas after repairs were made.

The load transfer efficiency of the joints in the main lanes was judged as good. Limited measurements were made with the FWD and all joints were in the 90 to 100% LTE range. None of the main lane joints exhibited any faulting and the main distress was spalling around the joint. The joints on the exit and entrance ramps were in poorer condition; the ramps themselves were badly cracked, and several of the joints were faulted.

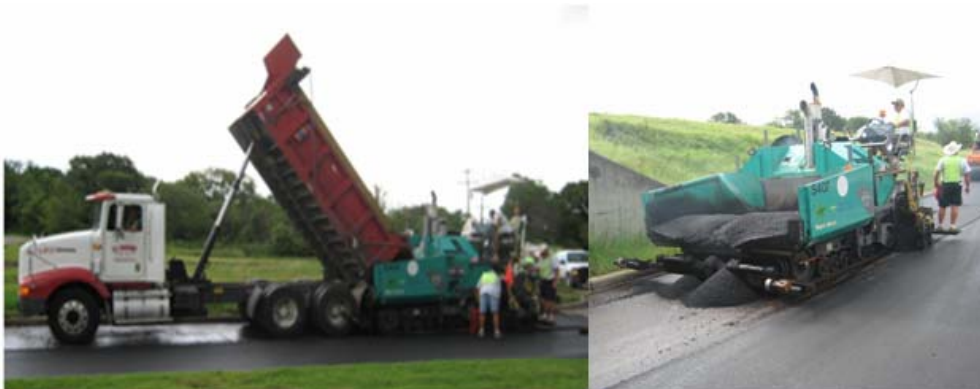
Figure 24. Paver Operation on the Pumphrey Drive, FTW.

The pavement surface temperature was about 106 °F, which meets the CAM SS 3109 recommendations (TxDOT, 2007). According to the Tarrant County construction crew, the air temperature should at least be 42 °F and rising for lay-down operations such as the Pumphrey Drive project. The air temperature was about 78 °F at the start of the construction operation which satisfied the ≥ 42 °F recommendation. No material transfer device was engaged in this lay-down operation. The trucks dumped the hot mix directly into the paver. This operation is shown in Figure 24.

It is worth noting that two overlay mat thicknesses were used in this overlay project due to different traffic levels. The HMA overlay was 1.5-inch thick starting from the Naval Air Base entrance to the middle of the overlay project where the traffic volume is much higher than the rest of the project in which only 1-inch thick mat was used.

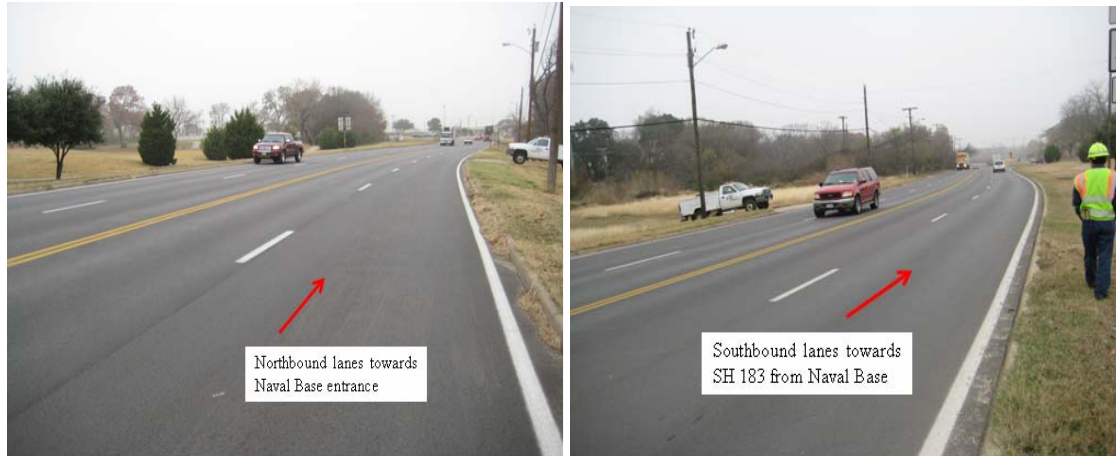
Figure 25. Overview on the Main Lanes between SH 183 and the Naval Base Entrance.

The visual inspection that was conducted on the overlay is presented in this section. This includes photos of the main lanes, on/off ramps, and the surface distresses observed. Figure 25 gives an overview of the main lanes and indicates satisfactory performance.

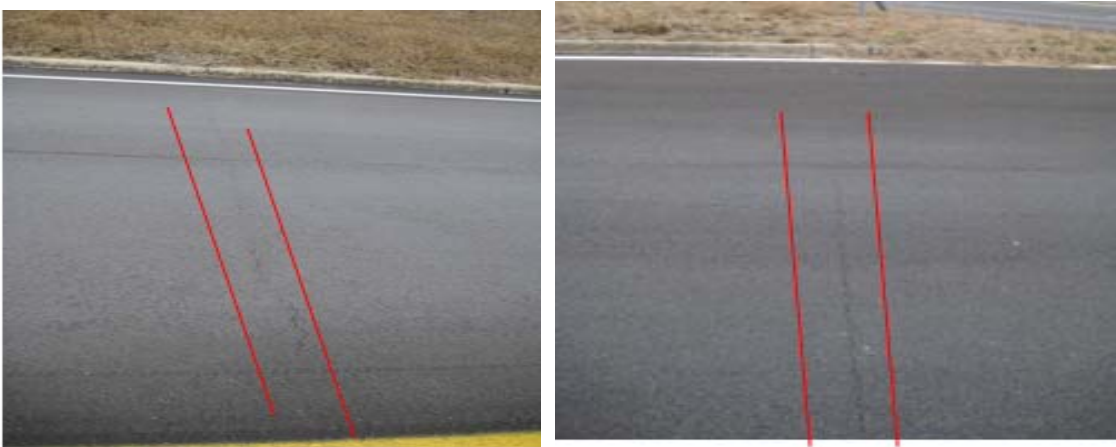
Figure 27a. Example of Transverse Cracks on Ramp R1 (see Figure 1).

Transverse cracking reflecting through the thin overlay from the underlying jointed concrete pavement structure was the predominant surface distress that was visually observed, in particular on the on/off ramps. These transverse cracks occurred periodically at regular interspaced distances, consistent with the underlying concrete joints. The transverse cracks were mostly on the on/off ramps with none on the main lanes. However, the southbound on-ramp merging into SH 183 on the extreme eastern side was not as transverse cracked as the other ramps, especially toward the end section with SH 183. Figure 27 displays a photographic illustration of some of these transverse cracks.

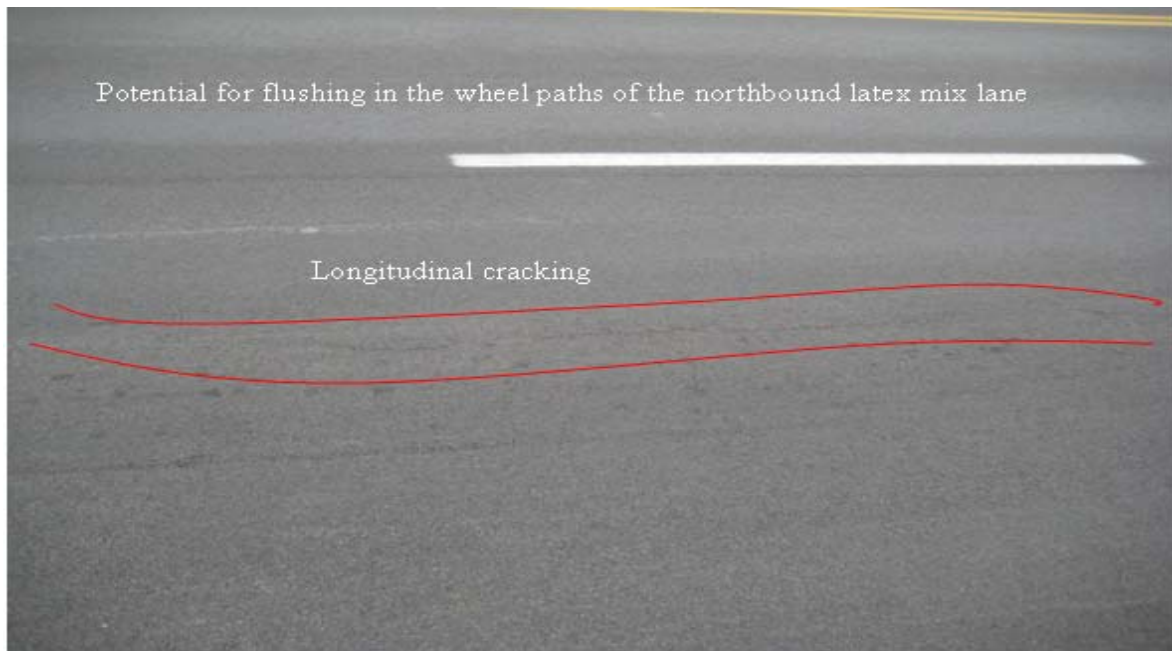
Figure 28. Longitudinal Cracking in the Outside NB Main Lane toward the Bridge.

There was visual evidence of longitudinal cracking in the outside northbound lane on two locations of the section towards the Naval Base entrance between the SH 183 overpass and the bridge. These longitudinal cracks are shown in Figure 28 and are considered to be caused by differential settlement of the foundation, which was also suspected prior to overlay placement. Inevitably, this distress will require a structural rehab in the foreseeable future.

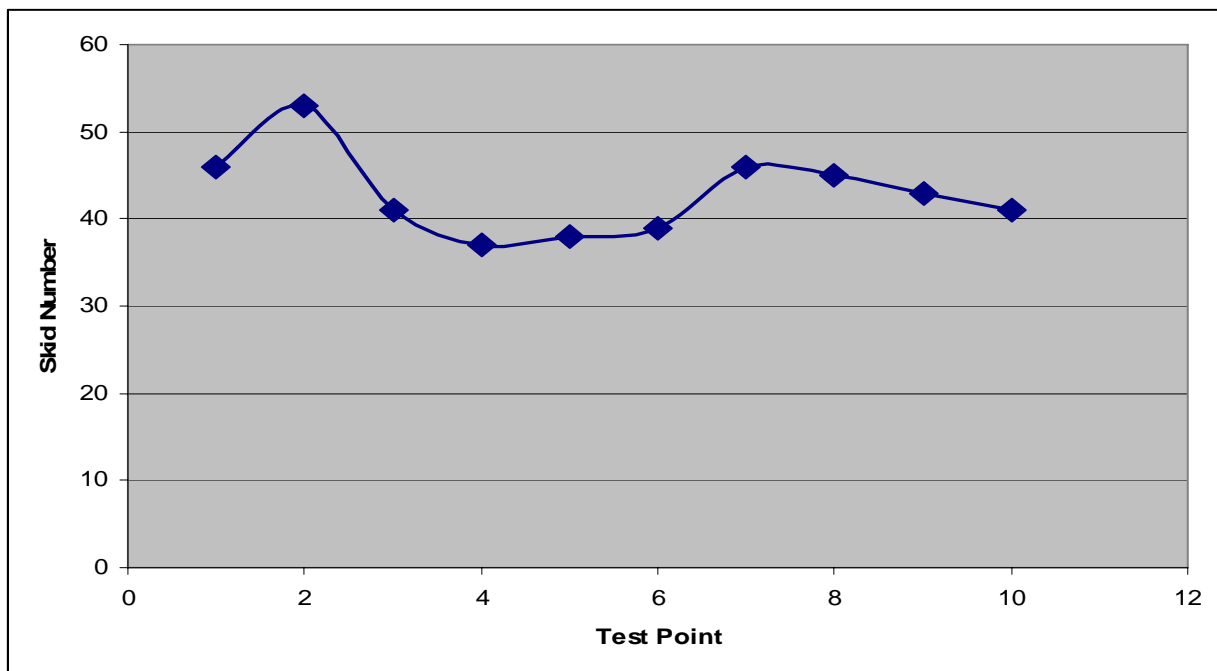
Figure 33. Skid Numbers from Loop 20 in Laredo.

Locked wheel skid measurements were made on lanes of the CAM mix. Figure 33 graphs the results. The skid numbers for this gravel mix are outstanding with an average value of 42.9.

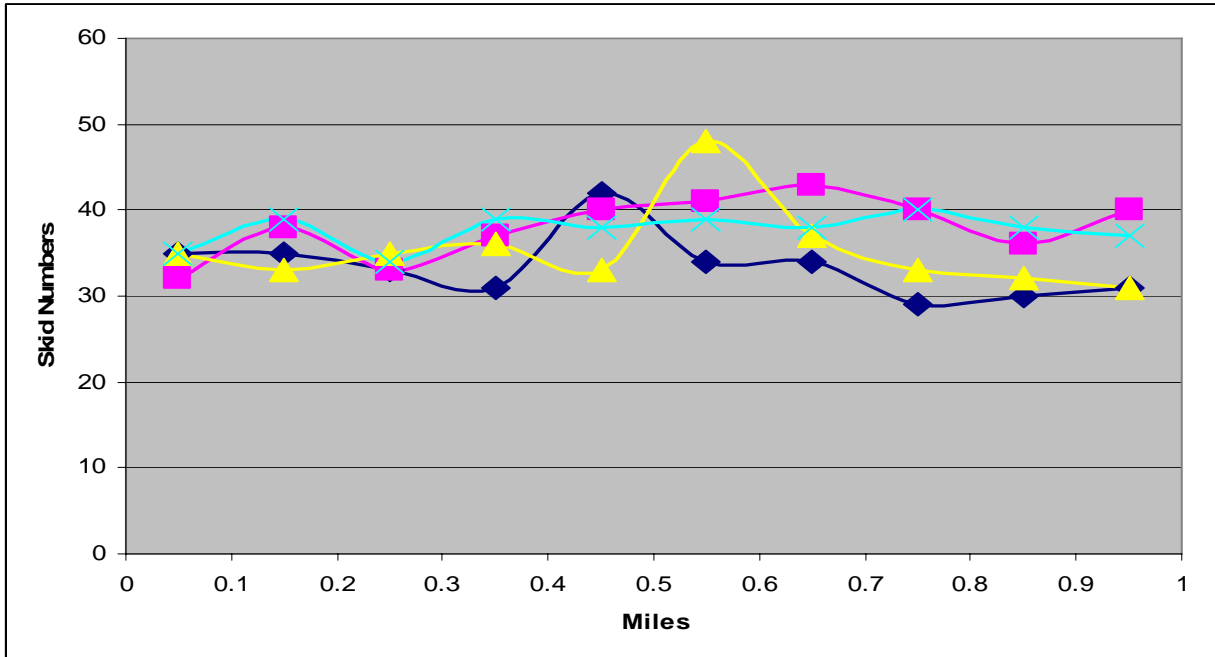
Figure 36. Skid Data from US 281 (Values for All Four Lanes).

The initial skid data from this project looks very promising. The average skid value for all four lanes was 35.2, which is rated as very good (Figure 36).

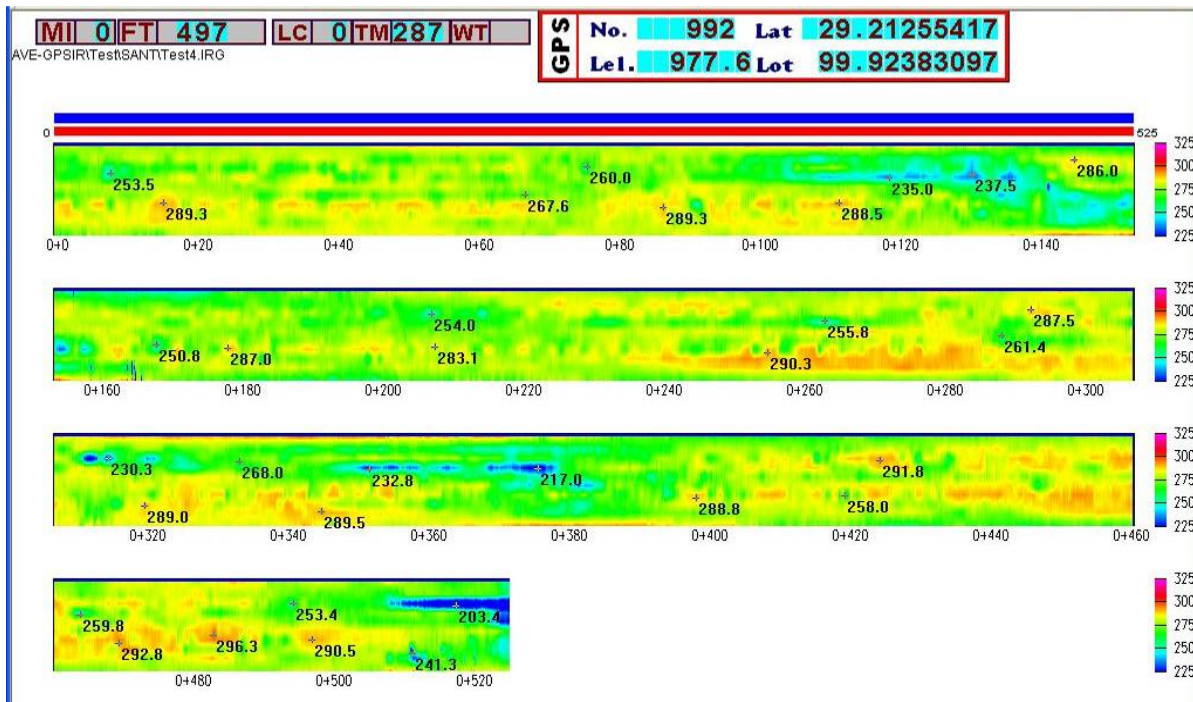
Figure 39. Infra-Red Results from a Typical Section of US 90 (525 ft by 12 ft Wide Section).

The CAM mix on US 90 was placed at a relatively low temperature, and more significantly there were major cold spots in the mat. As shown in Figure 39 streaks with temperatures at placement of 203 °F were found. The recommended temperature at placement should have been close to 280 °F. Figure 40 shows the consequences of the low placement temperature, where there is clear indication of thermal segregation, low density, and the resulting surface raveling.

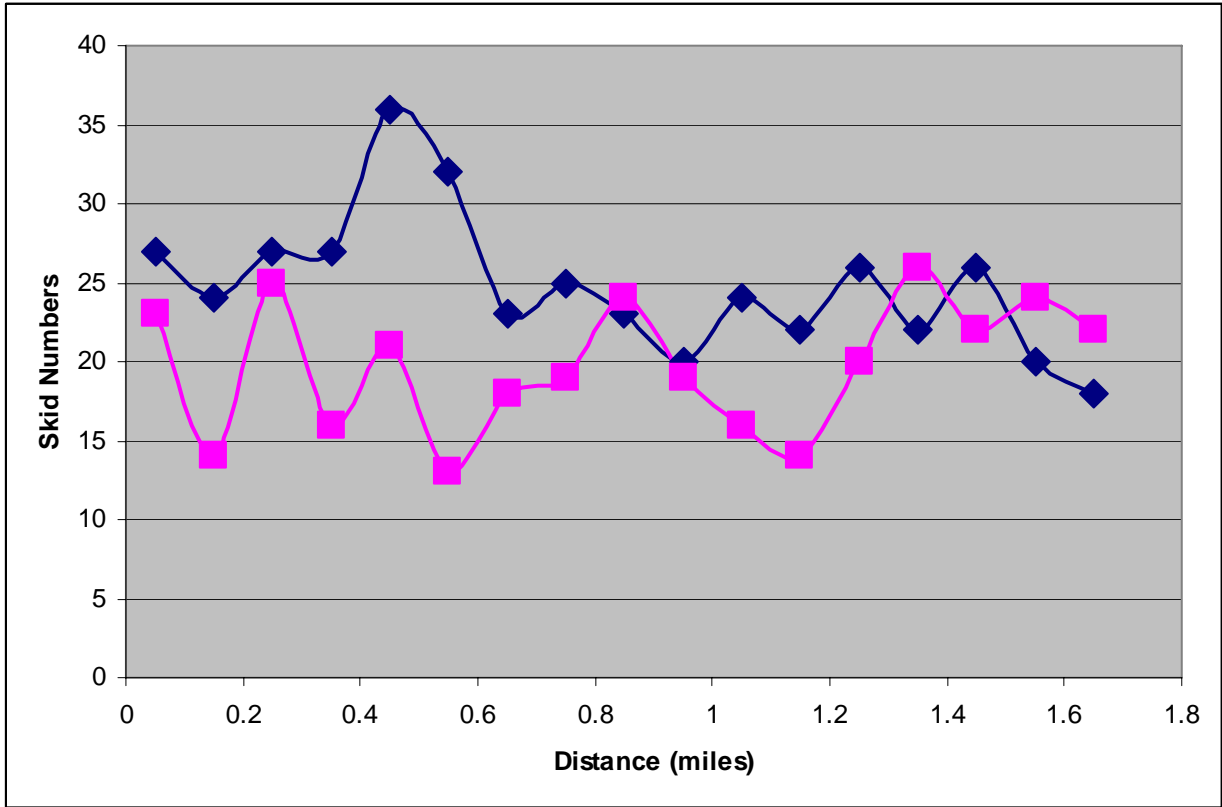
Figure 41. Skid Data from US 90 (Blue WB, Pink EB).

Skid data were collected approximately one month after placement, and the results from this mix were low as shown below in Figure 41.

The average values are 24.8 WB and 19.8 EB. These are substantially less than the values found on earlier projects. The US 90 project is the only CAM project placed to date where performance problems have been observed. The poor visual appearance of the mat is primarily related to the low placement temperatures. The reason for the low skid numbers are not known at this time.

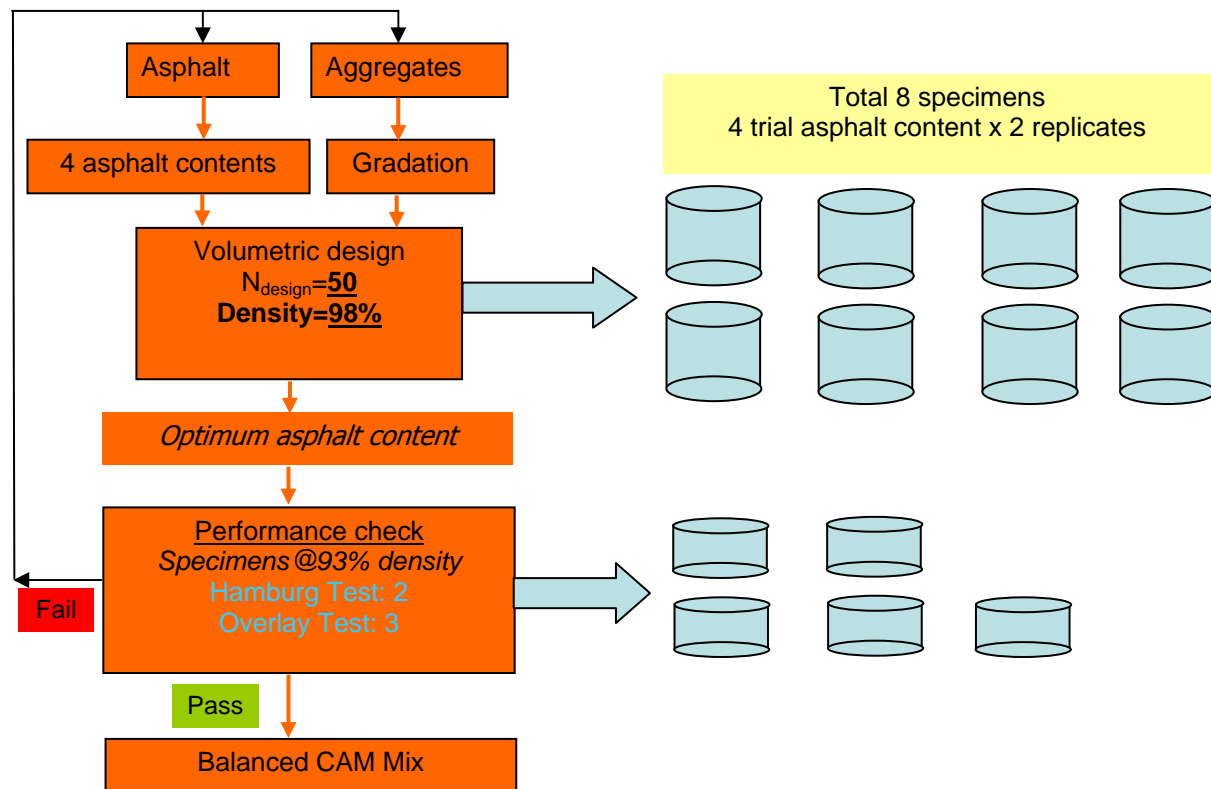
Figure 42. TxDOT's SS3109 Approach.

The SS3109 approach is the only official CAM mix design procedure. This design process is illustrated in Figure 42. This approach follows the general TxDOT process of designing Superpave performance hot-mix asphalt (HMA) mixes (Item 344). The only difference is to determine the optimum asphalt content (OAC) based on $N_{\text{design}}=50$ and 98 percent instead of 96 percent design density. Also for the CAM both the minimum rutting and cracking resistance is specified at optimum asphalt content using Hamburg Wheel Tracking Test (HWTT) and the Overlay Test (OT) criteria. If both rutting and cracking criteria are met, the design is finished; otherwise, start over again. The total number of specimens required is 13; eight specimens for volumetric design and five specimens for performance check, as shown in Figure 42. The main

advantages of this approach are simplicity, it requires minor changes to current HMA mix design system, and consequently, it would be easy to implement. Meanwhile, its serious disadvantage is that this approach checks only one asphalt content ($N_{\text{design}}=50$ and 98 percent density). Consequently, this approach may not select the optimum asphalt content (OAC). This will be described later when discussing the case study of San Antonito CAM mix design. Additionally, the OAC based on $N_{\text{design}}=50$ and 98 percent density may be too high potentially there could still be room to further reduce the asphalt content to get a more economic CAM mix.

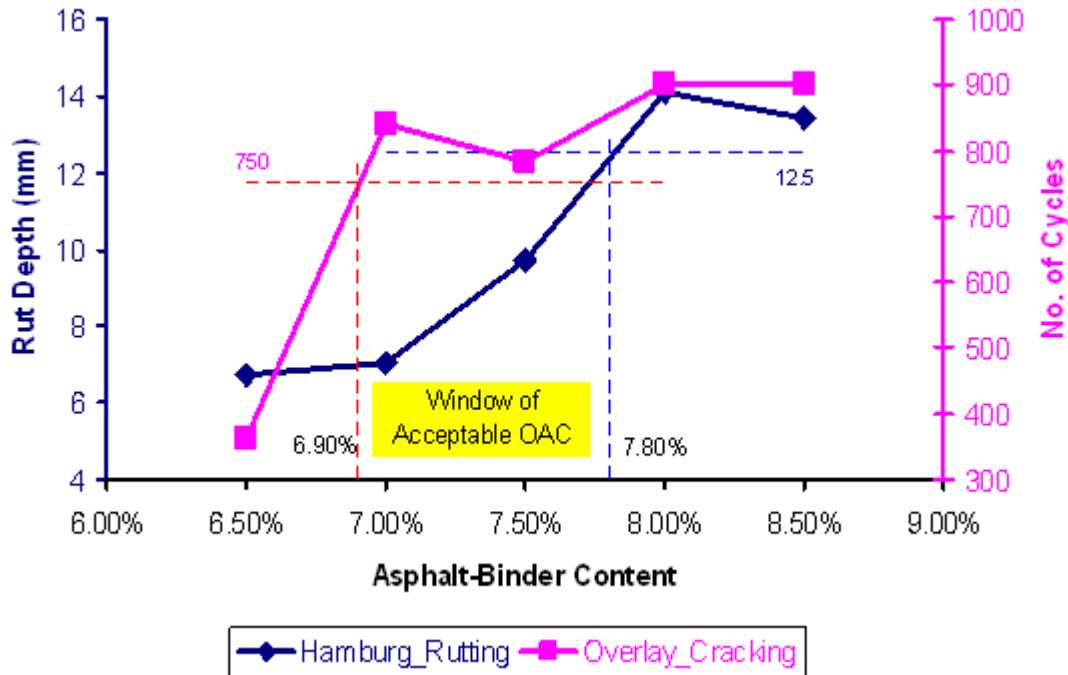
Figure 44. Lab Test Results and OAC Selection from Approach 2.

- Select the OAC as the asphalt content simultaneously meeting both the Hamburg rutting and overlay cracking criteria. A window of acceptable OAC will usually be determined, as shown in Figure 44. In this case the Hamburg requirement is met at all

binder contents below 7.8%, and the overlay tester requirement is met at all asphalt contents above 6.9%. Therefore the window of acceptable asphalt contents ranges from 6.9% to 7.8%. The binder content in the middle of the range would be selected for validation testing.

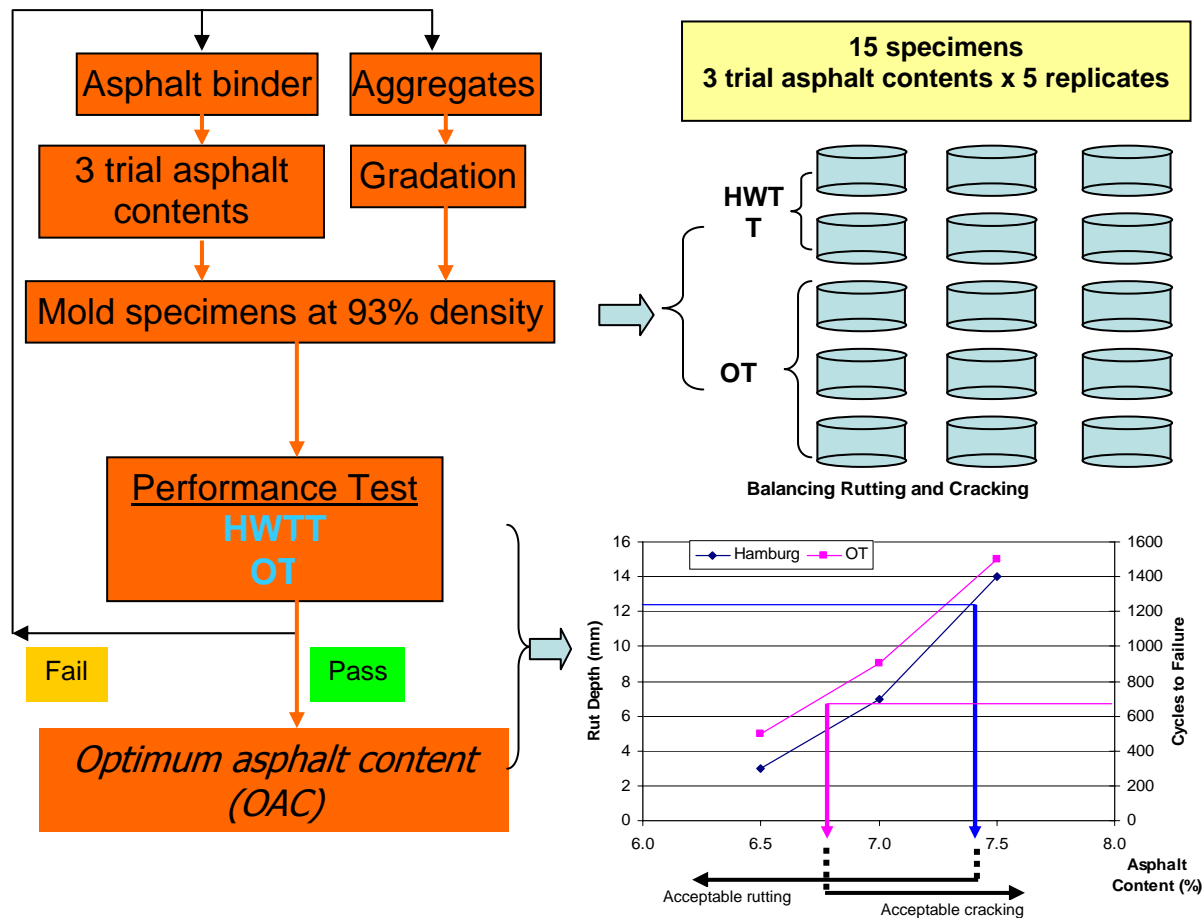
Figure 45. Simplified Version of Balanced Mix Design Approach (Zhou et al., 2006).

The proposed approach is simple, straight forward, and easy to follow. However, the major problem with this approach is unknown N_{design} for quality control (QC) and quality assurance (QA) during the production.

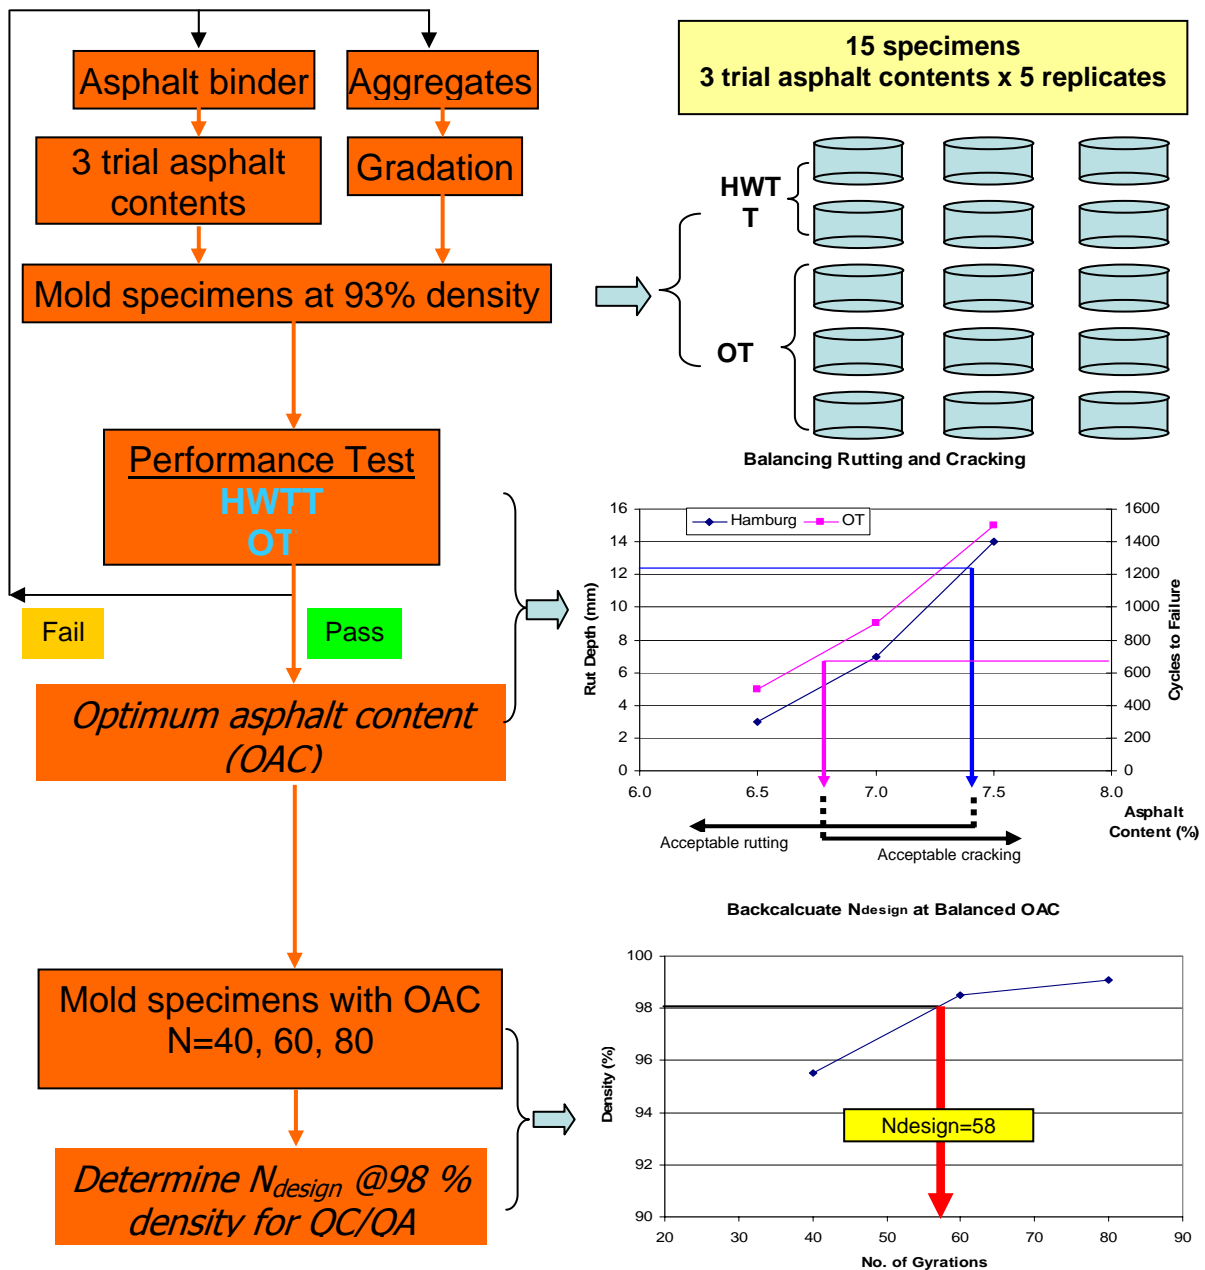
Figure 46. Recommended CAM Mix Design Procedure.

Figure 46 shows the recommended CAM mix design procedure. This procedure is composed of three steps: 1) material selection, 2) determination of balanced OAC, and 3) backcalculation of N_{design} at pre-selected design density.

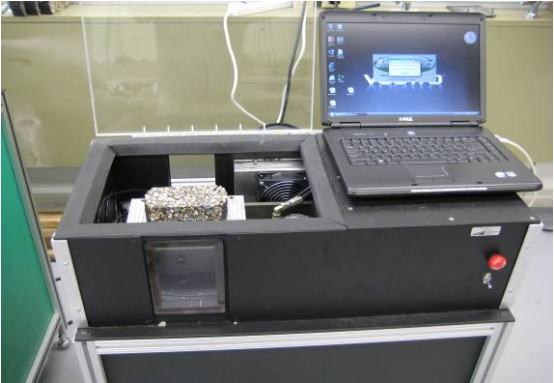
(a) Overlay Testing

In accordance with Tex-248-F, run the Overlay test and in accordance with Tex-242-F, run the Hamburg test; see Figure 52 (a) and (b), respectively. Record the test results.
