Dynamic Testing of the T223 Bridge Rail

Technical Report 0-5210-8

1. Report No. FHWA/TX-09/0-5210-8		2. Government Accession No.		3. Recipient's Catalog No.	
4. Title and Subtitle DYNAMIC TESTING OF THE T223 BRIDGE RAIL				5. Report Date April 2009 Published September 2009

Project Title: Roadside Crash Testing Program
for Design Guidance and Standard Detail Development

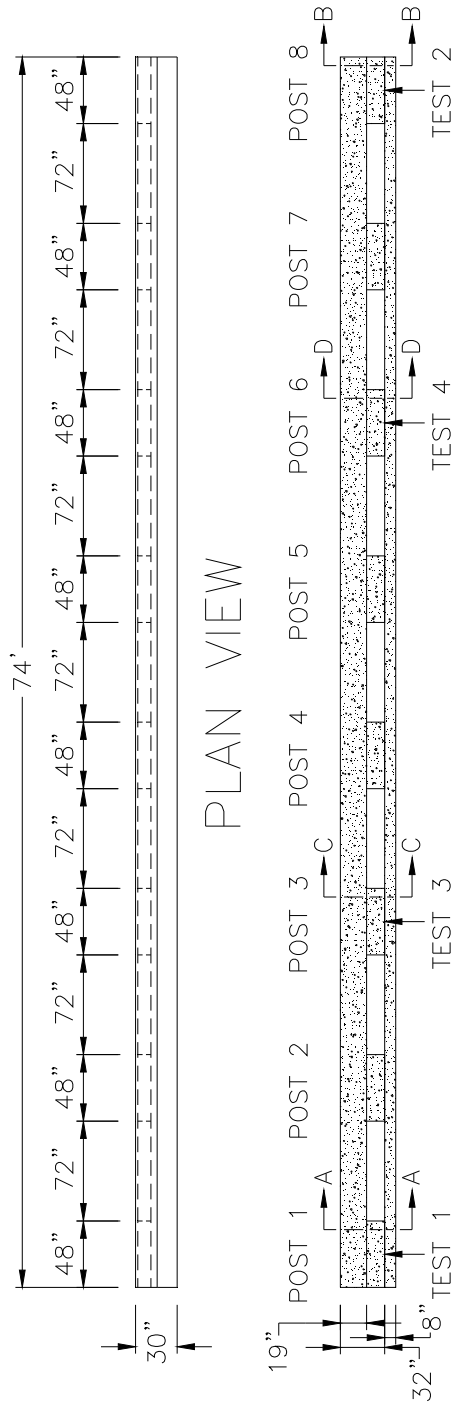
Figure 1. Layout of the T223 Bridge Rail Installation.

The Texas Department of Transportation (TxDOT) Type T223 bridge rail consists of a 19 inch x 15-1/2 inch concrete beam supported by 9-1/2 inch thick x 4 ft-0 inch wide concrete posts spaced on 10 ft-0 inch centers. The height of the bridge rail is 32 inches. Reinforcement in the beam consisted of nine #5 longitudinal reinforcing bars with four bars located on the front and back faces of the beam and one bar located in the top center of the beam. The longitudinal reinforcement in the beam was placed within #3 stirrup bars spaced at 6 inches on center along the entire length of the rail. For this project, TTI constructed approximately 74 ft of T223 bridge rail anchored on top of a 30-inch wide by 8-inch thick concrete deck cantilever constructed adjacent to a concrete apron at the TTI Proving Ground. The transverse reinforcement in the top layer of reinforcing in the deck cantilever consisted of #5 bars spaced at 6 inches on centers for all the posts excepts those on the ends of the installation. For the posts located on the ends of the installation, the transverse top reinforcement consisted of #5 reinforcing bars spaced at 3-1/2 inches on centers. The transverse reinforcement in the bottom layer of reinforcing consisted of #5 steel bars spaced at 18 inches on centers for the entire length of the installation. The longitudinal reinforcement in the top of the deck cantilever consisted of #4 bars spaced approximately 9 inches on centers. The longitudinal reinforcement in the bottom of the deck consisted of two #5 steel bars on the field side of the deck spaced at 3 inches on centers with the next adjacent # 5 steel bar spaced approximately 12 inches away towards the traffic face. All steel reinforcement used in the deck cantilever was bare steel (not epoxy coated) with minimum specified yield strength of 60 ksi.

The concrete posts were anchored to the deck using #5 “U” bars cast within the concrete deck. These bars extended approximately 10 inches from the top of the deck upwards into the concrete posts. The spacing of the “U” bars varied at the different test locations. For the posts located on the ends of the installation (test locations 1 and 2), the “U” bars were spaced at 3-1/2 inches on centers. For the remaining posts in the installation (including test locations 3 and 4), the “U” bars were spaced at 6 inches on centers and were placed with the transverse #5 top

reinforcement in the deck. Additional transverse reinforcement was provided in the deck. This additional reinforcement consisted of #5 “L” bars placed alongside the “U” bars in the top layer of deck reinforcing steel. Please refer to Figures 1 through 10 for additional information.

Please refer to [Figures 1 through 10](#) for additional information. [Figure 11](#) shows photographs of the test installation.

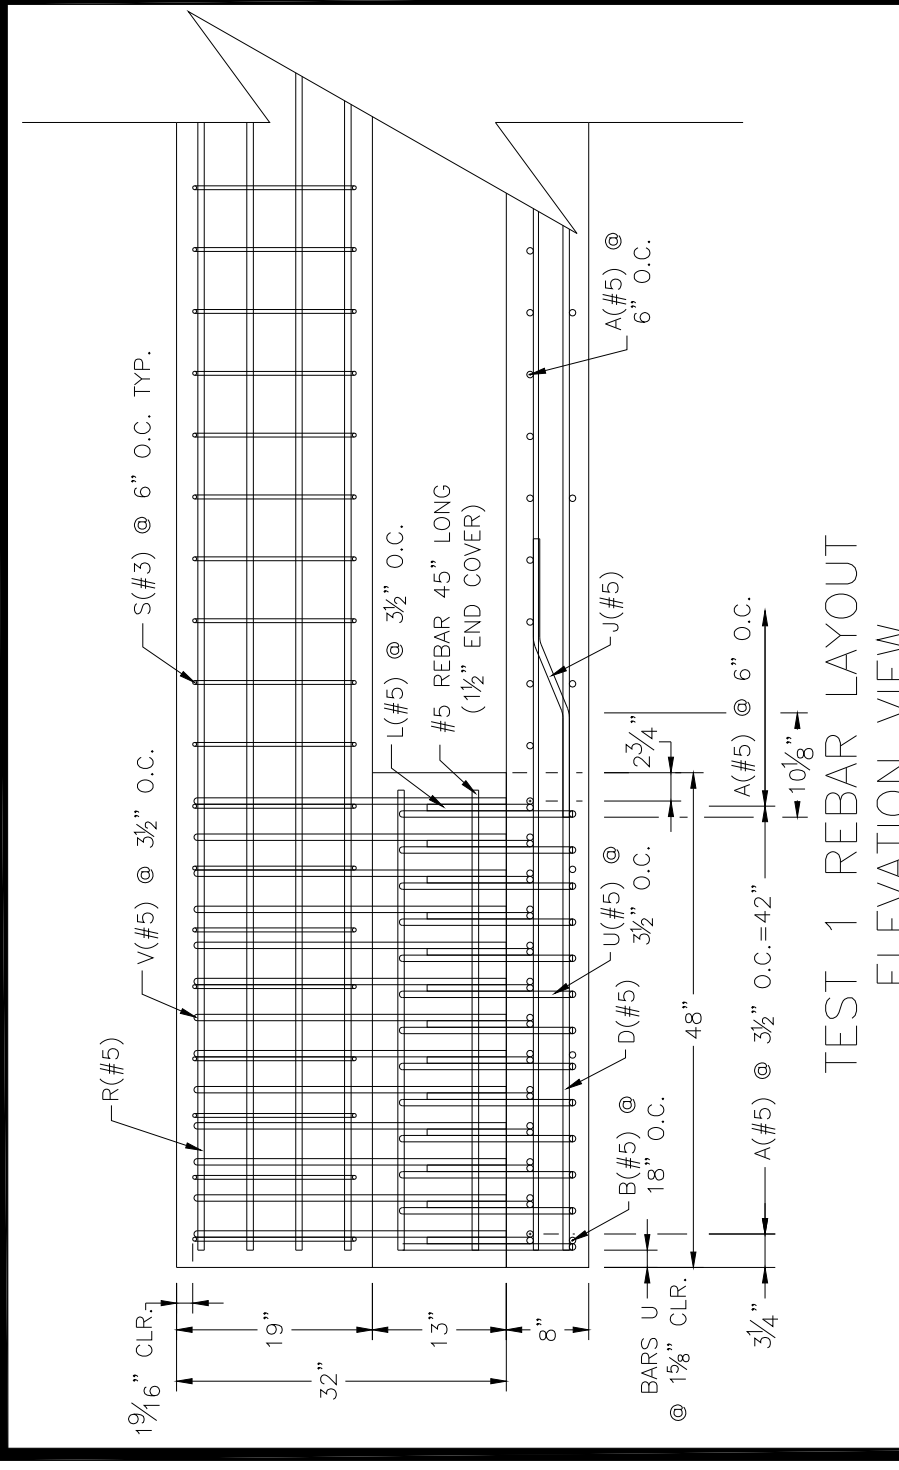
Figure 2. Rebar Layout at Post 1 for Test B1.

For Test B1 – Post No. 1, the 13 #5 “U” bars anchoring the post to the concrete deck were spaced at 3-1/2 inches on centers. Thirteen #5 “L” bars were placed in the deck and provided additional reinforcement to the post. The top transverse #5 reinforcing steel was spaced at 3-1/2 inches on centers in the deck. Thirteen #5 upright “V” bars (bent at top of rail) were constructed in the post and provided reinforcement for the post and beam. In addition, one #5 “J” bar was placed in the deck near the field side edge and provided additional deck reinforcement. The peak 50-ms average impact force measured in the dynamic bogie test was 61.3 kips.

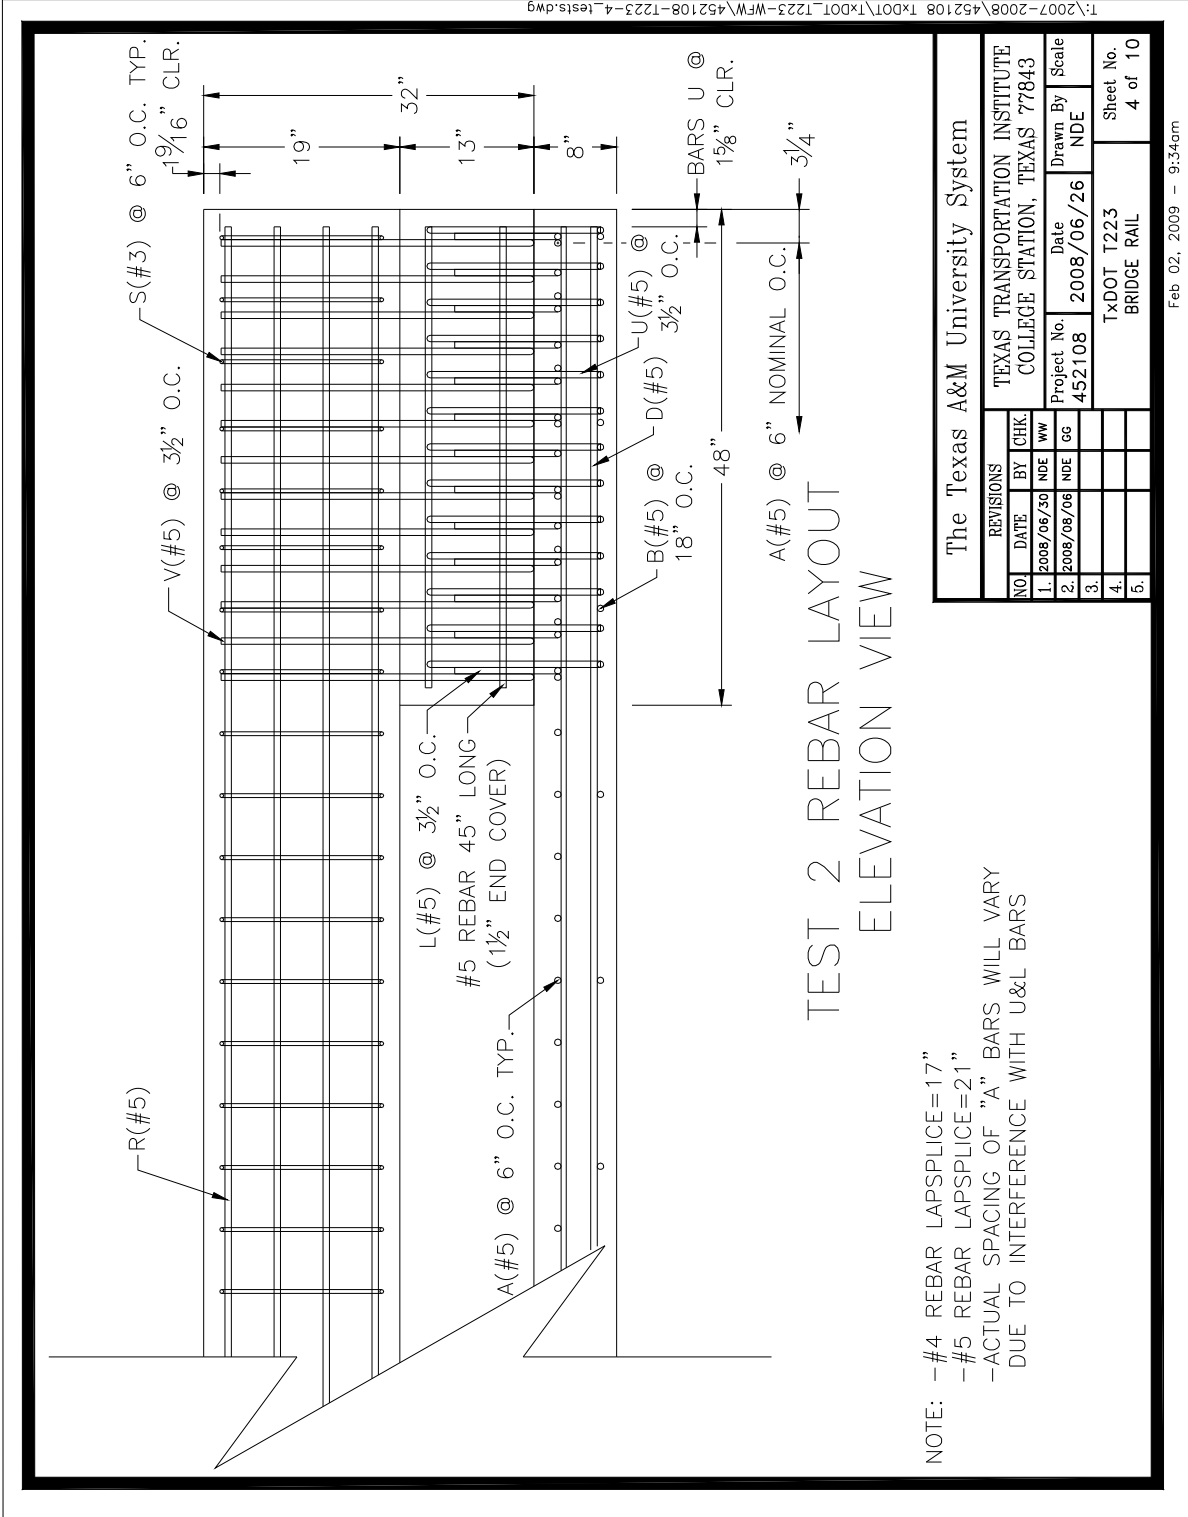
Figure 4. Rebar Layout at Post 8 for Test B2.

For Test B2 – Post No. 8, the 13 #5 “U” bars anchoring the post to the concrete deck were spaced at 3-1/2 inches on centers. Thirteen #5 “L” bars were placed in the deck and provided additional reinforcement to the post. The top transverse #5 reinforcing steel was spaced at 3-1/2 inches on centers in the deck. Thirteen #5 inverted “V” bars (bent at bottom of the post) were constructed in the post and provided reinforcement for the post and beam. The #5 “J” bar was omitted in this test. The peak 50-ms average impact force measured in the dynamic bogie test was 60.2 kips.

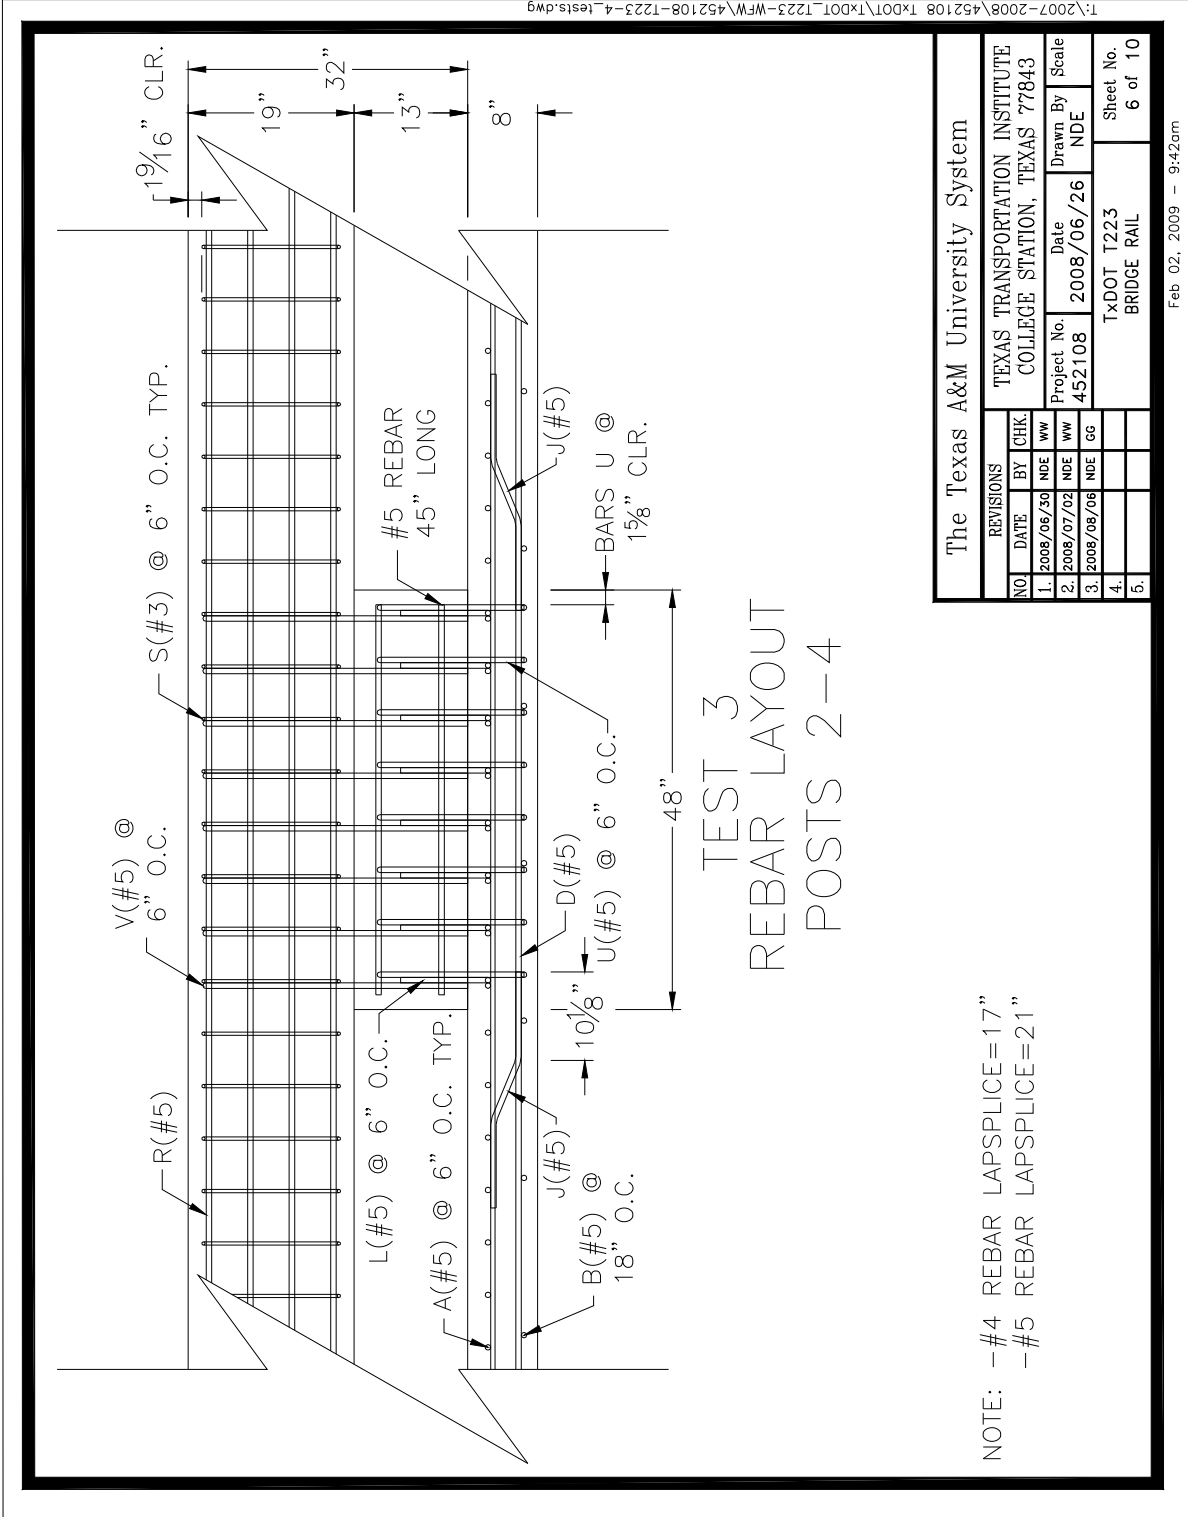
Figure 6. Rebar Layout at Posts 2-4 for Test B3.

For Test B3 – Post No. 3, the eight #5 “U” bars anchoring the post to the concrete deck were spaced at 6 inches on centers. Eight #5 “L” bars were placed in the deck and provided additional reinforcement to the post. The top transverse #5 reinforcing steel was spaced at 6 inches on centers in the deck. Eight #5 upright “V” bars (bent at the top of rail) were constructed in the post and provided reinforcement for the post and beam. In addition, one #5 “J” bar was placed on each side of the post in the deck near the field side edge and provided additional deck reinforcement. The peak 50-ms average impact force measured from the dynamic bogie test was 89.7 kips.

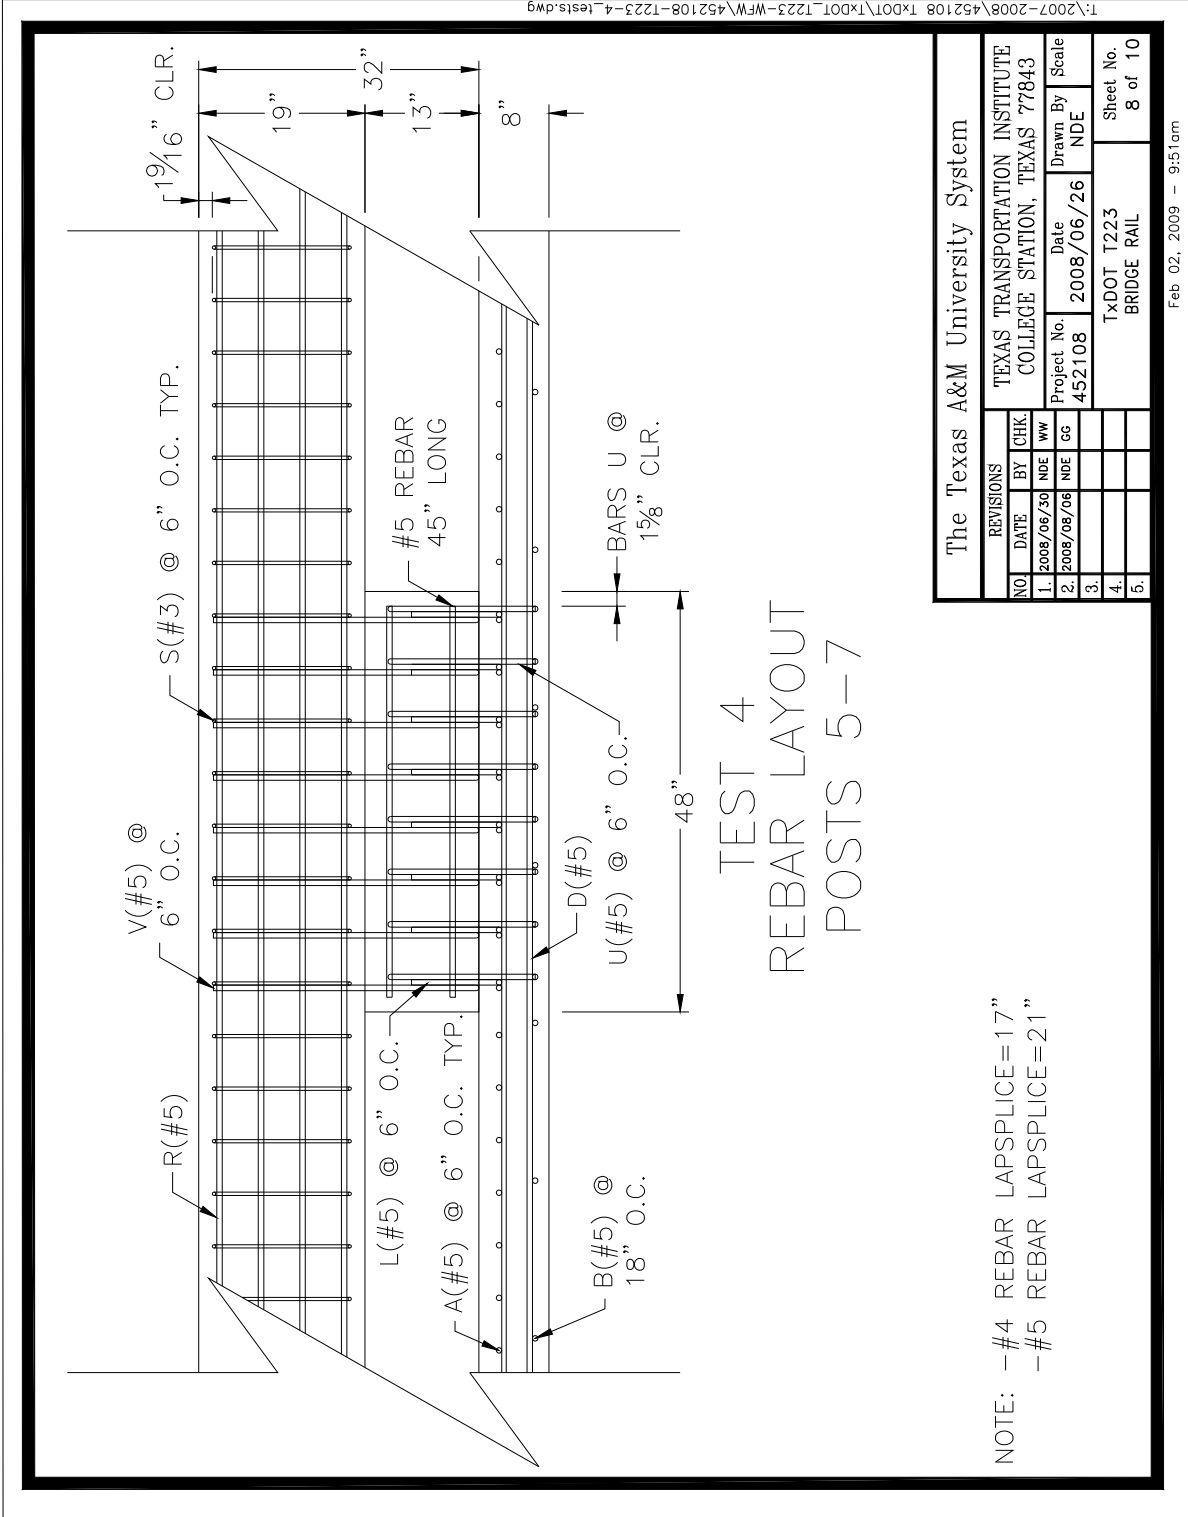
Figure 8. Rebar Layout at Posts 5-7 for Test B4.

For Test B4 – Post No. 6, the eight #5 “U” bars anchoring the post to the concrete deck were spaced at 6 inches on centers. Eight #5 “L” bars were placed in the deck and provided additional reinforcement to the post. The top transverse #5 reinforcing steel was spaced at 6 inches on centers in the deck. Eight #5 inverted “V” bars (bend at the bottom of the post) were constructed in the post and provided reinforcement for the post and beam. The peak 50-ms average impact force measured in the dynamic bogie test was 89.6 kips.

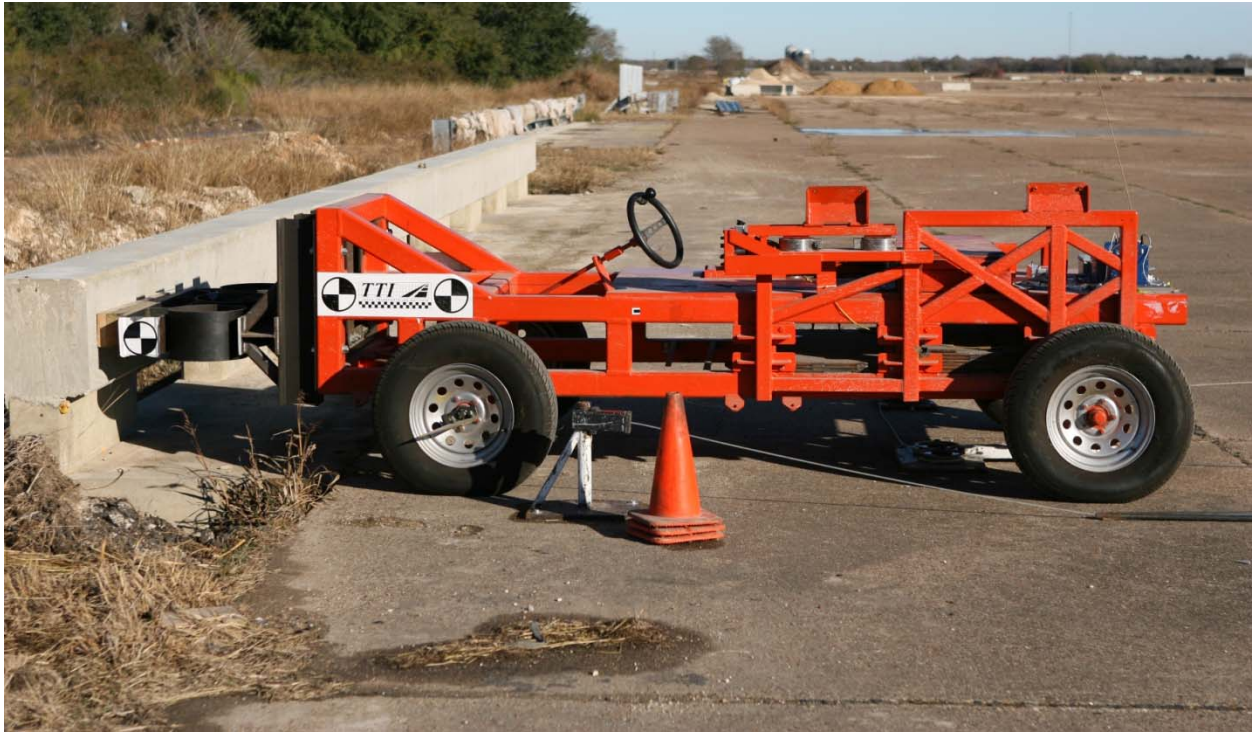
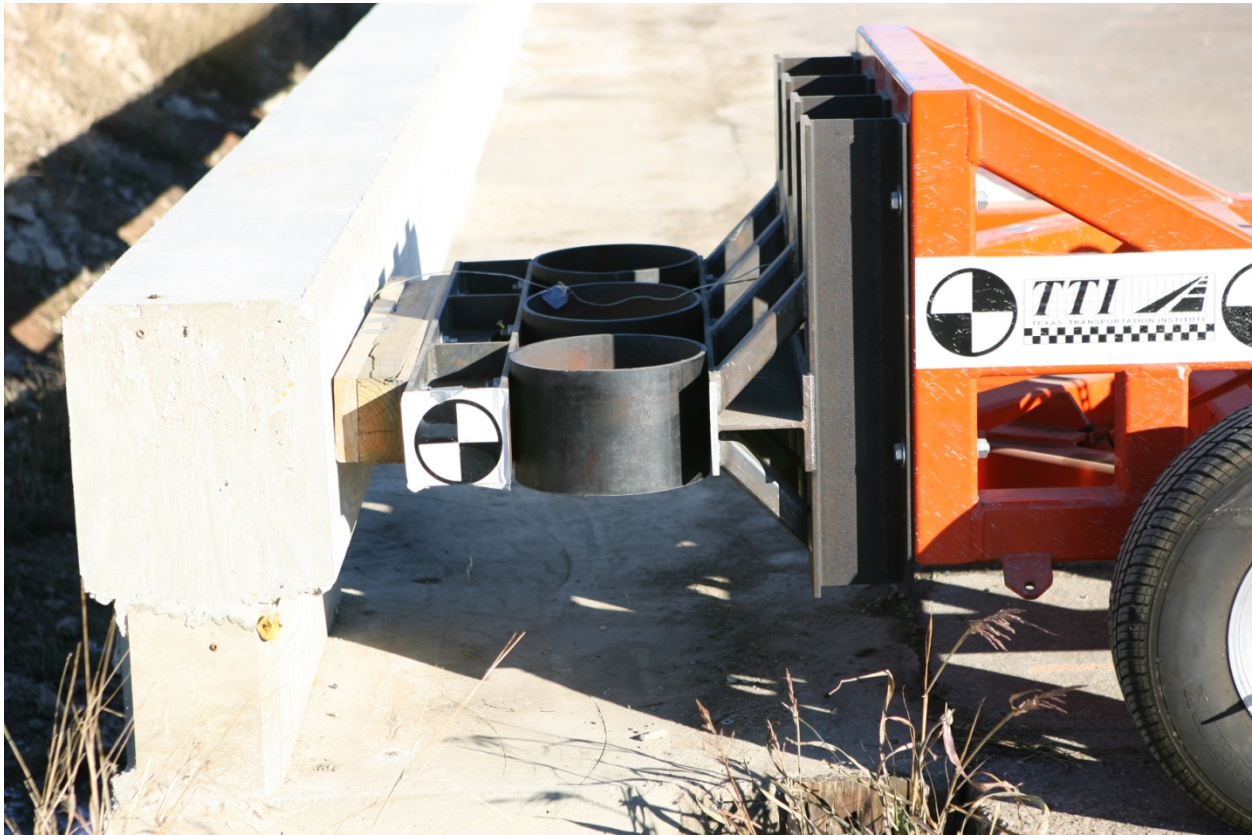
Figure 12. Bogie/Installation Geometrics for Test 452109-B1.

A bogie vehicle, shown in [Figure 12](#), was used for the crash test. Test inertia weight of the vehicle was 5004 lb. The height to the lower edge of the bogie's collapsible pipe nose was 18.5 inches, and it was 26.5 inches to the upper edge of the pipe nose. The bogie vehicle was directed into the installation using the cable reverse tow and guidance system and was released to be free-wheeling and unrestrained just prior to impact.

The bogie vehicle, traveling at an impact speed of 15.4 mi/h, impacted post 1 of the T223 Bridge Rail at 90 degrees. [Figure 12](#) depicts the orientation of the bogie with the bridge rail at impact. At approximately 0.060 s, the pipe sections began to deform. At 0.094 s, the bogie began to rebound. The bogie lost contact with the bridge rail at 0.115 s, traveling at an exit speed of -3.3 mi/h. [Figure B1](#) in [Appendix B](#) shows sequential photographs of the test.

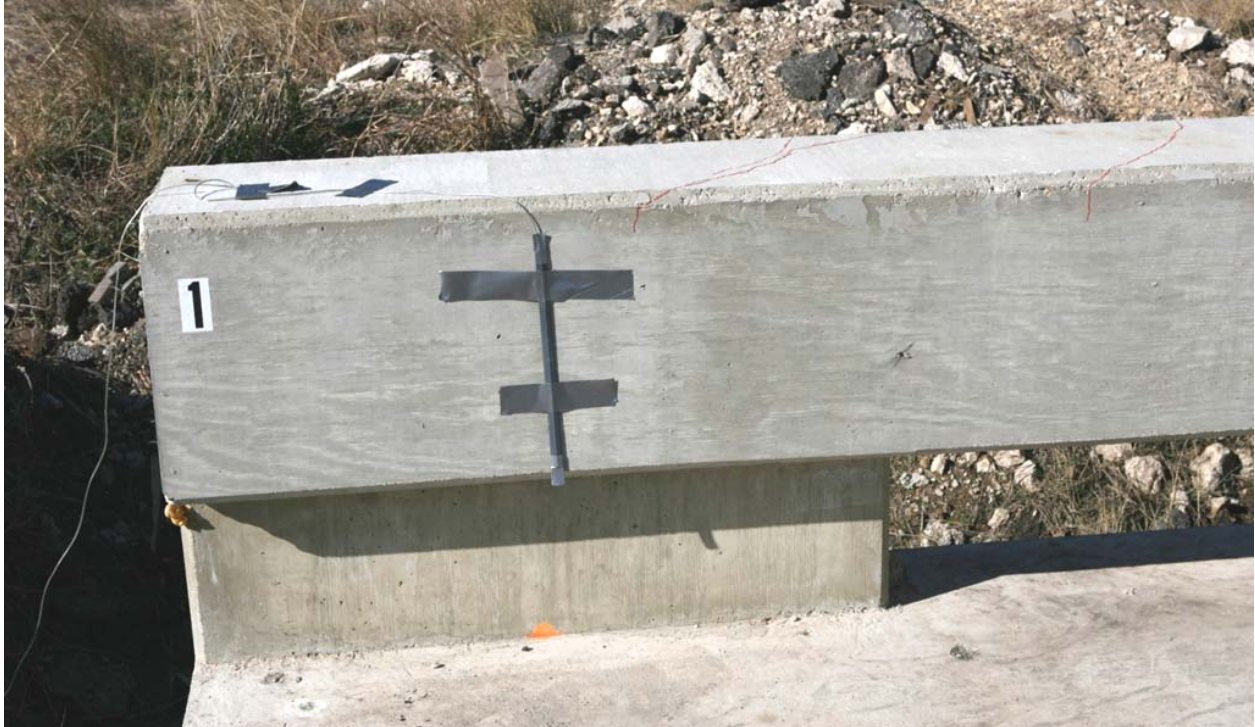
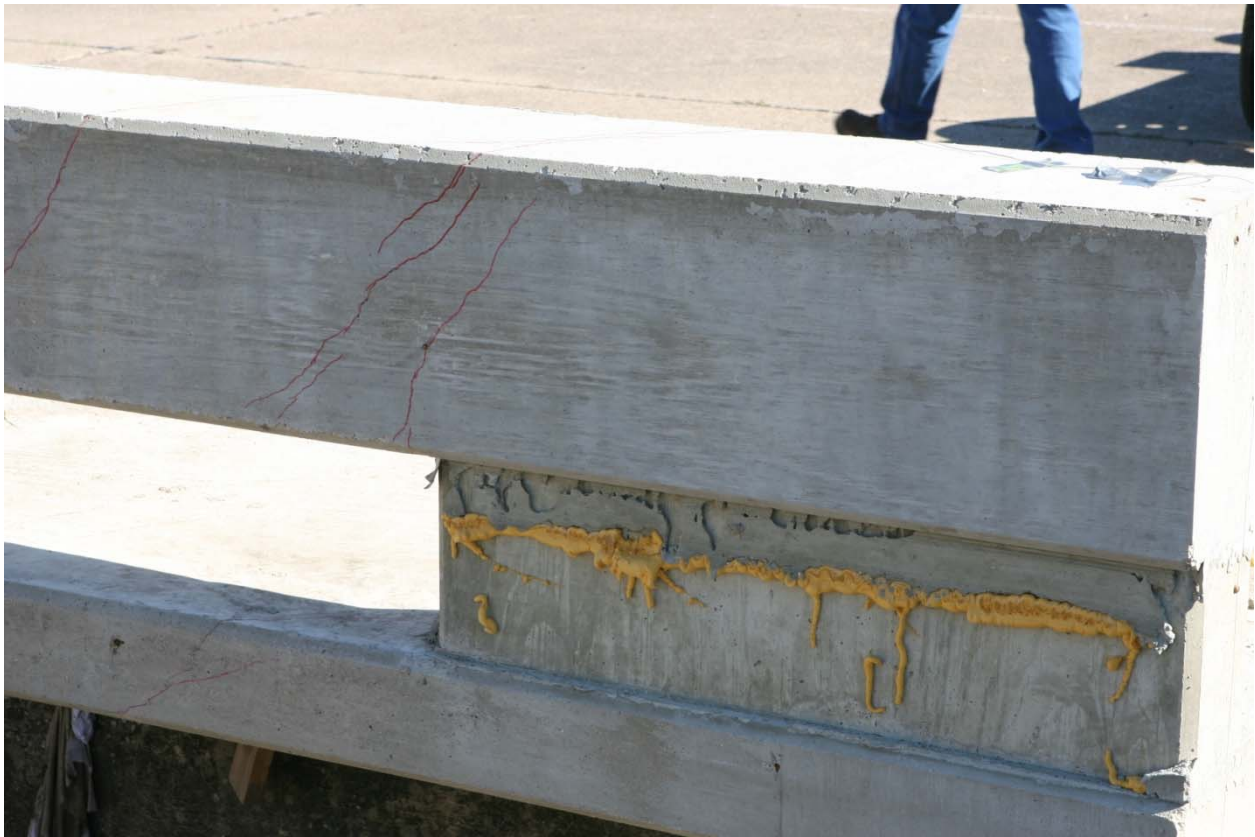
Figure 13. Installation after Test 452109-B1.

[Figure 13](#) shows damage to post 1. Several cracks in the beam above the post were noted. Also, a crack radiated out from post 1 on the side adjacent to post 2. This crack began 2.5 inches toward the field side of the traffic face of the post and radiated toward the field side a distance of 15.5 inches. The crack then extended down the edge of the deck toward post 2 a distance of 23.5 inches. Maximum deflection of the bridge rail during the test was 0.99 inches. The deck and rail were still serviceable after the test.

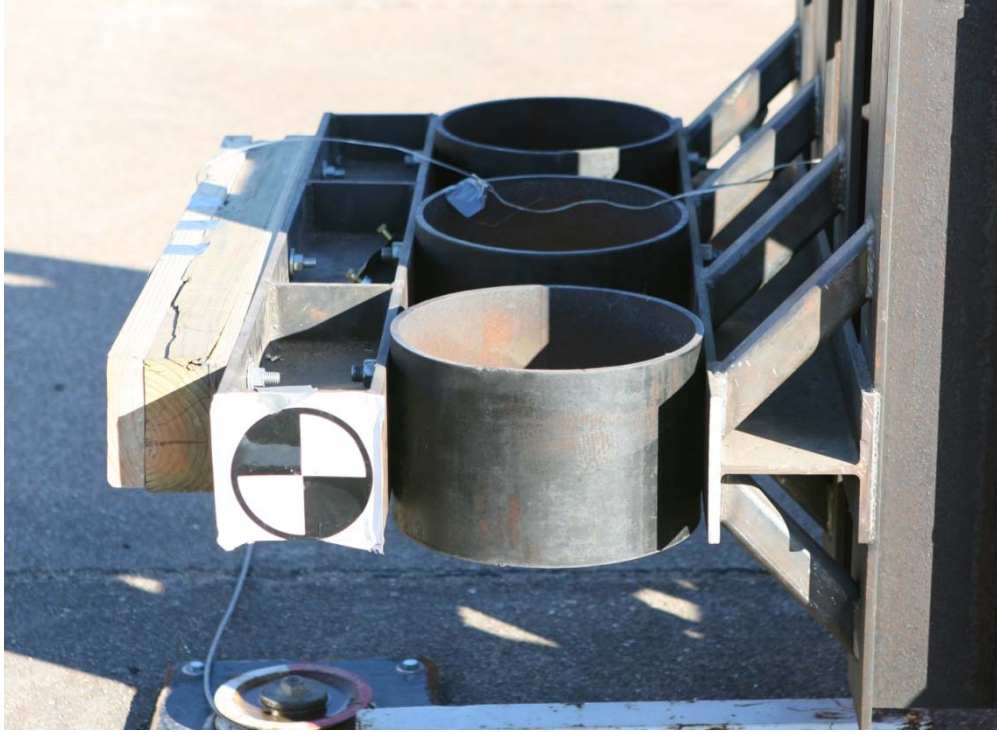
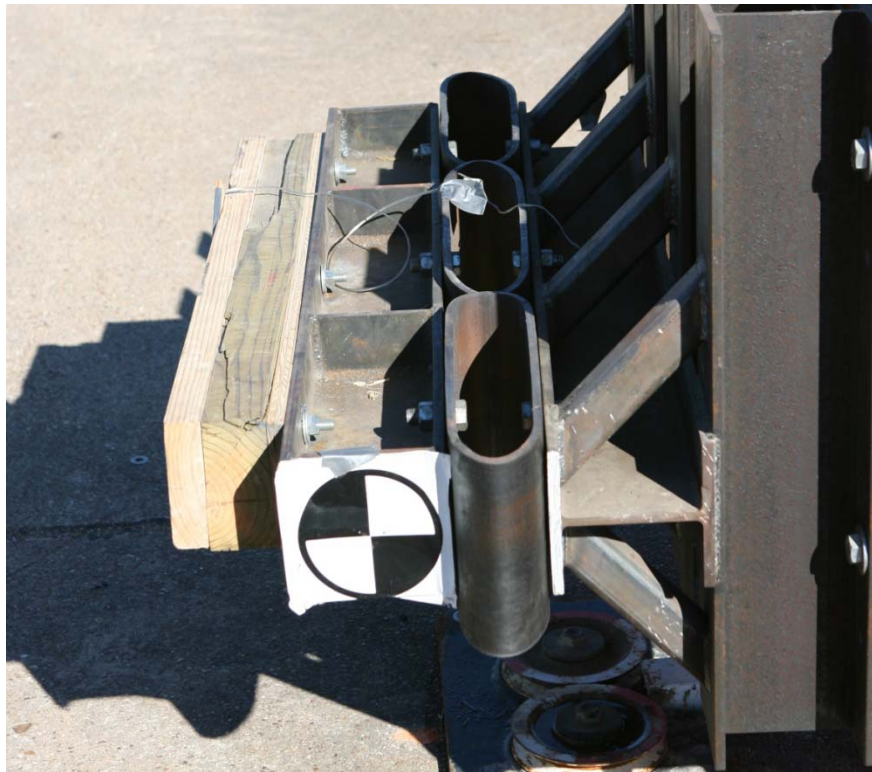
Figure 14. Bogie before and after Test 452109-B1.

Maximum crush of the pipe nose was 9.0 inches. The bogie nose before and after the test is shown in [Figure 14](#).

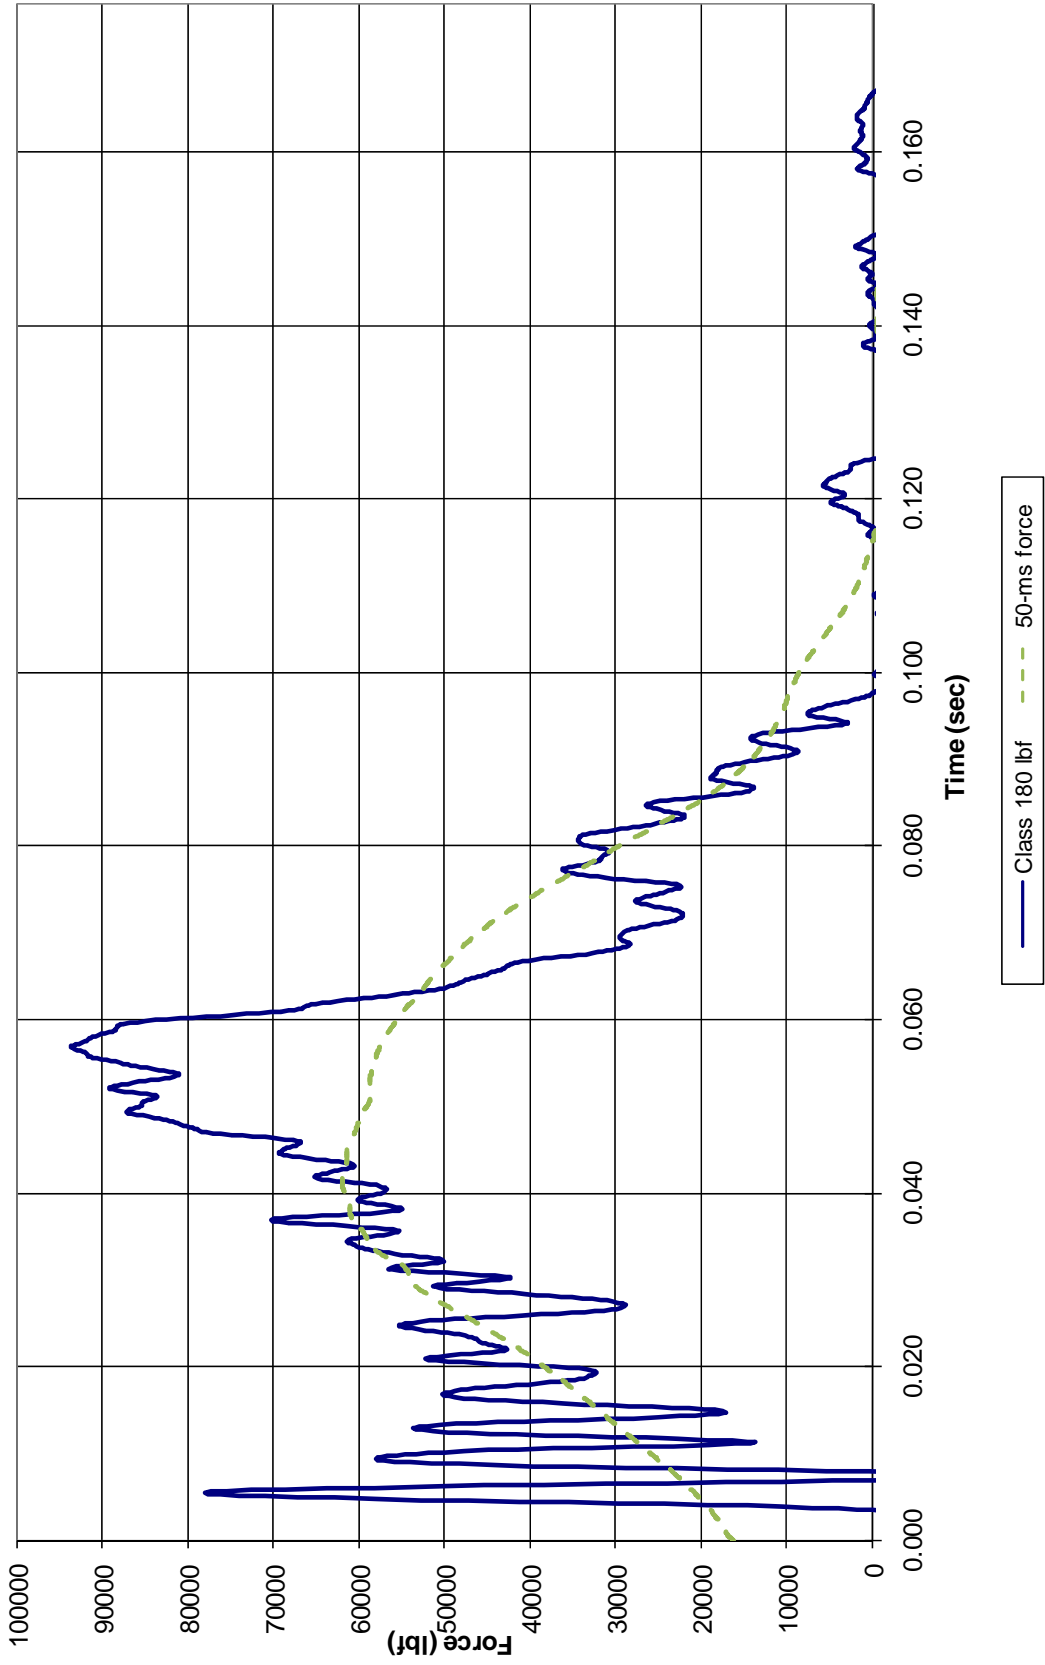
Figure 15. Force Trace for Test 452109-B1.

Data from the accelerometer, located at the bogie center of gravity, were digitized and used to calculate a force-time history, which is shown in [Figure 15](#). The maximum 50-ms average impact force was 61,985 lb, which exceeds the design impact force of 54,000 lb for a TL-3 impact.

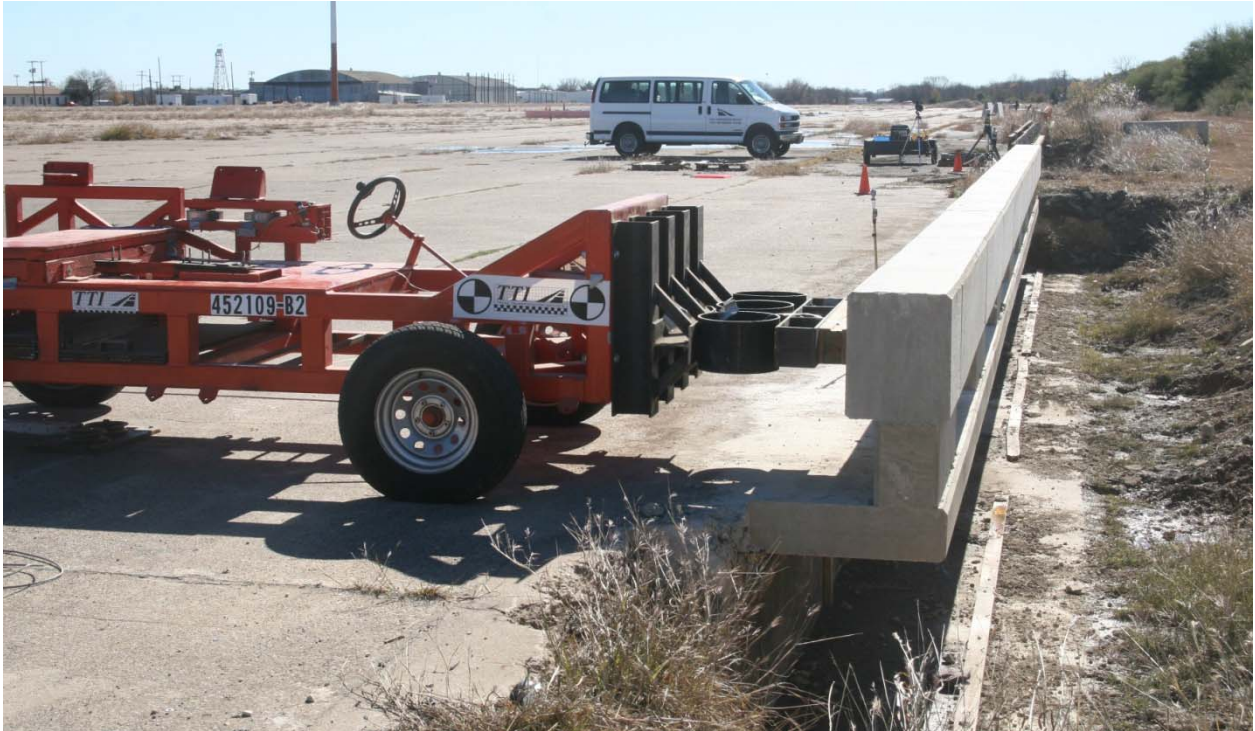
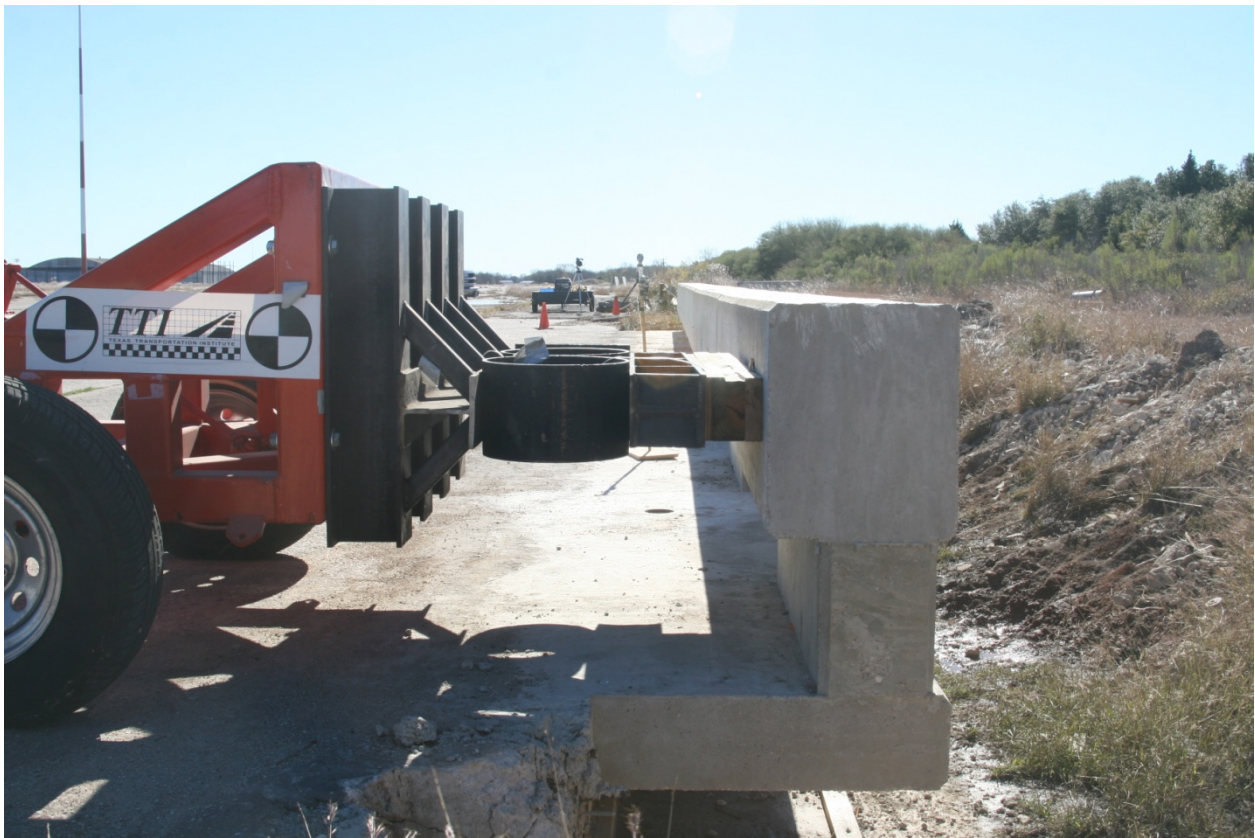
Figure 16. Bogie/Installation Geometrics for Test 452109-B2.

The bogie vehicle, traveling at an impact speed of 15.8 mi/h, impacted post 8 of the T223 Bridge Rail at 90 degrees. [Figure 16](#) depicts the orientation of the bogie with the bridge rail at impact. At approximately 0.046 s, the pipe sections began to deform. At 0.120 s, the bogie began to rebound. The bogie lost contact with the bridge rail at 0.125 s, traveling at an exit speed of -3.2 mi/h. [Figure B2](#) of [Appendix B](#) shows sequential photographs of the test.

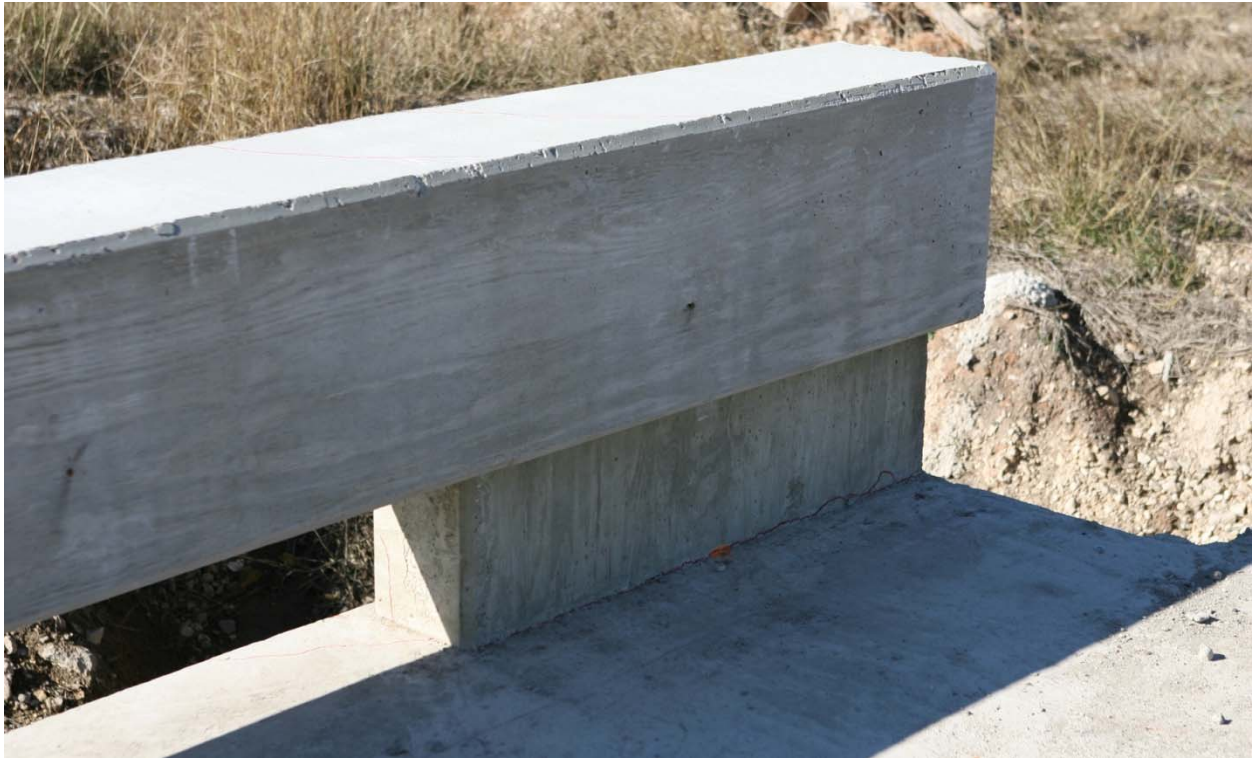
Figure 17. Installation after Test 452109-B2.

Damage to post 1 is shown in [Figure 17](#). Several cracks in the beam above the post were noted. Two cracks radiated out from post 8 on the side adjacent to post 7. One crack began 2.5 inches toward the field side of traffic face of the post and radiated toward the field side a distance of 11.5 inches. The crack then extended down the edge of the deck toward post 7 a distance of 23.0 inches. Another crack began at the field side corner, radiated toward the edge of the deck for 2 inches, and then joined the first crack about mid-height of the edge of the deck. The bridge rail had no measureable deflection during impact.

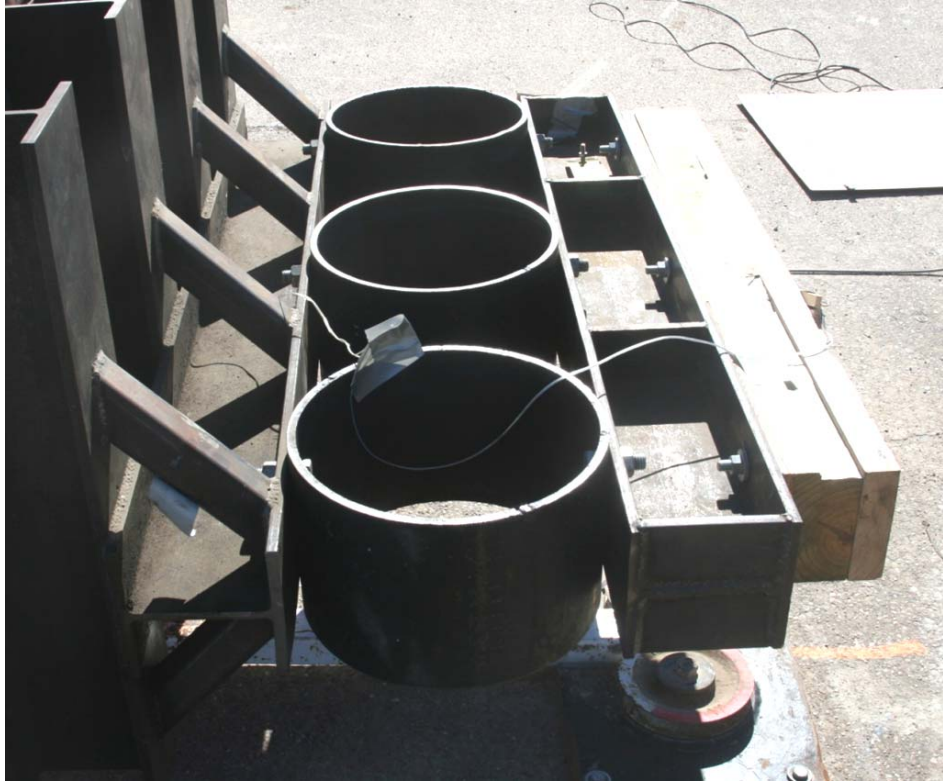
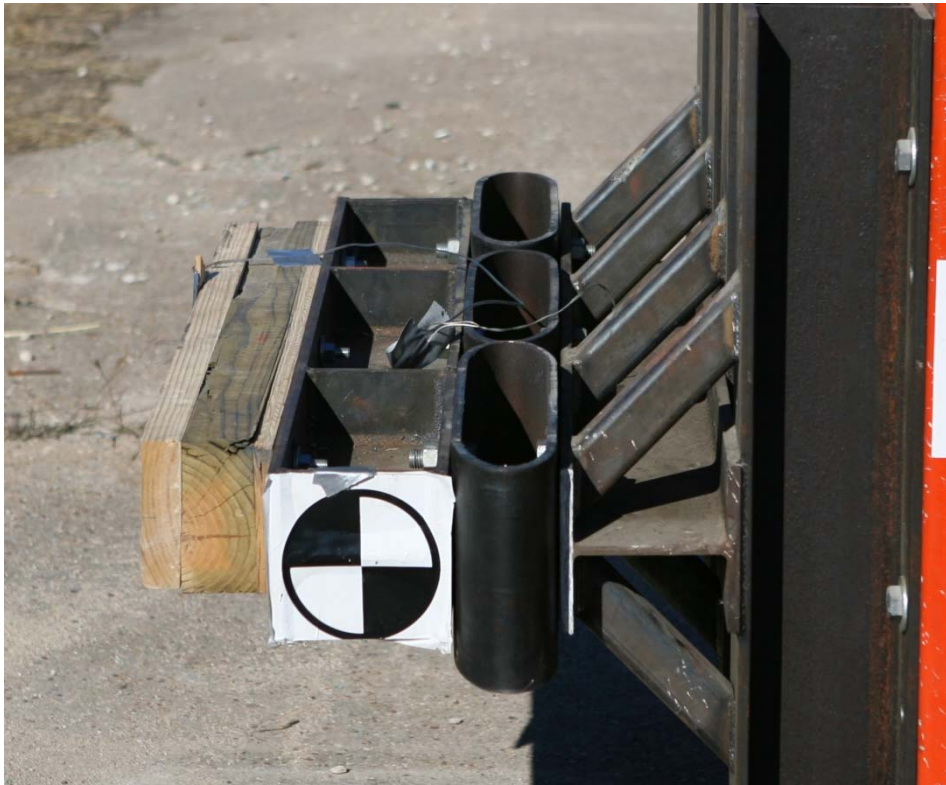
Figure 18. Bogie before and after Test 452109-B2.

Maximum crush of the pipe nose was 8.9 inches. Before and after photographs of the nose are shown in [Figure 18](#).
