Dynamic Testing of the T223 Bridge Rail

Technical Report 0-5210-8

1. Report No. FHWA/TX-09/0-5210-8		2. Government Accession No.		3. Recipient's Catalog No.	
4. Title and Subtitle DYNAMIC TESTING OF THE T223 BRIDGE RAIL				5. Report Date April 2009 Published September 2009

Project Title: Roadside Crash Testing Program
for Design Guidance and Standard Detail Development

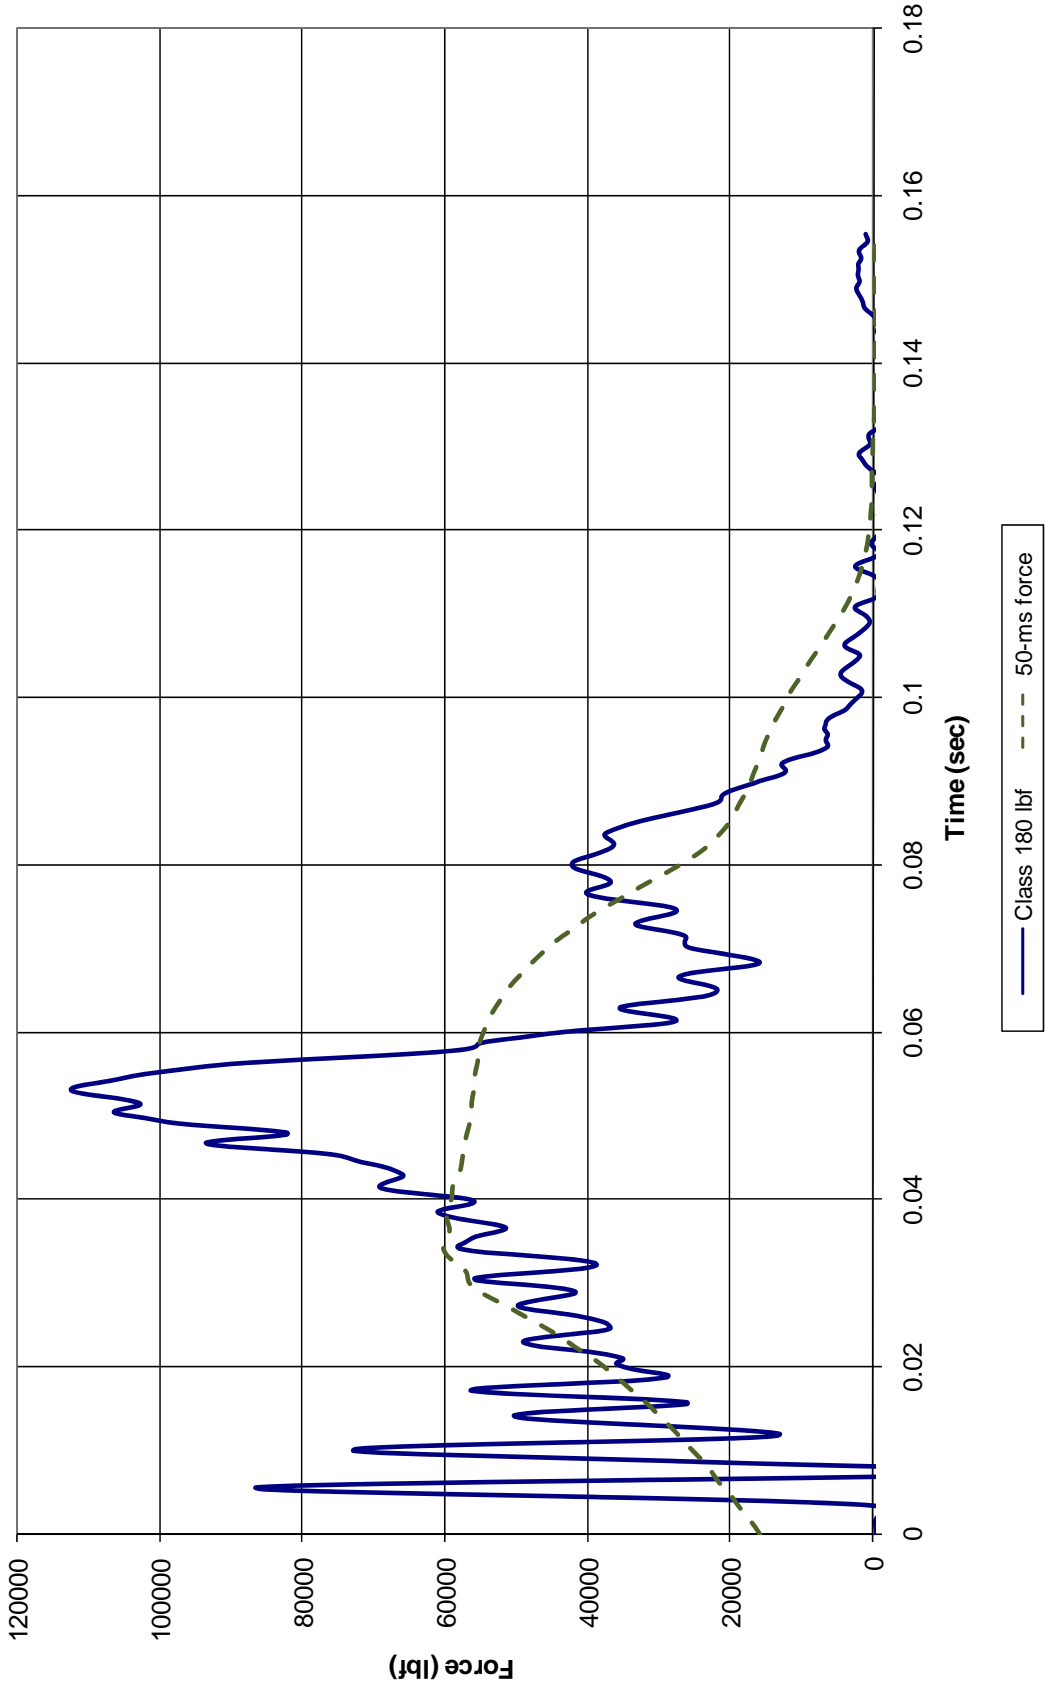
Figure 19. Force Trace for Test 452109-B2.

Data from the accelerometer, located at the bogie center of gravity, were digitized and used to calculate a force-time history, which is shown in [Figure 19](#). The maximum 50-ms average impact force was 60,257 lb, which exceeds the design impact force of 54,000 lb for a TL-3 impact.

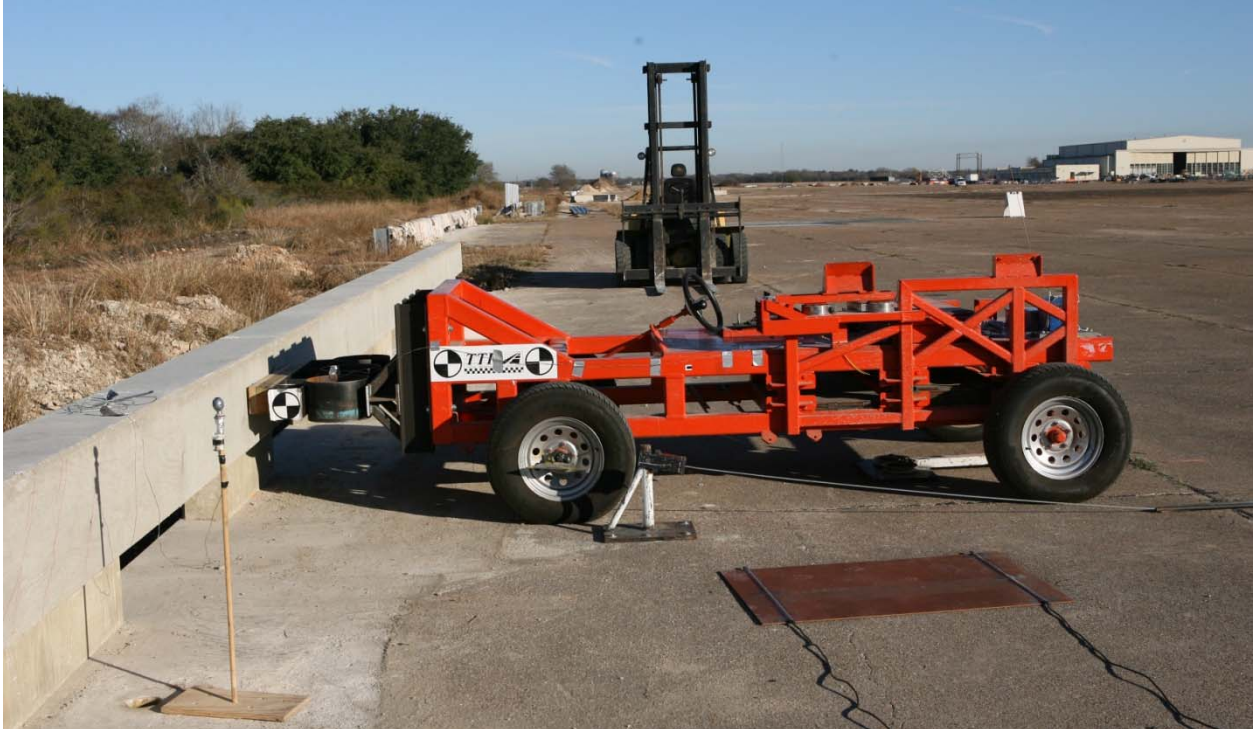
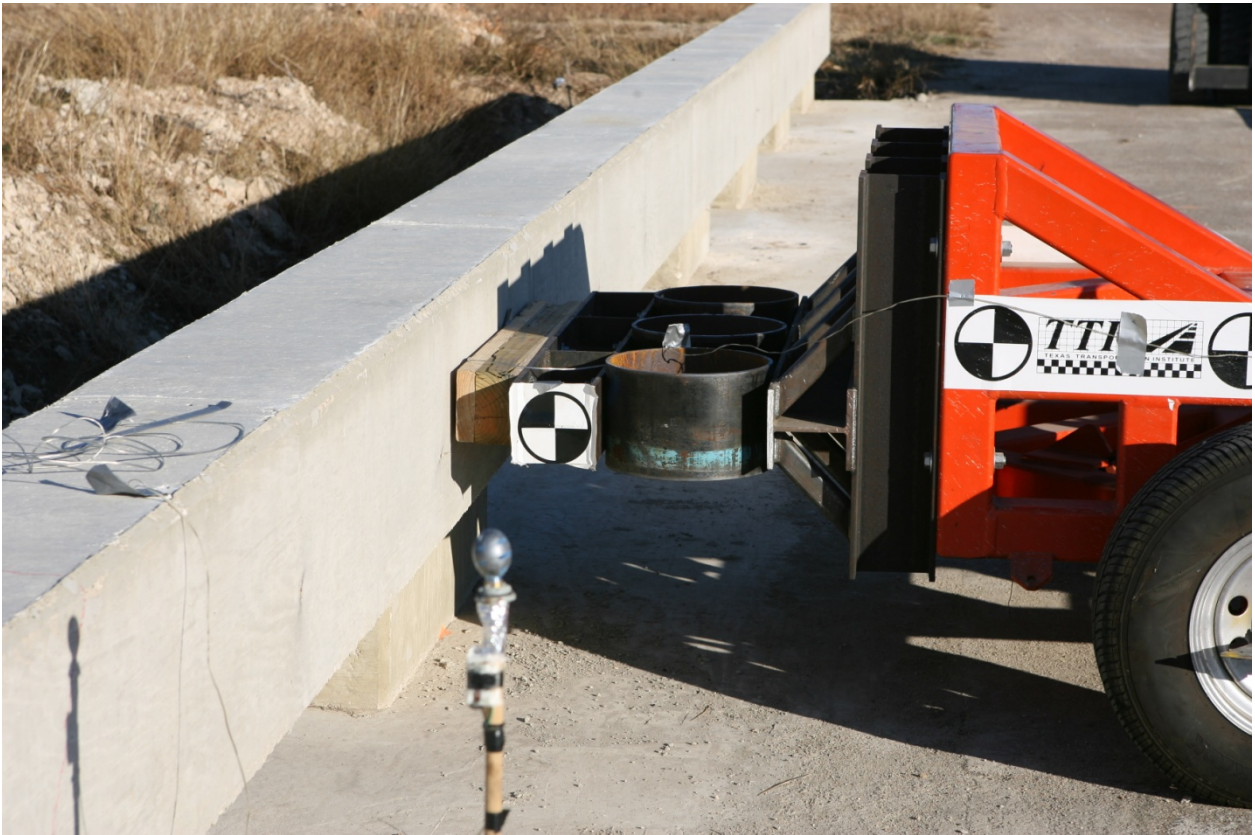
Figure 20. Bogie/Installation Geometrics for Test 452109-B3.

The bogie vehicle, traveling at an impact speed of 20.1 mi/h, impacted post 3 of the T223 Bridge Rail at 90 degrees. [Figure 20](#) depicts the orientation of the bogie with the bridge rail at impact. At approximately 0.041 s, the pipe sections began to deform. At 0.080 s, the bogie began to rebound. The bogie lost contact with the bridge rail at 0.104 s, traveling at an exit speed of -2.7 mi/h. [Figure B3](#) in [Appendix B](#) show sequential photographs of the test.

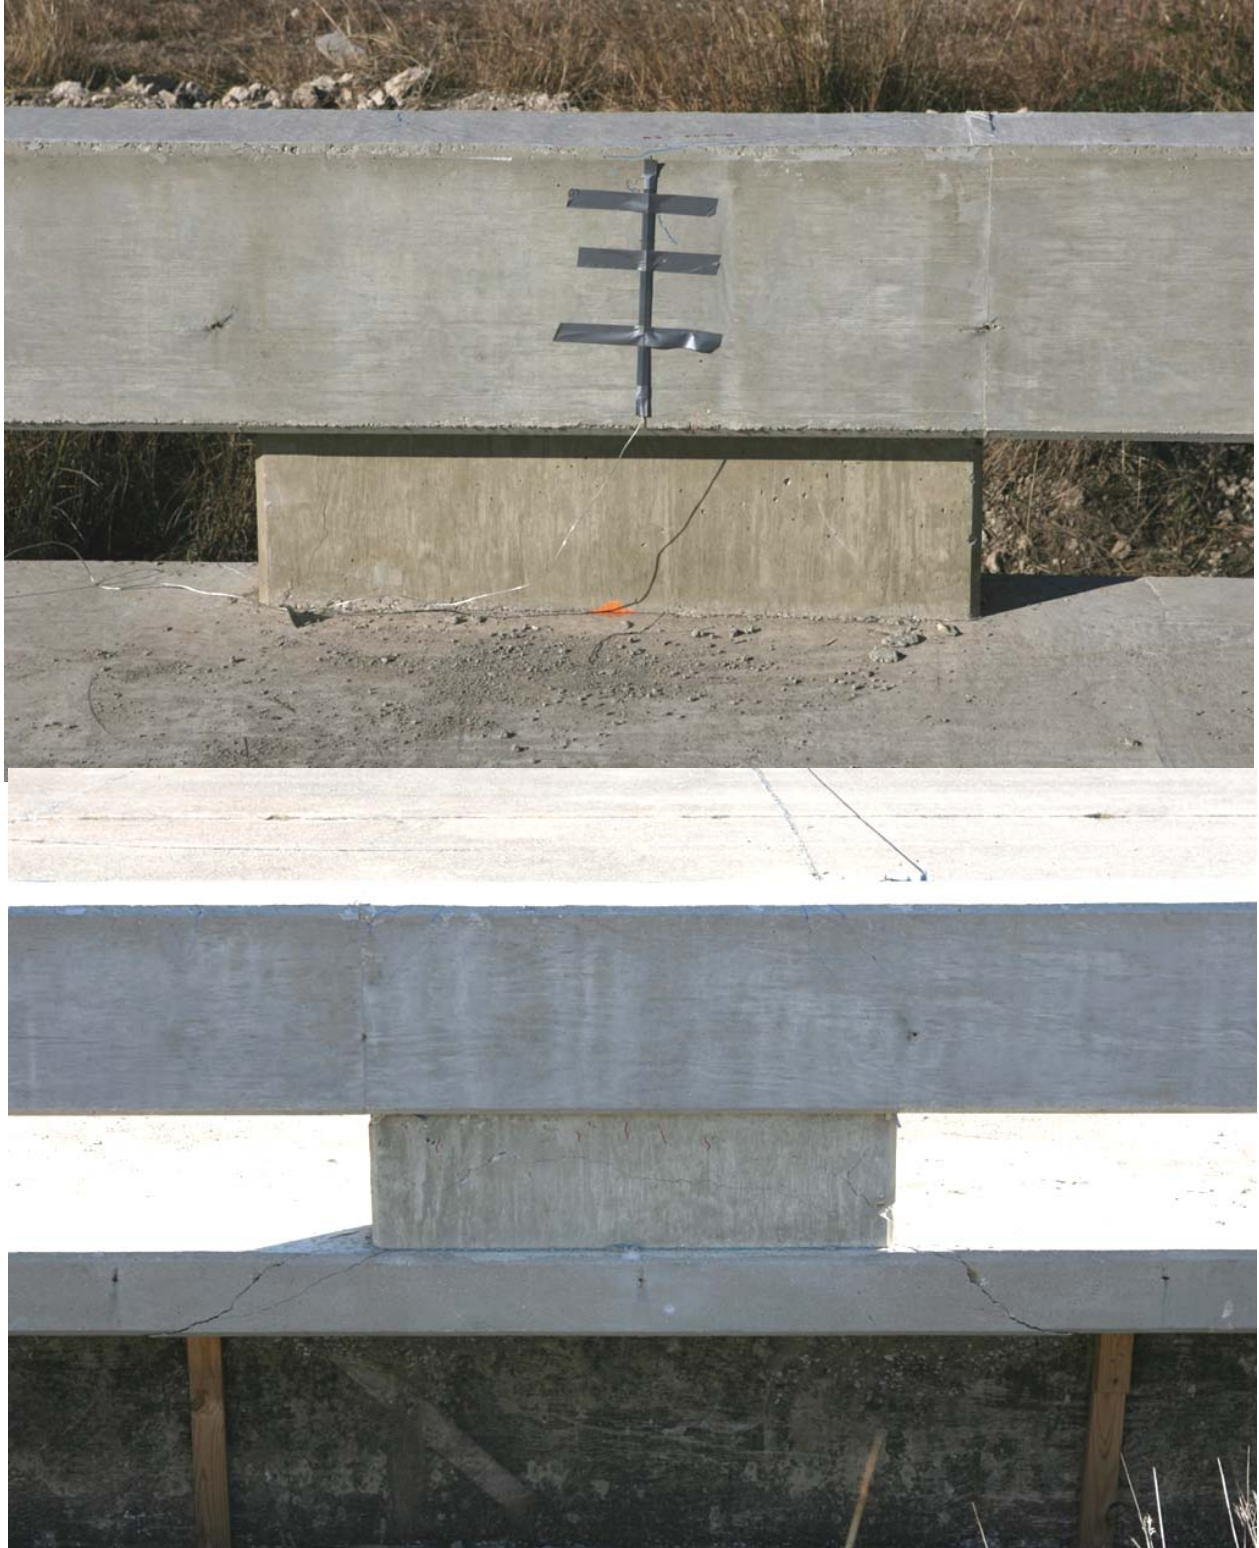
Figure 21. Installation after Test 452109-B3.

[Figure 21](#) shows the damage to the bridge rail. Several cracks were evident in the beam and the rear of the post. Two cracks in the bridge deck on each side of post 3 radiated out toward the field side of the deck. These then radiated down and outward along the edge of the deck. The bridge rail had no measureable deflection during the impact.

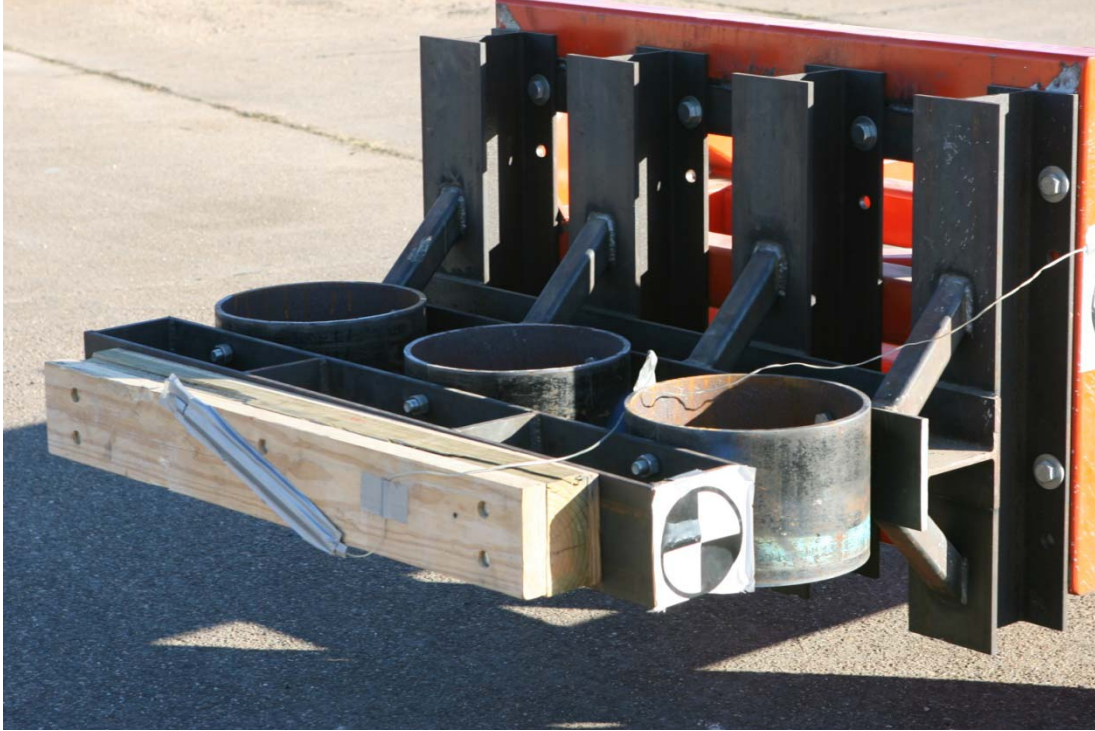
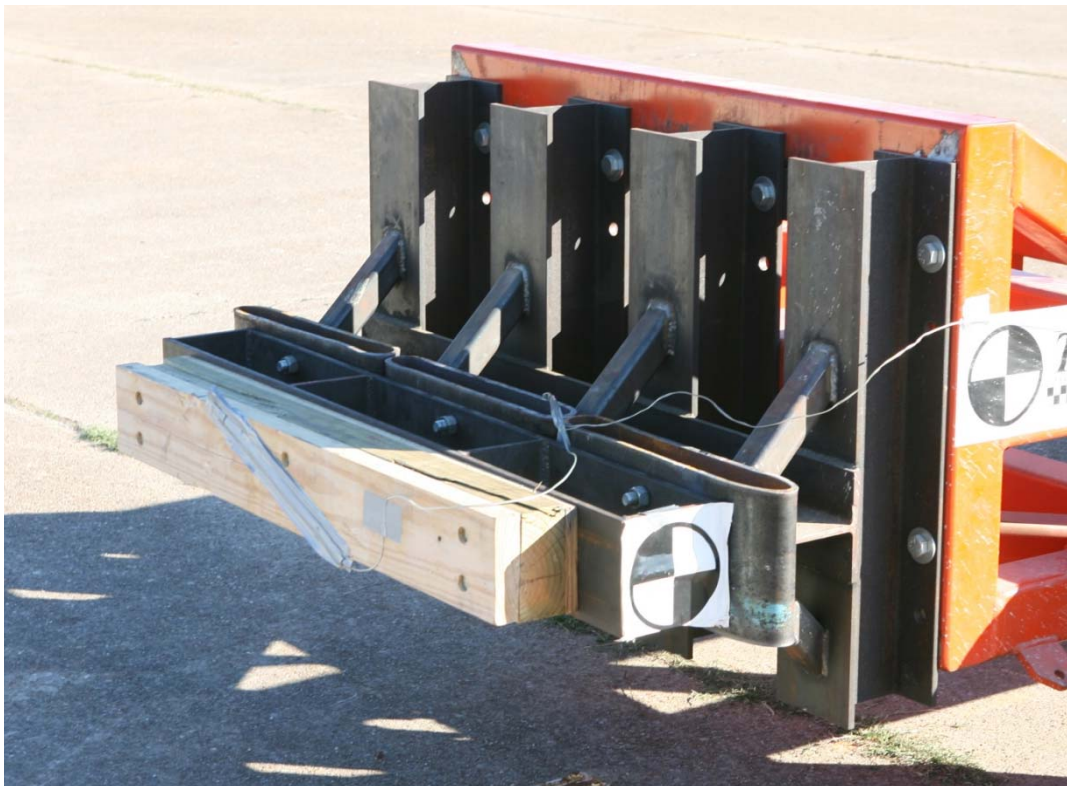
Figure 22. Bogie before and after Test 452109-B3.

Maximum crush of the pipe nose was 10.5 inches. [Figure 22](#) shows the bogie nose before and after the test.

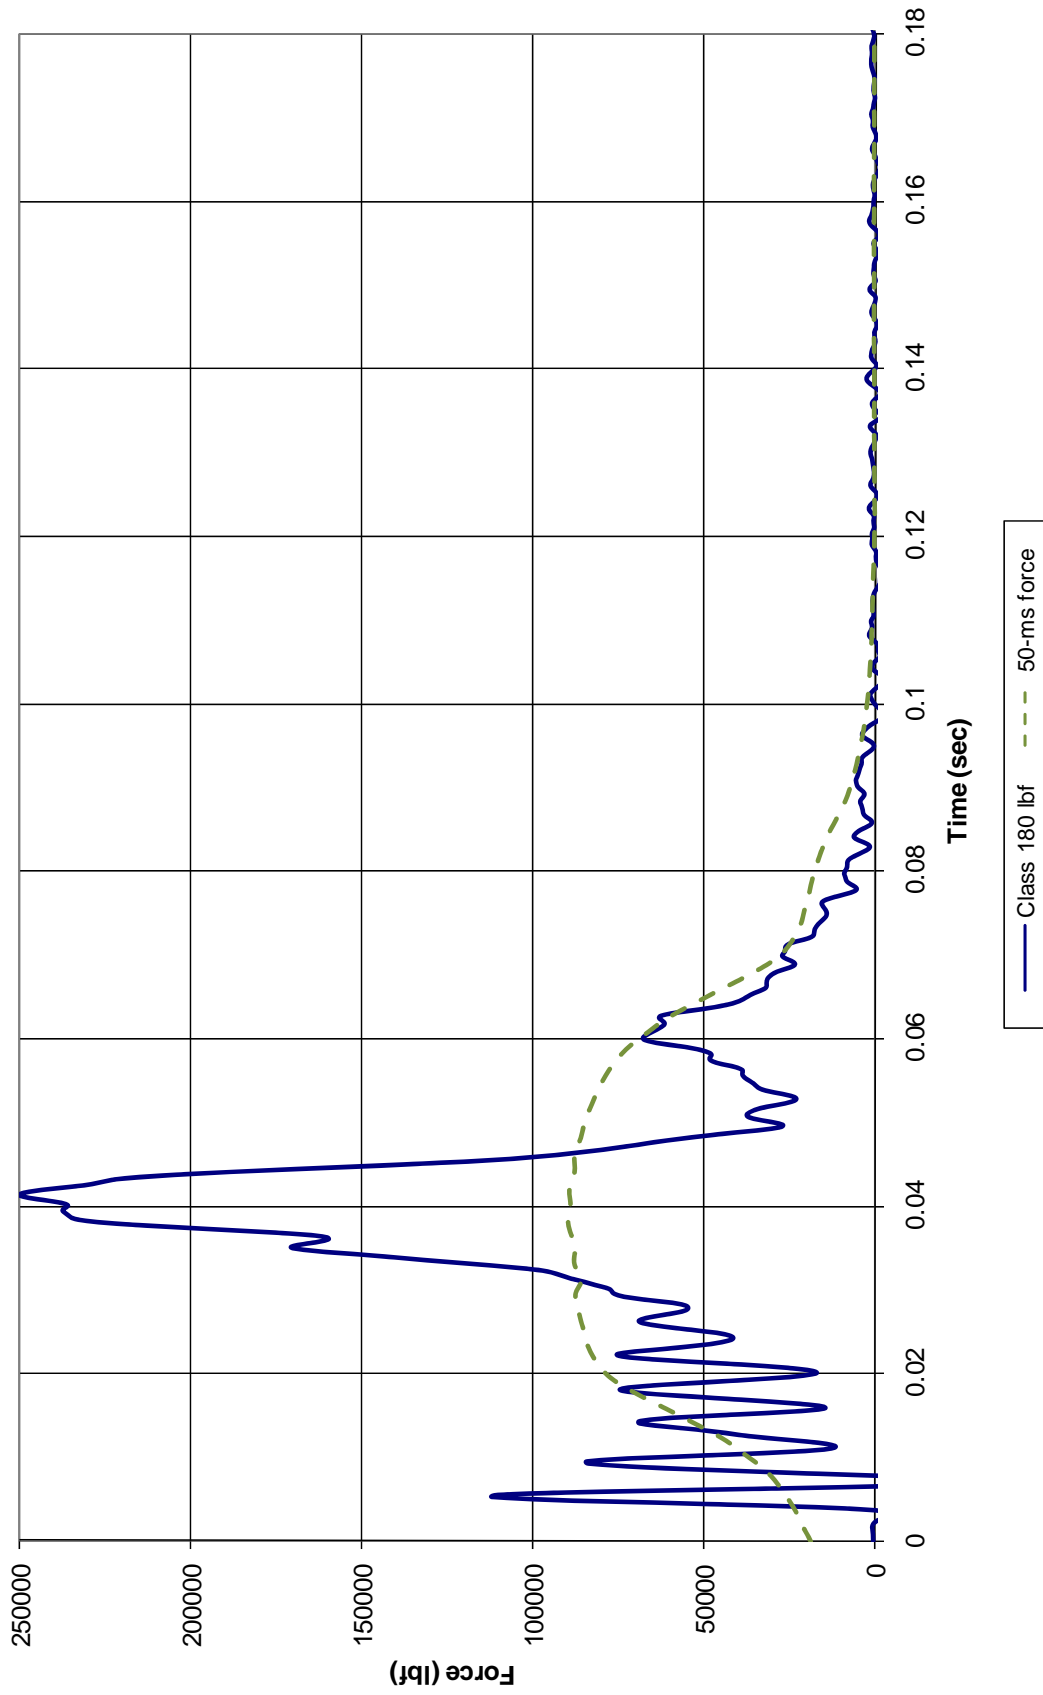
Figure 23. Force Trace for Test 452109-B3.

Data from the accelerometer, located at the bogie center of gravity, were digitized and used to calculate a force-time history, which is shown in [Figure 23](#). The maximum 50-ms average impact force was 89,676 lb, which exceeds the design impact force of 54,000 lb for a TL-3 impact by 66 percent.

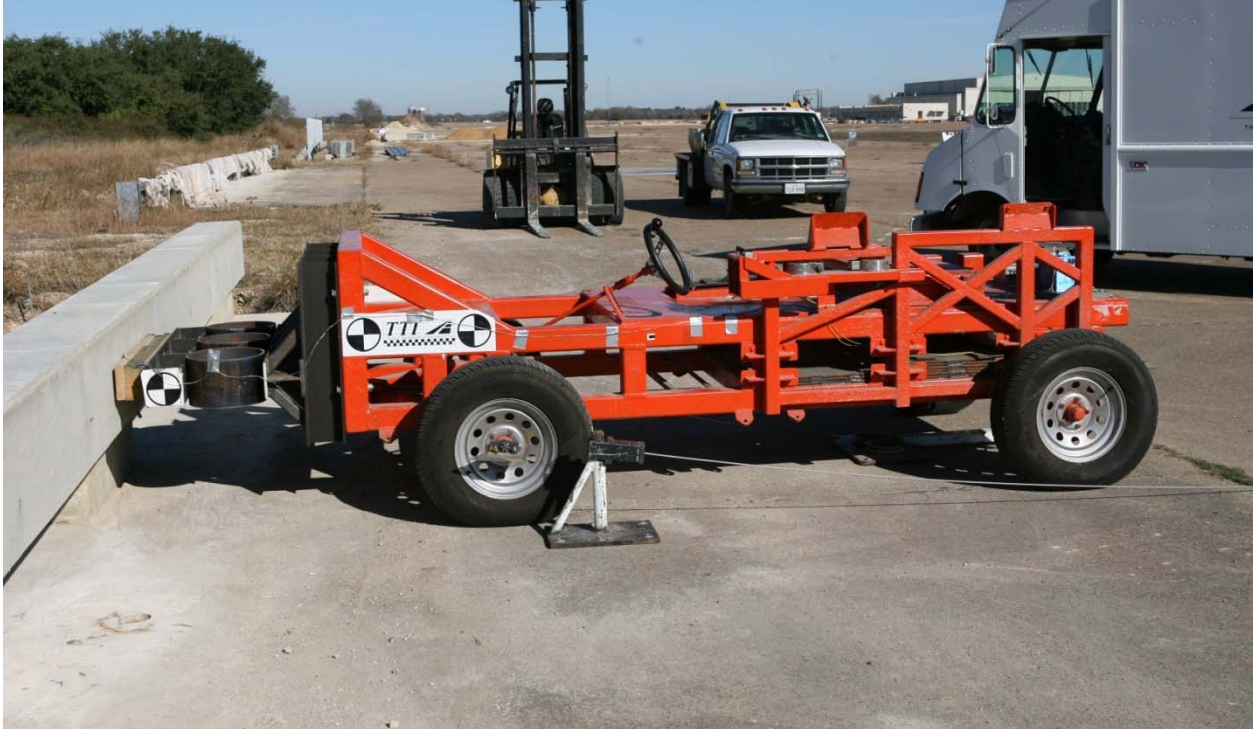
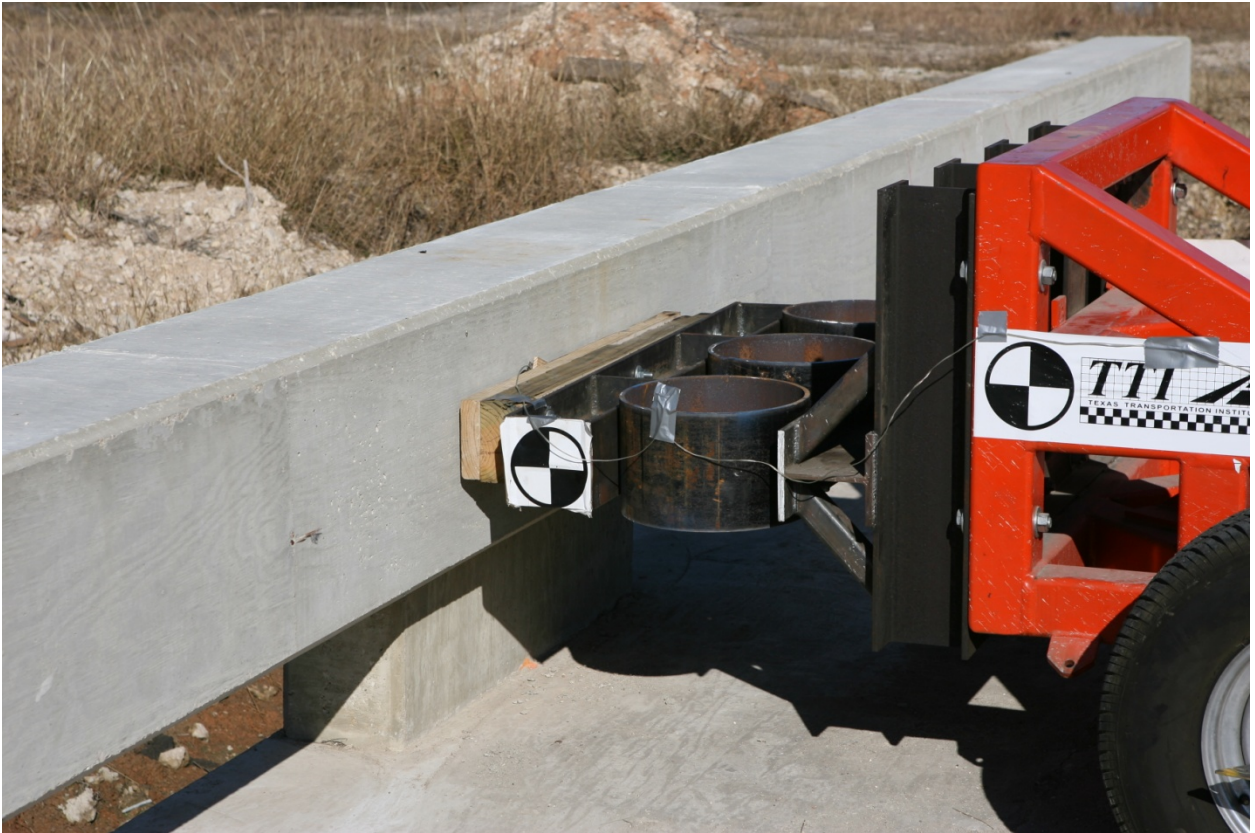
Figure 24. Bogie/Installation Geometrics for Test 452109-B4.

The bogie vehicle, traveling at an impact speed of 20.6 mi/h, impacted post 6 of the T223 Bridge Rail at 90 degrees. [Figure 24](#) depicts the orientation of the bogie with the bridge rail at impact. At approximately 0.044 s, the pipe sections began to deform. At 0.068 s, the bogie began to rebound. The bogie lost contact with the bridge rail at 0.121 s, traveling at an exit speed of -2.9 mi/h. [Figure B4](#) in [Appendix B](#) shows sequential photographs of the test.

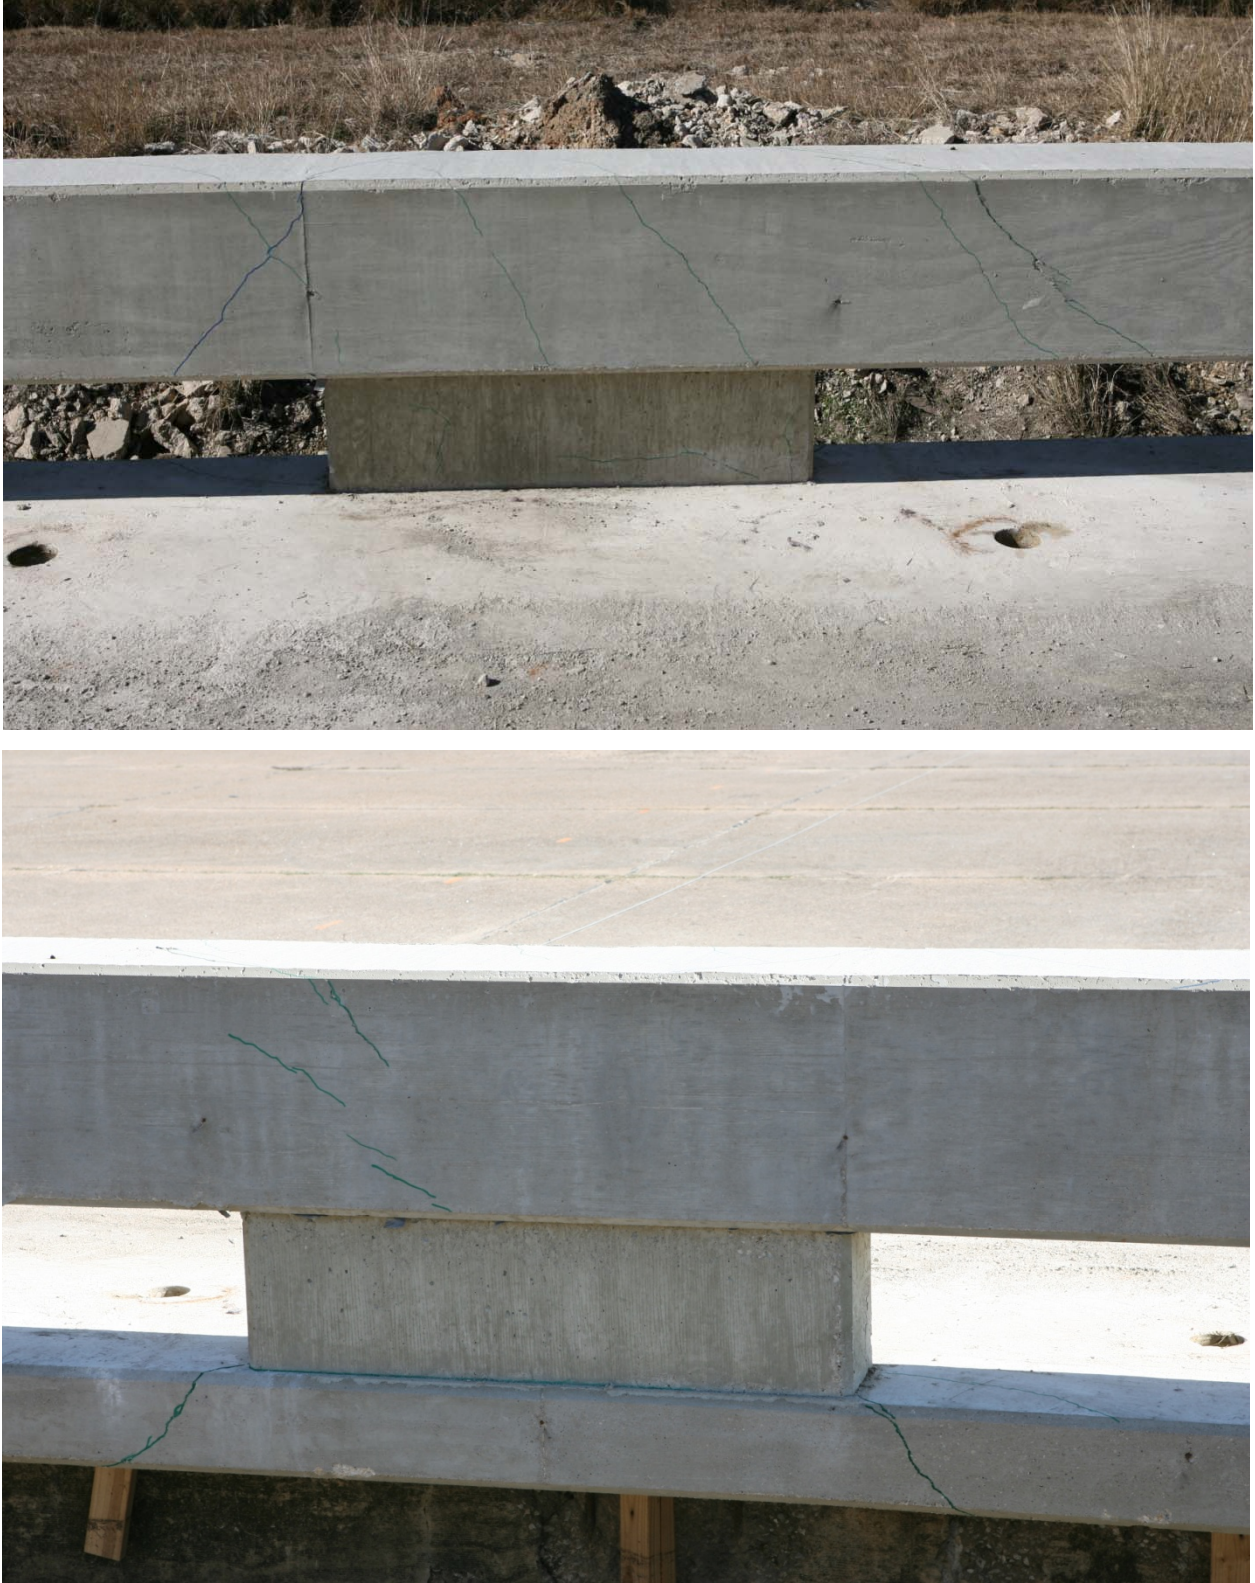
Figure 25. Installation after Test 452109-B4.

Damage to post 6 is shown in [Figure 25](#). The darker marks represent shrinkage cracks that were present before the test. The lighter marks represent the cracks sustained by impact with the bogie. Three cracks were noted in the traffic face of the beam and one in the traffic face of the post near the deck. Scattered cracks were observed on the top and field side of the beam. Two cracks in the deck radiated out from the left side of the post, one from the traffic face that radiated just to the edge of the deck, and the second from the field side corner of the post down the field side of the deck. One crack radiated from the right side of the post from the field side corner directly to the edge of the deck and down the field side of the deck. Maximum deflection of the bridge rail during the test was 0.99 inch.

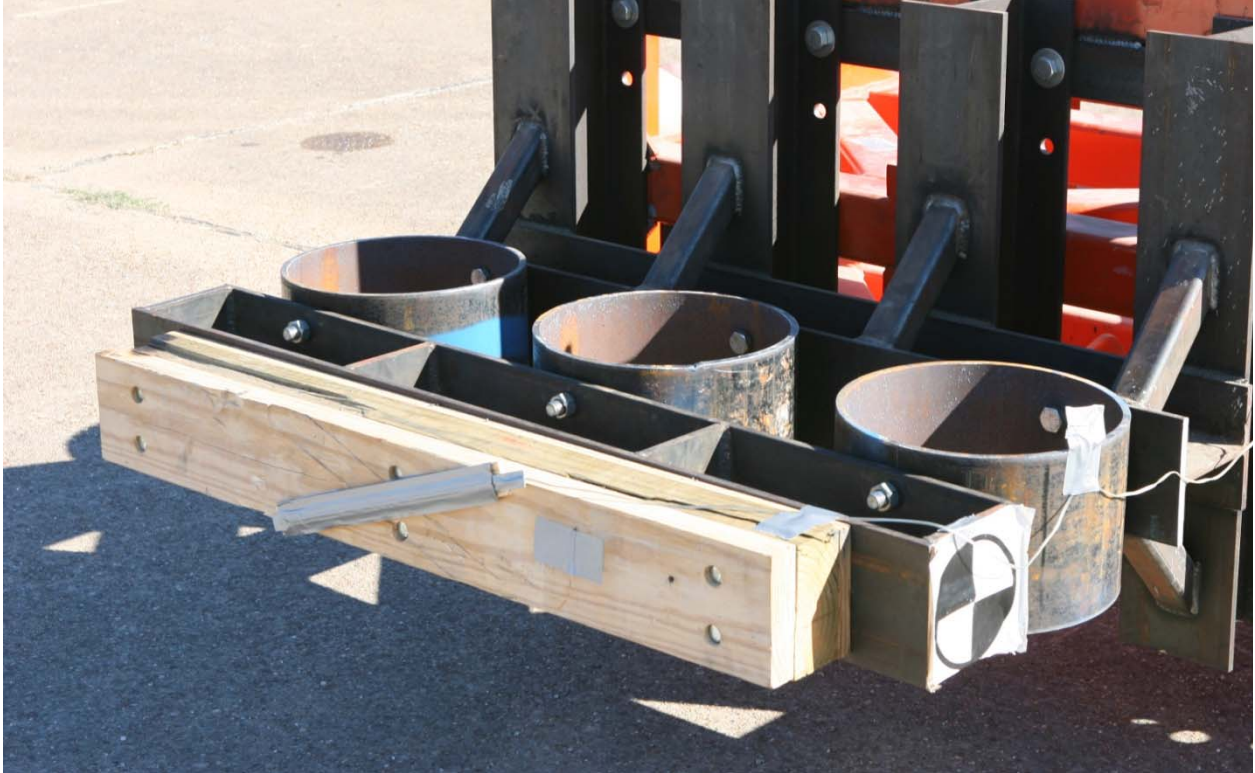
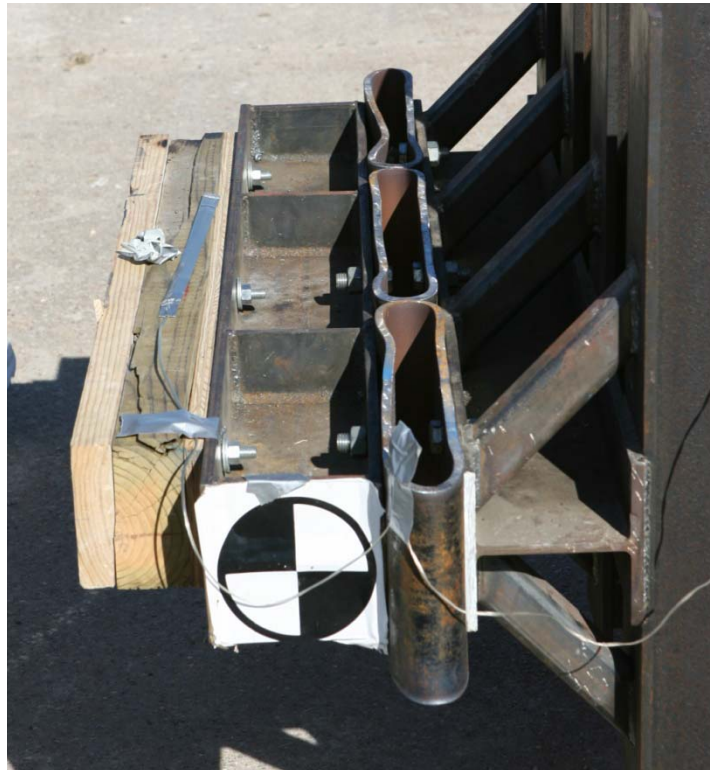
Figure 26. Bogie before and after Test 452109-B4.

Maximum crush of the pipe nose was 10.8 inches. Photographs of the bogie nose before and after the test are shown in [Figure 26](#).

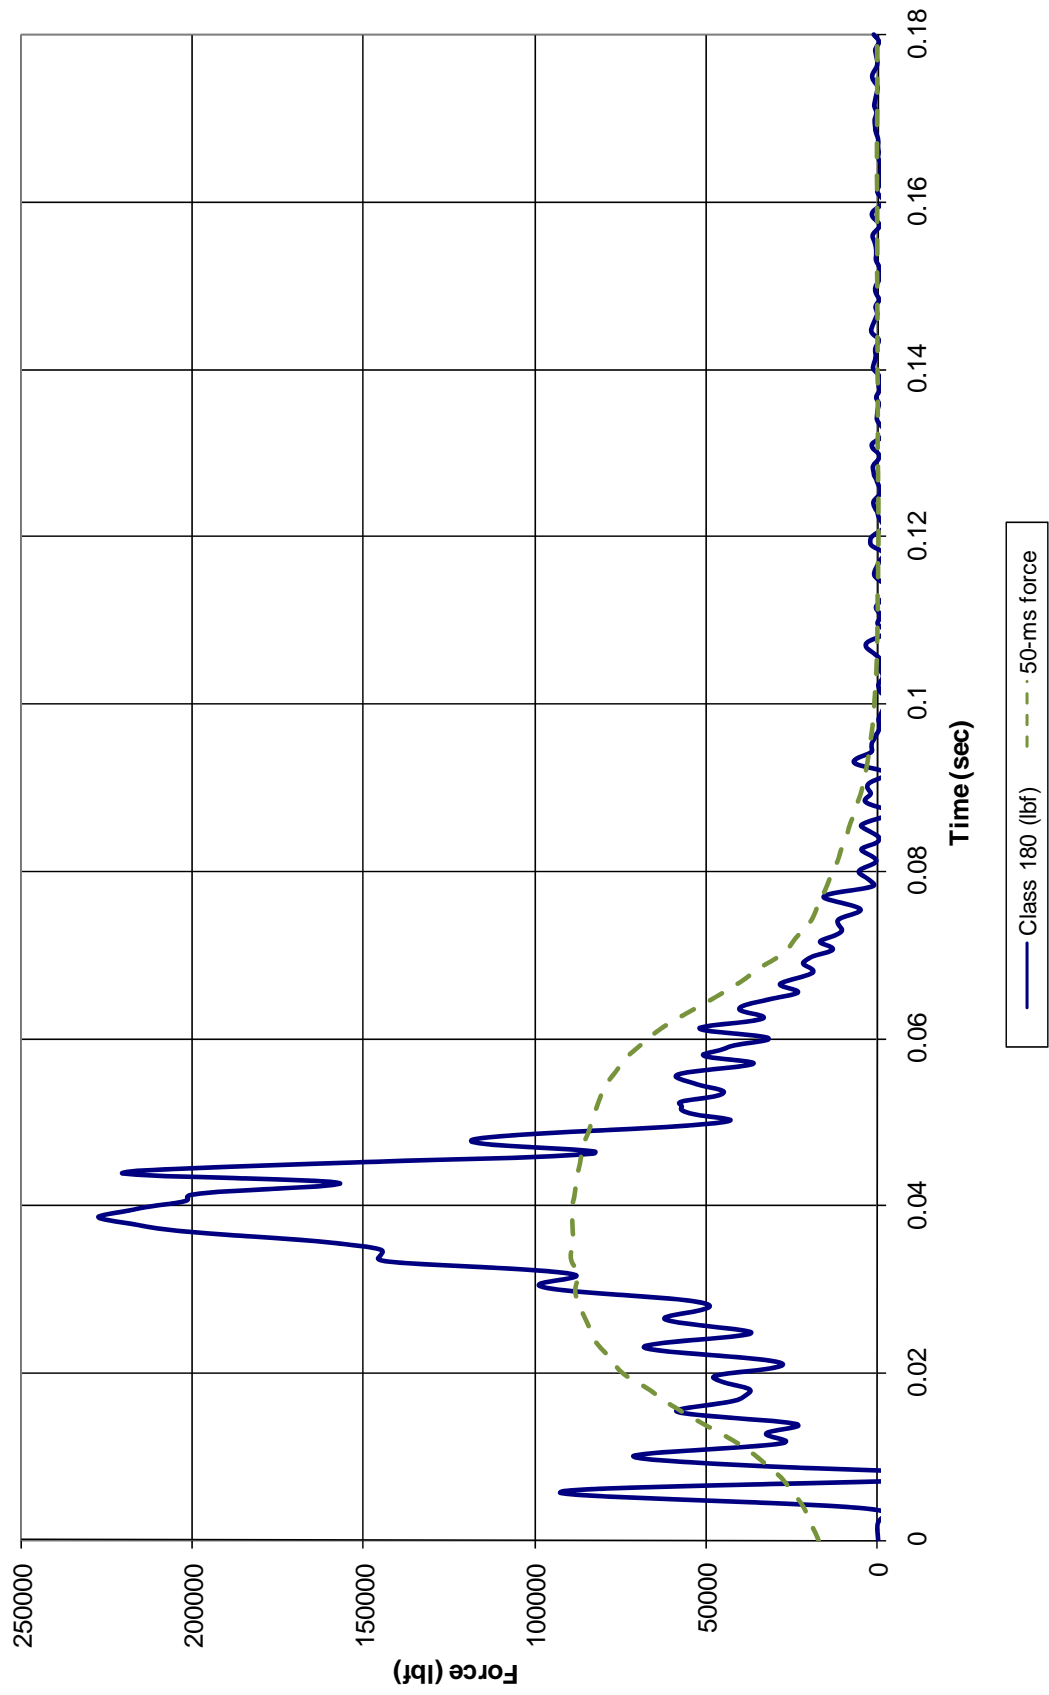
Figure 27. Force Trace for Test 452109-B4.

Data from the accelerometer, located at the bogie center of gravity, were digitized and used to calculate a force-time history, which is shown in [Figure 27](#). The maximum 50-ms average impact force was 89,590 lb, which exceeds the design impact force of 54,000 lb for a TL-3 impact by 66 percent.

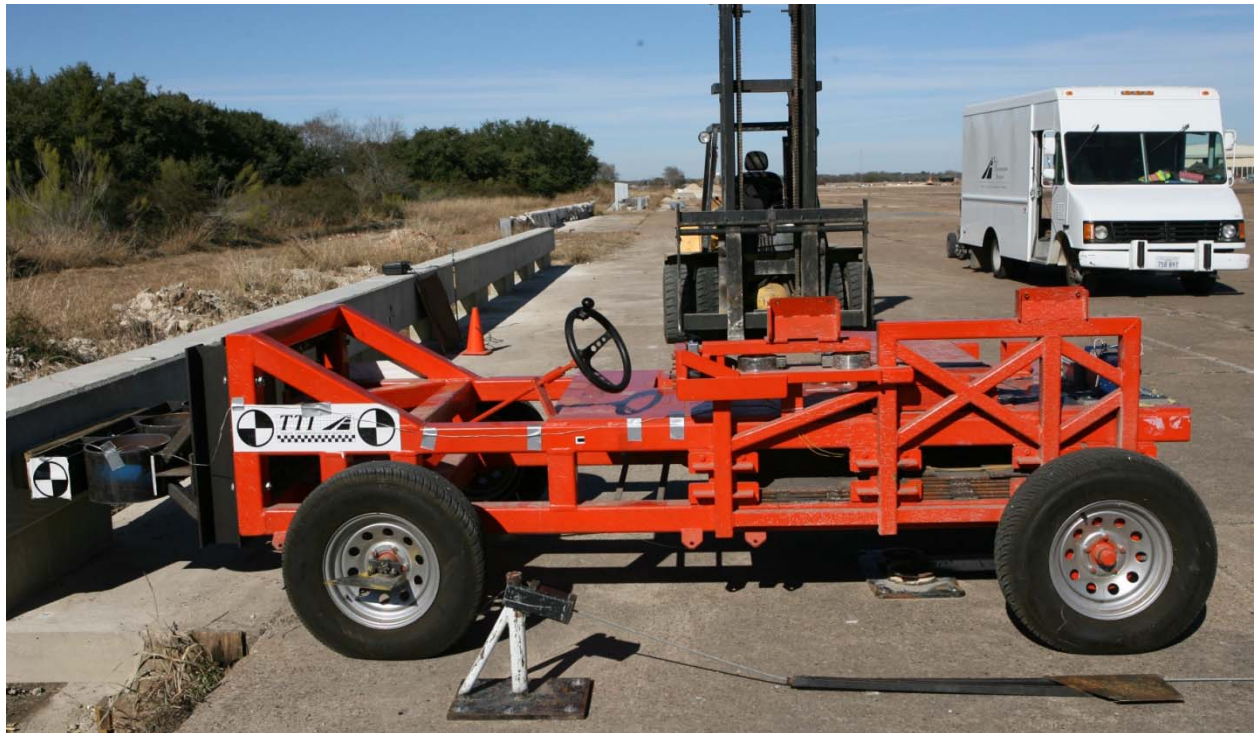
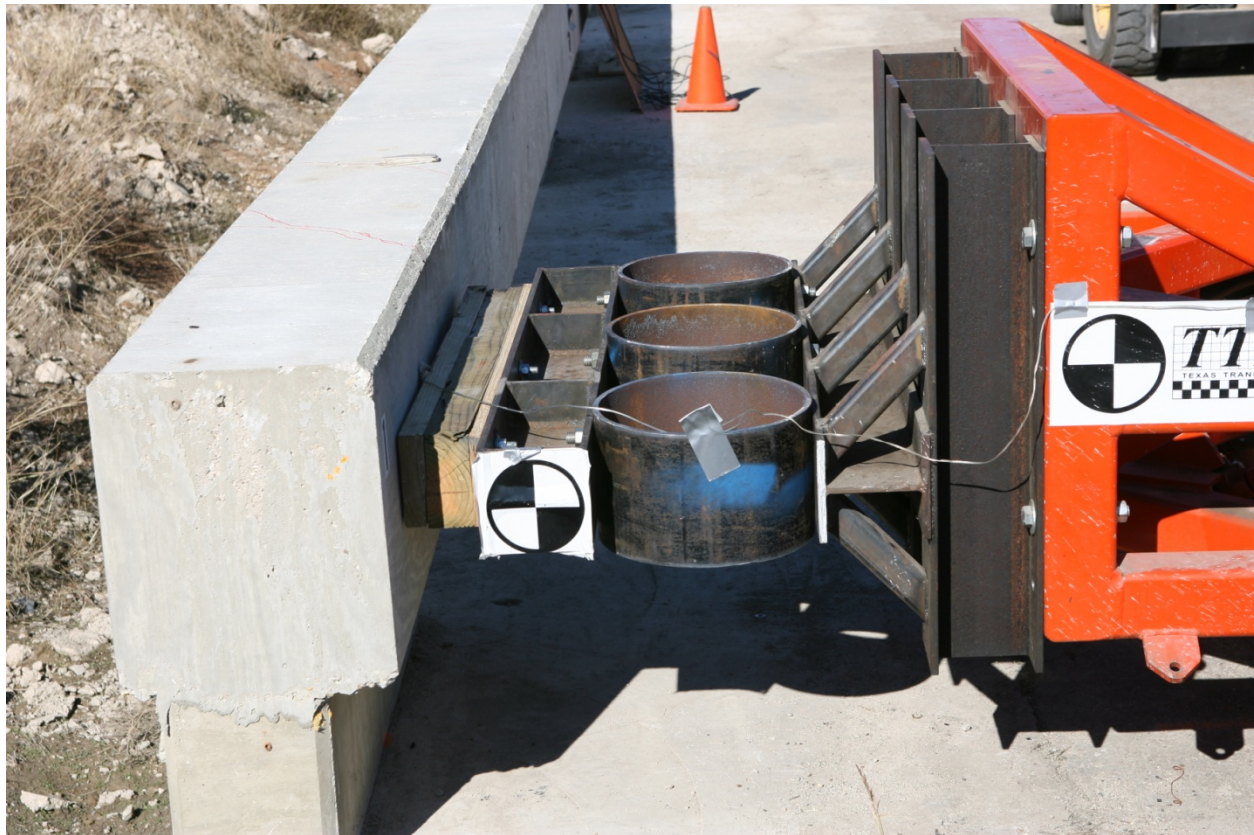
Figure 28. Bogie/Installation Geometrics for Test 452109-B5.

This test was a repeat of the first test on post 1. [Figure 28](#) depicts the orientation of the bogie with the bridge rail at impact. The bogie vehicle, traveling at an impact speed of 15.8 mi/h, impacted post 1 of the T223 Bridge Rail at 90 degrees. At approximately 0.058 s, the pipe sections began to deform. At 0.070 s, the bogie began to rebound. The bogie lost contact with the bridge rail at 0.138 s, traveling at an exit speed of 3.5 mi/h. [Figure B5](#) in [Appendix B](#) shows sequential photographs of the test period.

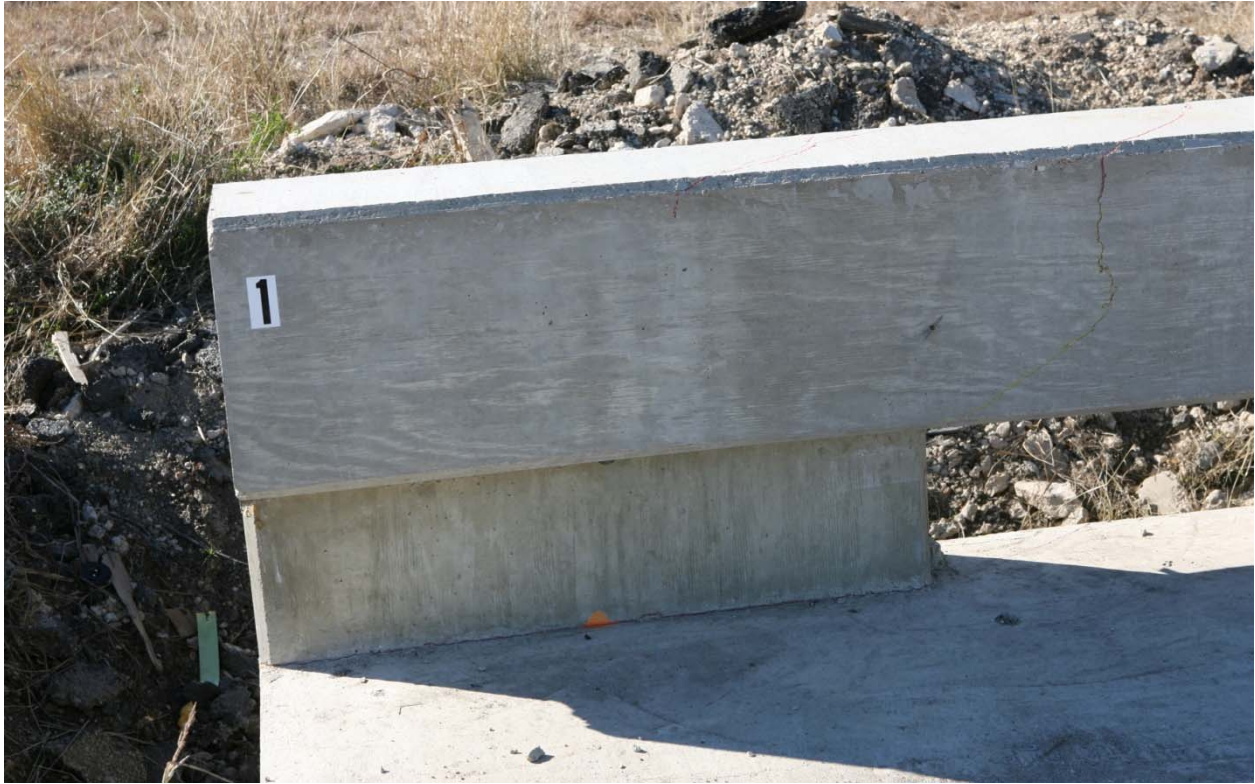
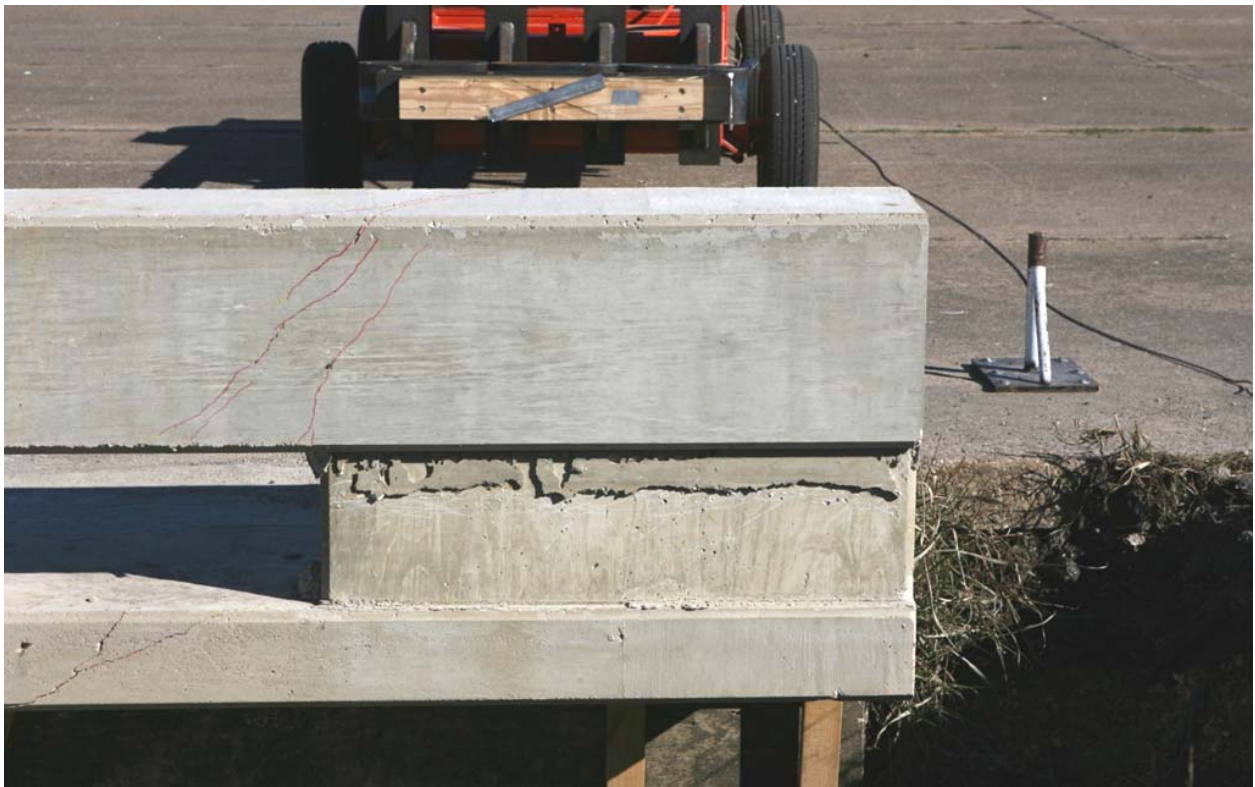
Figure 29. Installation after Test 452109-B5.

[Figure 29](#) shows the damage to post 1. The darker marks represent cracks from impact in test B1, and the lighter marks represent the cracks sustained in test B5. The cracks marked in red increased in width on average of 1/16-inch from the previous test. The cracks in the beam from test B1 also extended further out with this impact. Maximum deflection of the bridge rail during the test was 2.14 inches.

A second dynamic bogie test was performed at Post No. 1 to evaluate its reserve capacity after a severe impact. Some cracking was present in the bridge rail, post, and deck from the previous test performed at this location, and after the second impact, the cracks increased in width by 1/16-inch and also extended further out. The peak 50-ms average impact force from the second test at this location (Post No. 1) was 55.4 kips.

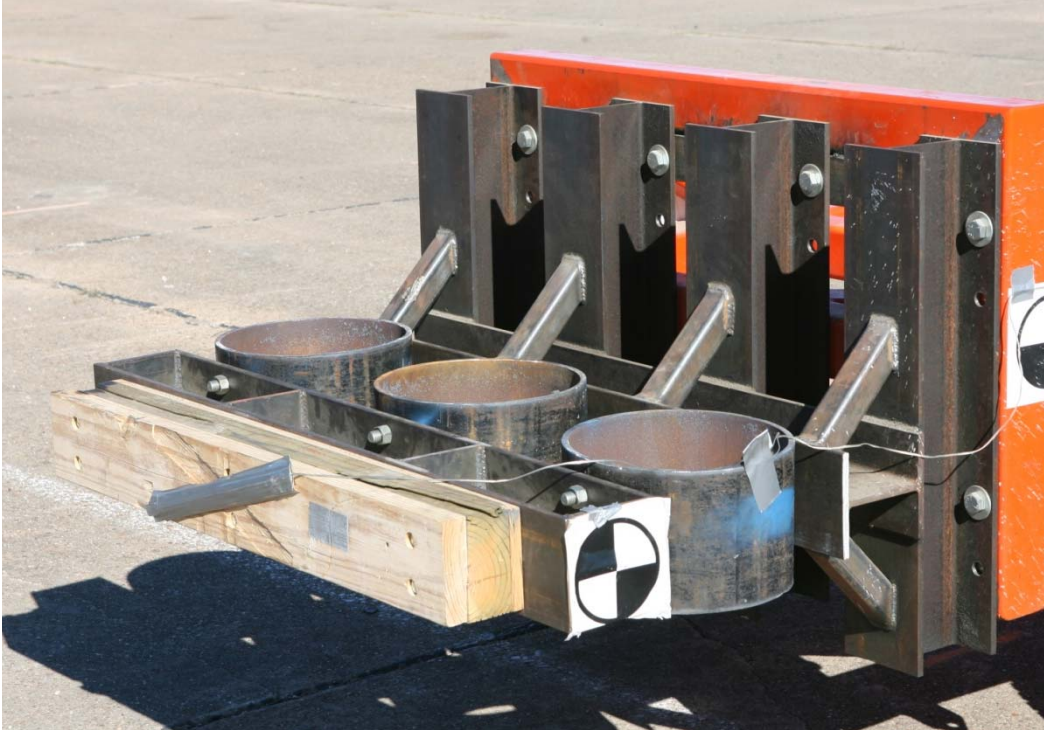
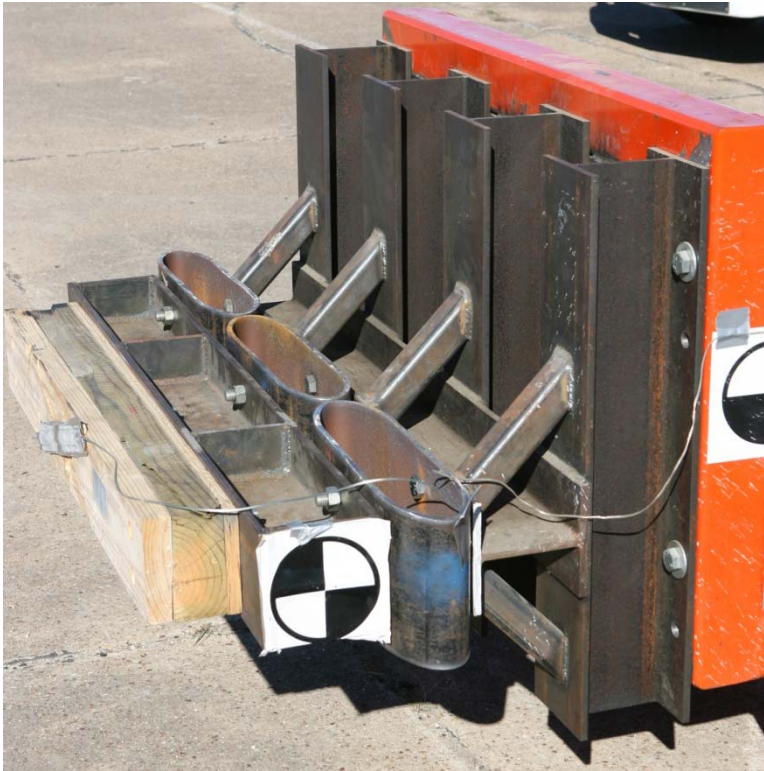
Figure 30. Bogie before and after Test 452109-B5.

Maximum crush of the pipe nose was 8.7 inches. Before and after photographs of the nose are shown in [Figure 30](#).
