Dynamic Testing of the T223 Bridge Rail

Technical Report 0-5210-8

1. Report No. FHWA/TX-09/0-5210-8		2. Government Accession No.		3. Recipient's Catalog No.	
4. Title and Subtitle DYNAMIC TESTING OF THE T223 BRIDGE RAIL				5. Report Date April 2009 Published September 2009

Project Title: Roadside Crash Testing Program
for Design Guidance and Standard Detail Development

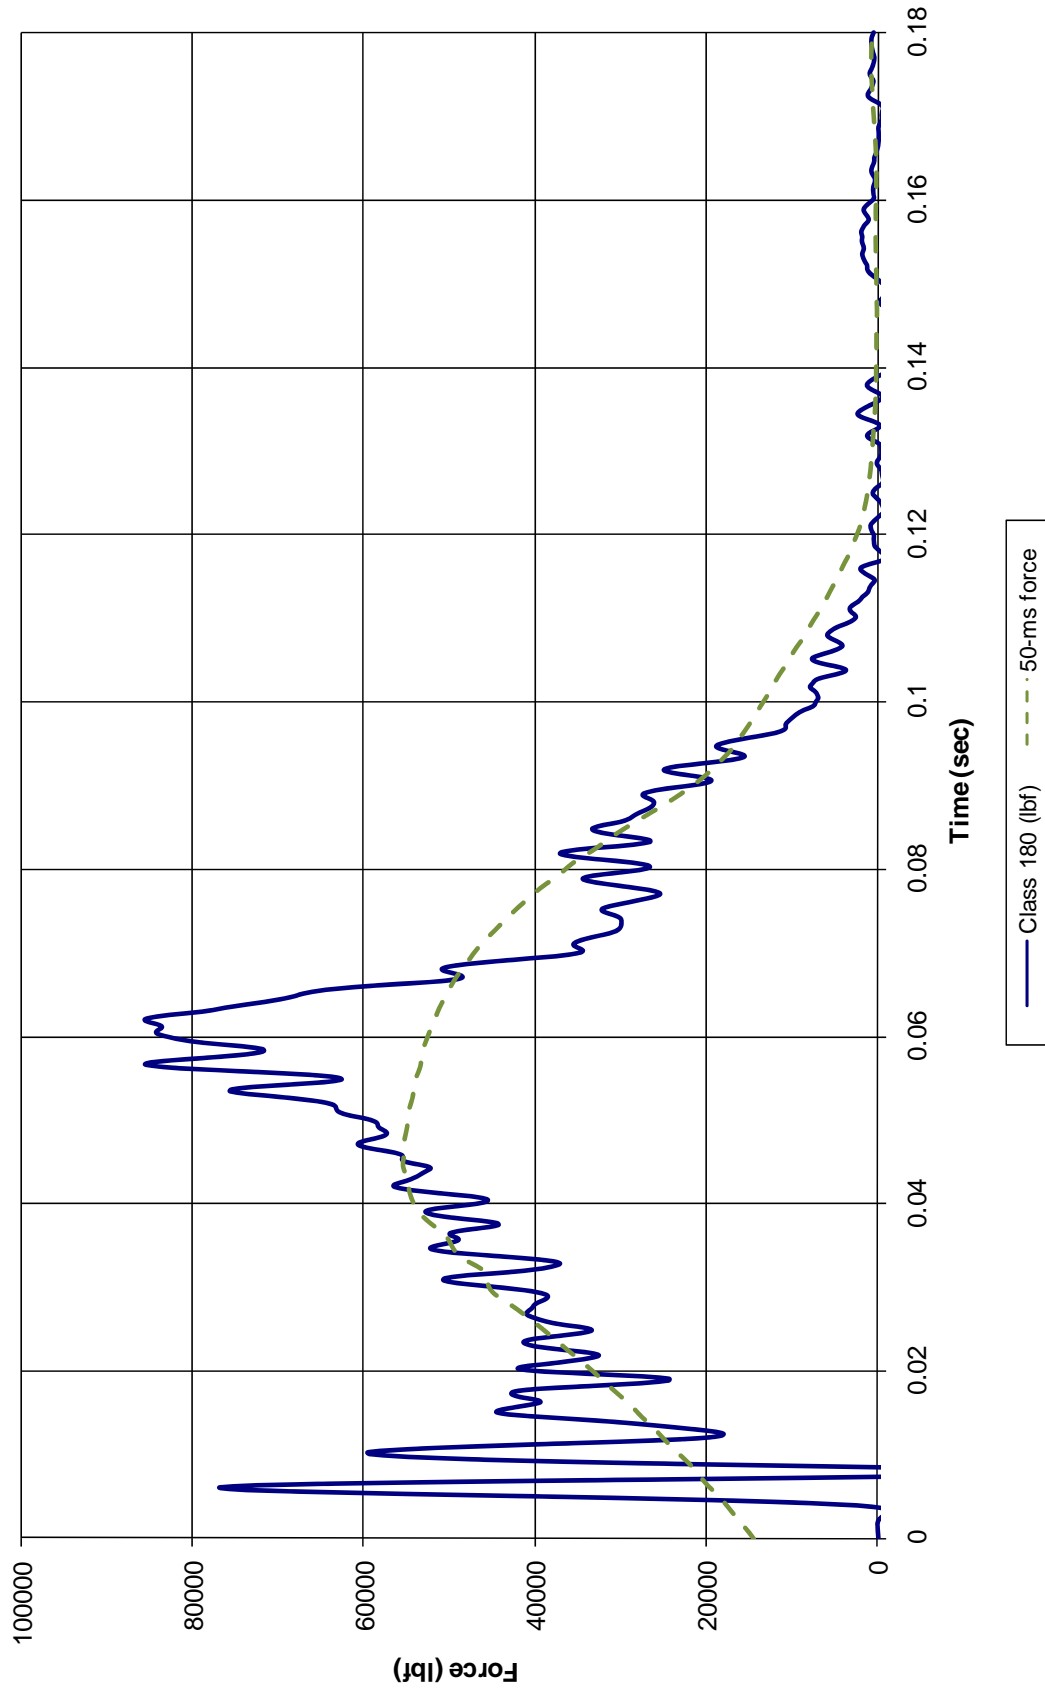
Figure 31. Force Trace for Test 452109-B5.

Data from the accelerometer, located at the bogie center of gravity, were digitized and used to calculate a force-time history, which is shown in [Figure 31](#). The maximum 50-ms average impact force was 55,442 lb, which exceeds the design impact force of 54,000 lb for a TL-3 impact. The end post had sufficient reserve capacity after test B1 to sustain a second design impact event with only moderate damage to the deck and rail.
