## U15: Tripped Rollover (Phase A)

Douglas B. Pape, Jason T. Holdridge, J. Caleb Chitwood, and Alex W. Stilwell, Battelle

August 2009

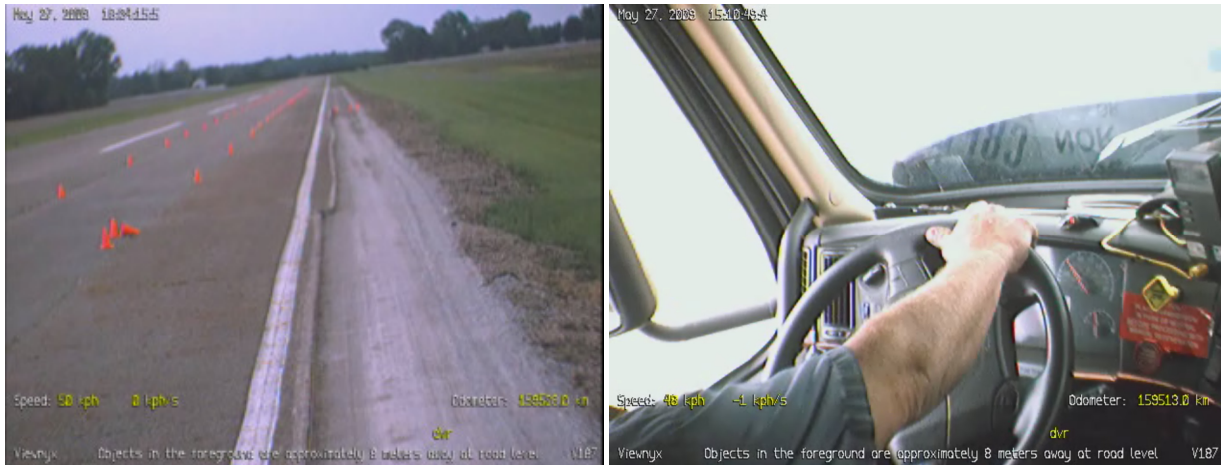
**Figure 2. Photograph. Videos of the forward view and of the test driver’s handwheel motion will be invaluable in communicating safe recovery techniques to drivers.**

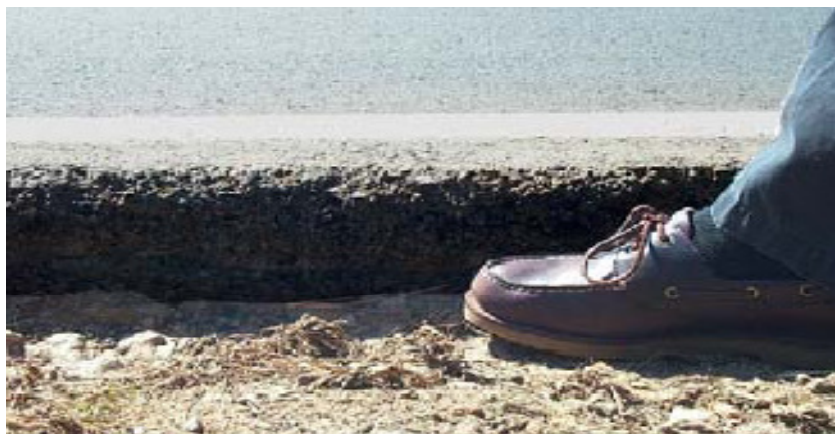
**Figure 4. Photograph. A vertical pavement edge with an unusually high drop-off.**

Tripped rollovers can occur during a recovery maneuver after a vehicle has driven off the road. A severe drop-off, such as that shown in Figure 4 may lead directly to the rollover. Research with light vehicles has documented several ways this can happen. If a heavy vehicle suddenly mounts the drop-off and is on the pavement with a high crab angle (where the vehicle is pointed across the pavement but it still traveling more or less along the pavement), it can roll over. Also, overcoming the edge drop-off in a recovery maneuver can add to the centrifugal force causing rollover if the driver attempts to maintain lane integrity.

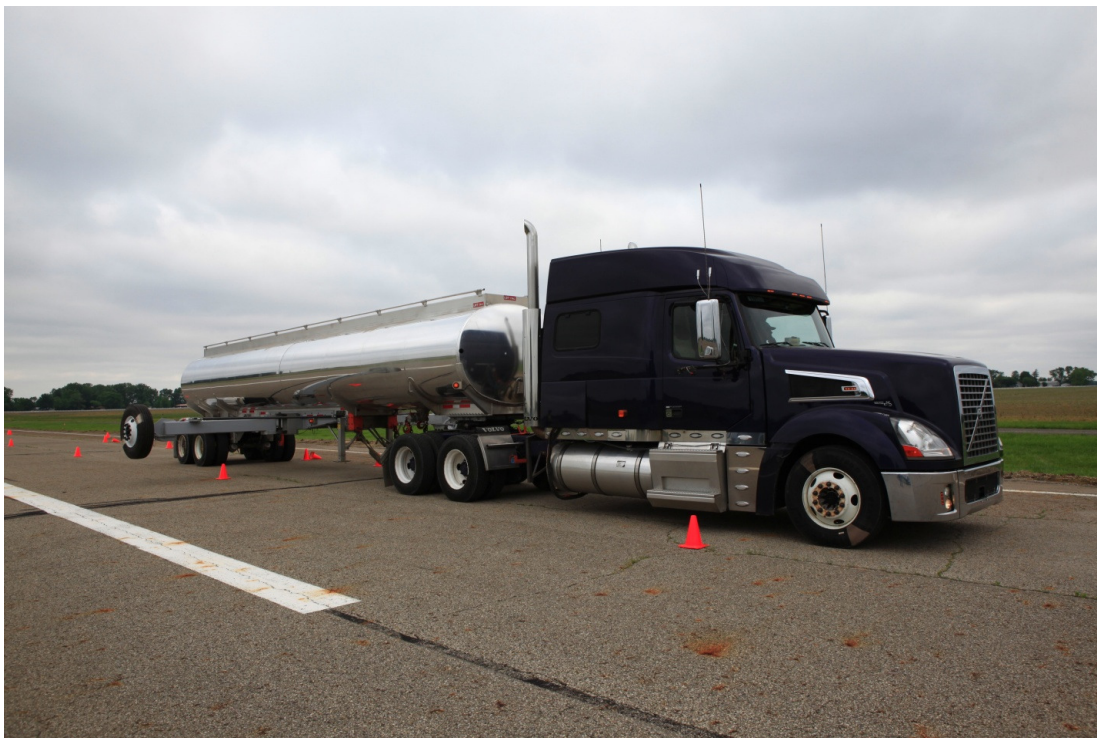
**Figure 5. Photograph. The test truck on the runway at the airport.**

A photograph of the test vehicle with its outriggers deployed is in Figure 5. The tractor was a 2007 model year Volvo VT830. Its overall wheelbase was 282 inches, and its tandem spacing was 53 inches. It had a leaf spring suspension in the front and air bags on the drive axles. Its weight was approximately 16,500 lb. It has been used extensively by Volvo for corporate testing, and it is the same tractor used in Phases A and B of NTRCI's Heavy Truck Rollover Characterization program. [NTRCI, 2009a and NTRCI, 2009b].

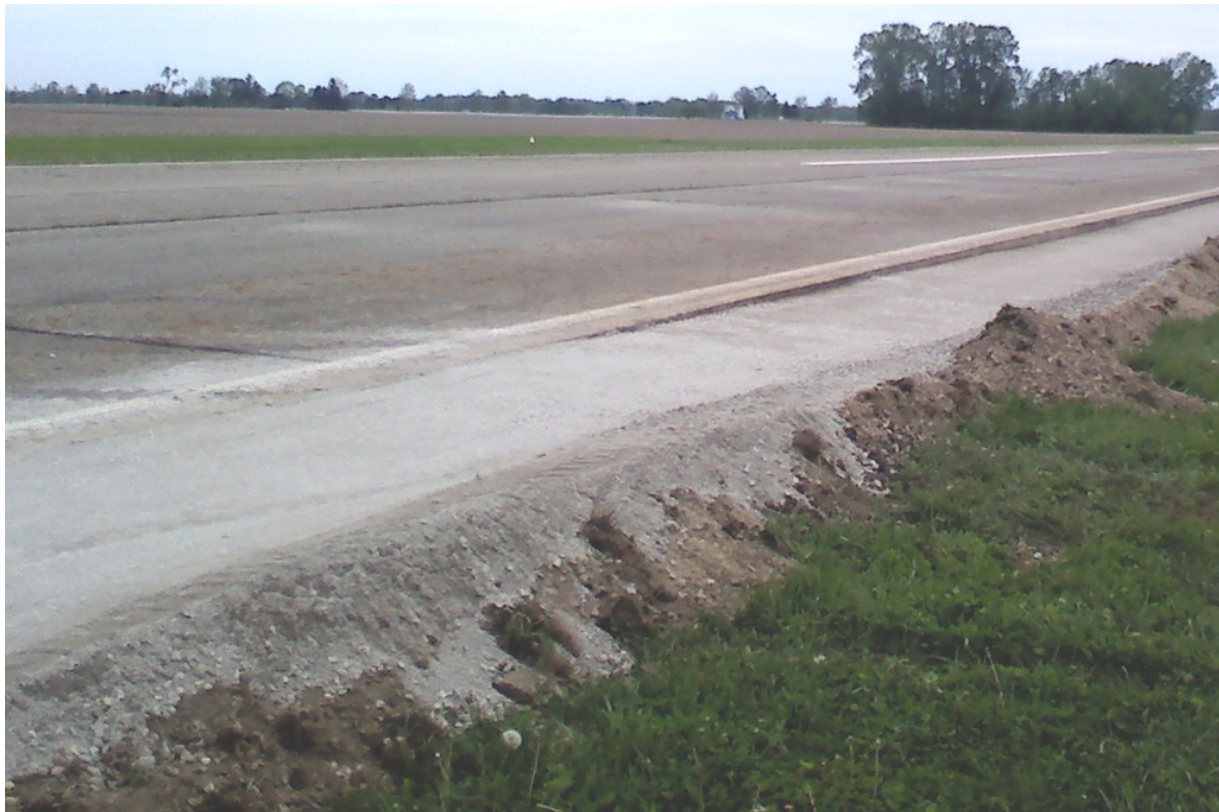
**Figure 6. Photograph. The beginning of the gravel shoulder was flush with the runway, as is visible at the left. A ramp leads to the four-inch vertical edge.**

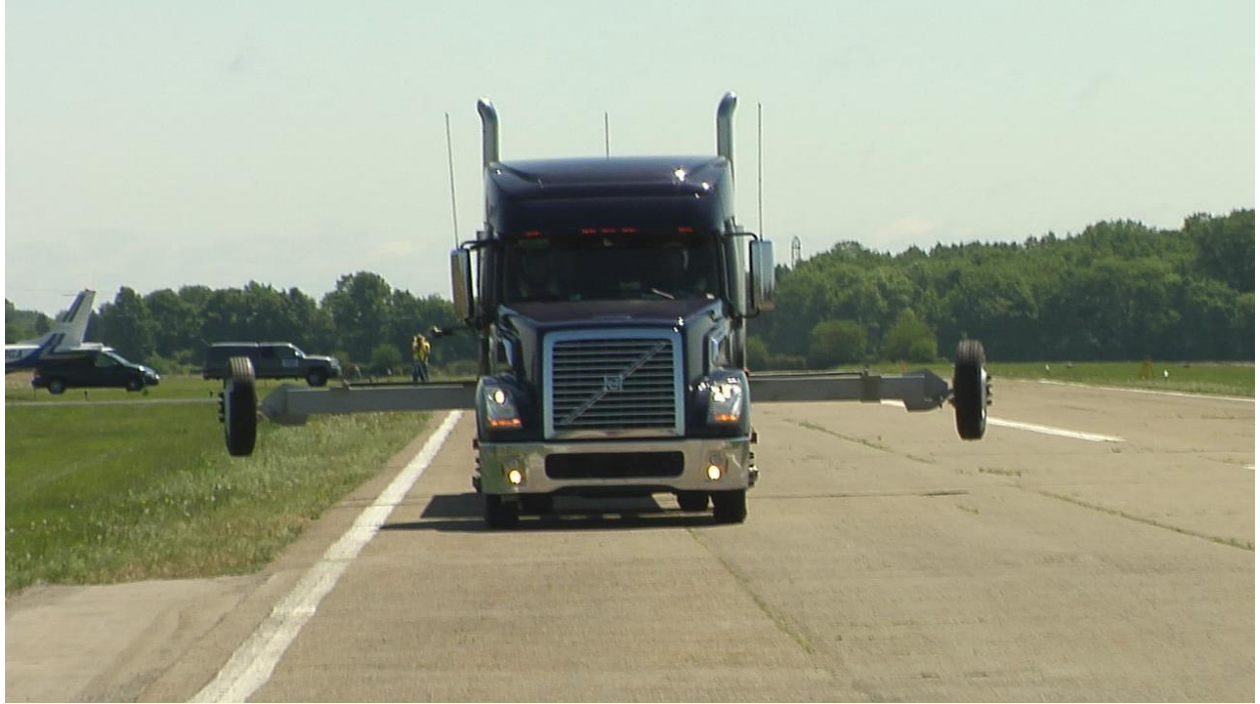
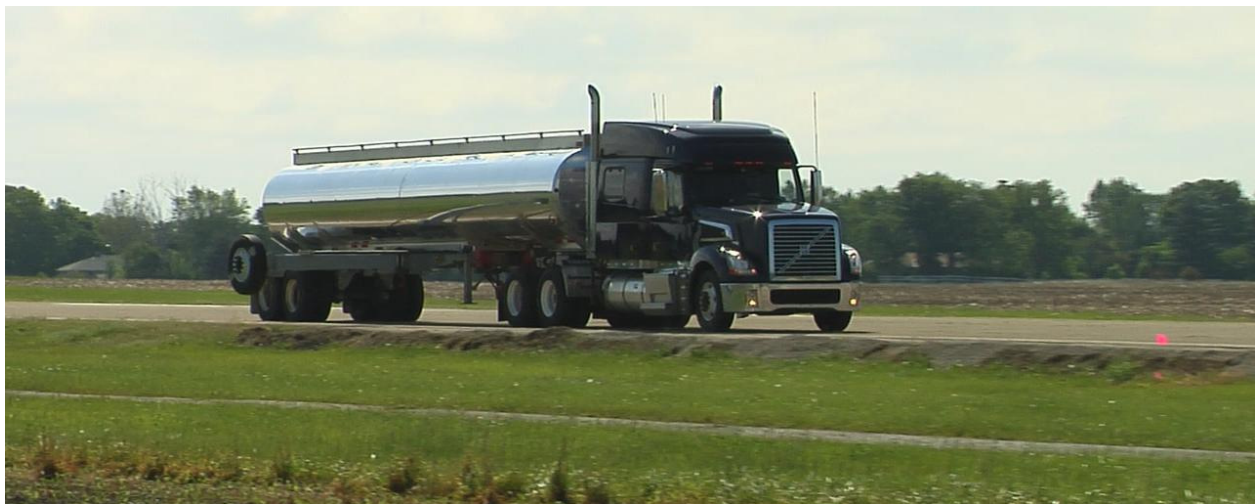
**Figure 8. Two photographs. The truck approaches the shoulder at the test speed.**

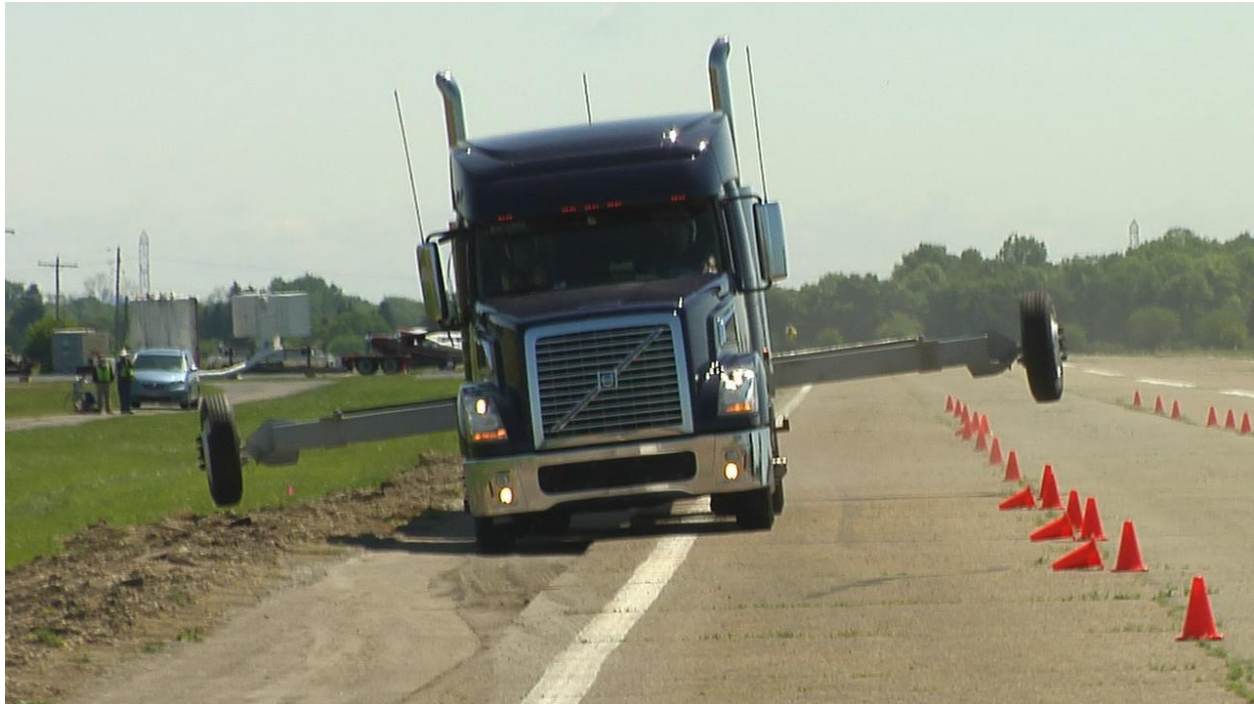
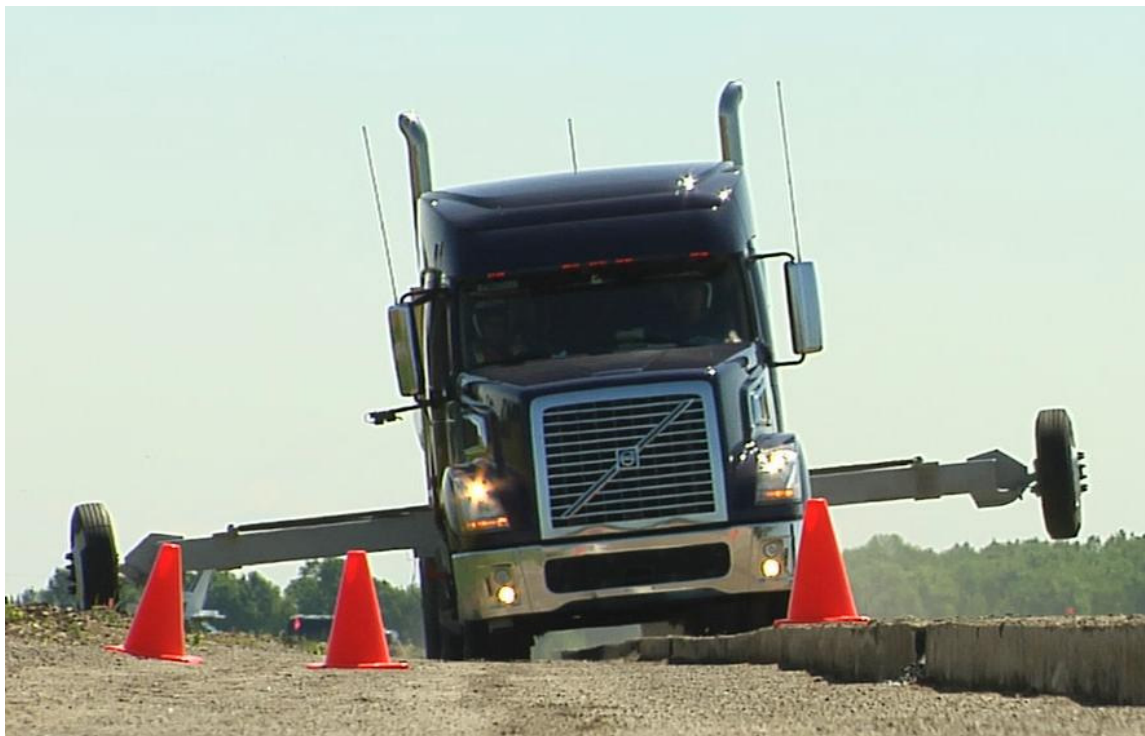
**Figure 9. Two photographs. The truck is in a stable straight path with its left tires on the pavement and its right tires in the gravel shoulder.**

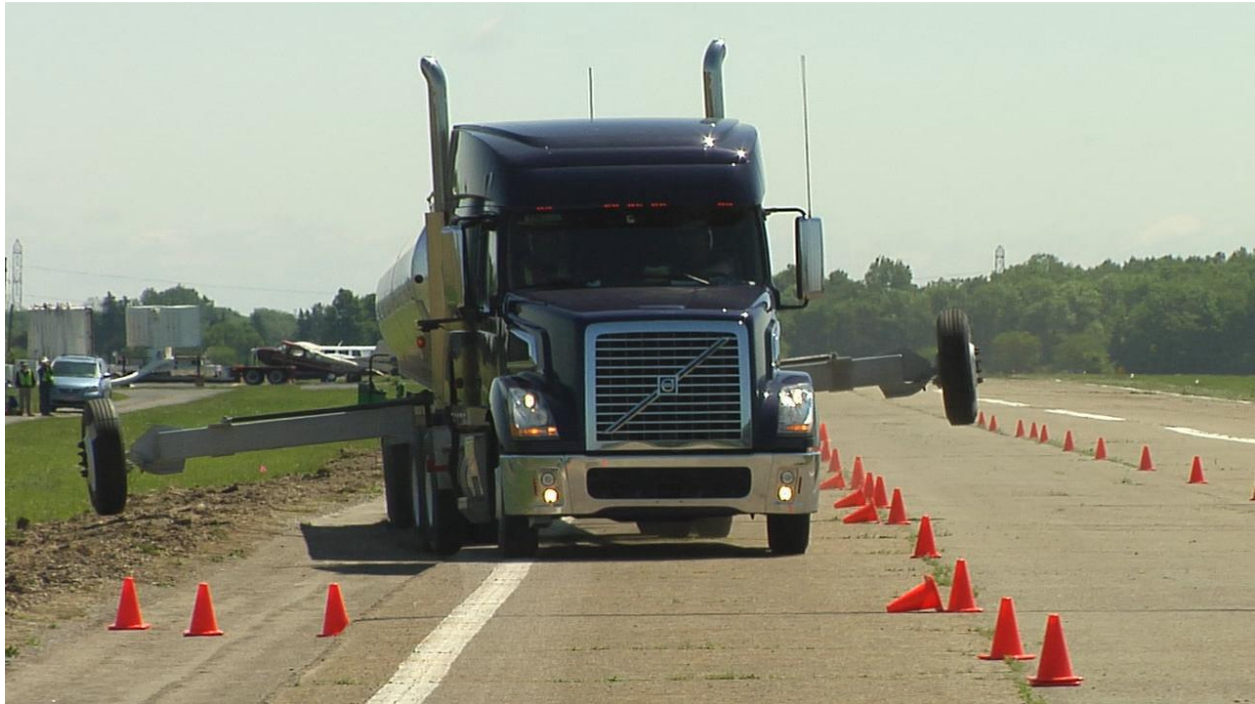
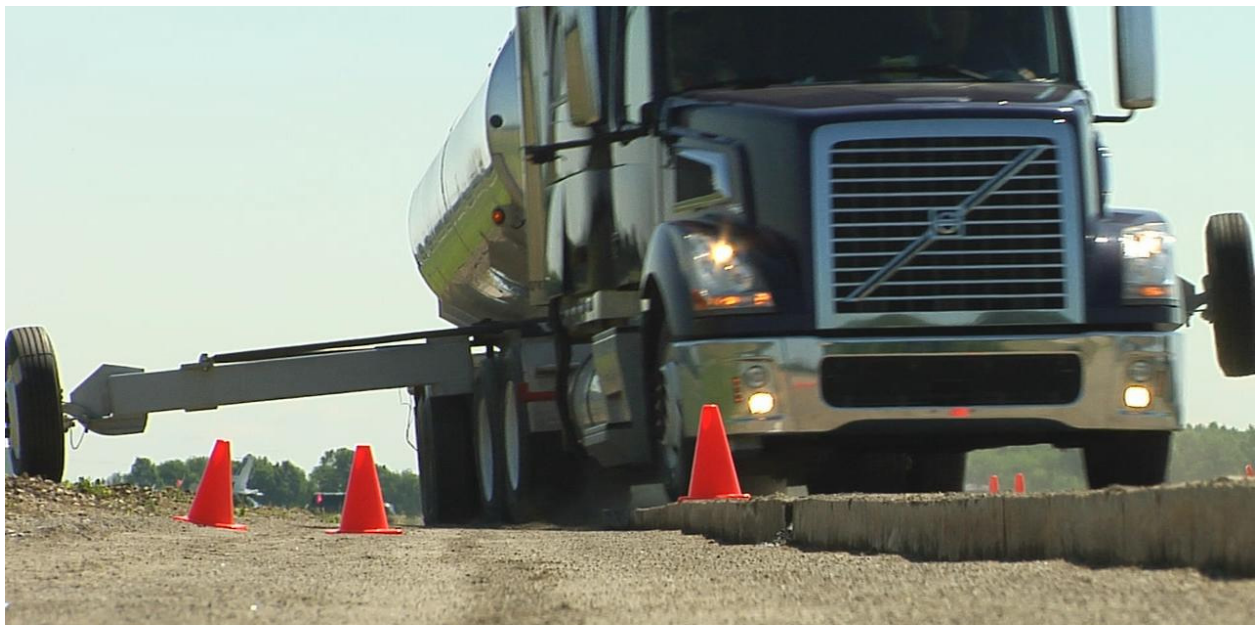
**Figure 10. Two photographs. The tractor has climbed the vertical edge, and the trailer will soon follow.**

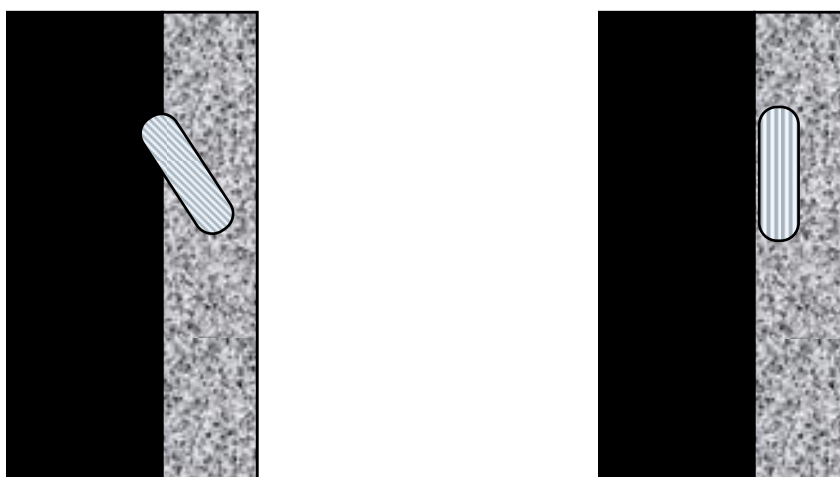
**Figure 11. Illustration. Illustrated on the left is a recovery maneuver approaching the pavement edge at an oblique angle. Adjacent is an illustration of a tire grazing the edge of the pavement. Both of these maneuvers were executed during the experiment.**

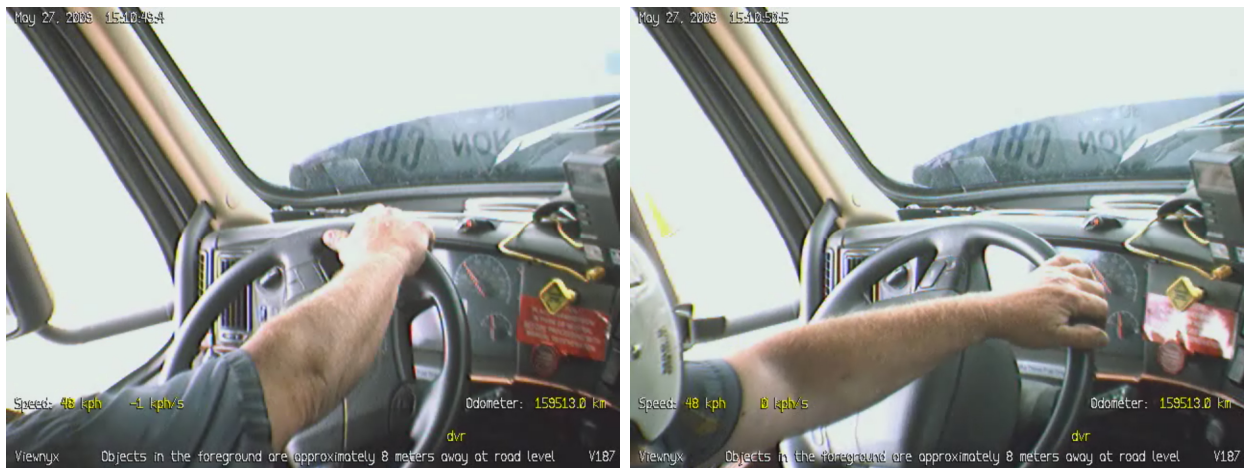
**Figure 13. Two photographs. Driver making a recovery maneuver onto the pavement (left) and then countersteering to remain in the original lane (right).**

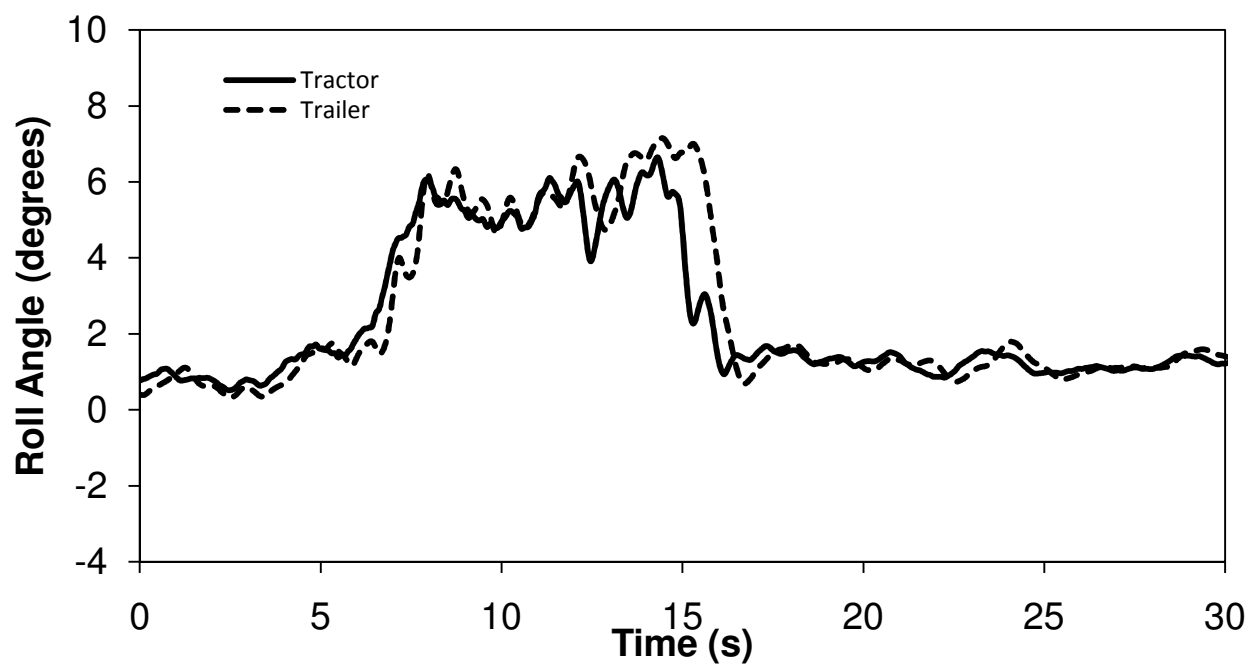
Figure 17 shows the tractor and trailer roll angles during the grazing recovery maneuver.

Figure 17. Graph. Roll angles during 30-mph grazing recovery.

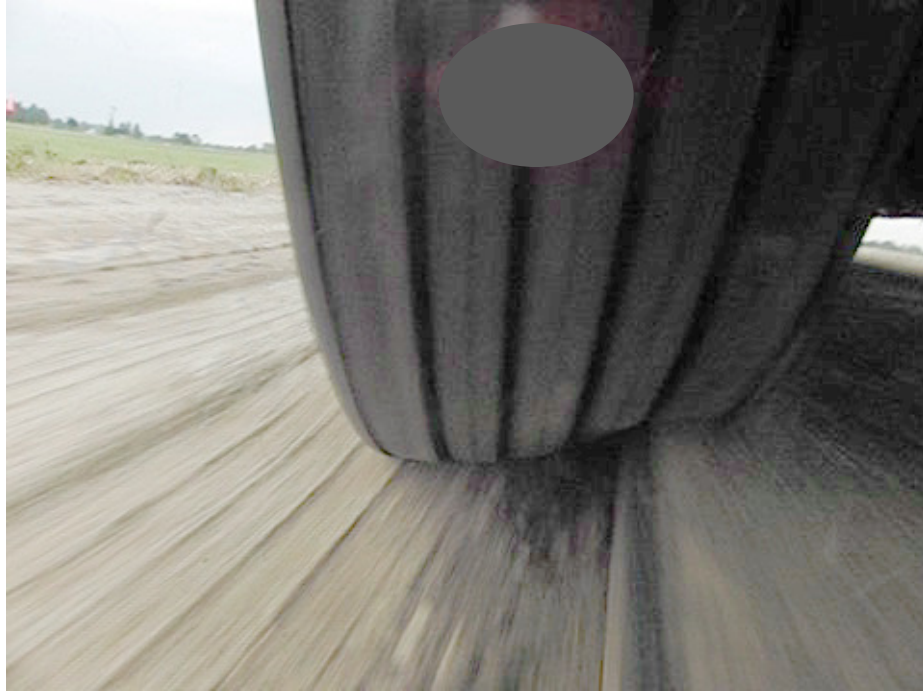
**Figure 20. Photograph. A still from the high-speed video of the right steer tire, at the instant it climbs the pavement edge in the grazing-incidence maneuver.**

negative.) At 13.5 seconds, the handwheel angle begins to increase as the turning force on the tire is enough to climb the edge. Figure 20 is a still picture taken from the high-speed video of this run. In the image, the inside half of the tire has mounted the pavement but the outside half of the tire remains at the level of the shoulder. High-speed video revealed that this behavior was typical of a grazing incidence recovery maneuver. During this particular maneuver, the video shows the tire briefly rotating back towards the shoulder as one half of the tire is on the pavement while the other half is off. This rotation corresponds to the brief drop in tie rod force at approximately 13.75 seconds. As the tire turns back away from the shoulder and continues to steer the truck onto the pavement, the edge of the pavement severely deforms the tire and causes the large peak load. Shortly afterwards, the outside half of the tire climbs onto the paved surface. As the tire returns to the roadway, tie rod force returns to near zero and the driver begins to decrease the handwheel input angle to finish the recovery maneuver.

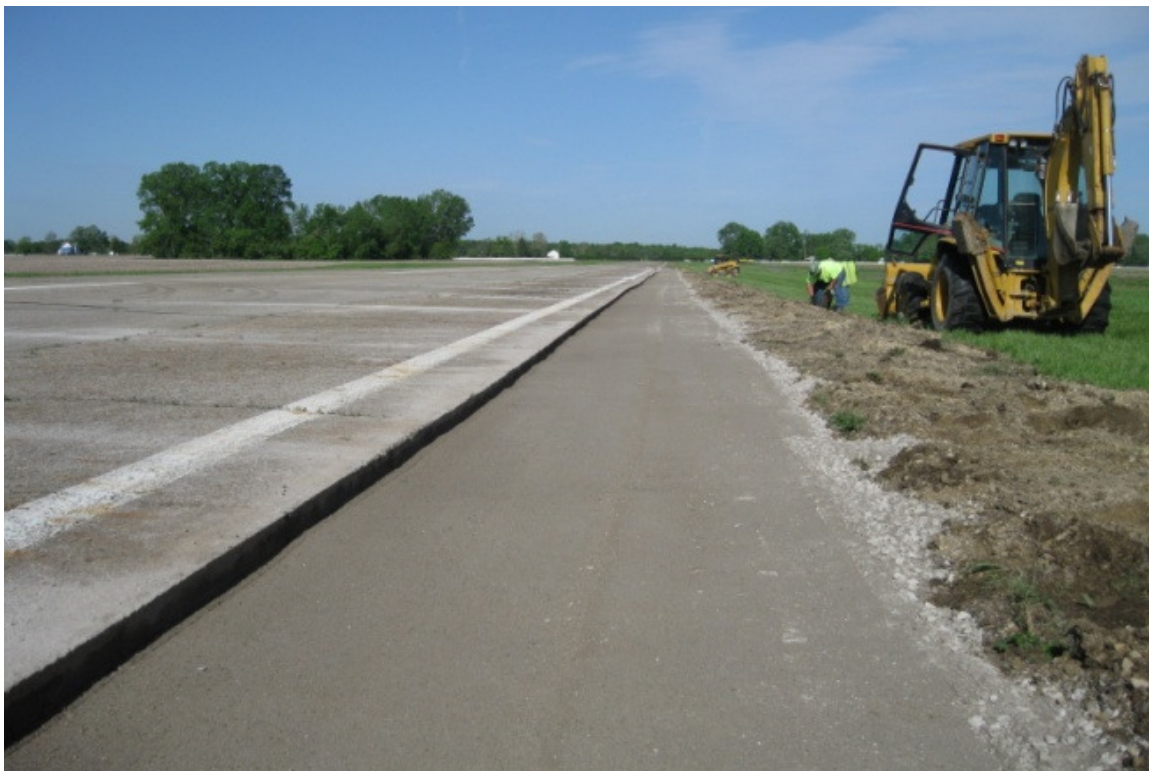
**Figure B- 2. Photograph. Prepared shoulder.**

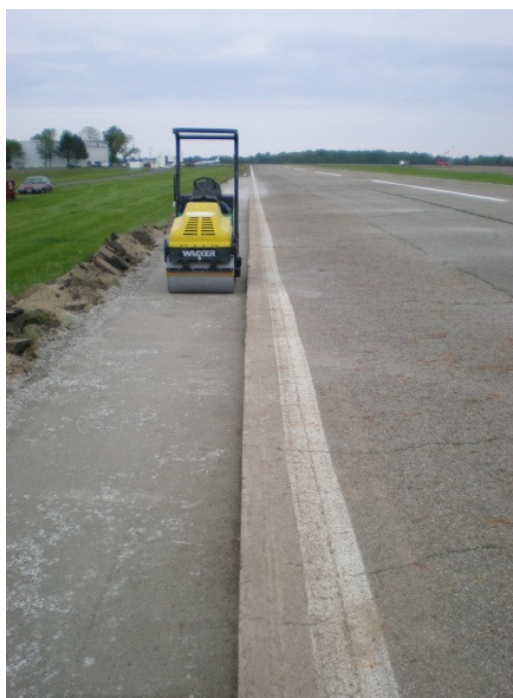
**Figure B- 3. Photograph. Shoulder compaction roller.**

The sub grade below the gravel aggregate was compacted in accordance with Ohio Department of Transportation (ODOT) Item 203, "Roadway Excavation and Embankment". The gravel aggregate conformed to ODOT Item 411, "Stabilized Crushed Aggregate." The stabilized crushed aggregate was compacted before and during testing with a vibratory compaction roller as shown in Figure B- 3.

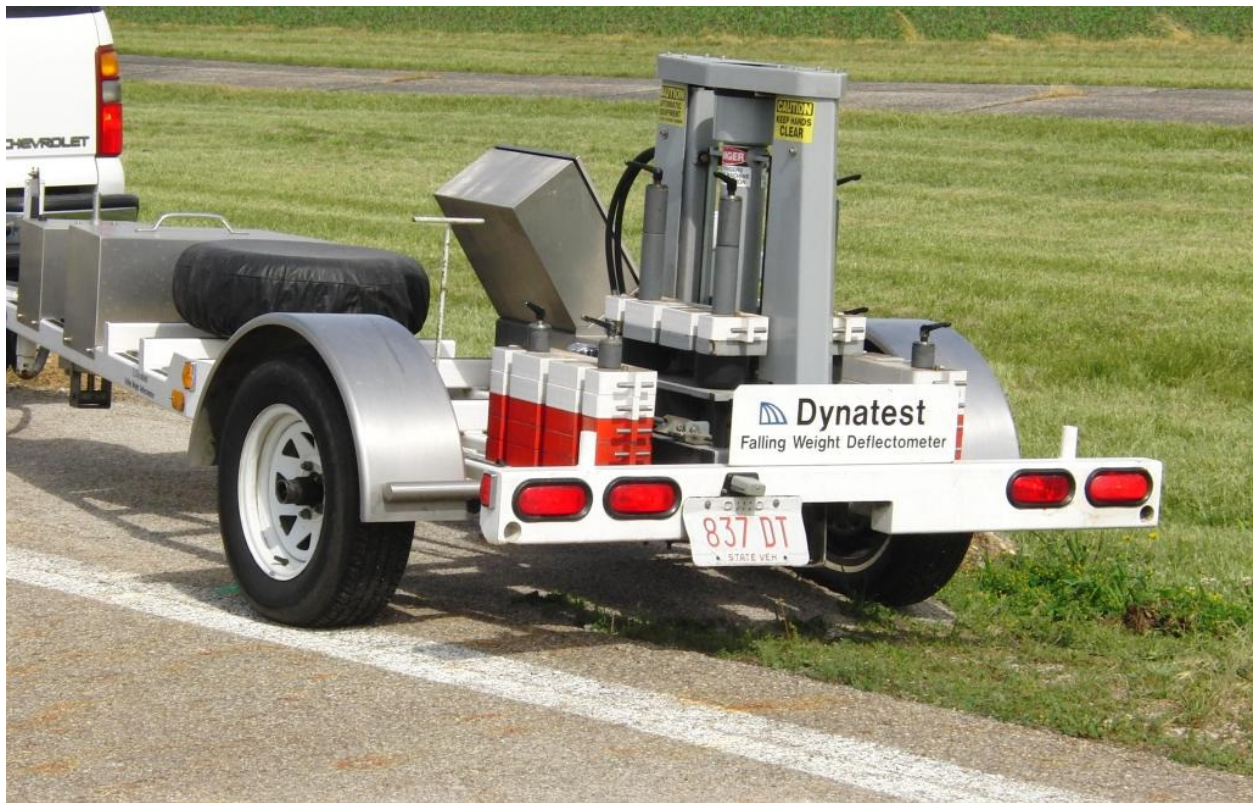
The modulus of elasticity of the shoulder was determined at 21 locations along the shoulder length. This was measured using the Falling Weight Deflectometer (FWD) method, as shown in Figure B- 4. The measurements and analysis below were provided courtesy of the Ohio Department of Transportation. To perform this testing, weight was dropped on a pressure plate that impacted the shoulder surface. Sensors measured the deflection due to this impact. Using the weight and deflection information, the modulus was calculated for each location. The shoulder modulus ranged from 2000 to 22000 psi as shown in Figure B- 5. This is the effective modulus and represents the combined modulus of the soil and stabilized crushed aggregate. The figure shows the variation in effective modulus over the length of the shoulder. The region from approximately 400 ft to 750 ft is where water collected after a heavy rain and was therefore softer than the surrounding shoulder. Even in this region, though, the values are typical for a shoulder prepared with these materials in this manner.

**Figure B- 4. Photograph. The falling weight deflectometer.**

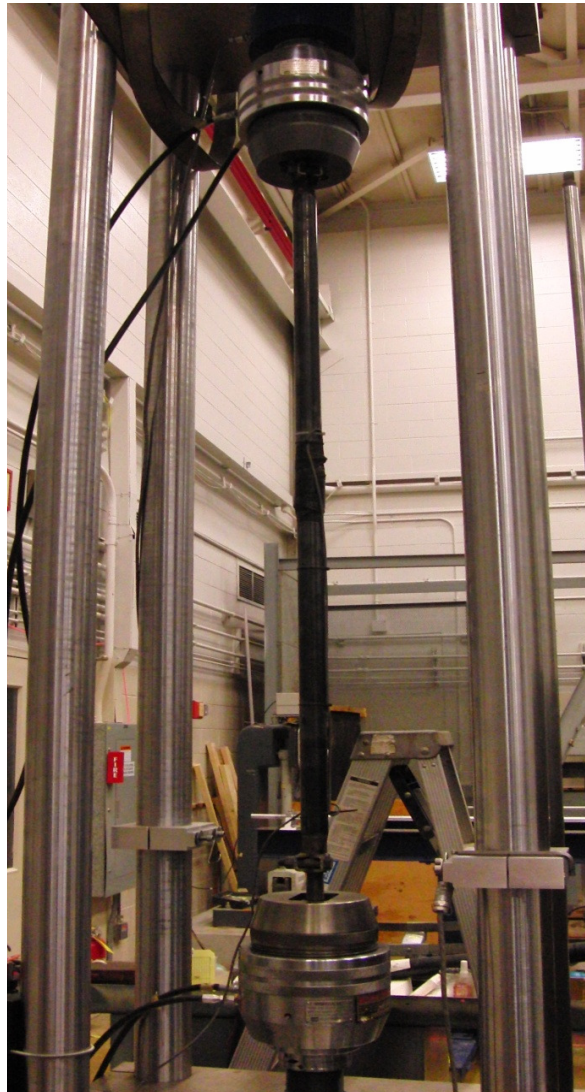
Post test, the tie rod was mounted in a mechanical test machine for calibration, as shown in Figure C-4. Known loads of both compression and tension were applied at 500-lb intervals up to 5000 lb using the same Ektron amplifier used during the tests. Zero and gain of the amplifier during the calibration were unchanged from the settings used during the field tests, so an indicated zero during the calibration assures that indicated zero load during the tests is indeed actual zero load.

**Figure C- 3. Photograph. Tie rod being calibrated in the mechanical test machine.**
