1. Report No. FHWA/TX-09/0-5210-6		2. Government Accession No.		3. Recipient's Catalog No.	
4. Title and Subtitle NCHRP REPORT 350 TEST 3-11 OF THE MODIFIED T8 BRIDGE RAIL				5. Report Date December 2008 Published: April 2009

**NCHRP REPORT 350 TEST 3-11  
OF THE MODIFIED T8 BRIDGE RAIL**

Report 0-5210-6  
Project 0-5210  
Project Title: Roadside Crash Testing Program  
for Design Guidance and Standard Detail Development

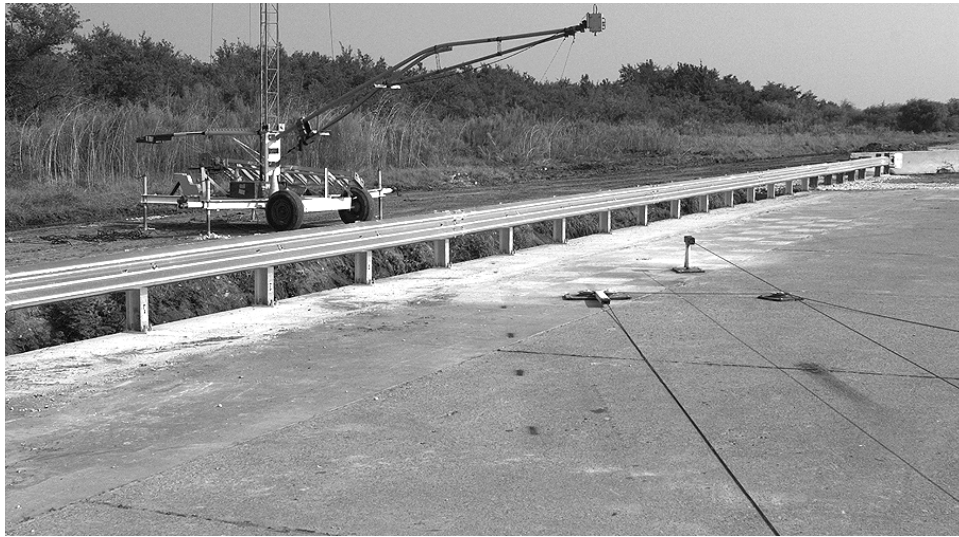
**Figure 1.1. T6 Bridge Rail System.**

Since its original development in 1978, the Texas Type T6 bridge rail system has been widely used as a bridge rail in Texas (1). Figure 1.1 shows a typical T6 bridge rail installation. The system was specifically designed for use on culverts and thin bridge decks. A breakaway mechanism incorporated into the posts is intended to minimize the transfer of forces to the concrete deck, thus reducing the extent of damage to the deck.

Primary components include a tubular W-beam rail element and W6×9 steel posts welded to baseplates, which are bolted to the deck. The tubular rail is fabricated by welding two standard 12-gauge W-beams back to back using a 6-inch long intermittent skip weld. The two beam sections are staggered 1.25 ft in order to accommodate a bolted lap splice connection. The rail is mounted on W6×9 posts spaced 6.25 ft on center using a 5/8-inch diameter button head bolt. A pipe sleeve is used between the tubular rail and post.

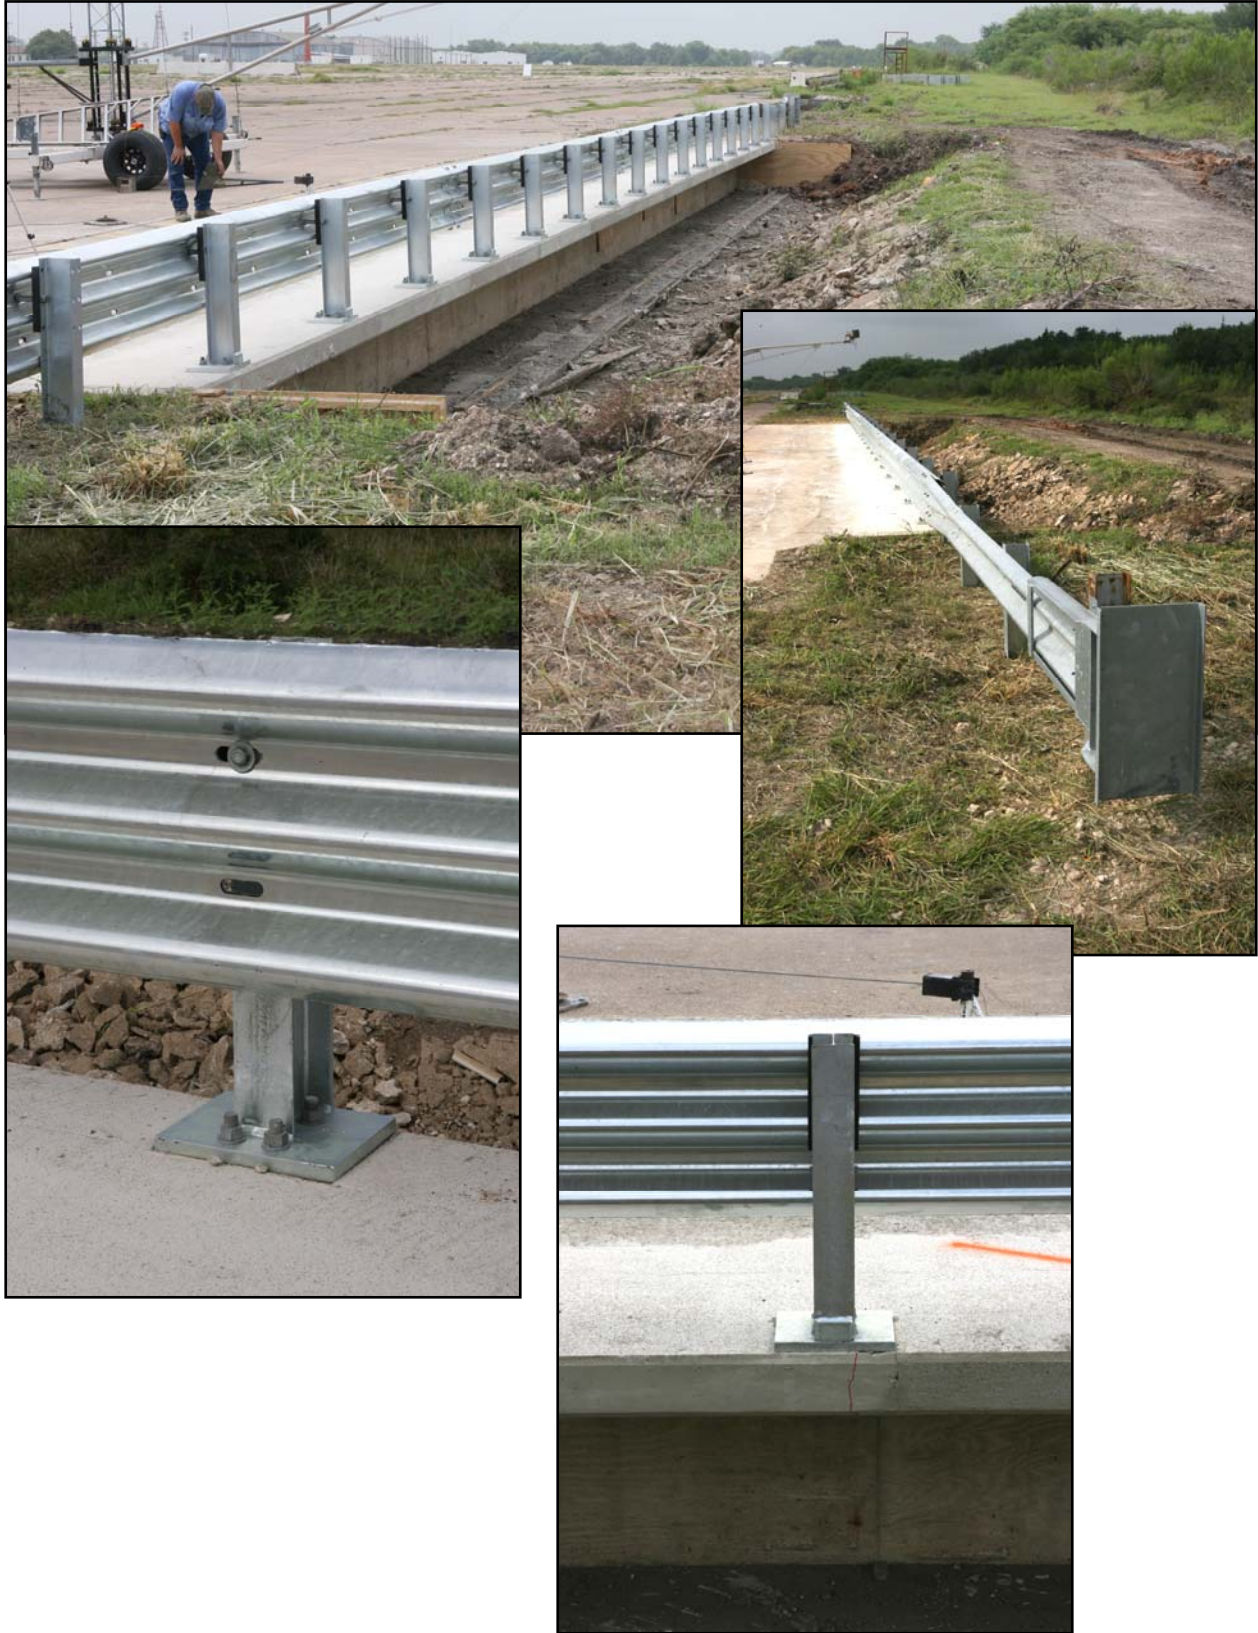
**Figure 2.10. T8 Bridge Rail Installation before Test 452108-7.**

Photographs of the completed test installation are shown in Figure 2.10.

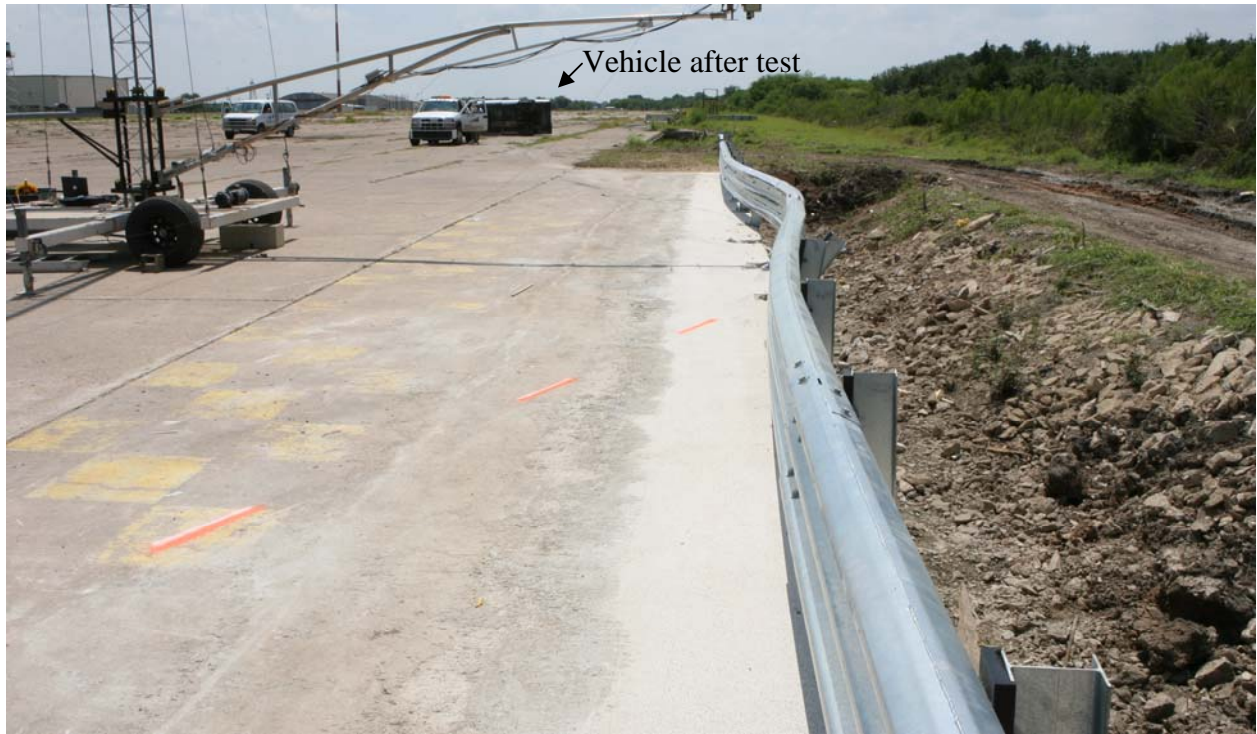
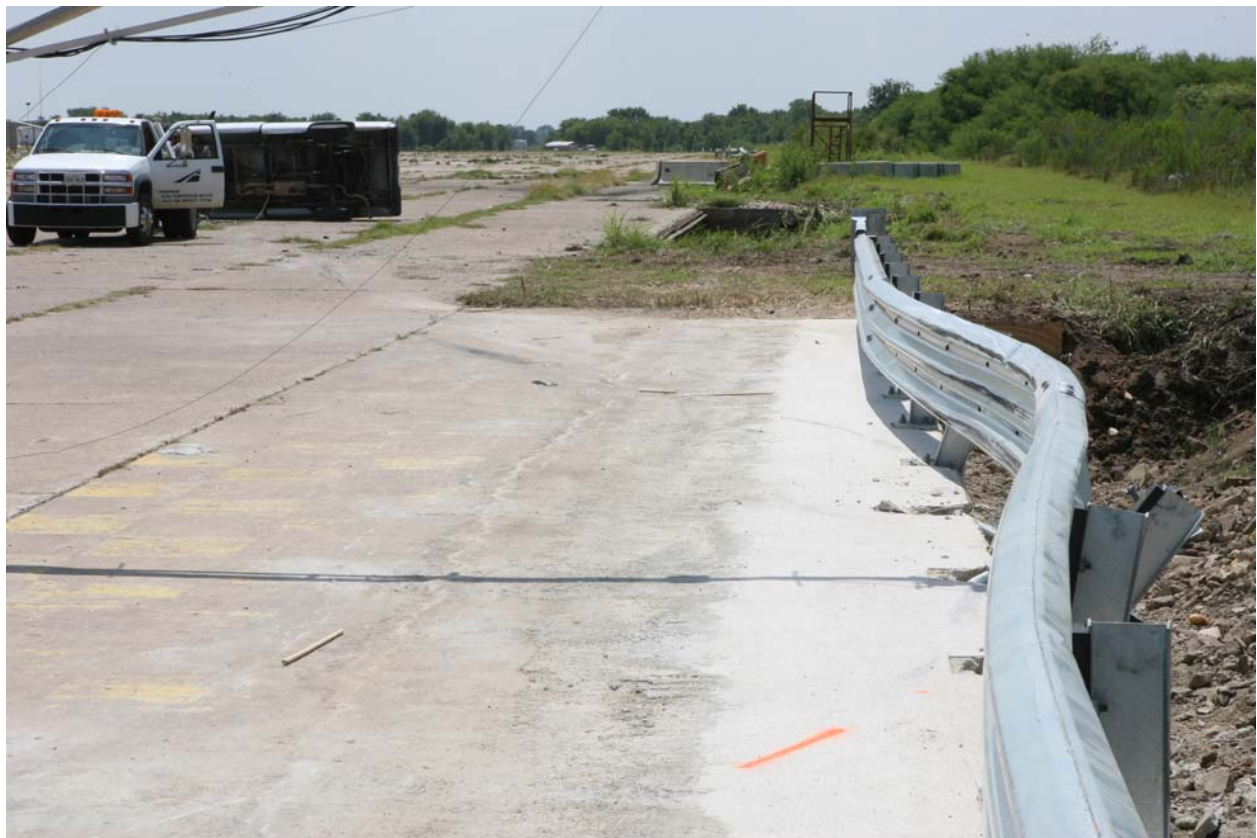
**Figure 3.4. After Impact Trajectory Path for Test 452108-7.**

Damage to the T8 bridge rail is shown in Figures 3.3 and 3.4. Posts 5 through 9 rotated 5 degrees clockwise. Posts 10 through 15 were deformed and deflected toward the field side as listed in Table 3.1.

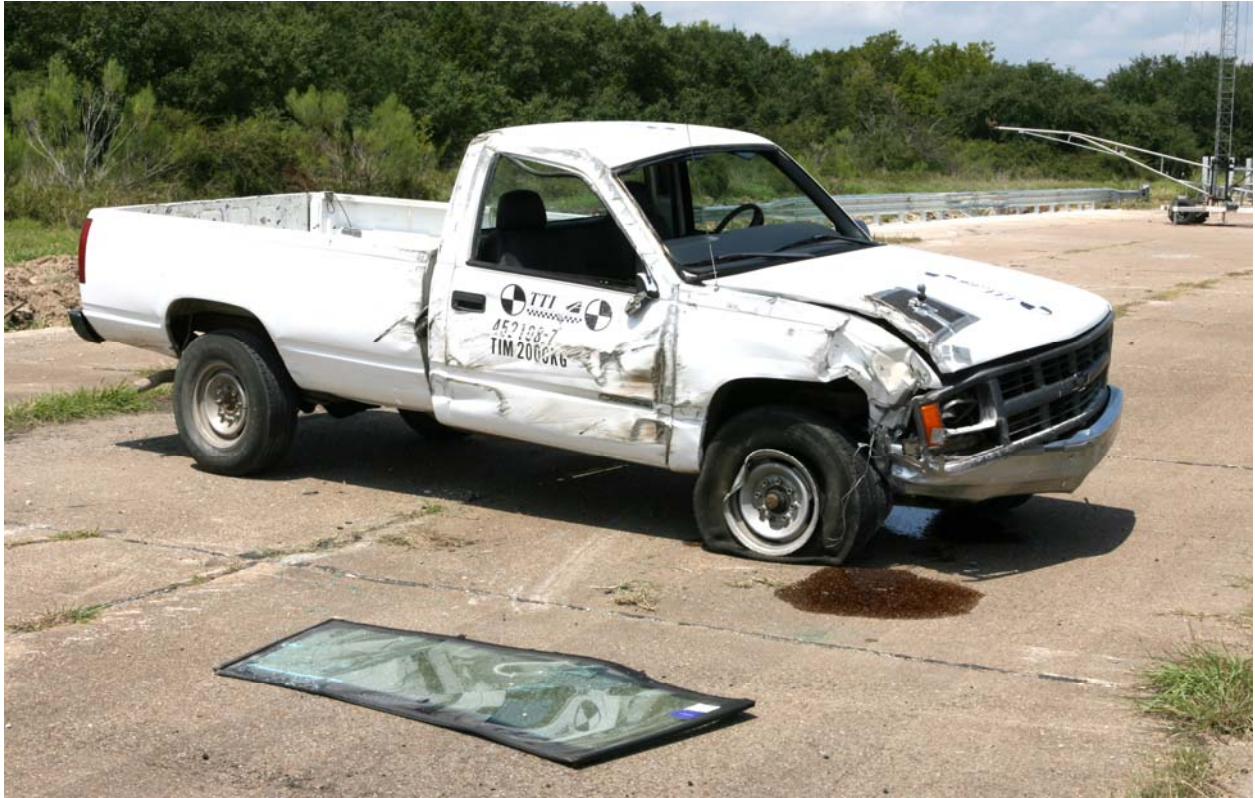
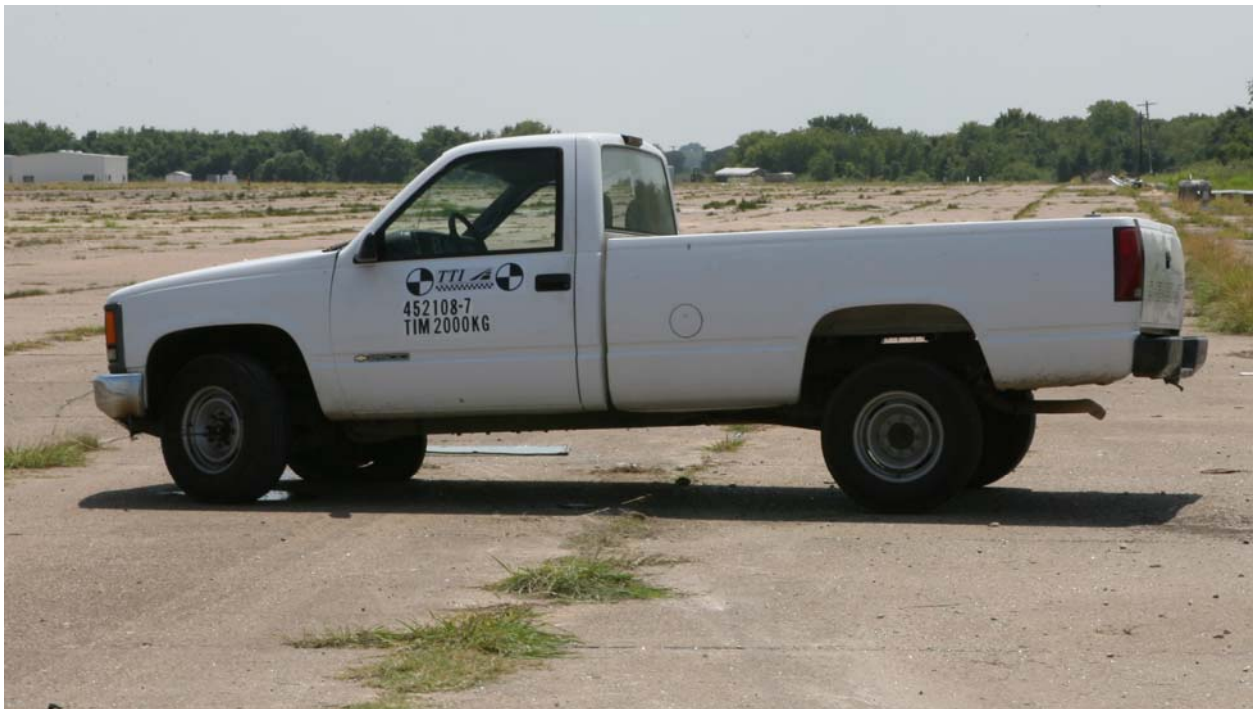
**Figure 3.6. Vehicle after Test 452108-7.**

Figure 3.5 shows the damage to the 2000P vehicle. The left upper and lower A-arms, left outer tie rod end, and frame rail were deformed, as well as the A and B pillars. Also damaged were the front bumper, hood, grill, left front fender, left tire and wheel rim, left door, and left rear exterior bed. The windshield and door glass broke when the vehicle rolled onto its side. Maximum exterior crush to the vehicle was 13.0 inches in the front plane at the left front corner at bumper height. The left firewall and floor pan were also deformed. Maximum occupant compartment deformation was 1.2 inches at the left A-pillar. Photographs of the interior of the vehicle are shown in Figure 3.6. Exterior vehicle crush and occupant compartment measurements are shown in Tables B1 and B2 of Appendix B.

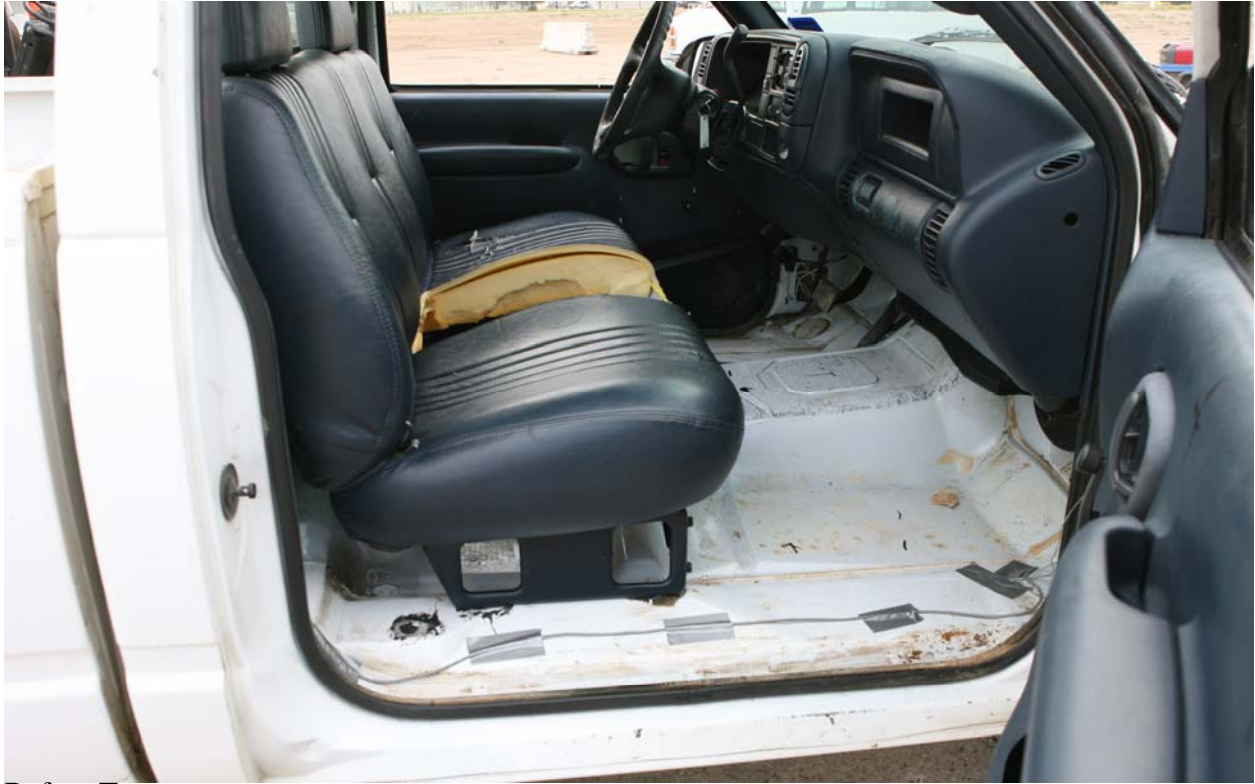
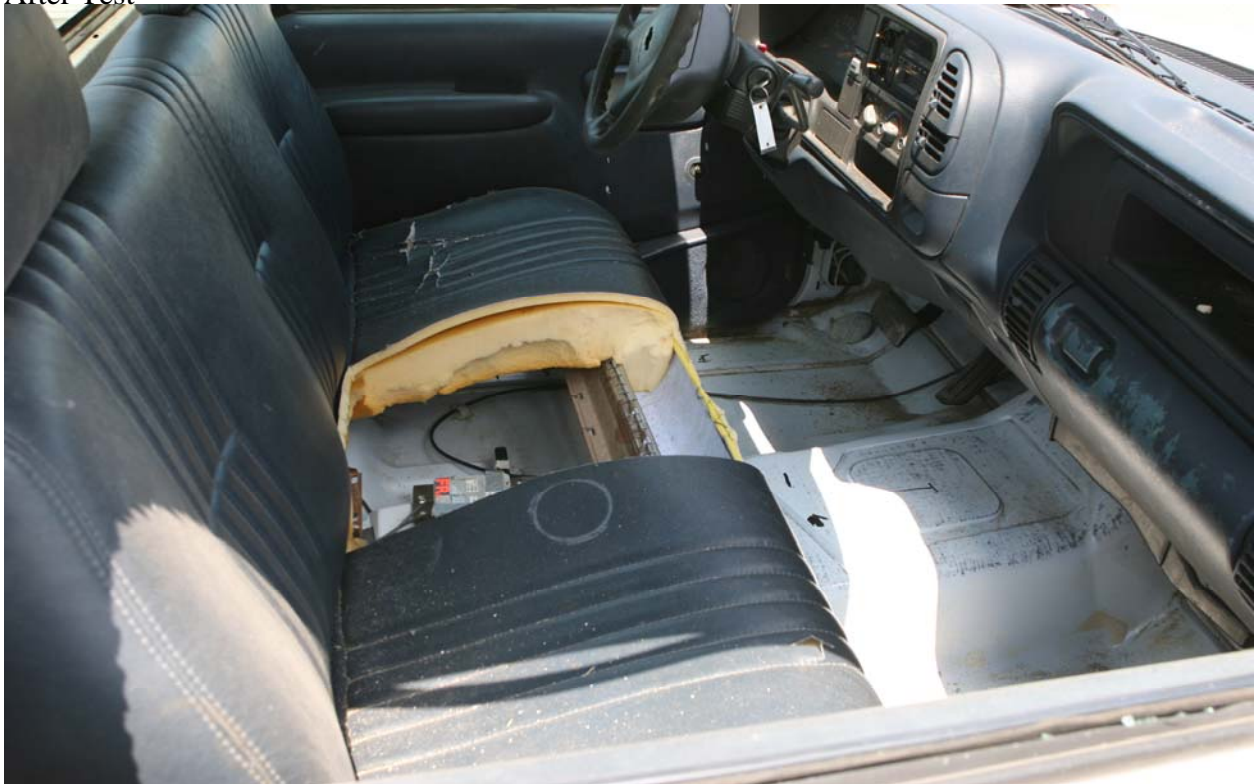
**Figure 3.7. Interior of Vehicle for Test 452108-7.**

**Result:** No detached elements, fragments, or other debris from the test article were present to penetrate or show potential for penetrating the occupant compartment, or to present undue hazard to others in the area. Maximum occupant compartment deformation was 1.2 inches. (PASS)

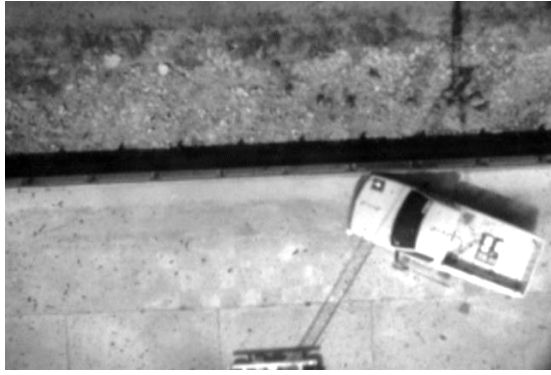
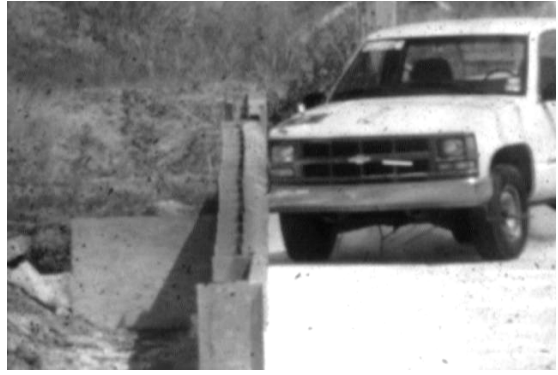
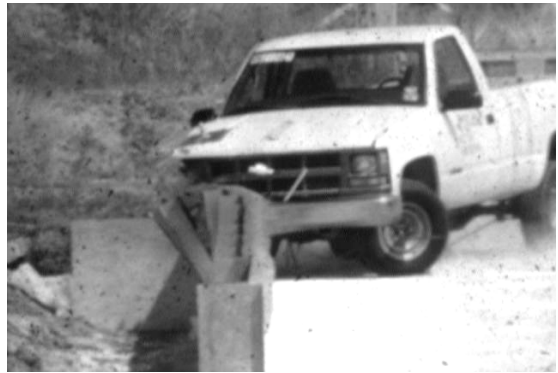
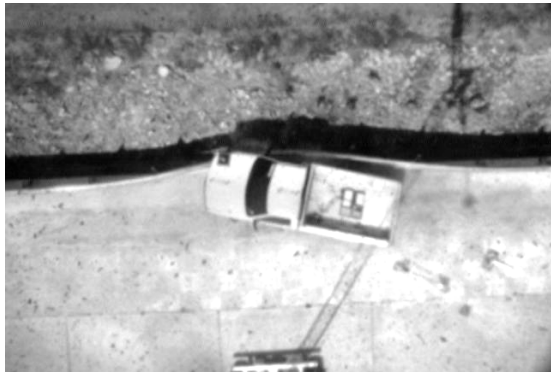
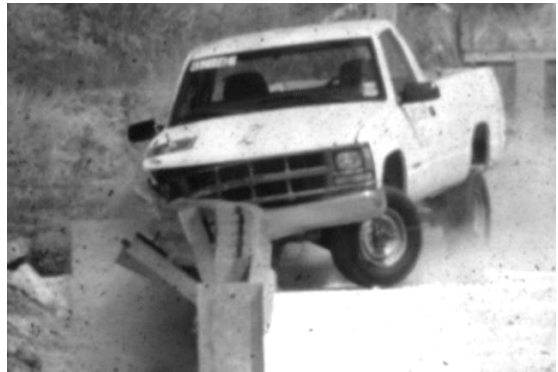
**Figure C1. Sequential Photographs for Test 452108-7  
(Overhead and Frontal Views).**

The 2000P vehicle, traveling at an impact speed of 62.1 mi/h, impacted the T8 bridge rail 20.0 inches upstream of post 11 at an impact angle of 23.8 degrees. At 0.027 s after impact, post 11 began to deflect toward the field side, and at 0.056 s, the 2000P vehicle began to redirect. Posts 12 and 13 began to deflect toward the field side at 0.061 s and 0.068 s, respectively. At 0.259 s, the vehicle began to travel parallel with the bridge rail at a speed of 48.1 mi/h. The 2000P vehicle began to roll at 0.267 s. The vehicle continued to roll as it exited the view of the overhead camera. The 2000P vehicle subsequently came to rest on its right side 163 ft downstream of impact and 48 ft forward of the traffic face of the rail. Figures C1 and C2 in Appendix C show sequential photographs of the test period.
