1. Report No. FHWA/TX-09/0-5845-1	2. Government Accession No.	3. Recipient's Catalog No.	
4. Title and Subtitle ALTERNATIVE VEHICLE DETECTION TECHNOLOGIES FOR TRAFFIC SIGNAL SYSTEMS: TECHNICAL REPORT		5. Report Date October 2008 Published: February 2009

ALTERNATIVE VEHICLE DETECTION TECHNOLOGIES FOR TRAFFIC SIGNAL SYSTEMS: TECHNICAL REPORT

TEXAS TRANSPORTATION INSTITUTE
The Texas A&M University System
College Station, Texas 77843-3135

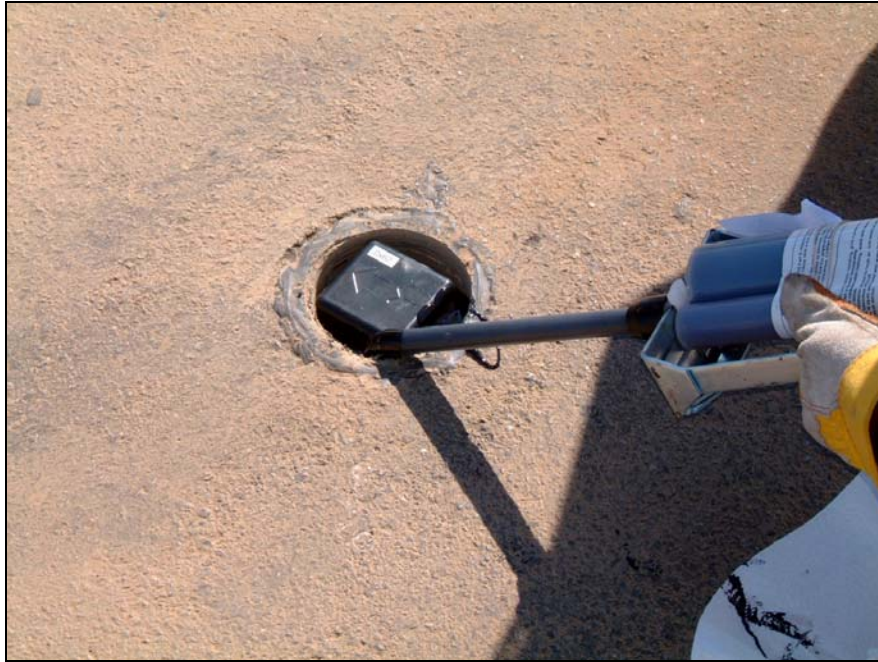
Figure 4. Sensys Networks VSN 240 Flush Mount Magnetometer Installation.

One negative aspect of the magnetometer system must also be acknowledged, and that is the need to close lanes for installation and replacement of the sensors. Installing each sensor only takes about 30 minutes and requires coring and extracting a small cylindrical-shaped core of pavement and backfilling around the sensor with a recommended epoxy. Figure 4 shows the sensor and the backfilling process. TTI has installed these sensors at two freeway field labs (I-35 in Austin and S.H. 6 in College Station). According to the manufacturer, the battery life range is from 8.5 to 13 years, so unless a major failure occurs inside the SN, the sensor's life-cycle costs should be similar to that of its competitors. In case of failure, a major cost will be for traffic control to close the lane.

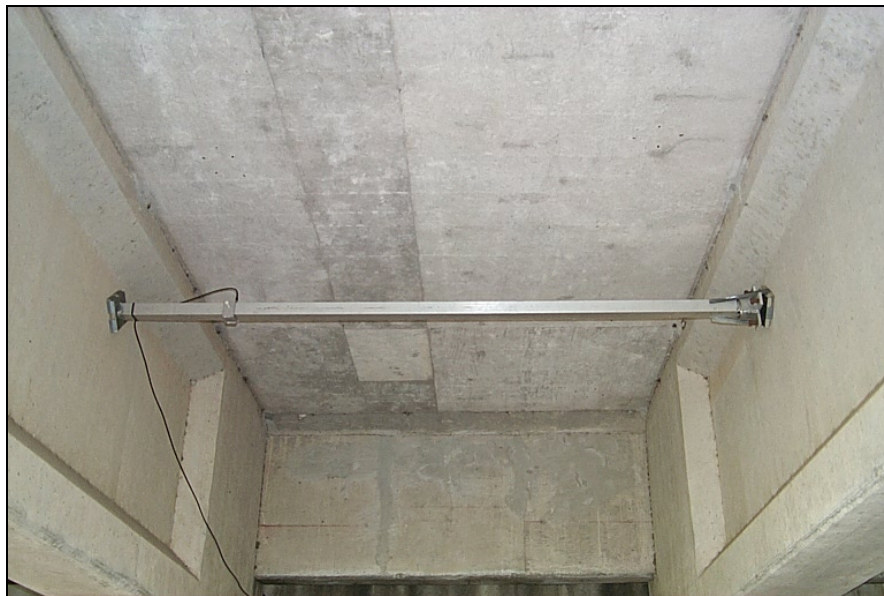
Figure 6. GTT Microloop Probe Support under F.M. 60 Bridge in College Station.

Figure 6 shows a photograph of an installation under the F.M. 60 bridge crossing over S.H. 6 in College Station (6). TTI designed this support, made of aluminum, for maintaining the vertical orientation and position of the detector by pressure applied at each end instead of physically fastening anything to the beams. Installers must first check the magnetic field strength along the width of the bridge to ensure proper detection since proximity of embedded vertical reinforcement steel can have an adverse impact on vehicle detection. Note that this probe is close to a bridge beam, which would have vertical steel, but the probe still worked well. Findings of the magnetic flux survey may force movement of the detection probes a few inches one way or the other to effectively detect vehicles from underneath the bridge. These detectors have performed extremely well under S.H. 6 at the TTI field lab for about 8 years (they were only tested under the bridge for a short time).

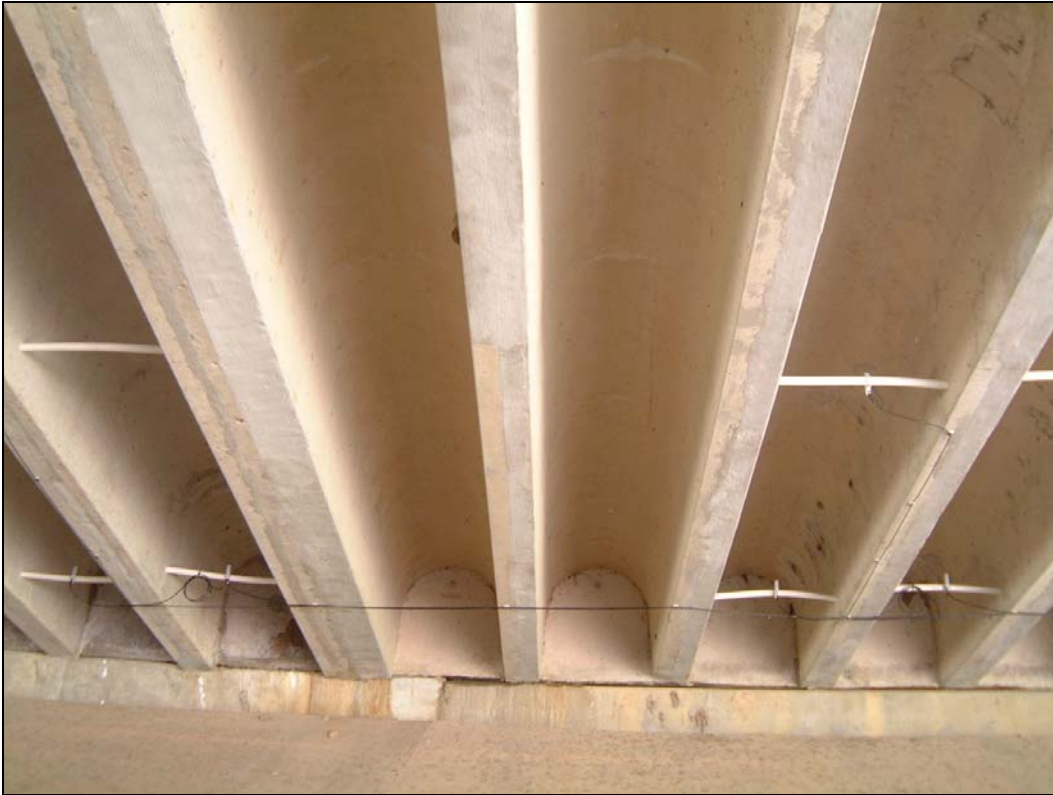
Figure 10. View underneath the F.M. 60 Bridge with GTT Probes in Place.

Using the noted F.M. 60 site for testing the GTT magnetometers required installing the microloops under the F.M. 60 bridge and using the TxDOT video camera for verification. Data

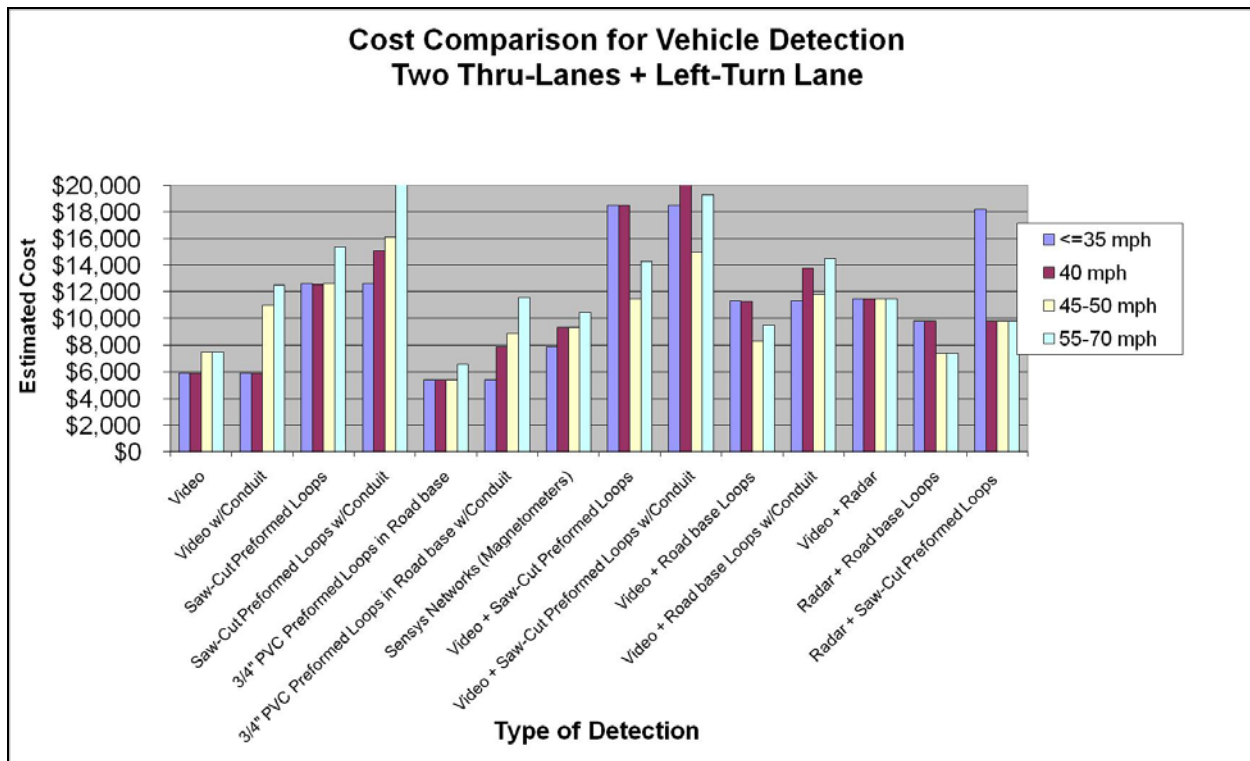
Figure 16. UDOT Cost Comparison for Two Thru-Lanes Plus Left-Turn Lane.

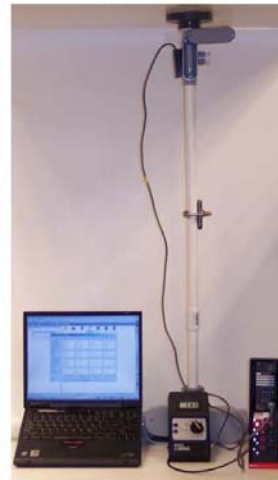
Figure 4. Using 701 Traffic Sensor Attached to C924 Vehicle Detector Combined With C900 CS to Measure Response to Vehicles

The magnetic field increase caused by adjacent-lane vehicles should be less than 5 milligauss. The average decrease in inductance induced by passenger vehicles in the adjacent-lane should be less than 25 nanohenries. In an ideal situation, the inductance change caused by a truck in the adjacent-lane is 1/10 or less of the inductance change caused by a typical passenger vehicle.
