| 4. Title and Subtitle<br><b>SUBBASE AND SUBGRADE PERFORMANCE INVESTIGATION FOR CONCRETE PAVEMENT</b> | | 5. Report Date<br><b>January 2009</b><br><b>Published: May 2009</b> | |
| 7. Author(s)<br><b>Youn su Jung, Dan G. Zollinger, Moon Won, and Andrew J. Wimsatt</b> | | 8. Performing Organization Report No.<br><b>Report 0-6037-1</b> | |
| 9. Performing Organization Name and Address<br><b>Texas Transportation Institute<br/>The Texas A&amp;M University System<br/>College Station, Texas 77843-3135</b> | | 10. Work Unit No. (TRAIS) | |

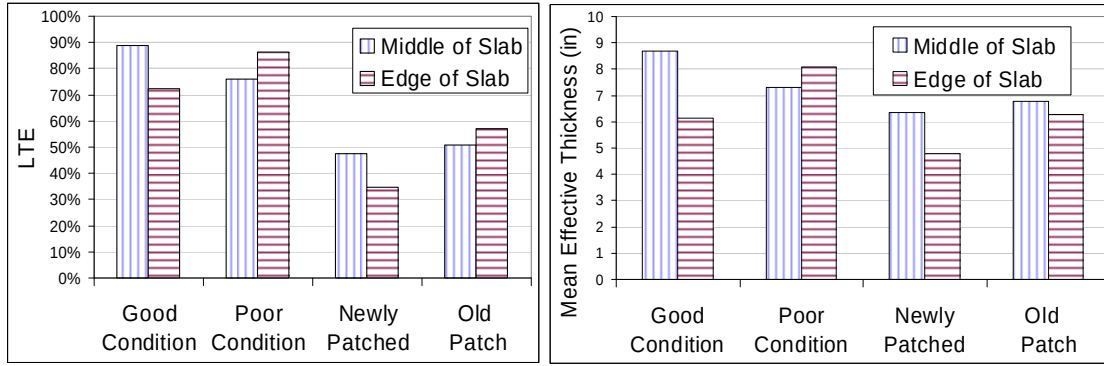
**Figure 5. LTEs and Effective Thickness of Test Sections on US 75.**

Figure 5 shows joint LTE and effective thickness along the center and the edge of slab. Interestingly, the patched sections had low LTE and effective thickness as if eroded conditions were present. The reason for low LTE in these sections is perhaps due to the lack of aggregate interlock along the joints. LTE and erosion are typically highly related to each other; joints with low LTE are often associated with high rates of erosion due to independent deflection behavior between two slabs; an eroded base also contributes to higher wear out rates of the aggregate interlock. Patches in pavements tend to create areas of low stiffness and consequently potential problem locations for future repair.

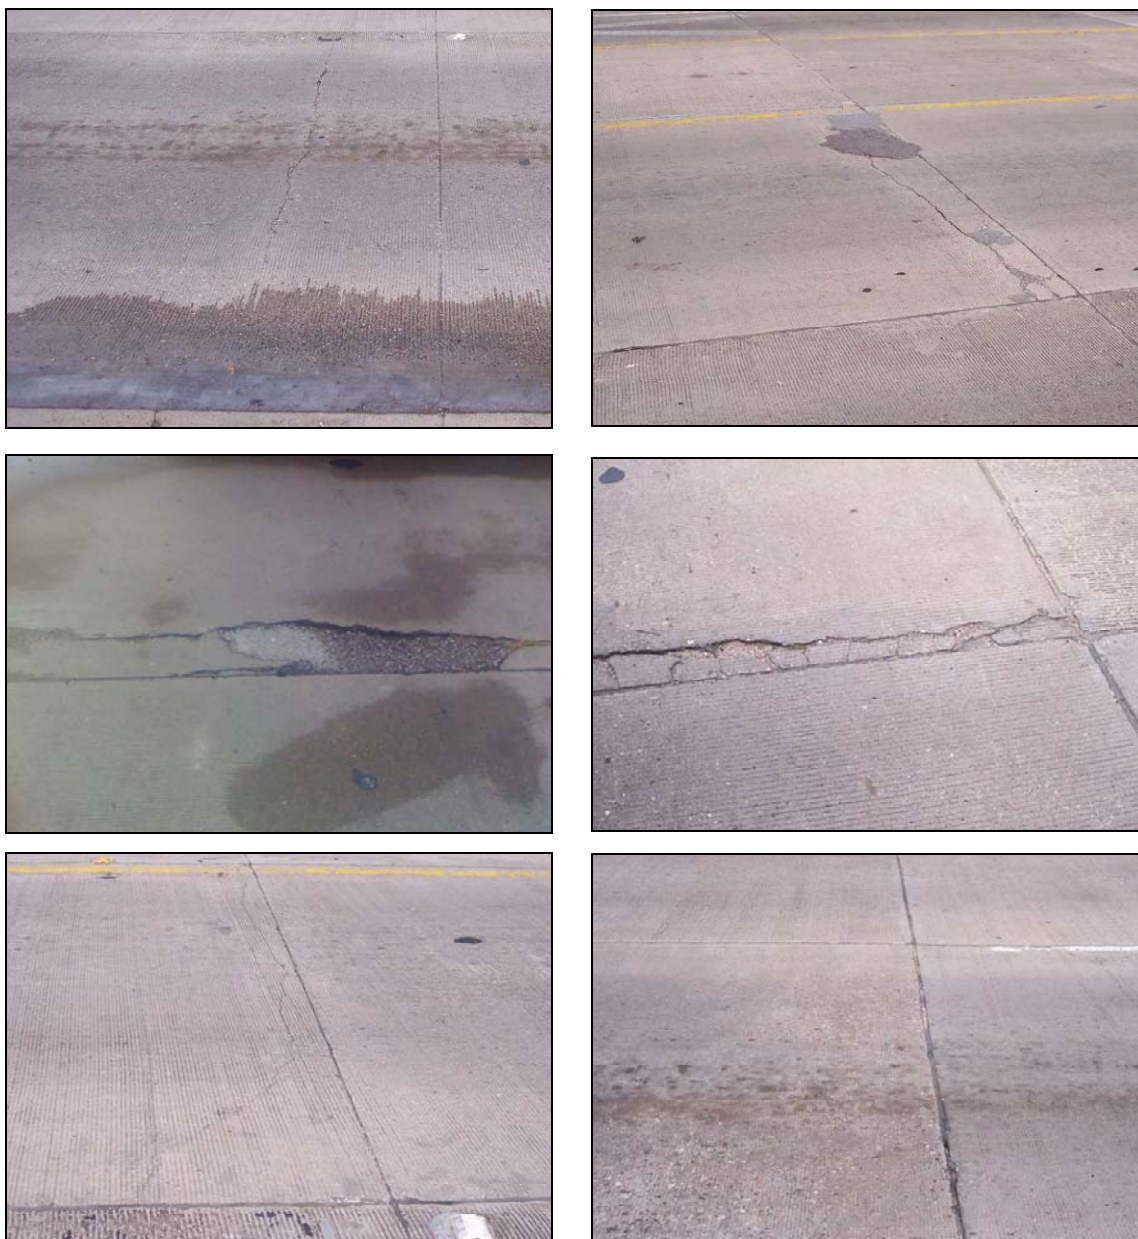
**Figure 17. Surface Conditions of Sampled Section on FM 364.**

A sample section on FM 364 in Beaumont consisted of a jointed 10 in thick pavement with a 15 ft joint spacing over 6 in cement stabilized oyster shell base. It was opened to traffic in 1985 and current traffic is 21,000 ADT with 2.5 percent trucks. Figure 17 shows the surface condition of the sample section. Some slabs had transverse cracks near the joints (about 1 ft apart) possibly due to late sawcutting. The joint seal condition was generally good, but not all the cracks were sealed properly promoting water intrusion and erosion of the base.

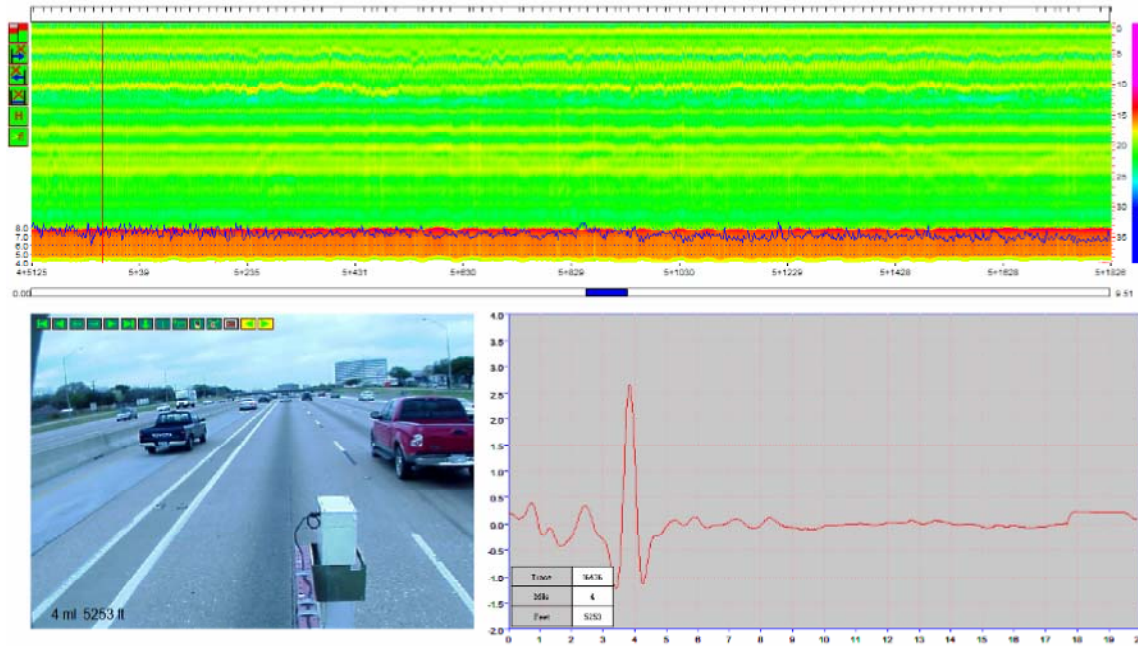
**Figure 28. GPR Image of Sampled Section on IH 635.**

GPR image in Figure 28 showed some moisture areas under the concrete slab but no significant sign of erosion was identified. DC values of overall sections are around 7 to 8 representing a low level of moisture on the base layer.

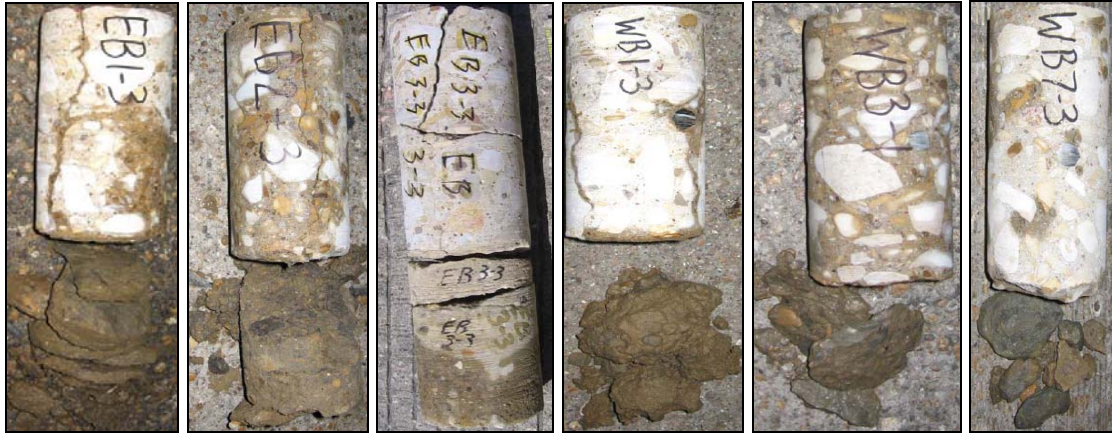
**Figure 31. Cores of Sampled Section on IH 635.**

Erosion was found only at areas where the condition of the longitudinal construction joint was not well maintained and moisture had penetrated the pavement (Figure 31). The stabilized base consisted of cemented sand with gravel and ranged in thickness from 3 to 5 in, while the subgrade mainly consisted of clay material. The pavement support is not presently as issue but could soon become serious if maintenance activities are terminated or diminished for an extended period of time. Life extension could be facilitated by addressing the areas in the pavement structure that do not drain well and allow water to penetrate below the surface of the pavement.
