## Repair Method for Prestressed Girder Bridges

FINAL REPORT

June 2009

Kent A. Harries, Ph.D., F.ACI, P.Eng.  
Jarret Kasan  
Can “John” Aktas  
University of Pittsburgh

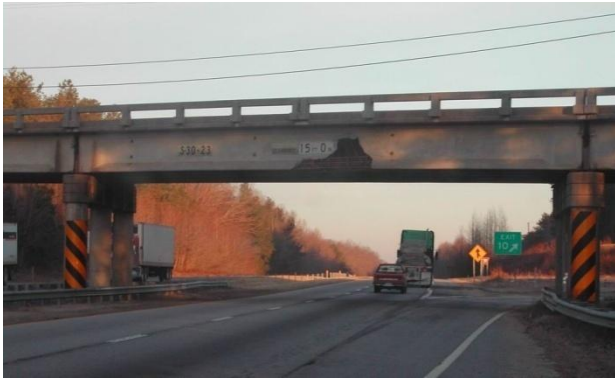
**Figure 1.1** Loss of section of AASHTO girder due to vehicle impact (Harries; not taken in PA).

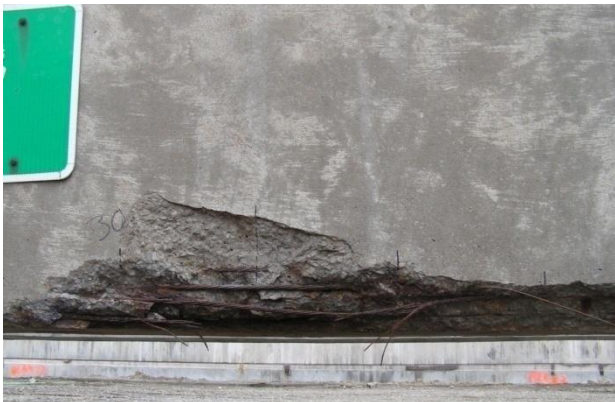
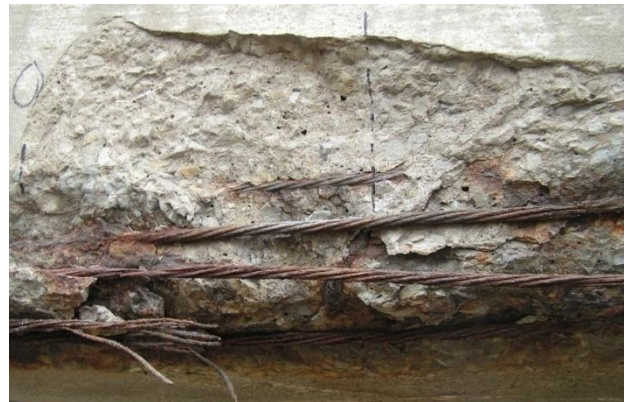
**Figure 1.4** Exposed and ruptured strand due to vehicle impact (Lake View Drive Bridge; Harries 2006).

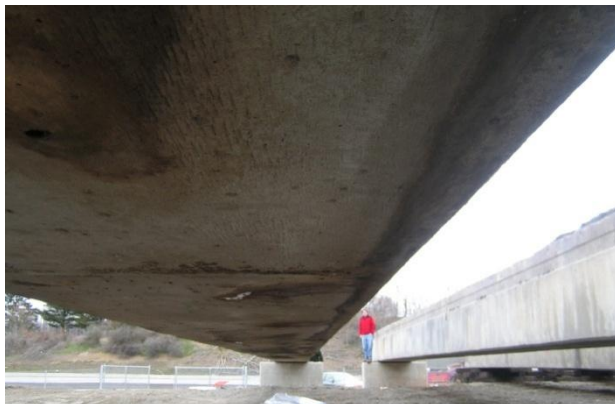
**(a)** water coming down exterior face of adjacent box girder (Harries 2006).

**Figure 1.6** Evidence of water on soffits of adjacent box girders.

(Figure 1.6). Spray from trucks travelling beneath the bridge may introduce additional chloride-laden water to the underside of the bridge superstructure. Although not an issue in the present study, bridges located near an ocean environment are also subject to enhanced chloride attack. Related to the presence of water (whether chloride-laden or not), is the potential for damage associated with freezing and thawing cycles. Such freeze/thaw damage in prestressed structures typically requires other damage to be present (allowing water ingress) before initiating.

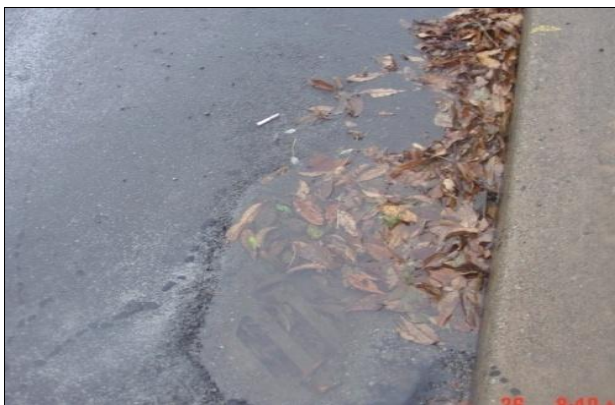
**(a)** water pooling due to clogged deck drain (PennDOT).

**Figure 1.7** Water may come from unanticipated sources.

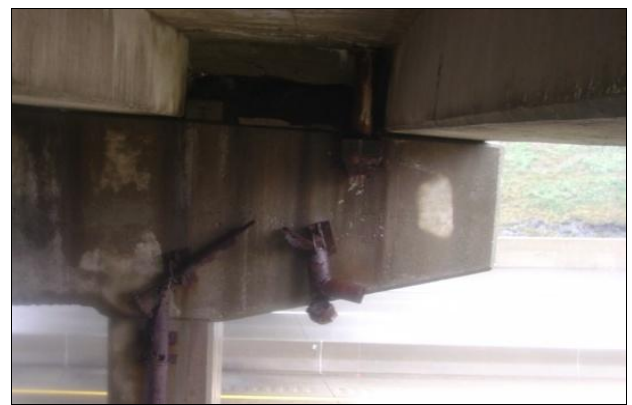
**(b)** damaged drain system resulting in water affecting superstructure (PennDOT).

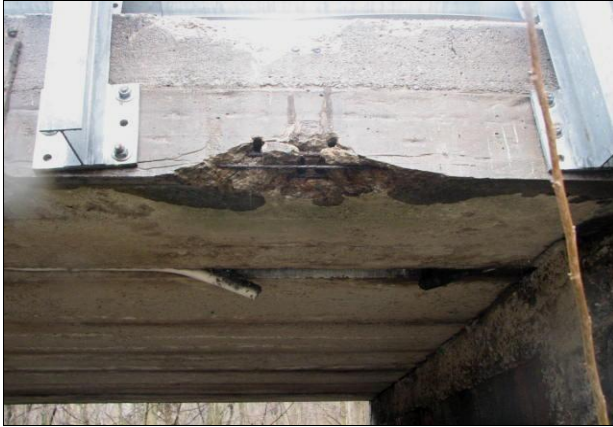
**(a)** spalling at original attachment and possible future damage at sight of new attachment

**Figure 1.8** Damage to strands caused by relocating barrier supports (PennDOT).

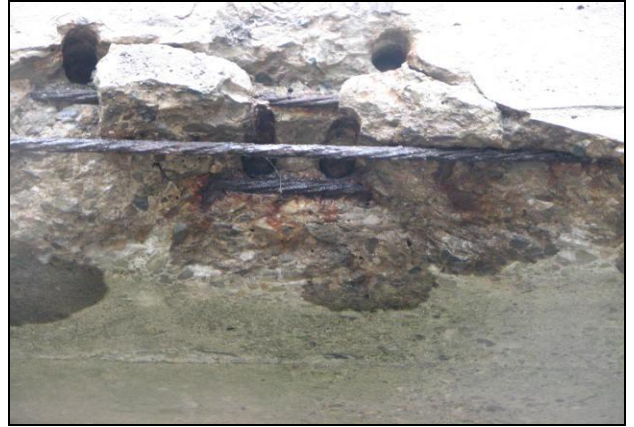
**(b)** unpatched holes at sight of original attachment result in exposed strands.

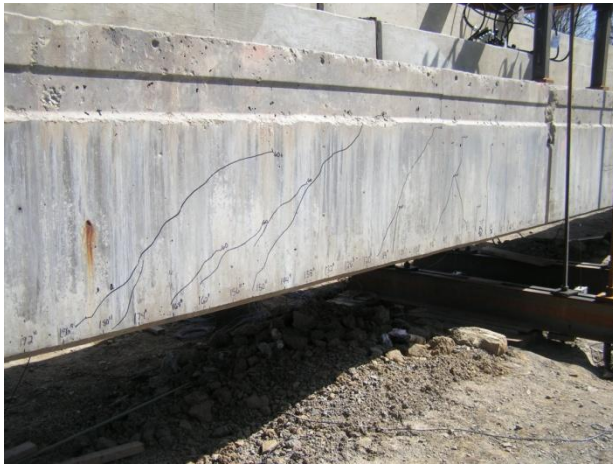
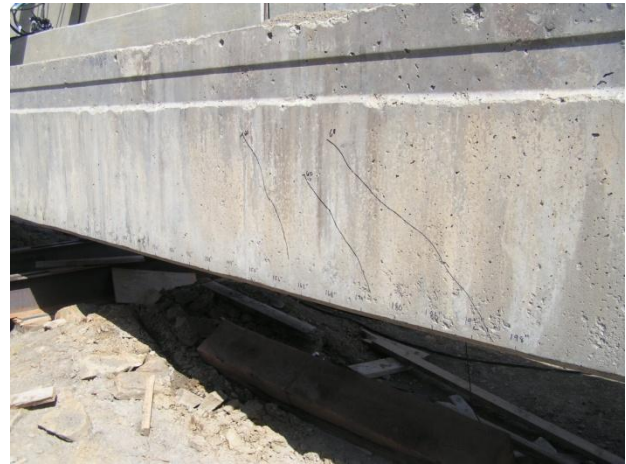
**Figure 1.12** Representative shear distress (Lake View Drive EXTERIOR test girder; Harries 2006).

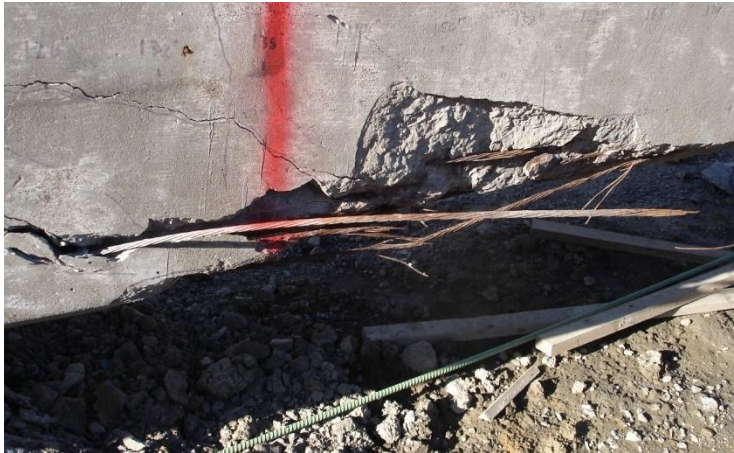
**Figure 7.1** Strand following induced failure of Lake View Drive girder. The 3/8" strand is entirely lost to corrosion at right of image. At left of image, where it was pulled out of sound concrete (left of red paint line) the strand is 'bright steel' with no section loss. (photo: Harries)

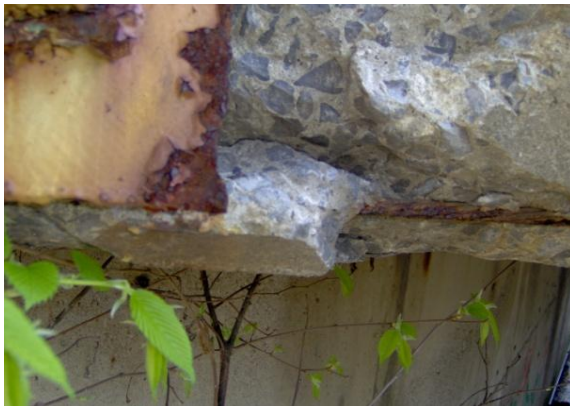
Spalling and strand exposure at beam end

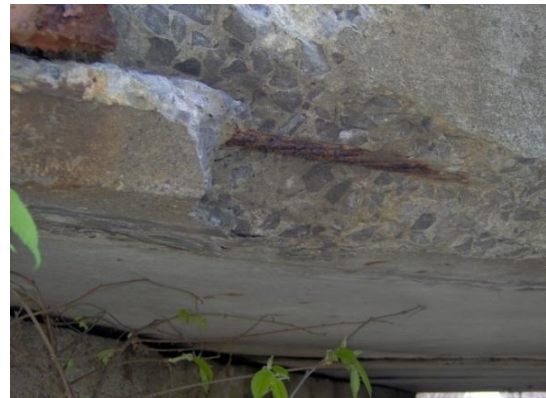
Continuation of spalling and strand exposure

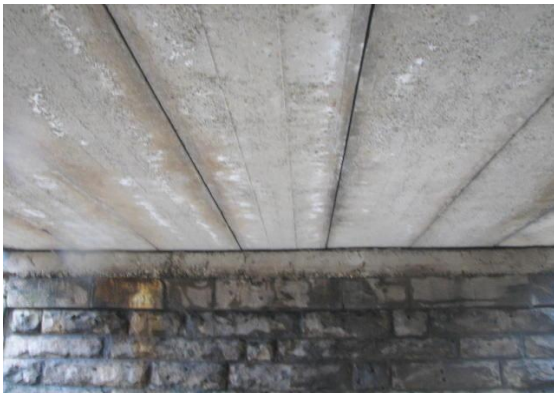
Underside of bridge with moisture and staining in between beams

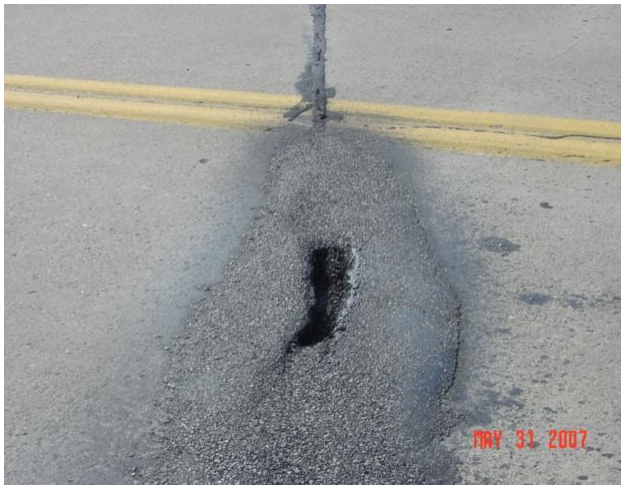
Hole in joint over pier

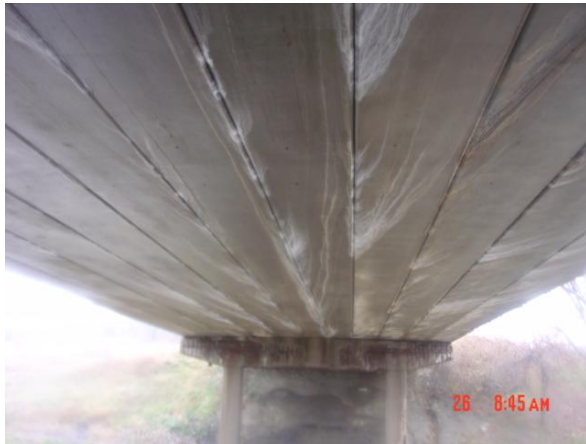
Heavy leakage between beams in Span 2

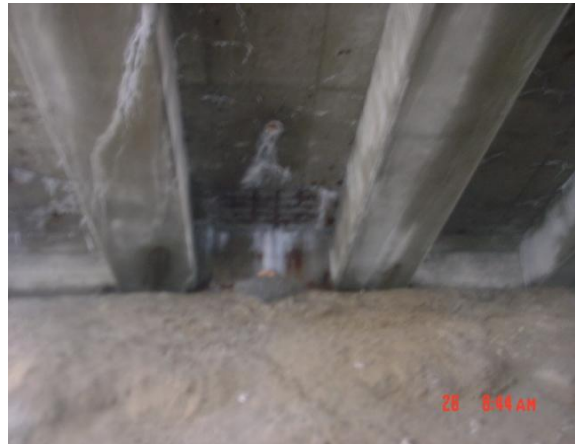
Exposed rebar in the underside of the deck between beams 4 and 5

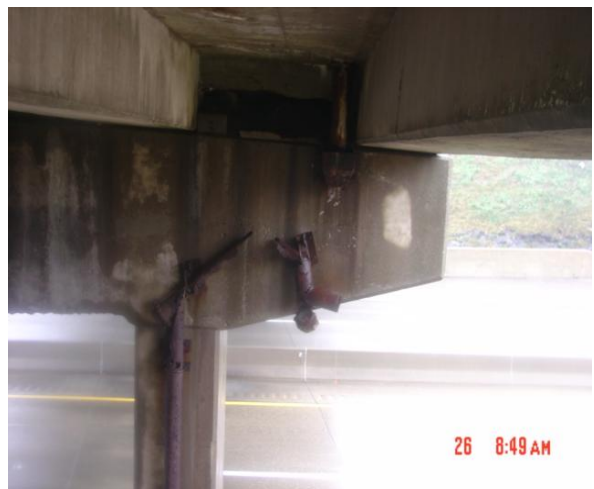
Poor downspout condition, typical for all on this bridge

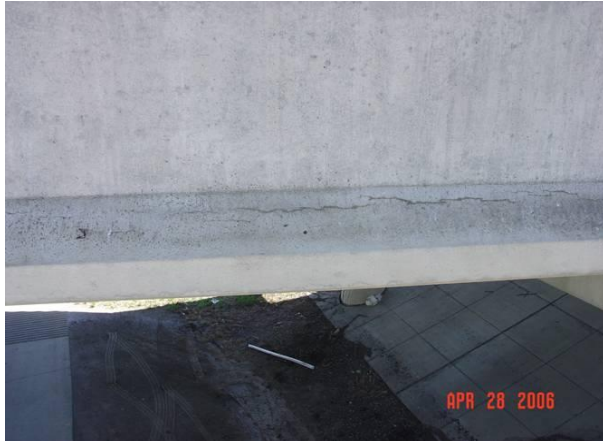
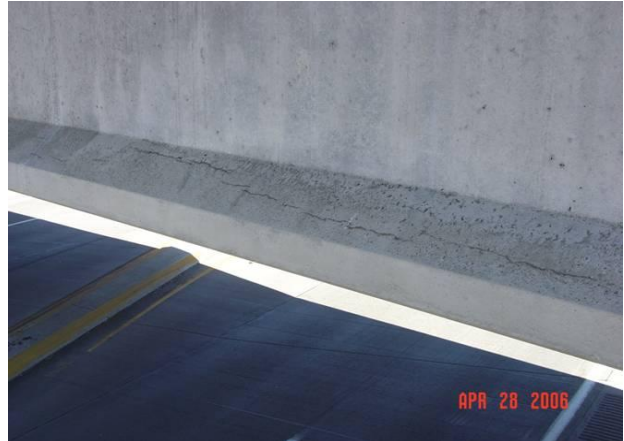
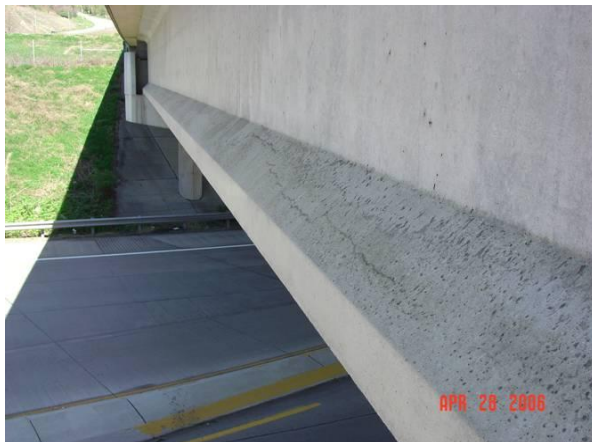
- Longitudinal crack on B1's bottom flange
- Minimum of 15'-0" vertical clearance
- Remaining superstructure in good shape

Longitudinal cracks in the bottom flange of B1

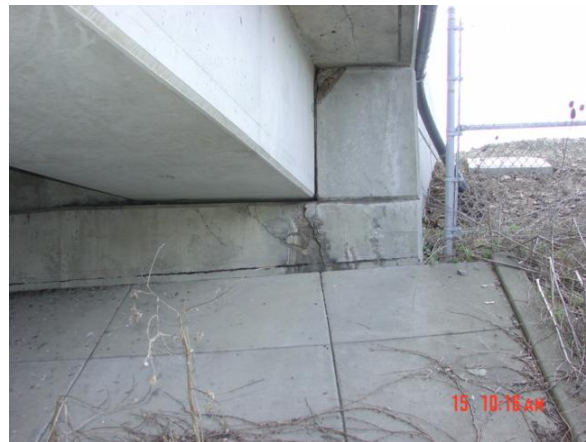
Spalling under B1 at NAB

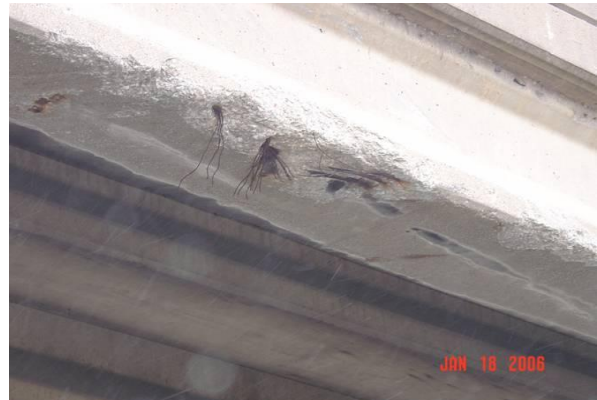
Span 3, Beam 8 – close up

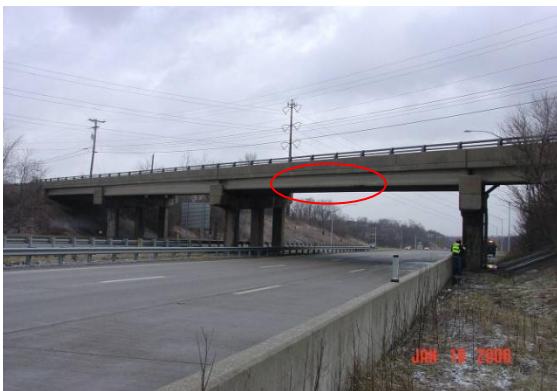
Location of collision damage on Beam 8

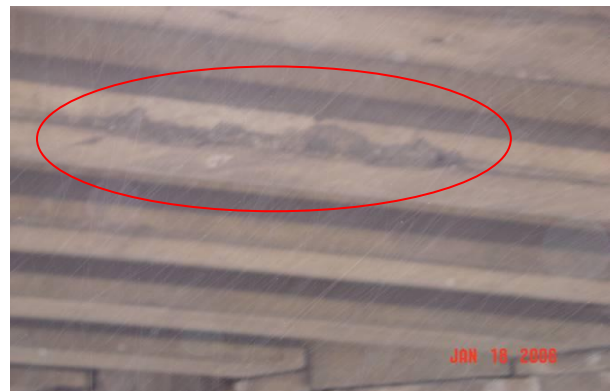
Span 3, Beam 6 – collision damage with spalling

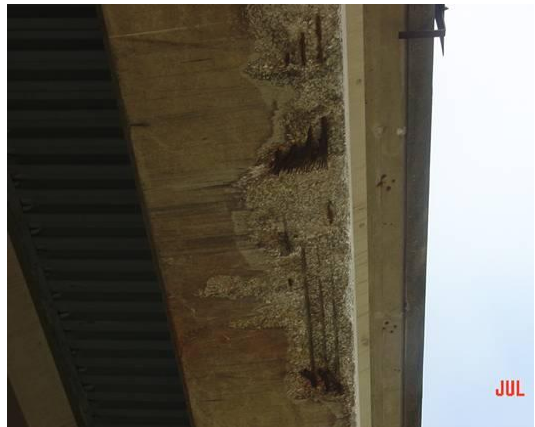
4 broken strands in Beam 1 at location of collision damage

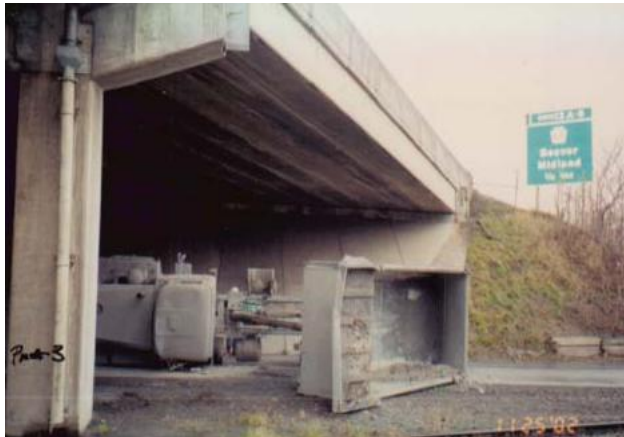
Collision damage

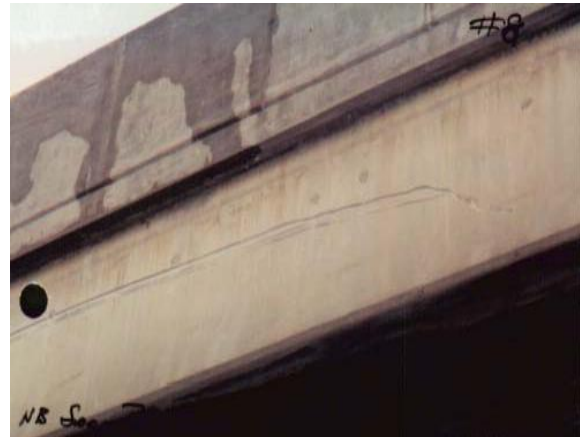
Longitudinal crack from impact damage

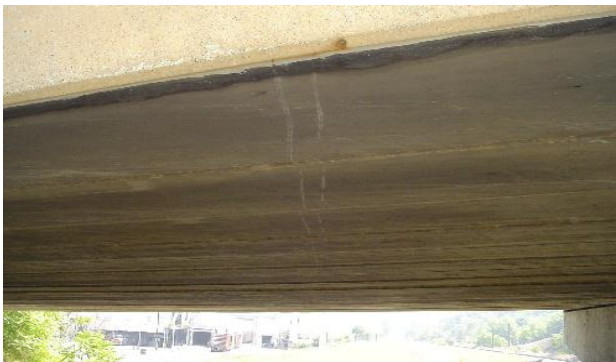
Scraping on underside of Span 4

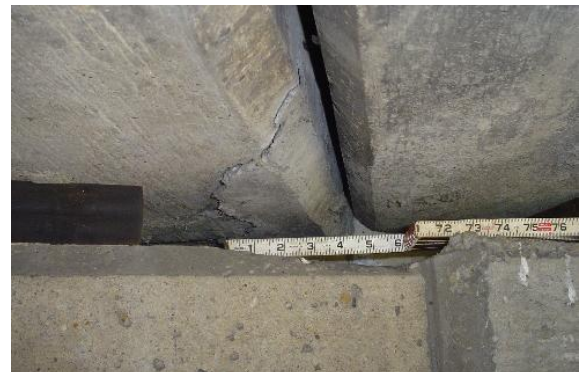
Bottom corner of beam S7, cracked and delaminated at pier
