CORROSION INHIBITORS FOR CONCRETE BRIDGES

FINAL REPORT

FHWA/NC/2006-25

**Prepared for
North Carolina Department of Transportation**

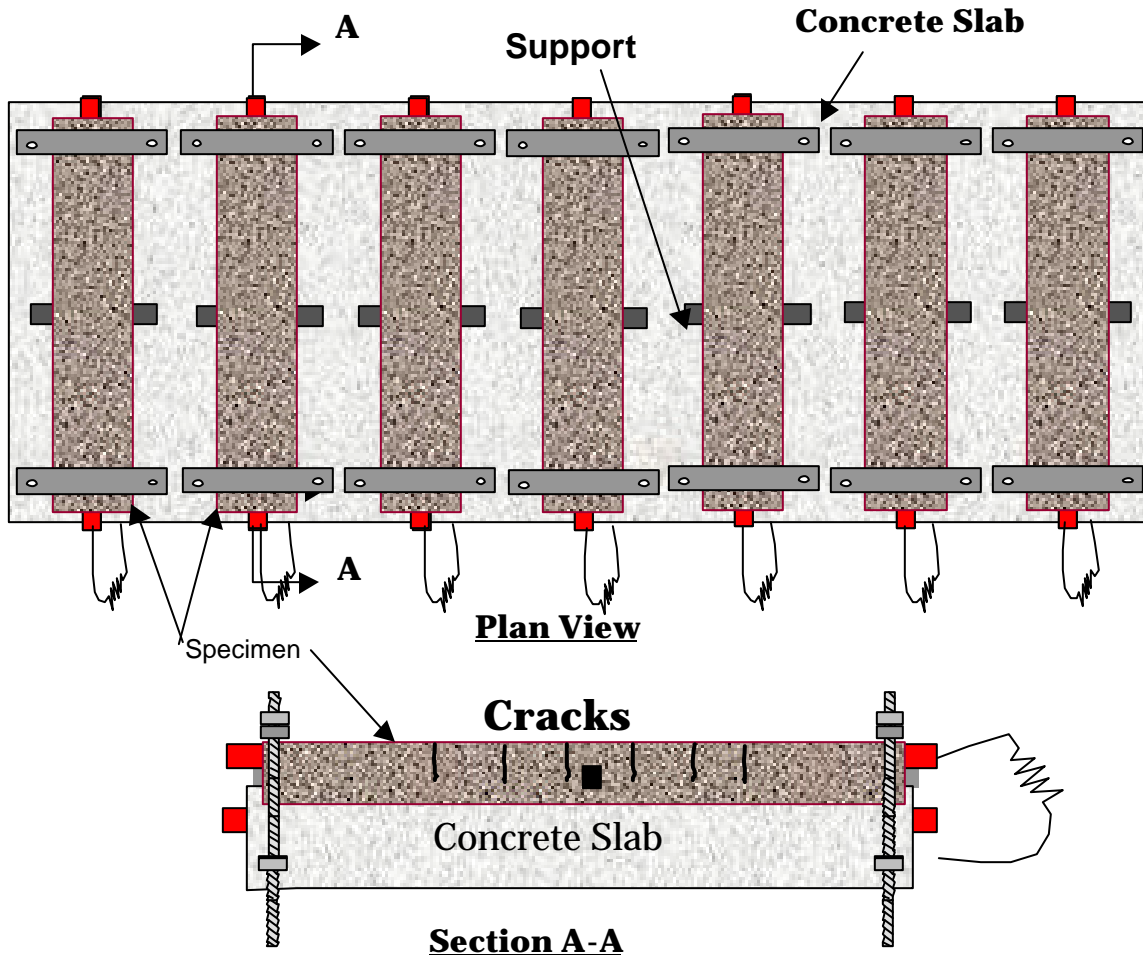
Figure 3.7 – Test Setup

proper corrosion inhibitor products applied to each specimen, ½ in of grout was added on the top of each slab. The purpose for the grout was to provide continuity in the concrete between the specimens and the slabs so that an electrochemical current could freely pass between the two mediums. The grout was made of the same mix as the specimens, except that it did not contain any aggregates. Figure 3.7 shows the test setup.

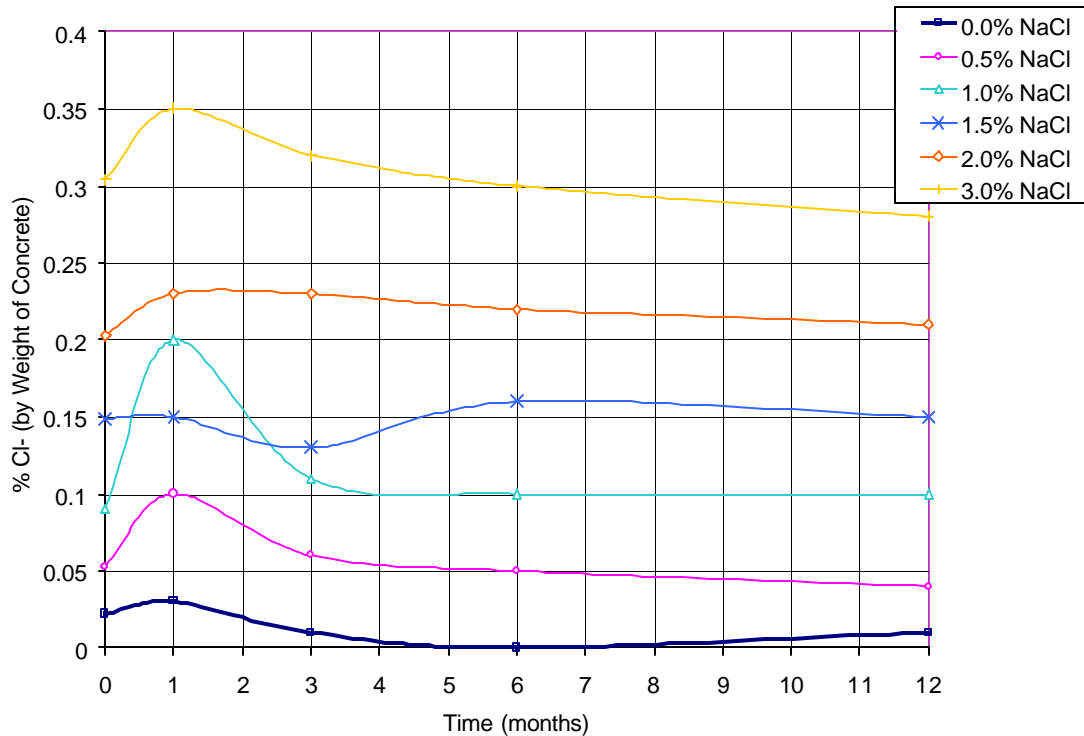
Figure 4.14 - Chloride Content for Control Specimens

The control specimens display the behavior that would be expected. The higher the initial chloride content, the higher the chloride ion percentage tested. There is slight overlap between the 1.0% and 1.5% at one month, but that may be attributed to the collection of the sample of powder, which may or may not include part of the aggregates. Figure 4.15 shows the chloride content for several bath specimens.

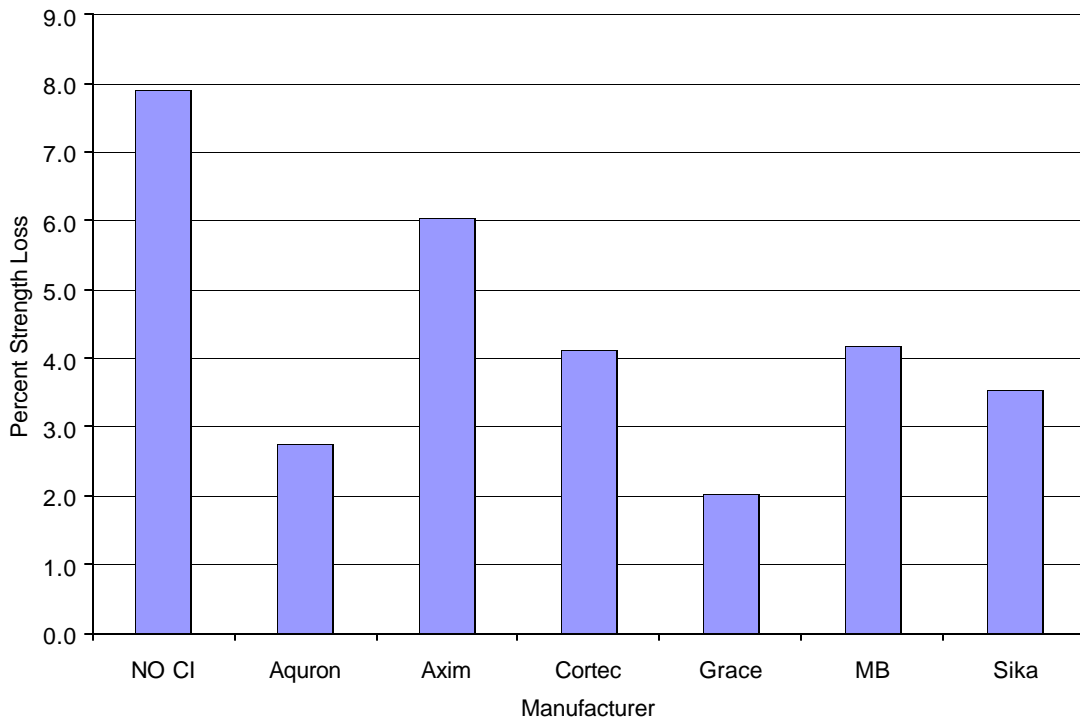
Figure 4.40 – Percent Strength Loss Based on Tension Tests for Chamber 0.5% Chloride, Shelf 4, Pre-Cracked

Figure 4.40 shows the percent strength loss for a set of chamber specimens. The no corrosion inhibitor specimen displays higher percent strength loss than other specimens in this figure. As with the bath specimens this trend does not hold true for most data sets. The specimens at 0.0% and 0.5% initial chloride contamination have a higher occurrence of this trend, as expected. Some products still appear to be effective at levels above 0.5% initial chloride content. Additional tension test results are shown in Appendix G.

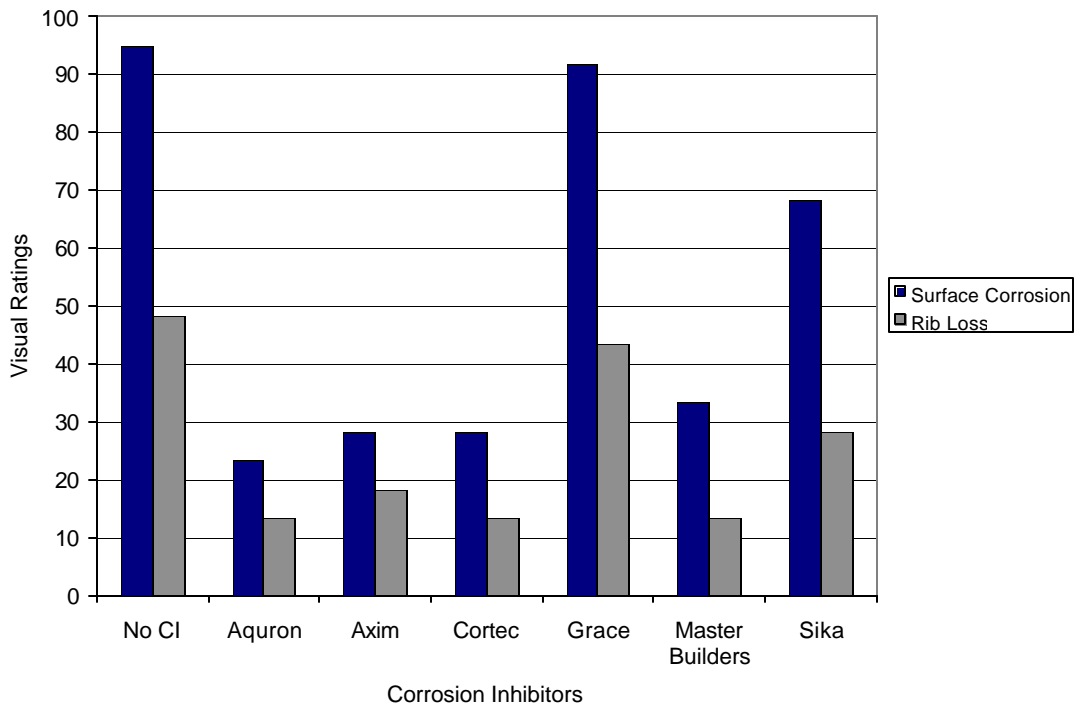
Figure 4.41 – Visual Ratings for Bath 2, 0.0% Chloride, Pre-Cracked Specimens

Although each graph is on a very different scale, it is evident that the same pattern of behavior exists for the corrosion inhibitors in both graphs. The specimen with no corrosion inhibitor performs worst in both visual rating analysis as well as mass loss/strength loss analysis. Most graphs for the bath data exhibit the same pattern of behavior for both visual ratings and mass loss/strength loss graphs when compared side by side. There are, of course, a few exceptions to this pattern. The next two figures show similar graphs for the chamber specimens.

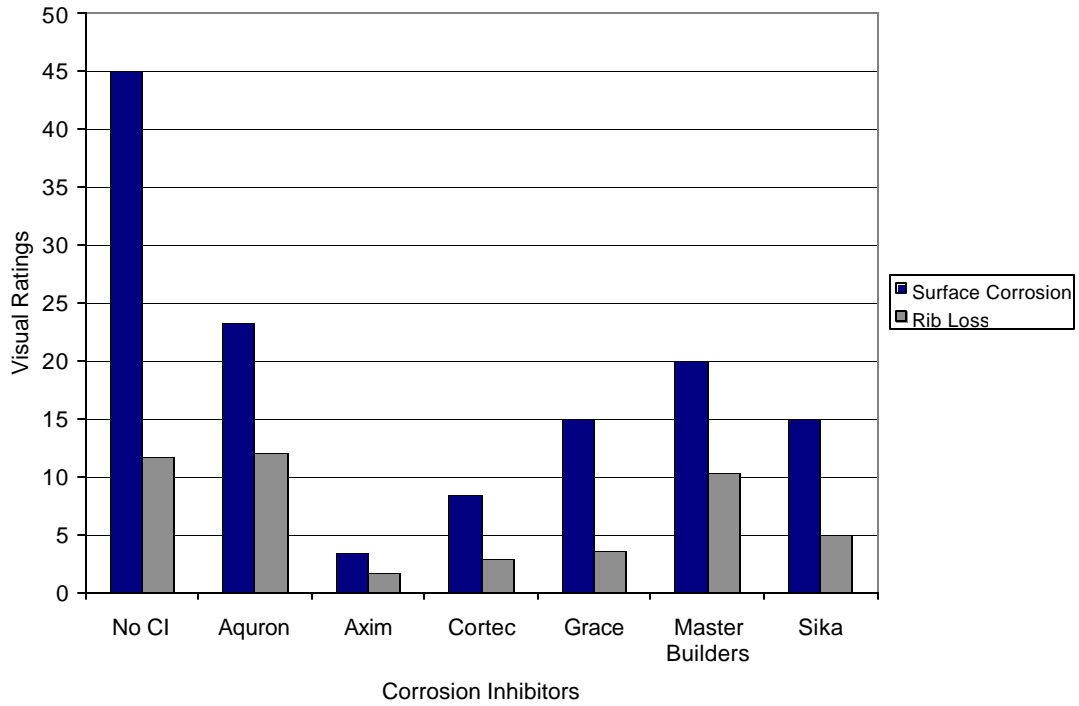
Figure 4.43 – Visual Ratings for Chamber 0.5% Chloride, Shelf 2, Pre-Cracked Specimens

Some of the same results were found with these comparative data sets as the earlier analyses. As the initial chloride contamination level increased, the effectiveness of all corrosion inhibitor products decreased. Along with this, the difference between the performance of the specimens with no corrosion inhibitor products and those with the products also diminished. Although all products show improvement over the control specimens in the lower levels of chloride contamination and earlier stages of exposure, some products seem to show more consistent results than others. All comparisons between the visual ratings and the mass/strength loss can be found in Appendix G.
