**Comparison of the Use of Notched Wedge  
Joints vs. Traditional Butt Joints in Connecticut  
Final Report  
Report No. CT-2249-F-08-4**

Research Project  
SPR-2249

Connecticut Advanced Pavement Laboratory  
Connecticut Transportation Institute  
University of Connecticut  
Storrs, Connecticut

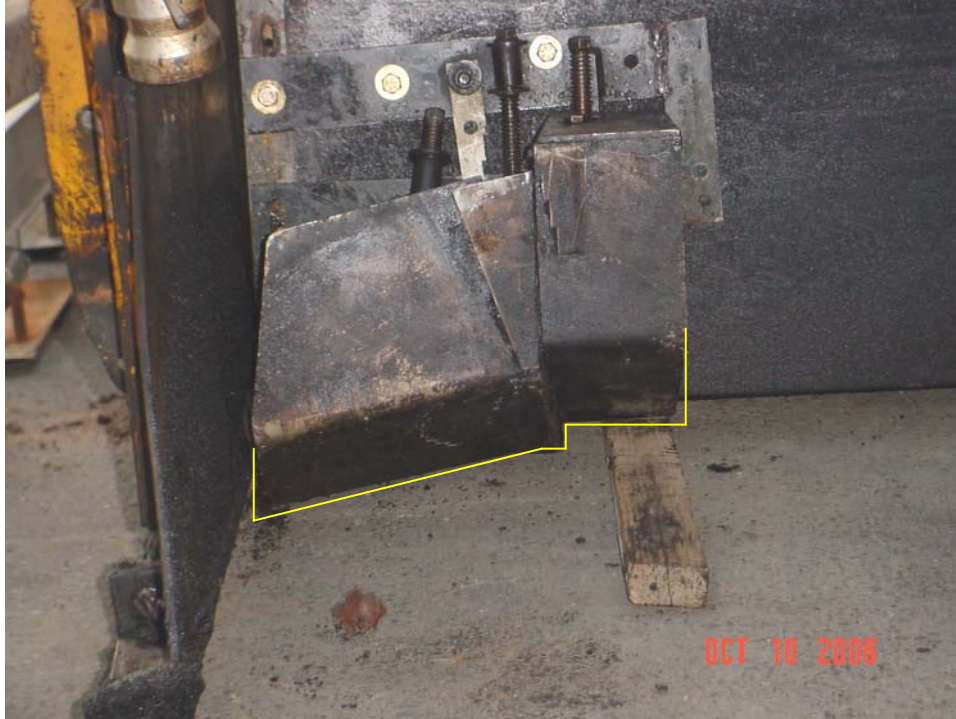
The notched wedge joint was formed by using a Contractor-supplied device attached within the wing of the paver to form its shape (Figure 2). The device was designed to create a notched wedge joint to meet the State’s trial specifications. The device allowed for adjustment in the formation of the wedge in its length and slope. The depth of the notch is also adjustable. To compact the wedge, a vibrating plate compactor was used. The plate is connected to the paver and is set just behind the wing directly over the wedge (Figure 3). The resulting notched-wedge joint is shown via a theoretical diagram in Figure 4.

**Figure 2 Notched Wedge Forming Device**

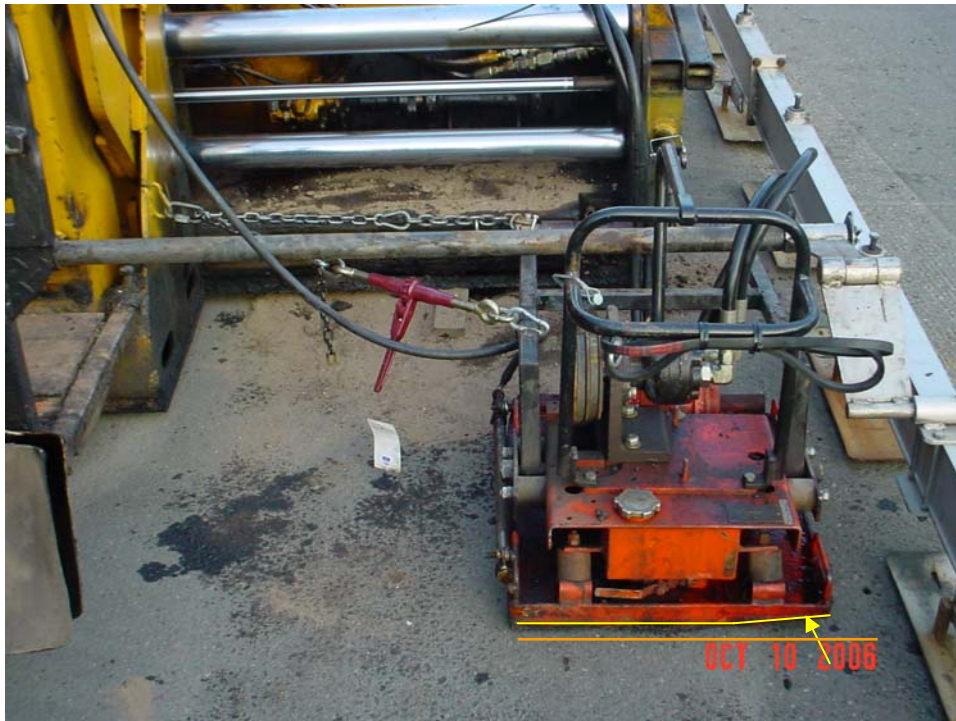
**Figure 3 Wedge Compaction Device and Setup**

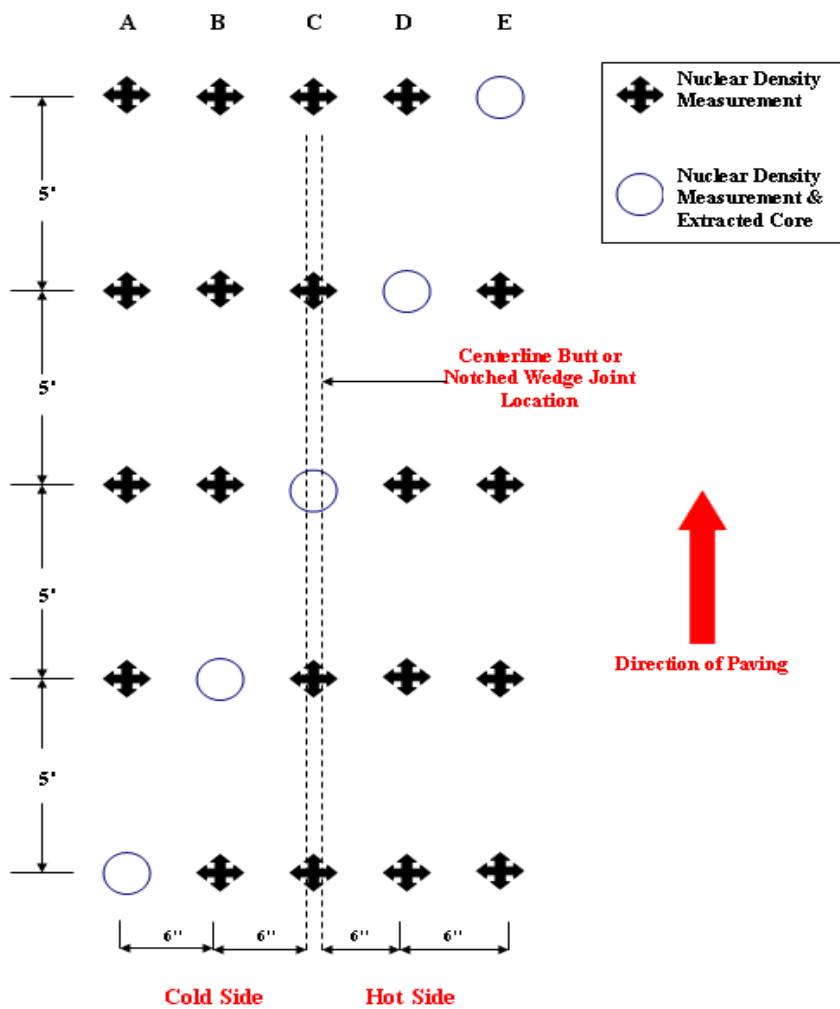
This data was obtained through vigorous nuclear density testing of the material and finally extraction of cores in several of the nuclear density test locations for laboratory measurement. Unfortunately, while it is possible to perform non-destructive nuclear density tests immediately adjacent to one another, cutting cores immediately adjacent to one another to form a profile is not possible. First, subsequent cores that would be cut would have been disturbed by the extraction of the previous core. Second, the amount of damage to such a small area of the mat may have been problematic. Therefore, nuclear density profiles were measured across the joint starting 1 foot from the joint on the cold side and continuing in 6-inch increments to 1 foot from the joint on the warm side (Figures 5 and 6). In addition, profiles were created at 5-foot intervals in the direction of paving. Cores were extracted from the first profile in the location where the nuclear density testing took place 1 foot from the joint on the cold side. Moving to the next profile which would be 5 feet in the longitudinal direction, a core was extracted in the location where the nuclear tests were performed 6 inches from the joint on the cold side. 5 feet from that location in the direction of paving another core was extracted directly on the joint where nuclear measurements took place. The core extraction was repeated 6 inches from the joint on the warm side, and finally, 1 foot from the joint on the warm side. Thus, five nuclear density profiles and five cores were obtained over each 20-foot section (Figure 6).

**Figure 6 Data Collection Diagram (Typical Test Section)**

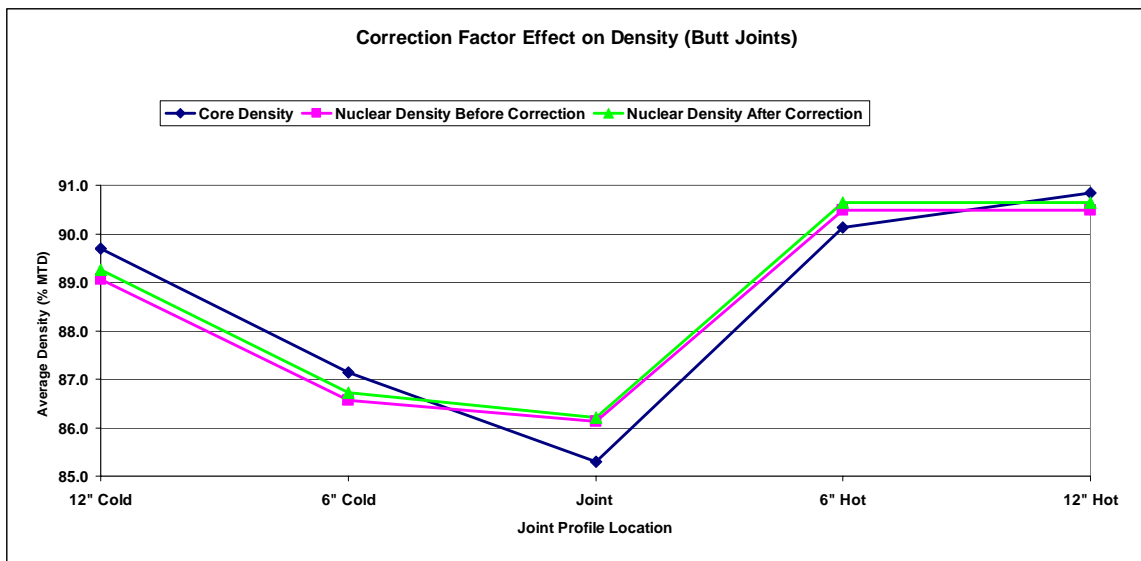
Appendix B. Figure 7 shows the overall comparison of average nuclear density values to average core density values both before and after the application of the correction factor. Locations B and C correspond to the areas within the average profile that exhibit the lowest density. The fact that the correction factor appears to be least effective in location C (the joint location) may be due in part to a number of things. First, in determining correction factors, there were fewer useable cores for this region of the joint than in each of the locations A, B, D and E. This is because several of them were broken upon extraction. There is also a possibility that nuclear density gauges produce readings of lesser accuracy at lower density levels and, in turn, better accuracy at higher density levels.

**Figure 7 Plot of Correction Factor Effect on Butt Joints**

It should be noted that the data used to compile the comparison for Table 2, Appendix B and for Figure 7 does not include data from Project 174-332H, Rt. 341 in Kent. There are no nuclear density data available for that project. However, all further butt joint data analyses and comparisons will include and use volumetric core density data from that project.

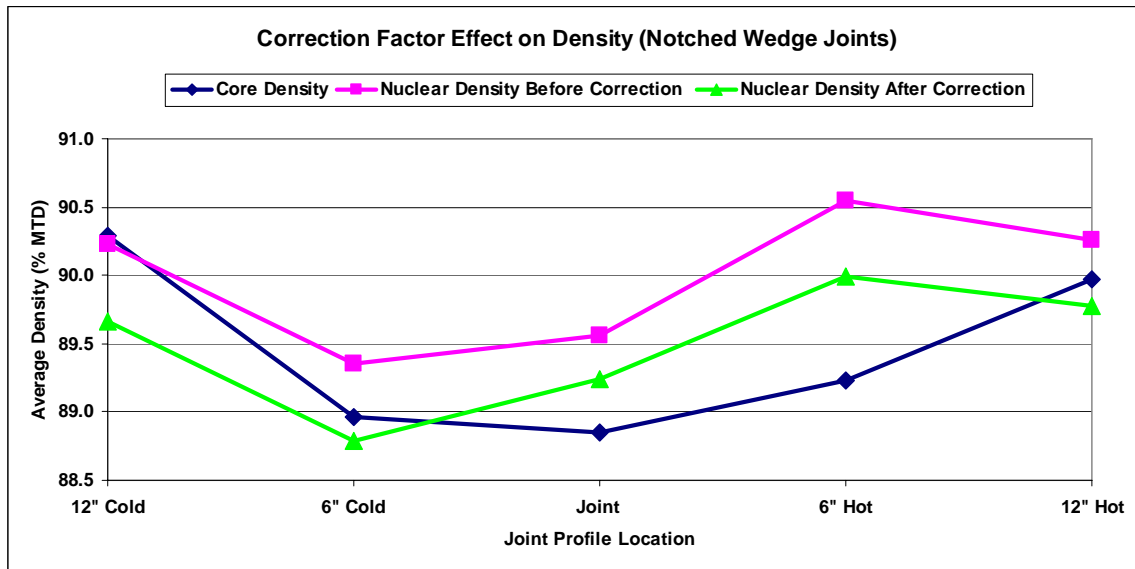
**Figure 8 Plot of Correction Factor Effect on Wedge Joints**

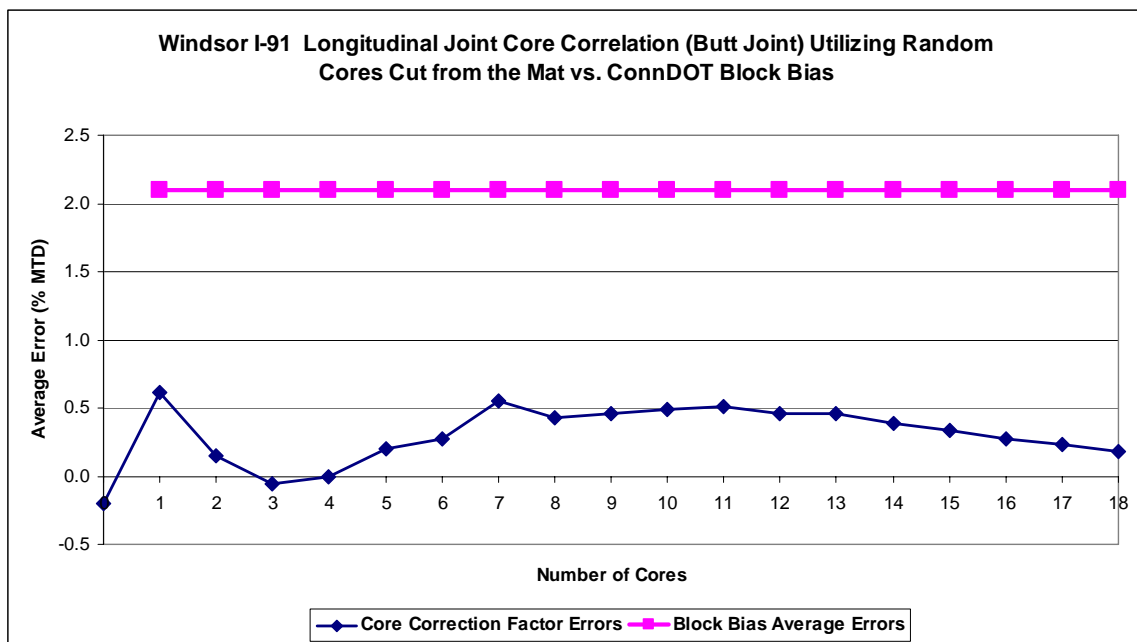
correction factor which produced the corresponding average error on the y-axis for the correlation procedure. The block bias procedure is simply one number added to, or subtracted from, a nuclear gauge reading. This is the reason for the constant average error shown for the block bias data series. Figure 9 indicates for butt joints the core correction factor procedure kept the error well within 1% of maximum theoretical density. The block bias application for the butt joints yielded an error of 2.1% of maximum theoretical density on the butt joints. Figure 10 shows that for notched wedge joints the application of the core correction factor resulted in errors all less than 1.0% of maximum theoretical density. The block bias application resulted in an average error of 1.8% maximum theoretical density. It should be noted that all of the cores and nuclear density values used for these comparisons came from the same project (63-577, I-91 constructed in 2007). This project was selected for this comparison because this is the project with the largest random mat core dataset as well as the largest butt joint and notched wedge joint dataset.

**Figure 9 Comparison of Correction Factor Procedures for Use on Butt Joints**

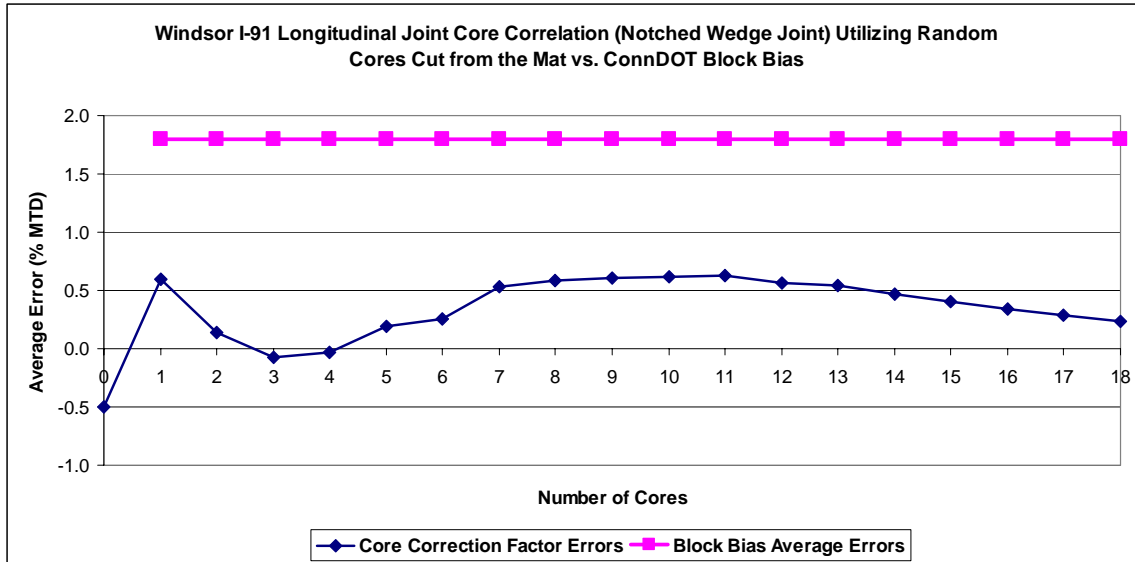
**Figure 10 Comparison of Correction Factors for Use on Notched Wedge Joints**

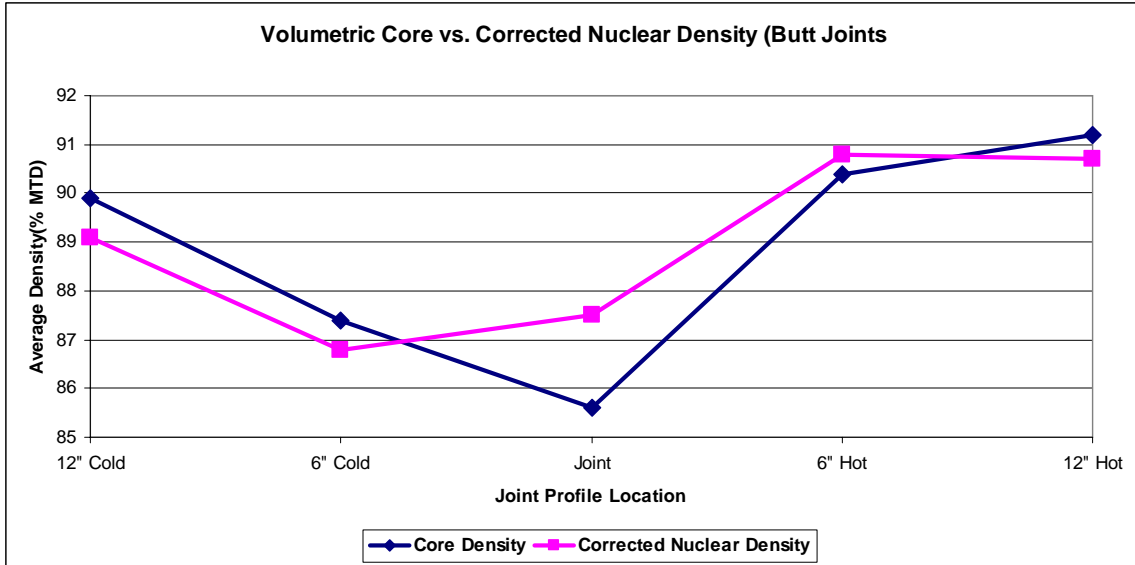
The two sets of data are shown in profile in Figure 11. The volumetric core density average values in Figure 11 do include the values from the Rt 341, Kent project.

**Figure 11 Butt Joint Core and Corrected Nuclear Density by Profile Location**

Given the data and graphical depictions of the density in Tables 4, 5 and in Figure 11, it is clear that the density in the vicinity of 6 inches on the cold side to the joint location itself (Locations B and C) exhibit a significantly lower density value than all of the other areas (Locations A, D and E). It can also be observed that the density at Locations D and E exhibit the highest level of density within the profile. The difference from Location C to Location D, is the largest (most significant) change in density over the profile whether looking at nuclear density data or volumetric core data. This is largely due to the presence of lateral confinement from the previous pass when paving the second pass and finishing the longitudinal joint.

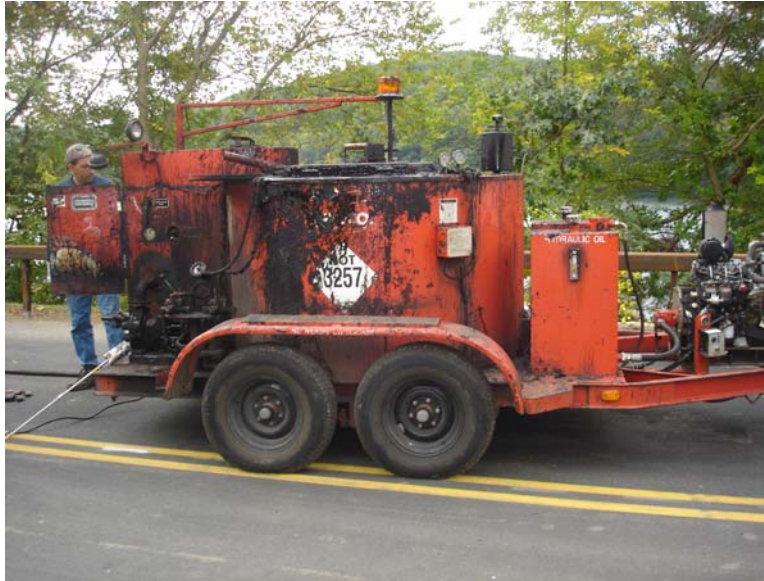
**Figure 12 Rubberized Joint Sealant Melting Pot on Trailer**

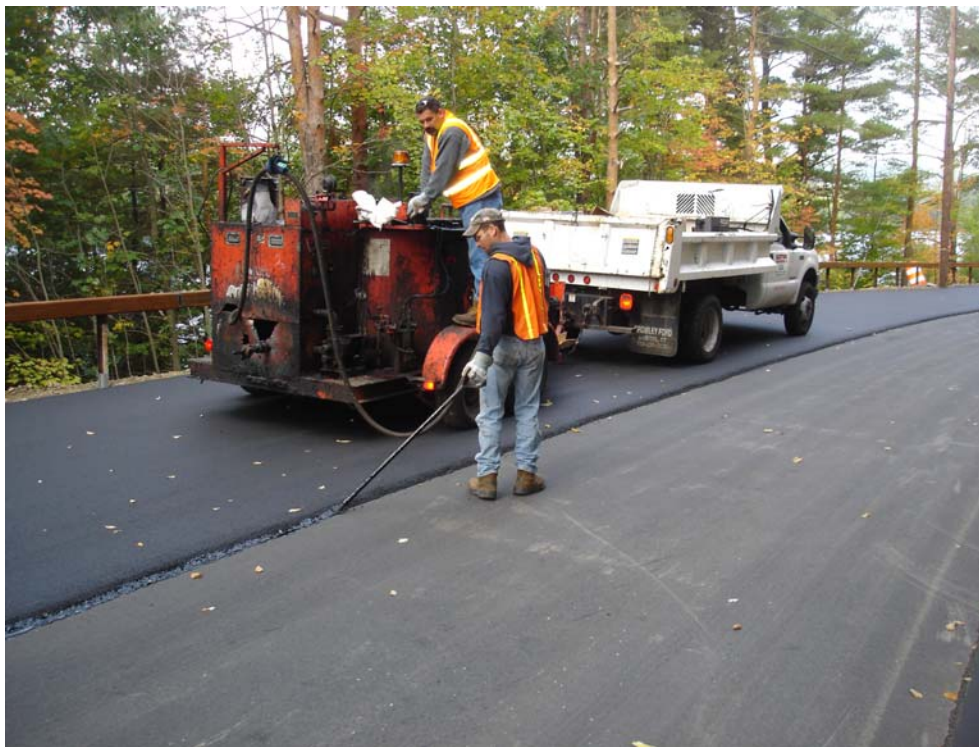
**Figure 13 Rubberized Joint Sealant Application**

*Field Observations- Constructability:* The method of application consisted of the trailer mounted melting pot being pulled by a pick-up truck with a technician applying the joint adhesive by wand to the joint. The application rate was controlled by a valve on the wand handle. The “foot” applicator at the end of the wand was dragged along the face of the butt joint spreading the joint seal material.

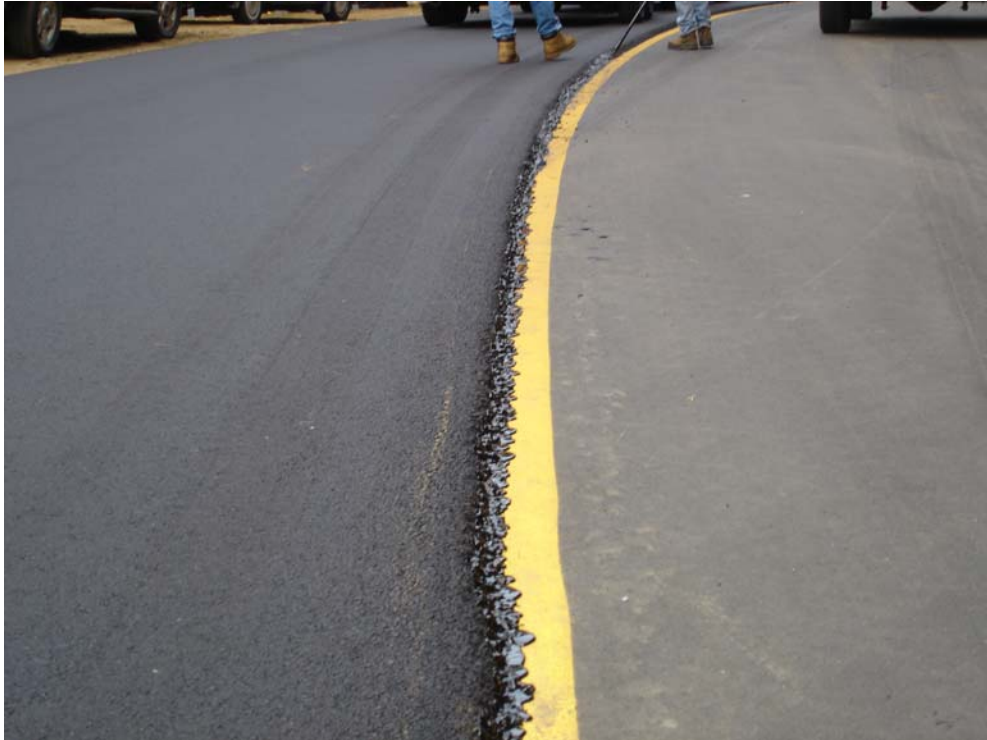
**Figure 14 Rubberized Joint Sealant Applied to Cold Side of Joint**

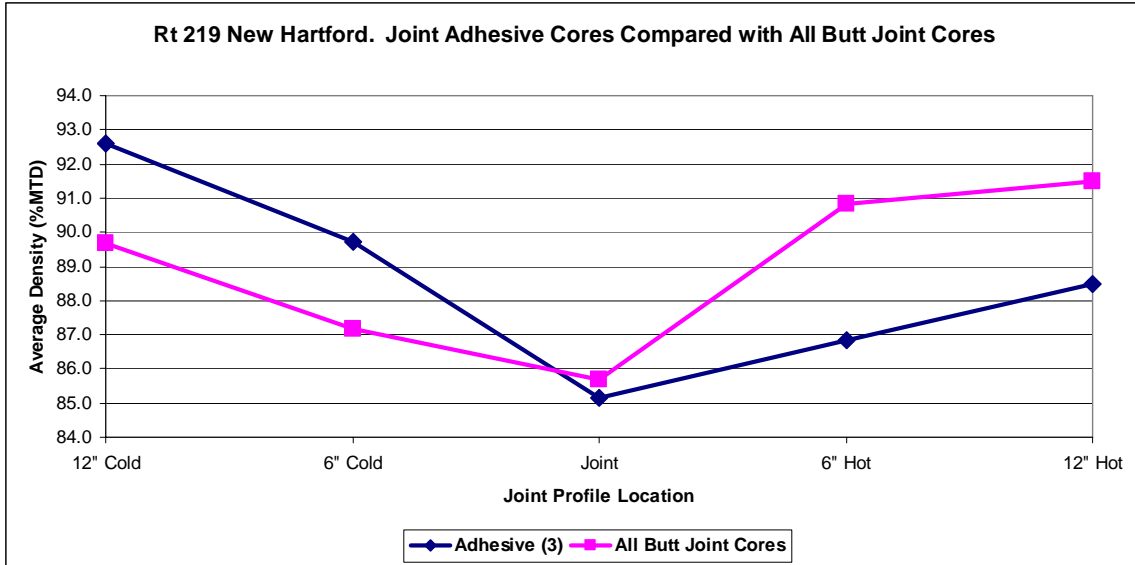
A performance analysis on the use of the rubberized joint sealant is difficult at this time in that it depends on the length of time for which the joint remains durable. This analysis may be performed in the future. For purposes of this research, it was desired to try and combine this data with the data already collected for the butt joint. There were only 20 cores (4 sections) of data collected on this project. To make the determination as to whether or not this data could be combined with the existing butt joint data, the density averages of those sections which were paved using the joint sealant were simply plotted against the existing density averages. This plot is shown in Figure 15.

**Figure 15 Effect of Rubberized Joint Sealant**

As seen in Figure 15, the joint adhesive had little (if any) effect on the density behavior at the joint location. The density plots also cross over each other indicating some similarity. As such, it was decided by the research team that this data could be included with the butt joint data and there was no reason to treat it any differently. That decision being made, all butt joint data presented in this report includes the cores and nuclear density values obtained from Project #91-108.

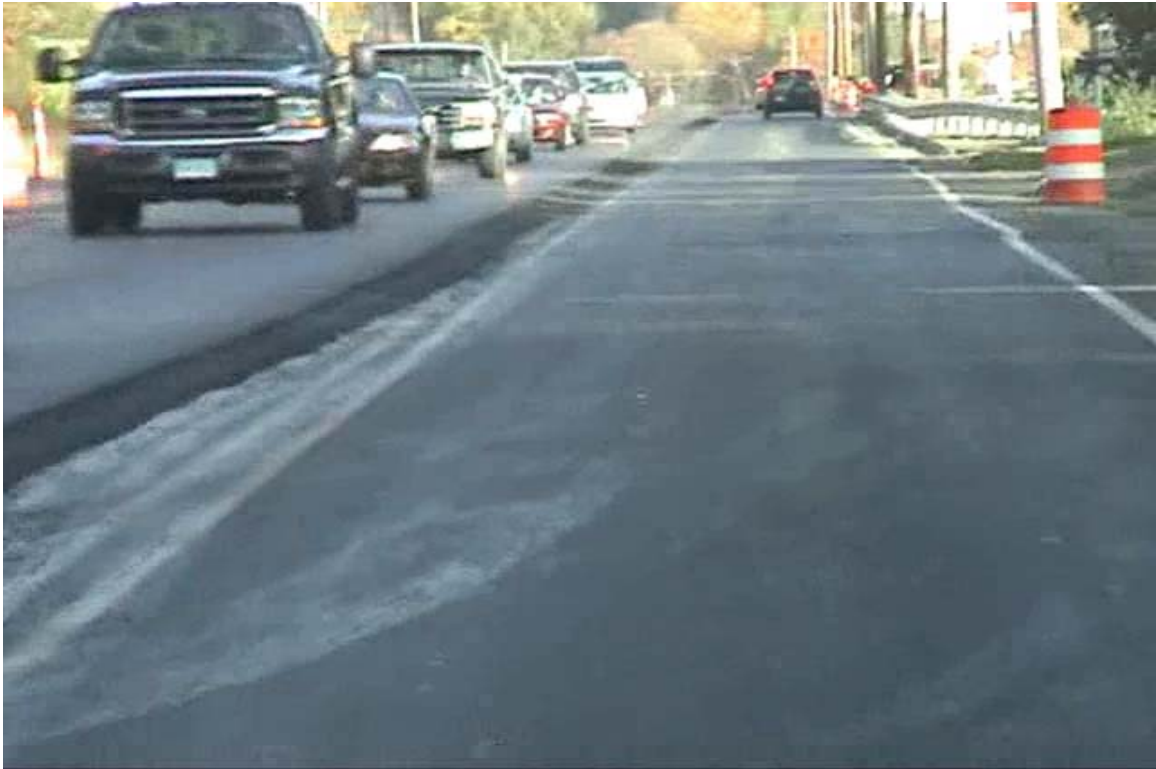
**Figure 17 Traffic on Open Notched Wedge Joint**

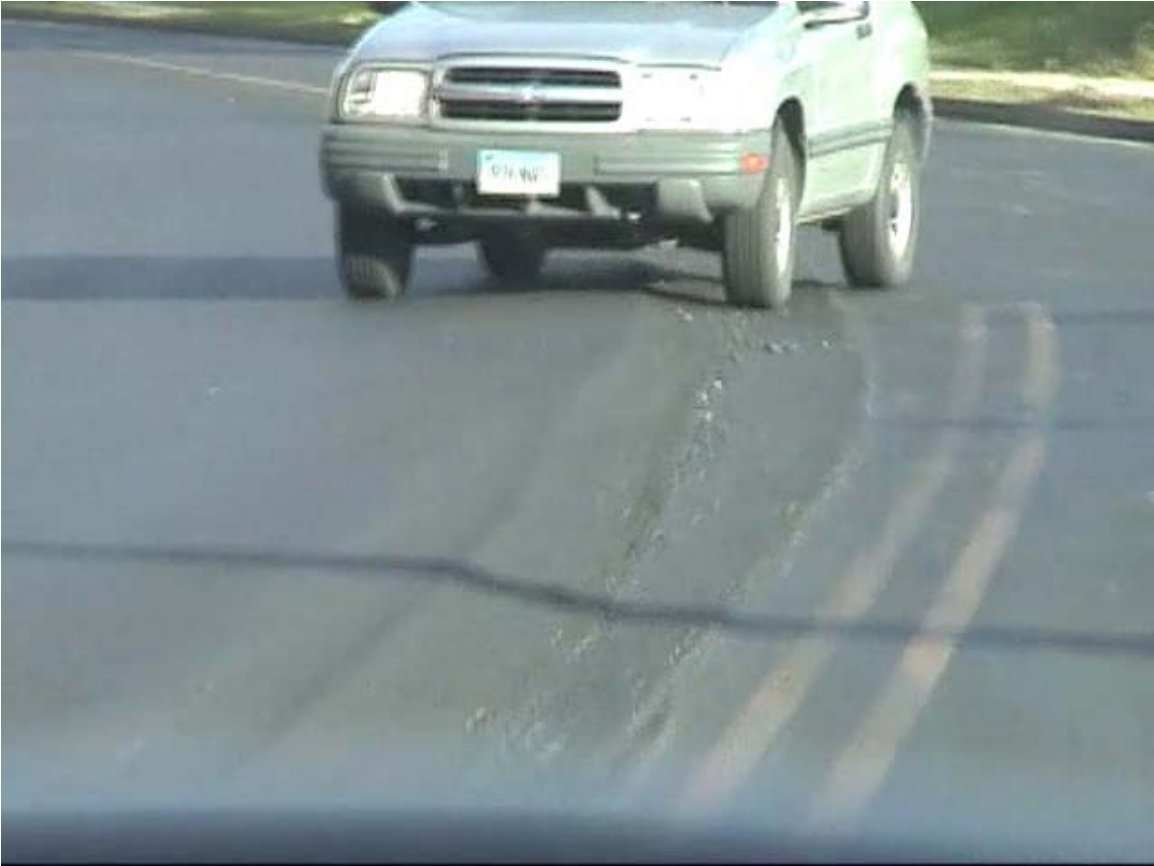
The construction and use of the exposed joint as it was opened to traffic was filmed once again by ConnDOT's Pavement Advisory Team. Because the joint was located at the centerline of opposing traffic, it was not traversed as regularly as it was on the previous project. It was only traversed when cars were entering/exiting businesses and side streets. This resulted in very little loose aggregate visible in the travel lanes. No additional sweeping was performed as it was deemed not to be necessary. Once again, cars and trucks had no problem traversing the notched wedge joint (Figure 19).

**Figure 19 Traffic Traversing Open Joint**

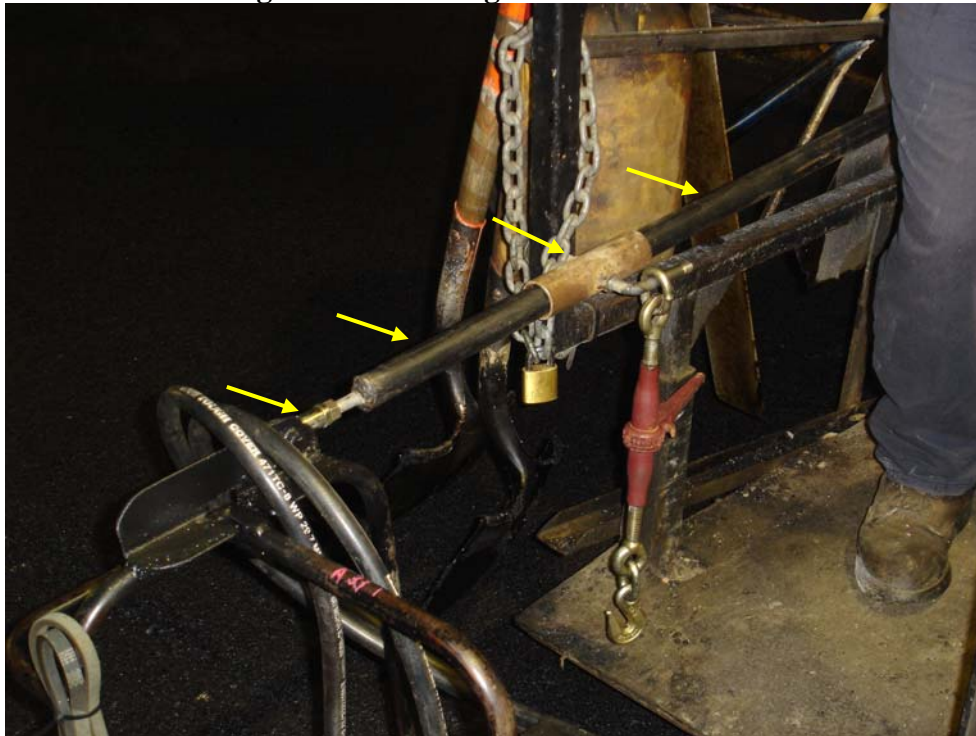
***Project Equipment:*** Tilcon utilized the same notched wedge joint device and vibrating plate as the previous two pilot projects. It was, however, modified once again in the way that the vibrating plate was attached to the paver. The chain and ratcheting device were replaced by a steel bar that was able to be more quickly adjusted and fixed at any length, thus reducing the time for plate adjustments. See Figures 20 and 21.

**Figure 20 Vibrating Plate Attachments**

**Figure 21 Vibrating Plate Attachments**

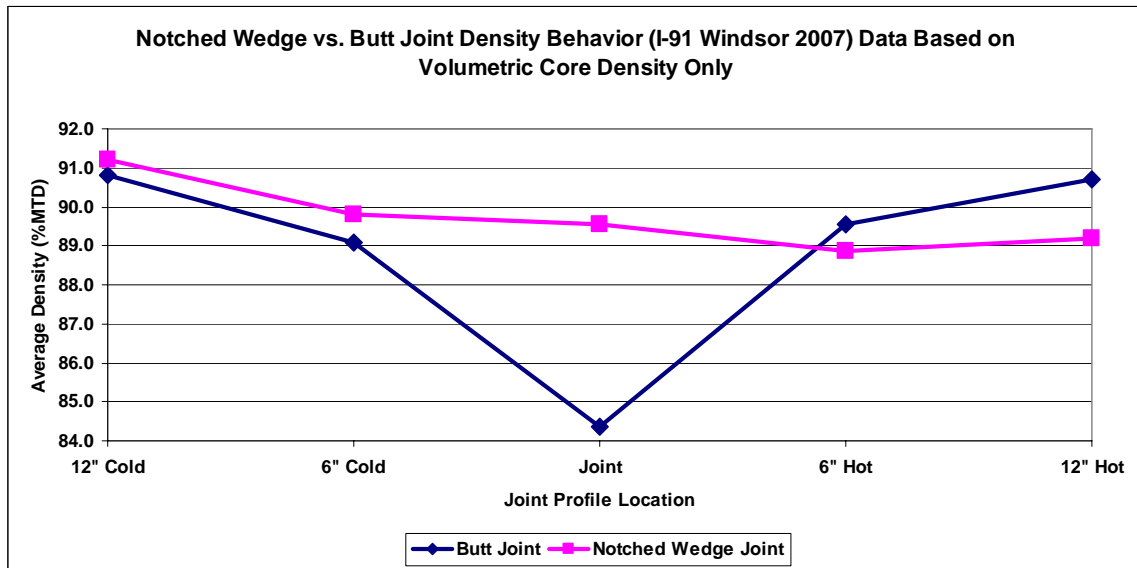
**Figure 22 I-91 Windsor Average Joint Density Comparison (Notched Wedge vs. Butt Joint)**

In viewing the plots in Figure 22, it is clear that the density in the sections which utilized the butt joint exhibited a large decrease in density (~4.5 % MTD) moving from 6" on the cold side to the joint location itself. There is also a drop in density (~2.0% MTD) from 12" on the cold side to 6" on the cold side. This decrease in density is then mitigated moving from the joint location to 6" on the hot side of the joint. This inconsistency is not present when viewing the plot which outlines the density of the notched wedge sections. The notched wedge plot remains relatively uniform moving across the longitudinal joint in comparison with the plot of butt joint density. Also of importance in this comparison is simply the improvement in the level of density at the joint location with the use for the

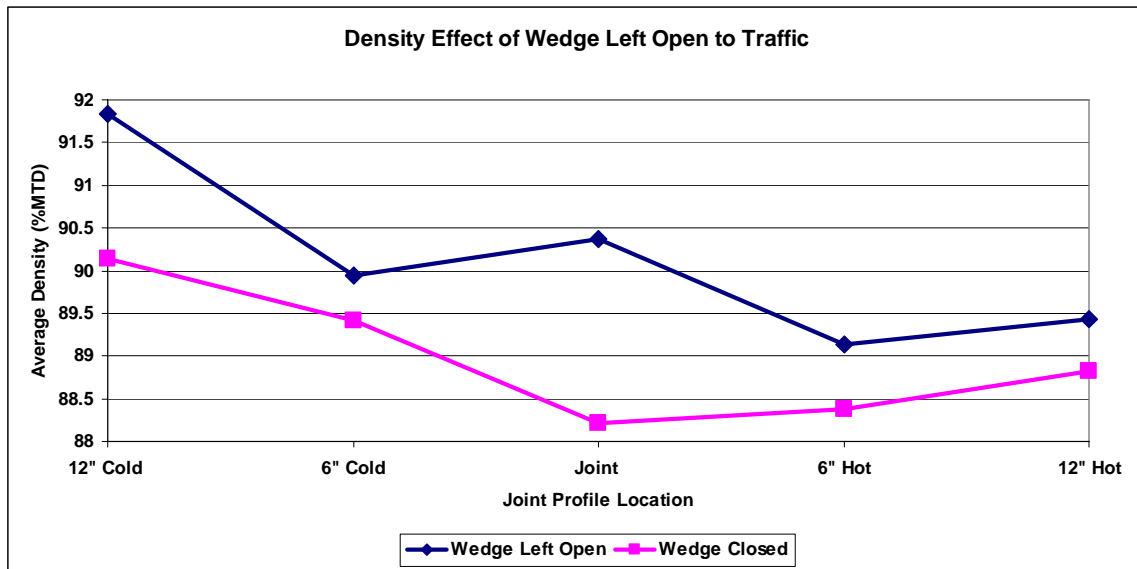
Also investigated during the course of the data analysis for this specific project, was the effect on density performance when the wedge was left exposed to traffic for a period of time before the hot side of the joint was placed. Figure 23 shows a density plot of the notched wedge as left open to traffic versus having been completed in the same night.

**Figure 23 Closed vs. Exposed Notched Wedge Joint Average Density Behavior**

The plots show in Figure 23 that there is no adverse effect on density performance when the wedge portion of the joint is left exposed to traffic. If there was indeed an effect, it was positive. This is important to note as it could be desirable to leave wedges exposed to expedite paving efficiency on some projects if the notched wedge joint is adopted in the State of Connecticut.

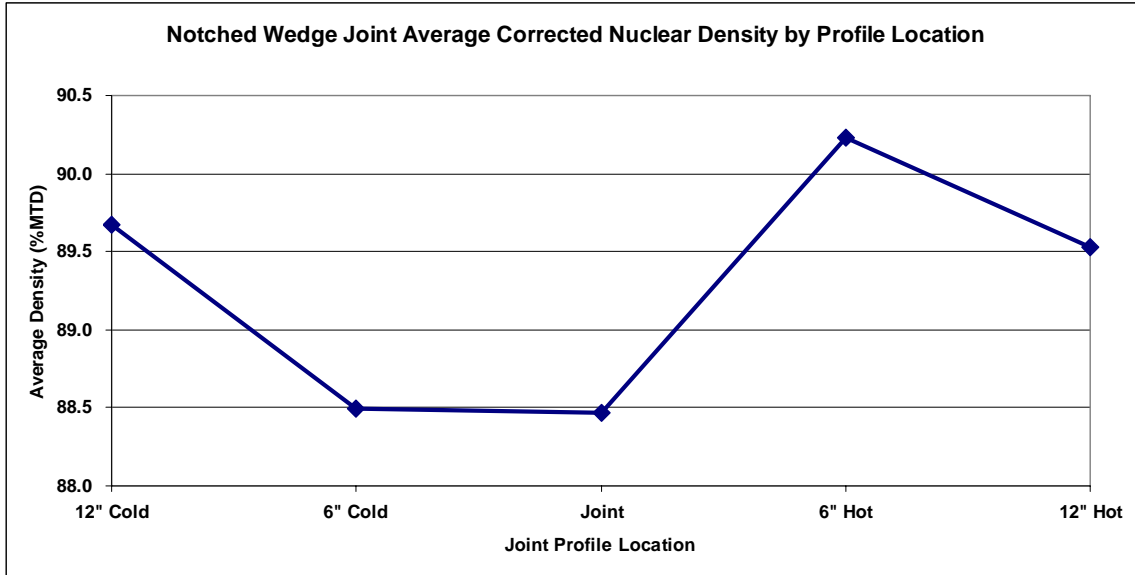
Figure 24 shows a plot of the average nuclear density behavior. The cold side of the joint overall appears to maintain lower density and more specifically the area of lowest density occurs from 6 inches on the cold side of the joint to the joint location itself which was also the case for traditional butt joints which will be discussed later in further detail. This may be due in part to less lateral confinement present during the compaction of the first paver pass. During the compaction of the second paver pass, the first paver pass provides the lateral confinement that the second pass can be compacted against. This holds true for traditional butt joints as well.

**Figure 24 Notched Wedge Average % Corrected Nuclear Density by Profile Location**

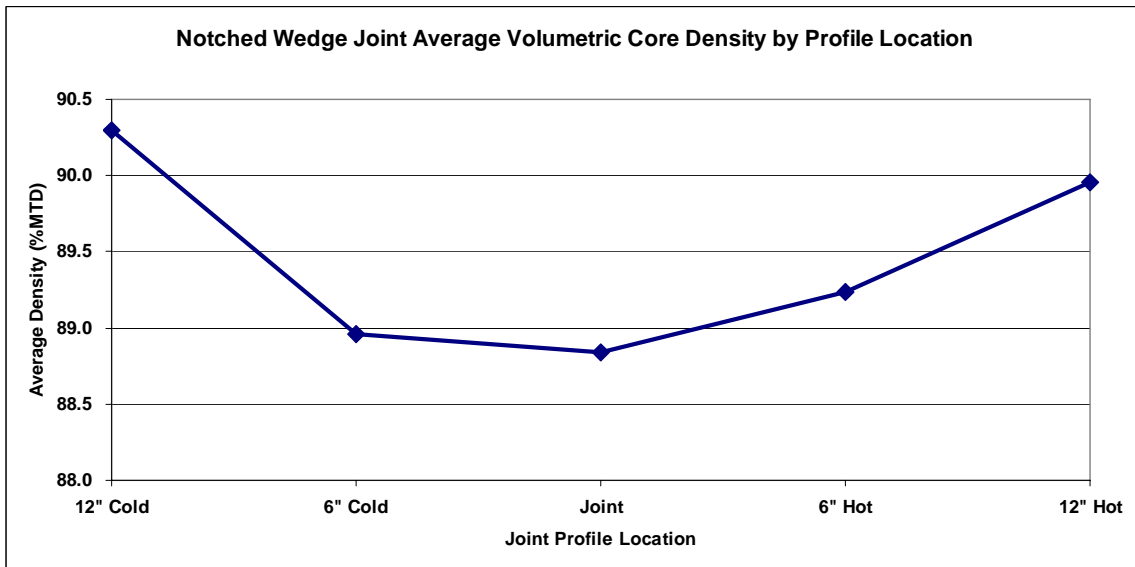
**Figure 25 Notched Wedge Average % Volumetric Core Density by Profile Location**

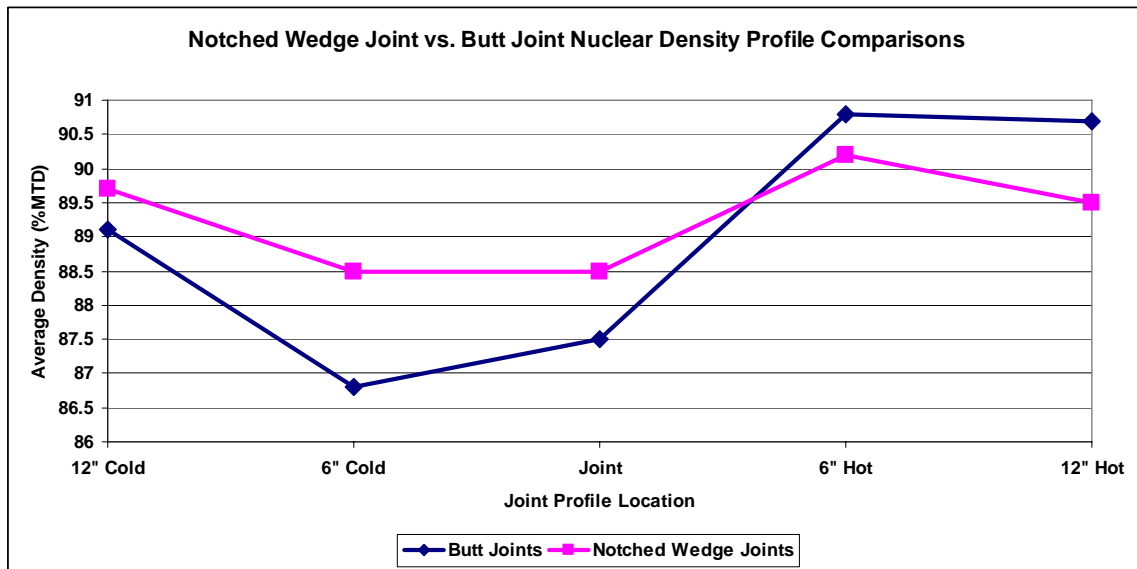
**Figure 26 Butt Joint vs. Notched Wedge Joint (Nuclear Density)**

It appears, based upon these comparisons, that the notched wedge joint provides a higher level of density on the cold side of the joint than does the butt joint. This is the case with both of these two comparisons. This could perhaps be a result of the material present in the wedge acting as lateral confinement for the material being compacted at locations A and B. The density at the joint itself appears to be higher on the notched wedge joint than the butt joint when examining both the core density values as well as the nuclear density values. The density at location D (6 inches on the hot side) appears to be less than 1% lower on the notched wedge joint than the butt joint on both plots. The density of the material at location E (12 inches on the hot side) is also lower for the notched wedge joint than the butt joint when examining the core and nuclear density as well. In both cases, the difference is less than 1.5% and this level of variation can be expected as density is observed across a pavement mat. The profiles illustrating the density performance for the butt joints is less uniform than that of the notched wedge joint as well. The range of density within the butt joint averages is 5.6% MTD while that of the notched wedge joint

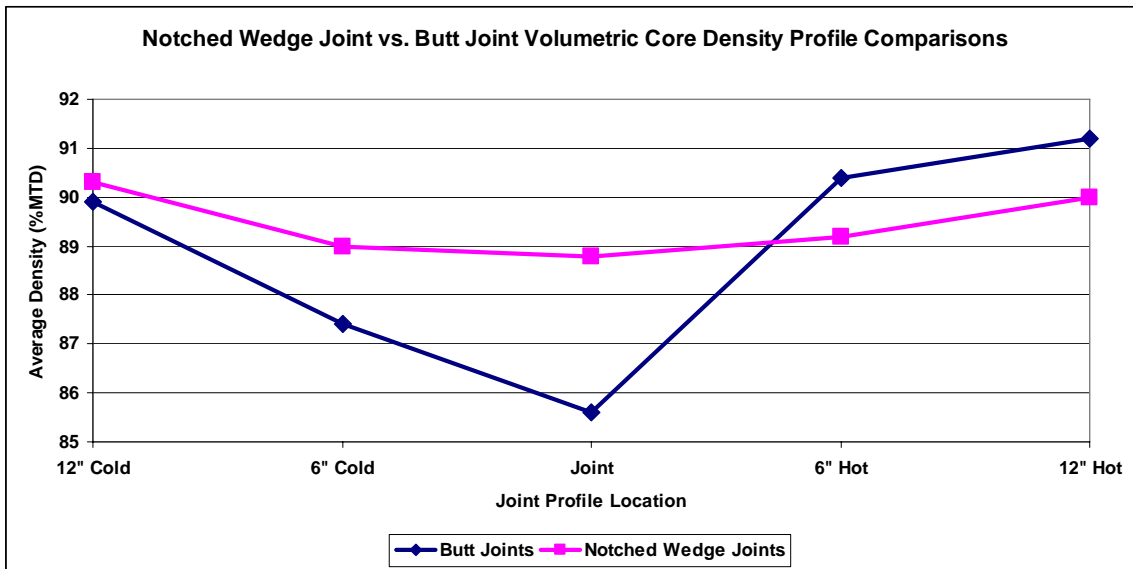
**Figure 27 Butt Joint vs. Notched Wedge Joint (Core Density)**
