**EFFECT OF VOIDS IN GROUTED, POST-TENSIONED CONCRETE  
BRIDGE CONSTRUCTION: VOLUME 2 – INSPECTION, REPAIR,  
MATERIALS, AND RISKS**

Product 0-4588-1: Volume 2

Project 0-4588

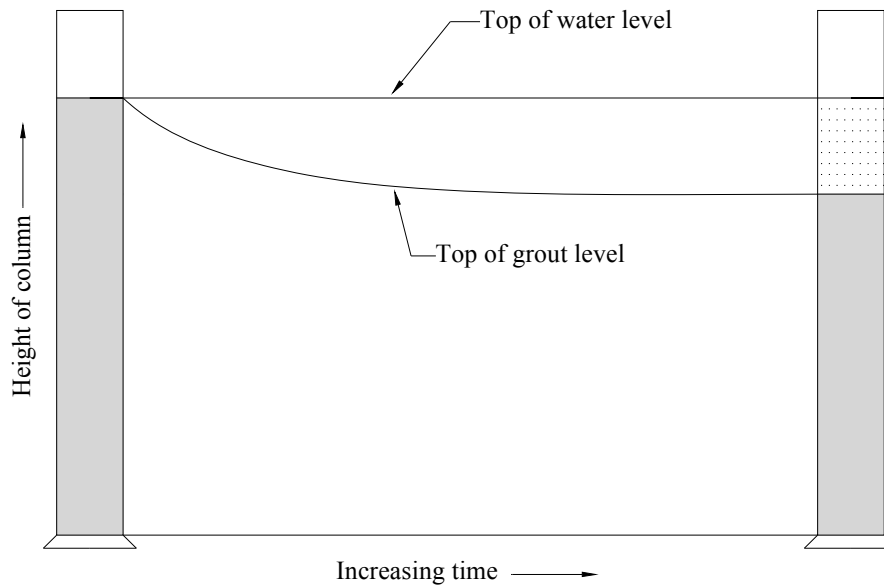
**Figure 2-1. Illustration of a typical bleed process in graduated cylinder (ASTM C940).**

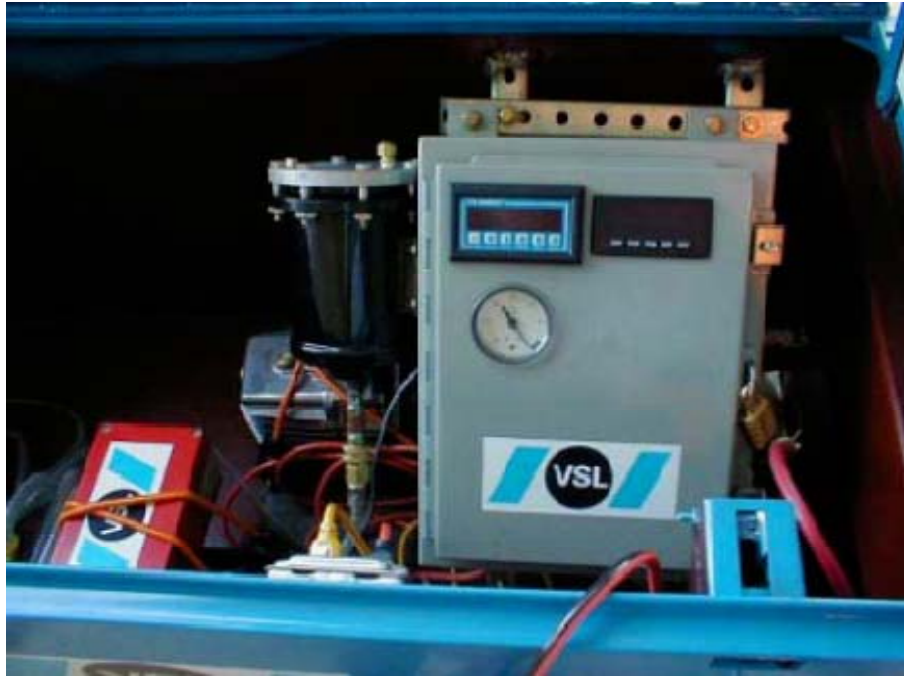
**Figure 2-4. Vacuum Control and Grouting Equipment for Voided Tendons (VSL 2002).**

While a lot of research has been carried out on the initial-grouting of PT systems, significantly less research has been done on the repair-grouting (i.e., repair of voids). Raiss (1995) recommended the vacuum grouting (VG) method for repair. However, he mentioned that it could be ineffective when the ducts are not in an air-tight condition. Moreover, most studies recommend the VG method for filling large voids in ducts (FDOT 2001a; FHWA 2004; Pielstick 2002; Shoji et al. 2003; VSL 2002). Shoji et al. (2003) reported the use of the water-jet method for safe drilling and application of VG method. The Federal Highway Administration (FHWA) recommended the application of VG method (FHWA 2004). A report by VSL (2002) described the repair-grouting by using the VG method, where the vacuum pump can be used to reduce pressure in the duct by 80 percent. Figure 2-4 shows the vacuum control and grouting equipment developed by VSL International Ltd.

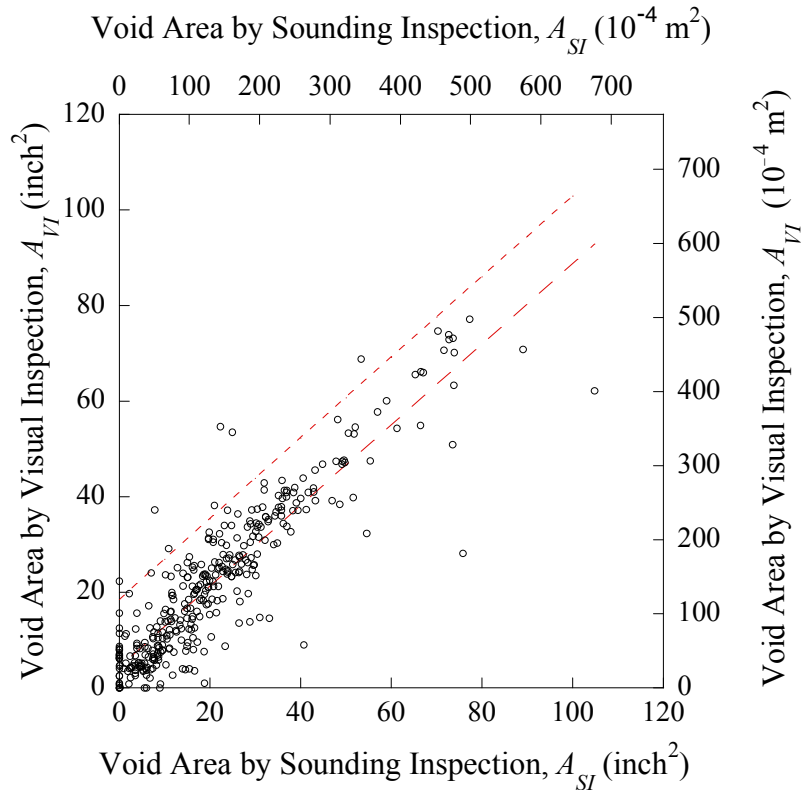
**Figure 3-12. Scatter Plots between the Void Areas Obtained from Sounding and Visual Inspections.**

$$A_{VI} = 0.844A_{SI} + 18.522 \text{ (U.L.)}$$
$$(A_{VI} = 0.844A_{SI} + 119.499 \text{ (U.L.) for SI unit}) \quad (3.3)$$

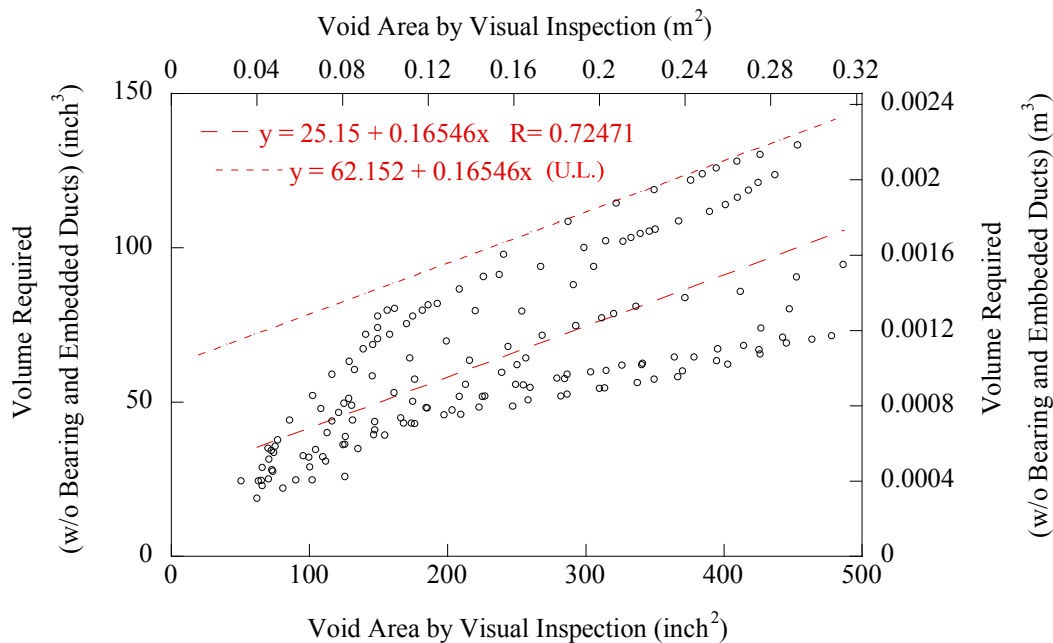
**Figure 3-13. Scatter Plot between the Void Areas from Visual Inspection and the Void Volume Repaired.**

$$(V_{req} = 0.420A_{VI} + 1018.501 \text{ (U.L.) for SI unit})$$

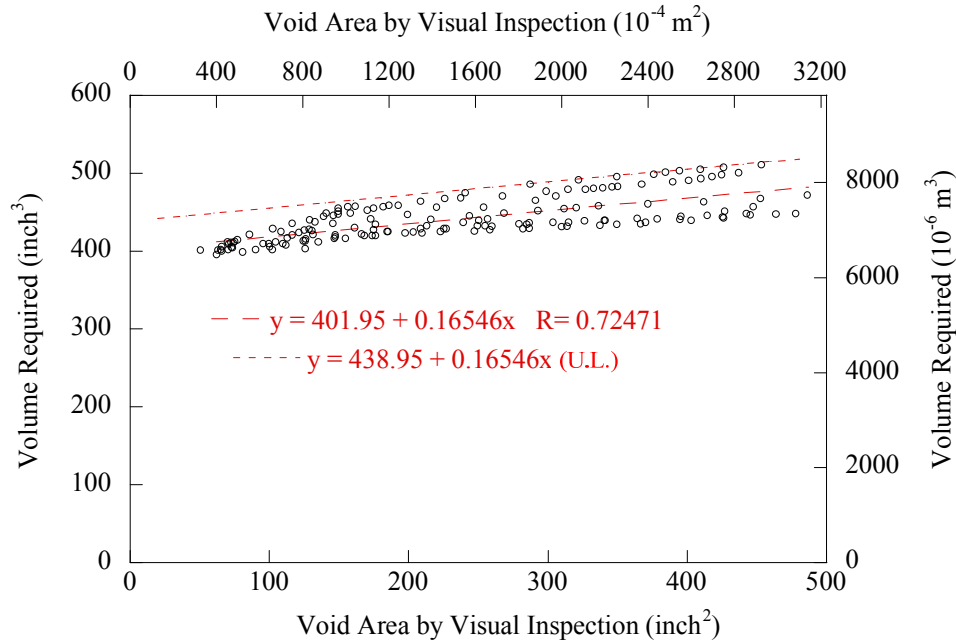
**Figure 3-14. Scatter Plot between Void Area by Visual Inspection and Void Volume Repaired (Including the volume of the Voids in Bearing Plate and Ducts inside the Upper Anchorage).**

The repair volume of each specimen was estimated based on the cross sections of each test specimen. However, this relationship does not include the void volume contained in embedded ducts and bearing plate in diaphragm; the embedded duct and bearing plate in the concrete diaphragm in the field cannot be examined by the sounding inspection. To ensure sufficient grout is prepared, the volume estimates of the repair grout should be performed assuming that the embedded ducts and bearing plate contain no grout.

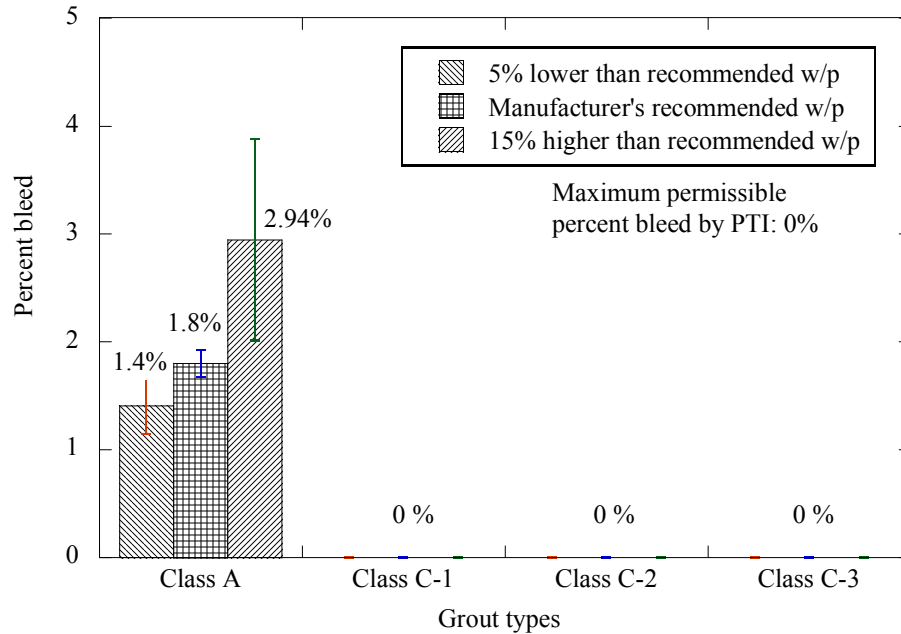
**Figure 4-12. Wick-induced Bleed Results for Grouts Based on Different w/p Using M2 Mixer.**

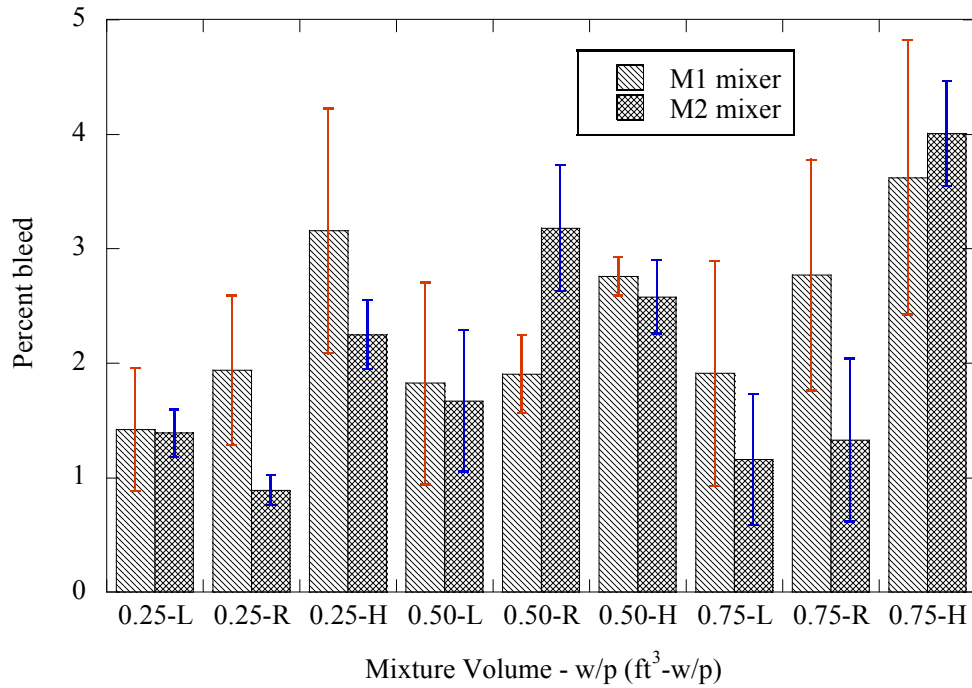
**Figure 4-13. Wick-induced Bleed Results for Class A Grout.**

The variation of Class A grout bleed water with respect to the w/p, mixture volume, and mixer type is shown in Figure 4-13. Here, the L, R, and H represent the corresponding 5% lower (0.42), recommended (0.44), and 15% higher (0.51) w/p's, respectively. The values 0.25, 0.50, and 0.75 represent the size of the mixture volume as 0.25, 0.50, and 0.75ft<sup>3</sup> (0.0071, 0.0142, and 0.0213 m<sup>3</sup>). Because a set of three bleed cylinders were tested for each mixture, the lines on the top of the bars represent the standard deviation in the bleed results obtained from three cylinders.

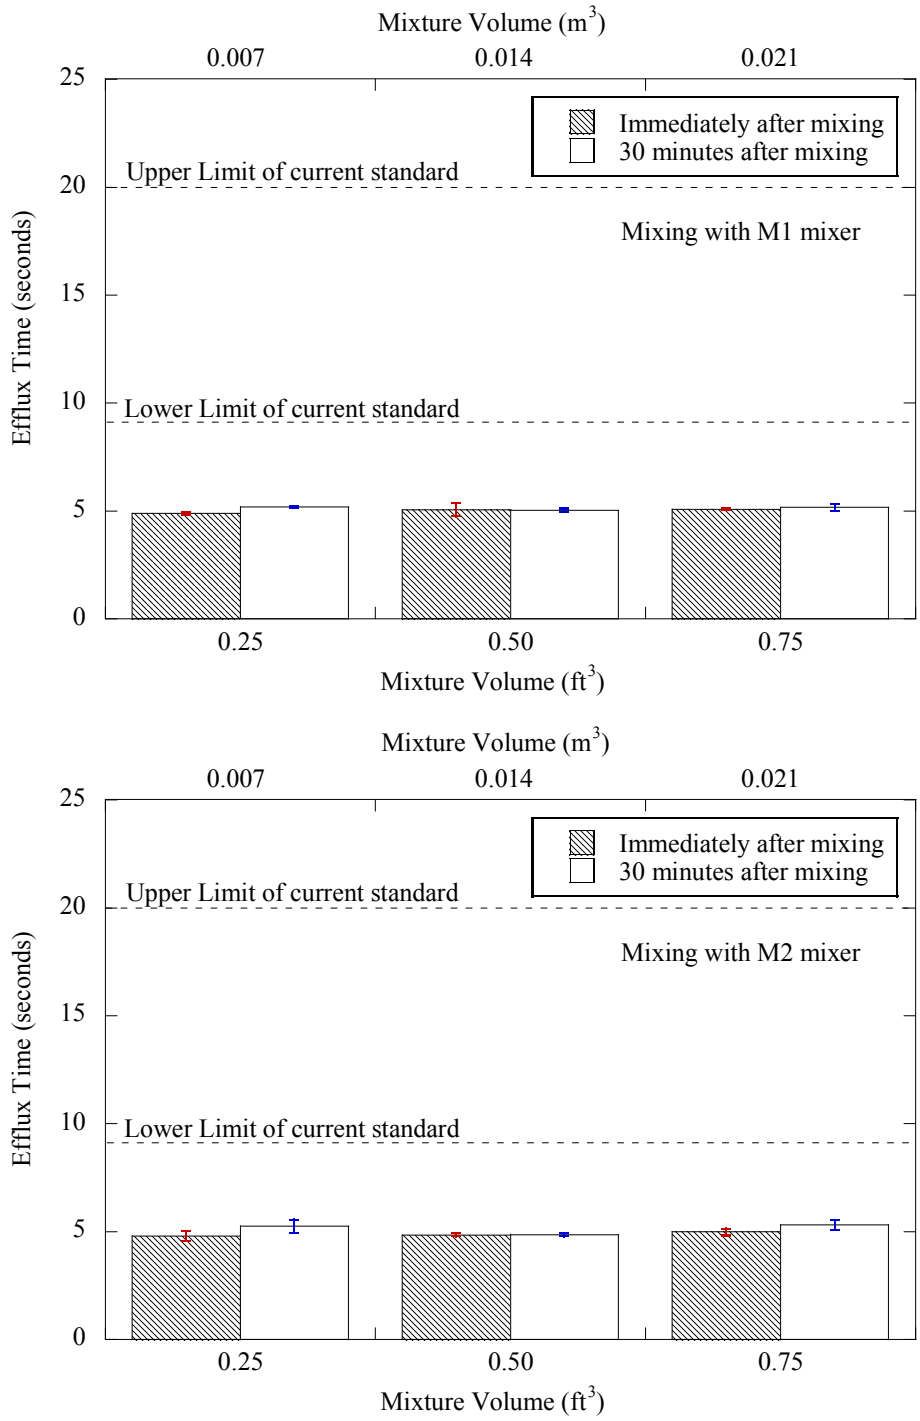
**Figure 4-16. Efflux Time versus the Volume of Mixture for Class A Grout: (a) Using M1 Mixer and (b) Using M2 Mixer.**

The results obtained from the testing are shown in Figure 4-16, Figure 4-17, Figure 4-18, and Figure 4-19. These figures show the variation of the efflux time as the mixture volume changes. The efflux time measurements shown in these graphs are from mixes with w/p values equal to their manufacturers' recommended w/p and using M1 and M2 mixers for mixing.

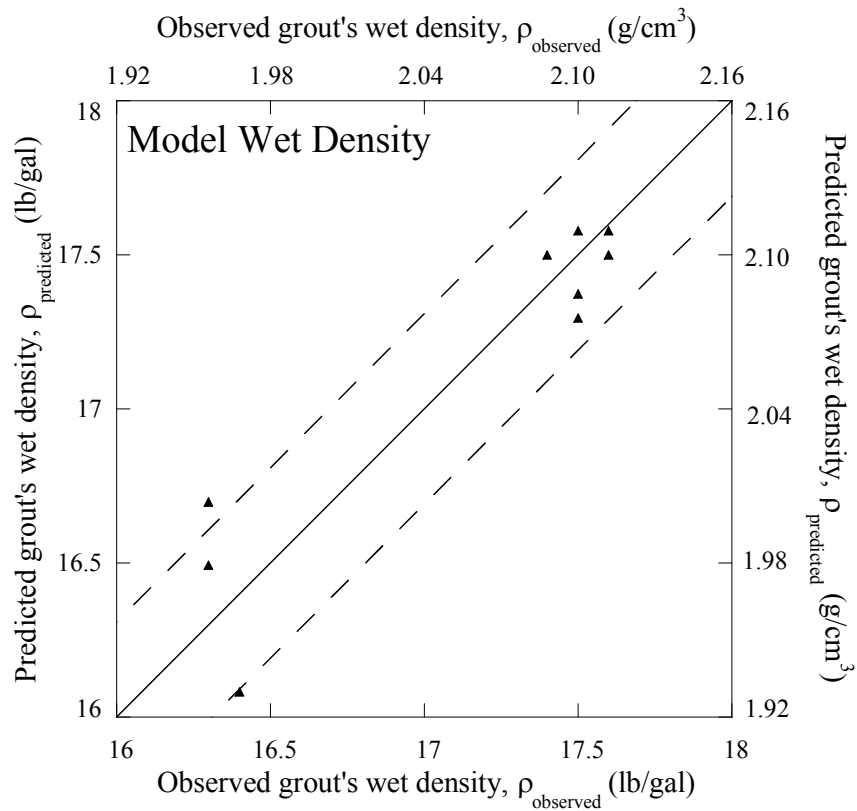
**Figure 4-23. Validation Plot for the Wet Density Model.**

The Baroid mud balance test can be used in the field as a quality control measure. Any significant change in grout wet density can be determined instantly and necessary actions should be taken to ensure proper grouting of PT ducts. Therefore, the Baroid mud balance test is recommended in the field. The observed wet density can be compared with the manufacturer’s specified wet density corresponding to the w/p.

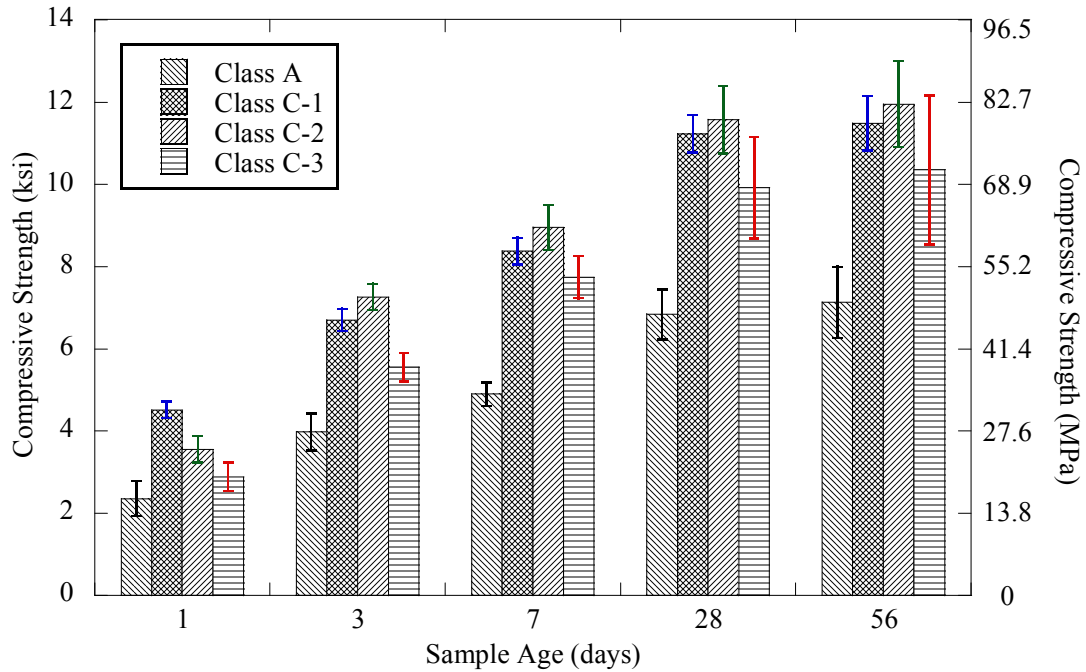
**Figure 4-27. Compressive Strength Results at Various Sample Ages for the Grout Types at Recommended w/p.**

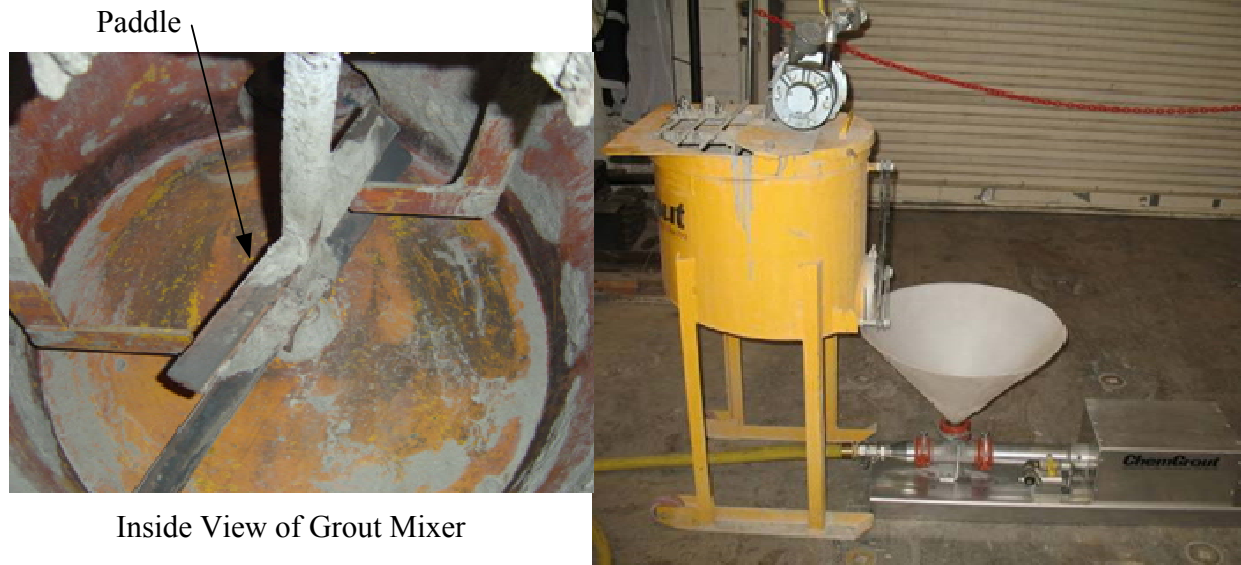
**Figure 5-1. Grout Mixer for Initial Grouts and Grout Pump.**

Two types of mixers are used to prepare Class A grout. At first, the Class A grout was mixed (for 5 minutes) using an air-powered paddle mixer as shown in Figure 5-1. Then, mixing was stopped to add colorant, and then further mixing (for one additional minute) was performed using a 2500 rpm drill with a mixing paddle (Figure 5-2). Further mixing was then performed with the air-powered grout mixer for an additional 5 minutes. Thus, the total mixing time was 11 minutes for the Class A grout.

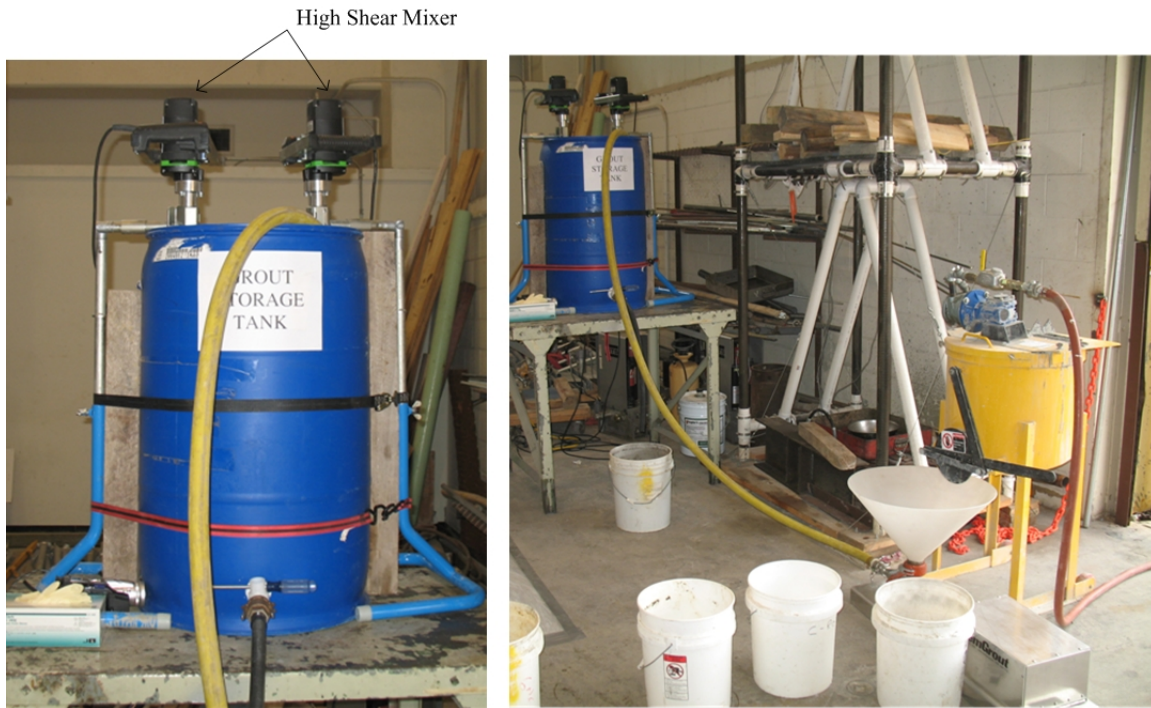
**Figure B-4. Grout Storage Tank and High Shear Mixer.**

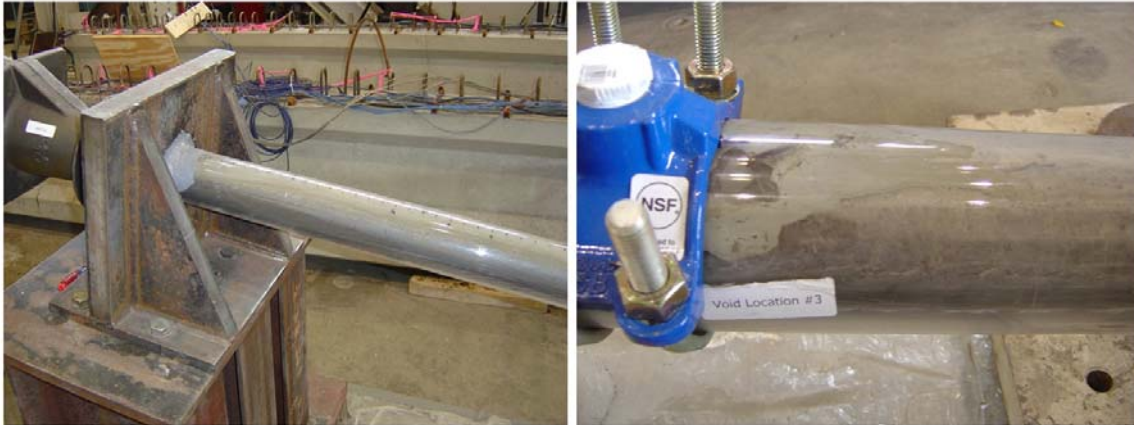
**Figure B-5. Repair Grouted Ducts of Specimen VG-C2-1.**

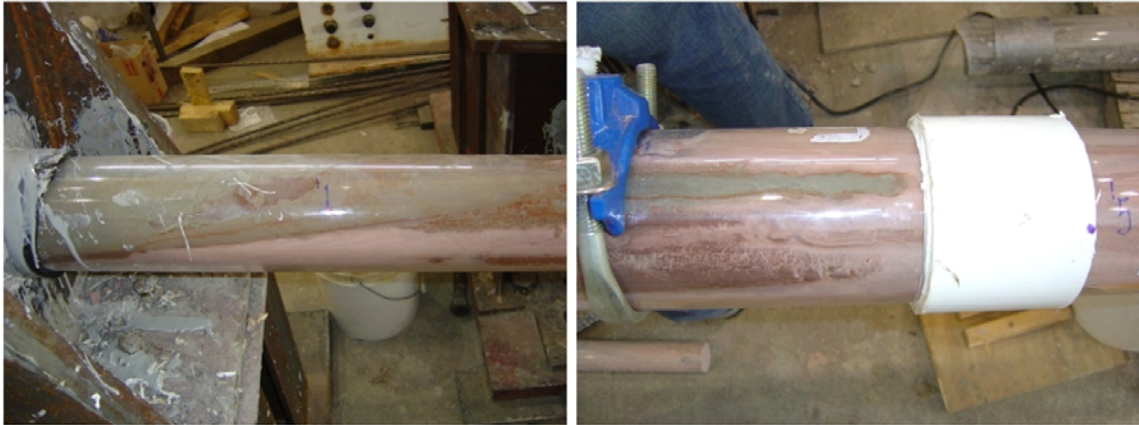
**Figure B-19. Repair Grouted Ducts of Specimen PG-C2-1.**

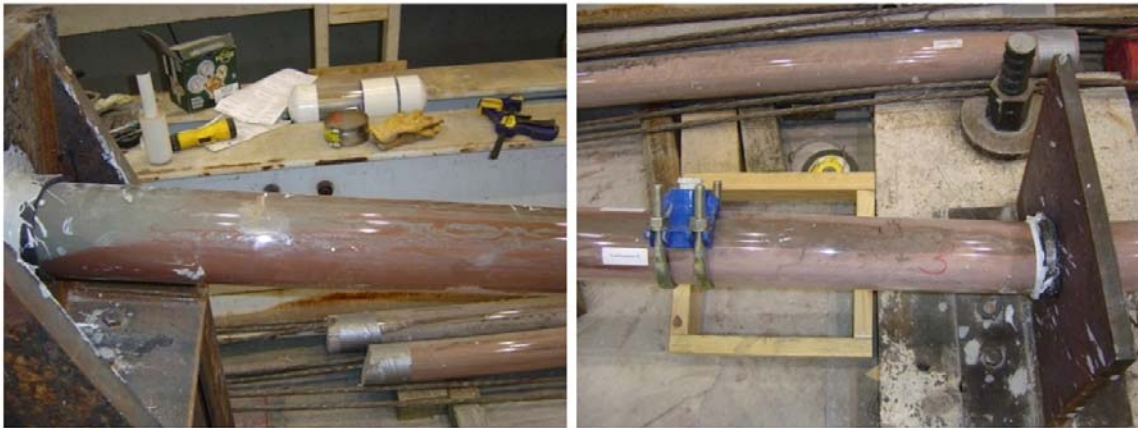
**Figure B-31. Repair Grouted Ducts of Specimen PVG-C1-1.**

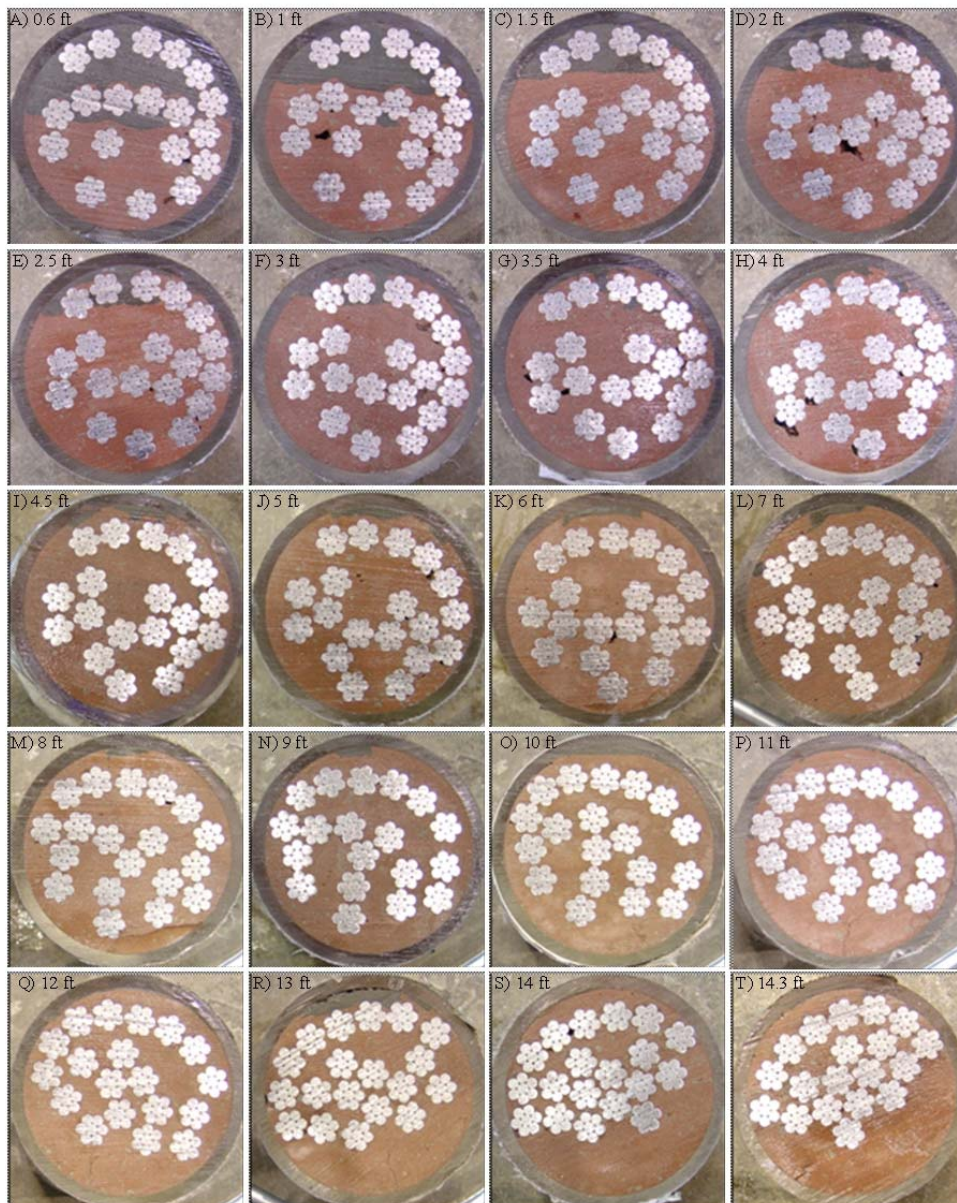
**Figure B-35. Cut Sections of Specimen PVG-C1-2 for the Filling Analysis of Repair Grout.**

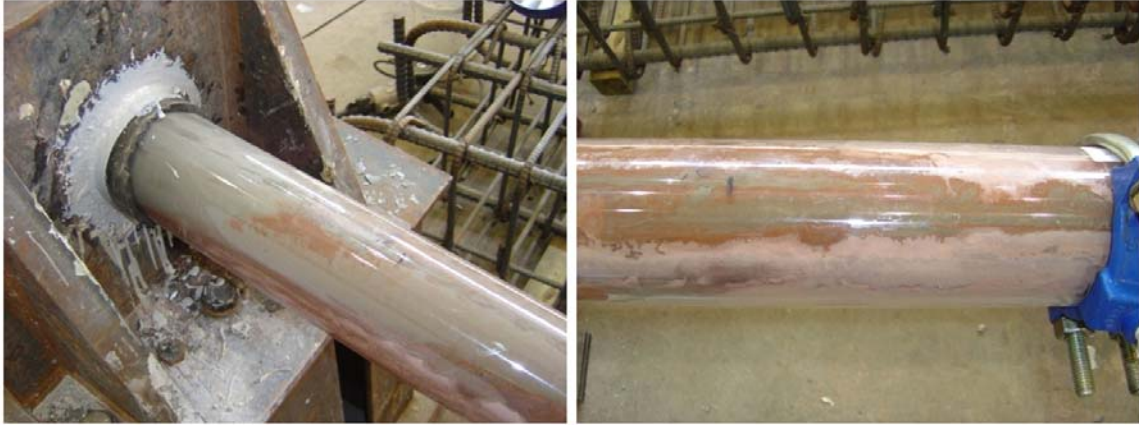
**Figure B-43. Repair Grouted Ducts of Specimen PVG-C3-1.**
