# FINAL REPORT

## ELECTRICAL ENGINEERING SUPPORT FOR TELEMETERED TRAFFIC MONITORING SYSTEMS

**FDOT Contract No. BD-543-3**

**March 2009**

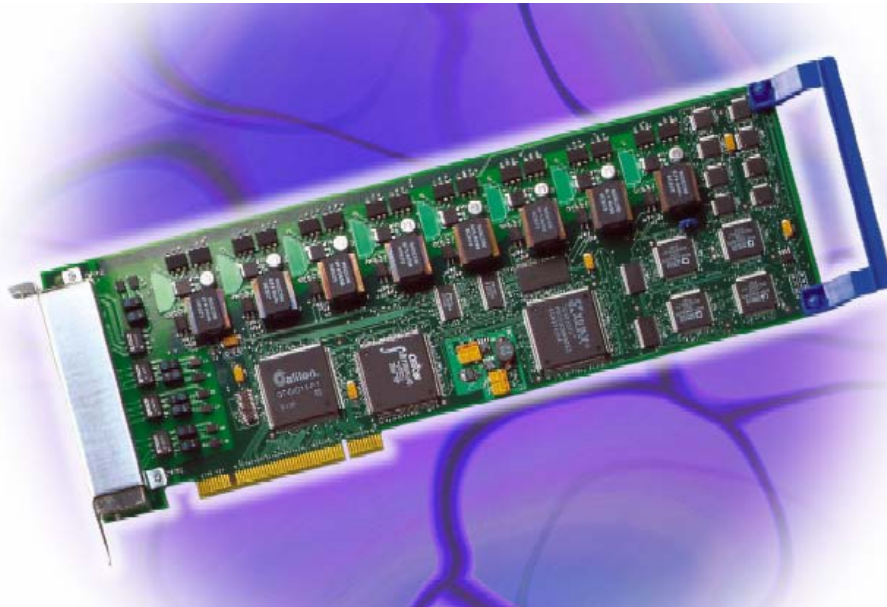
**Figure 1. The Digi AccelePort RAS PCI Board**

The Digi AccelePort RAS 8-modem PCI board (see Figure 1) is an internal computer card intended for personal computers or workstations based on Windows, Linux or UNIX operating systems. The card allows the computer to establish 8 simultaneous modem connections. The modems are capable of up to 56K rates using the V.90 or K56Flex standards. It is compatible with the modem speeds and standards used by the FDOT for TTMS installations. A data sheet for the Digiboard is included in Appendix A.

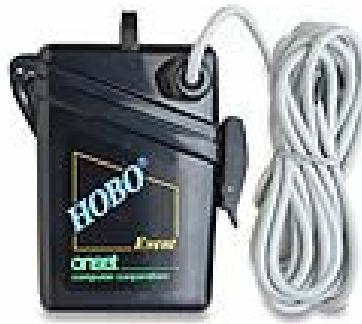
**Figure 5. HOBO H07 Event Logger**

A HOBO H07 Event Logger (Figure 5) from Onset Computer Corporation was used to record the lightning surges from the in-pavement sensors. The HOBO H07 is designed to log the time and date of a contact closure. It is capable of recording contact closures separated by as little as 1/2 second.

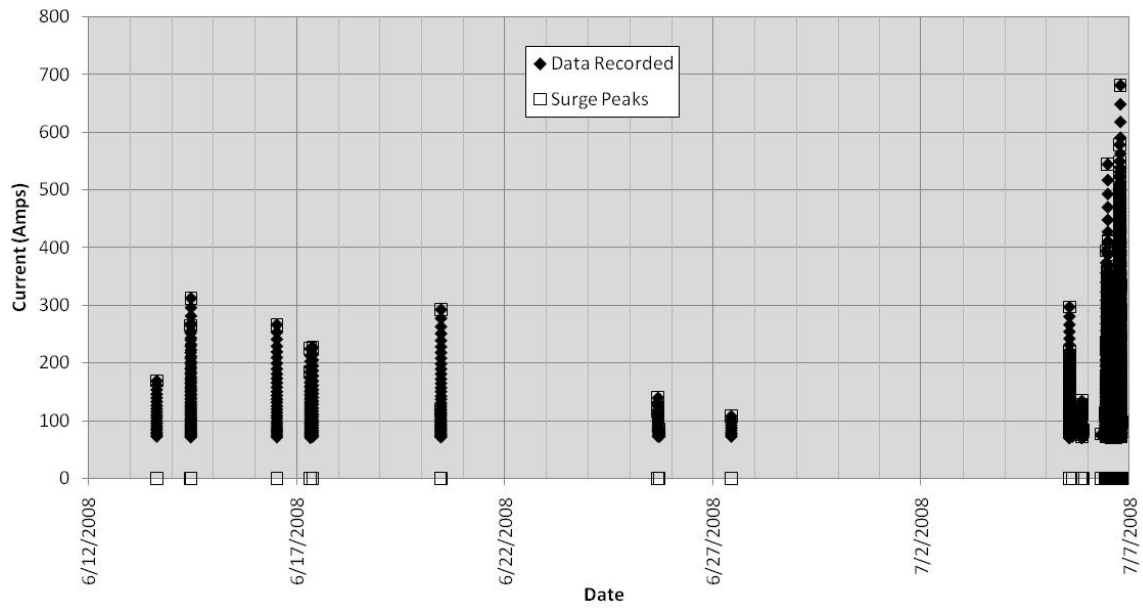
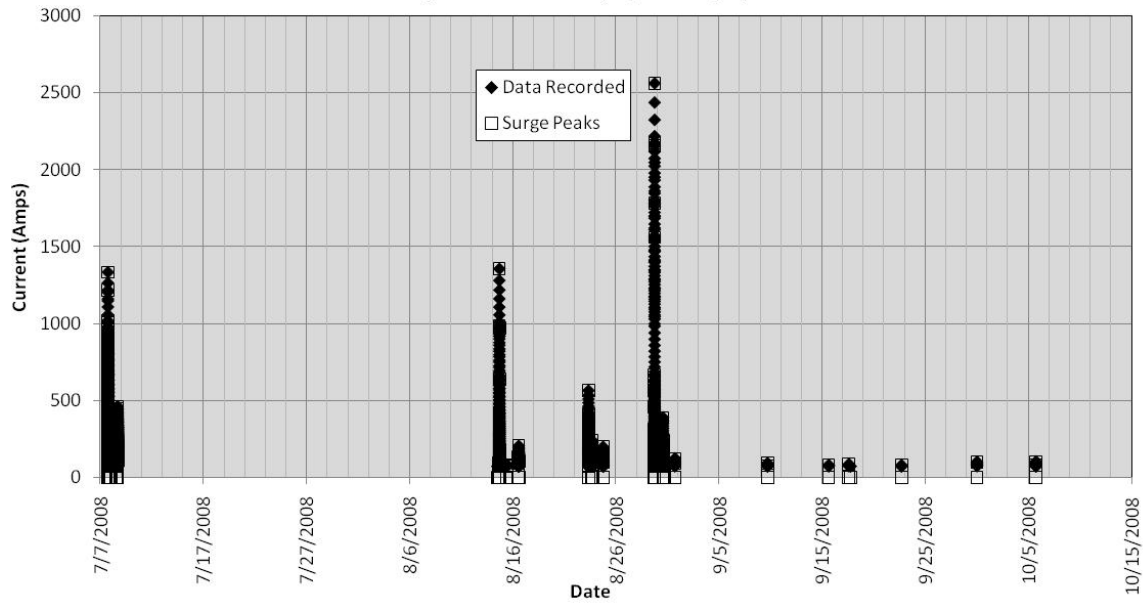
Figure 12. 2008 Surge Data and Peak Surges for Piezoelectric Sensor at Site 86

Surge Data and Peak Surges  
Site 86, Piezo Sensor, 6/1 - 7/6/2008

Surge Data and Peak Surges  
Site 86, Piezo Sensor, 7/7 - 10/6/2008

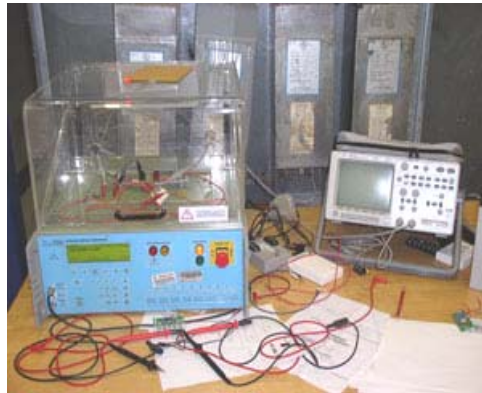
**Figure 1. Test Station**

In order to test the necessary components an EMC-Partner modular impulse generator and an Agilent mixed signal oscilloscope were utilized. The modular impulse generator has the capability to produce up to 6 KA of surge current. The test setup, as shown in

Figure 1, feeds two oscilloscope probes into the generator chamber to measure the output voltage and the input voltage (only on low current tests).

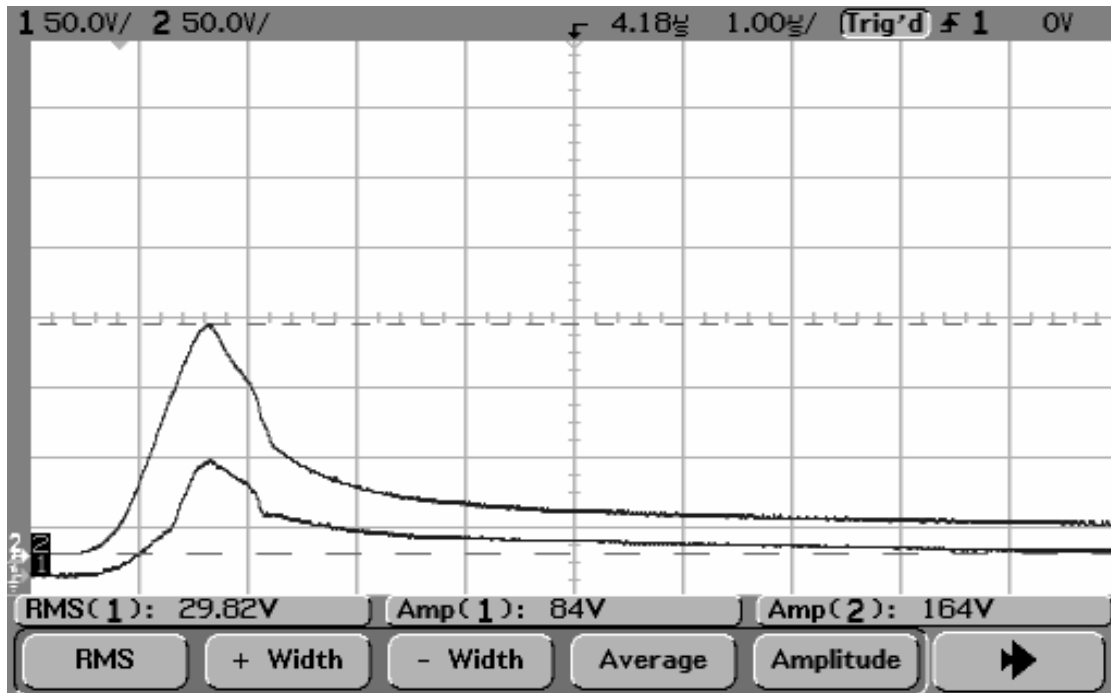
**Figure 4. EDCO SRA6LCA-916 at 250A**

The EDCO SRA6LCA-916 was first tested at 250A as shown in Figure 4. The lower line indicates the output of the suppressor and the upper line indicates the input voltage to the suppressor.

The graph in Figure 4 shows an initial rise in voltage from the impulse and approximately 3 to 4 microseconds to return to the normal operating voltage. Figure 5 shows the same suppressor at 500A of input current. This graph illustrates a sharper incline in the initial pulse but a slower time of decline (about 7 to 8 microseconds) to nominal voltage. Therefore, it can be seen that as the surge magnitude increases so also did the time required to return to normal operating voltage. The time it takes for the suppressor output to return to acceptable voltages is significant. The longer it takes for the voltage to return to safe levels, the greater the amount of energy delivered to the sensor boards and the greater the potential for damage. Similar tests were done with the EDCO SRA6LA-716 and can be seen in Section 5.1.1.

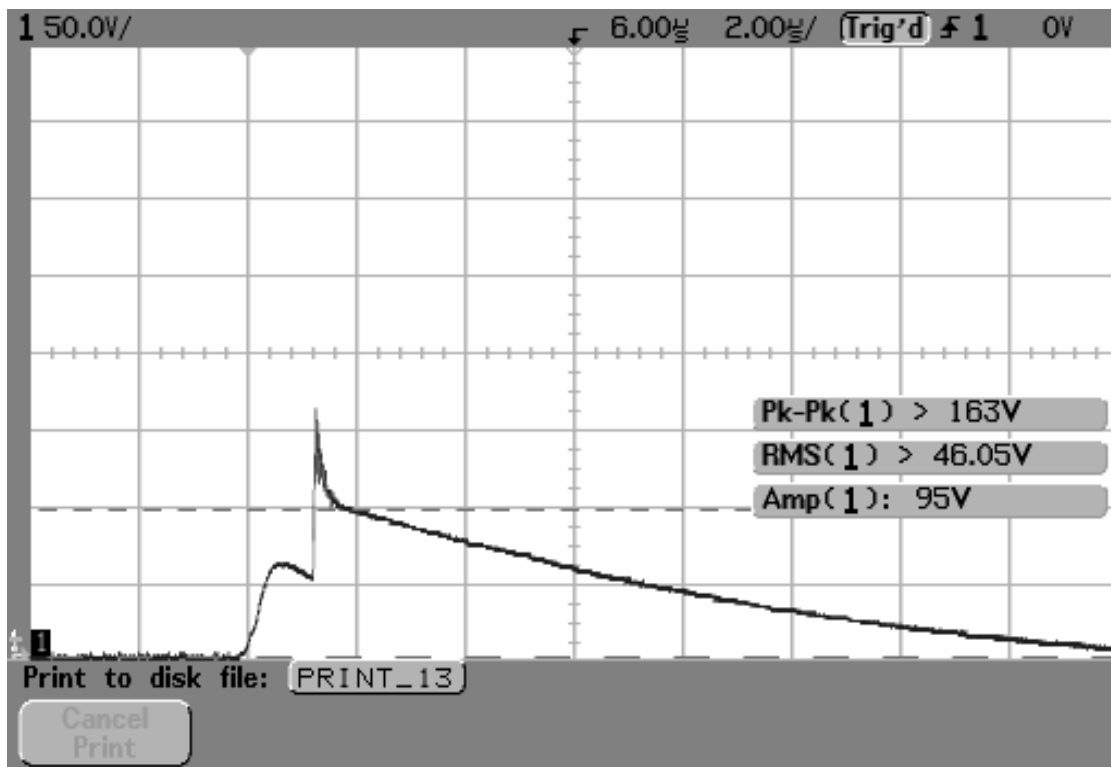
Figure 6. CITEL BP1-06 at 1000A

Since each suppressor yielded similar results, the BP1-06 will be taken into consideration for this analysis. Figure 6 depicts the response of the BP1-06 suppressor at 1000A.

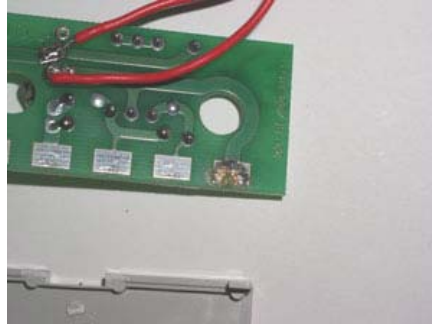
**Figure 8. CITELE BP1-06 Endurance**

Eventually, there was no direct contact remaining and the surges arced between the metal bar and the circuit card causing even more damage. The damage from the endurance testing is illustrated in Figures 8 and 9. The damage was obvious after roughly 1100 to 1500 surges (at 6 KA), as the current began to arc.

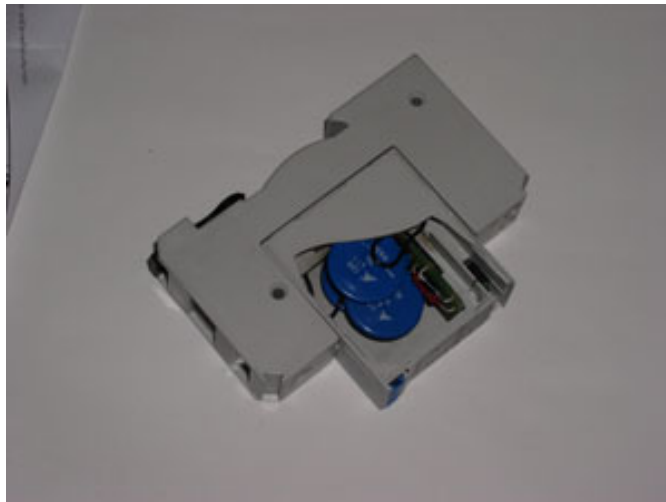
**Figure 12. Damage to CITEL DS210-12VDC Suppressor**

Endurance testing was conducted on the CITEL DS210-12VDC suppressor. The suppressor was tested at 2000A (maximum discharge current allowance) for an extended period of time. After roughly 155 hits at 15-second intervals, the impulse started to arc at the input and eventually the suppressor buckled under pressure. Figure 12 illustrates the outcome of the endurance test.

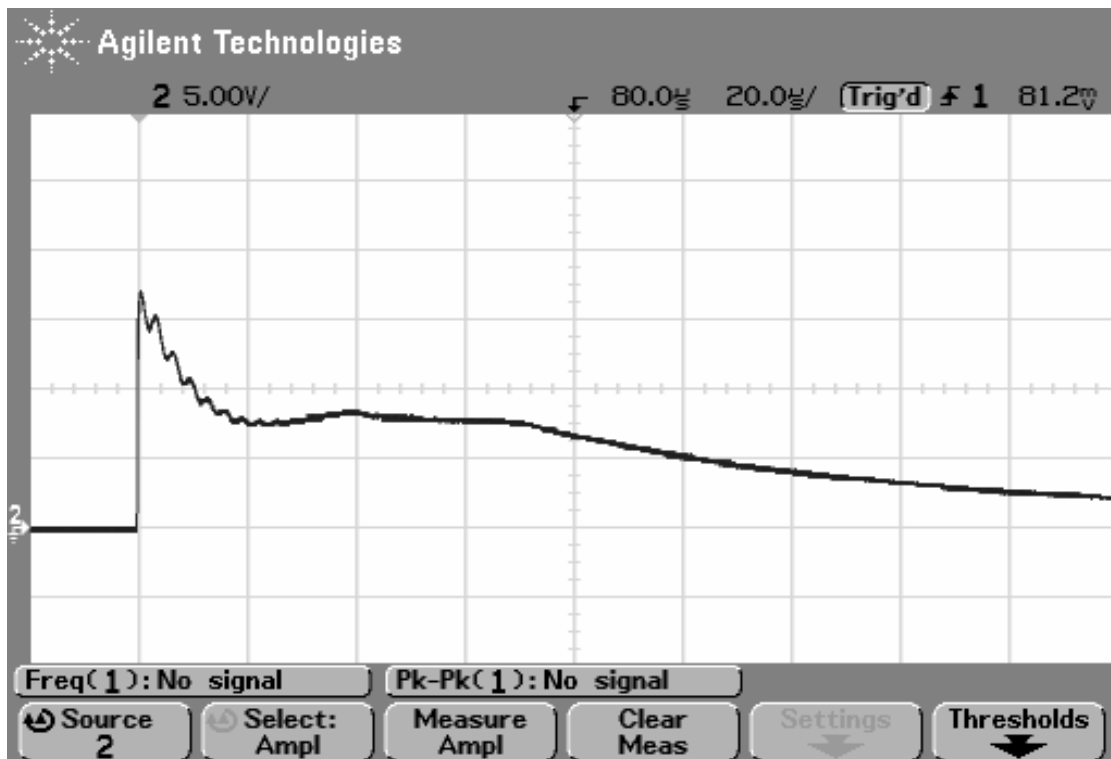
**Figure 13. Atlantic Scientific 24516 output for 2000A input current**

There were four different devices from Atlantic Scientific that were used for this study. The device model numbers were 24516, 24528, 24538, and 90489. The device 24516 was rated for maximum let through voltage of 12V at 2000A, device 24528 rated for 12V at 5000A, device 24538 rated for 25V at 5000A, and device 90489 rated for 10V at 5000A. Since the surge suppressor devices from Atlantic Scientific had lower voltages, they were ideal for the application of the in-pavement sensors. Figure 13 illustrates the output of the device 24516 for a surge current of 2000A.

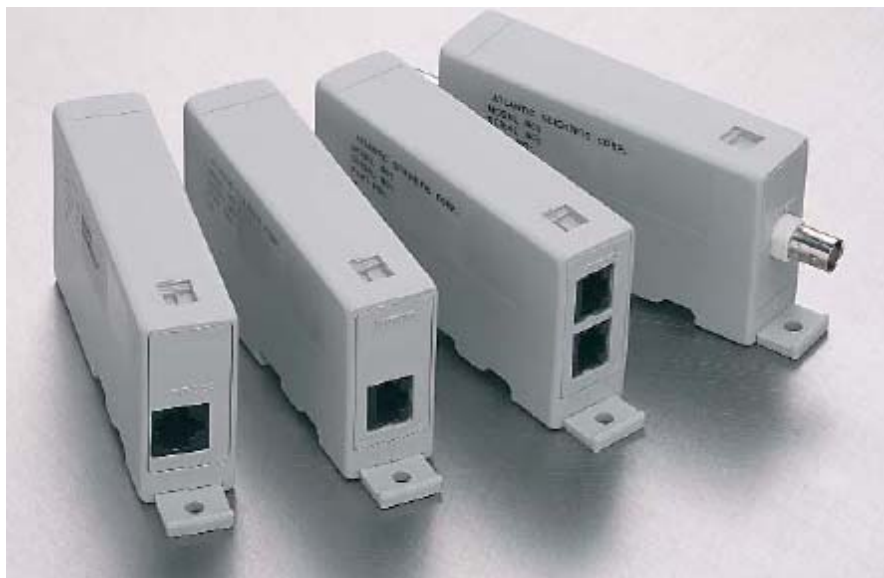
Atlantic Scientific Series Surge Suppressors

**Endurance test on Atlantic Scientific Device # No: 24516**

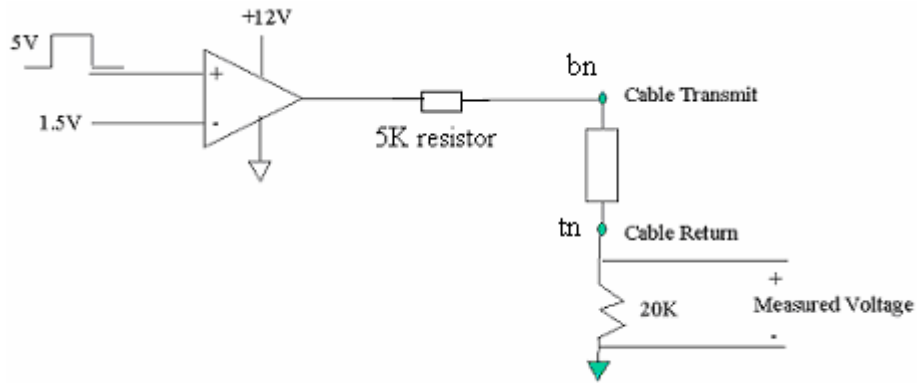
**Figure 4. Circuit Model for Capacitance Testing.**

The segmented sensor was connected to a test circuit via a 25-foot Cat5E Ethernet cable (chosen for its high bandwidth). The Ethernet cable consists of 4 twisted pairs of wire. The wires in each twisted pair were connected to t0 and b0, t1 and b1, t2 and b2, or t3 and b3. A 12-volt, 50 microsecond pulse was transmitted through a 5 kΩ resistor to one of the base connectors (b0 – b3). The individual segment connectors (t0 – t3) were connected through a 20 kΩ resistor to ground (see Figure 4). The output voltage across the 20 kΩ was measured and used to determine either the pass-through capacitance (open segment) or the shunt capacitance (closed segment) for the sensor.

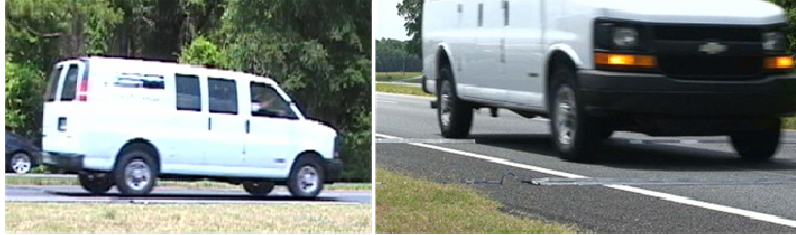
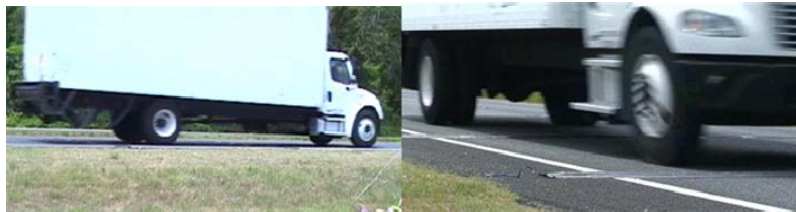
An example, from the July 2, 2007 field test, of the demonstrated benefit of using tire widths (dual tire detection) in classifying vehicles is shown in Figure 13. The pictures are frame captures from video cameras used to provide ground truth during the field test. The first vehicle is a 2-axle standard van (class 3) with all single tires. The second vehicle is a class 5 truck with dual tires on the rear axle. The text is the sensor data transmitted by the interface electronics and the recorded output of the classification algorithm in George Dinwiddie's software (indicated by lines preceded by '#'). The blue text and brackets are comments provided to aid the reader in identifying the axles hitting each sensor. As can be seen in the data from the electronic interface, the dual tires closed more segments than did the single tires. The software was able to detect the dual tire and correctly classify the vehicles.

S0x109 T0xbcae } Axle 1. Sensor 1  
 S0x108 T0xbcae }  
 S0x109 T0xbd4e } Axle 2. Sensor 1  
 S0x108 T0xbd4e }  
 S0x207 T0xbd8e } Axle 1. Sensor 2  
 S0x206 T0xbd8e }  
 S0x207 T0xbe2e } Axle 2. Sensor 2  
 S0x206 T0xbe2e }

**Class 3**  
**Example**

# Axle{48.70 MPH,2321.45 feet,2 elements wide}  
 # Axle{48.70 MPH,11.43 feet,2 elements wide}  
 # (Mussa) Vehicle{class 3: OTHER (LIMO, VAN, RV) [-/2  
 11.4/2] 48.7 MPH}

S0x10a T0x136e } Axle 1. Sensor 1  
 S0x109 T0x136e }  
 S0x209 T0x141e } Axle 1. Sensor 2  
 S0x208 T0x141e }  
 S0x10c T0x1466 } Axle 2. Sensor 1  
 S0x10a T0x1466 }  
 S0x109 T0x1466 }  
 S0x20b T0x1516 } Axle 2. Sensor 2  
 S0x208 T0x1516 }  
 S0x20a T0x151e }  
 S0x209 T0x151e }

**Class 5**  
**Example**
