**UPDATE ON CONDITION OF REINFORCED
EARTH WALL STRAPS
Contract No. BD544-32**

Final Report to Florida Department of Transportation

**A. A. Sagüés
Principal Investigator
Department of Civil and Environmental Engineering**

**UNIVERSITY OF SOUTH FLORIDA
Tampa, FL 33620
March 31, 2009**

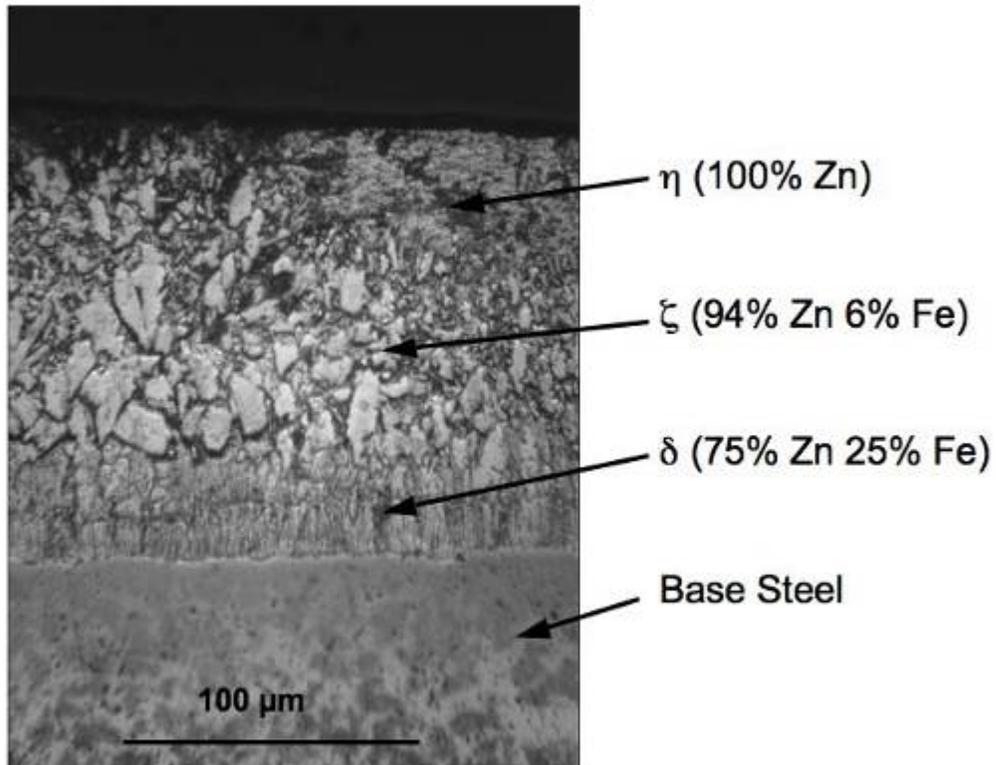
Figure 1 - Microstructure of galvanized steel from an unexposed archival MSE strip, and identification of layers and compositions. [6]

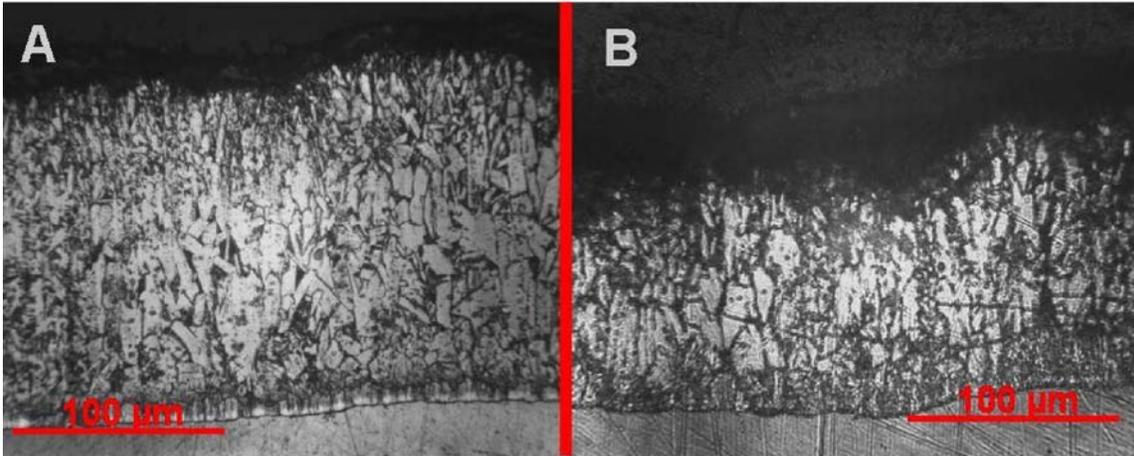
Figure 4 - Examples of metallographic cross sections showing low (A) and high corrosion wastage (B). The base metal is at the bottom.

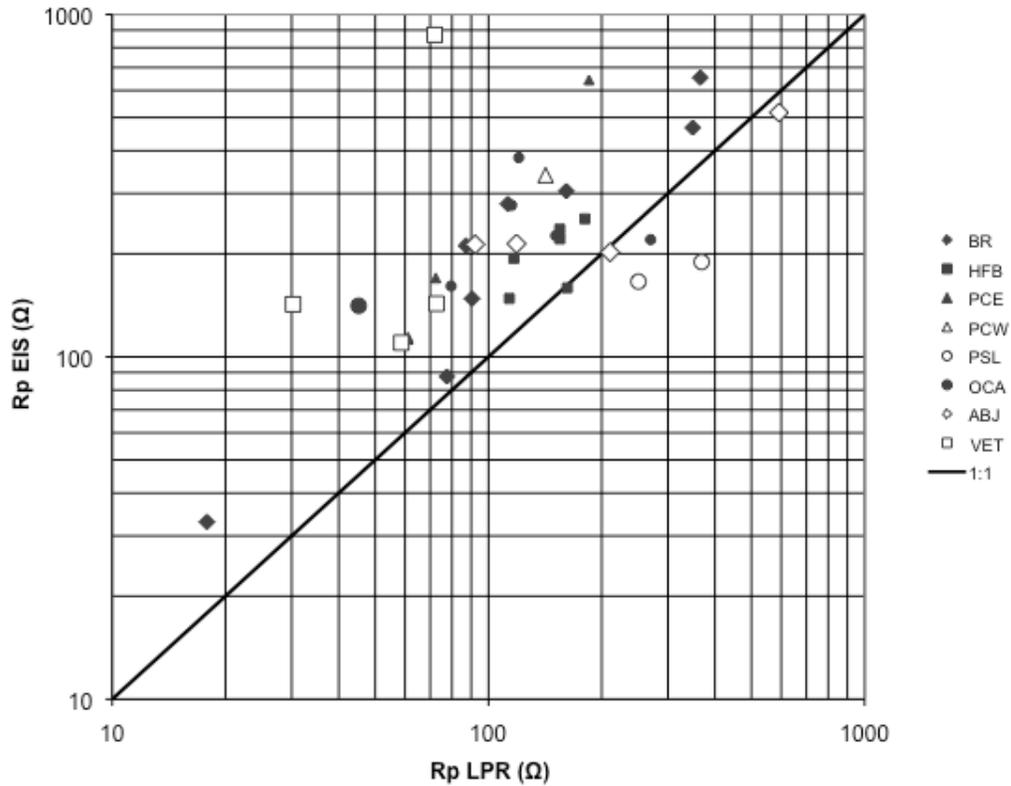
Figure 5 - Comparison of Rp values obtained by LPR and EIS for the same galvanized steel elements and during the same field visit for the indicated walls. The diagonal line corresponds to an ideal 1:1 correlation.

Comparison of polarization resistance values obtained by LPR and EIS are shown in Figure 5 and Figure 6. Detailed listing of EIS parameters obtained for each EIS test of the present survey, as well as the corresponding ACR values is presented in Tables A2-8 to A2-14 of Appendix 2.

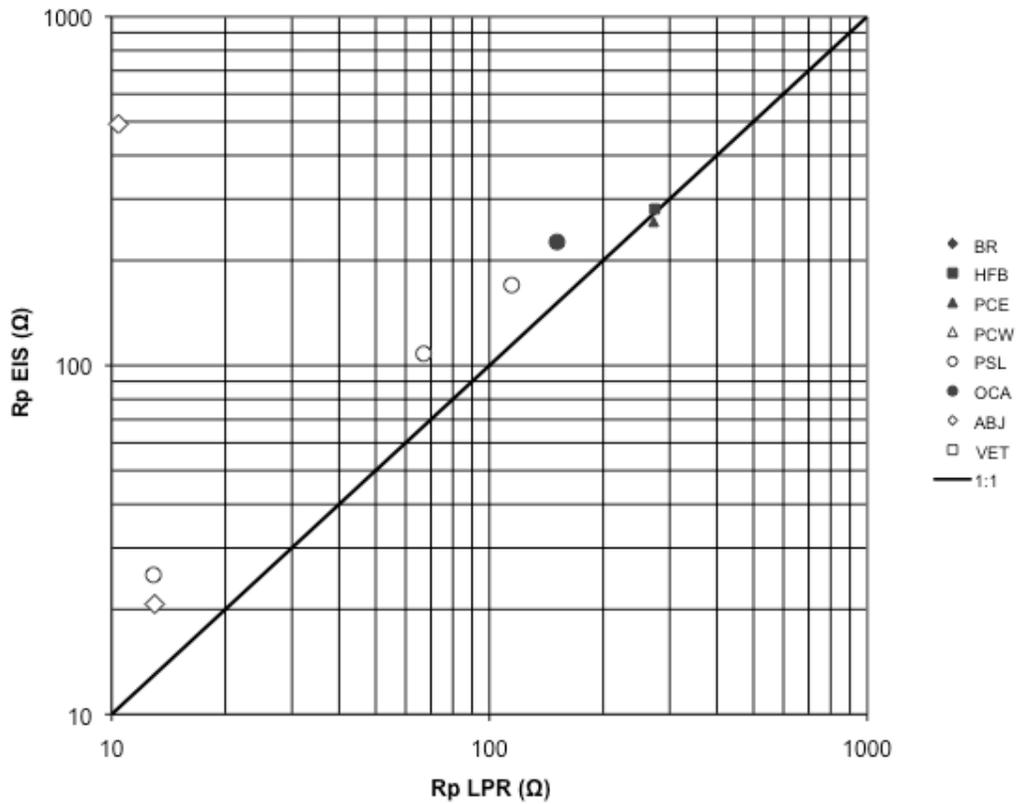
Figure 6 - Comparison of Rp values obtained by LPR and EIS for the same plain steel elements and during the same field visit for the indicated walls. The diagonal line corresponds to an ideal 1:1 correlation.

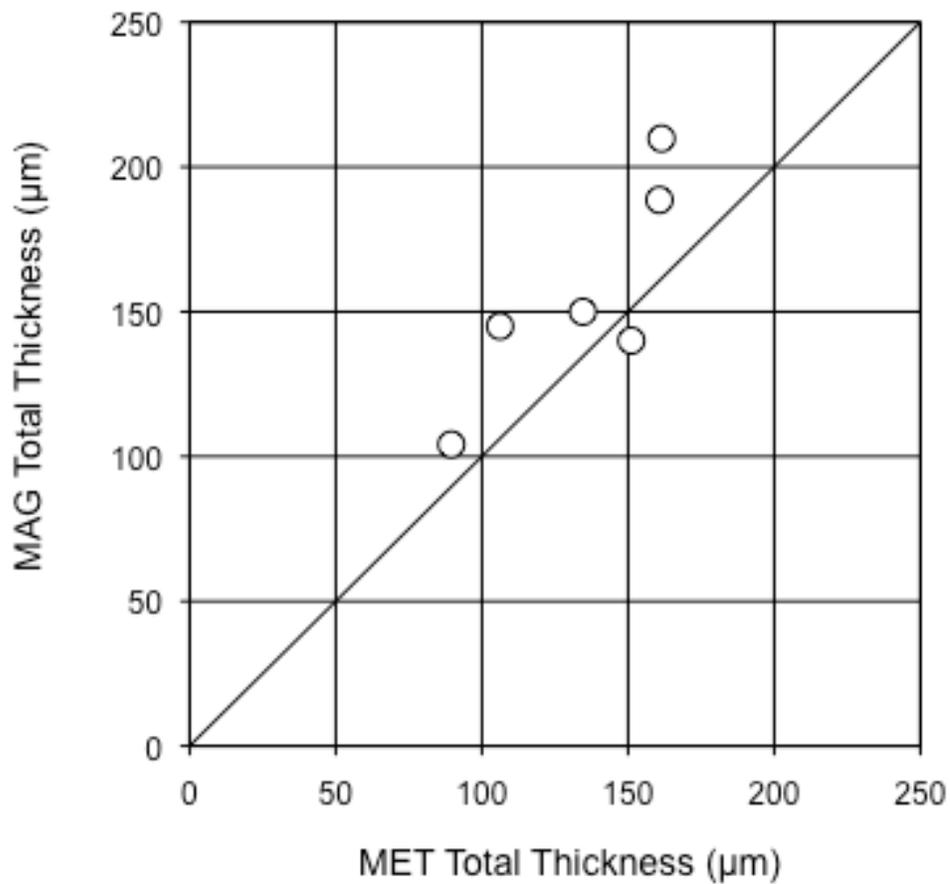
Figure 7 - Comparison of galvanized layer plus corrosion product thickness from metallographic measurements (MET Total Thickness) with total film thickness determined with a magnetic thickness gage (MAG), averaged for coupons extracted in the present survey from each Wall. The diagonal line corresponds to an ideal 1:1 correlation. Data from Table 3.5.

between the metallographic total thickness results and the magnetic gage measurements. Quantitative analysis of the results to estimate integrated corrosion rates and comparison with results from electrochemical measurements is presented later on.

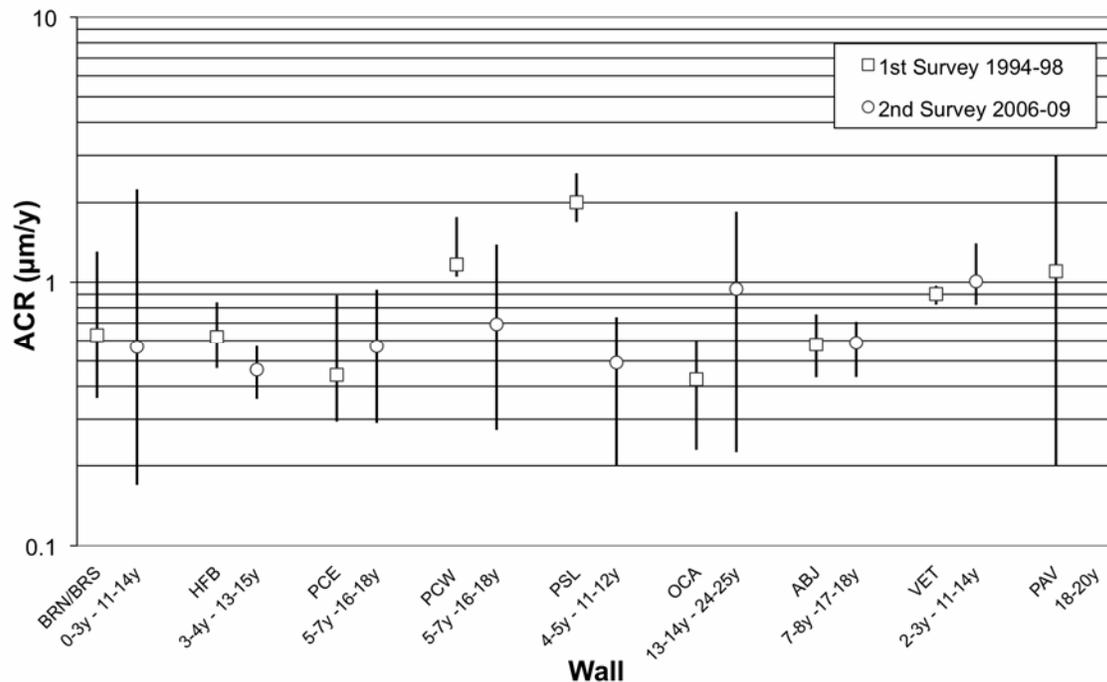
Figure 8 - Wall averaged galvanized steel ACR values for the present and previous surveys.

The information from Table 3.2 was used to obtain ACR averages for each galvanized reinforcing element over all visits in the present survey. The highest and lowest element ACR averages for each wall (except for BR where the two walls at that site were treated as one) were noted. Those element averages were in turn averaged for each wall. The results including high and low values are displayed in Figure 8, along with similar results for the 1994-98 survey, indicating the structure age range spanned in each survey.

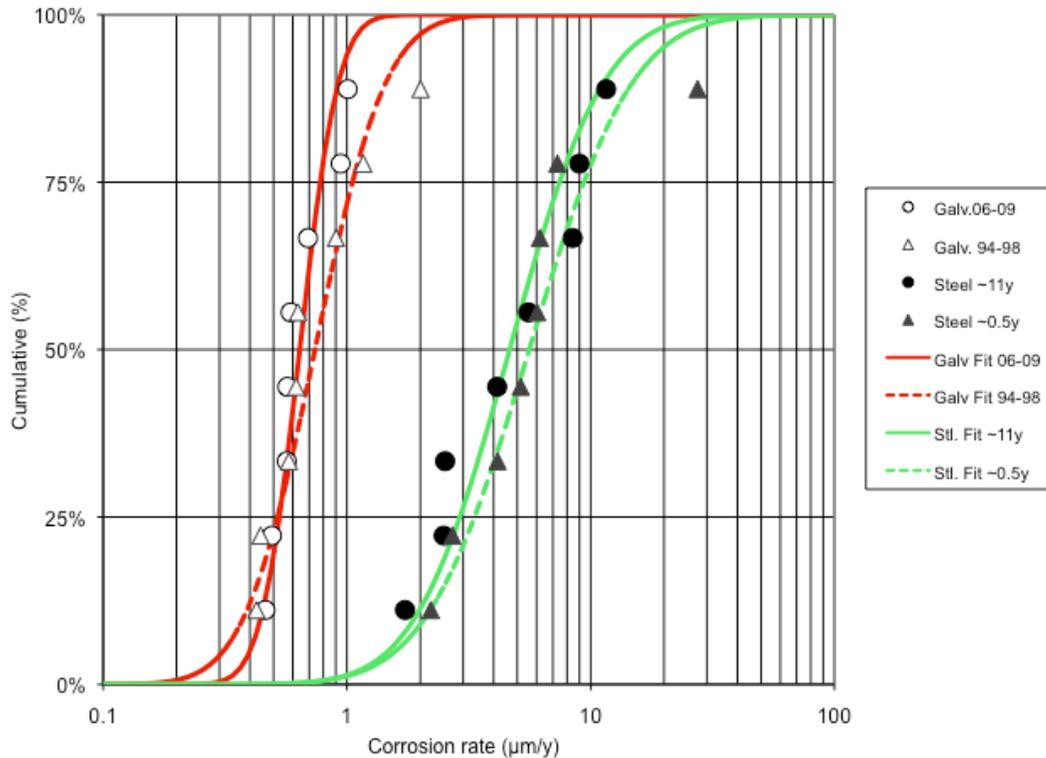
Figure 9 - Cumulative distributions of ACR averaged for each wall from the 1994-98 and 2006-09 surveys, fitted with cumulative lognormal distributions. Results for Galvanized steel are grouped per survey. Results for plain steel rods are grouped per element age group as indicated in the text.

thus obscuring any effect of interim aging on ACR. To assist in revealing overall trends, the results were graphically summarized in Figure 9, which shows cumulative distributions of ACR for both surveys.

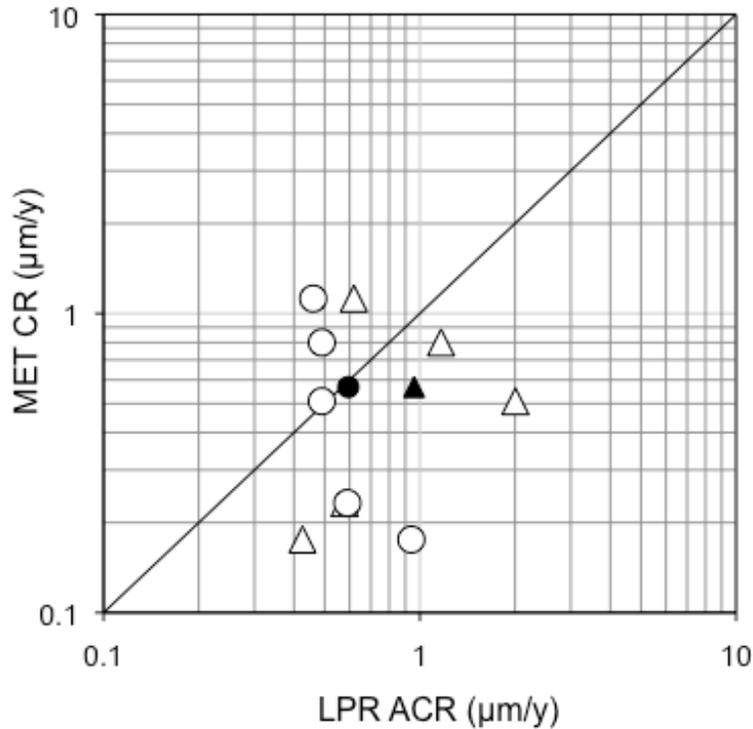
Figure 10 - Comparison of integrated corrosion rates evaluated from metallographic measurements (MET) of coupons extracted from five walls in the present survey, averaged for coupons from each wall, with corresponding average ACR values from LPR measurements. The calculations assumed that the corrosion products behaved as solid $Zn(OH)_2$. Triangles: 1994-98 survey. Circles: 2006-09 survey. Open symbols: results from individual walls. Filled symbols: average of all values in each survey. The diagonal line corresponds to an ideal 1:1 correlation.

A validation check of the accuracy of the ACR determinations was conducted for galvanized steel elements by comparison with integrated wastage estimates from the metallographic examinations. The corrosion products were assumed to have a zinc content (66 wt%) and density (3.05 gcm^{-3}) similar to those of solid Zn(OH)_2 , a common composition for zinc corrosion products [20]. The average corrosion product thickness for each structure per Table 3.5 was converted accordingly to the equivalent thickness of solid zinc as an estimate of galvanized layer wastage. The wastage thickness was divided by the age of the wall at the time of coupon extraction to obtain a metallographically estimated corrosion rate (MET CR) reflecting the average corrosion rate experienced during the entire exposure period. Results are shown in Figure 10, where the diagonal line represents ideal agreement between LPR ACR and MET CR results. There is order-of-magnitude agreement between metallographic and electrochemical corrosion assessments for individual walls based on either survey, and significantly better correlation when the average of all walls is considered (filled symbols). It is emphasized that the metallographic method result reflects metal wastage rate averaged over the entire exposure period, while the electrochemical measurement determine instantaneous corrosion rate. Thus the value of a direct comparison is limited by variability in corrosion rates both long term (as in the expected gradual decrease of rate with time while the galvanized layer is in place) and short term reflecting seasonal and tidal influences. Further limitation is due to the small amount and size of reinforcement coupons available, and that the coupons were always from one region of the wall, closest to the outer surface thus introducing a sample bias that may not reflect conditions further in. In contrast, the electrochemical measurements involve the entire buried element length. Keeping in mind these factors and the typical method uncertainty and actual variability in corrosion distribution, the metallographic results generally support the validity of the electrochemical LPR measurements.

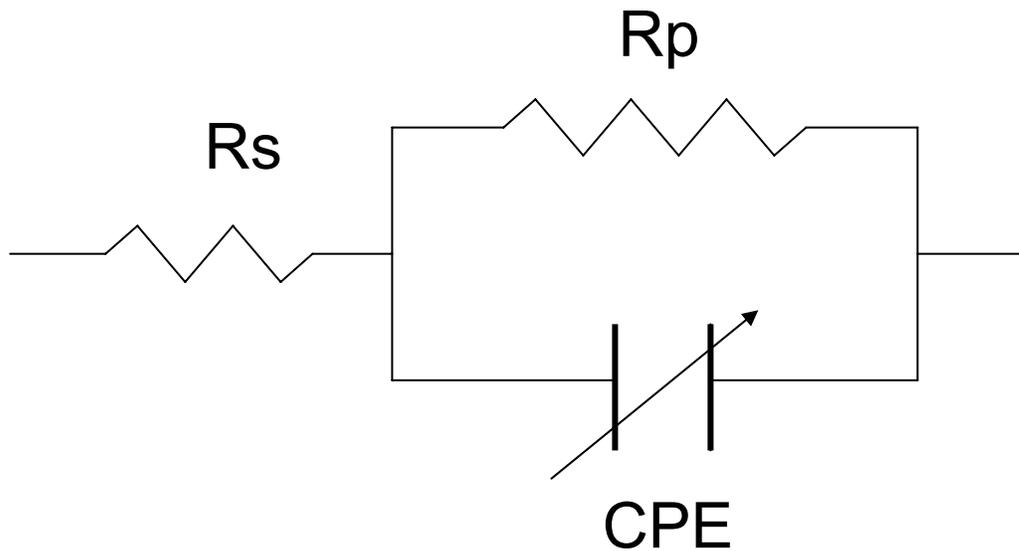
Figure 11 - Analog circuit used to analyze the EIS data. The constant phase angle element (CPE) has parameters $Y_0 (S \cdot s^n)$ and n .

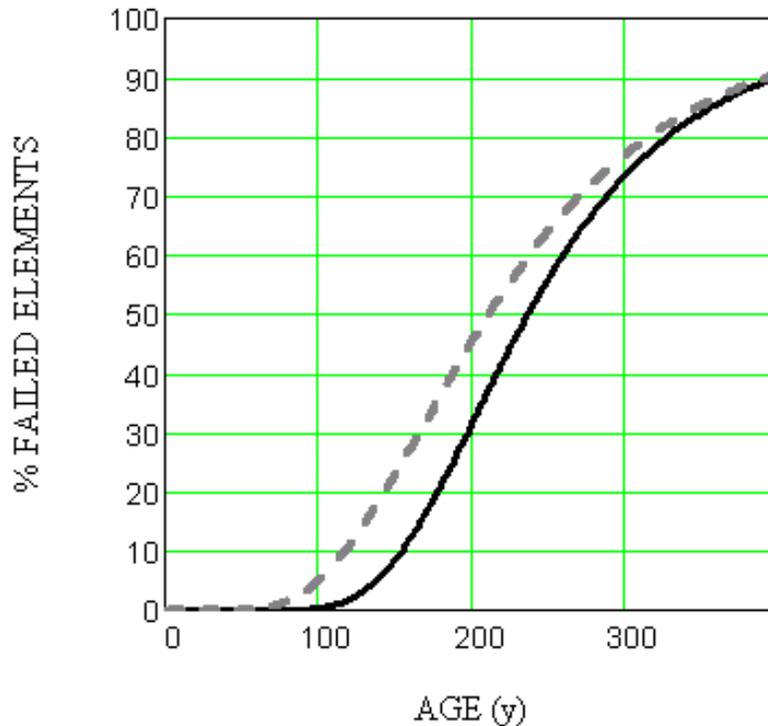
Figure 12 - Model projections of percentage of damage elements in a generic MSE wall as function of wall age. The projections are based on the lognormal distribution parameters in Table 4.1. The dashed and solid lines correspond to the parameters abstracted from the 1994-98 and the 2006-09 survey data respectively.

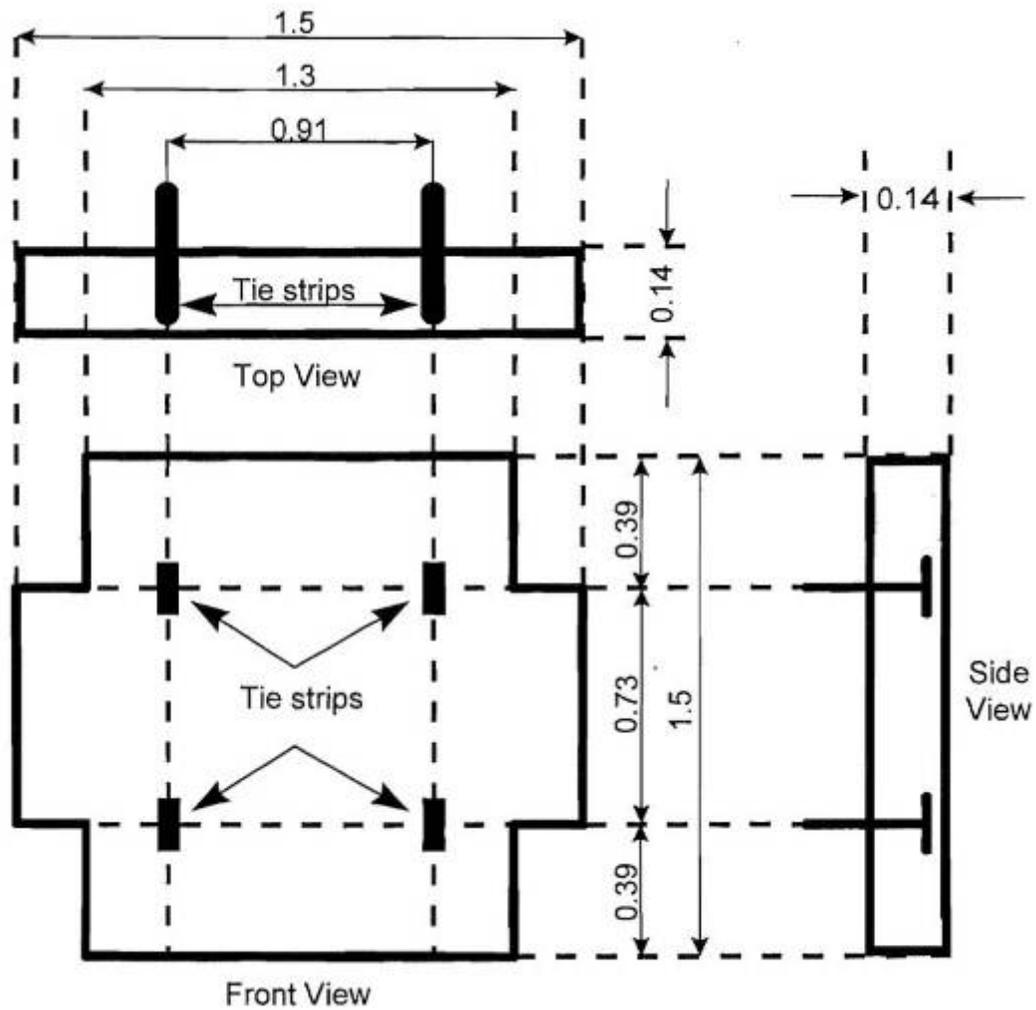
Figure 16 - Dimensions of typical concrete panels and tie strip locations for the BR. site. All dimensions are in meters [15].

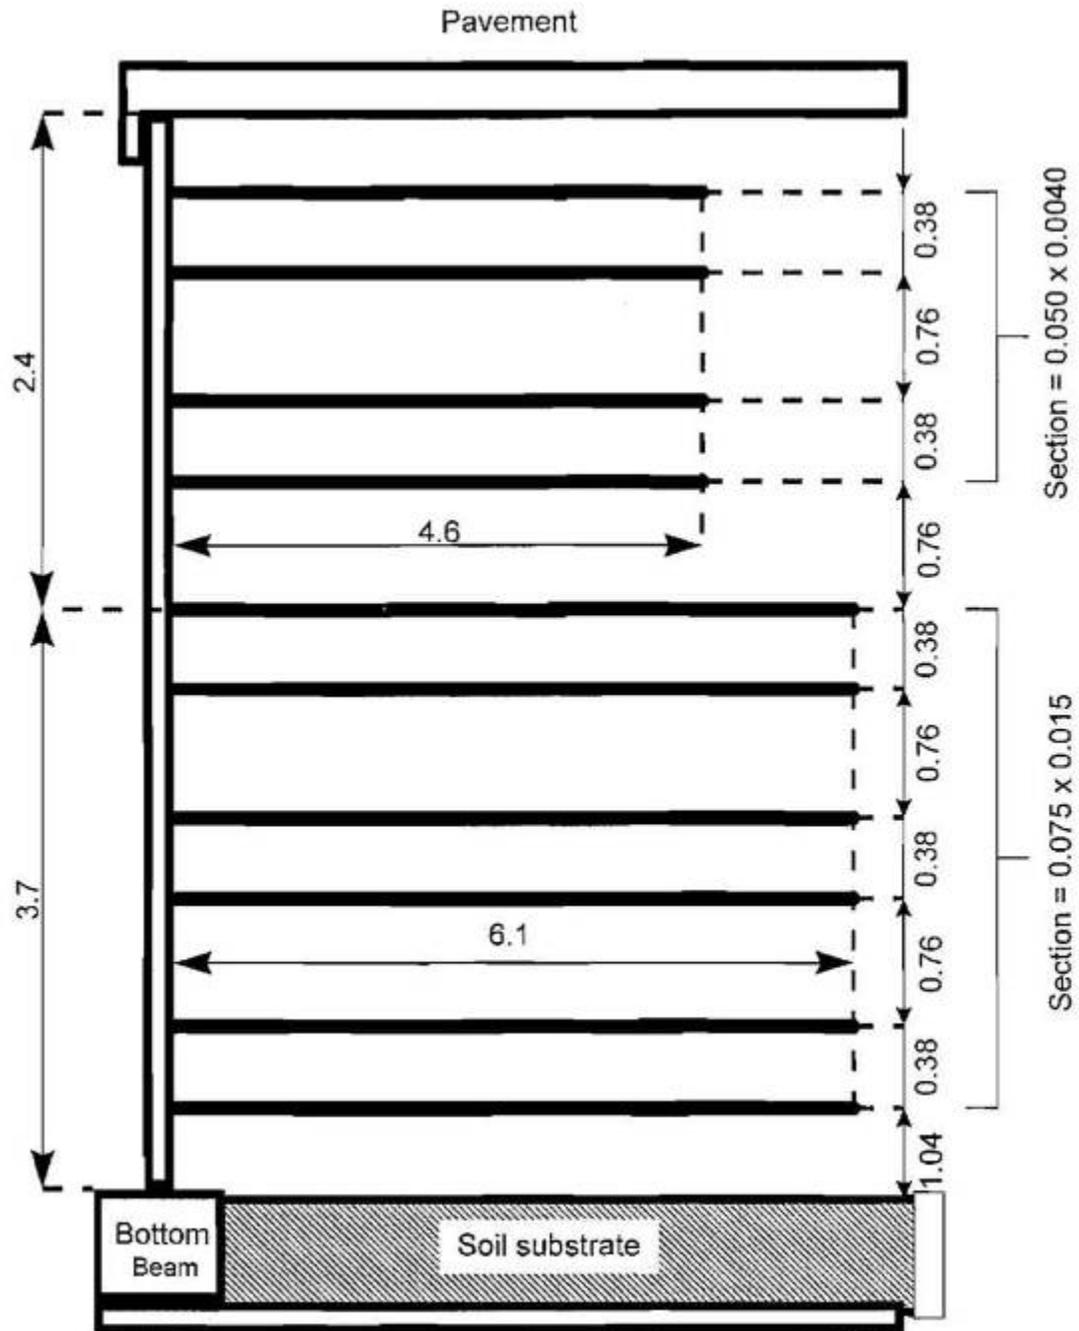
Figure 17 - Reinforcement placement in BR site MSE walls. All dimensions are in meters [15].

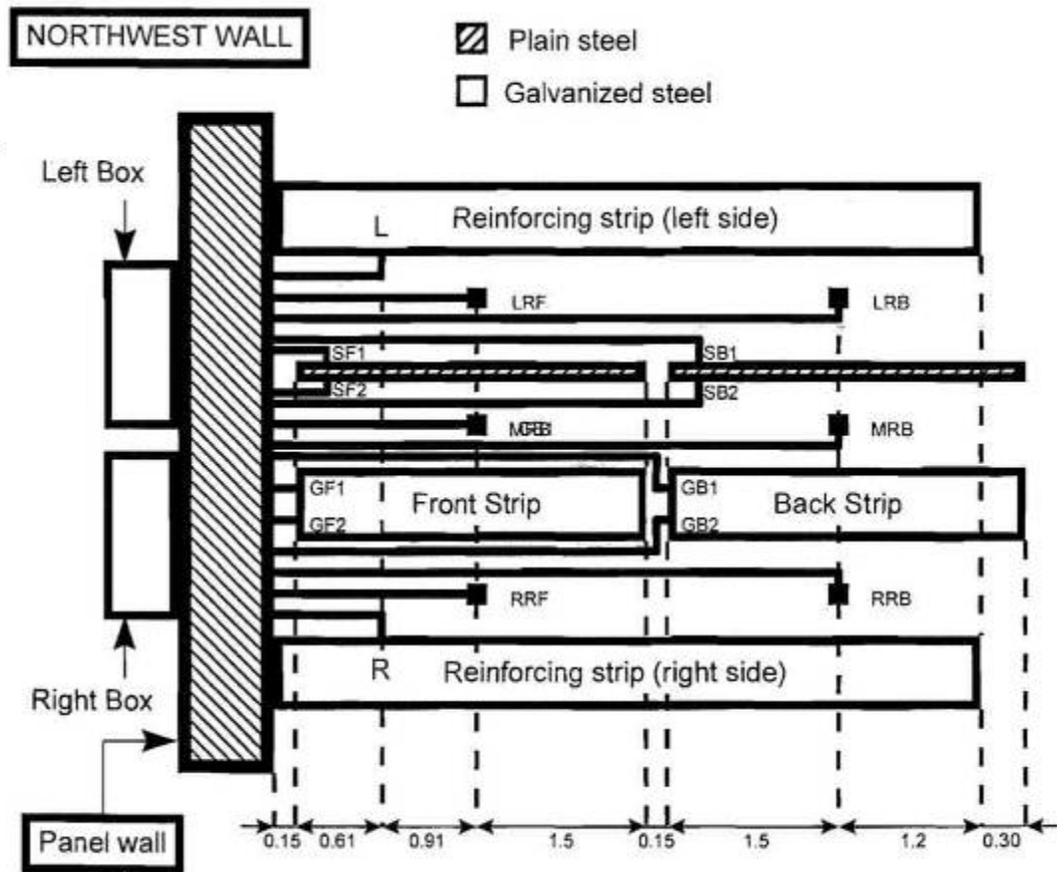
Figure 18 - Cluster diagram showing layout of elements in BRN. All dimensions are in meters [15].

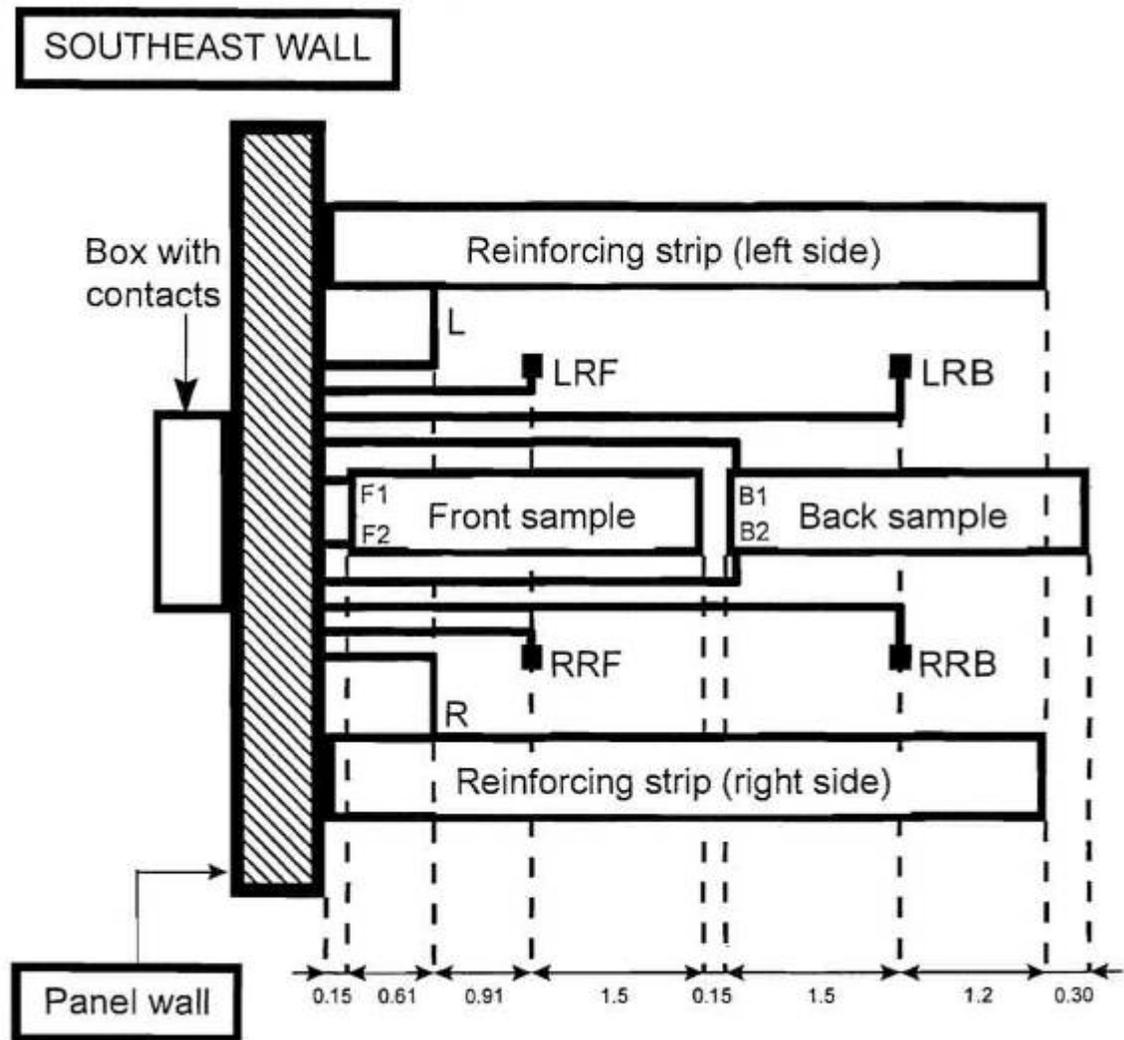
Figure 19 - Cluster diagram showing layout of elements in BRS. All dimensions are in meters [15].

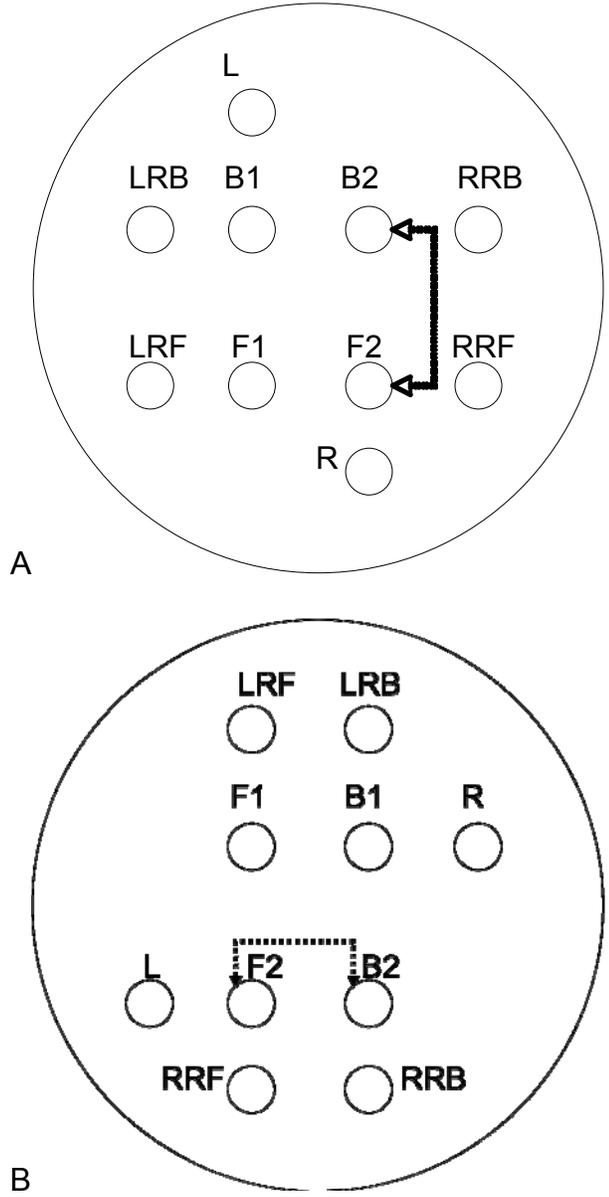
Figure 22 - Test points BRS top (A) and bottom (B) layers. Normally connected jumpers shown.

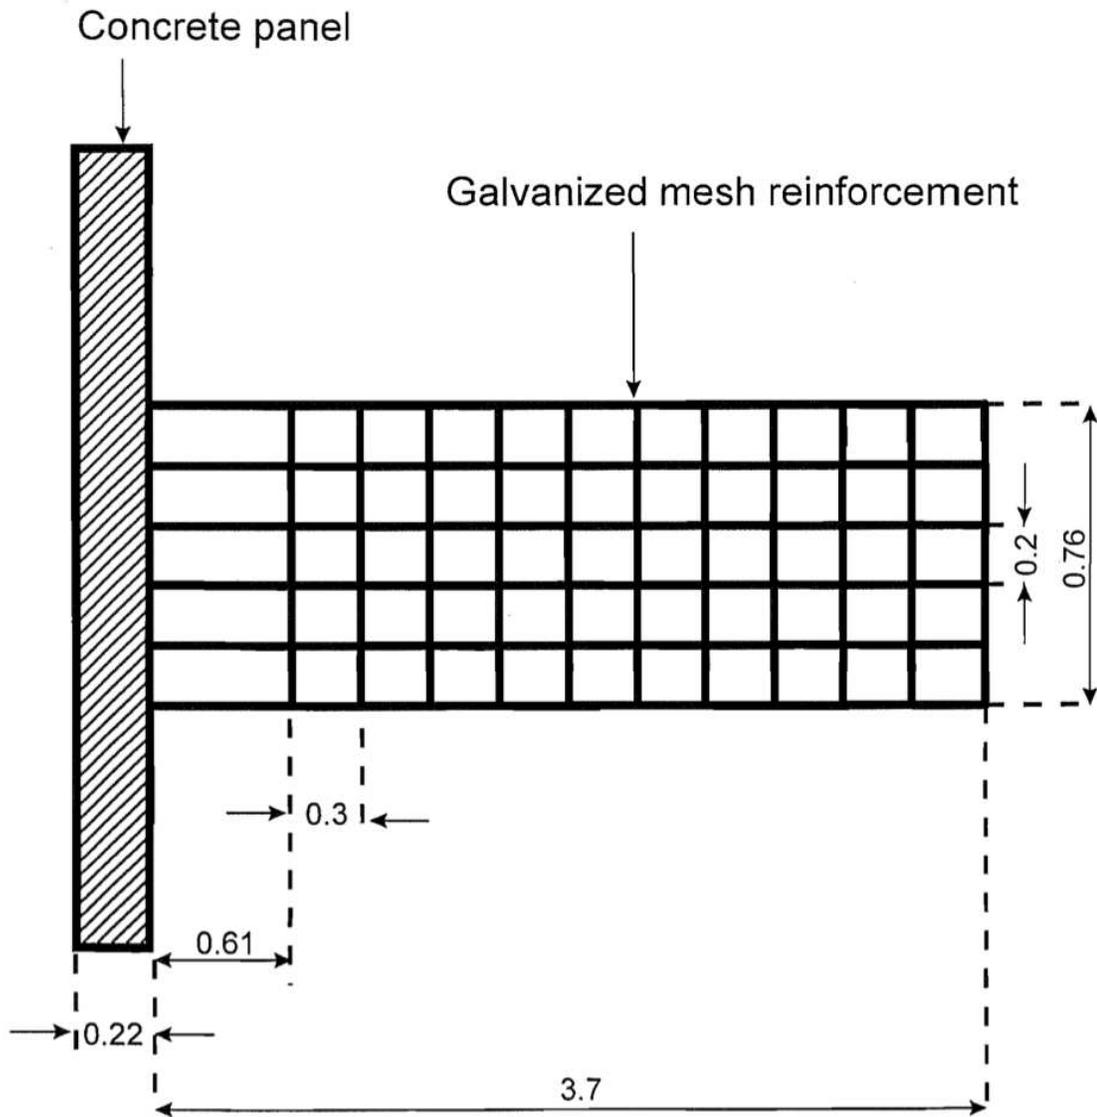
Figure 25 - Top view of a mesh and panel at HFB. All dimensions are in meters and not to scale [15].

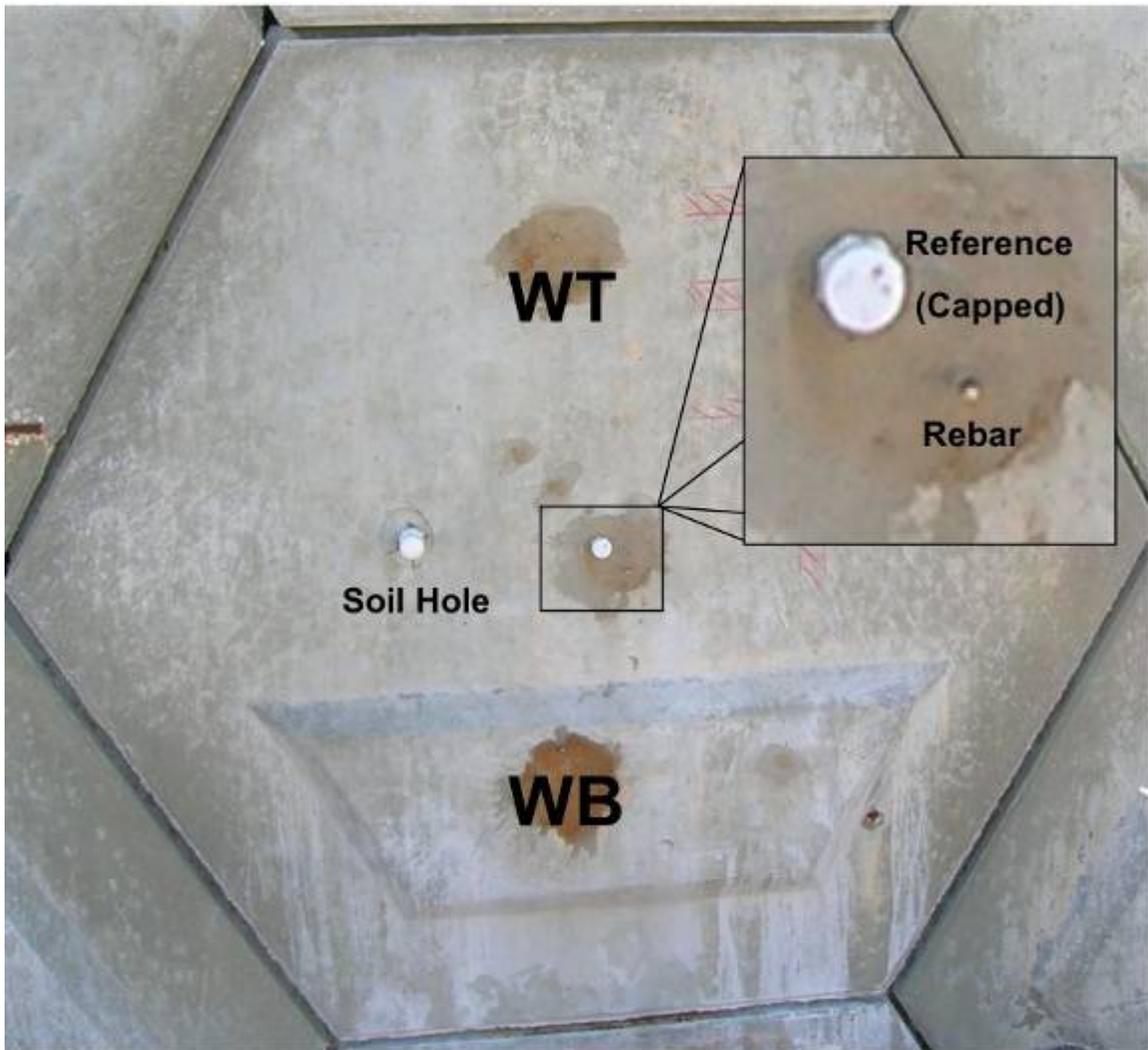
Figure 26 - Panel layout for HFB panels R7, R9, R15, and R21. Panel R9 is shown in this figure. Panels R7 and R15 do not have PVC caps over their reference electrode covers. WT and WB refer to the top and bottom mesh connectors respectively.

In August 2006, two additional panels were instrumented (R9 and R21). The instrumentation of the two panels utilized similar methods to those used in the first survey, by attaching stainless steel rods to the galvanized meshes and other added electrodes.

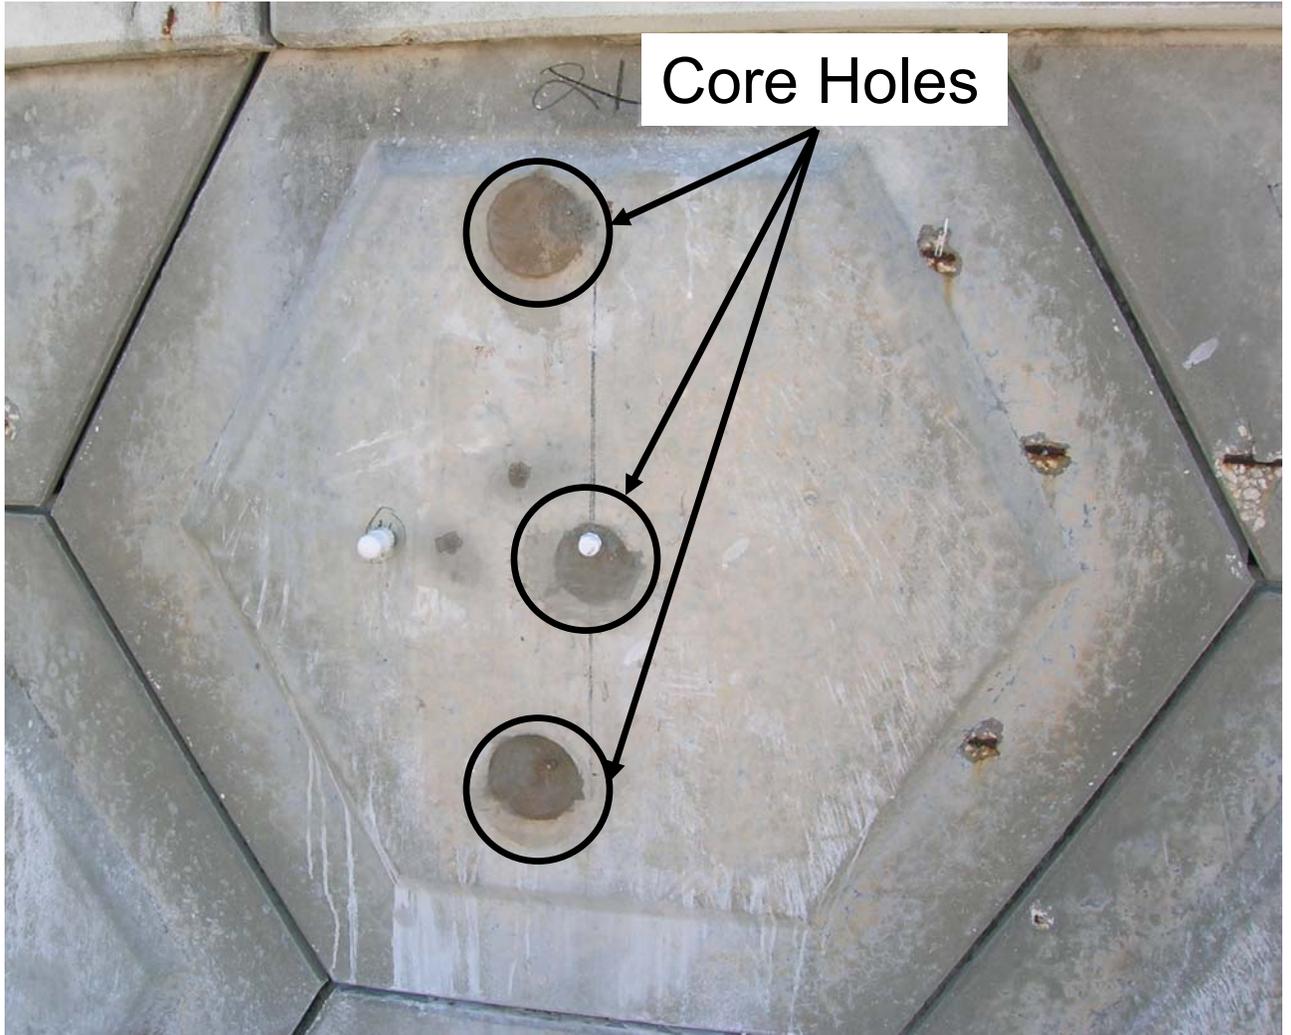
Figure 30 - Core hole locations in HFB panel R21. Metal reinforcement coupons were only removed from the top and bottom holes. Small spalls, caused by panel concrete reinforcing steel corrosion at points of low concrete cover, are visible.

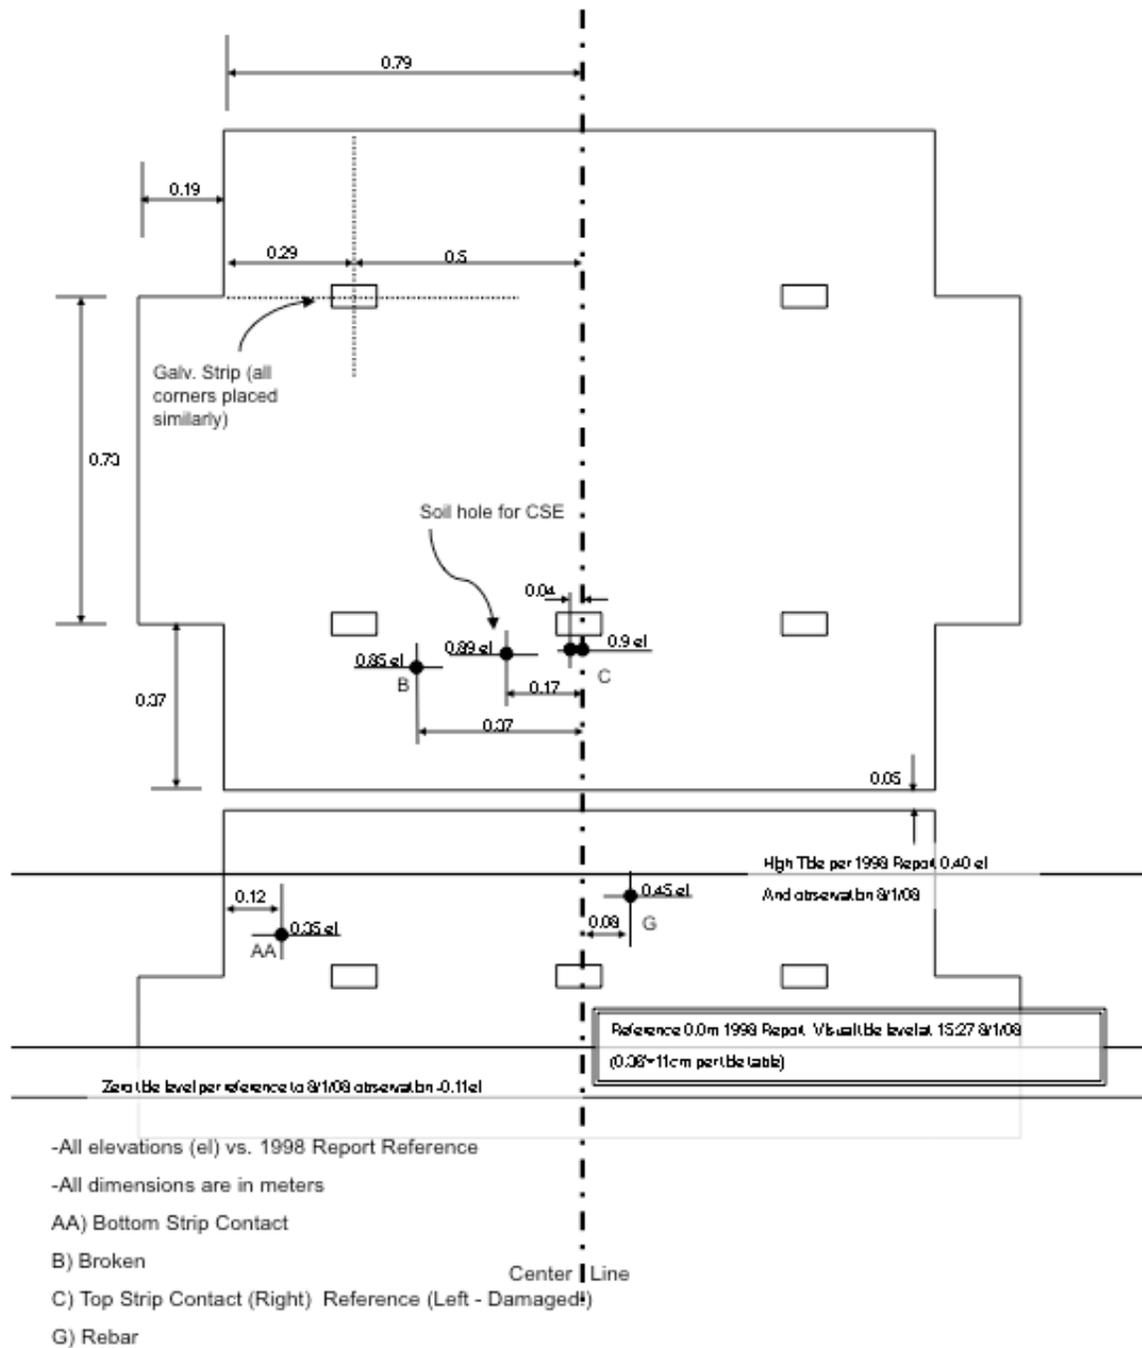
Figure 38 - Detailed panel information for panel R3W at PCW.

The reference electrode connection was damaged at the PCW Panel R3W and was initially repaired by inserting a stainless steel screw into the wire stump.

The repair was not effective, so a CSE temporarily inserted in the soil hole of the panel was used instead as a reference electrode for the polarization measurements. At PCE, the Panel R1 connection stainless steel rod to the bottom strip was broken where it emerged at the concrete surface, making electrical connections with alligator clips difficult but still feasible.

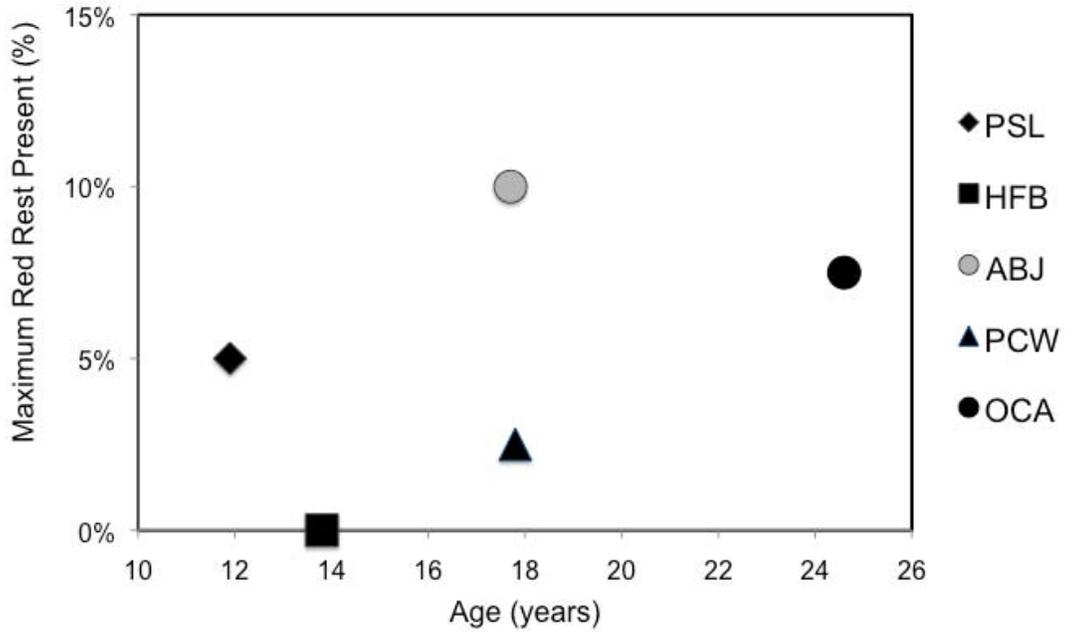
Figure 67 - Plot of percentage of red rust observed by age by site.

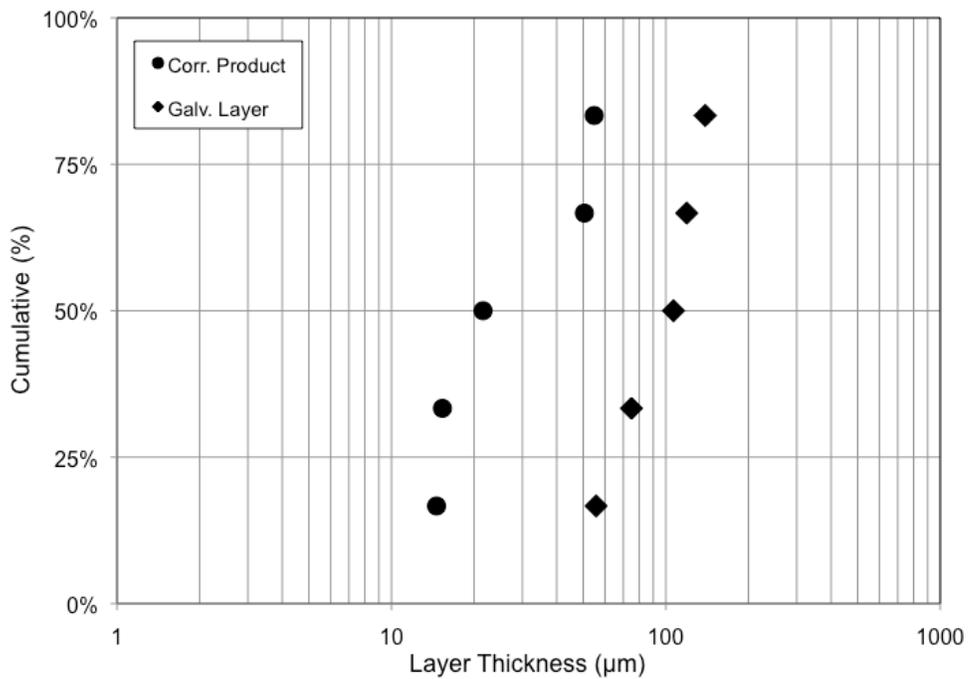
Figure 68 - Cumulative lognormal distribution of coating thickness measurements from coupons collected from the field.

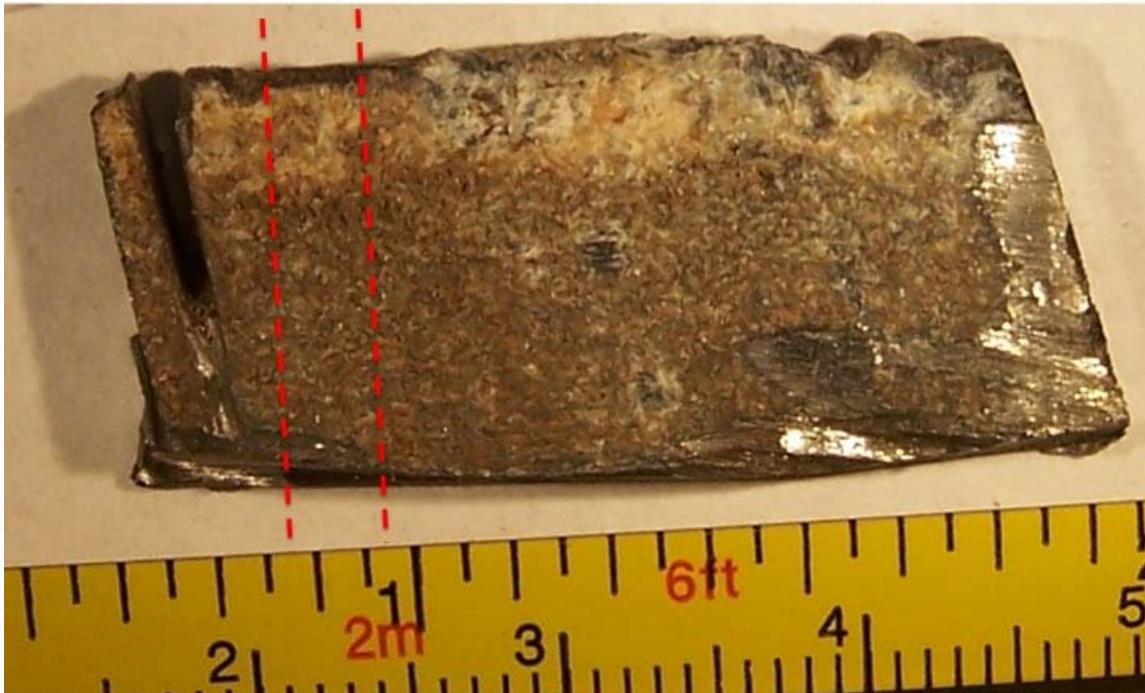
Figure 69 - The top side of the coupon from PCW panel 2W.

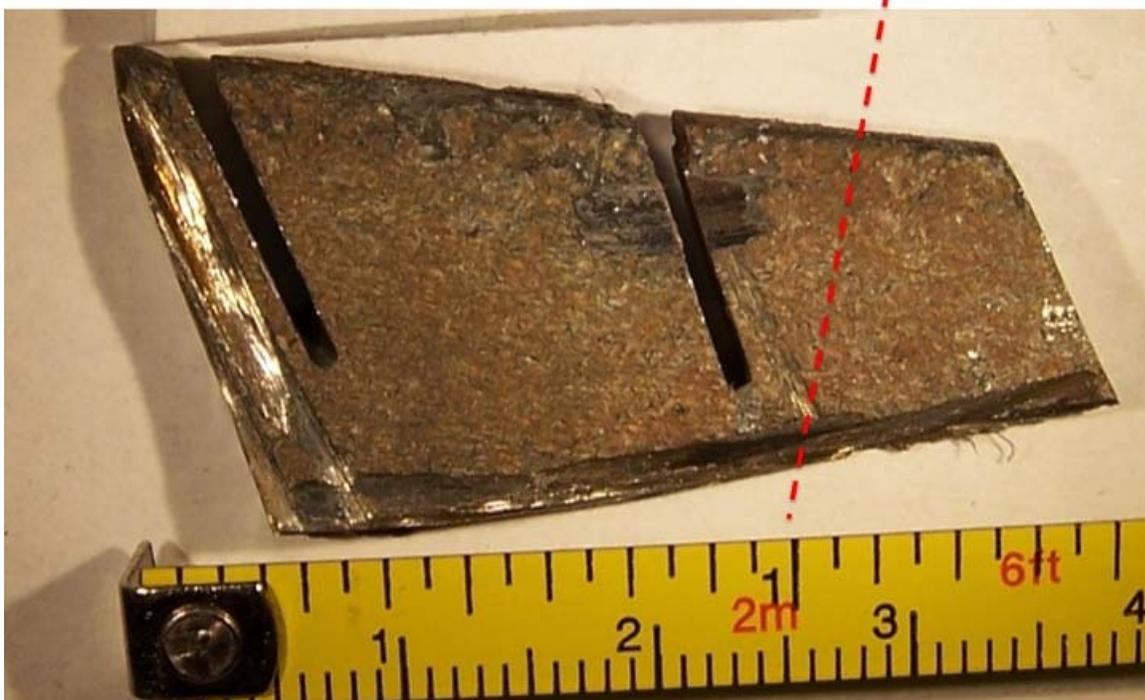
Figure 70 - The top side of the coupon from PCW panel 4W.
