**UPDATE ON CONDITION OF REINFORCED
EARTH WALL STRAPS
Contract No. BD544-32**

Final Report to Florida Department of Transportation

**A. A. Sagüés
Principal Investigator
Department of Civil and Environmental Engineering**

**UNIVERSITY OF SOUTH FLORIDA
Tampa, FL 33620
March 31, 2009**

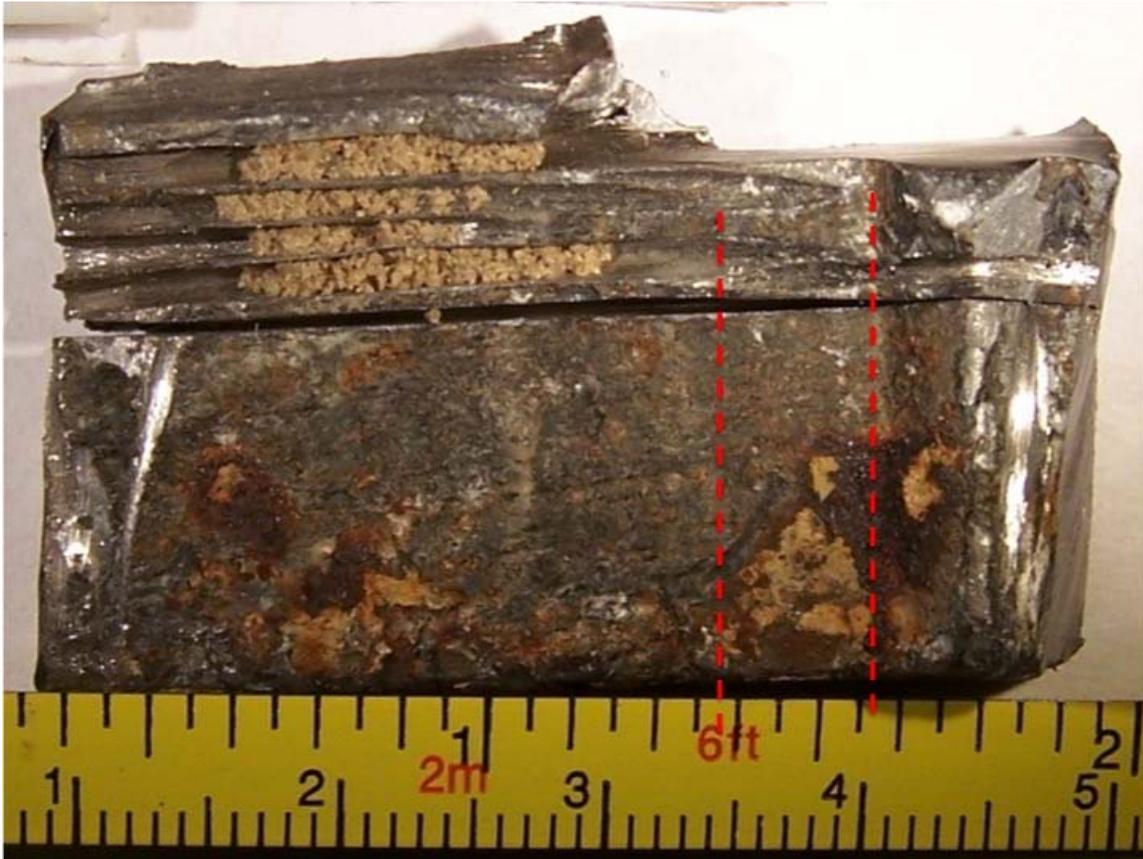
Figure 73 - The top side of coupon 'B' from OCA panel 5.

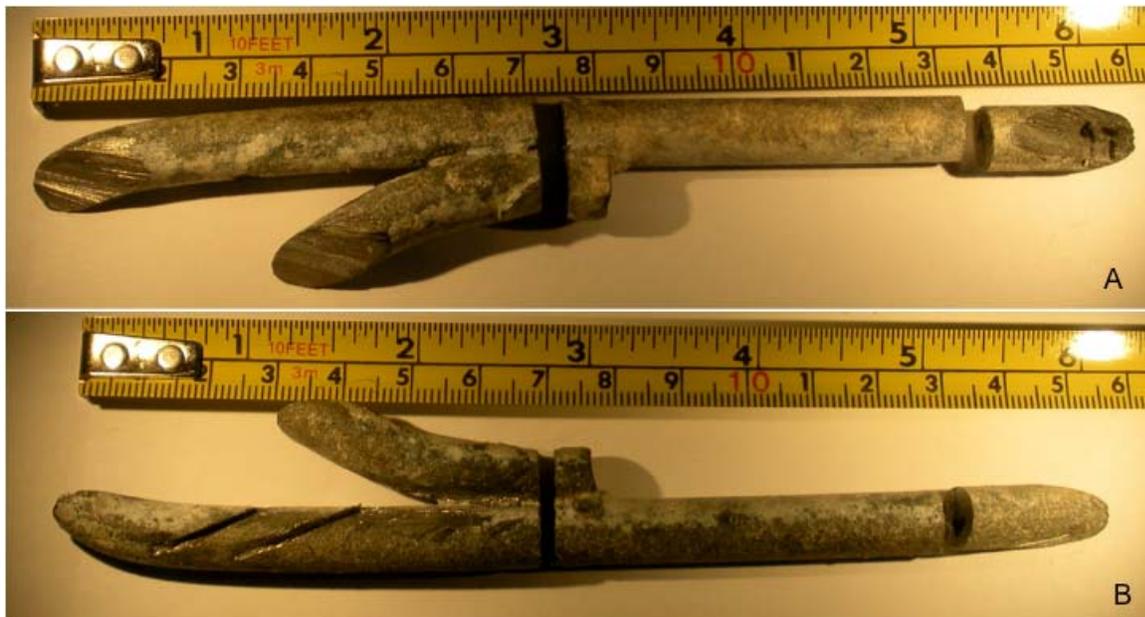
Figure 76 - Elevation views of the coupon from HFB panel 9 top mesh. A: Top is up. B: Opposite side, top is down. The wall panel connection is to the left in both pictures.

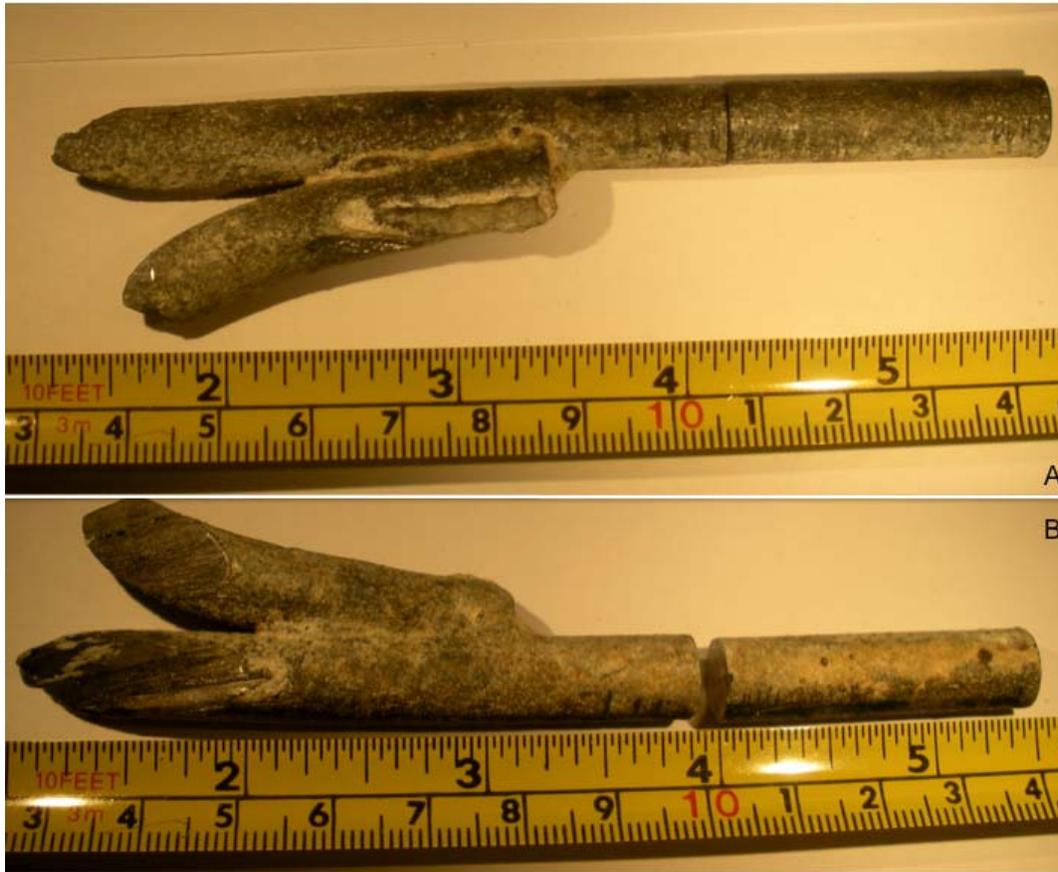
Figure 78 - Elevation views of the coupon from HFB panel 22 top mesh. A: Top is up. B: Opposite side, top is down. The wall panel connection is to the left in both pictures.

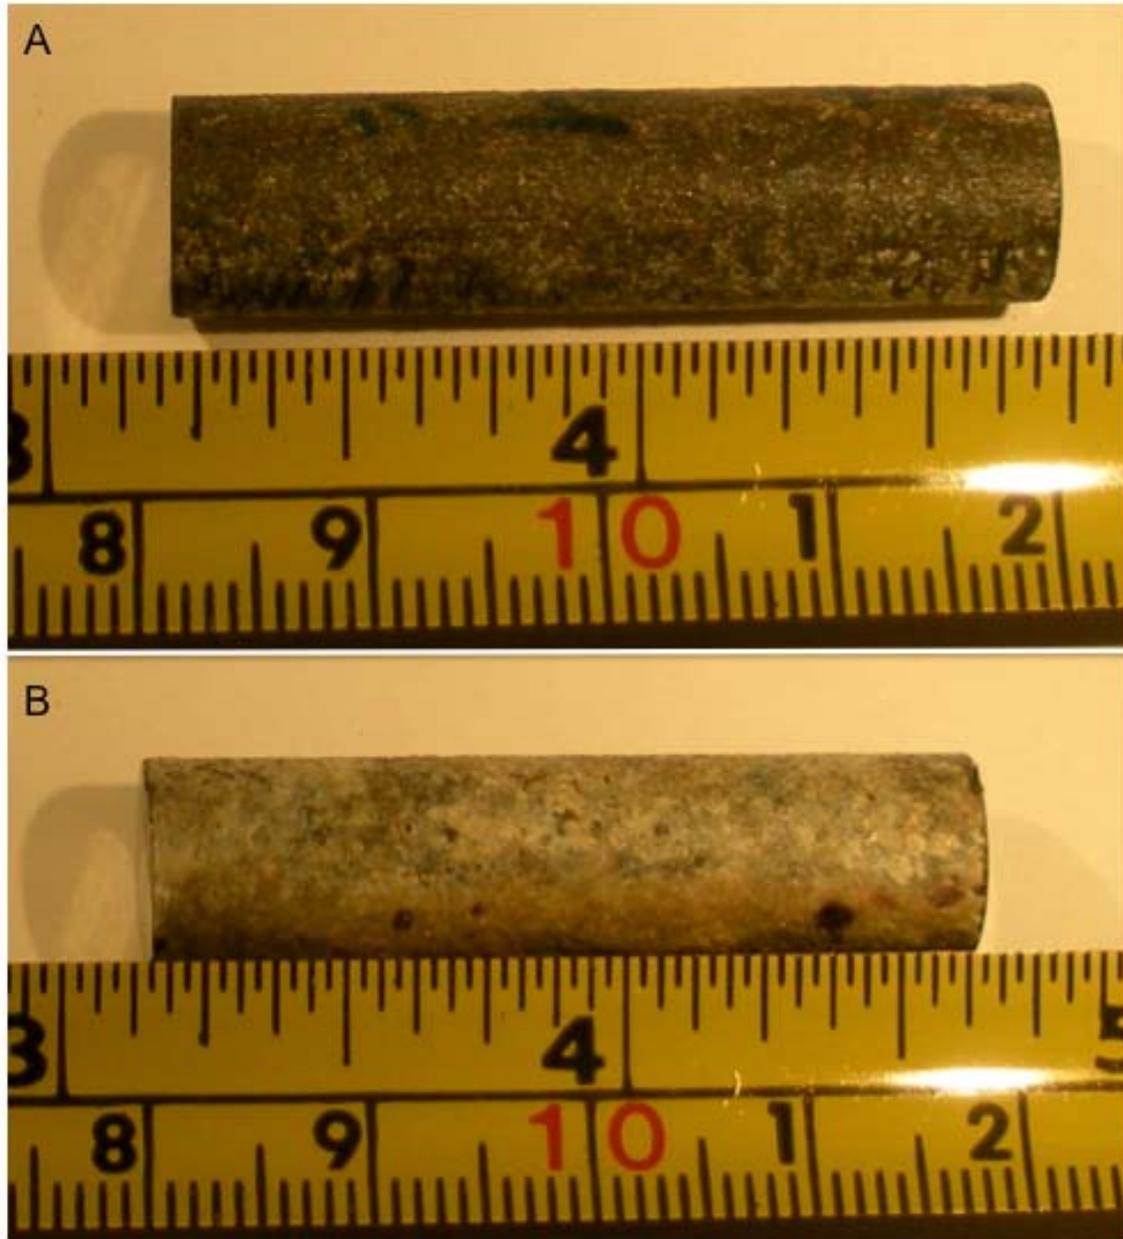
Figure 79 - View from above (A) and below (B) of part of the coupon from HFB panel 22 top mesh.

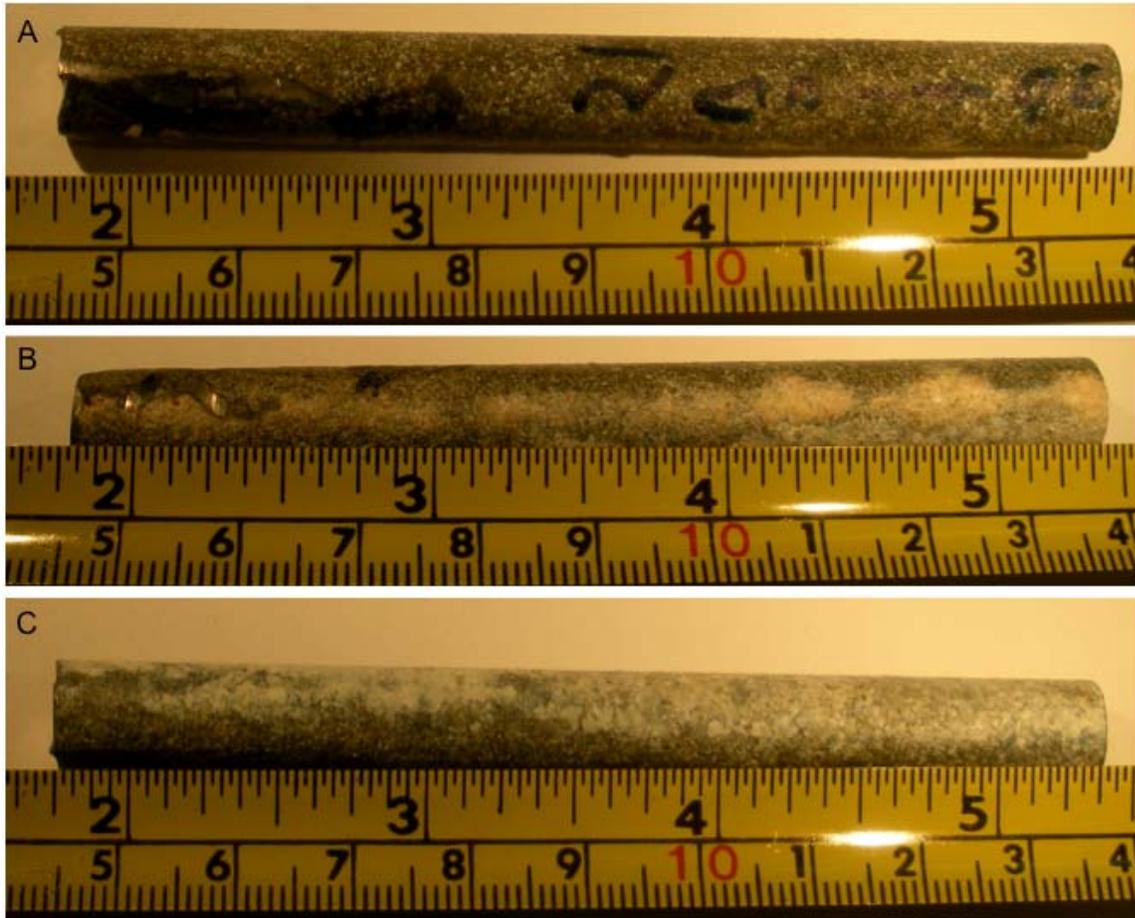
Figure 80 - View from top (A), side (B), and bottom (C) of part of the coupon from HFB panel 22 bottom mesh.

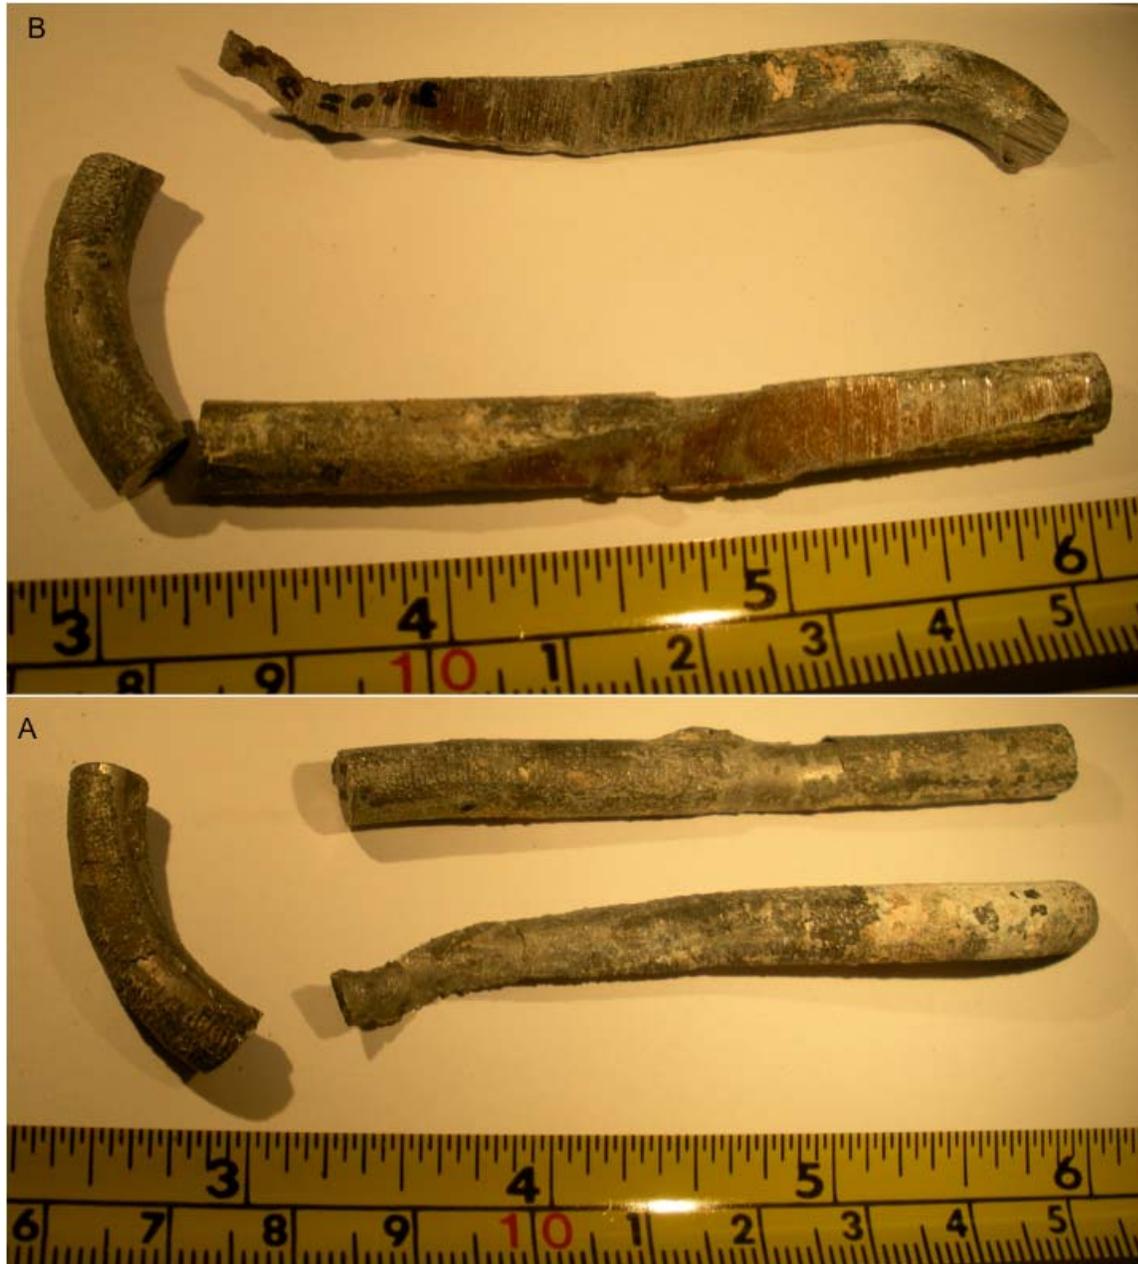
Figure 81 - Pictures of segments cut from a hook in HFB panel 9 in the top layer mesh. The hook was heavily deformed during the coring of the hole to make an electrical contact to the mesh causing much of the disbanding of the galvanizing and later the rusting (B).
