**Report No. BD544-36**

**Investigation of Automated and Interactive Crack Measurement Systems**

Submitted to  
Florida Department of Transportation  
By the

Department of Civil and Environmental Engineering  
College of Engineering  
University of South Florida  
Tampa, FL 33620  
Ph. (813)974-2275  
May 27, 2008

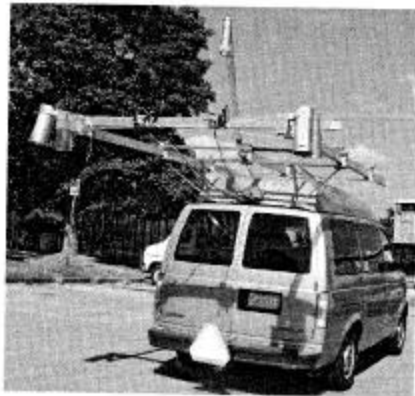
**Figure 1.3 Dual camera subsystem Wang (2000)**

The vehicle (Figure 1.3) is based on a full-digital design and the operating software environment is based on 32-bit technology. The vehicle's subsystem for pavement surface image collection has a frame-based digital camera and four strobe lights for illumination. They are extended from the back of the vehicle for data collection. The configuration diagram of this system is depicted in Figure 1.4. To obtain high-quality images at high shutter speed, the firing of the strobes and the shutter opening of the camera are synchronized. A dual-CPU computer is used for GPS data acquisition, DMI data, and images from the digital camera at 12 frames/s. The image processing system for cracks is called the distress analyzer. For real time distress analyzer, these data sets are moved to a multi-CPU computer.

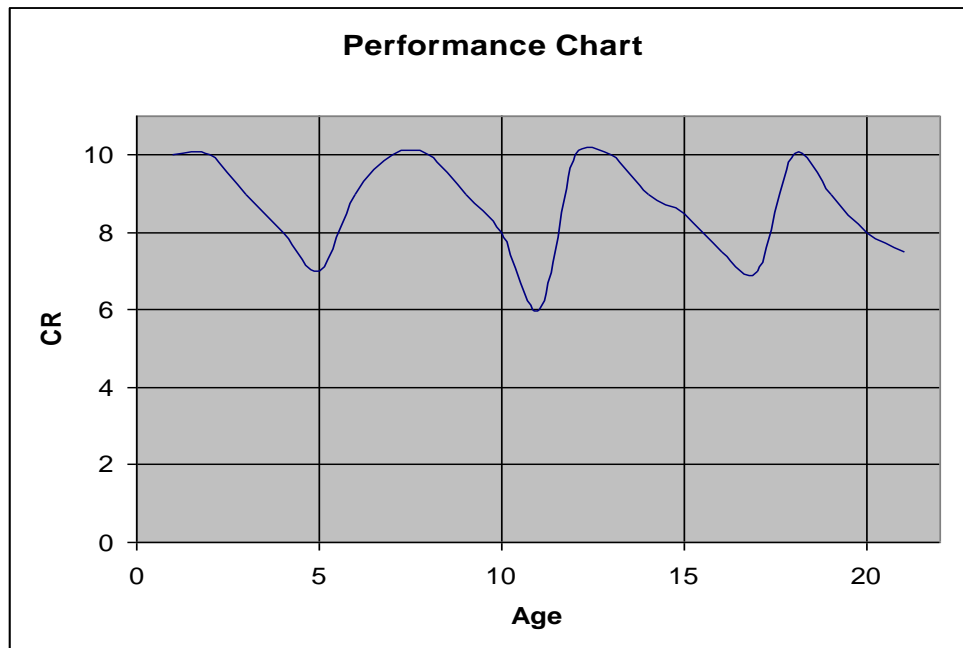
**Figure 2.2** Sample plot showing the cyclic variation of CR for a single pavement section

The construction cycle of a pavement indicates the number of overlays that have been placed on the original pavement. In order to distinguish and display the cyclic behavior of CR, i.e. the variation from one construction cycle to the next, the trend shown in Figure 2.2 has been developed. The CR of a given pavement section generally deteriorates with time and at the time it is overlaid an instantaneous significant improvement in CR could be expected as shown in Fig 2.2. Furthermore, from plots such as that in Figure 2.2, the number of construction cycles that the pavement has undergone can also be determined. An example CR Vs age plot for a group of pavements in FDOT District 3 with a traffic level of D and surface layer type FC5 is shown in Figure 2.3. Each individual plot in Figure 2.3 represents a specific pavement section in that group. Finally, a sample of all such plots obtained for the entire FDOT controlled highway network is given in Appendix A.

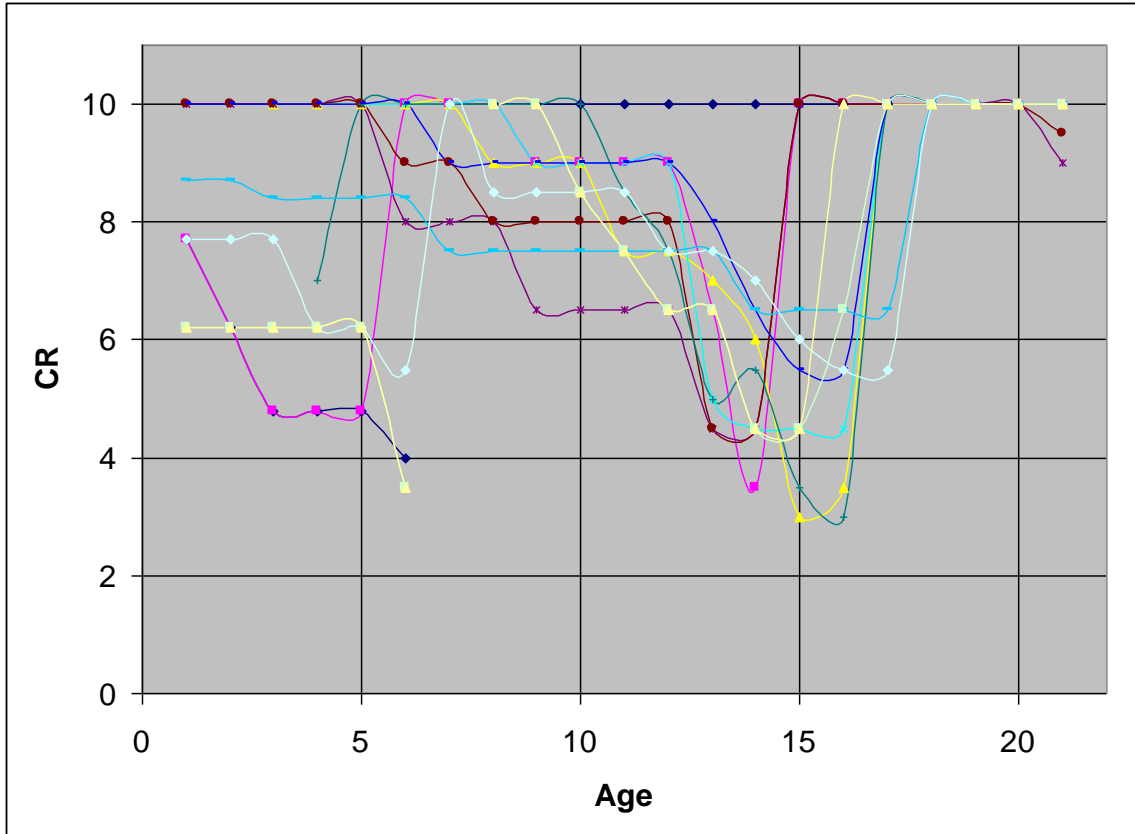
**Figure 2.3 Crack rating curves for District 3 Superpave sections (FC5 traffic level D)**

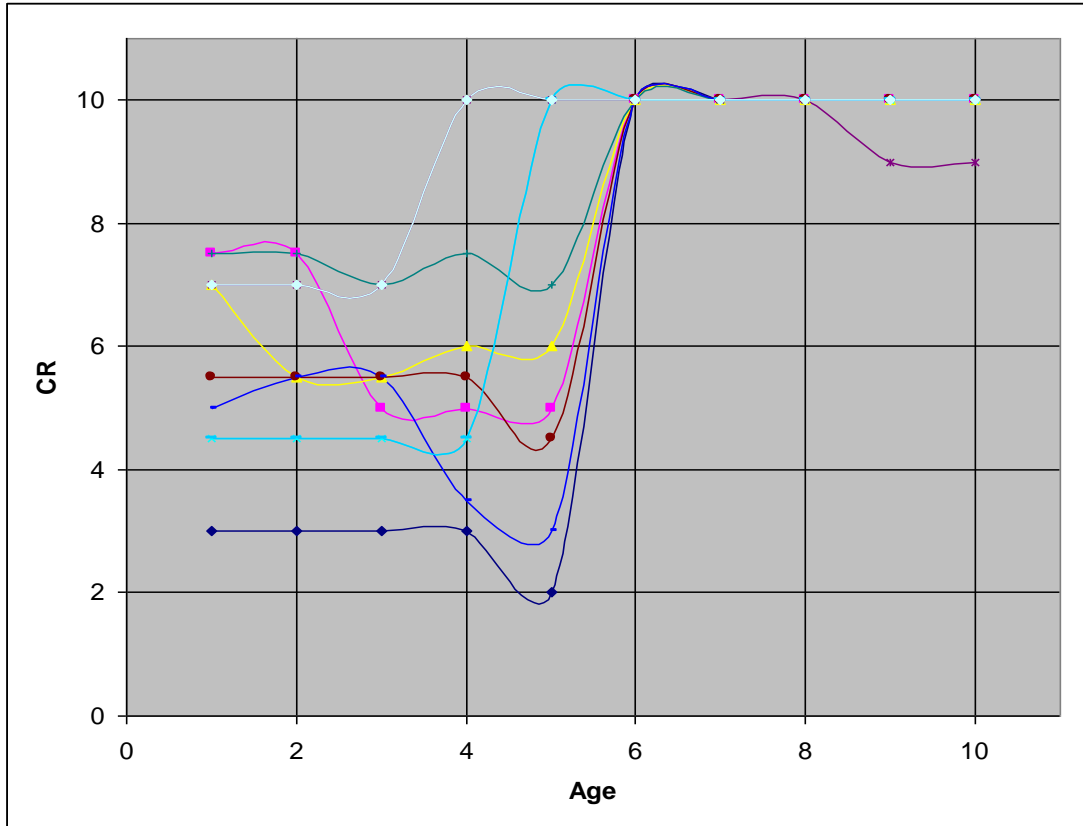
**Figure 2.4 Crack rating curves for District 1 Superpave sections (FC5 traffic levels C and D)**

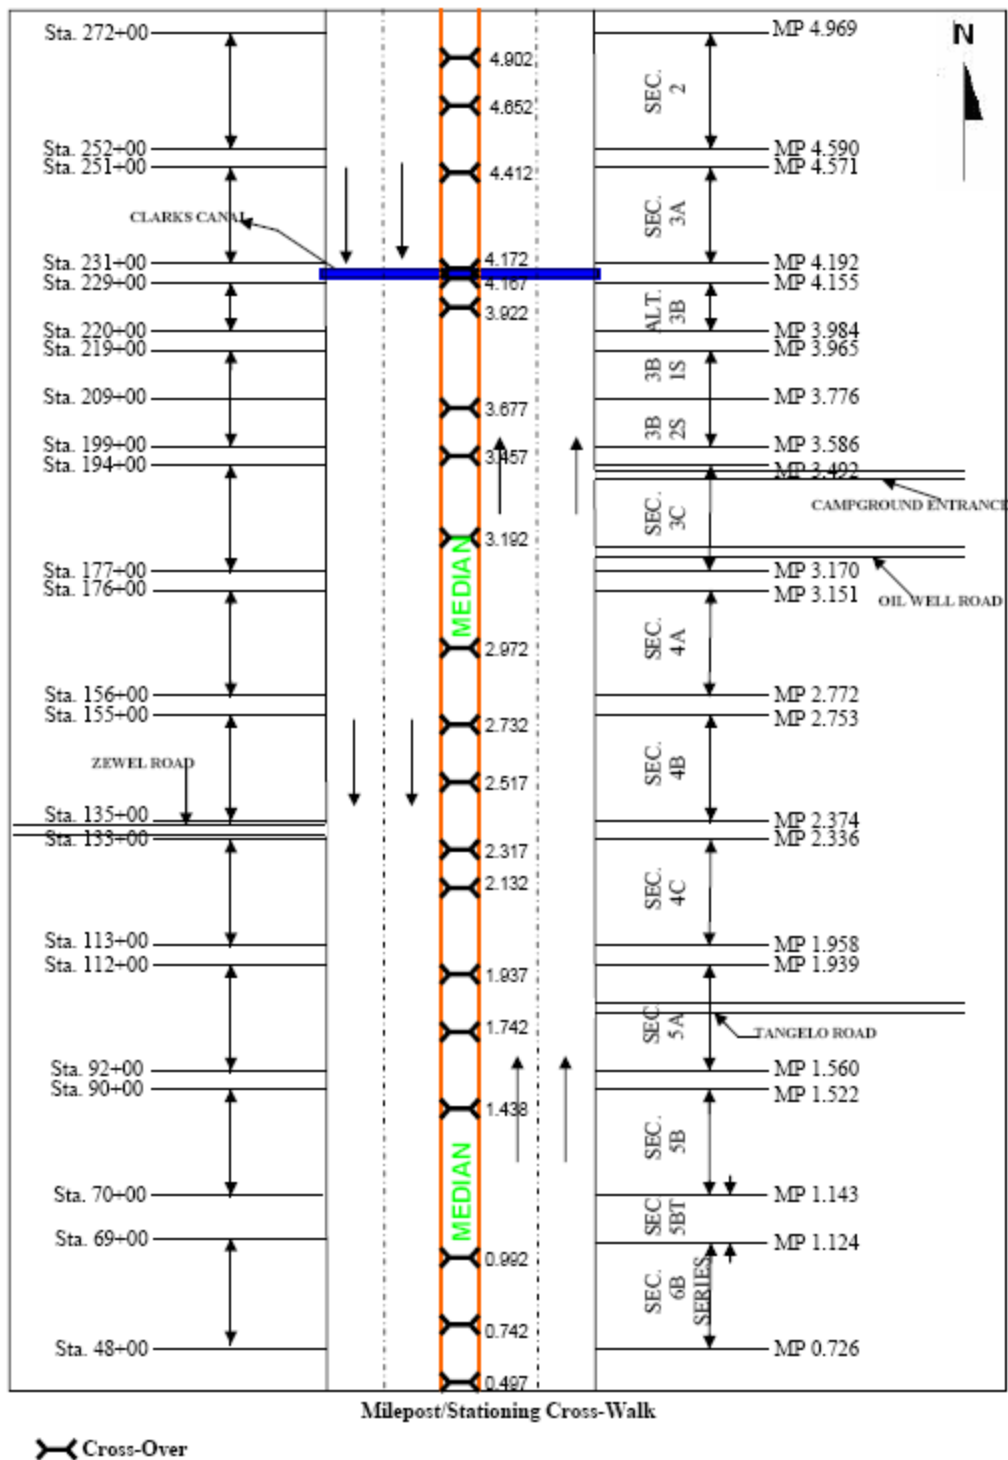
Figure 3.1 Configuration of SR 45/US 41 Econocrete section

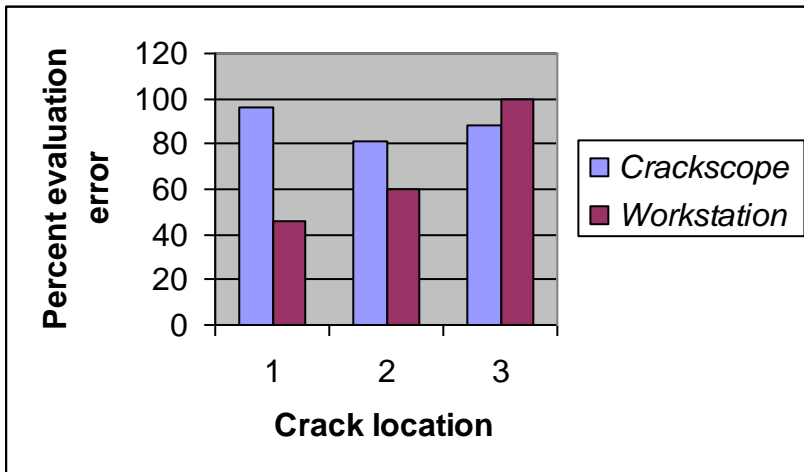
**Figure 5.2 Comparison of software evaluation errors for SR 212**  
 (1 – Outside wheel path, 2 – Inside wheel path, 3 – Between wheel paths)

However, the majority of the errors are once again positive indicating that the *Workstation* program has also consistently over-estimated the extent of cracks. The latter observation certainly supports the other previous explanation offered by the investigators that the evaluators could have missed a significant number of hairline cracks since the manual evaluations were performed during night time. The summary comparison of the results of the two programs in the evaluation of SR 54 and SR 212 test sections are illustrated graphically in Figures 5.1 and 5.2, respectively.

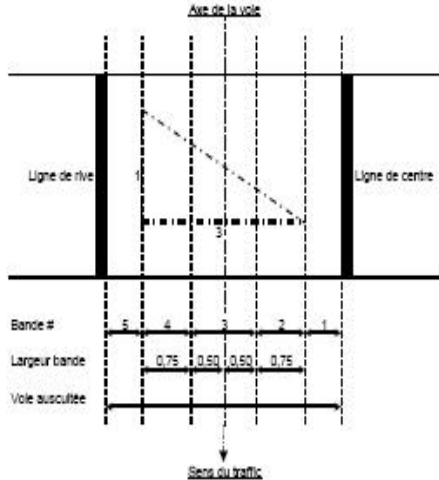
TYPE	DESCRIPTION	SCHEME OR PICTURE
Crack definition	Minimum length: 0,15 m Minimum width: 1 mm	N/A
Transversal cracking	Crack with an orientation $\leq 1:3$ (1 parallel et 3 perpendicular to the road axis) and which is present on 2 or more longitudinal strips.

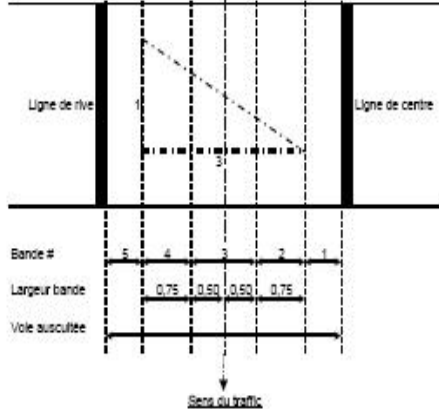
Longitudinal cracking	Crack with an orientation $> 1:3$ (1 parallel and 3 perpendicular to the road axis).

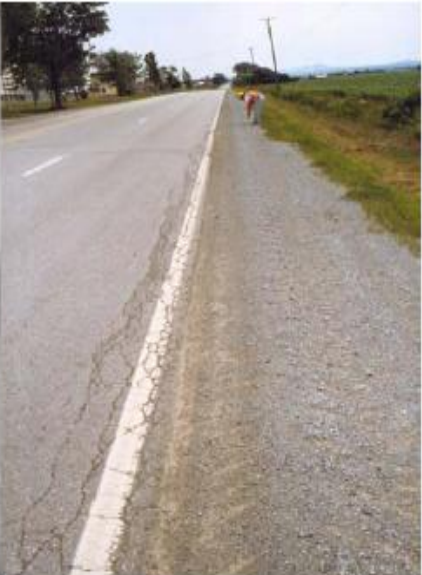
Edge cracking	Longitudinal crack distant less than 0.25 m from the edge of the road.

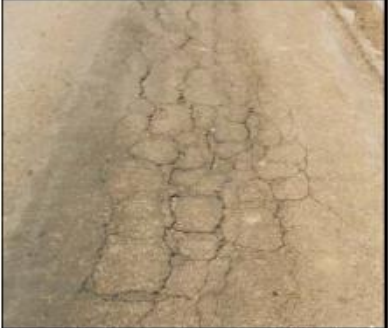
<p>Alligator cracking</p>	<p>Agglomeration of pavement cracks in the form of a grid, with at least 3 pieces in each direction, and where the diameter of each piece is less than 300 mm.</p> <p>If the diameter of the pieces is greater than 300 mm, then the cracks are considered as distinct.</p>

<p><i>alligator cracking (d ≤ 300 m)</i></p>

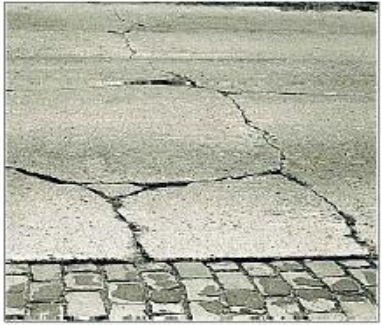
<p><i>distinct cracks (d &gt; 300 mm)</i></p>
<p>Multiple cracks</p>	<p>Agglomeration of pavement cracks that run parallel and that are less than 300 mm apart. If they are more than 300 mm apart, then the cracks are considered as distinct.</p>
