**FINAL REPORT**

**TIME RATE OF LOCAL SCOUR  
AT COMPLEX BRIDGE PIERS  
FIELD AND LABORATORY ANALYSES**

**FDOT CONTRACT NO.: BD 545 RPWO 19**

**APRIL 2009**

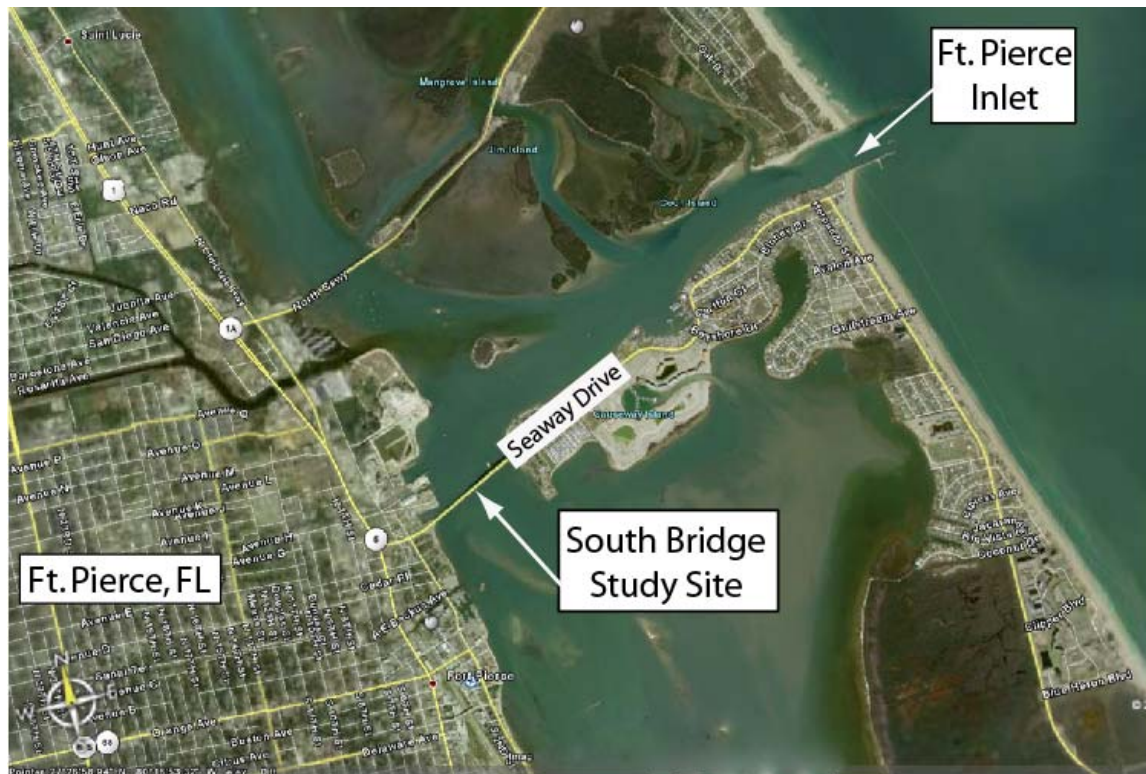
Figure 2 Aerial photograph showing test pier location relative to Fort Pierce Inlet.

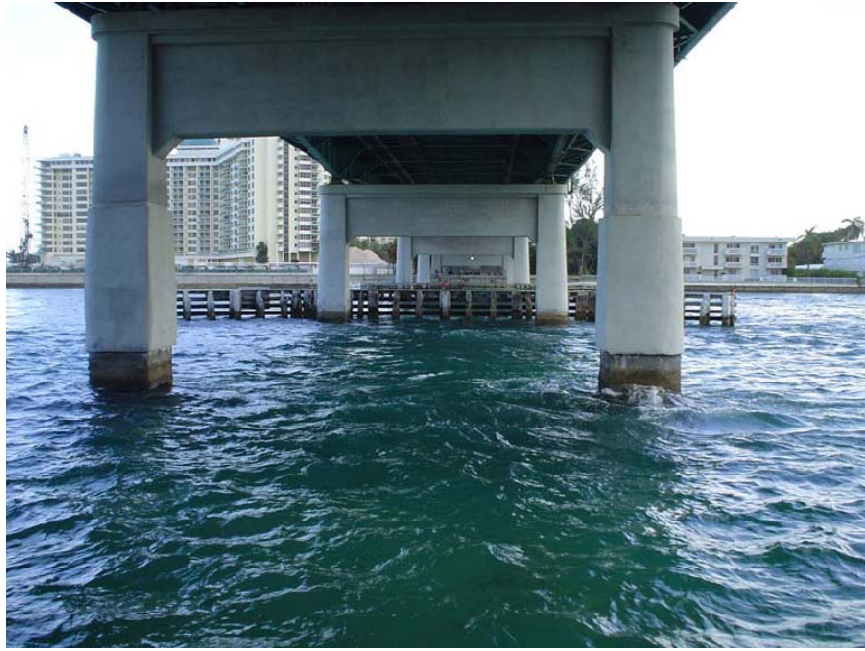
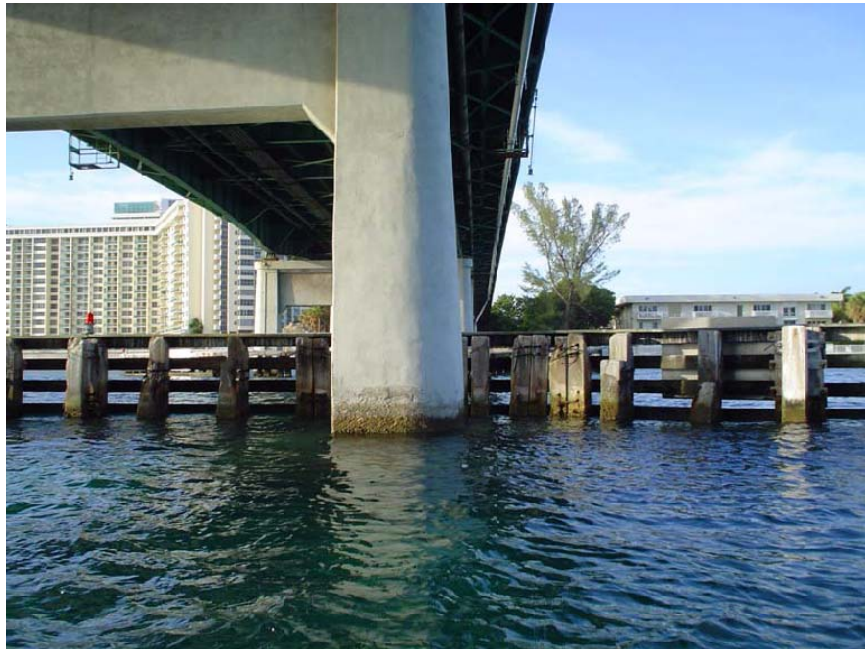
Figure B 1 Photographs of Bakers-Haulover Bridge piers.

Upon initially arriving at the sight it was discovered that all eight of the piers supporting the bridge were placed on top of pile caps. Sand probes revealed that the sand layer thickness varied from more than 2' to exposed rock.

Piers 7 & 8 contained the largest amount of exposed bed rock, covering roughly 50% of the scoured area. However, Piers 7 & 8 also showed the deepest scour hole, with Pier 7 having scour more than 1' below the pile cap on its leading edge (scour depth being further punctuated by a dozen lobster living beneath the edge). As before, the two scour holes of Piers 7 & 8 overlapped into each other.
