University of Florida
Civil and Coastal Engineering

Final Report

May 2009

SHEAR PERFORMANCE OF EXISTING PRESTRESSED CONCRETE BRIDGE GIRDERS

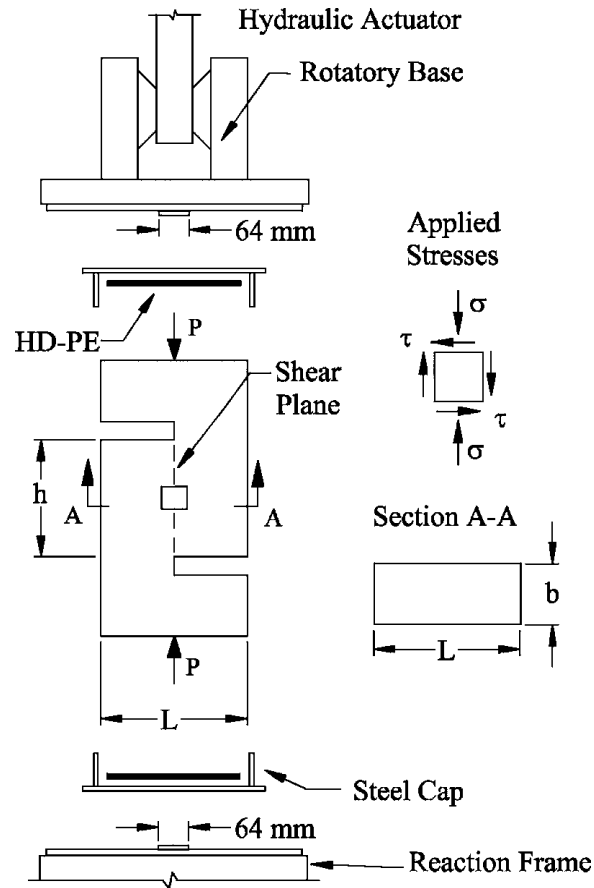
Figure 3 – Push-off test.

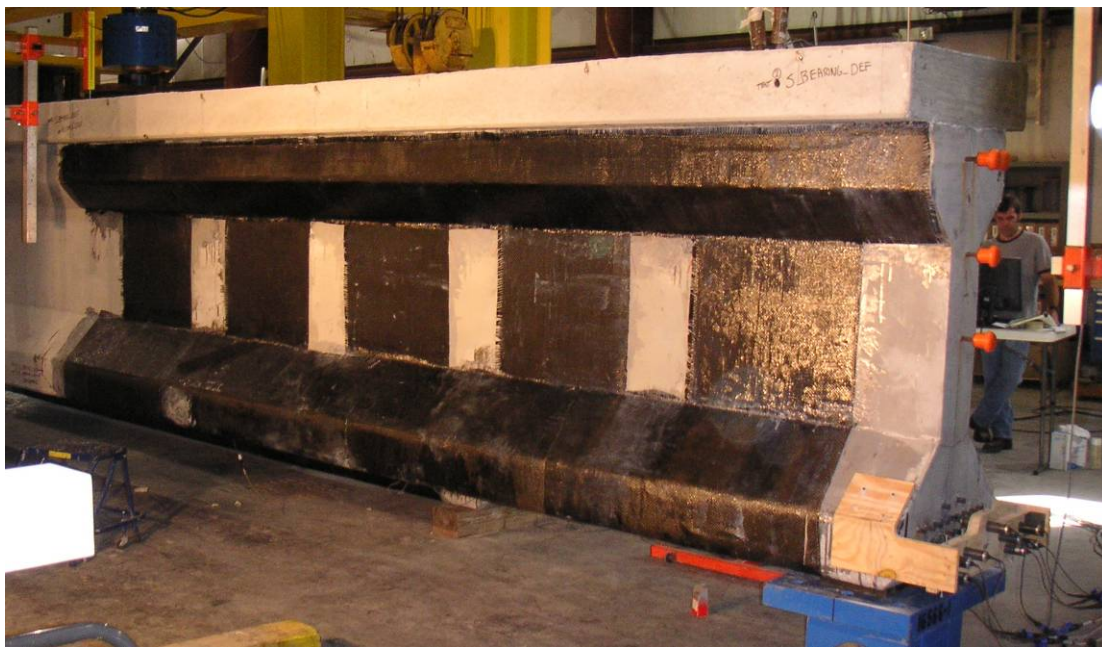
Figure 10 shows the finished CFRP repair. The CFRP installation for girder A1 was conducted by a repair contractor. The installation for girder A2 was conducted by the FDOT structures laboratory staff.

Figure 10 – Finished CFRP repair.

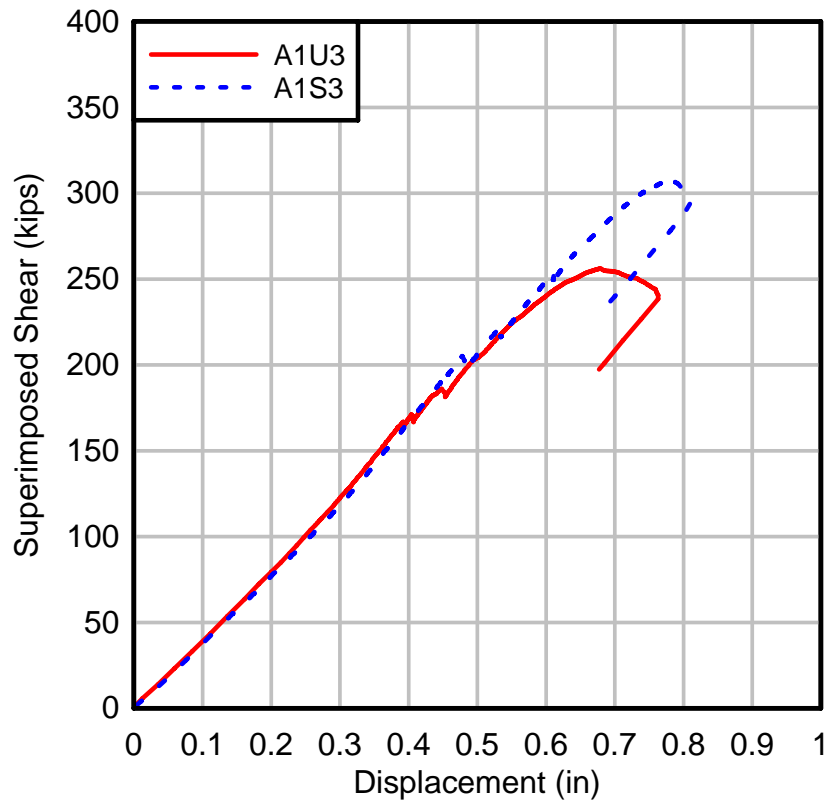
The unstrengthened girder (A1U3) reached a maximum shear of 256 kips, whereas the strengthened girder (A1S3) reached a maximum shear of 310 kips, a 10% increase. Thus, the FRP repair provided an increase in capacity but not stiffness for the a/d of 3 condition.

Figure 19 – A1U3 and A1S3 load vs. displacement.

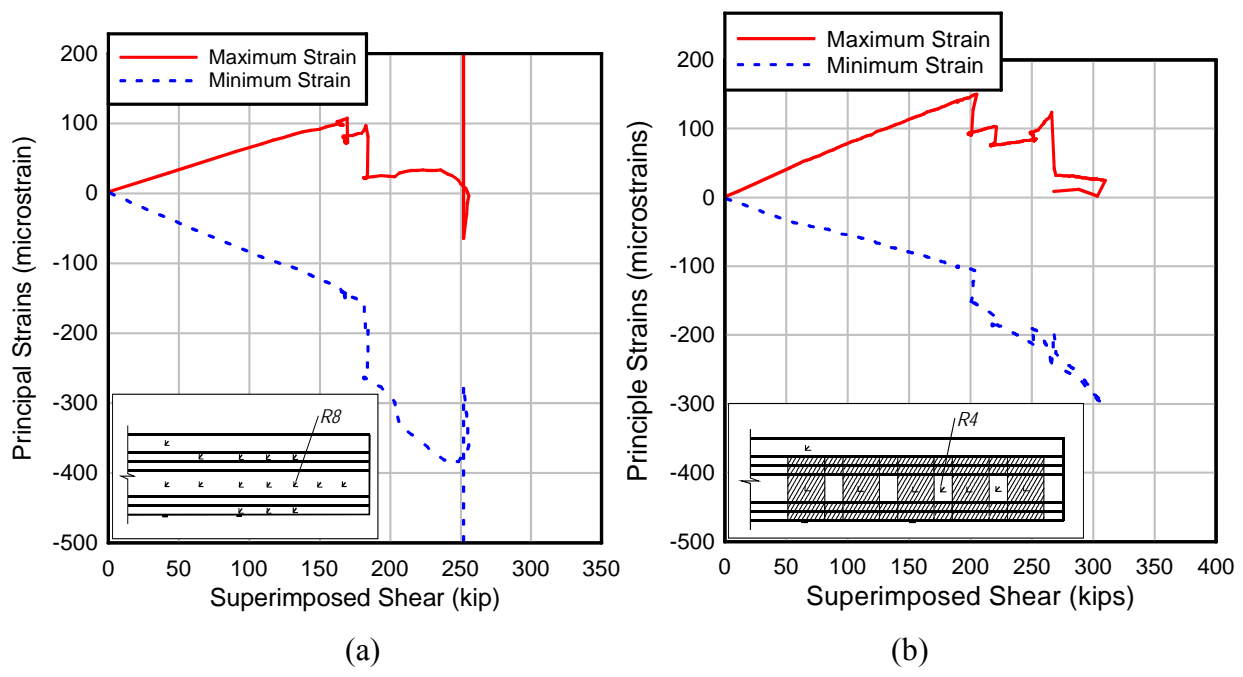
Figure 20 – Principal strains from rosettes: (a) A1U3R8 and (b) A1S3R4. (Tension is positive)

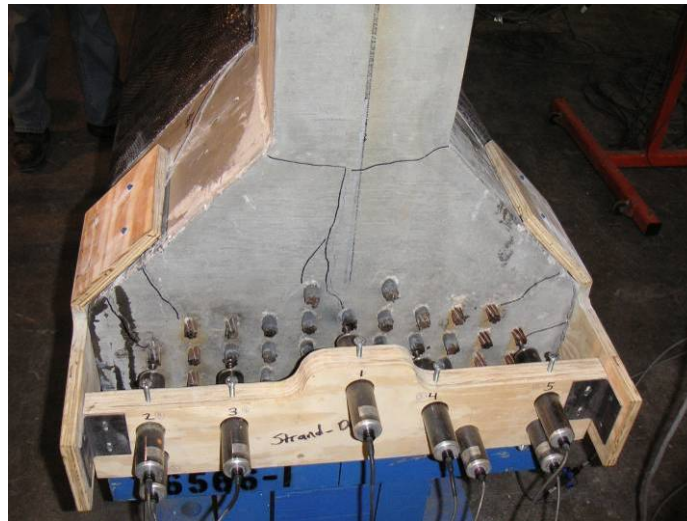
Figure 25 – Cracking at support and strand instrumentation.

Figure 26 shows the displacement of strands 2 and 6. A1U3L6 reports negative movement at strand 6, likely due to movement of the frame holding the LVDT (Figure 25). The greatest strand movement occurred just prior to reaching girder capacity. This movement is attributed to a combination of strand slip and bulb flange separation.

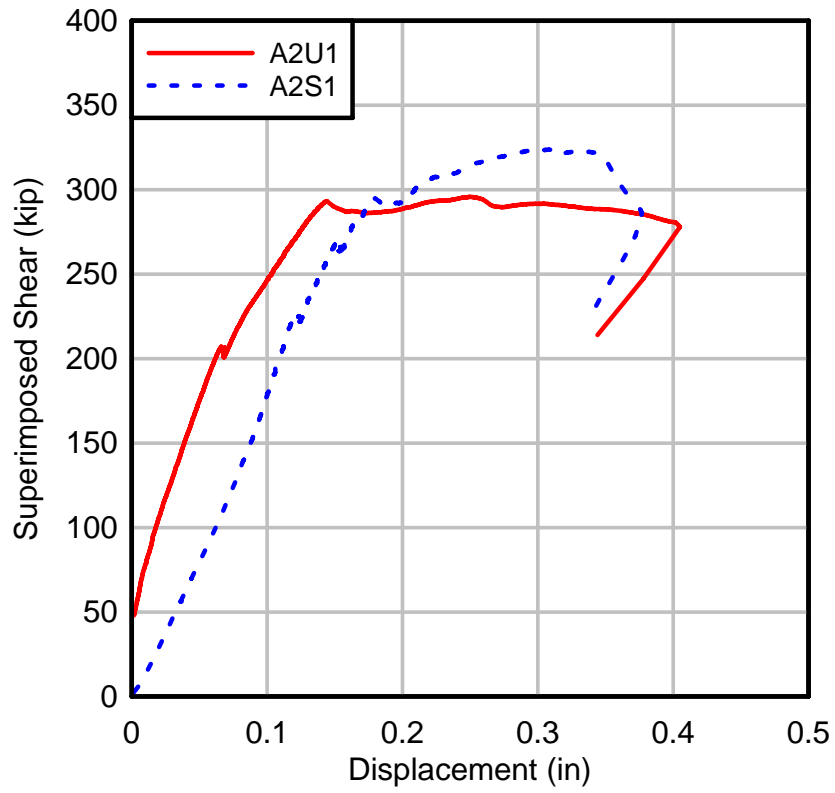
The second beam (A2) was tested using $a/d = 1$. Figure 27 shows the superimposed shear vs. displacement curves for A2U1 and A2S1. Test A2U1 shows a constant stiffness until a shear of 205 kips where the girder first cracked. The first crack for A2S1 appears to have occurred at a shear of 228 kips. Cracking loads were confirmed by strain rosette readings shown in Figure 28. The control girder, A2U1, reached a peak load of 296 kips while the strengthened specimen, A2S1, reached a peak load of 324 kips.

Figure 27 – A2U1 and A2S1 load vs. displacement.

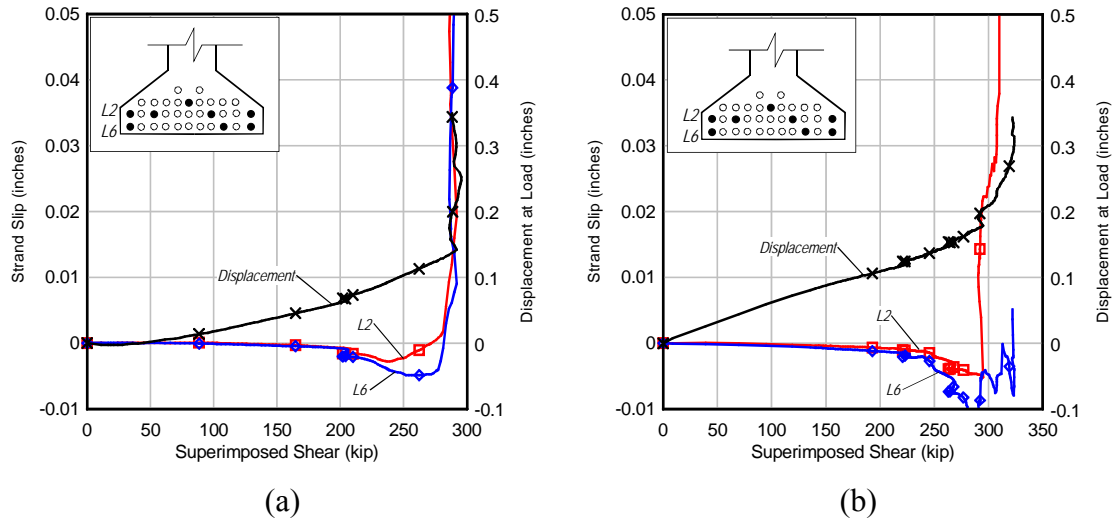
bulb, the bulb flange cracked and separated from the web. The lack of confinement steel allowed this transverse movement to occur after the bulb flange had cracked. Cracking in the bottom bulb also led to slipping of the strands (Figure 31).

Figure 31 – Strand slip and load displacement for (a) A2U1 and (b) A2S1

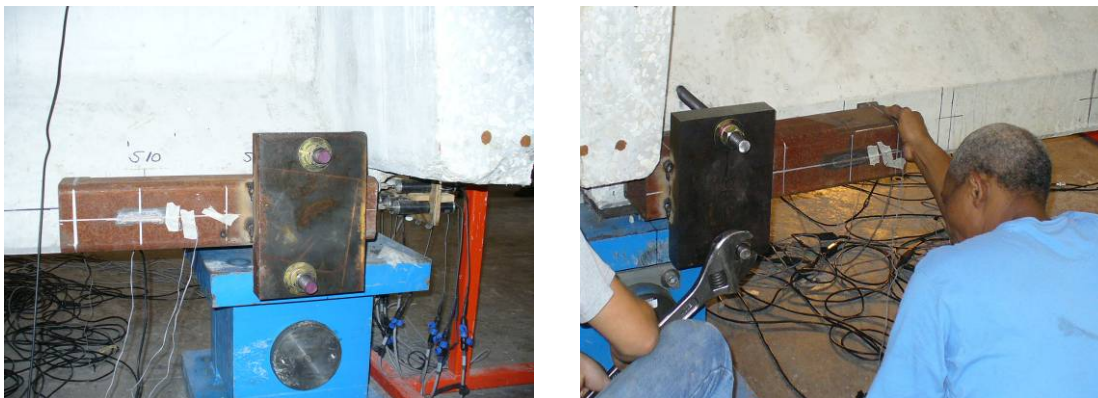
Figure 41 – B4S2 repair.

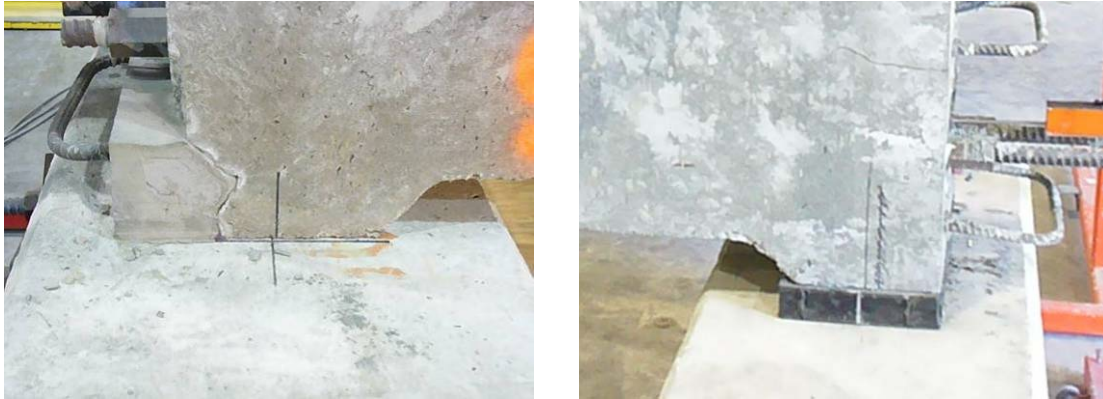
Figure 112 – Support Conditions, C1U3 (Left) and C2U3 (Right)
