Final Report

**Characterization of Chloride Thresholds in Florida
Coastal Concrete Bridge Substructures**
(Contract Number BD546, RPWO #05)

**Florida Department of Transportation Research Center
605 Suwannee Street
Tallahassee, Florida 32399**

**Francisco Presuel-Moreno
Department of Ocean Engineering
Florida Atlantic University – SeaTech Campus
101 North Beach Road
Dania Beach, Florida 33004**

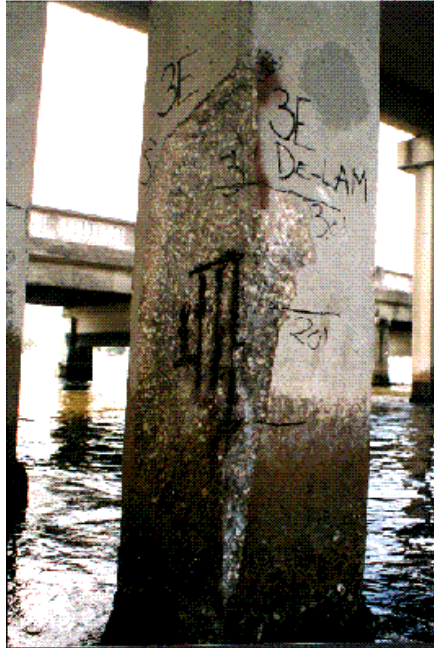
Figure 1: Photograph of a coastal bridge spalled piling.

The above distinction in C_T between 1) decks and presumably for ponded slab specimens also and 2) partially submerged prisms may have resulted because exposure is macroscopically uniform for the former but not for the latter. Thus, $[Cl^-]$ is high in the submerged zone of a prism specimen or substructure element and so reinforcement here becomes active; however, corrosion rate and resultant damage are generally nil because of O_2 depletion. On the other hand, in the atmospheric zone well above water, $[Cl^-]$ is relatively low and $[O_2]$ high. Consequently, reinforcement may remain passive here. However, $[Cl^-]$ is generally highest in the zone immediately above the water because of splash and possibly capillary transport from below. Oxygen concentration may be low here; however, proximity to the atmospheric zone above provides a macroscopic active-passive cell between the two with adequate $[O_2]$ in the region above the splash zone to drive the corrosion process. Thus, it is in the splash zone that corrosion rate is highest and cracking and spalling are most severe. Figure 1 shows an example of this damage in the case of a coastal bridge prestressed concrete bridge piling.

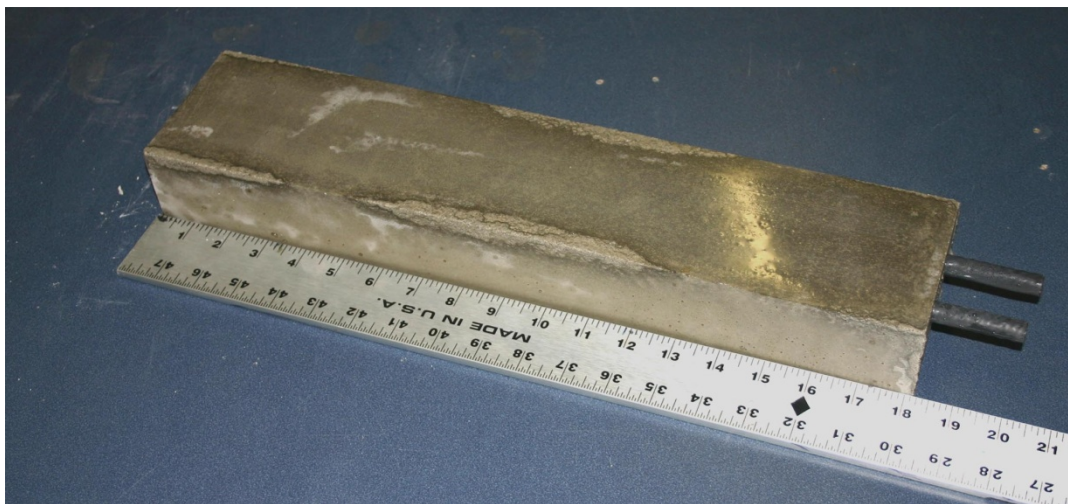
Figure 3: Photograph of an SPS specimen prior to exposure.

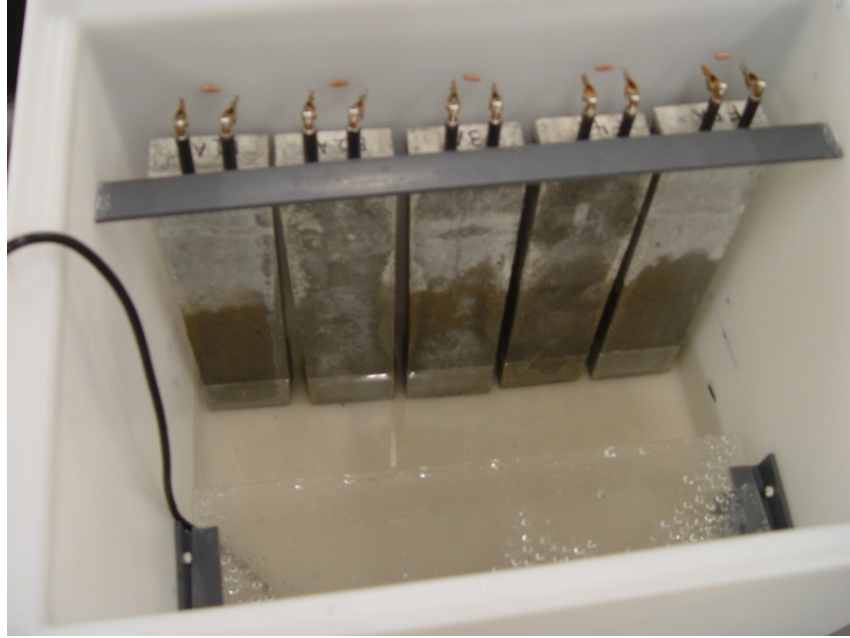
Figure 4: Photograph of sprayed specimens under exposure.

Subsequent to curing, specimens were positioned vertically in groups of four in polyethylene tanks and submerged in 15 wt% NaCl to a depth of 10 cm. Additionally, the minimum cover face of a subset of specimens was sprayed each day for ten minutes every 12 hours to a height of approximately 20 cm above the waterline with the same concentration NaCl solution. Figure 4 shows four specimens positioned in an exposure tank where spraying occurred. After approximately 70 days exposure, rebar of a subset of

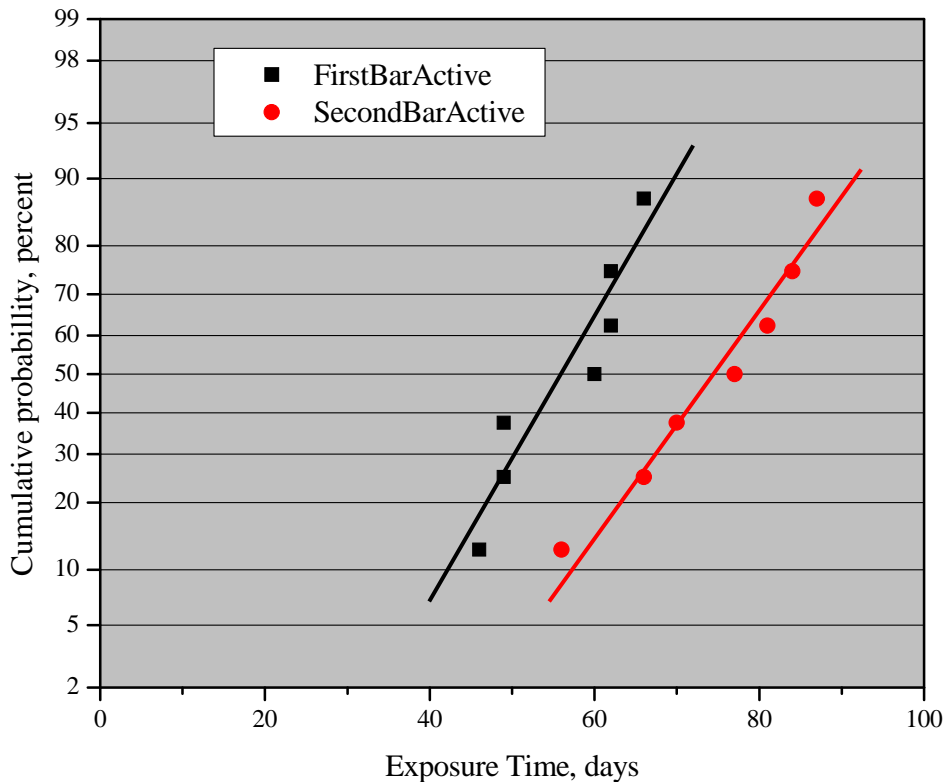
Figure 9: Cumulative distribution plot of T_i for free corrosion MD2 specimens.

all cases for both types of exposure. Thus, data for sprayed and non-sprayed specimens were treated as belonging to a common population. Figure 9 provides a cumulative distribution plot of the first and second bar activation T_i assuming that the times are normally distributed. While it can be reasoned based on the above findings that specimen designs with multiple bars is not the best choice, at the same time, such specimens may better represent an actual substructure element than do single bar specimens in that second bar activation relates to the C_T required for corrosion to initiate on bars adjacent to the initial one to activate and, hence, to the rate at which corrosion induced damage spreads.

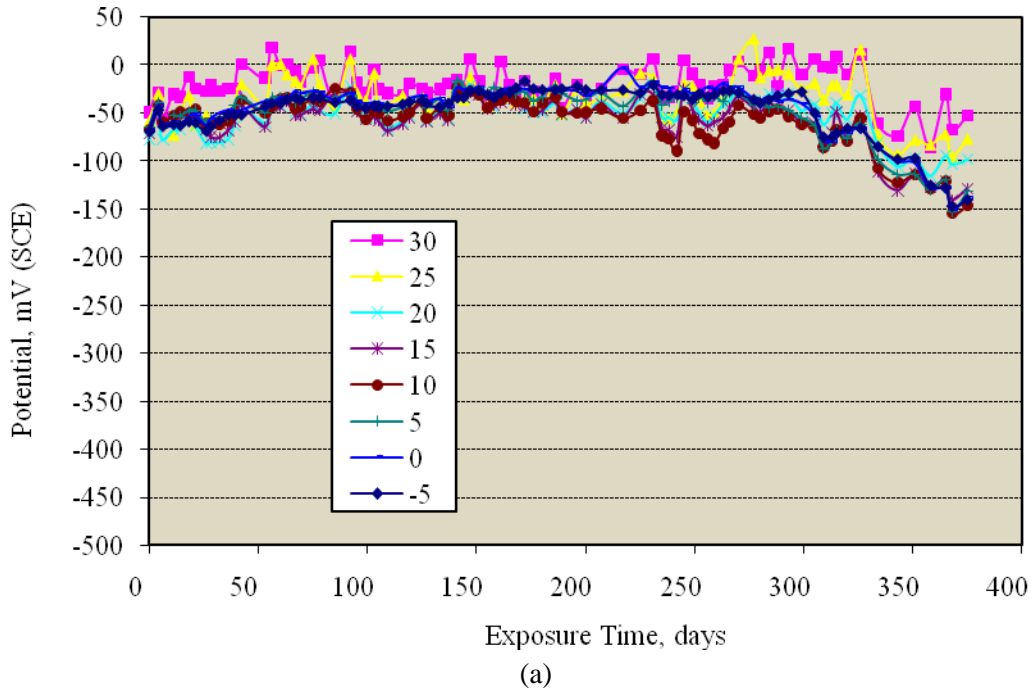
Figure 14: Potential of the left (a) and right (b) bars of Specimen 3A at different elevations as a function of exposure time (key shows measurement elevations in cm relative to the waterline).

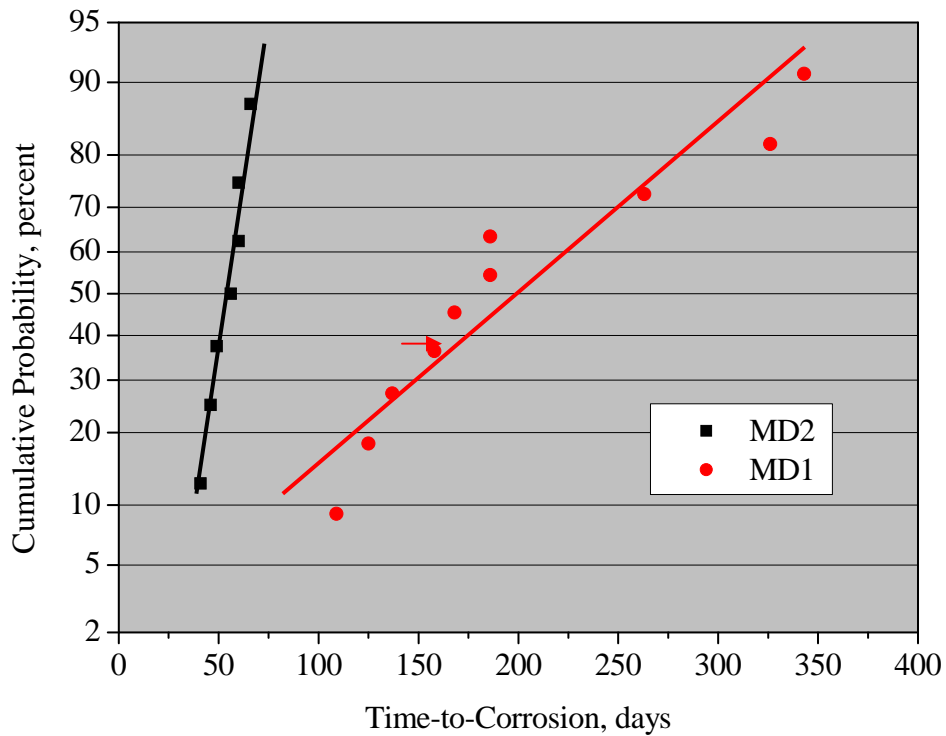
Figure 20: Cumulative distribution function plot of T_i for MD1 and MD2 free corrosion specimens.

Table 7 lists T_i for specimens in the present category, and Figure 20 provides a cumulative distribution function plot of these data. In this representation, the right bar of Specimen 3B, which had not initiated corrosion, was assumed to have activated at the time of exposure termination (data point with arrow in Figure 20). With the exception of Specimen 4A, there is no definitive indication from the potential data that corrosion initiation on the initial bar of a specimen to become active affected potential of the other, as was the case for freely corroding MD2 specimens as discussed above; and so data for all bars of MD1 mix specimens were considered to conform to a common population. Also shown in Figure

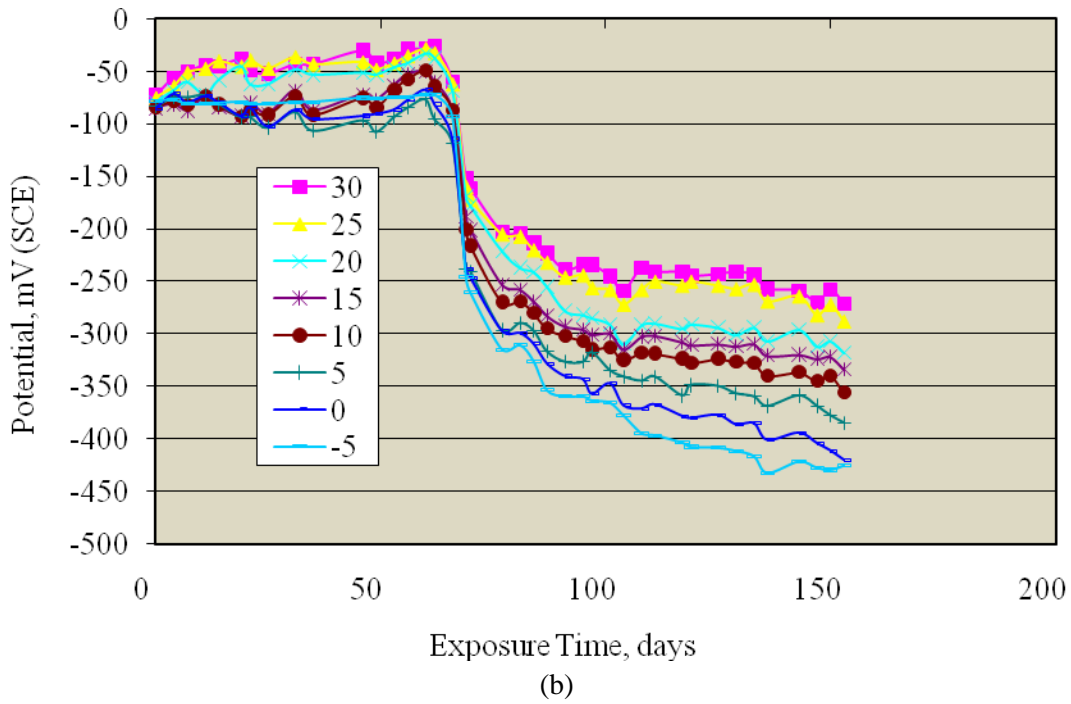
Figure 22: Potential of the left (a) and right (b) bars of Specimen 6A at different elevations as a function of exposure time (key shows measurement elevations in cm relative to the waterline). Arrow in graph (a) indicates the assumed T_i .

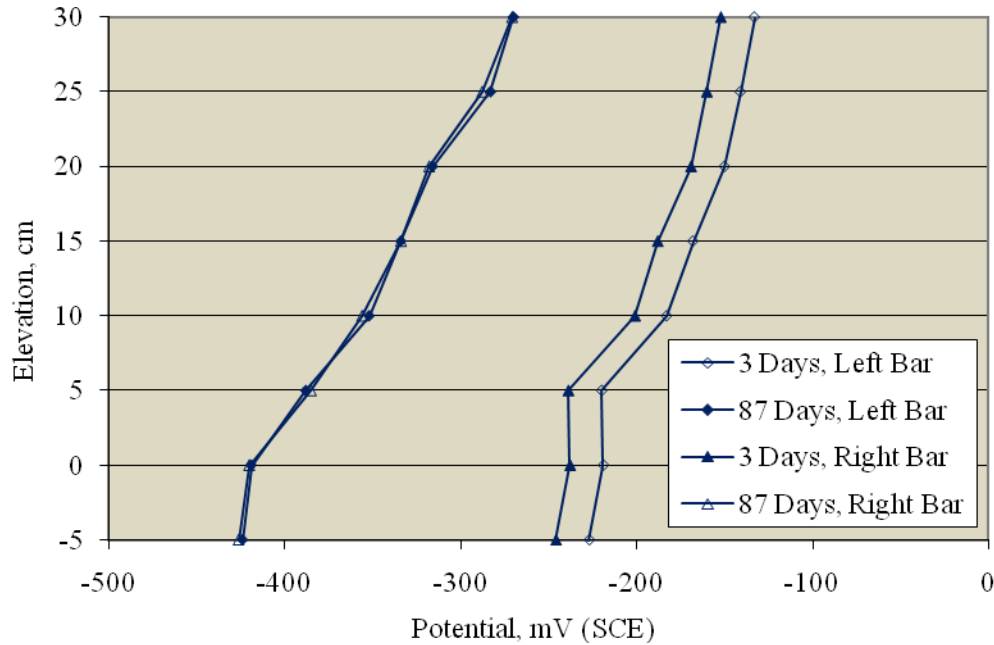
Figure 23: Potential of Specimen 6A as a function of elevation three days and 87 days after polarization.

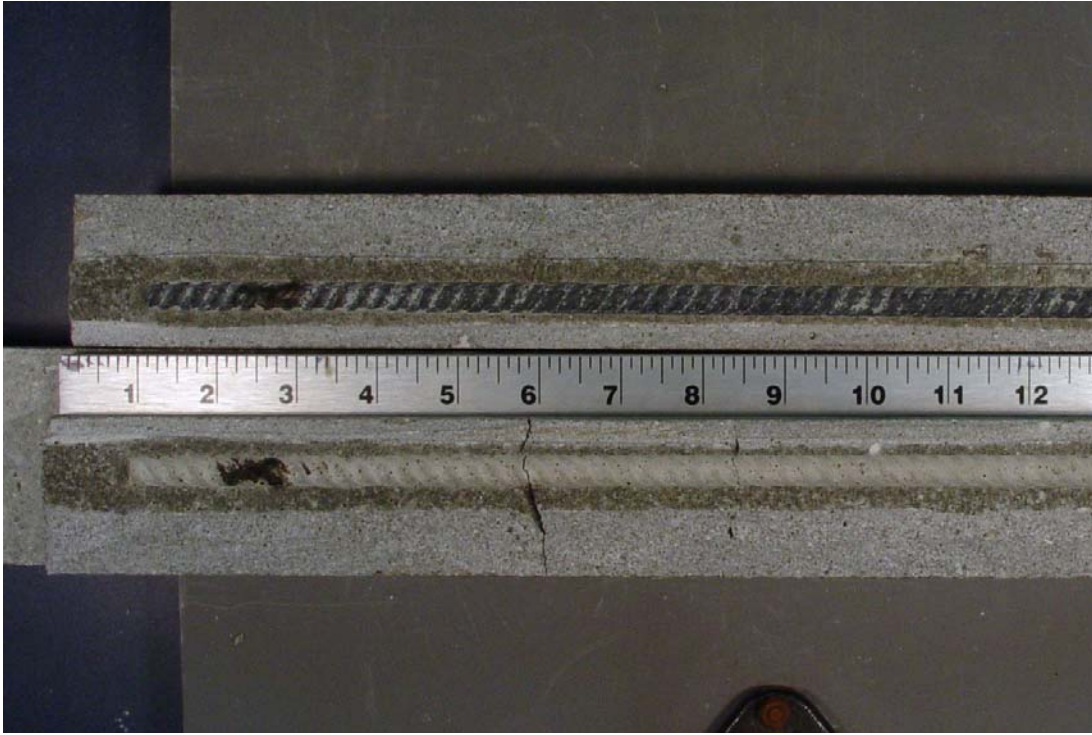
Figure 25: Potential of the left (a) and right (b) bars of Specimen 7A at different elevations as a function of exposure time (key shows measurement elevations in cm relative to the waterline).

Figure 25 provides potential versus time data for Specimen 7A; and Figure 26 shows photographs of the two bars after this specimen was opened. This indicates that corrosion initiated in both cases in the submerged zone. No post-connection potential plateau is apparent from the data for either of these bars.

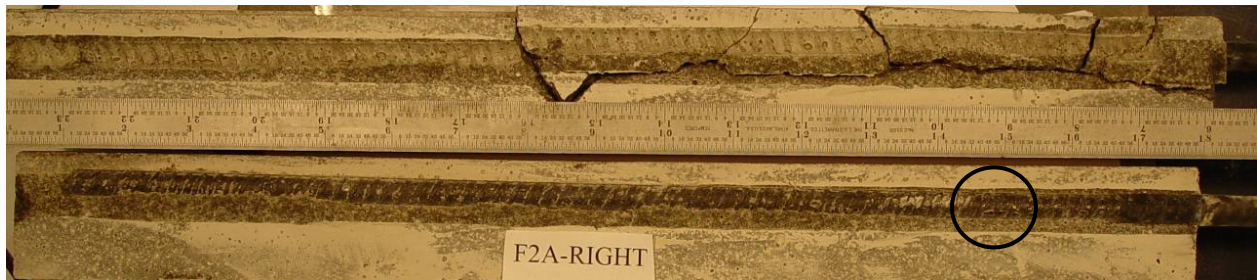
Figure 41: Photograph of corrosion on the left (a) and right (b) bars of Specimen 2A subsequent to dissection (mortar cracks resulted from the dissection process).

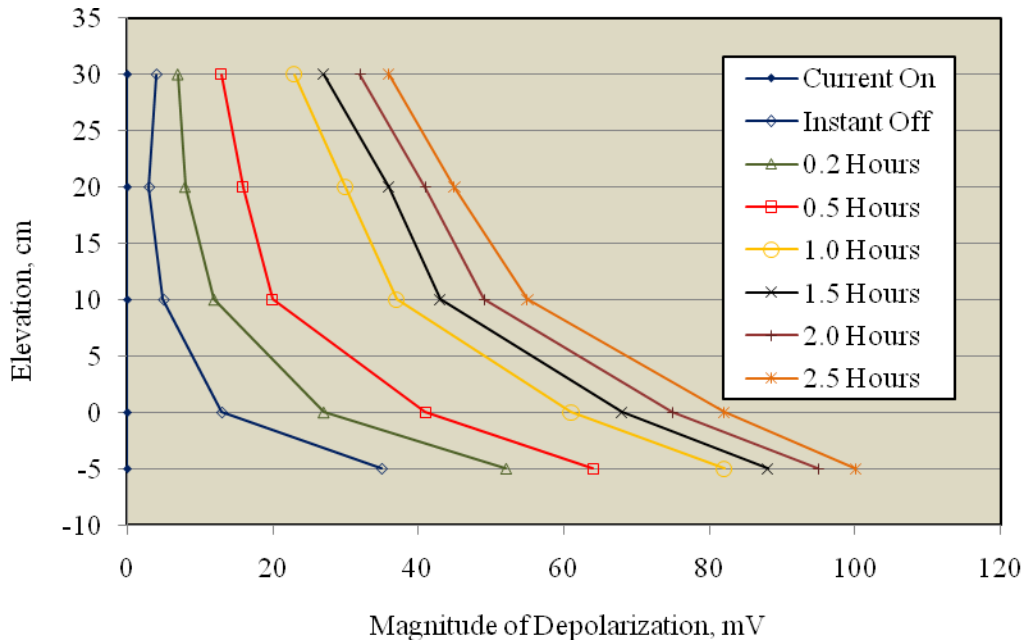
Figure 50: Example of potential versus time depolarized for a typical specimen (left bar Specimen 1A).

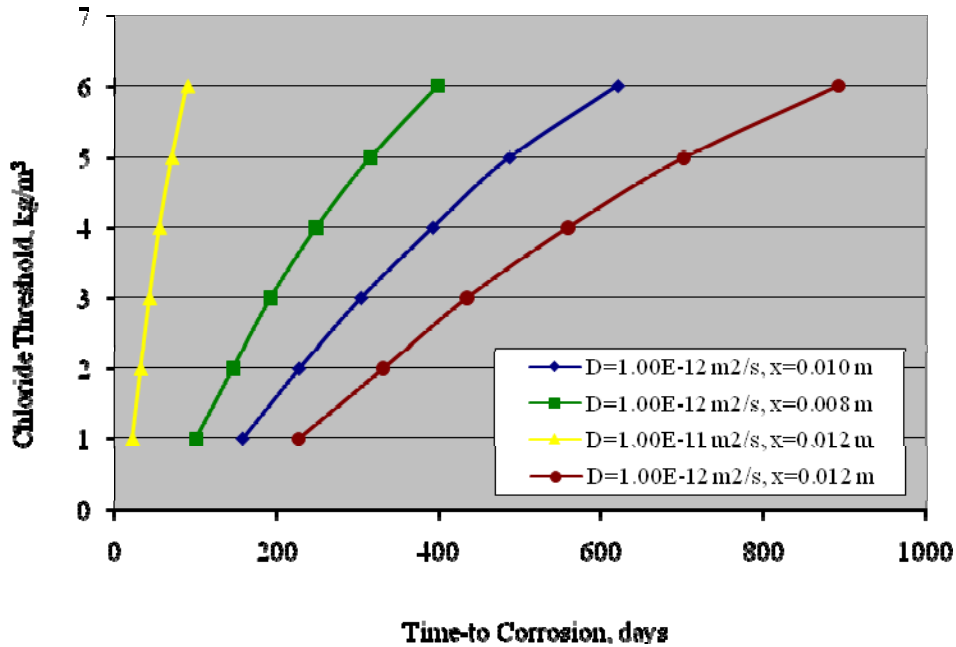
Figure A1: Time-to-corrosion as a function of C_T for the assumed D_{eff} and x values.

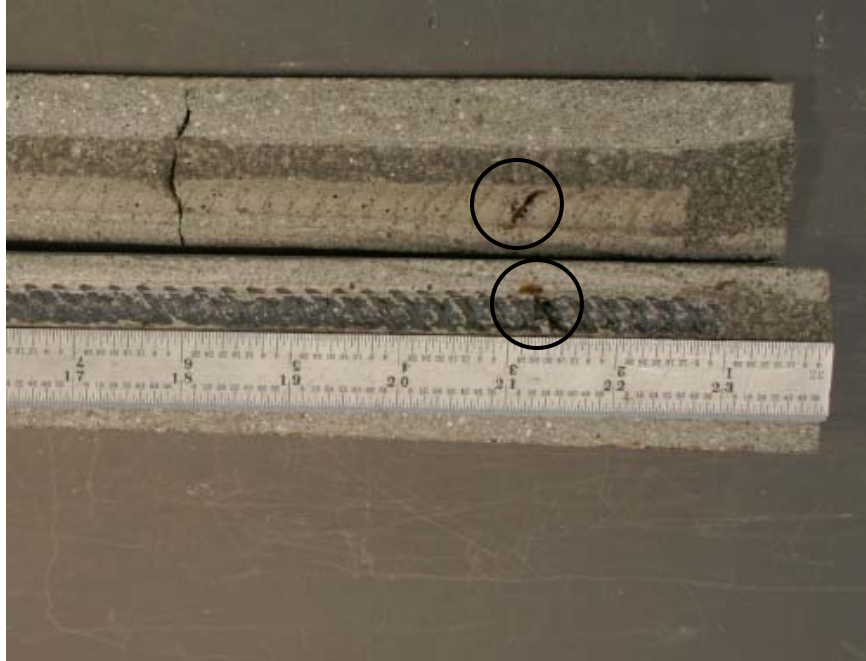
Figure C1: Photograph of the left (a) and right (b) rebar and mortar trace from Specimen 6B subsequent to dissection. Circled areas indicate corrosion or corrosion products (mortar cracks resulted from the dissection process and not from corrosion).

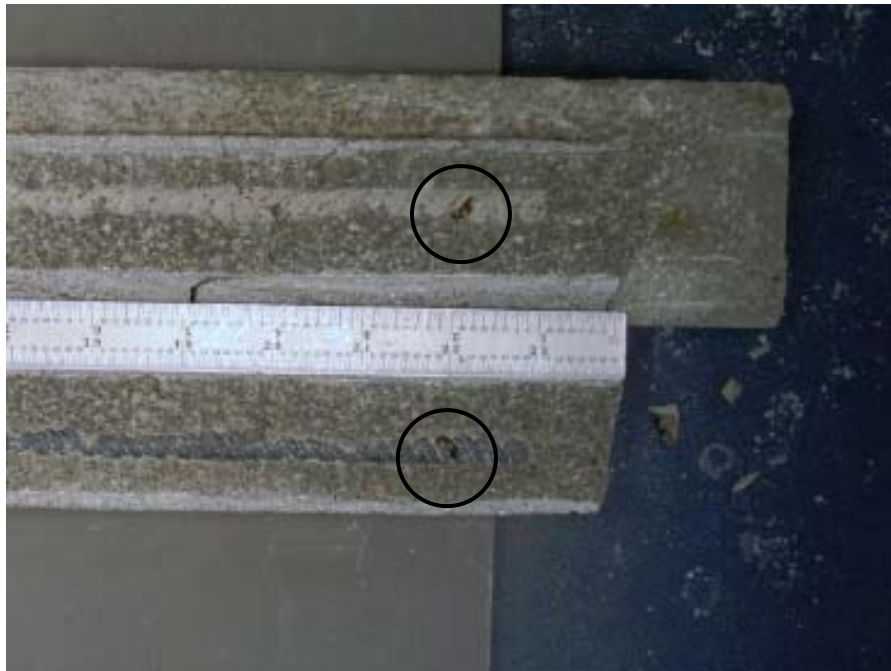
Figure C5: Photograph of the left (a) and right (b) rebar and mortar trace from Specimen 9B subsequent to dissection. Circled areas indicate corrosion or corrosion products (mortar cracks resulted from the dissection process and not from corrosion).

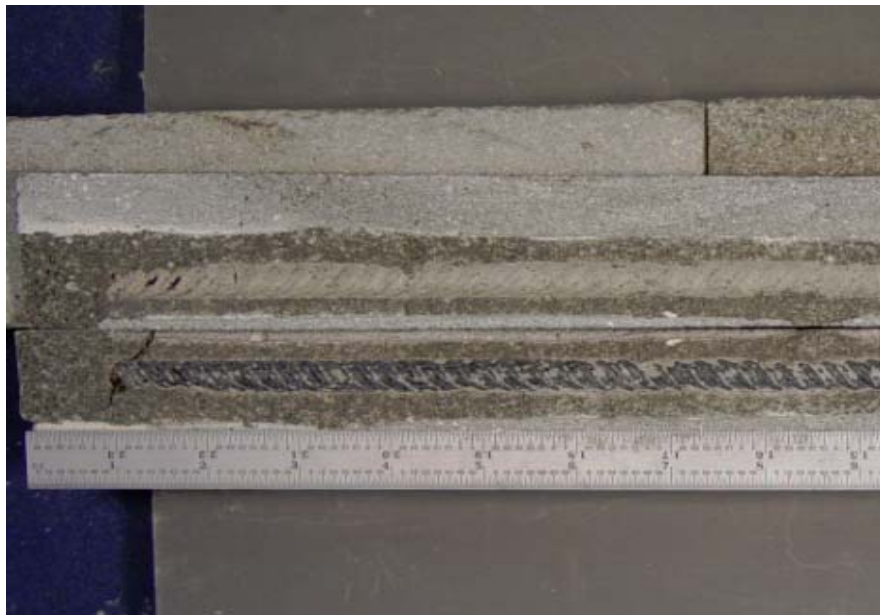
Figure F6: Photograph of the right bar and bar trace of Specimen 8B.

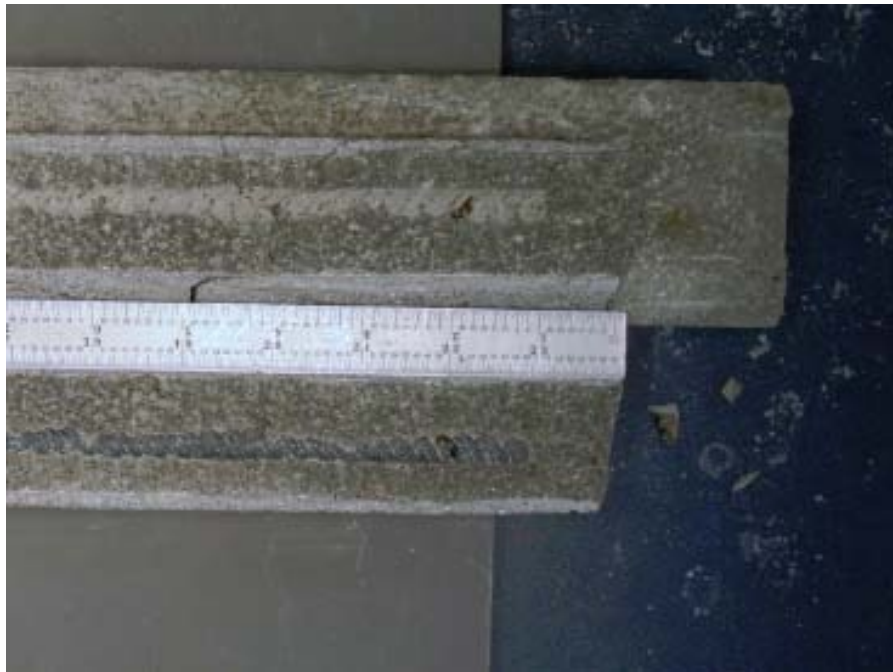
Figure F10: Photograph of the right bar and bar trace of Specimen 9B.
