Thermo-mechanical Durability of Carbon Fiber Reinforced Polymer Strengthened Reinforced Concrete Beams

University of Central Florida

BD550 - 06

FINAL REPORT

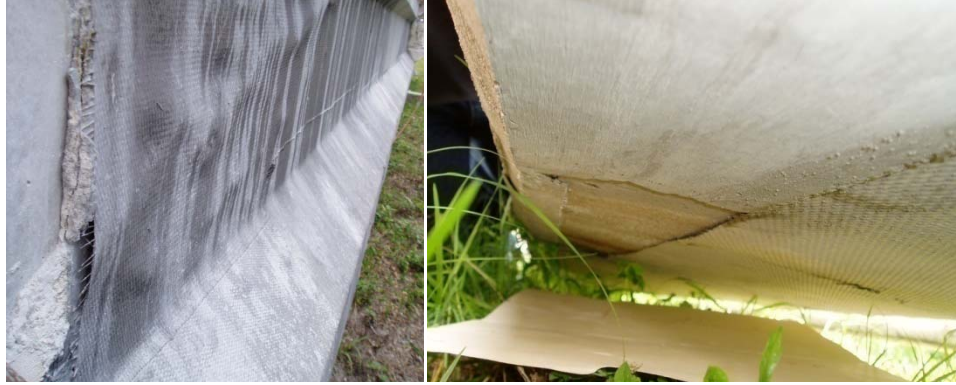
Figure 1: Beams Removed from I-95 Bridge

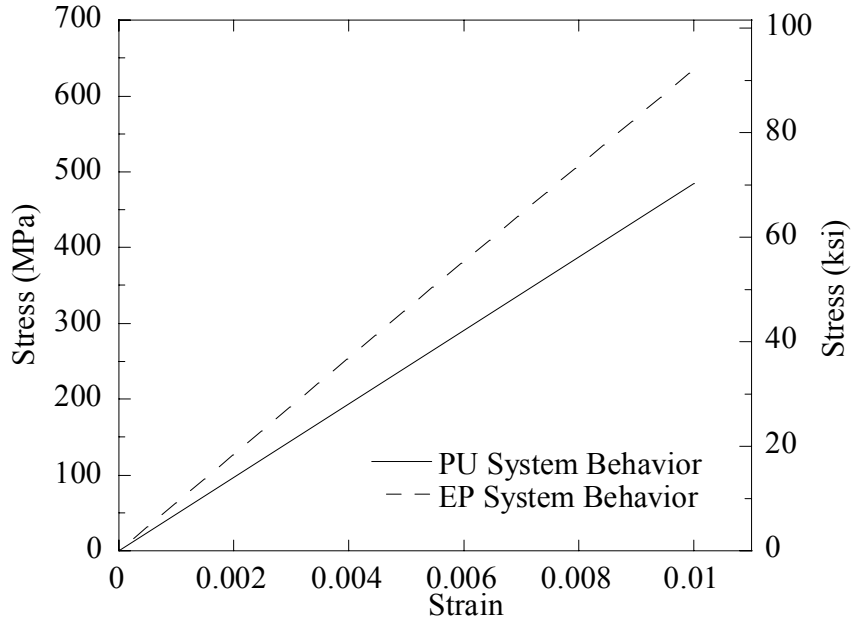
Figure 7: Material Model for CFRP

The material models for the externally bonded CFRP composite sheets were also defined through the use of experimental tensile test results. It was assumed that the CFRP materials behave perfectly linear until failure. Hence, the only two parameters needed to define the tensile behavior were the elastic modulus and the tensile rupture strain. The material models for the PU and EP systems can be seen below in Figure 7. It should be noted that due to lack of experimental and/or manufacture data for the GE system, the EP system material model was used to model the GE system as well.

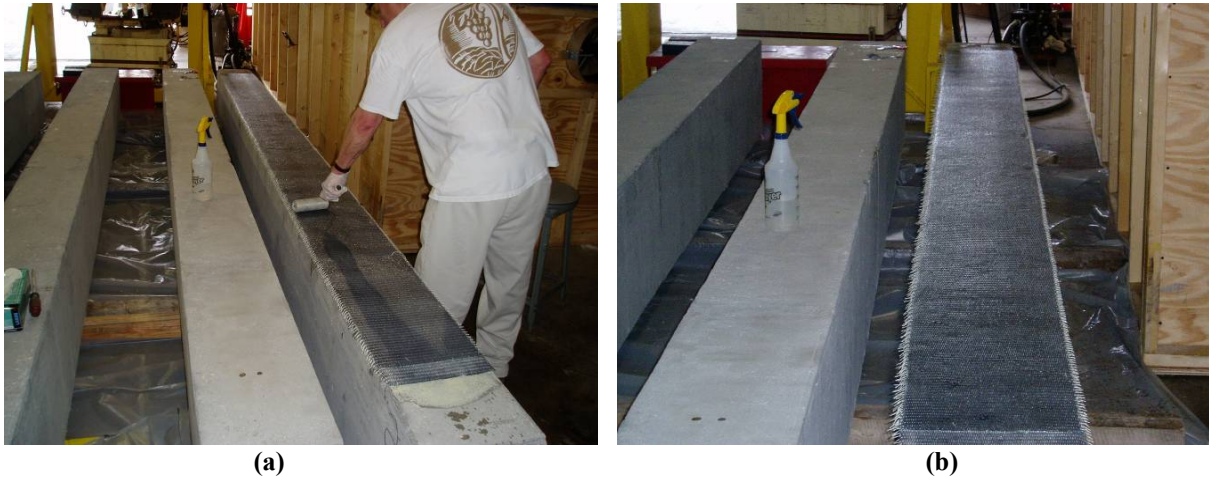
Figure 12: Installation of PU-System

The PU system came pre-impregnated with resin, and was delivered hermetically sealed packages ready to use. Installation of the PU system consisted of applying a primer (BP1 systems) to the beam then laying the first layer of pre-impregnated fiber. The layer is lightly misted with water to activate the resin and then the fabric was rolled with a metal roller to work out the air pockets that form due to the resin curing. After rolling the air pockets out of the first layer the second layer of pre-impregnated fabric was laid on top of the first. Then the second layer was misted with water and the air pockets were rolled out. See Figure 12 for photos from the lay-up of the PU system.

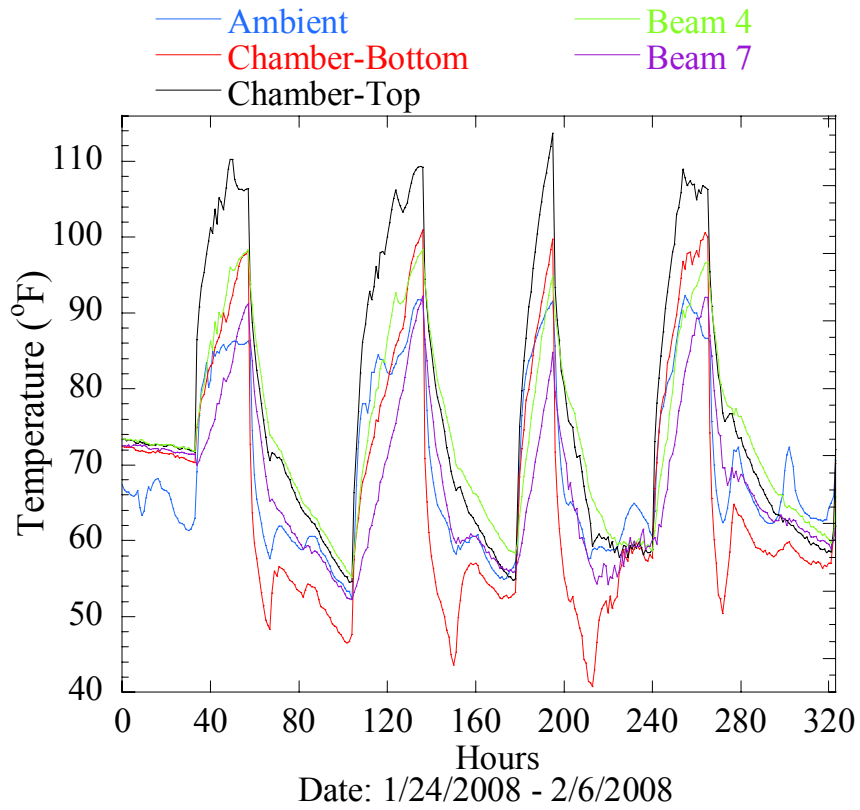
Figure 16: Conditioning Chamber Temperature Variation

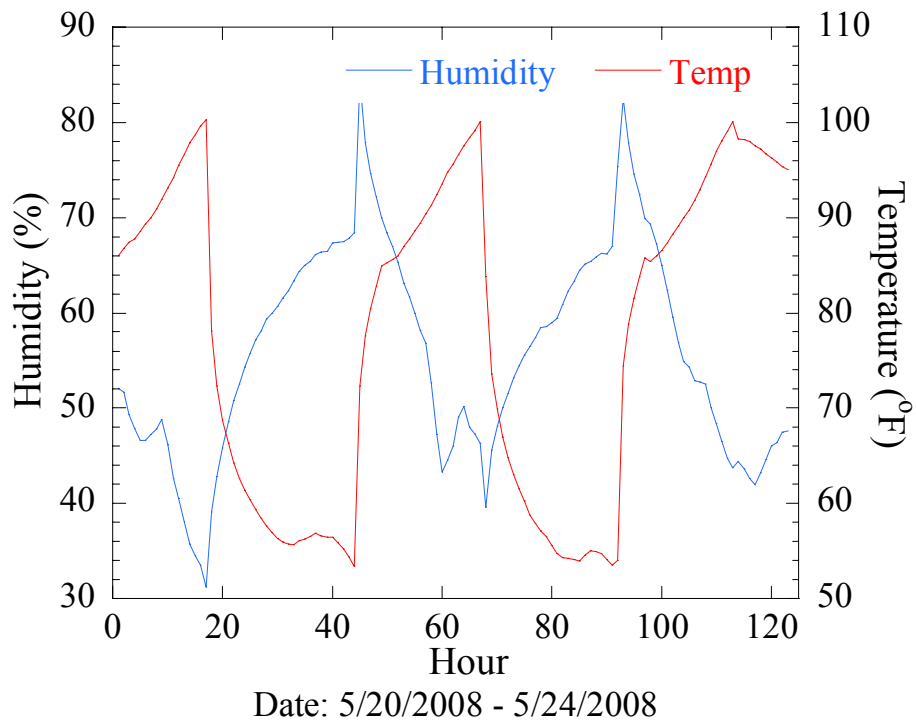
Figure 17: Humidity Variation within Chamber

Humidity measurements were also recorded during the conditioning period. A multi-day sample of this data can be seen in Figure 17. The humidity range achieved by the ECC was within the range of 19 – 89%. This was considered to be acceptable for a simulated “Florida-like” environment.

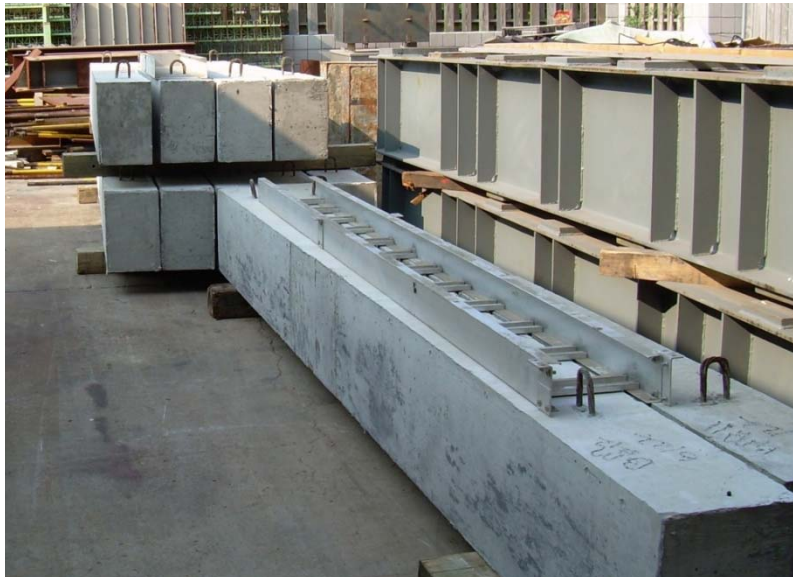
Figure 18: Specimens during Storage Time

It should be noted that all of the beams received some environmental conditioning due to outdoor storage at the FDOT SRC, as shown in Figure 18. See Figure 19 for the average monthly air temperatures for the duration the specimens were stored. See Figure 20 for the monthly precipitation for during the storage duration. The temperature and precipitation data was taken from the National Oceanic and Atmospheric Administration (NOAA) archives for the Tallahassee Regional Airport. The beams also received some thermal conditioning when inside of the SRC due to the fact that the facility does not have a climate control system for the testing area.

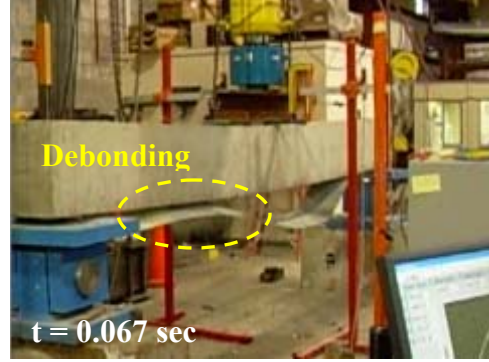
Figure 28: PU Baseline at Failure: Video Frame Shots

Failure of the PU baseline specimen ultimately occurred at 74.3 kips ($\Delta=1.82''$). The failure mode was determined to be CFRP rupture followed by laminate debonding. During the final three minutes of the load test, a video was recorded to capture the beam's failure. Figure 28 shows two frames from the video taken. Figure 28-a shows the first frame where failure was evident (initial CFRP rupture). This frame is denoted to have a time interval of $t = 0sec$ for reference. The initial ruptured occurred approximately 50" from the north support (between SG2 and SG3). Immediately after the CFRP rupture, laminate debonding occurred (see Figure 28-b). Furthermore, the debonding portion of failure can be justified by the load-strain plot depicted in Figure 30. Strain gauges 1, 2, 3, and 4, which are all located in or near the region of debonding, all indicate softening (flattening of the load-strain curve) near failure. Softening would indicate a loss of concrete-to-CFRP composite action (or debonding). It should be noted that debonding failure occurred within the urethane adhesive layer. Figure 29 shows a close-up picture of the debonding surface. It can be observed that a whitish colored layer of material (urethane) remains on the concrete substrate, supporting the conclusion of cohesive failure within the adhesive layer

(b) Debonding

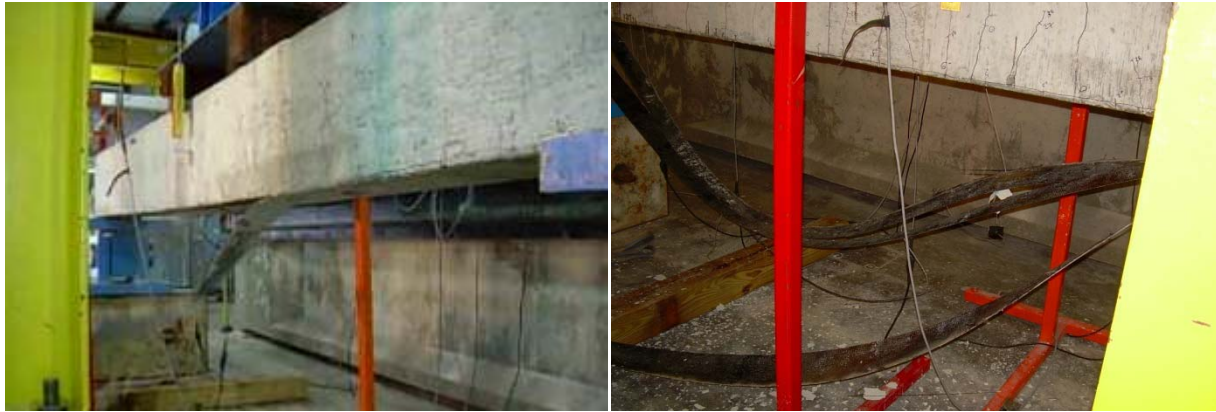
(a) Initial Failure via Debonding

Figure 54: EP-F Specimen at Fail and Post-fail

The failure of the EP-F specimen occurred initially at 63.5kip ($\Delta=0.86''$). The initial failure occurred by partial (approximately one half of the sheet width) debonding of the CFRP sheet from the north end of the specimen. This can be observed in photo shown in Figure 54-a. The load vs. strain plot (Figure 55) for the EP-F specimen shows softening in strain gauges located in the northern region of the specimen previous to failure. The initial debonding caused a 10.2% drop in applied load. The load test continued until the second portion of the north end CFRP debonded from concrete. This occurred at the load of 60kip. There was a significant amount of longitudinal splitting that occurred in the CFRP sheet during failure (refer to Figure 54-b).

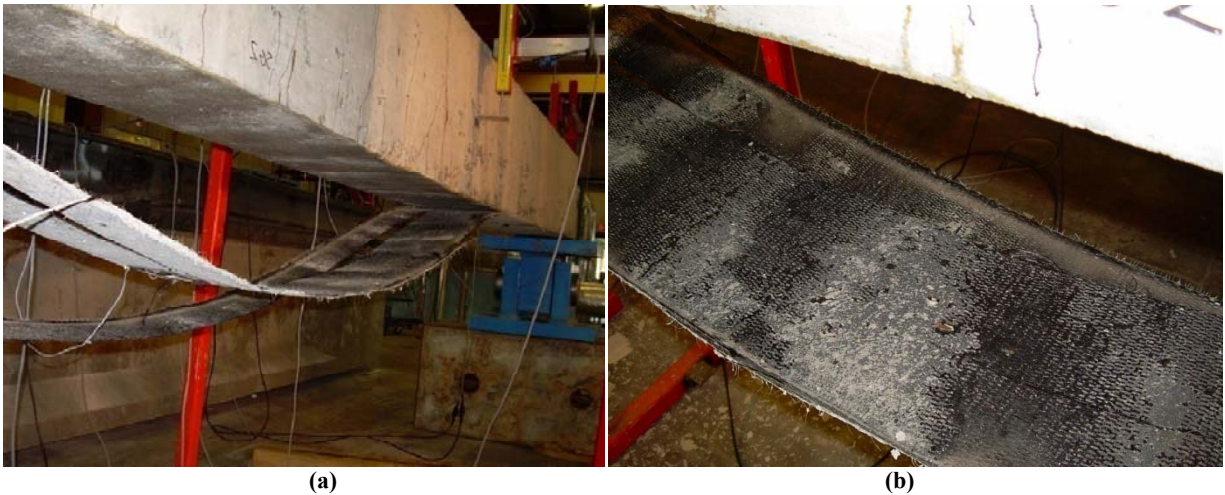
Figure 61: GE-F Specimen at Fail and Post-fail

Failure occurred in specimen GE-F at a load of 60.3kip ($\Delta=0.81''$). The dominate mode of failure was CFRP debonding (refer to Figure 61-a) at the north end of the specimen. Prior to failure, strain gauges 2 and 3 exhibit drastic increases in strain (Figure 62). Figure 61-b shows a picture of the debonded CFRP sheet. The same three distinct regions discussed in the results portion for the GE baseline specimen can be seen in Figure 61-b. This indicates non-uniformity in the bond.

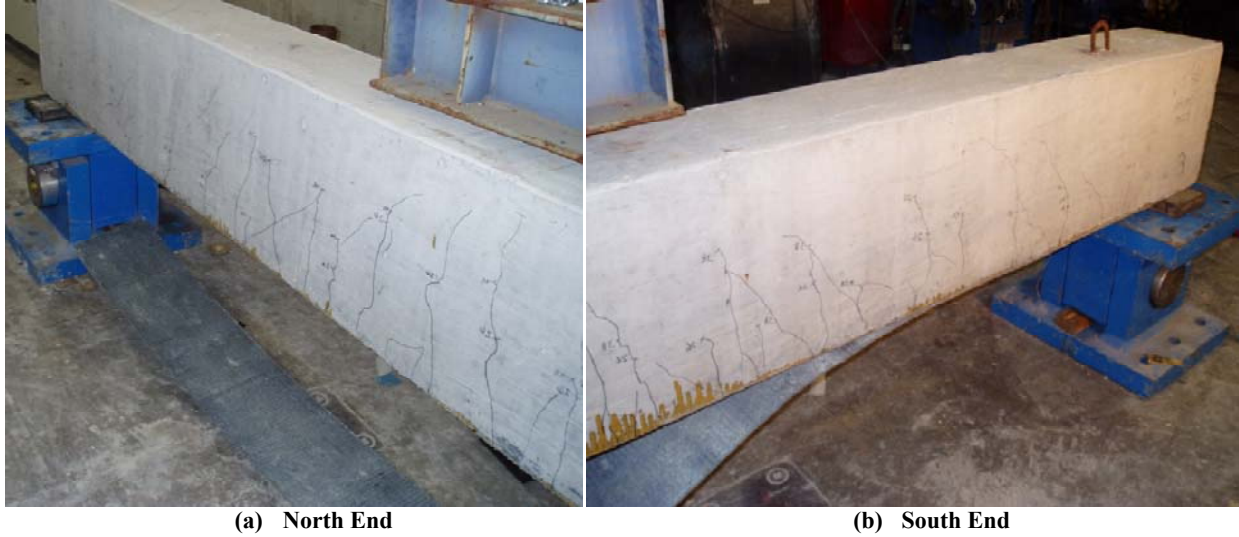
Figure 70: PU-T at Failure

As mentioned above, failure of the PU-T specimen ultimately occurred at a load of 74.3kip. This failure was caused by FRP debonding near the north end of the beam (refer to Figure 70). Inspection of the CFRP debonding surface revealed that failure occurred within the urethane adhesive layer i.e. cohesive failure
