Smart Infrared Inspection System Field Operational Test

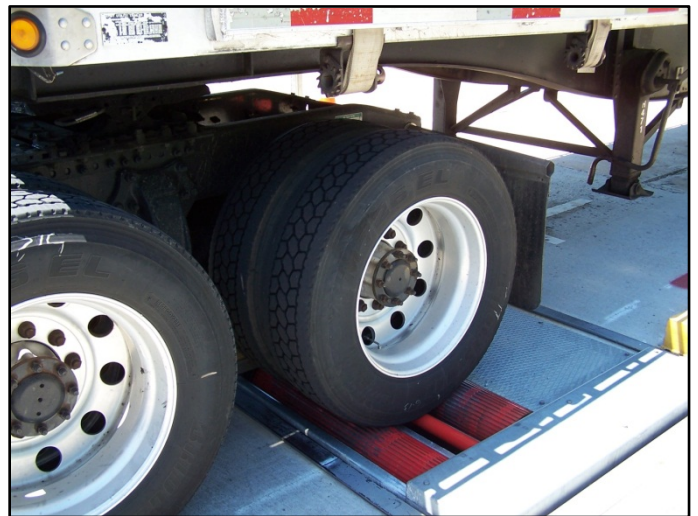
Figure 1. Image. PBBT located at the Greene County Inspection Station.

Once the vehicle was selected and driver information was checked, enforcement personnel directed the vehicle to the inspection pit in order to perform a Level-1 inspection. Following a complete inspection, the vehicle was directed to pull onto the Performance-based Brake Tester (PBBT), shown in Figure 1. A PBBT is a device that can evaluate the current brake efficiency of a vehicle by measuring brake forces developed as the vehicle engages in a braking event while stationed on the device. PBBT tests were performed last so that inspectors would not have any forewarning of possible brake defects when performing the initial Level-1 inspection.
