CENTER FOR TRANSPORTATION INFRASTRUCTURE AND SAFETY

A Laboratory Investigation on Three-Sided Structures

**NUTC
R227**

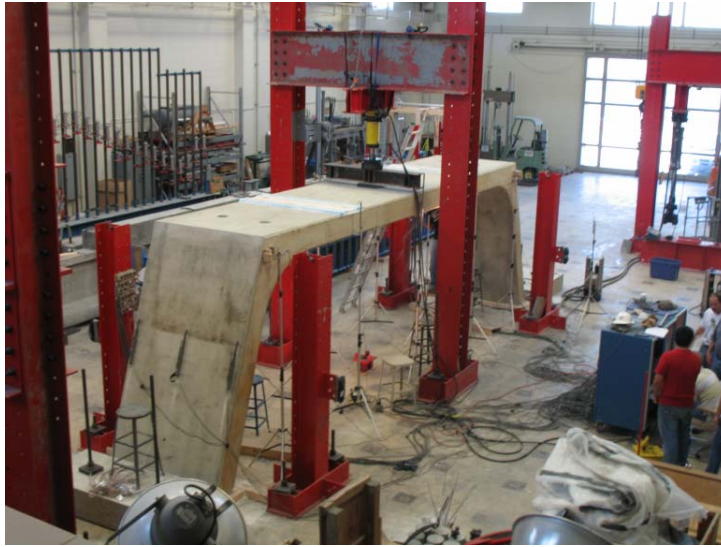
Figure 2.3. Photo of the Test in Progress

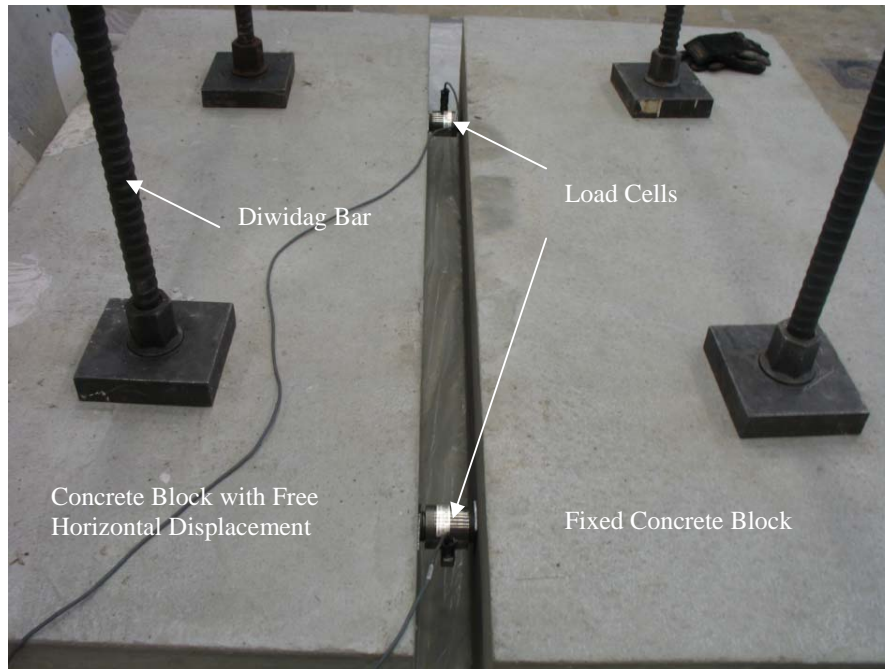
Figure 2.6. Photo of Concrete Block Assembly in the North Side

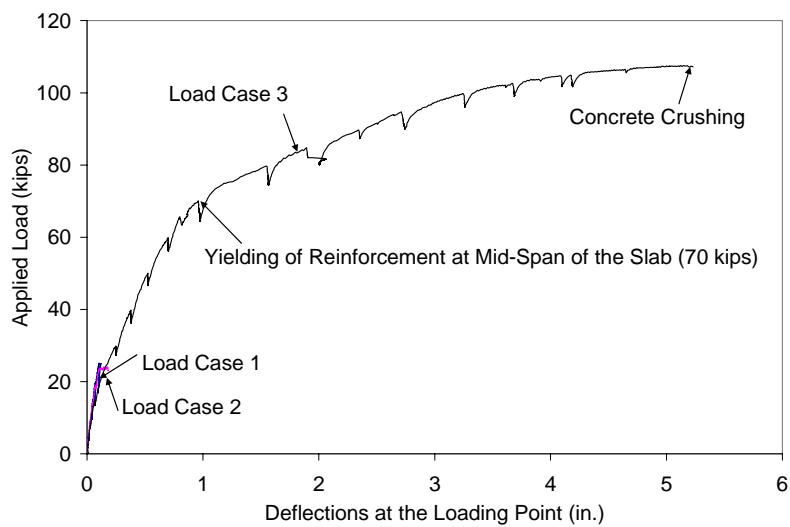
Figure 3.10. Applied Load vs. Deflection Curves

The yielding of the tensile reinforcement at the mid-span of the slab occurred at about 70 kips of applied load and 1.0 in. of the deflection. Beyond this load, the test specimen underwent a large deflection of up to 5.3 in., and eventually failed due to concrete crushing at the top of the slab at mid-span. Failure occurred at 107 kips of applied load as shown in Figure 3.10. Figure 3.11 presents the photos taken after the failure of the test specimen, and clearly shows the concrete crushing at the top of the slab.

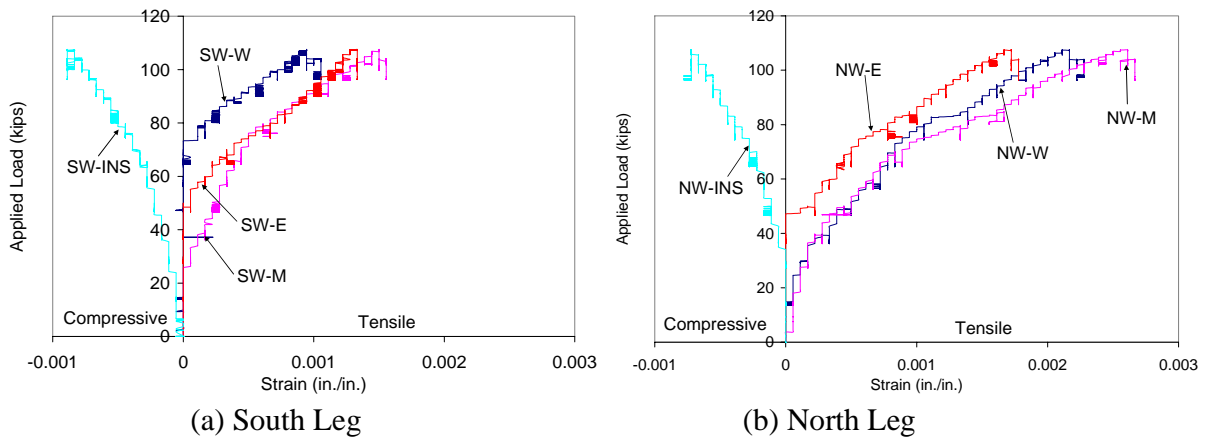
Figure 3.14. Strains in the Mid-Height of the Legs

In previous sections, the discussions were made with the focus on the flexural behavior of the slabs and the regions near the haunches. This section deals with the flexural behavior of the legs by investigating the strains measured with LVDTs at the mid-height of the legs. The LVDTs attached to the inside and outside of the legs had a gage length of 18 in and bridged over several cracks depending on their locations (see Figure 2.9 for more detail). Thus, the strains measured with these LVDTs would represent the average strains. Figure 3.14 shows the measured strains for both legs. As shown in Figure 3.14., the insides of the legs were compressed and the maximum compressive strains were less than 0.001 for both legs at the time of failure of the test specimen, while the outsides of the legs were subjected to tensile stresses and the maximum

tensile strains at the time of failure were 0.0016 and 0.0027 for the south and north legs, respectively. It should be noted, however, that the strains shown in Figure 3.14 do not represent either strains on the surface of concrete or strains in the reinforcement. As shown in Figure 3.15, LVDTs were attached to the legs and the locations of the LVDTs were about 1 in. above the concrete surface. Thus, the actual average tensile strains in the reinforcement would be significantly smaller than the strains measured with the LVDTs, which can be calculated based on the strain compatibility condition. The calculated maximum average tensile strains at the time of failure of the test specimen were 0.0010 and 0.0017 for the south and north legs, respectively. Therefore, it can be said that the reinforcement below the mid-height of the inclined legs would not yield during the entire loading history of the test specimen.

It should be also noticed from Figure 3.14 that the average tensile strains of the north leg were about 60% higher than those of the south leg. In order to find the reasons for the difference, the horizontal movements of the concrete blocks used to provide the horizontal restraint for the legs are investigated. One LVDT was attached at both the west and east side of each concrete block, respectively as shown in Figure 2.10. For the south side concrete block, one LVDT located at the west side was denoted S-CB-W and the LVDT located at the east side was denoted S-CB-E. Similarly, for the north side the LVDTs were denoted N-CB-W and N-CB-E. Then, the horizontal movements of the centerline of the concrete blocks were calculated using the two LVDTs located at the west and east side of the concrete block and identified as ‘AVERAGE’ in Figure 3.16. As shown in Figure 3.16, the average horizontal movement of the south side concrete block was about 0.34 in., while that of the north was 0.034 in. That is, the horizontal restraint provided to the south side leg was not as rigid as the horizontal restraint provided to the north side leg. As a result, the moment in the south side leg should be smaller than that of the north side leg. Note that the tensile strains measured from the LVDTs were also smaller in the south side leg than in the north side leg.

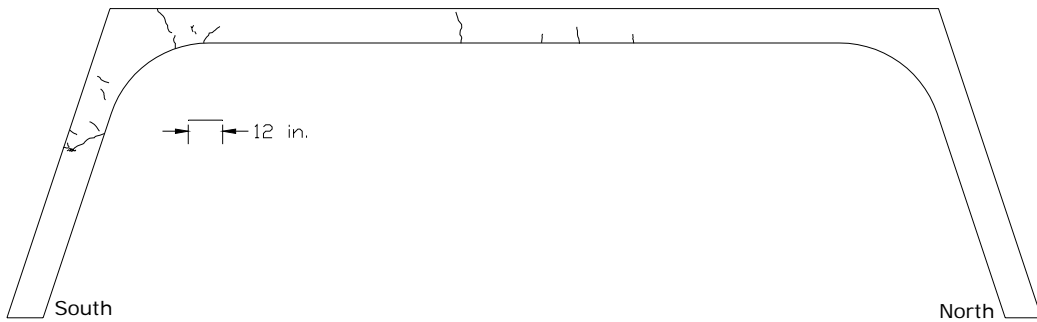
(a) Dry Shrinkage

(b) D-S + Load Case 1

(c) D-S + Load Case 1 + Load Case 2

(c) D-S + Load Case 1 + Load Case 2 + Load Case 3

Figure C.3. Crack Patterns for East Side

Before the test began, the existing cracks, which were considered to be shrinkage cracks, were found and are shown in Figures C.1(a), C.2(a) and C.3(a) in Appendix C. As shown in the figures, most cracks were found near the mid-span of the slab with some near the lifting anchors on the east side of the test specimen. The spacing between the cracks on the bottom surface of the slab was less than the thickness of the slab and the maximum spacing of the shrinkage and temperature reinforcement in the slab, both of which were 12 in.

Cracks were marked at each load step, i.e., 5, 10, 15, 20 and 25 kips of loading and the obtained crack patterns are provided in Figures C.1(b), C.2(b) and C.3(b) for Load Case 1 and Figures C.1(c), C.2(c) and C.3(c) for Load Case 2 in Appendix C.

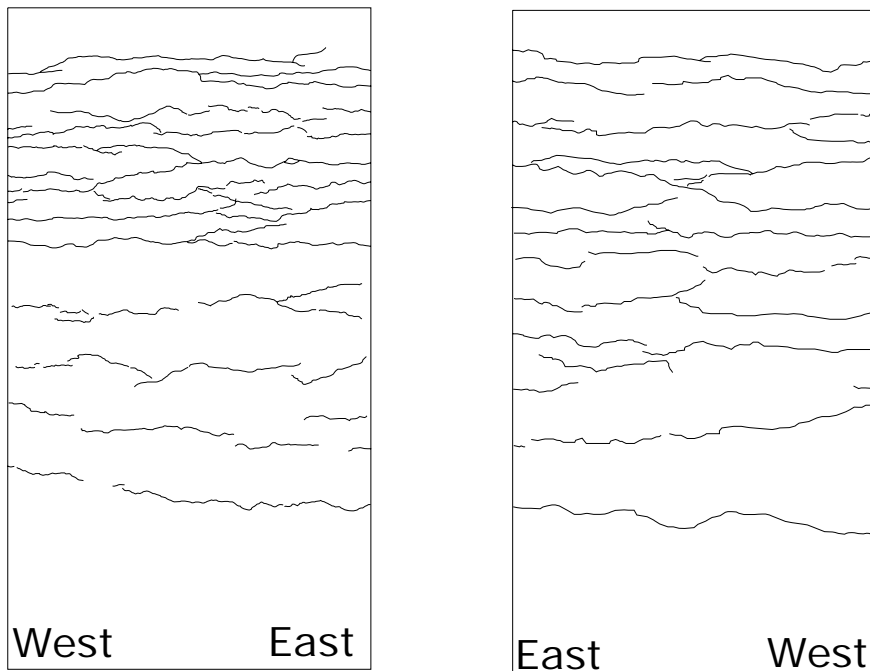
(a) South Leg

Figure C.5. Crack Patterns for the Legs
