Implementation of Weigh-in-Motion (WIM) Systems

FINAL REPORT
February 2009

***Center for Advanced Infrastructure & Transportation (CAIT)
Rutgers, The State University
100 Brett Road
Piscataway, NJ 08854-8014**

**New Jersey
Department of Transportation
Bureau of Research
and
U.S. Department of Transportation
Federal Highway Administration**

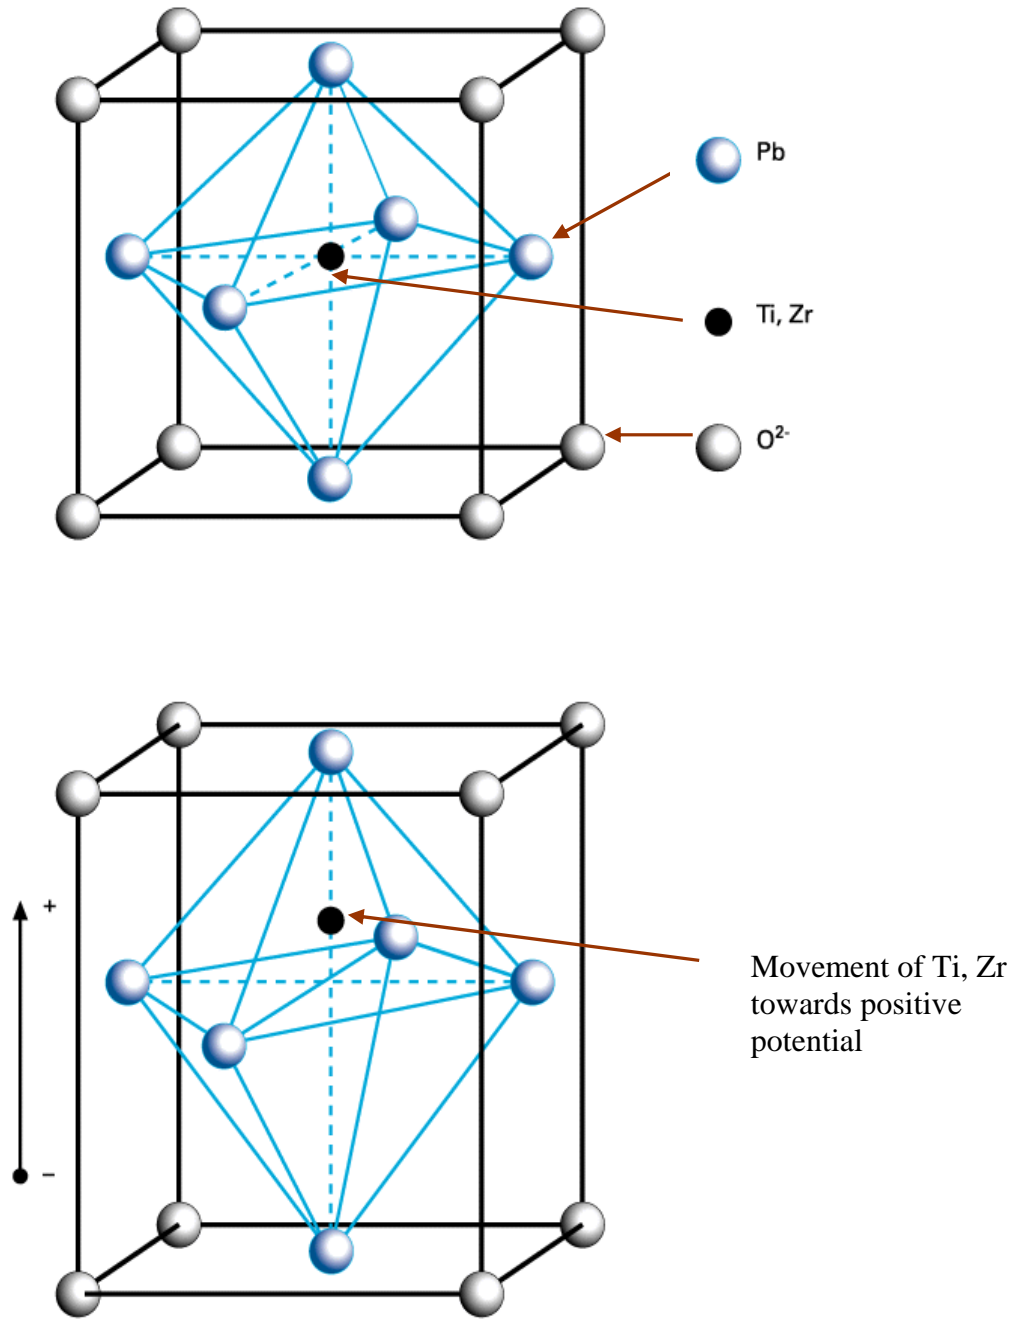
Figure 2 Diagram detailing the piezoelectric effect of PZT.⁸

PZT crystallites are a symmetric cubic but when a voltage is applied the structure becomes tetragonal, or vice versa when a load is applied. Therefore, the Zirconate Titanate is pulled toward the positive potential. With the lead crystal around it, the structure will change in dimensions to accommodate the new position of the Zirconate Titanate. As a result, there is a distortion which causes growth and an alignment of field, see Figure 2. As all the crystals are doing this at the same time and have the same electric dipole domain alignment; the crystals thereby generate a voltage, the cumulative of which can be quite large.

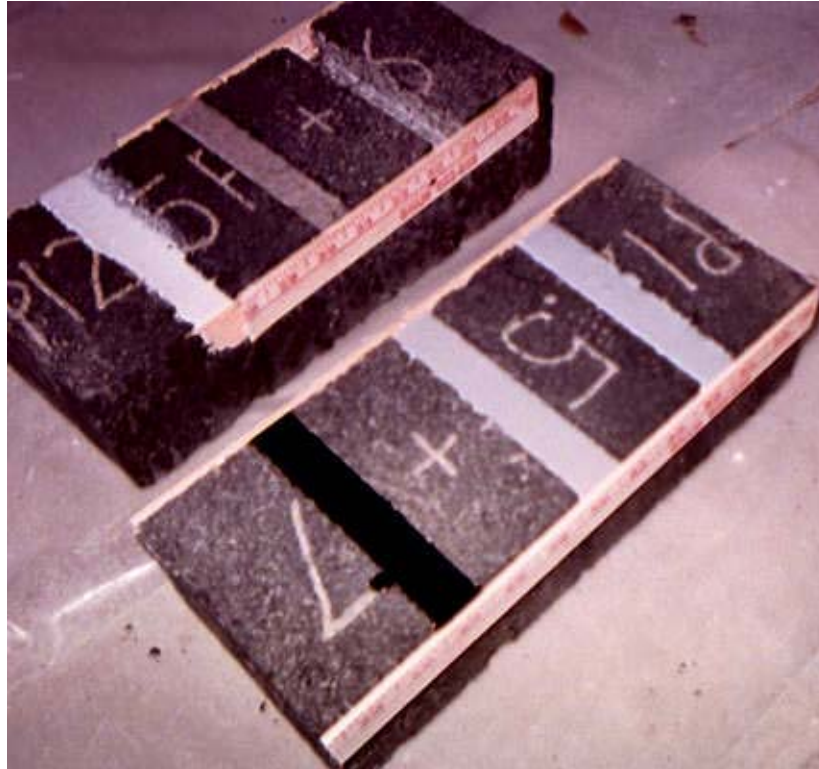
Figure 9 Photograph showing epoxy infiltration into the grooves previously cut into the HMA bricks.

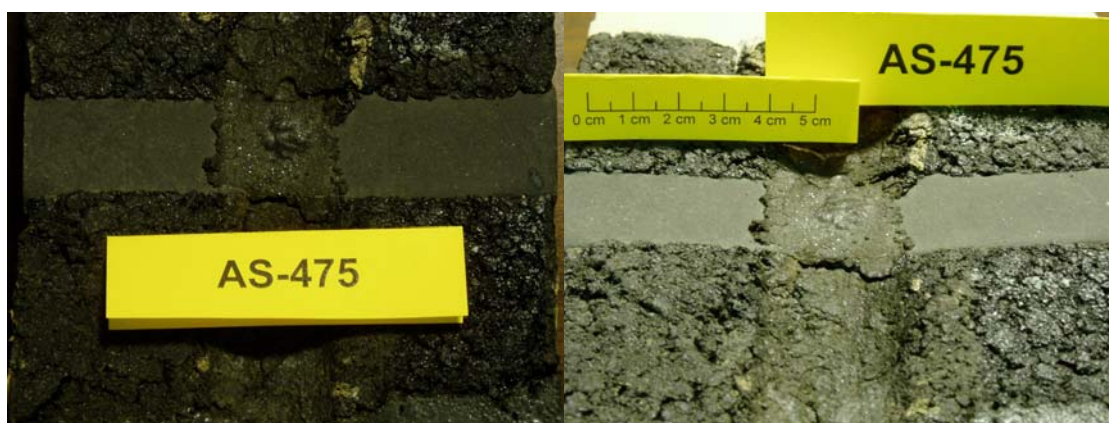
Figure 13 Photograph of APA Test rutting results of AS 475.

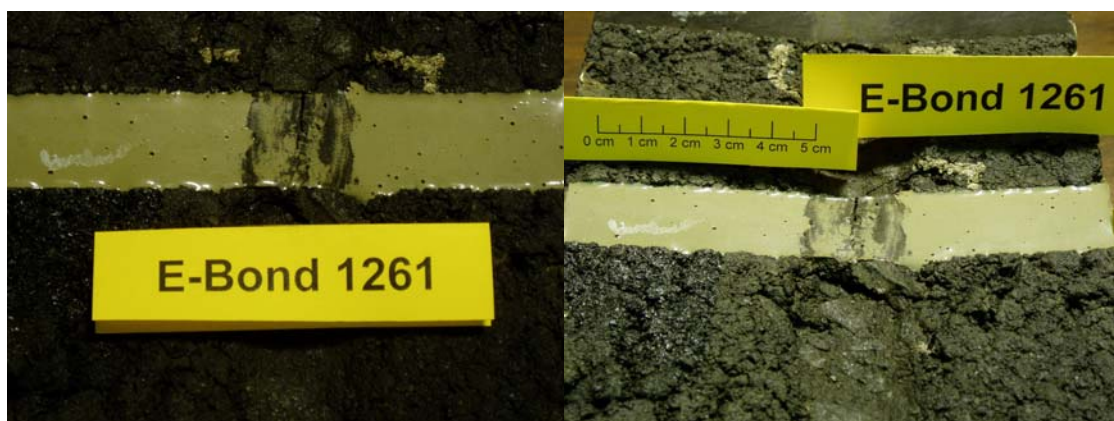
Figure 14 Photograph of APA Test rutting results of E-Bond 1261.

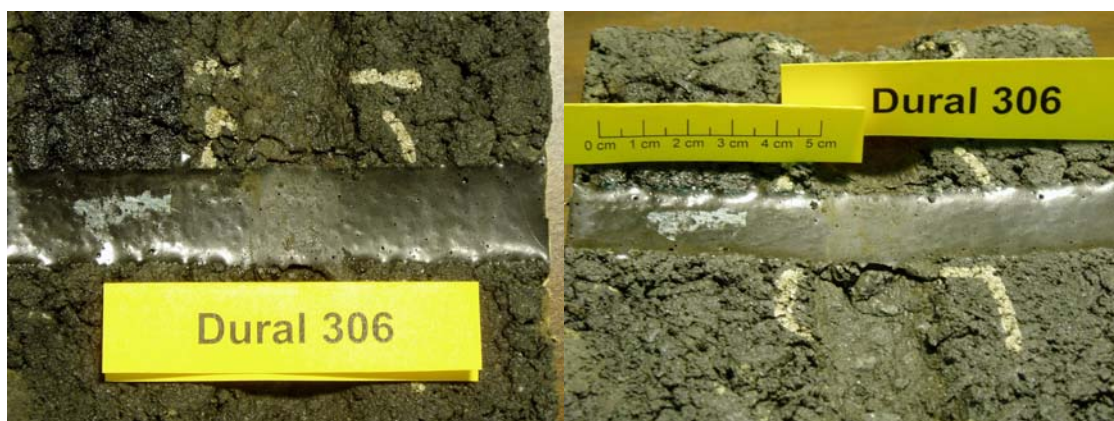
Figure 15 Photograph of APA Test rutting results of Dural 306.

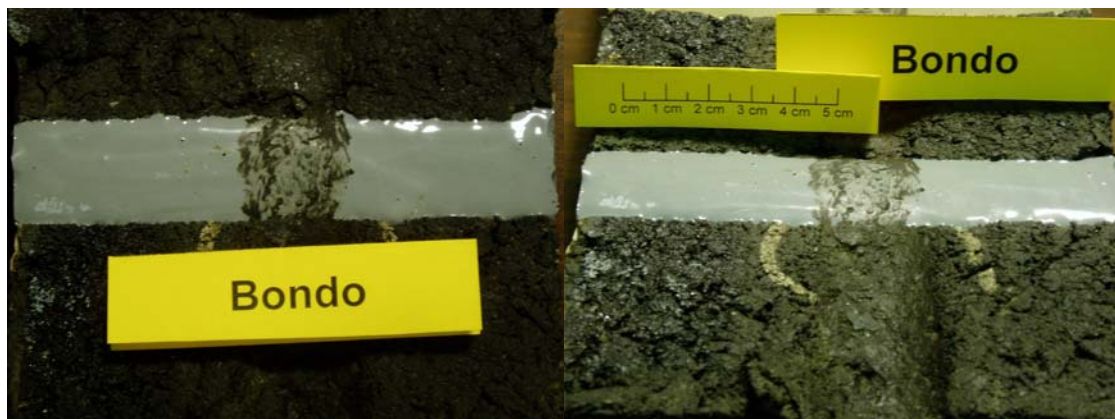
Product:	BONDO 7084
Properties	
Pot Life	17-25 minutes
Initial Cure	45 minutes
Traffic Ready	1 hour
Final Cure	1 hour
Viscosity	Unknown
Compressive Strength	Unknown
Tensile Strength	17.2 MPa (2500 psi)
Adhesive/Bond/Shear Strength	13.8 MPa (2000 psi)
Mixing Ratio	1:1 by volume
Flash Point	Not Available, assume >93°C (>200°F)
Other Observations	Bondo 7084 is very thick and extremely difficult to work with , rigidity may cause issues if the road ruts, however there was no delamination in APA tests.
Measured Delamination from 20,000 Cycle APA Test	0 mm (0in)
	0.69 mm (0.027 in)
Type of Delamination	None / Asphalt Cracking

Figure 17 Photograph of APA Test rutting results of Bondo 7084.

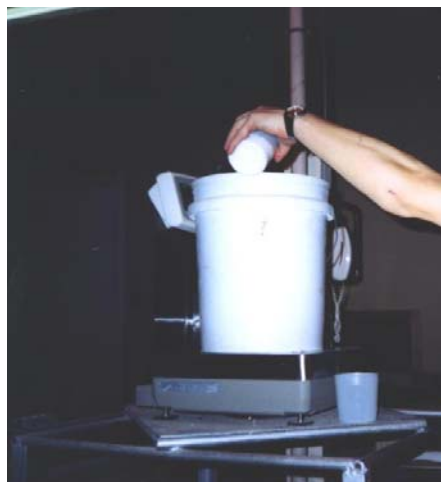
Figure 20 Addition of salt to form brine solution to ensure test would be performed under worst case environmental effects.

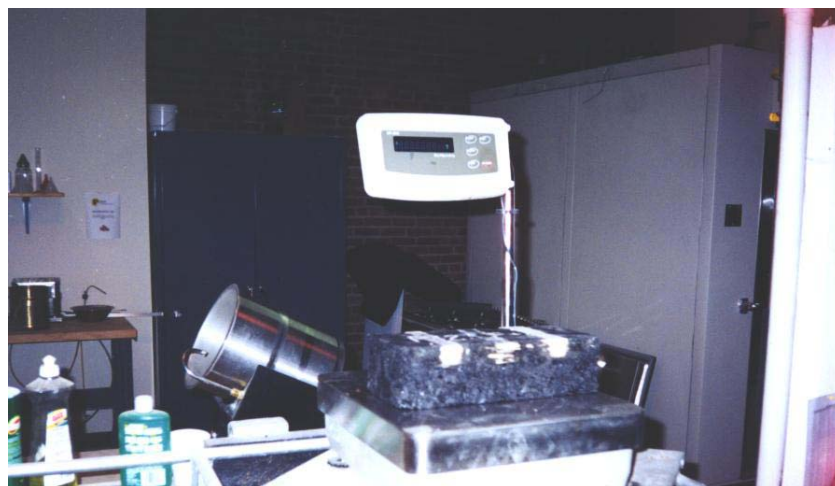
The saturated surface-dry mass of each sample was determined and is shown in Figure 21. Each brick was then subjected to vacuum conditioning for 15 minutes. The vacuum was then removed and the samples were allowed to sit in the solution for another 5 minutes. The samples were then removed from the vacuum container and the saturated surface-dry mass was re-measured and compared to the original measurement. The saturation for two HMA bricks was 62% and for the HMA third brick it was 66%. Therefore, within an acceptable tolerance of 55-80% according to T-283, all the samples had roughly the sample level of saturation and the testing was continued.²⁹

Figure 21 Weighing of samples to determine saturated surface dry (SSD) weight.

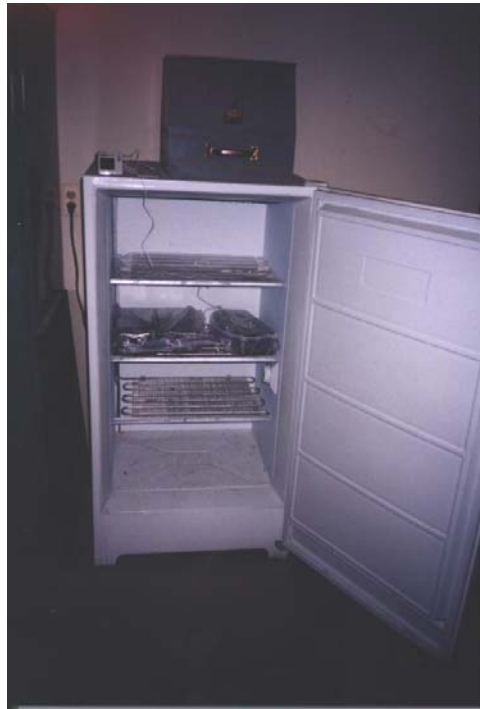
Each freeze/thaw cycle consisted of exposing the sample to the temperature of $-18^{\circ}\text{C} \pm 3$ degrees ($0^{\circ}\text{F} \pm 5$ degrees) for 16 hours and then removing them from the freezer, as shown in Figure 23, then exposing the samples to room temperature for another 8 hours. Each complete freeze/thaw cycle took 24 hours to complete.

Figure 23 Photograph of samples in freezer unit.

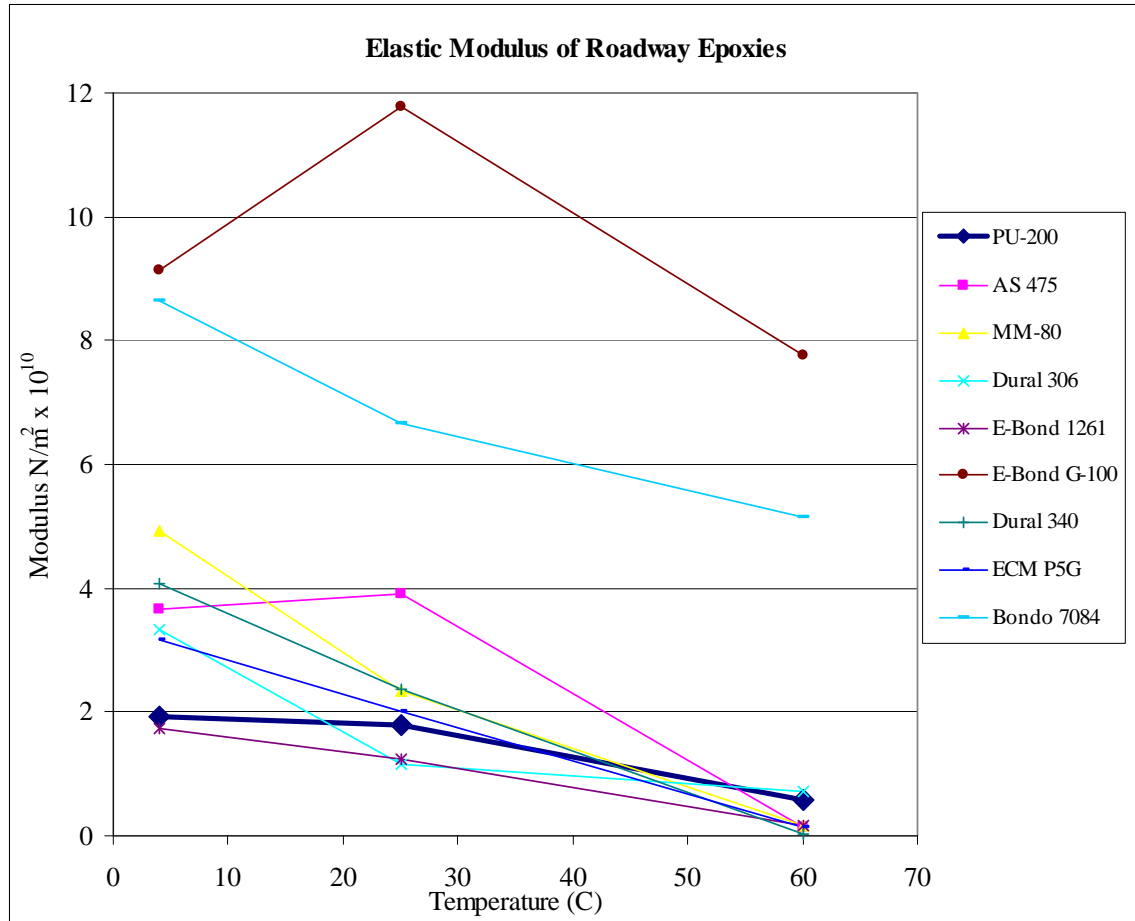
Figure 25 Comparison of Elastic Modulus.

The above materials were eliminated from Figure 25 and plotted along with HMA modulus in Figure 26. HMA has a typical range of 14,000 MPa (2,000,000 psi) at 0°C (32°F); 3,500 MPa (500,000 psi) at 21°C (70°F); and 150 MPa (20,000 psi) at 49°C (120°F).³¹ Ideally, the roadway epoxy properties should match that of the HMA pavement, however based on the testing data all the epoxies have higher modulus than HMA at all temperatures. At higher temperatures all the six remaining epoxies fall within the HMA comparative zone of elastic modulus. However at 25°C (77°F) only the PU-200 and the Dural 306 fall within this zone; whereas at 4°C (40°F) only PU-200 remains within this HMA comparative zone of Elastic Modulus.

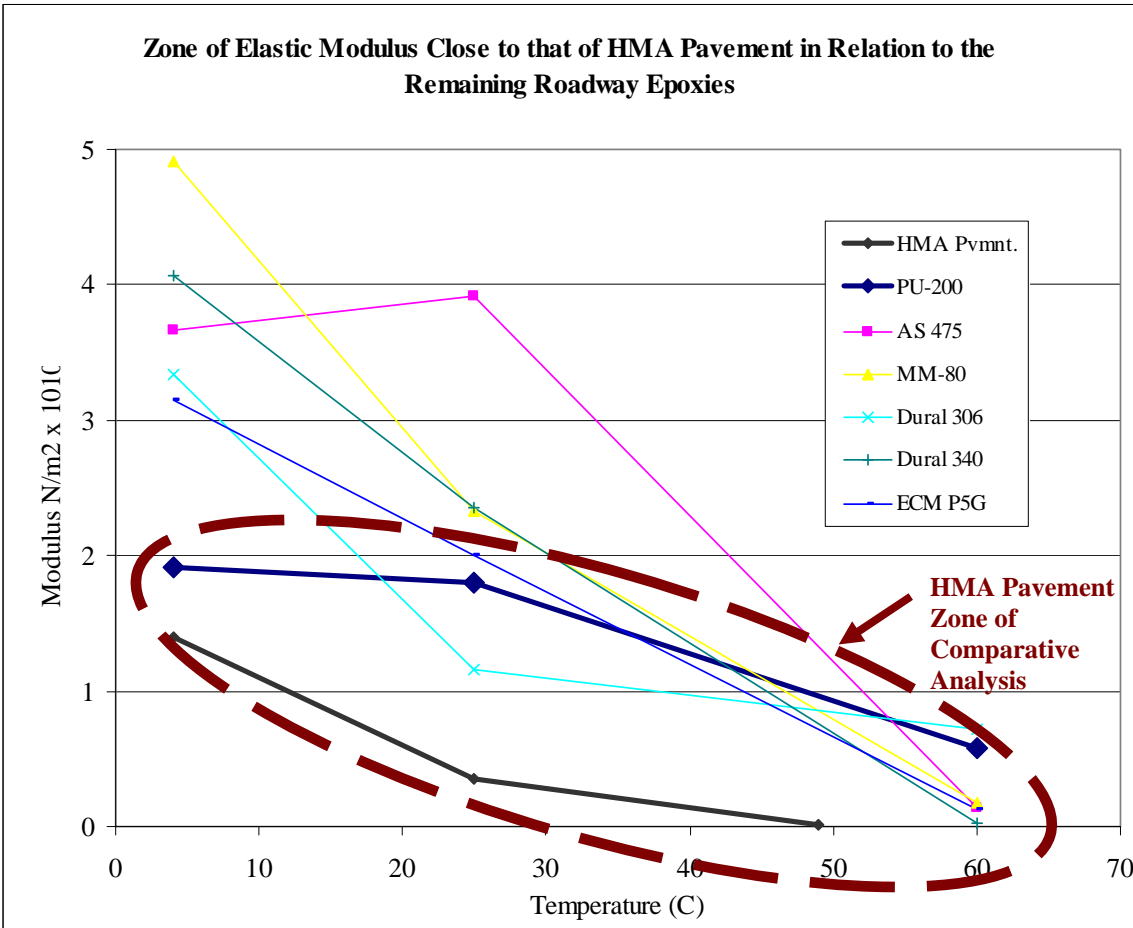
Figure 26 Zone of Elastic Modulus close to that of HMA pavement in relation to the remaining roadway epoxies

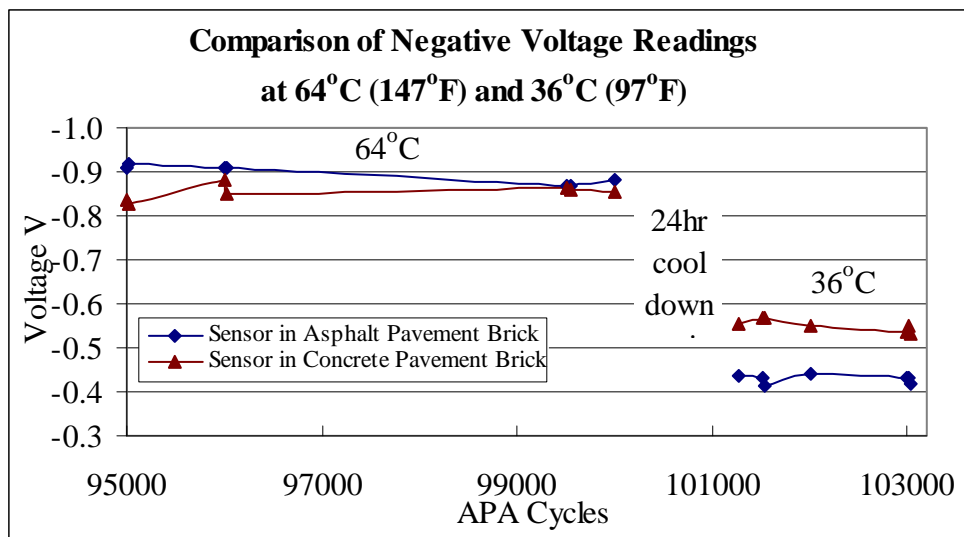
Figure 48 Comparison of negative voltage output at 64°C (147°F) and 36°C (97°F).

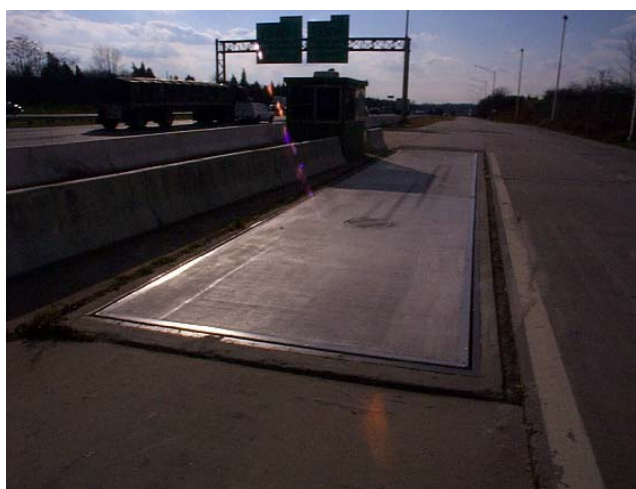
Figure 49 Route 287 weigh station static scale.

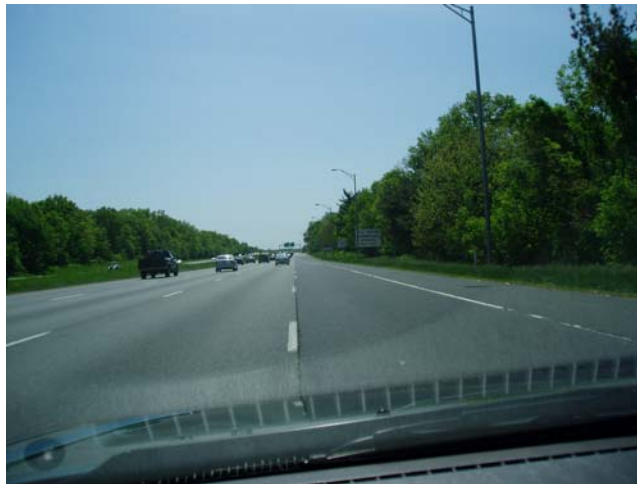
Figure 53 Photograph of Route 287 northbound at milepost 8.8, just prior to the weigh station.

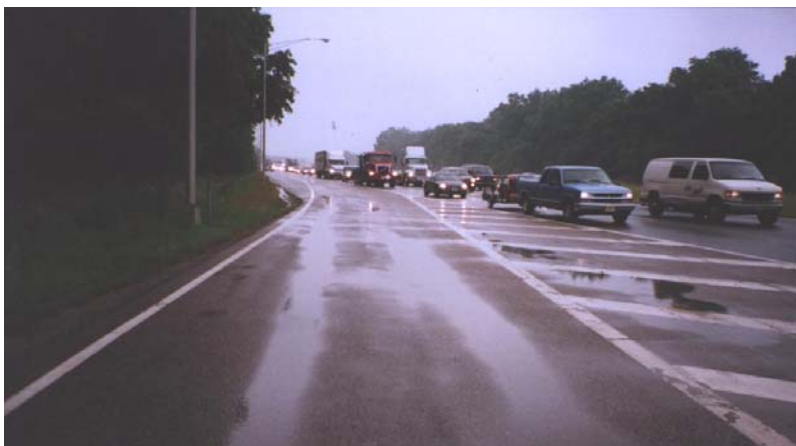
Figure 54 Field observation of water ponding in the wheel paths.

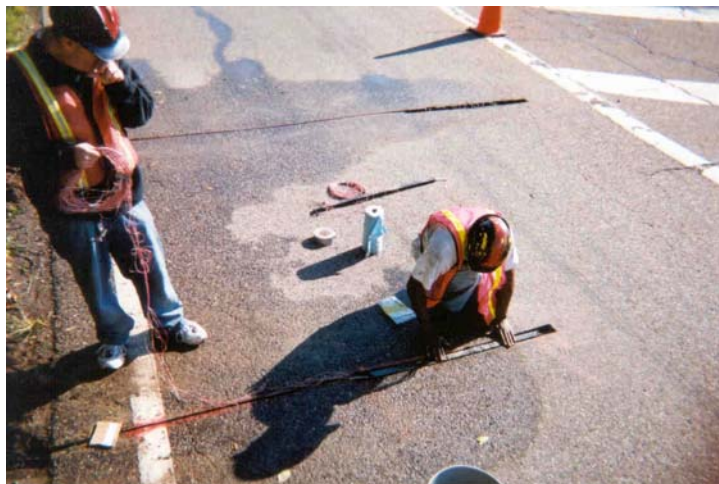
Figure 61 Photograph of ceramic-polymer composite sensor assembly being placed in groove at the Route 287 weigh station.

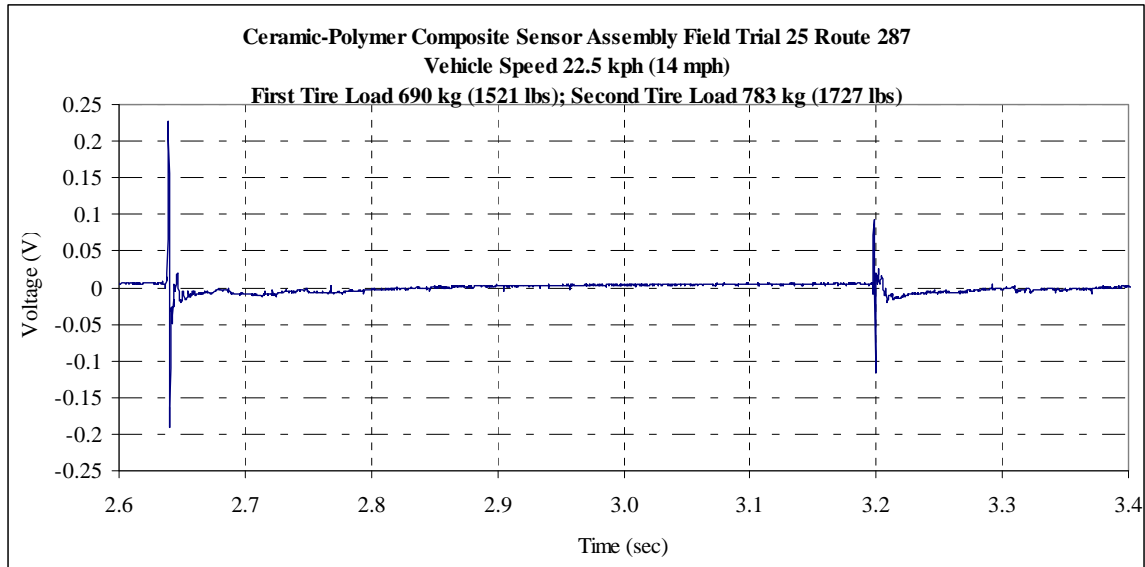
Figure 69 Ceramic-polymer composite sensor assembly field trial Rt. 287 results after winter season at 22.5 kph (14 mph).

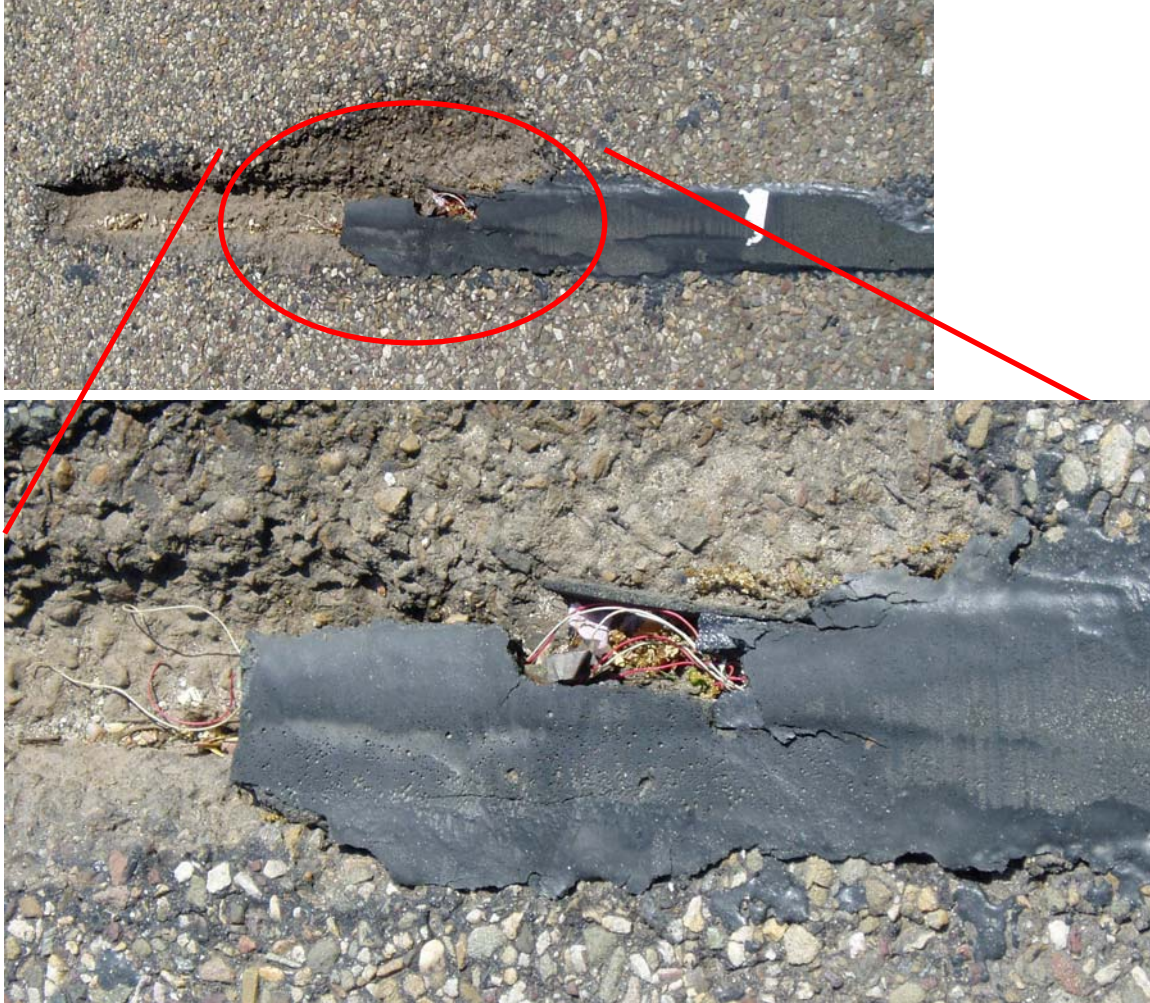
Figure 77 Close-up examination of failed outside of lane sensor assembly.

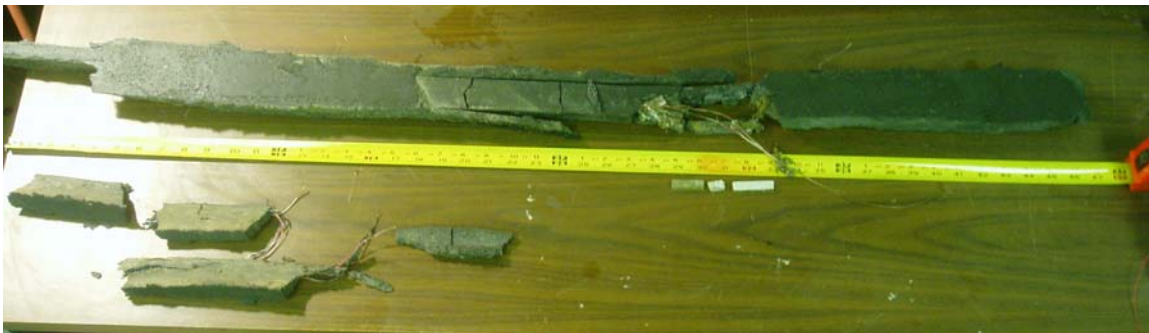
Figure 82 Recovered sensor assembly from Rt. 287 field installation.
