VALUE ENGINEERING AND COST EFFECTIVENESS OF VARIOUS FIBER REINFORCED POLYMER (FRP) REPAIR SYSTEMS

Research Project 2004-15

Final Report

Department of Civil Engineering
North Carolina State University
Raleigh, NC 27695-7908

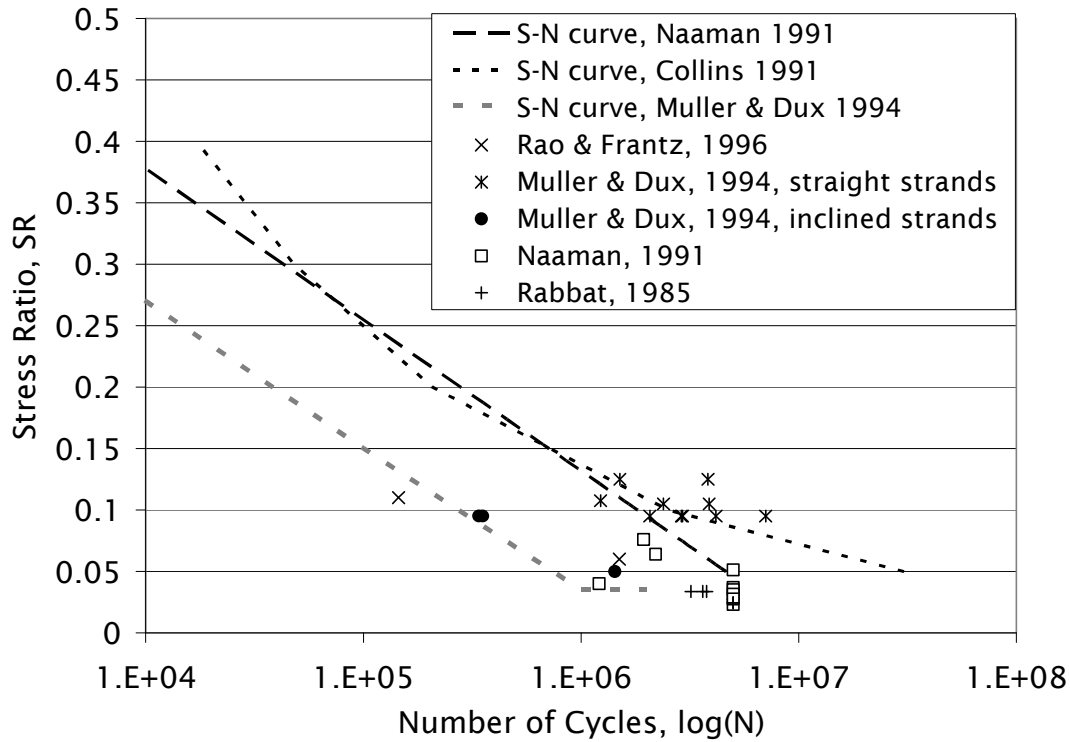
Figure 2.1 S-N Behavior of prestressing strands

Both of these equations are plotted in Figure 2.1.

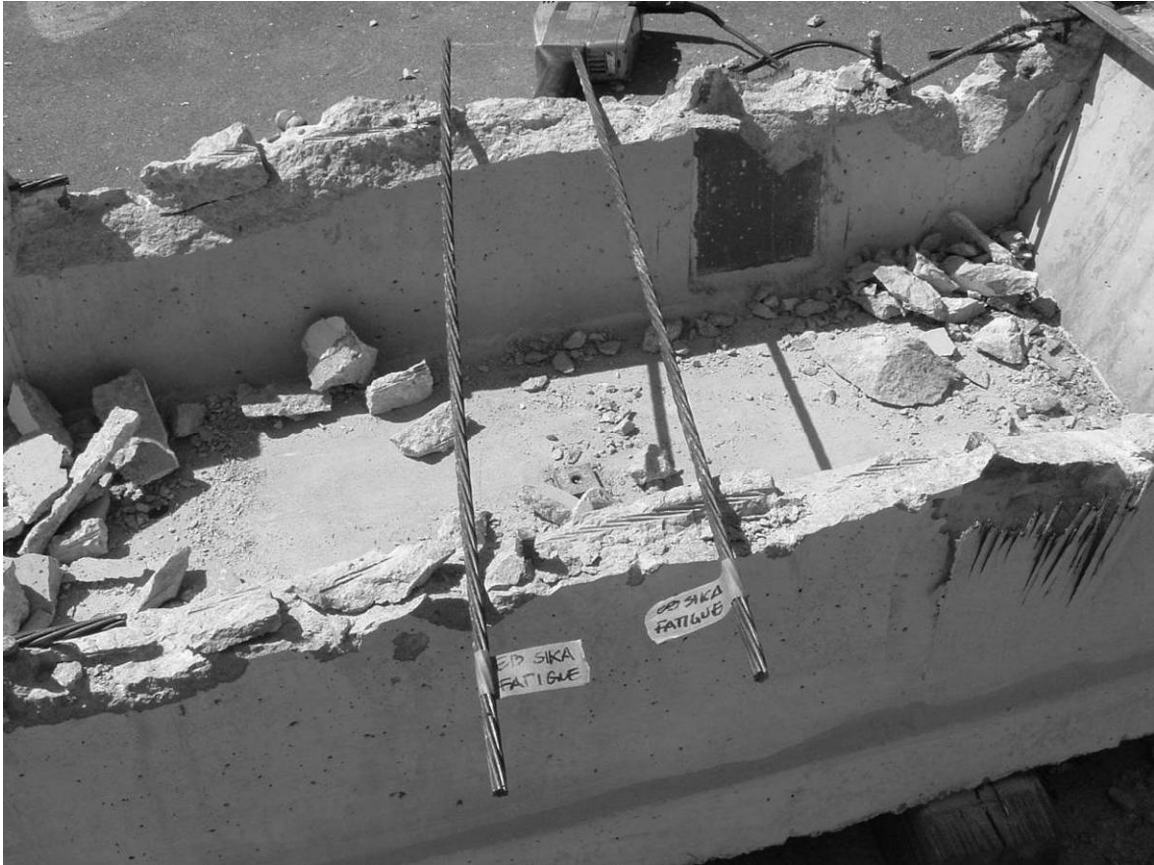
Figure 3.5 Prestressing strand extraction

prestressing strands were extracted near the supports. Care was taken in removal of the strands to prevent any unraveling of the strands while cutting. The prestressing strand specimens after removal from the girder are shown in Figure 3.5.

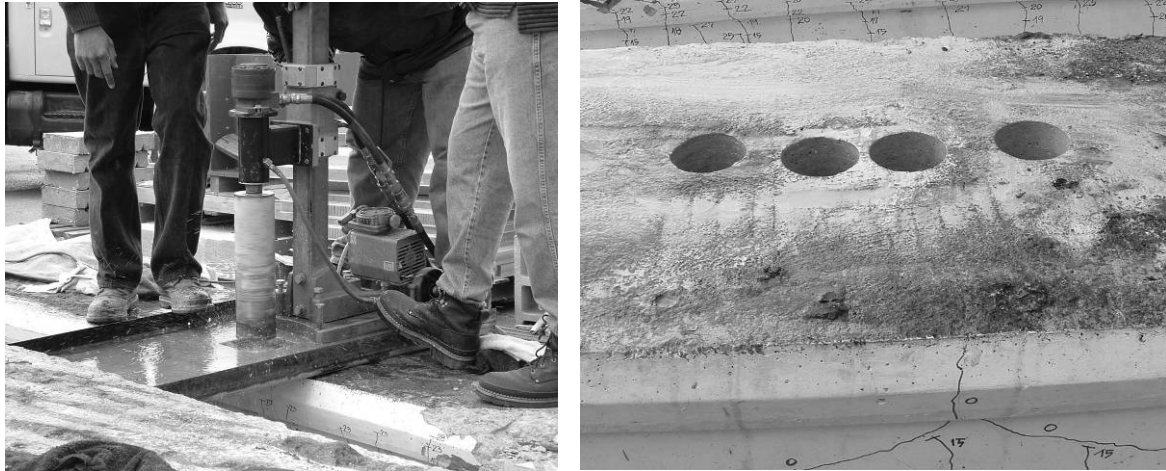
Figure 3.7 Concrete core drilling operation for C-Channel girders

concrete strength was 9360 psi (64.5 MPa) and 7380 psi (50.9 MPa) for the Type I and Type II girders respectively.

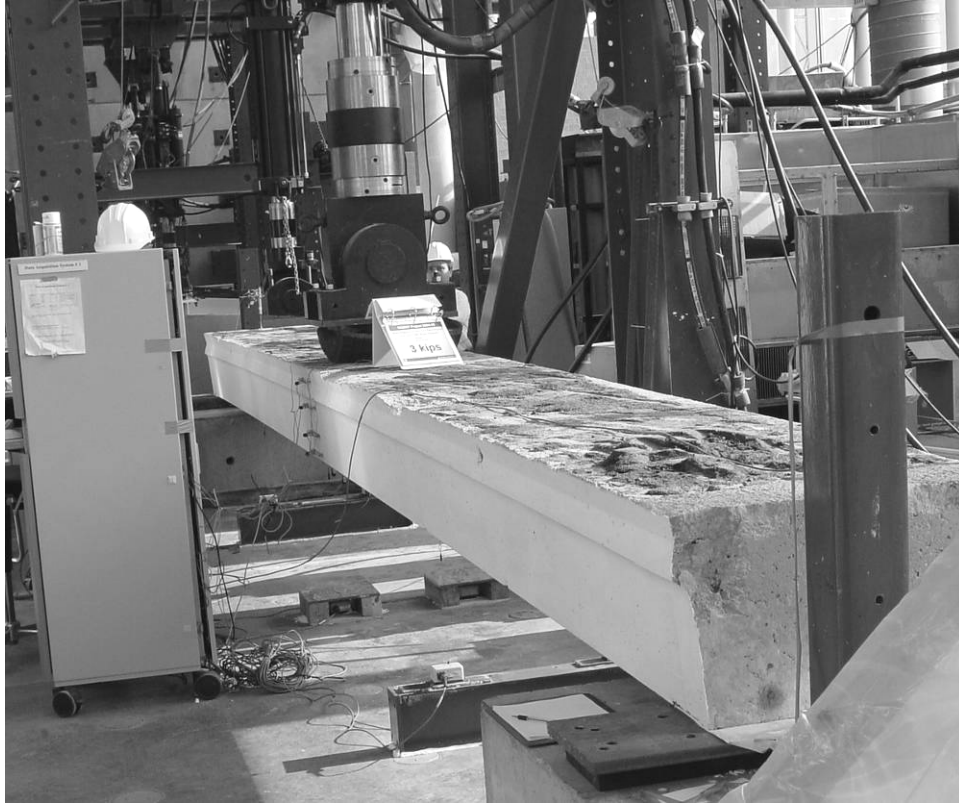
Figure 3.10 Typical test setup for C-Channel girders tested under static loading conditions

The displacement behavior of the girders during testing was monitored using three sets of string potentiometers, placed at quarter spans, and two linear potentiometers to measure vertical displacement over the supports. The compressive strain in the concrete was measured using a combination of PI gauges (a strain gauge mounted to a spring plate) and two 2.36 in (60 mm) TML FLA-60-11 120 Ω electric resistance strain gauges located at midspan. PI gauges were also placed at various locations at the level of the lowest prestressing strand to measure the crack width and to determine the strain profile along the depth of the girder. The tensile strain in the CFRP reinforcement was measured using six 0.236 in (6 mm) TML FLA-6-11 120 Ω electric resistance strain gauges: two at midspan, two at 6 in (150 mm) from midspan and two at 12 in (305 mm) from midspan. Figure 3.10 shows a typical test setup for the C-Channel girders under static loading conditions.

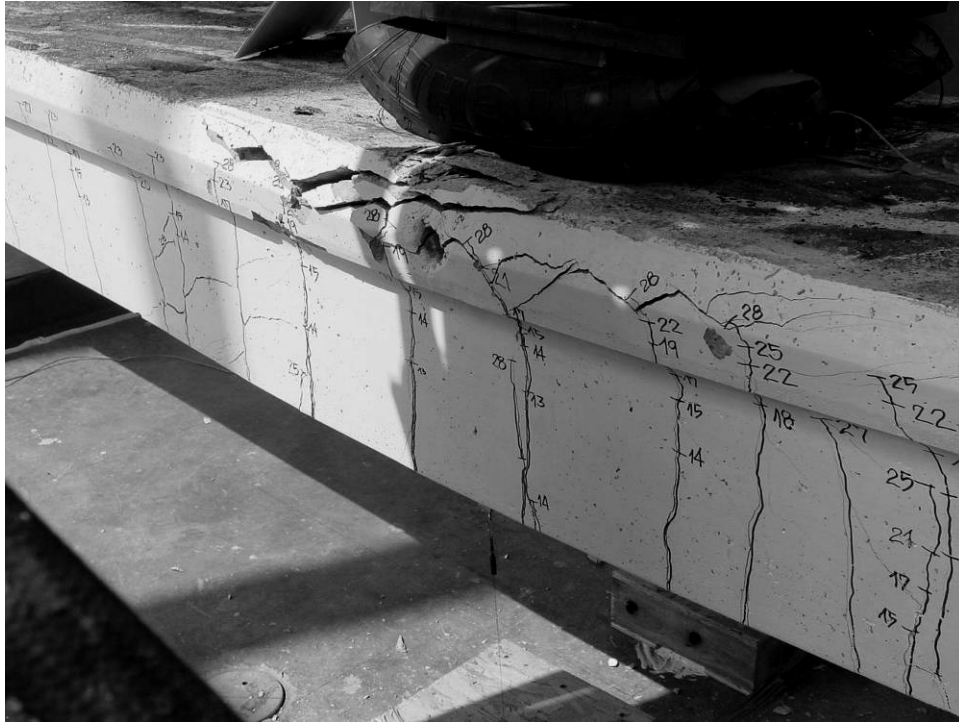
Figure 3.11 Failure due to concrete crushing of girder CS

The girder was loaded statically up to failure. The effective prestress force given in Table 3.6 was determined from the cracking load for this girder, which occurred at a load of 12.6 k (55.8 kN). After cracking, flexural cracks were evenly distributed along the length of the girder and located approximately at the location of mild steel stirrups. Yielding of the lower prestressing strands took place at a load level of 25.8 k (115 kN) according to readings of the PI gauges. Failure occurred due to crushing of concrete at a load level of 33.2 k (148 kN) at an ultimate deflection of 9 in (228 mm) as shown in Figure 3.11. Due to the confining effect induced by the loading tires, crushing of the concrete occurred first at the edge of the girder at midspan before it extended underneath the loading area.

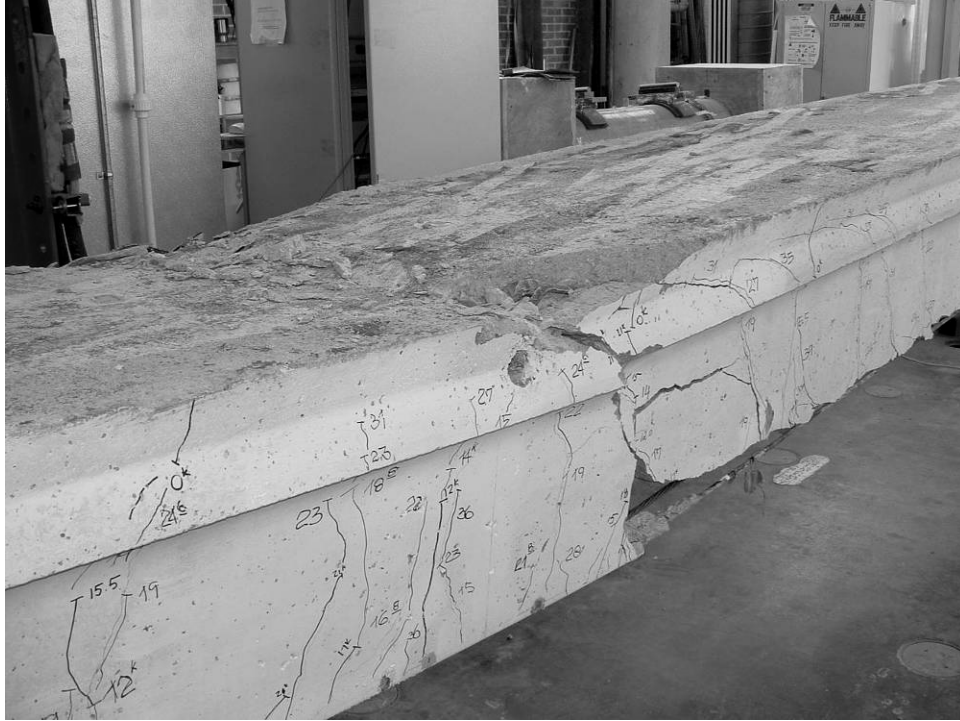
Figure 3.12 Failure due to concrete crushing of NSM1

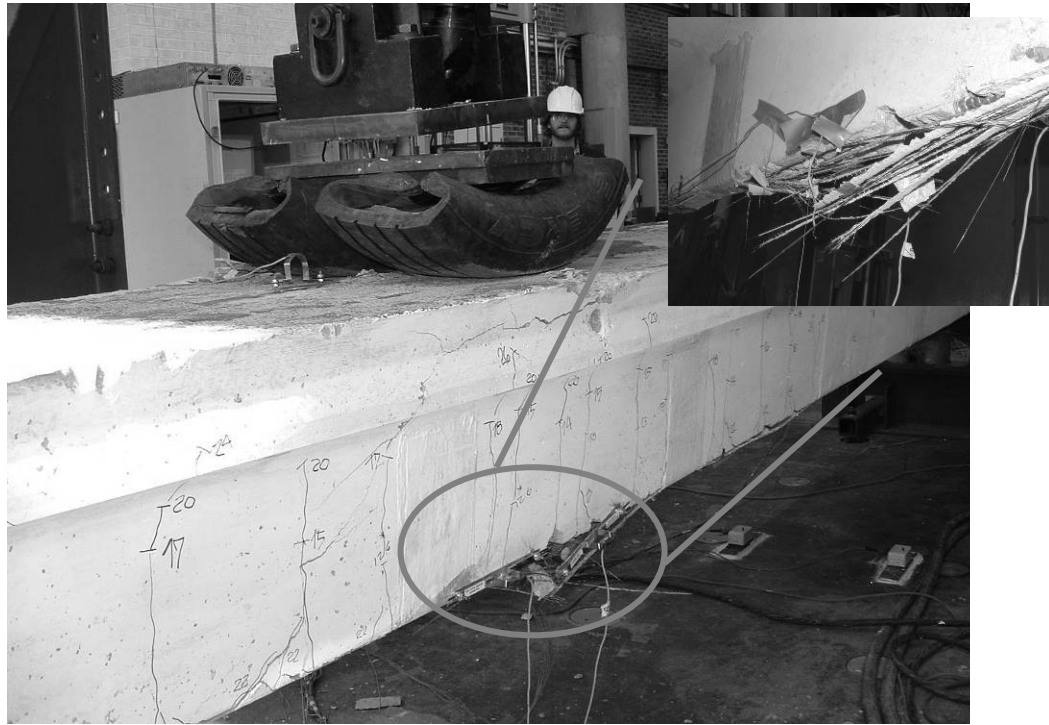
Figure 3.14 Failure due to rupture of CFRP sheets in girder EB2S

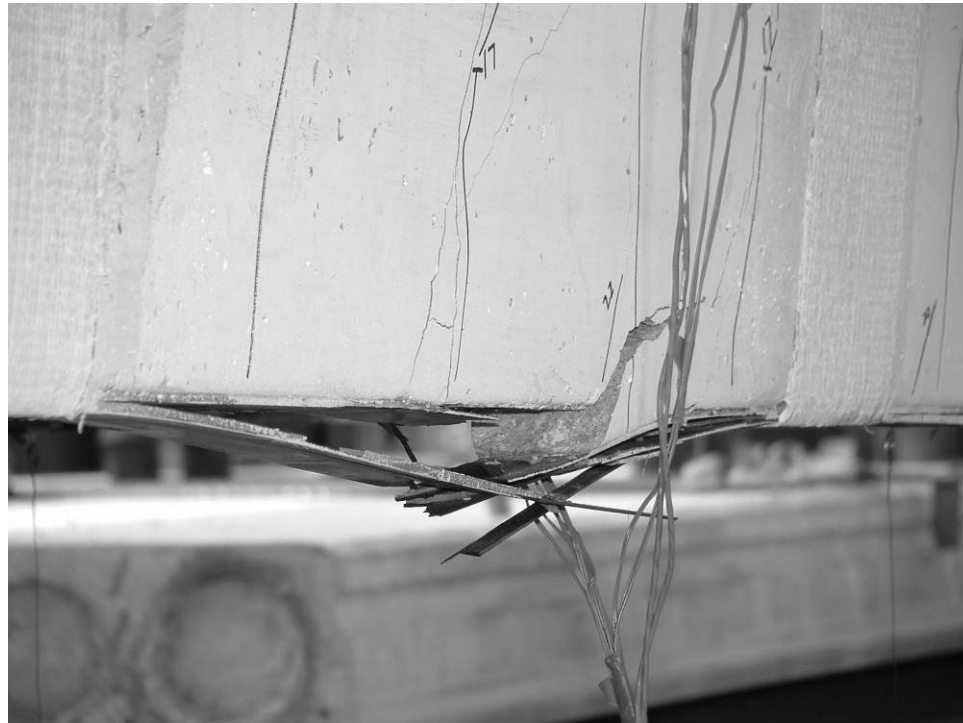
Figure 3.15 Rupture of high modulus CFRP strips in girder EB3S

After rupture of the CFRP strips, the test was continued until concrete crushing occurred at a load of 29.1 k (129 kN). The lower level of maximum measured load in comparison to the control girder could be due to the sudden failure of the CFRP material imparting an impact load on the girder.

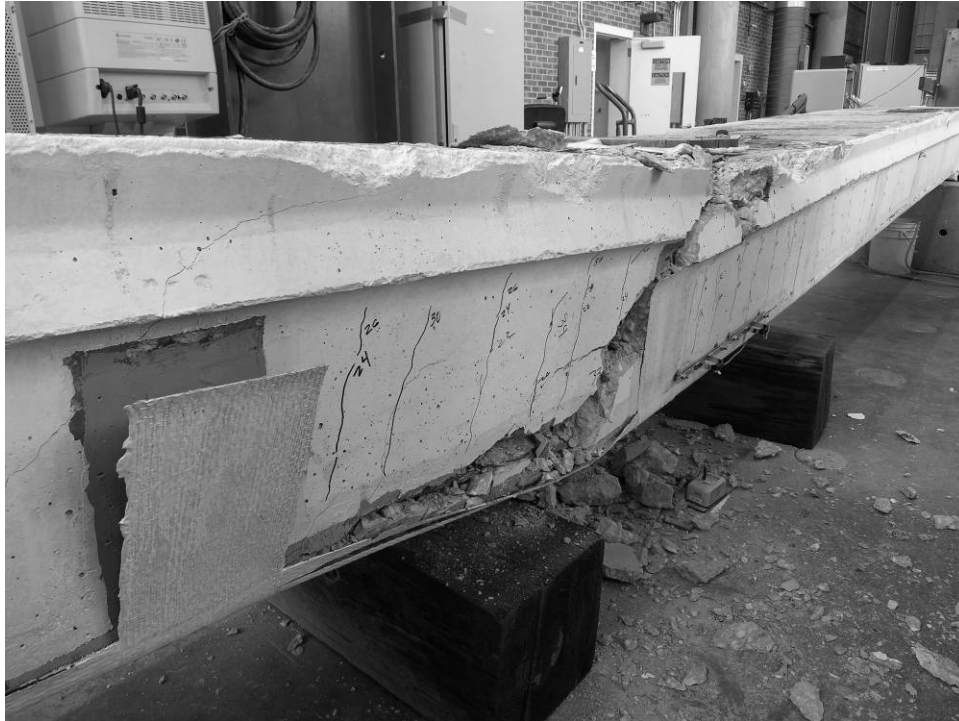
Figure 3.17 Failure of girder EB5S due to concrete crushing

exceeded the design values due to a high rupture strain measured in the CFRP during the test, which was 18.8 percent higher than the value reported by the manufacturer.

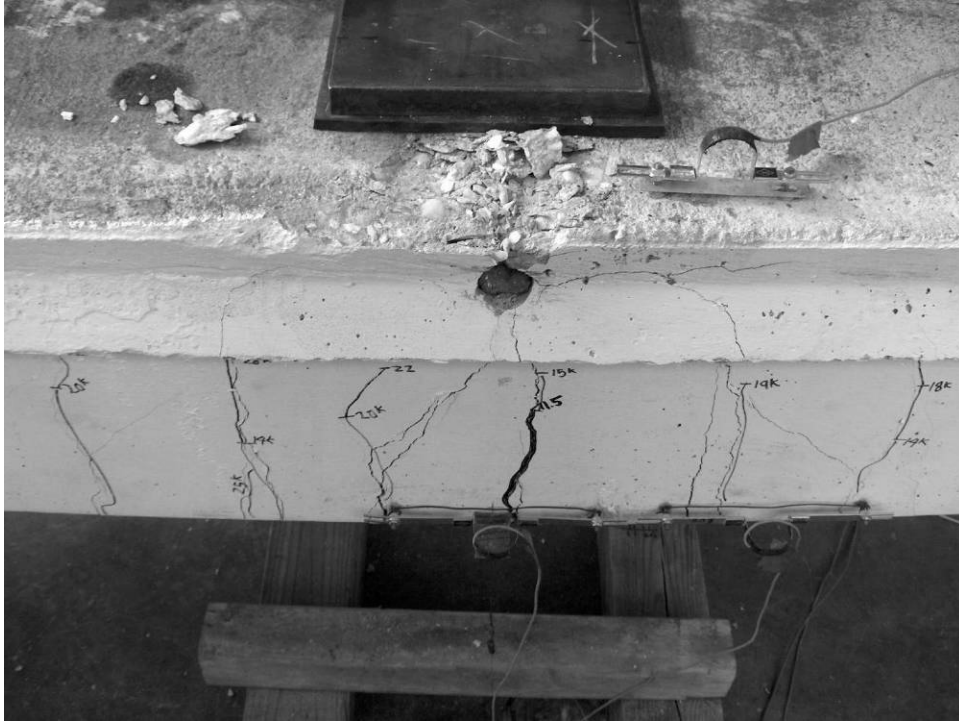
Figure 3.21 Concrete crushing failure of girder CF2 during final static test

configuration (CS). Failure of the girder was due to crushing of the concrete as shown in Figure 3.21.

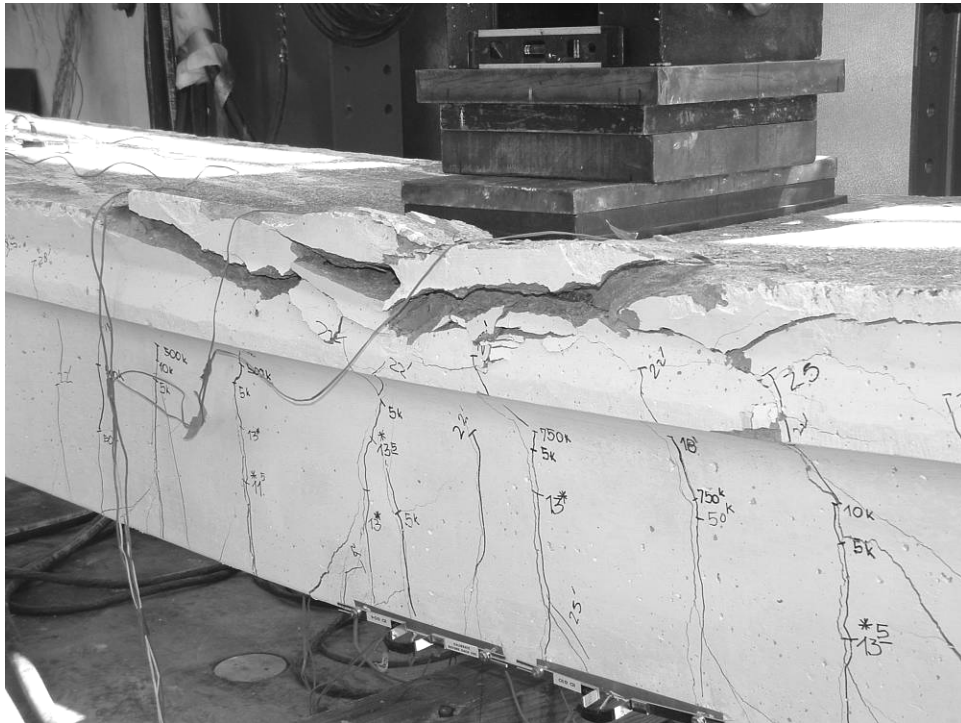
Figure 3.22 Concrete crushing failure of girder NSM2F during final static test

respectively. After the initial loading, the strengthened girders were tested at a frequency of 2 Hz and load range of 2k to 11 k (8.9 kN to 57.6 kN), which corresponds to a live load 41 percent higher than HS-13 loading. For both girders, the largest degradation in stiffness occurred during the first 10,000 cycles. After completion of 2 million cycles, very little degradation was observed for either girder. The girder were tested up to failure and showed little difference in their behavior and the behavior of the girders tested under static loading conditions. For girder NSM1F, failure was due to crushing of the concrete at a load of 40.2 k (178 kN) as shown in Figure 3.21. The girder tested under static load (NSM1S) failed at a load of 40.8 k (181 kN). Girder NSM2F also failed due to crushing of concrete at a load of 36.9 k (163 kN), compared to the statically tested girder which failed at a load of 40.7 k (180 kN). Typical concrete crushing failure of the NSM strengthened girders during the final static test after the fatigue cycling is shown in Figure 3.22.

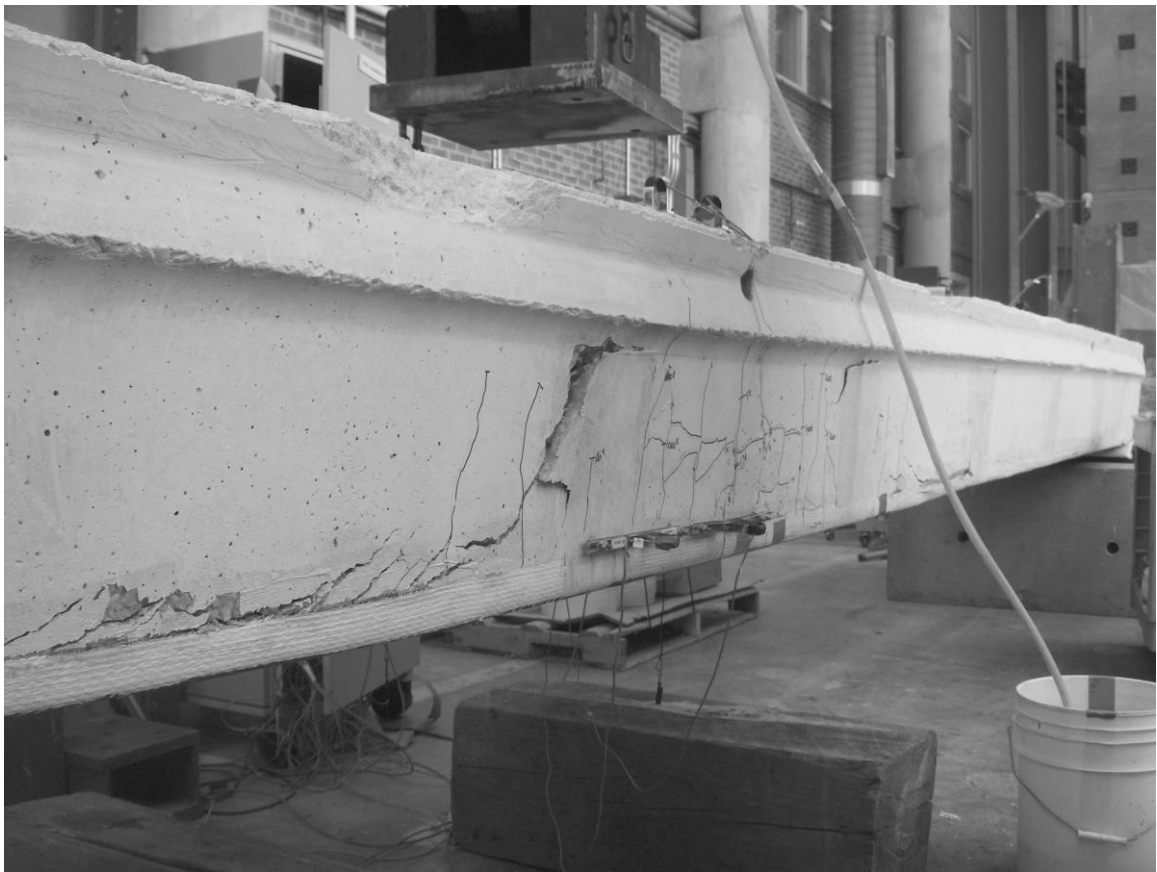
Figure 3.25 IC debonding in girder EB5F during final static test

17 k (75.6 kN) signs of debonding began appearing. Interface cracks in the concrete just above the CFRP sheets expanded at locations of the flexural cracking. These interface cracks joined between the flexural cracks and the debonding propagated from midspan towards the supports, peeling off a layer of cover concrete between the lower prestressing strand and the CFRP as shown in Figure 3.25. The slow debonding of the CFRP sheets due to the presence of the transverse U-wraps provided a ductile failure as shown in Figure 3.25. The maximum load level observed was 31.1 k (138.3 kN).

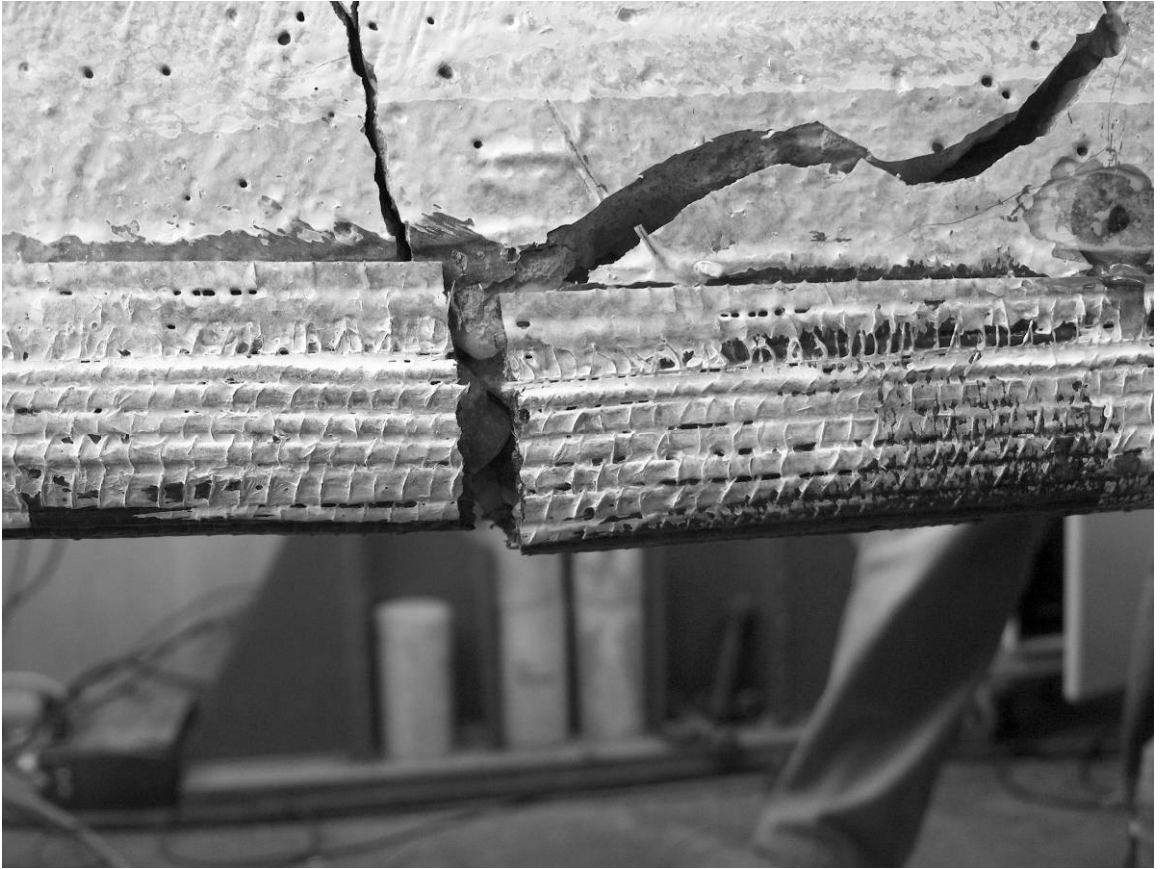
Figure 3.26 Rupture of high modulus CFRP sheets

Although a change of stiffness was noticed in the test data from the PI gauges placed at midspan, no visible cracking was noticed at the beginning of the fatigue loading. After two million cycles of fatigue loading, no visible cracks were observed. A final static test was performed, and rupture of the HM CFRP sheets occurred at a load of 30.0 k (133.4 kN) as shown in Figure 3.26. The rupture strain of the HM material observed during the test was 0.24 percent comparable to the 0.26 percent observed in the static test on girder EB6S. Both were below the 0.30 percent value given from manufacturer. The small difference in rupture strain between girder EB6S and EB6F could be due to slight degradation of the CFRP material from the fatigue loading. After rupture of the sheets at midspan, the girder lost 23 percent of the applied load. The applied load at which rupture of the high modulus sheets was first observed was exceeded at a higher value of displacement. This shows that the high modulus material had a significant effect on the stiffness of the girder, even when not continuous throughout its length. After progressive rupture events, the girder followed the approximate load path of the control girder and the test was terminated after crushing of the concrete in the compression zone at a displacement of 7.6 in (193 mm).

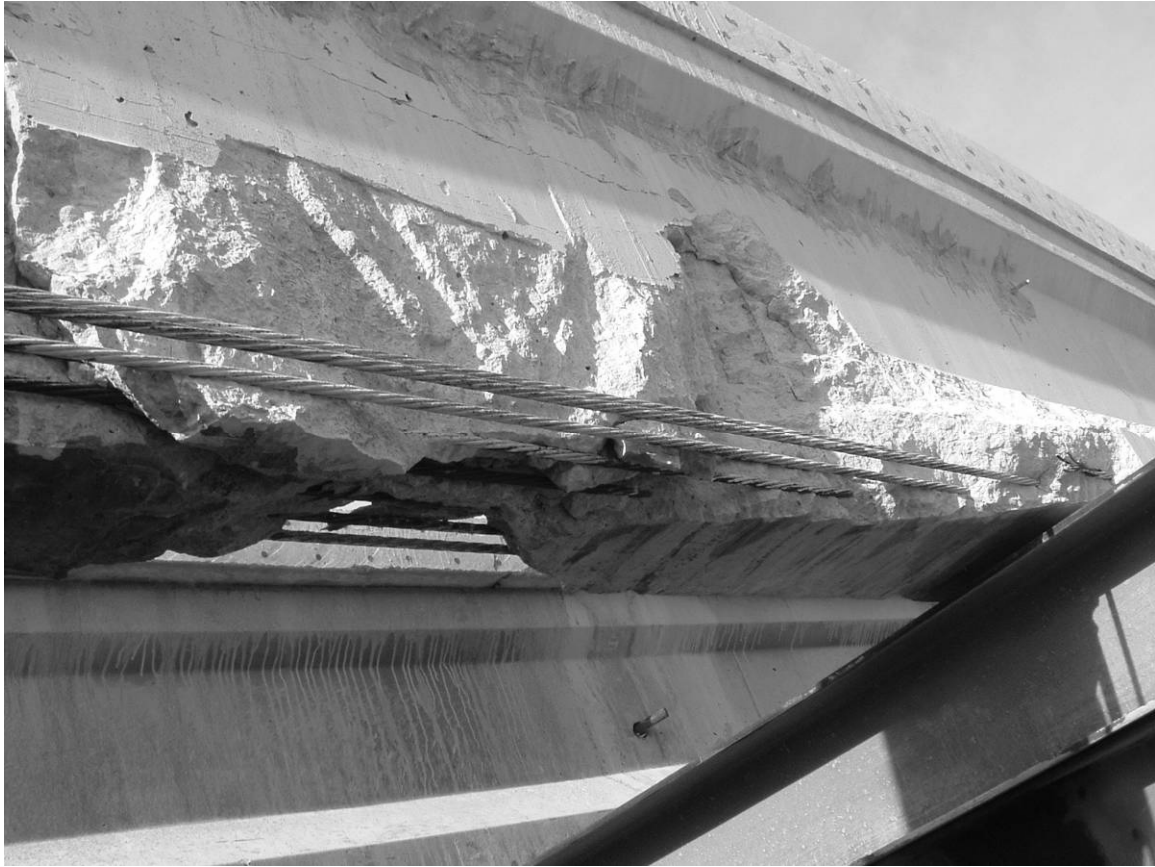
Figure 4.2 AASHTO girder prior to repair work

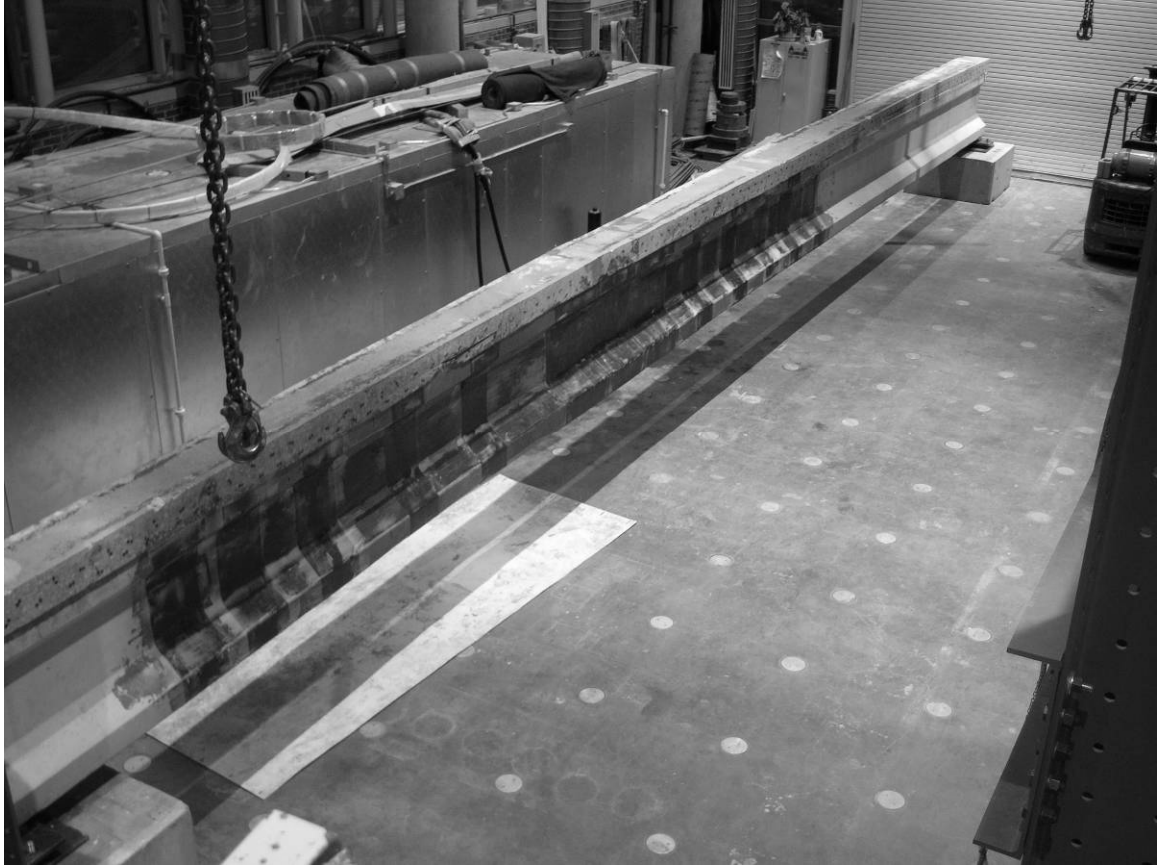
Figure 4.4 CFRP Repaired AASHTO girder

- 2) To control transverse shrinkage and flexural cracks, two additional CFRP sheets were provided longitudinally along the length of the repaired area: two 6 in (152 mm) wide CFRP sheets attached to the angled portion of the bottom flange, and two 12 in (254 mm) CFRP sheets attached to the web of the girder on each side. This reinforcing, acting as tension struts, alleviated the flexural contribution of the main longitudinal reinforcement, and acted as a crack growth inhibitor in the damaged region. In order to provide adequate anchorage, the sheets were extended beyond the damaged region to the extents of the main longitudinal CFRP reinforcing.

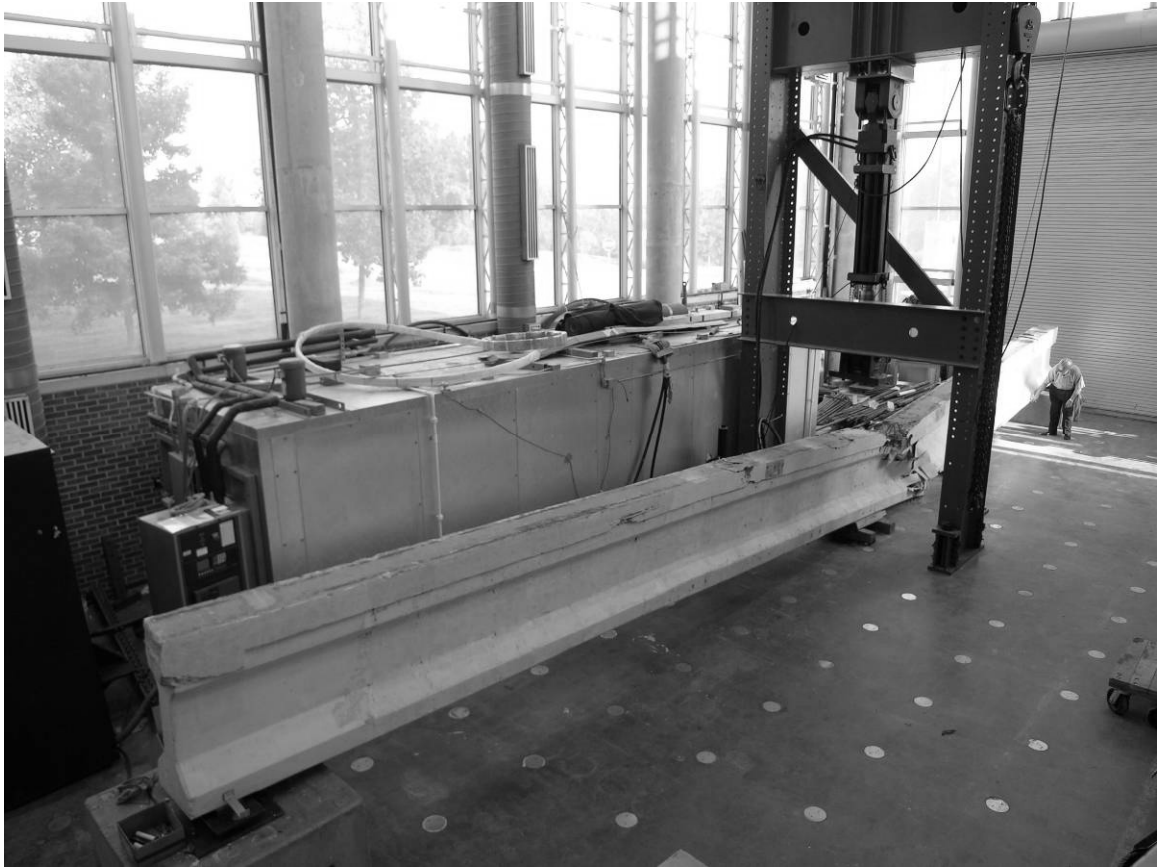
Figure 4.8 Repaired AASHTO girder after failure

concrete crushing zone near the edge of the loading plate and caused catastrophic failure as shown in Figure 4.8. Complete test results are presented in Section 5.6.

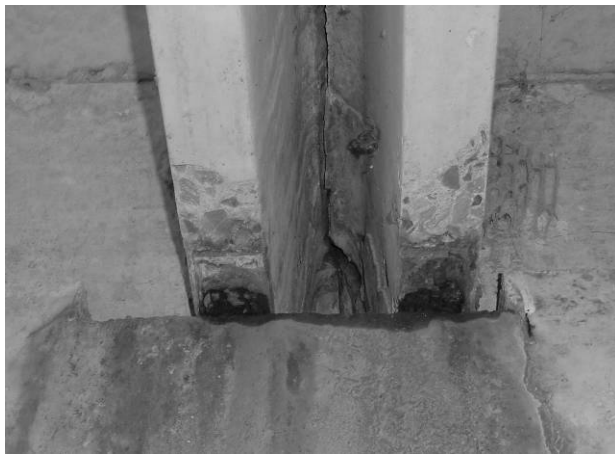
Figure 6.1a Corrosion of bearing plate at support

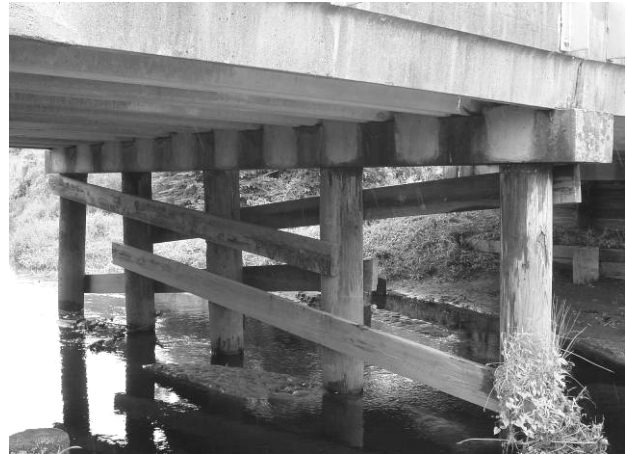
Figure 6.1b Typical timber substructure

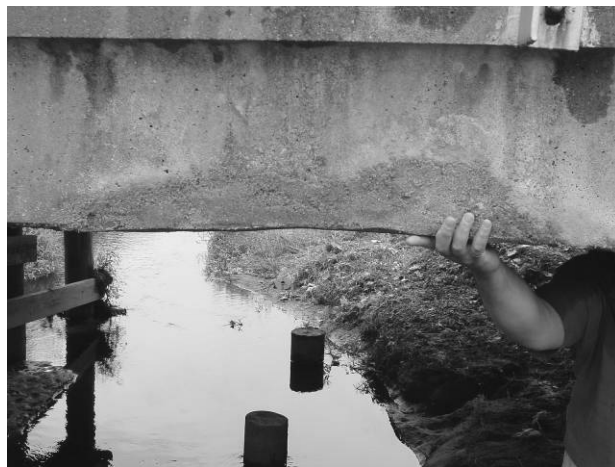
Figure 6.1c Concrete spalling repair

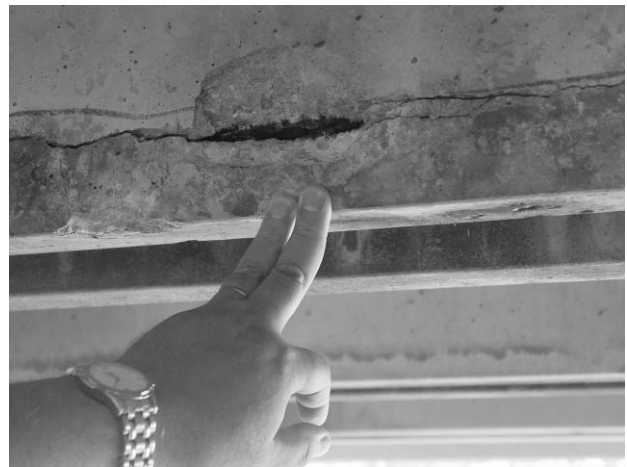
Figure 6.1d Corrosion of lower prestressing strand

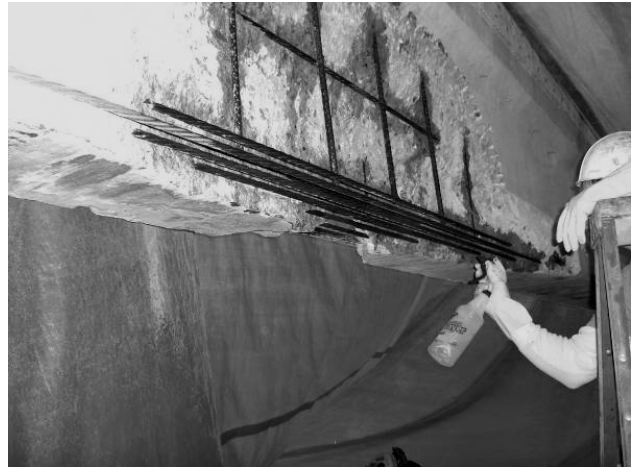
Figure 7.2 Application of corrosion inhibitor

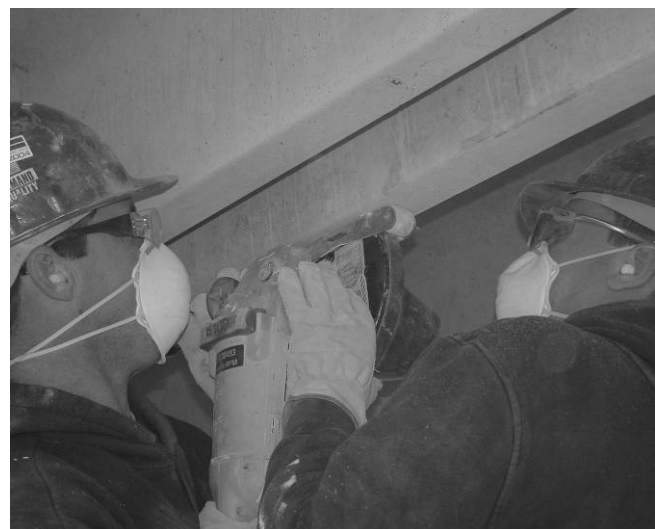
Figure 7.4 Cutting of NSM groove

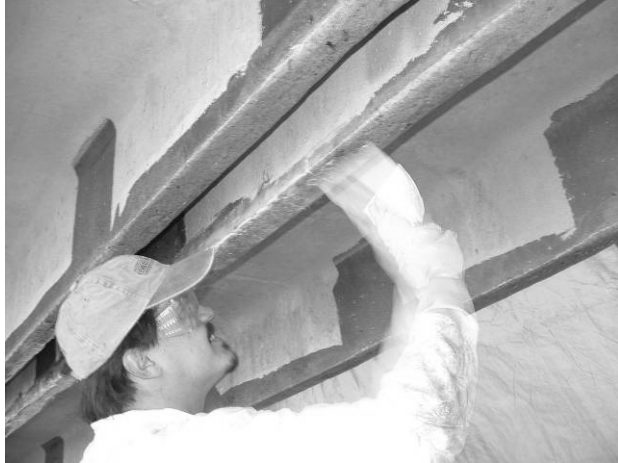
Figure 7.7 Application of putty for wet lay-up

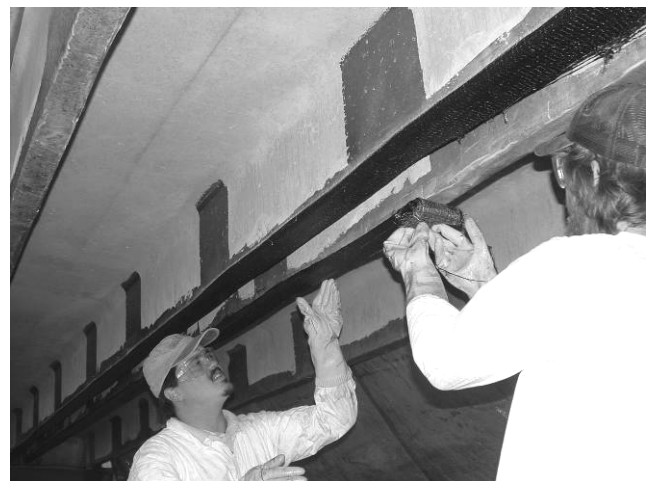
Figure 7.8 Installation of CFRP sheets
