# **Evaluating Systems to Reduce Road Improvement Impacts on Mountain Streams**

North Carolina Department of Transportation  
PROJECT AUTHORIZATION NO. HWY- 2005-05

1. Report No. <b>FHWA/NC/2006-44</b>	2. Government Accession No.	3. Recipient's Catalog No.	
4. Title and Subtitle <b>Evaluating Systems to Reduce Road Improvement Impacts on Mountain Streams</b>		5. Report Date <b>August 14, 2007</b>

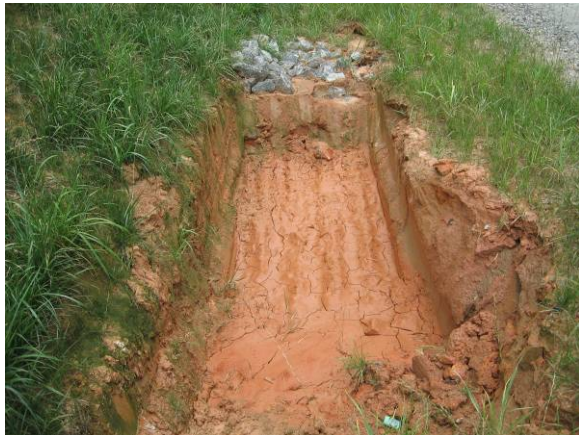
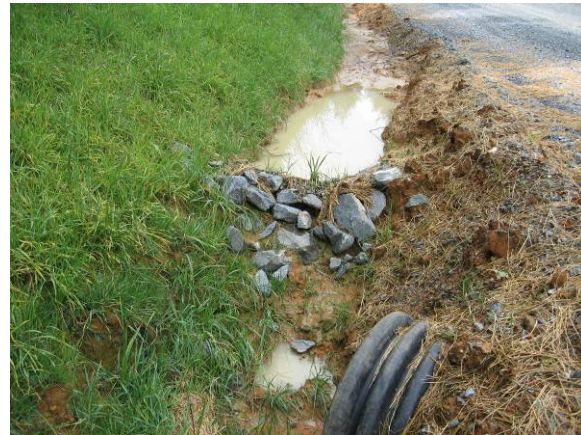
Figures 1 and 2. Examples of standard DOT BMPs.

The standard DOT BMPs found on these sites consisted primarily of small sediment basins (Temporary Sediment Basins – Type B) followed by rock check dams (Temporary Rock Silt Checks – Type B) located in the ditch channel, though at Steeltown and Fleming Chapel the entire ditch was also lined with Excelsior-brand erosion control blanket.

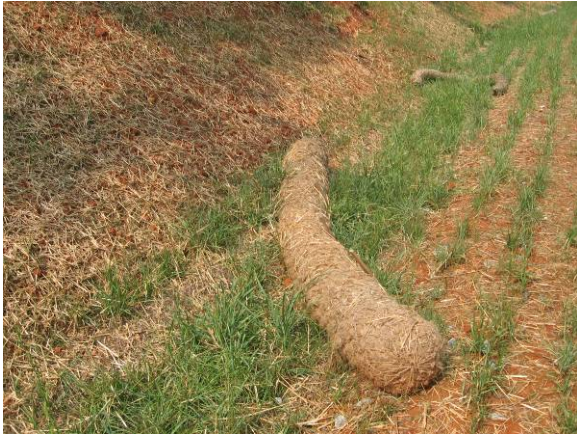
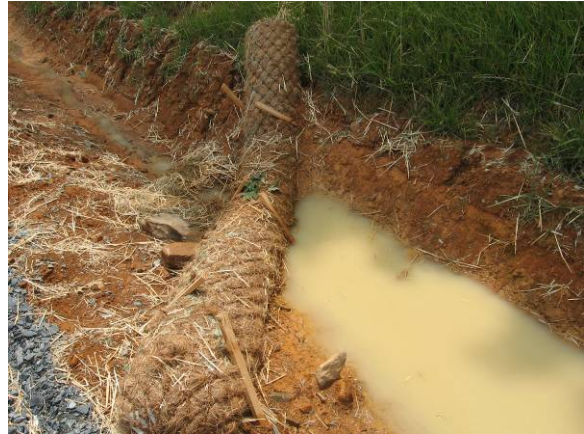
Figures 3 and 4. Examples of coir logs.

The largest and stiffest of the experimental types, the coir logs are made of woven coir fibers made from coconut husks. The logs used were 10' long and 12" diameter, costing around \$55 each. Approximately 5 of these logs were placed per experimental section at the Steeltown Rd and Curley Maple Rd sites. They were fairly difficult to manipulate, owing to their very stiff form, often resulting in inadequate surface contact with the bottom or sides of the ditch.

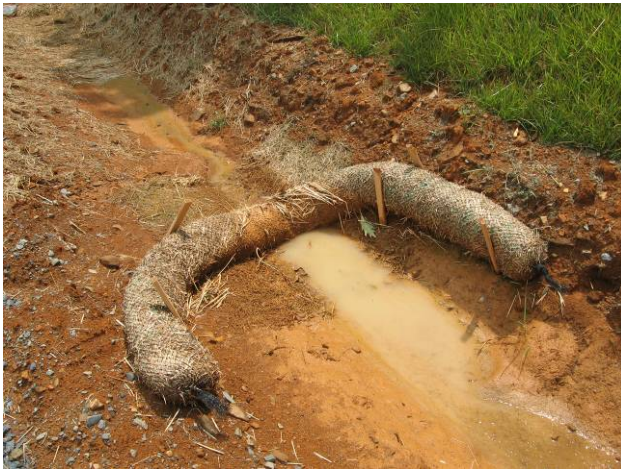
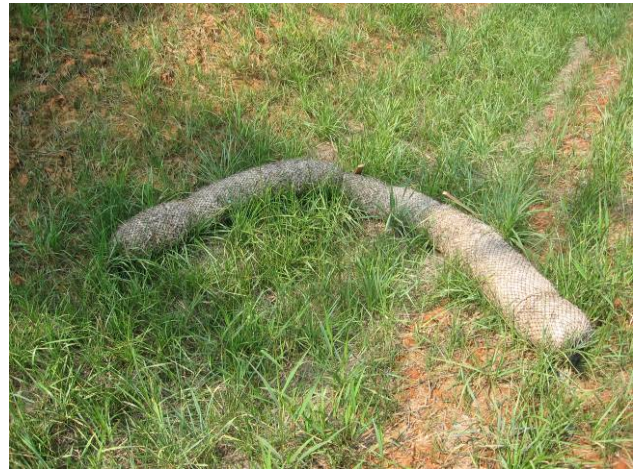
Figures 5 and 6. Examples of straw wattles.

Smaller, lighter, and more malleable than the coir logs, the straw wattles simply consist of straw packed into a plastic mesh casing. The wattles used were 10' long and 9" in diameter, costing around \$20 each. Approximately 15 of these wattles were placed per experimental section at the Steeltown Rd and Curley Maple Rd sites, where the coir logs were interspersed among them at even intervals. These wattles were very easy to manipulate and faster to install as compared to the coir logs.

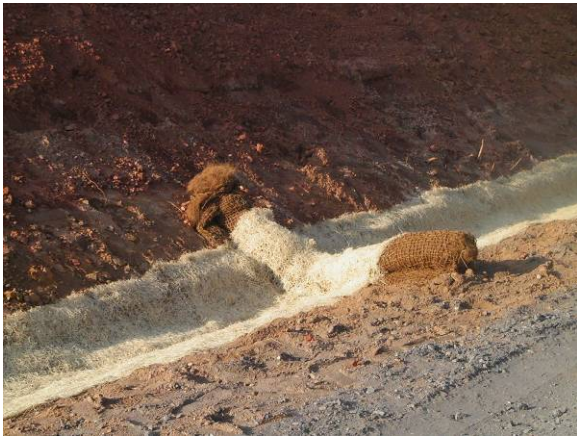
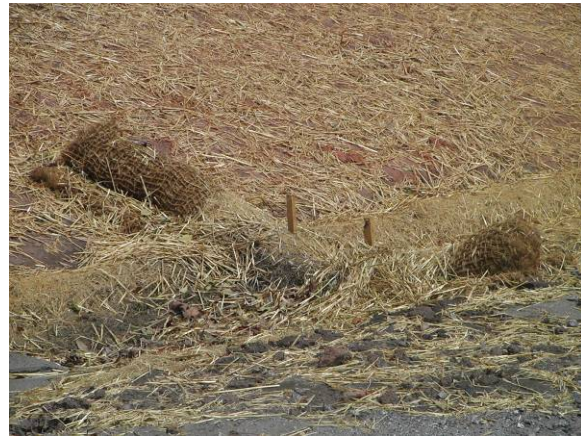
Figures 7 and 8. Examples of coir wattles.

These wattles were made of coir fibers like the coir log but were much smaller, lighter, and much less stiff than the coir logs. The wattles used were 6' long and were 6" and 9" in diameter (which were alternated during installation), but also had 1' wide 'wings' on the bottom to help secure them to the ground. They cost around \$25 each. These wattles were used exclusively in the experimental sections at the Fleming Chapel Rd site.

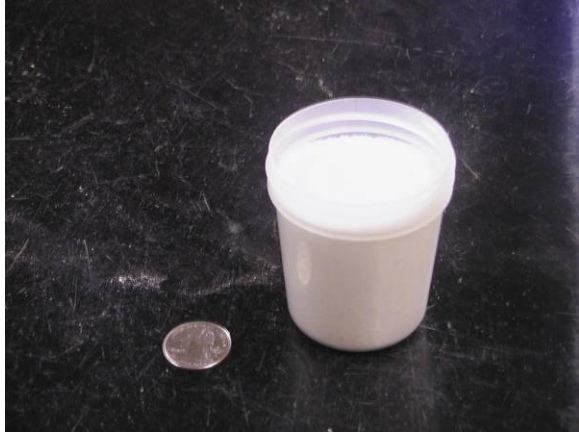
Additionally, for those sections that required it, 100 g of granulated PAM 705 was sprinkled over the lower, center portion of the wattle/log, so that when water flows over the top, it would mix into the runoff and begin to flocculate finer-sized sediment. This same amount of PAM was placed out after every major storm event, roughly once a month for these projects. The estimated cost of the PAM is about \$1.67 per 100 gram application.

Figure 9. 100g of granulated PAM 705.

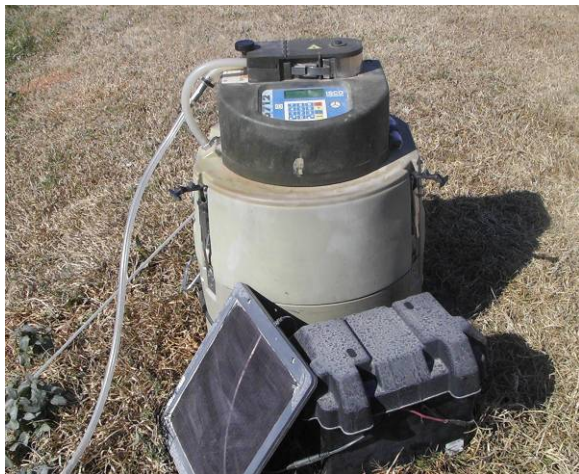
Runoff was collected by Teledyne ISCO brand 6712 portable water samplers programmed to collect samples after a set volume of water had passed. At Steeltown, they collected the samples from the front side of constructed weirs located at the end of each experimental section by the entrance to the discharge culvert. At Curley Maple, the samples were collected from the interior of the culverts themselves at the point of discharge off the site. At Fleming Chapel, samples were taken from small weirs that were placed over the discharge end of the culverts.

Figure 10. ISCO water sampler.

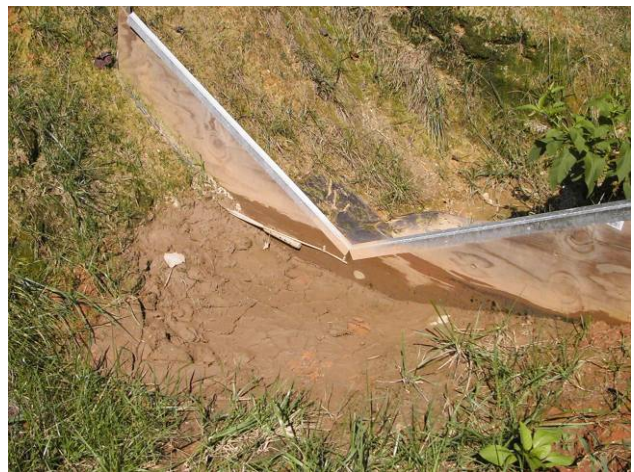
Figure 11. Weir at Steeltown Rd.

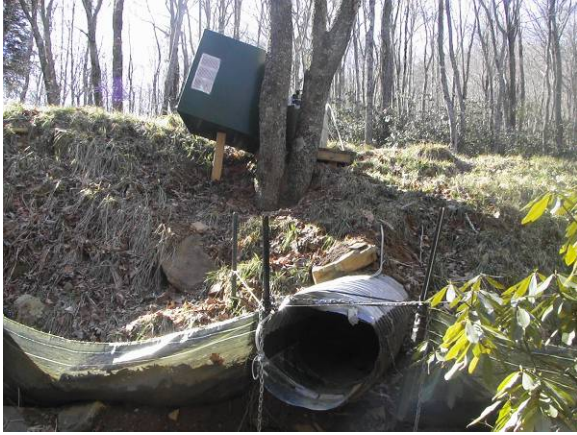
Figure 12. Pipe sampling at Curley Maple.

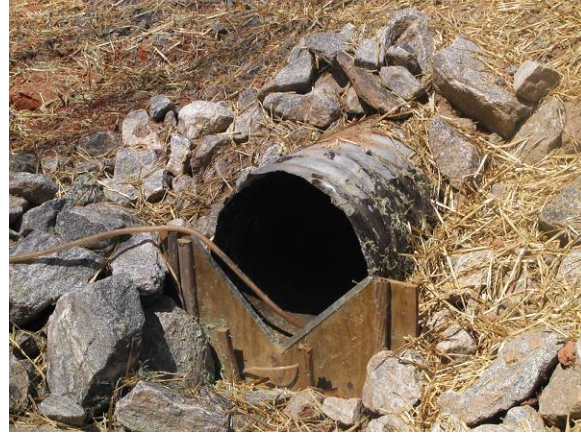
Figure 13. Weir at Fleming Chapel.

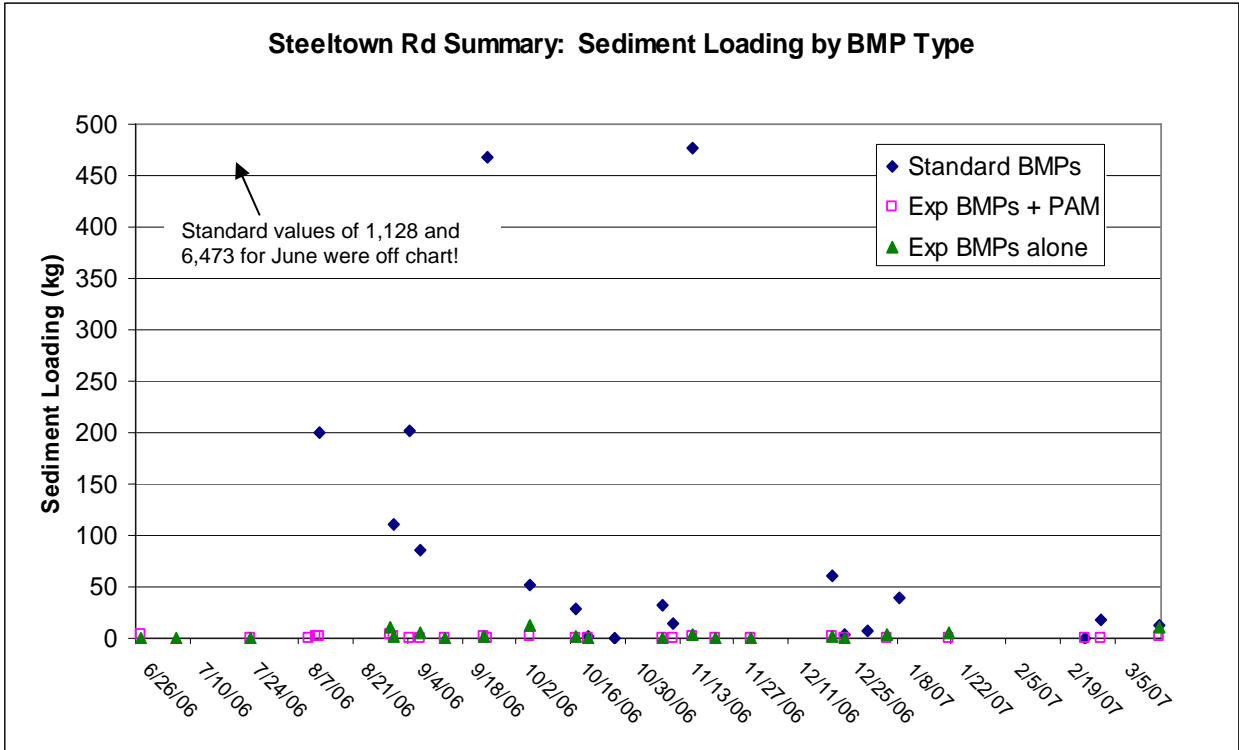
Figure 18. Steeltown Rd Summary: Sediment Loading by BMP Type.

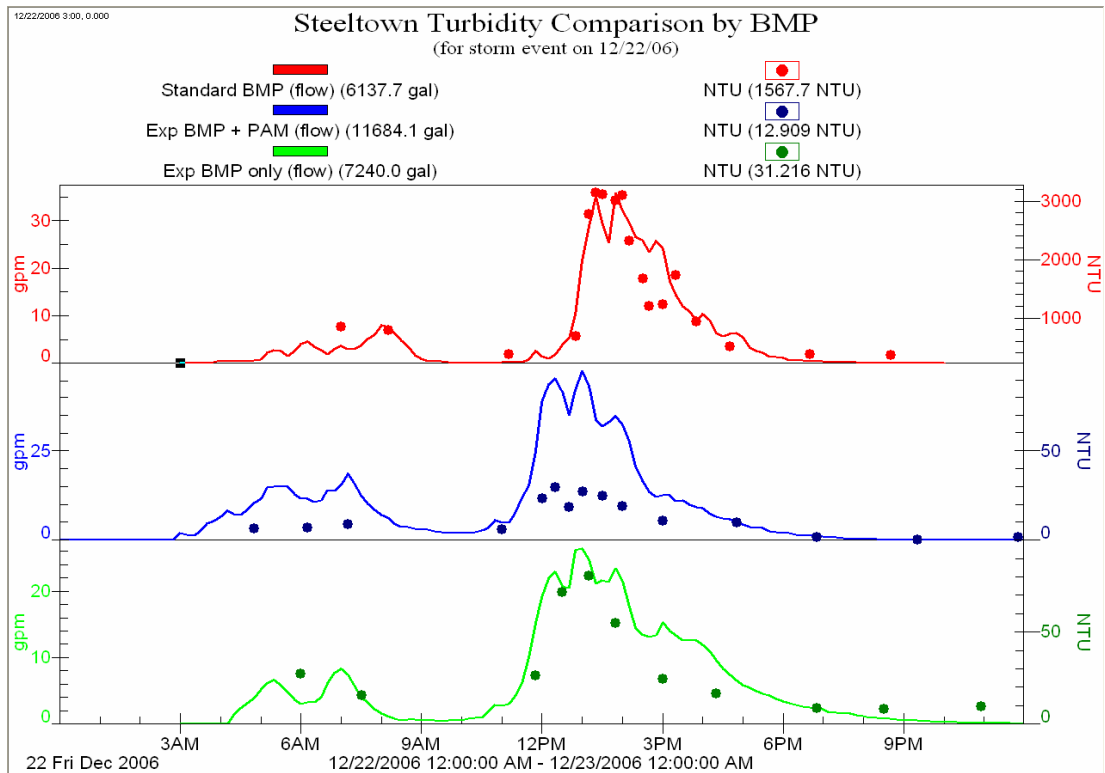
Figure 19. Sample Steeltown Rd Storm Event.

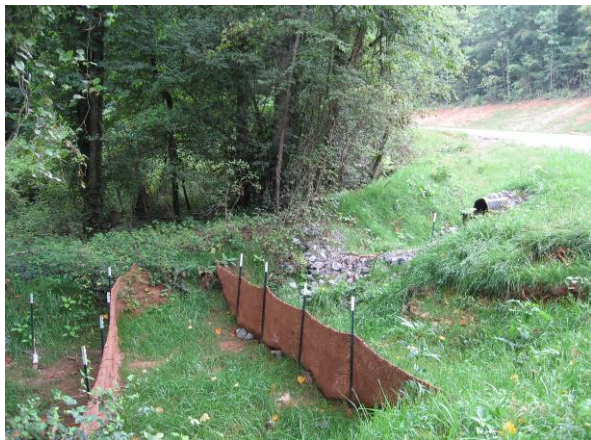
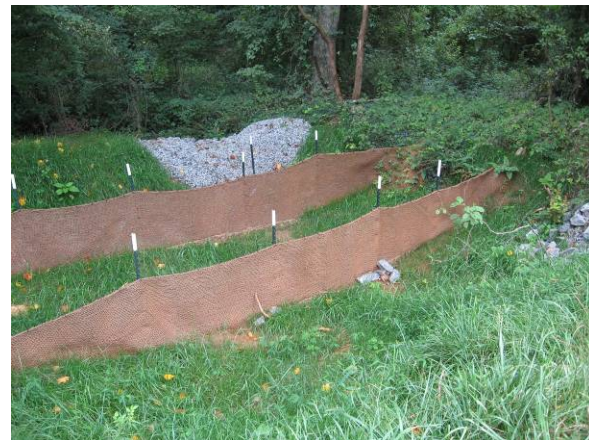
Figures 20 and 21. Steeltown Rd Basin.

A sediment trap was also located at the very bottom of the roadway section, complete with a separate small forebay and two rows of coir baffles in the main bay. It was intended to be used to study the effects of the baffles on water quality, but due to the awkward curve of the trap, a design quirk due strictly to unavoidable right-of-way constraints, the relatively small flow volume bypassed most of the baffle, instead just concentrating in a narrow channel to one side. As a result, it was abandoned for the original purpose, but the results are still interesting in comparison to the second experimental BMP section (without PAM), which discharged directly into the trap.

In evaluating the two sets of data, the trap outfall was considerably more turbid compared to the runoff flowing into the basin from the experimental BMP section. For the seven storms from which data was collected at both locations, we found an average increase in turbidity of 416 NTU as the water flowed through the trap. We did not determine flows from this basin so we did not calculate sediment losses.

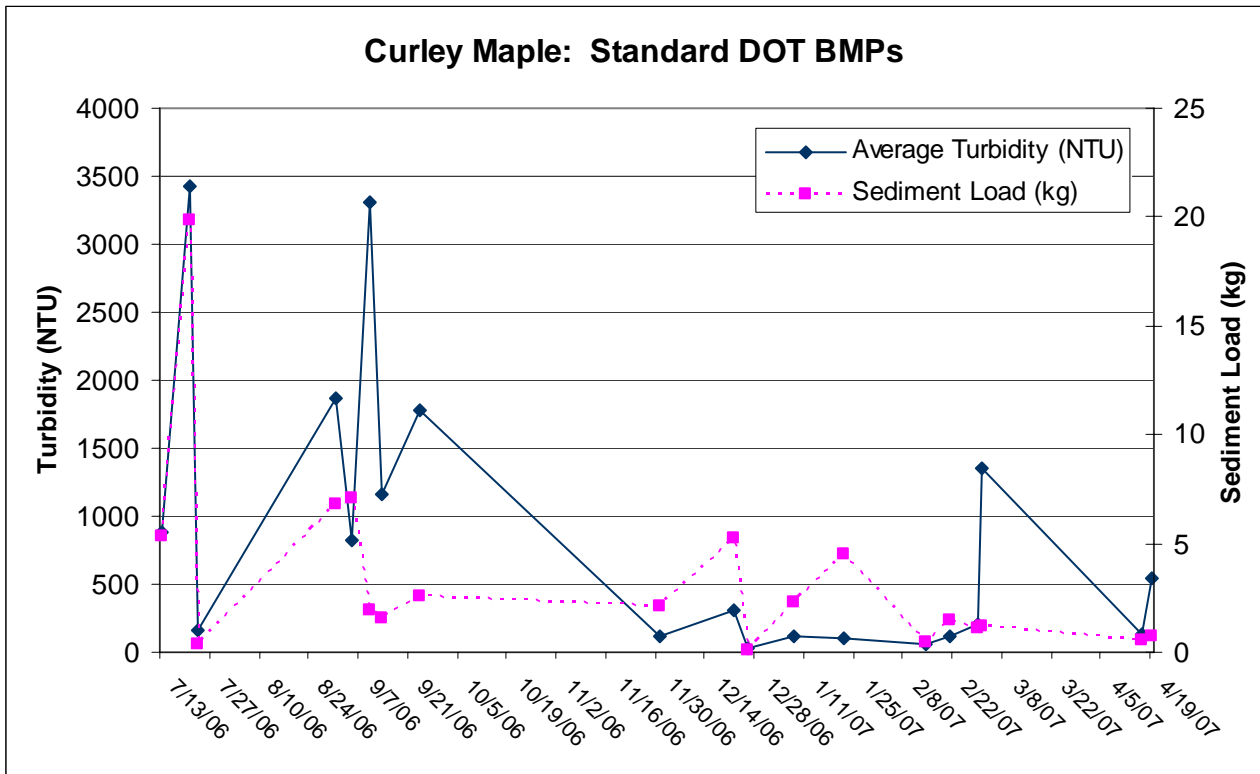
Figure 22. Curley Maple: Standard DOT BMPs.

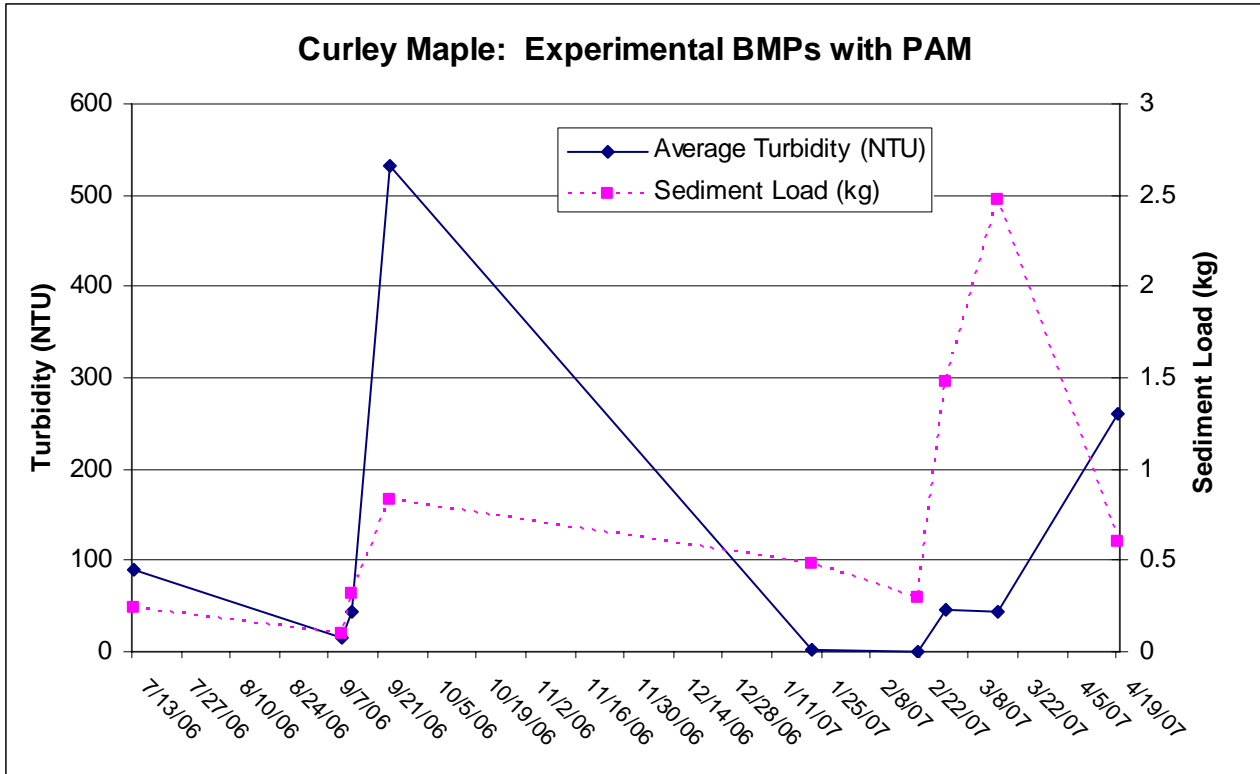
Figure 23. Curley Maple: Experimental BMPs with PAM.

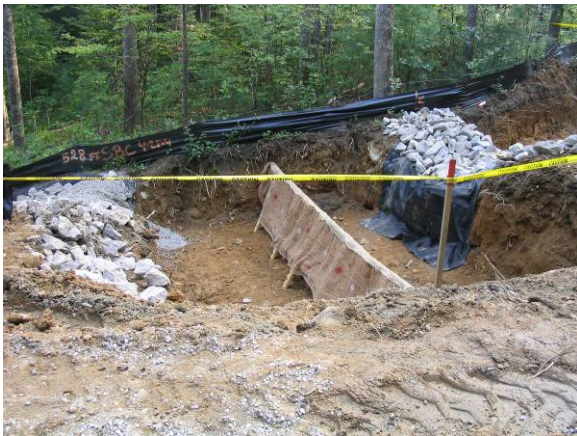
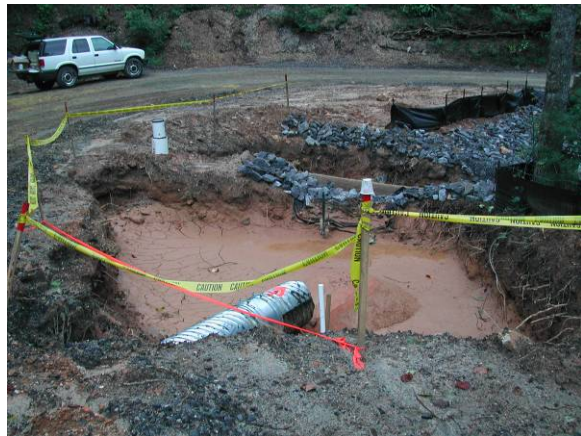
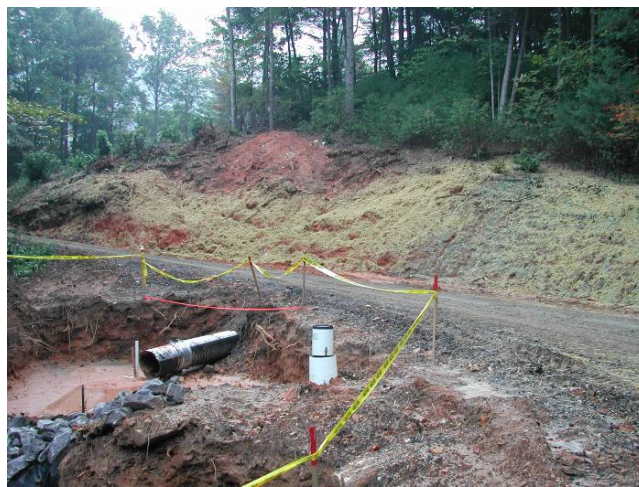
The Benge Ashe site was established in Sept. 2004 and consisted of a single, large sediment trap complete with a coir baffle (Figure A.1) and a sizeable forebay (Figure A.2). To collect the initial pre-construction background samples, an automated sampler was setup to capture runoff from the pipe discharging into the forebay, and single-stage samplers, commonly referred to as ‘bottles on a stick’ were placed at the outlets of both the forebay and main basin to look at sediment and turbidity differences within the basin itself.

Figures A.1, A.2, and A.3 above show the sediment trap design and adjacent slope at Benge Ashe.

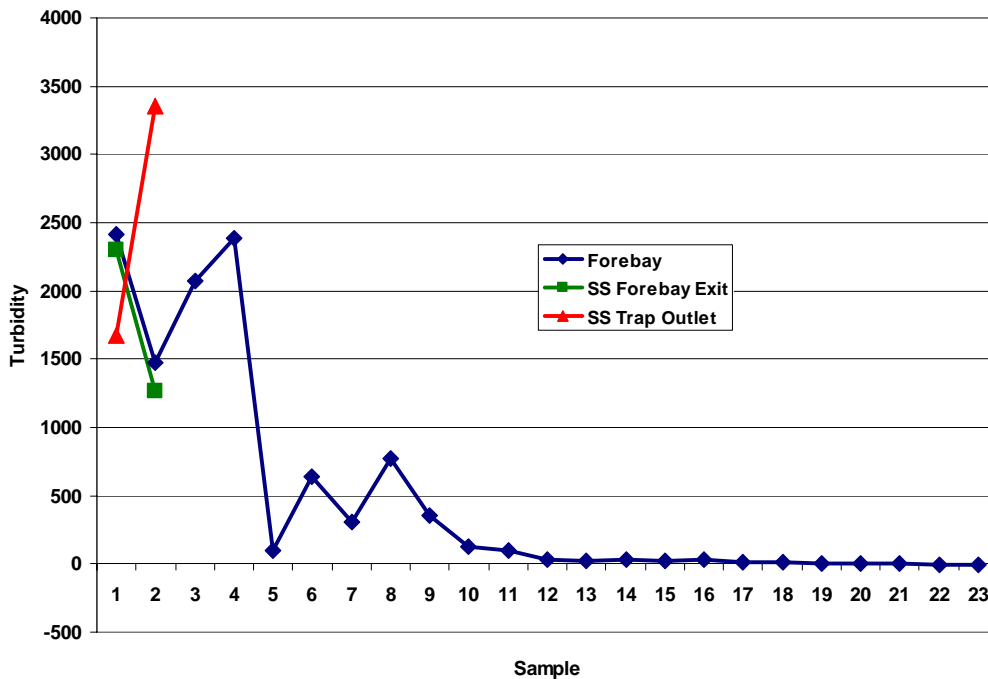
Results from storms from Sept. and Dec. (Figures A.4 through A.7) show how high the turbidities can get within the basin and at the outlet, with initial values ranging from 500 to almost 3,500 NTU! In the graphs below, the ‘in’ samples were those collected from the forebay, while the ‘out’ or ‘exit’ samples were those collected at the spillway, or exit, of main basin. The ‘lower’/‘bottom’, ‘middle’, and ‘upper’ designations refer to the bottles placement position on the post itself, thus they give us a snapshot of the turbidities present in the basin over the duration of the storm as the basin filled up with runoff. The summary graph for all six storms captured (Figure A.7) reveals a general pattern within the sediment trap. While the forebay often reduces turbidity somewhat from the very high initial values, the main basin does not appear to reduce the turbidity any further, in fact revealing consistent increases. However, the trap was effective in capturing sediment and in reducing the loading rates discharged out of the trap, it is only with regards to turbidity that it appears to have little important treatment effect.

Figure A.4. Benge Ashe Storm Turbidity for 9/20/2004

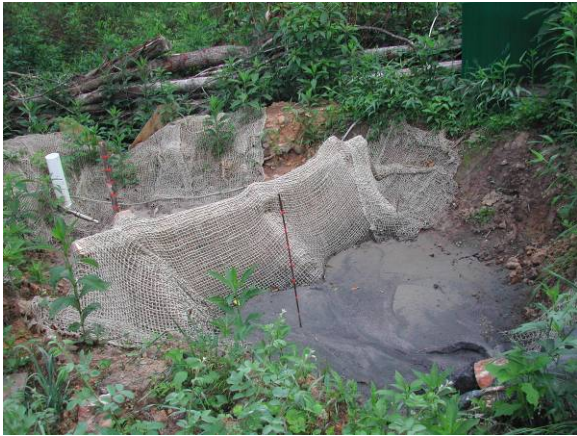
Figure A.10.

The Mulatto Mountain Rd site was monitored briefly from late 2004 to early 2005. This site consisted of a sediment trap with coir baffle (Figure A.10) as well as a second trap located a little farther downslope (Figure A.11). Automated water samplers were placed immediately adjacent to the road (Figures A.8 and A.9) and in both the traps to collect pre-construction background samples. However, samples in the traps ultimately proved quite difficult to capture here due to very high soil infiltration rates. For example, in the main trap (Figure A.10), the front of the coir baffle had a sizeable volume of sediment deposited on it, yet the rock spillway in the back was virtually clean and the sampler never recorded any runoff flowing overtop (and thus it captured no storm events).

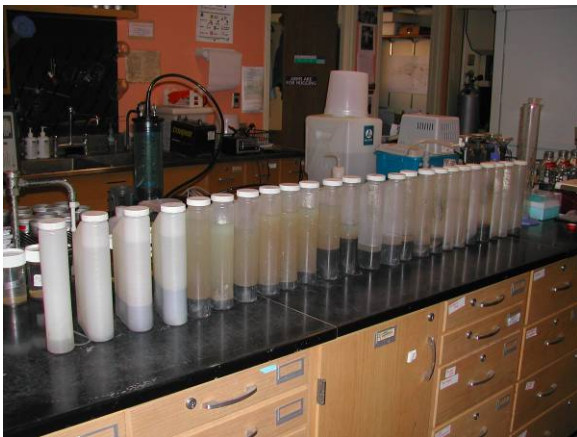
Figure A.12.

The road surface samples collected revealed that there is a very large sediment load coming off these unpaved roads. The sampler intake tubing was often clogged up before it completed a full sample load. A view of the sample bottles taken from one storm event (Figure A.12) show how for many of the bottles, there was actually more sediment than water. The results were similar for the four storm events captured (Figure A.13), each revealing high sediment loading rates, though the runoff from the Jan. storm was particularly rich in sediment.
