**Final Report**

**North Carolina Department of Transportation**

**Research project No. HWY-2005-22**

***Analysis and Testing of a Bridge Deck Reinforced  
With GFRP Rebars***

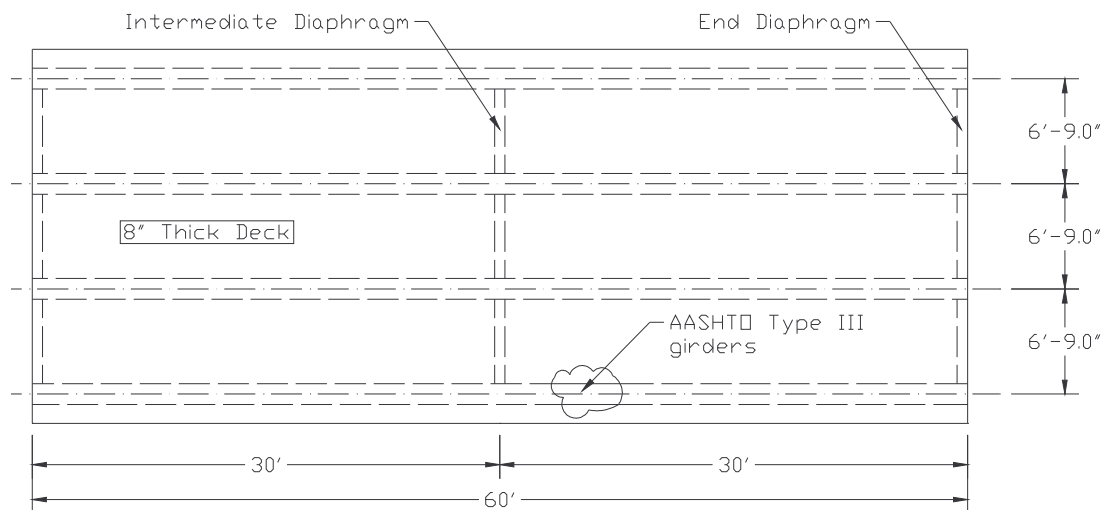
Figure 1.1 Plan View of Interior Span

A bridge in Macon County is currently being replaced by a bridge that will utilize GFRP rebars in the deck, instead of the more traditional epoxy coated steel rebars. The new bridge has two 50' exterior spans, and one 60' interior span. In this project the interior span of this bridge was investigated in more details (see Figure 1.1). The cross section of the bridge is composed by four AASHTO Type III prestressed girders and an 8" cast in place deck reinforced with GFRP rebars manufactured by Hughes Brothers (see Figure 1.2).

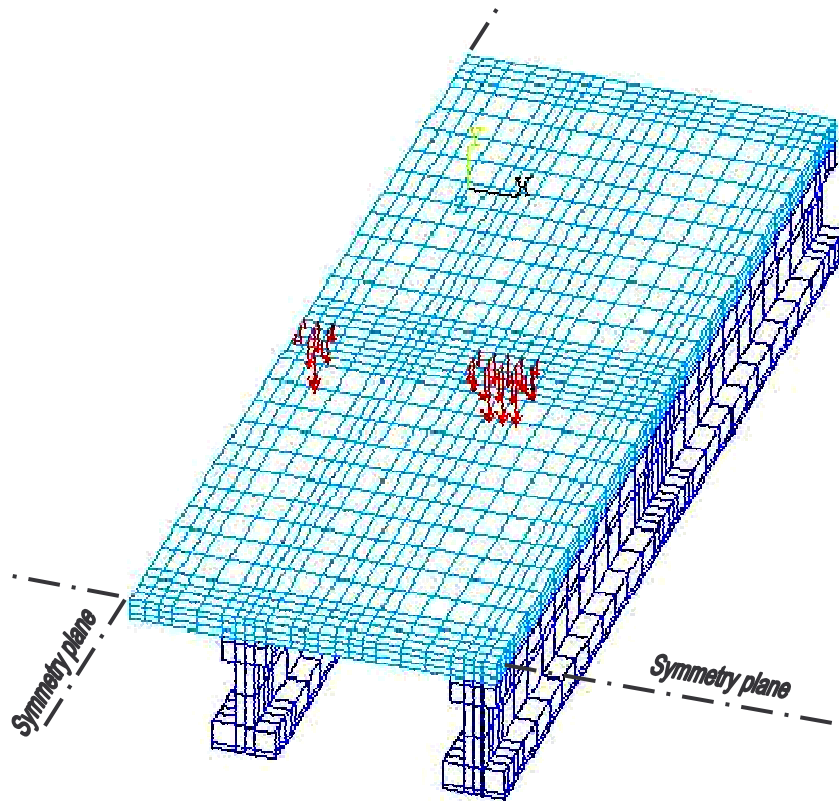
Figure 3.2 ANSYS Finite Element Model

The finite element model analyzed with the ANSYS software is presented in the Figure 3.2, and the batch input file is enclosed in the Appendix A.

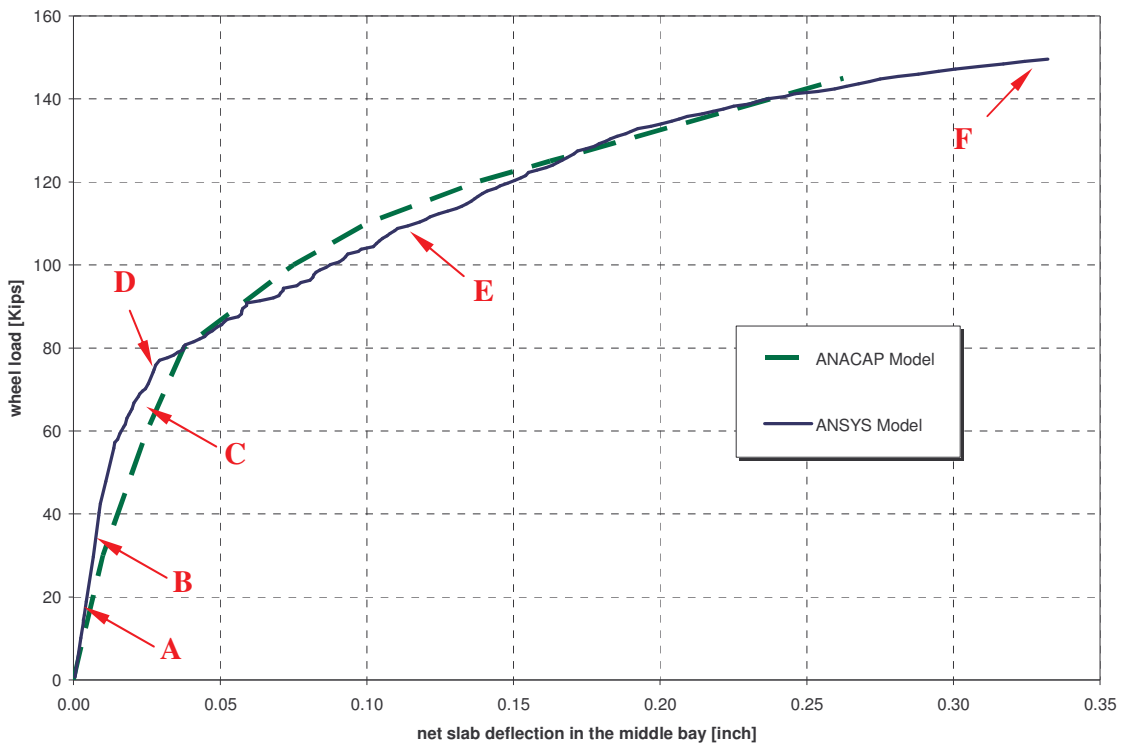
Figure 3.4 Comparison of ANACAP and ANSYS Numerical Results

Hassan and Rizkalla (2004) terminated the numerical analysis when the punching shear failure criterion developed by Kinnunen and Nylander (1960) was satisfied. Based on this, the punching load is determined when the circumferential compressive strain of the concrete reaches a critical value of 0.0019 in/in at a distance of  $B/2+y$  from the loaded area (see Figures 3.5 and 3.6); where  $B$  is the diameter of the idealized load area, and  $y$  is the location of centre of rotation of concrete wedges causing punching failure, which can be approximated by  $0.1d$ , where  $d$  is the thickness of slab.

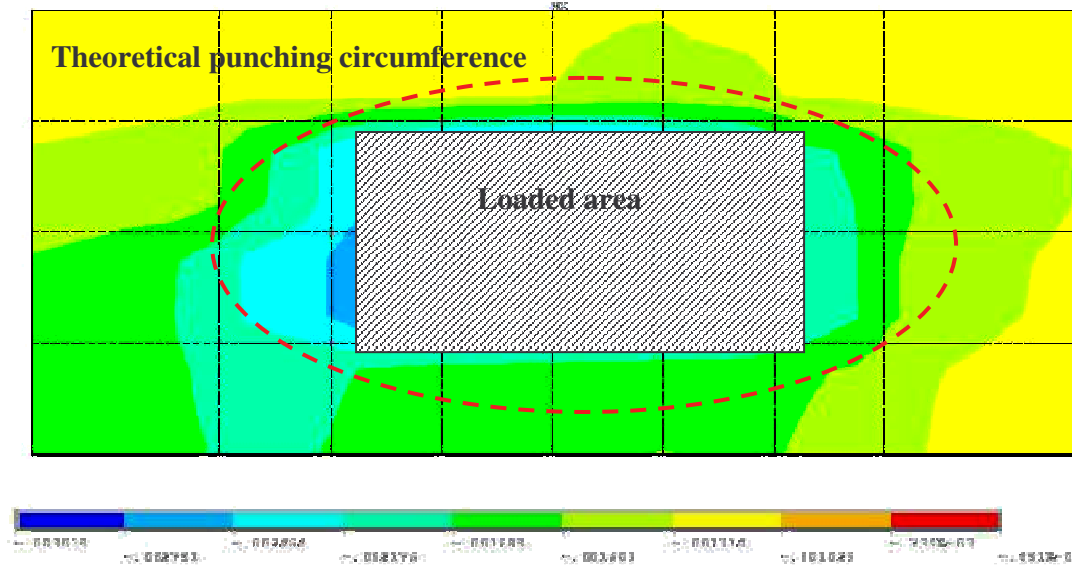
From Figure 3.7 it can be seen that the compressive strain values at the theoretical punching circumference are close to the value of 0.0019 in/in as recommended by Kinnunen and Nylander (1960).

Figure 3.7 Compression Strain Around Loaded Area

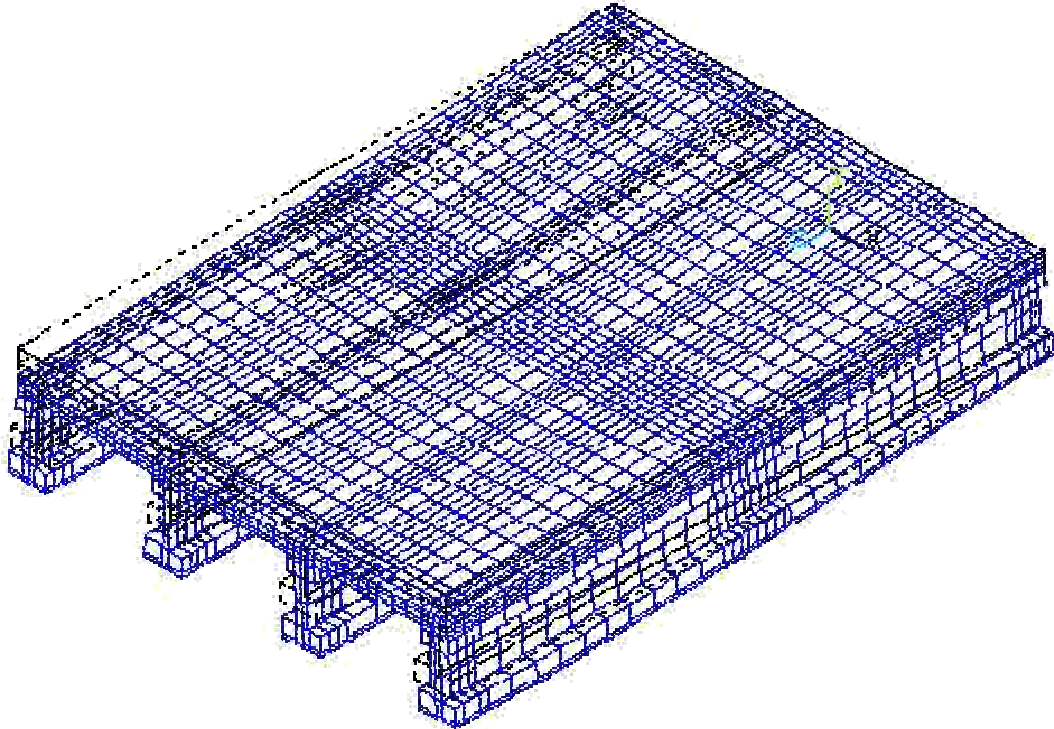
Figure 3.8 General View of the Deformed Shape (Half of the Bridge)

The following few figures are presented in order to illustrate the deformed shape of the structure and the cracking sequence under wheel loading. In Figures 3.8 and 3.9 the undeformed shape is represented by the dashed lines. In Figures 3.10 through 3.15 the cracking sequence is illustrated for the points A through F located on the load-displacement curve given in Figure 3.4.

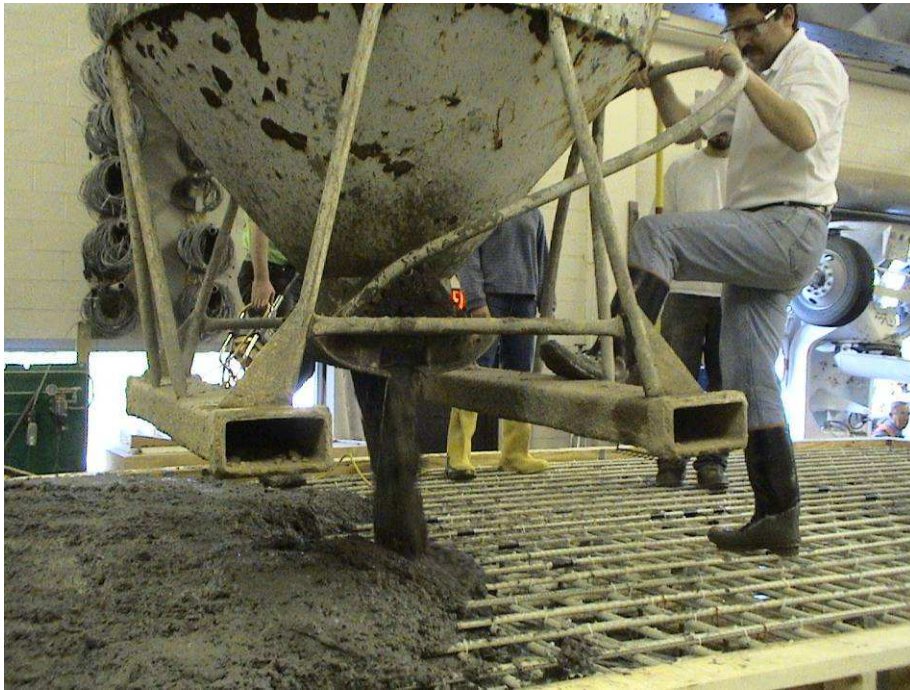
Figure 4.7 Concrete Placement for the Laboratory Deck Model

The approximate amount of concrete used was 6½ cubic yards. From this concrete batch, 4"x 8" cylinders were collected to later determine the compressive and tensile strengths. After finishing the surface, the deck was covered with plastic sheeting, and regularly sprayed with water. The lateral formwork was removed after 2 days, then the bottom forms at 8 days.

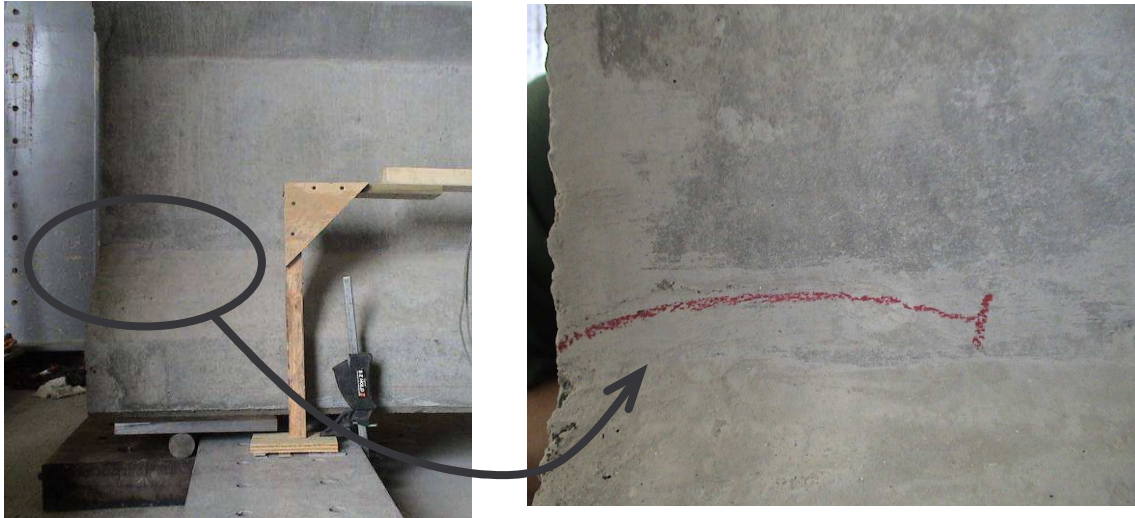
Figure 4.8 Initial Cracking in the Web of the Girder Ends

The Type III prestressed girders didn't satisfy the minimal shear reinforcement requirements for the girder ends. This, in addition by the short girder length (10'-10"), resulted in small cracks forming on the bottom part of the web (See Figure 4.8) after prestress release. A calculation based on AASHTO Standard Specifications for Highway Bridges (1998) proved the presence and extent of the cracks. In order to compensate for the required shear reinforcement, and to avoid a possible horizontal shear surface development, the girder ends were strengthened using carbon fiber reinforced polymer (CFRP) laminates (see Figure 4.9). Also, Figure 4.10 shows details of the strengthened girder-ends.

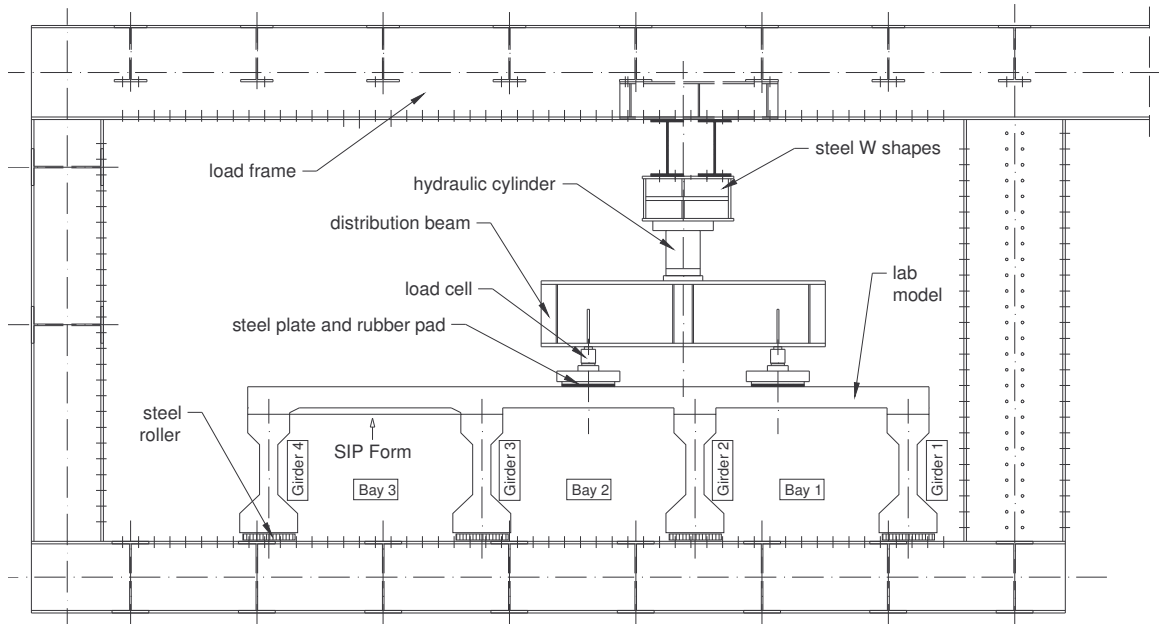
Figure 4.14 Experimental Setup for TEST 1

The load was applied in 50 Kips load steps until failure, and released to 0 Kips after each load step. The ultimate load reached was 155 Kips in the first bay, where the slab failed first. The load registered in the second bay was 170 Kips. See Figures 4.16 and 4.17 for the failure mode of the concrete deck.

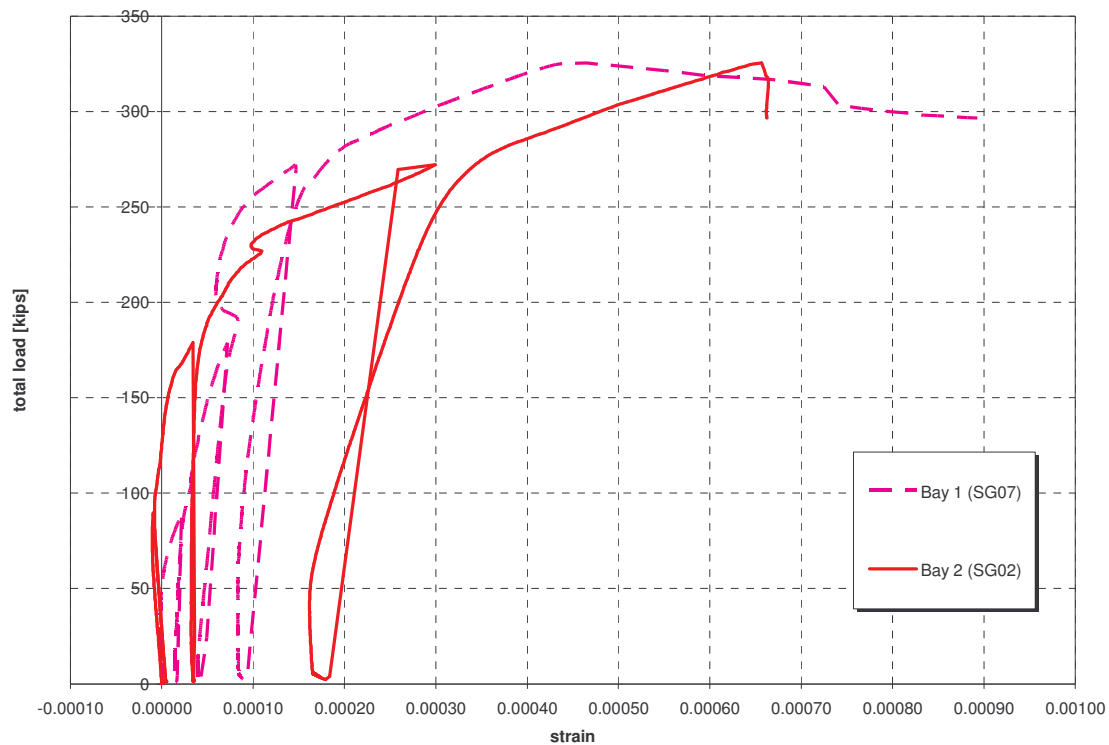
Figure 4.21 Longitudinal Strain in Top Reinforcement for Bays 1 and 2 (TEST 1)

The deformation was not restricted in the longitudinal direction. As a result, small tension was developed in the top reinforcement rebars (see Figure 4.21). However, in the transverse direction, the prestressed girders act like a support for the deck developing the arching effect. Consequently, compression strains are present in the top reinforcement rebars, as it can be seen from Figure 4.22. But this compression strain turns to tension after the crushing of the concrete under the loaded area and development of cracks over the girders. Tension strain is present in the bottom reinforcement layer in both directions (see Figures 4.23 and 4.24), also in the top reinforcement layer over the prestressed girders (see Figure 4.25).

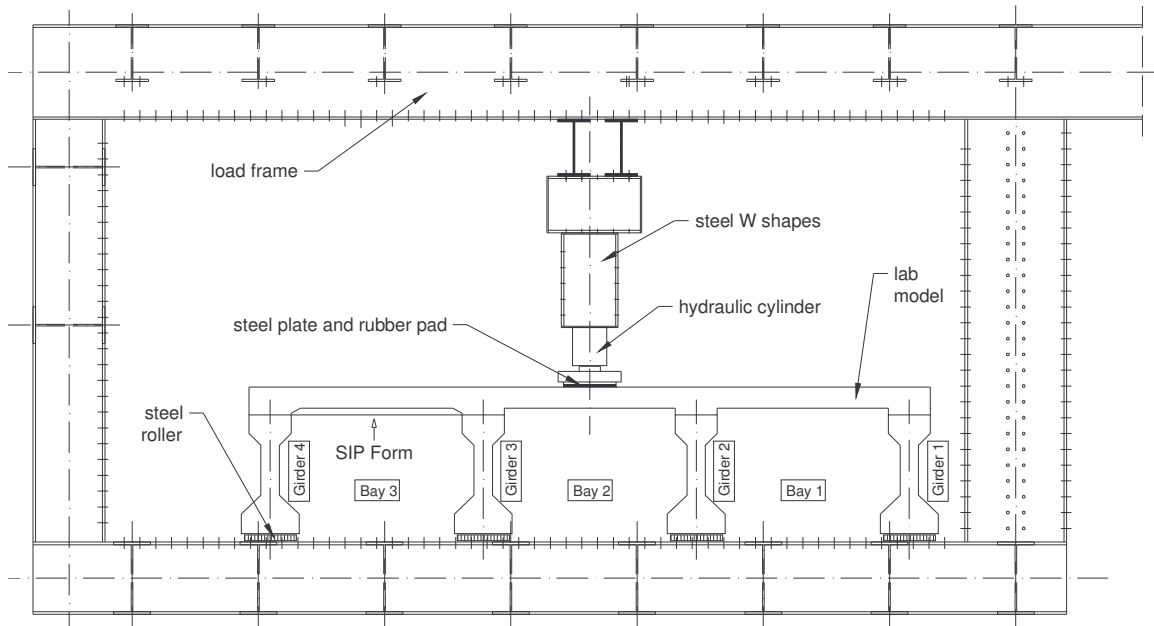
Figure 4.26 Experimental Setup for TEST 2

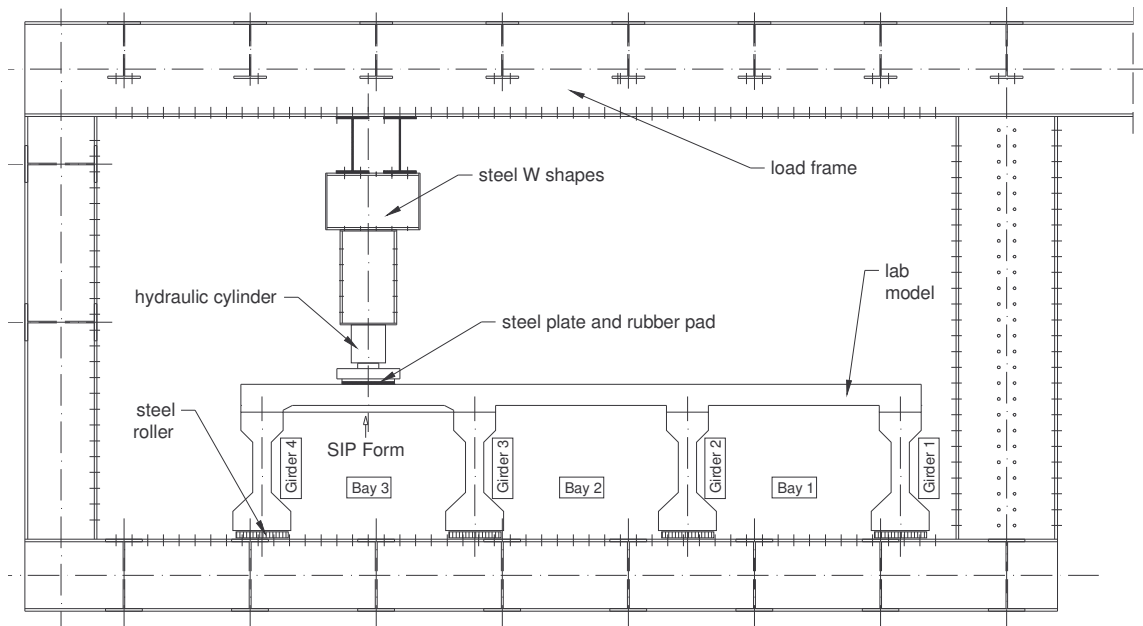
Figure 4.31 Experimental Setup for TEST 3

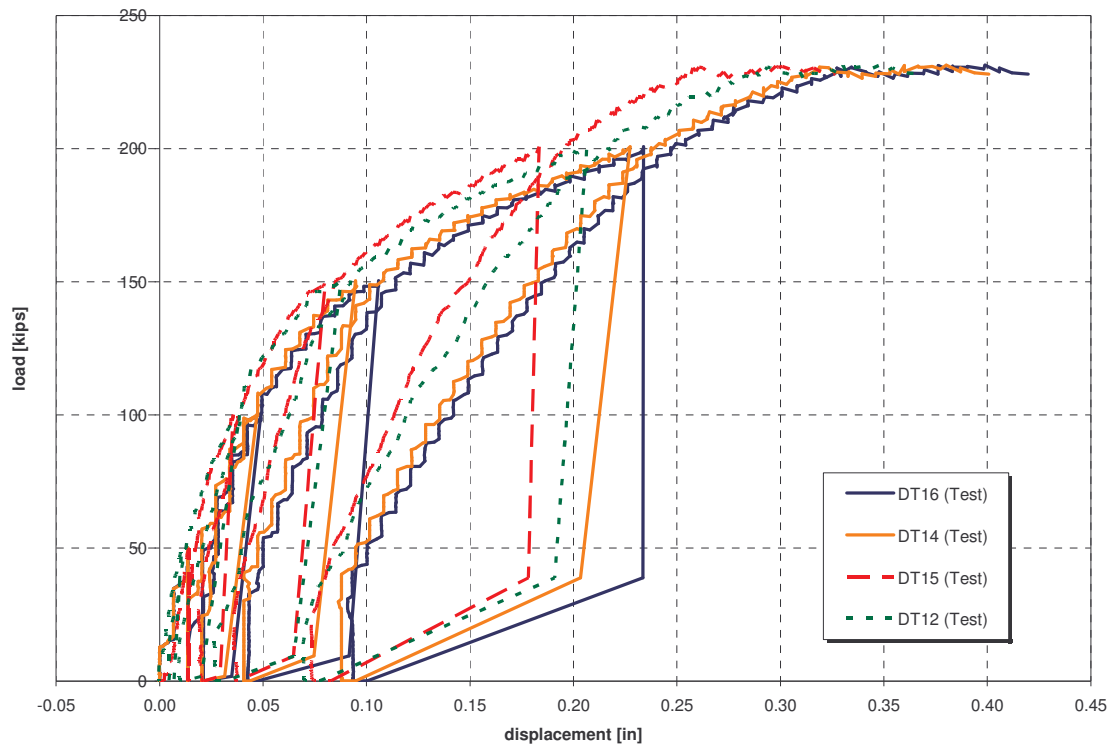
Figure 4.32 Displacements in Bay 3 (TEST 3)

The ultimate failure load was 232 Kips, and the failure mode was punching shear again. The variation of the global displacement of the deck, from under the loading area to the free edge of the Lab model is presented in Figure 4.32. As it can be seen, the displacements were about the same magnitude as in the two earlier test setups.

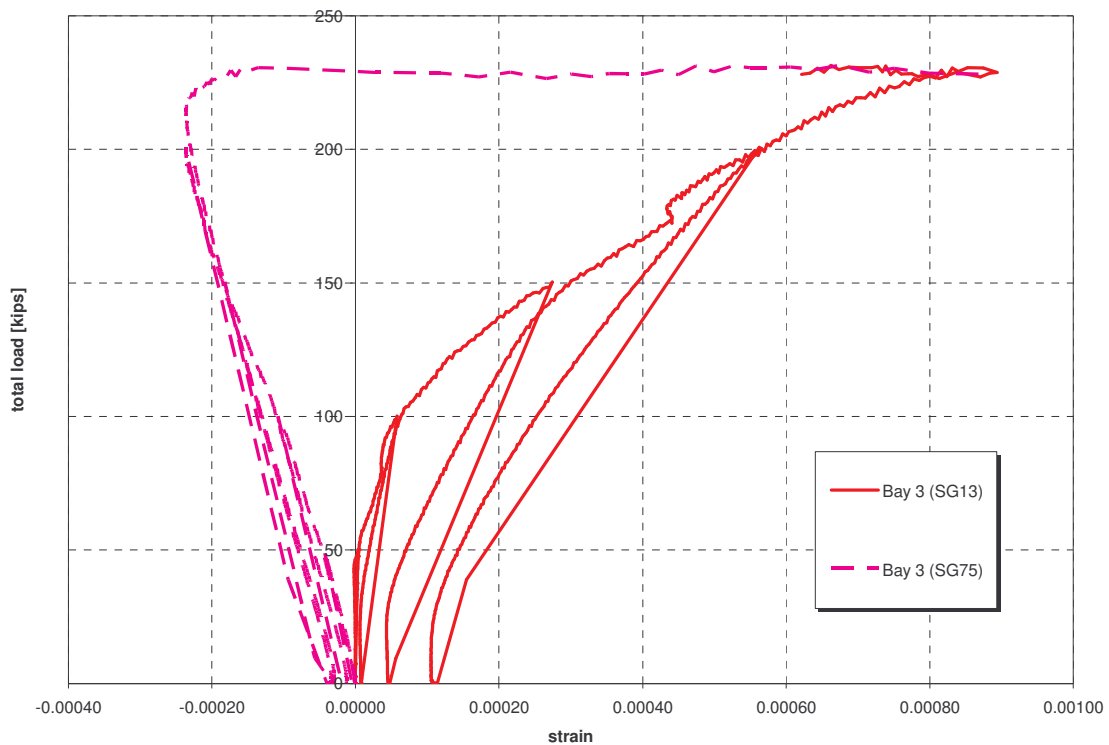
Figure 4.33 Transverse and Longitudinal Strain in Top Reinforcement (TEST 3)

The tension strain, in both transverse and longitudinal direction, in the bottom reinforcement layer was smaller then in the other two load cases. This occurred due to the presence of the SIP that acted as an extra reinforcement in the tension zone. The strain over the prestressed girders was at about the same level as in the two earlier test setups.

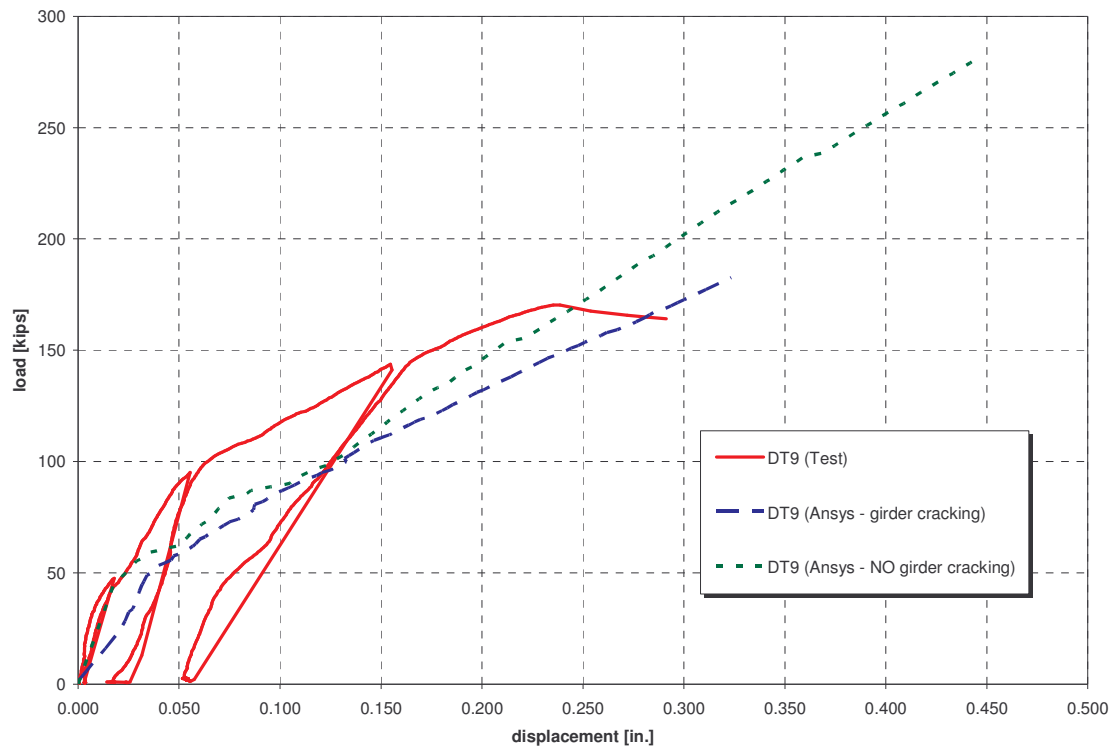
Figure 4.36 Effect of Allowing Cracking in the Prestressed Girders

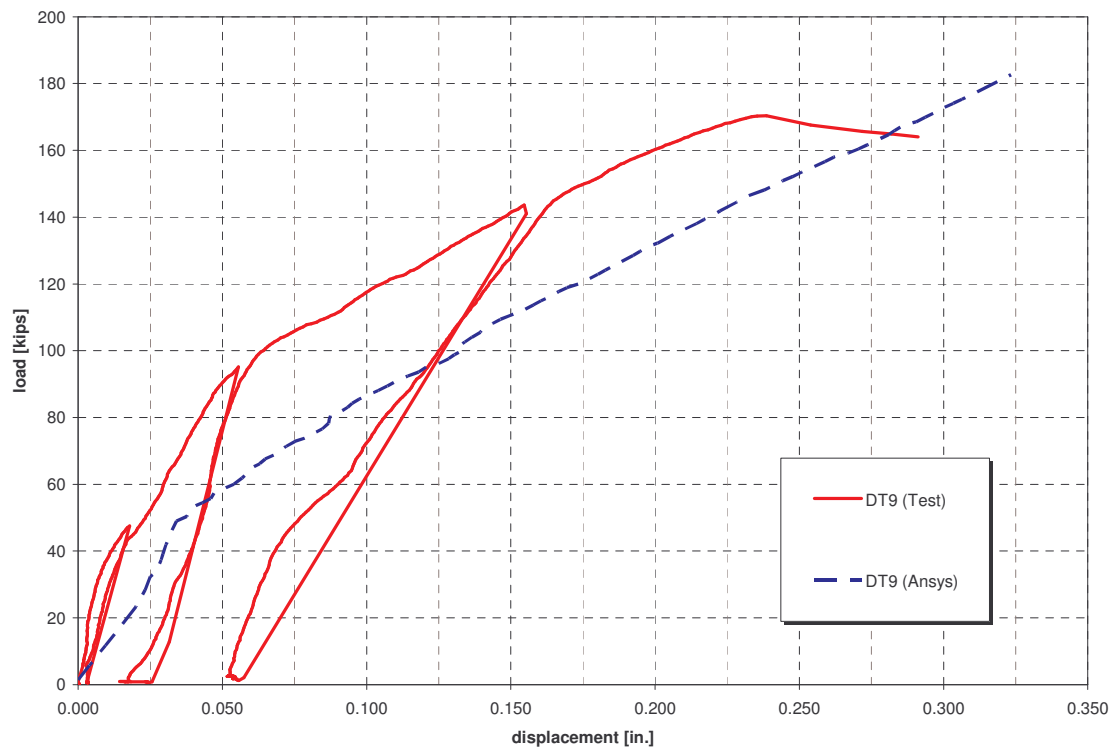
Figure 4.37 Test vs. Numerical Results for Deformation at Bay 1

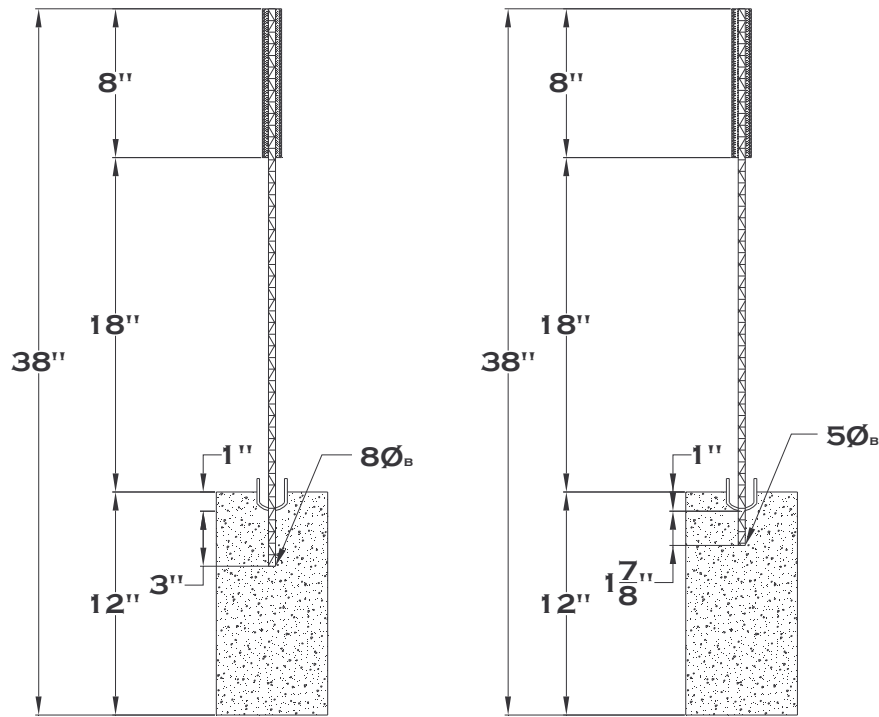
Figure 5.2 Bond-Slip Substrate Dimensions

Figure 5.2 shows a representation of the un-reinforced pullout specimen, where the anchorage system is an 8" (203.2 mm) steel pipe with expansive grout as the filler; the remaining 19" (483 mm) being exposed with no additional confinement around the GFRP bar. This test setup was used for the non-exposed specimens (dry conditions). The following section discusses the reasoning behind use of the reinforced specimen and the procedure implemented.

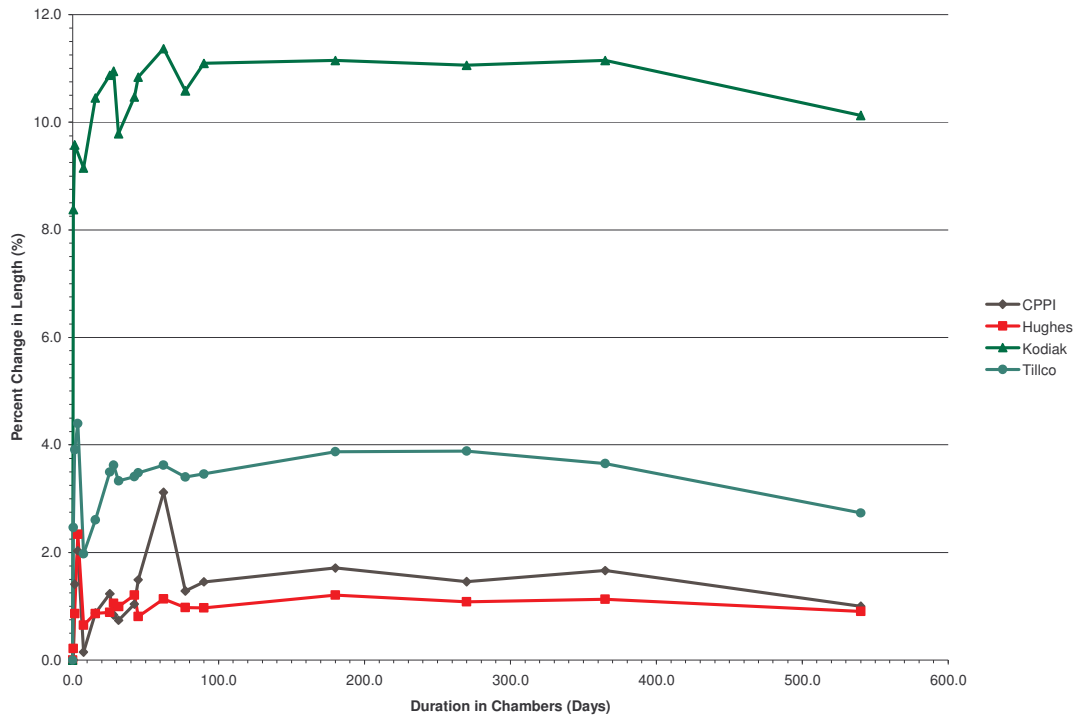
Figure 7.1 Extensional Effects Due to Moisture Uptake of Unscathed Specimens at Room Temperature

moisture uptake characteristics. The reason for some of the dramatic decreases in length changes could be due in part to the epoxy coating deteriorating at the ends. The other possibility could be due to the change and loss of material properties; this was especially true for the Kodiak rebars as further elaborated on in the following subsection.

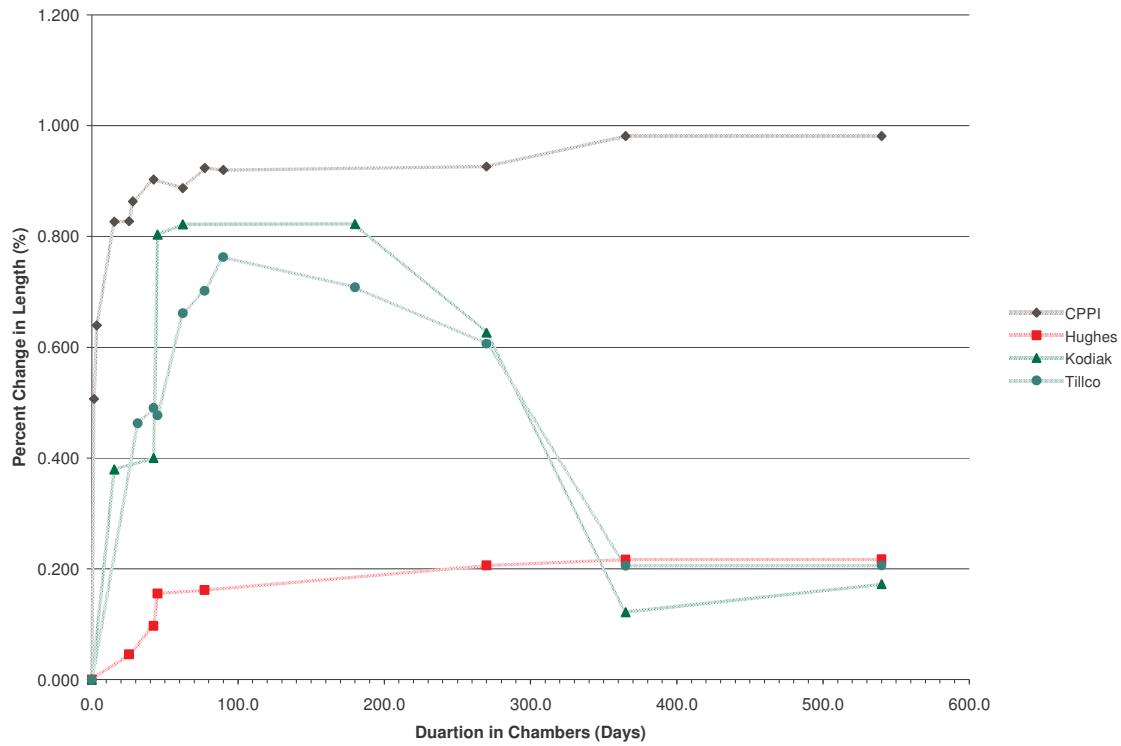
Figure 7.2 Extensional Effects Due to Moisture Uptake of Nicked Specimens at Room Temperature

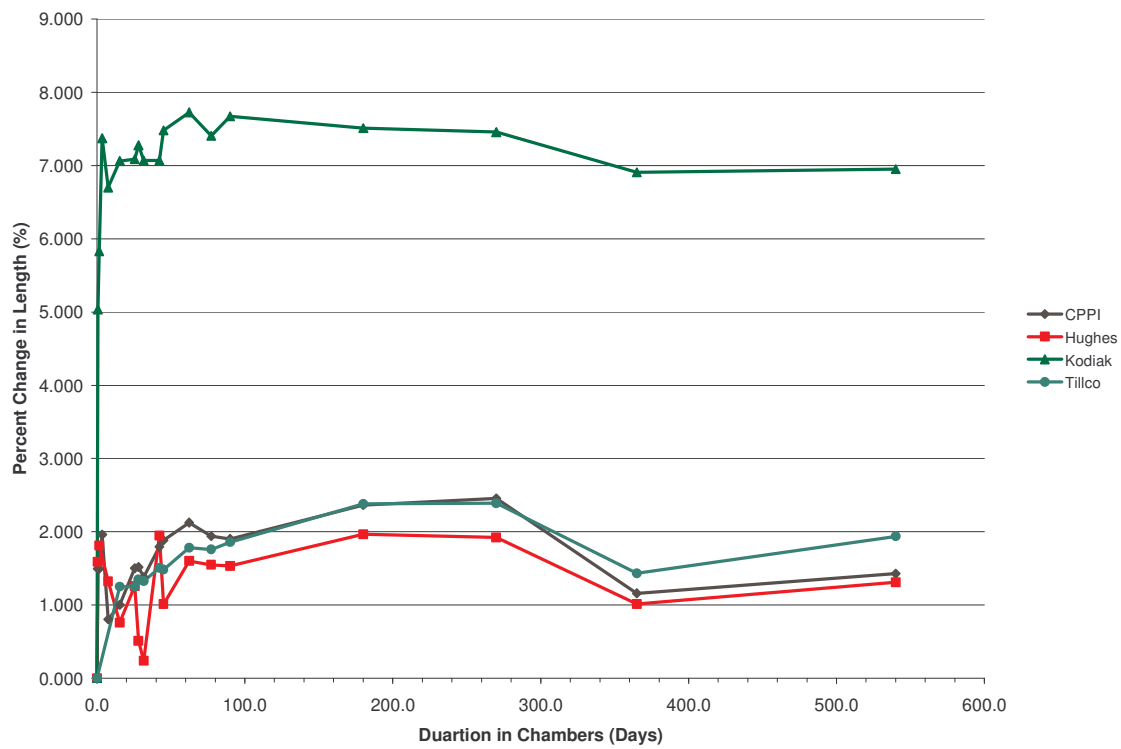
Figure 7.3 Extensional Effects Due to Moisture Uptake of Unscathed Specimens at 100°F

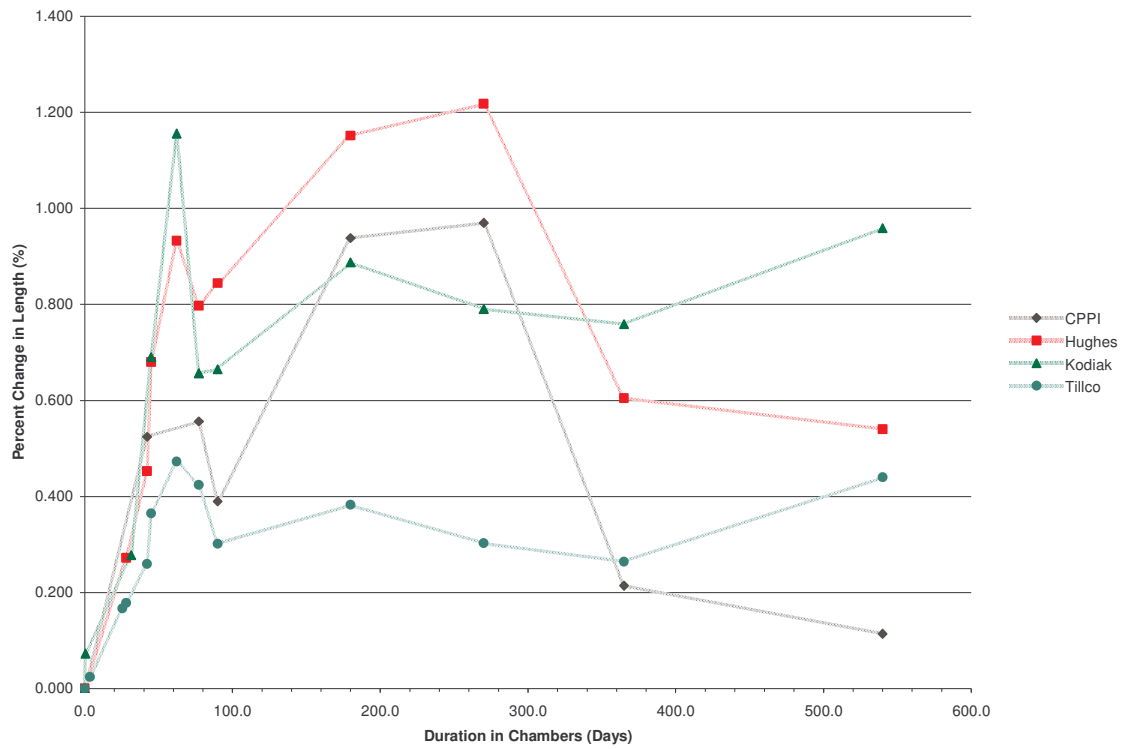
Figure 7.4 Extensional Effects Due to Moisture Uptake of Nicked Specimens at 100°F

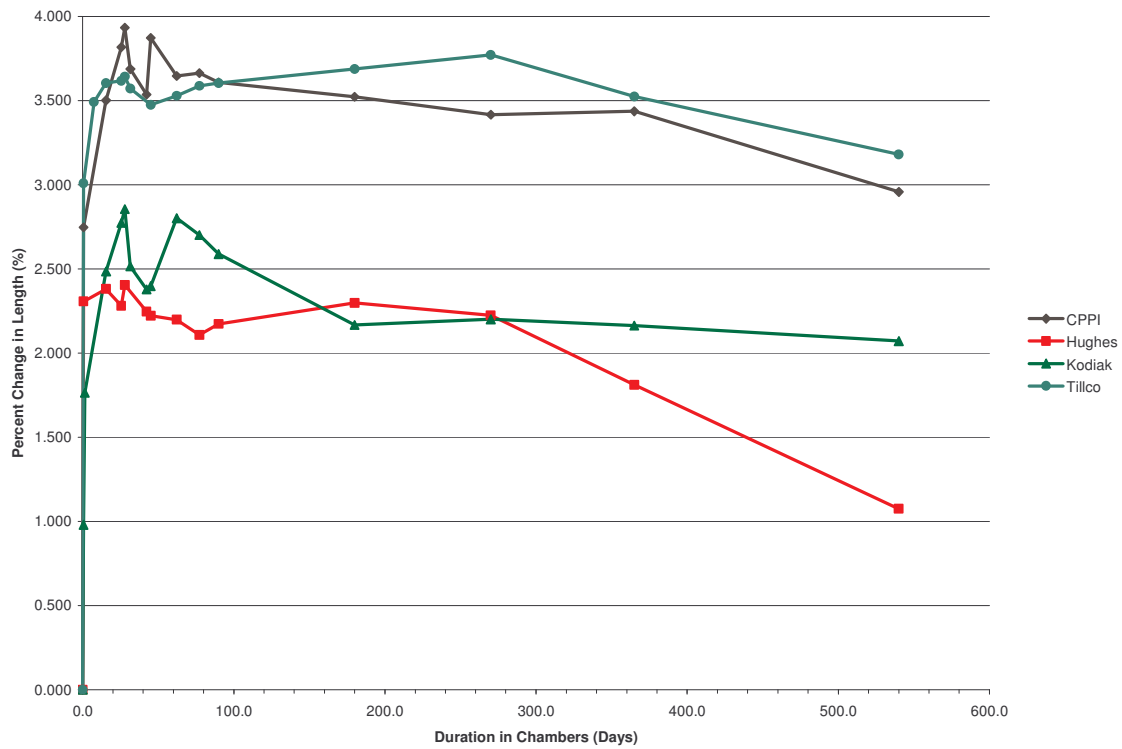
Figure 7.5 Extensional Effects Due to Moisture Uptake of Unscathed Specimens at 130°F

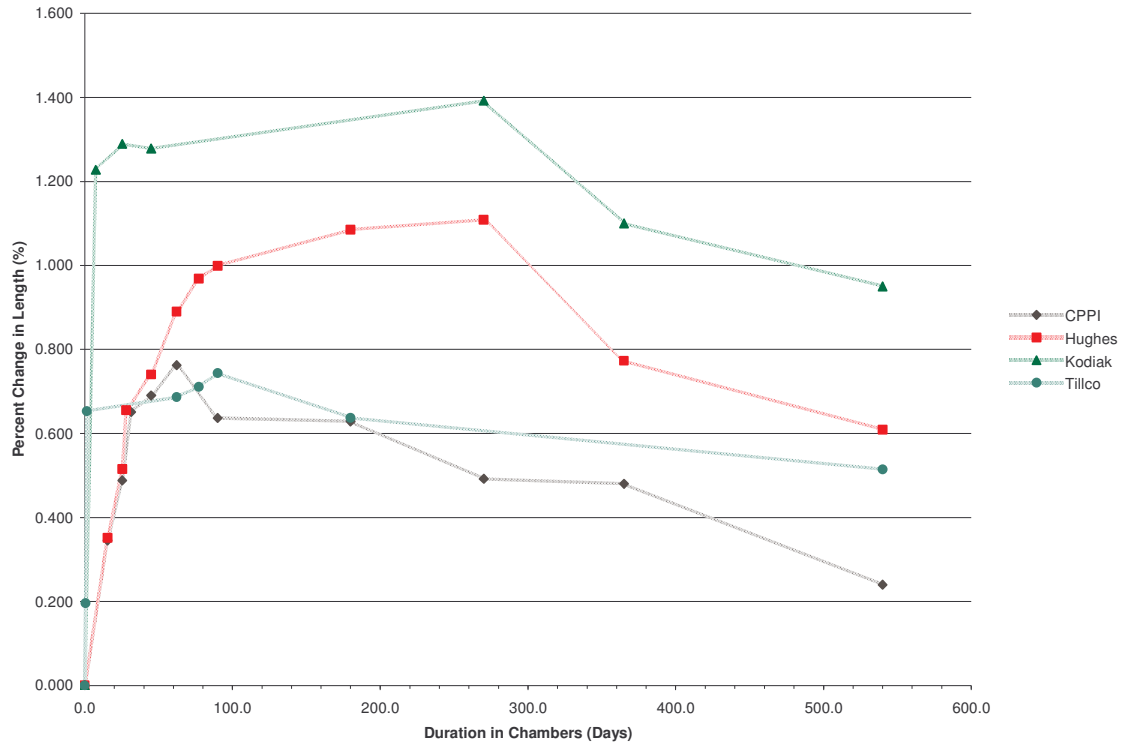
Figure 7.6 Extensional Effects Due to Moisture Uptake of Nicked Specimens at 130°F

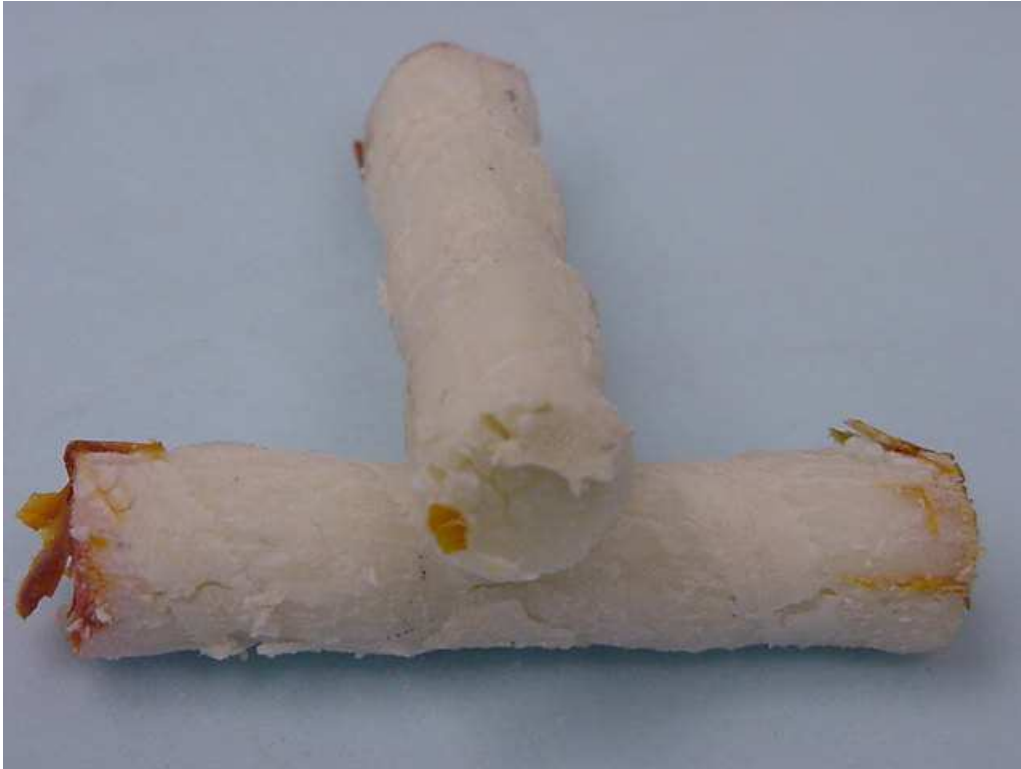
Figure 7.7 Kodiak 130°F Absorption Specimens at 9 Month Duration

In Figures 7.12 and 7.13, there is a dramatic increase in moisture absorption after the 90 day duration period. From observations at the 90 day duration, the Kodiak glass fibers were found to have debonded from the resin matrix allowing moisture to be absorbed in the exposed pores. The change in diameters is also accounted for because of the separation of the fibers from the resin, as compared to the dry samples. This observation is seen in Figure 7.7 correspondingly, as longitudinal cracks and failure of the helical wrap within the Kodiak specimen together with fiber debonding at the specimen ends.

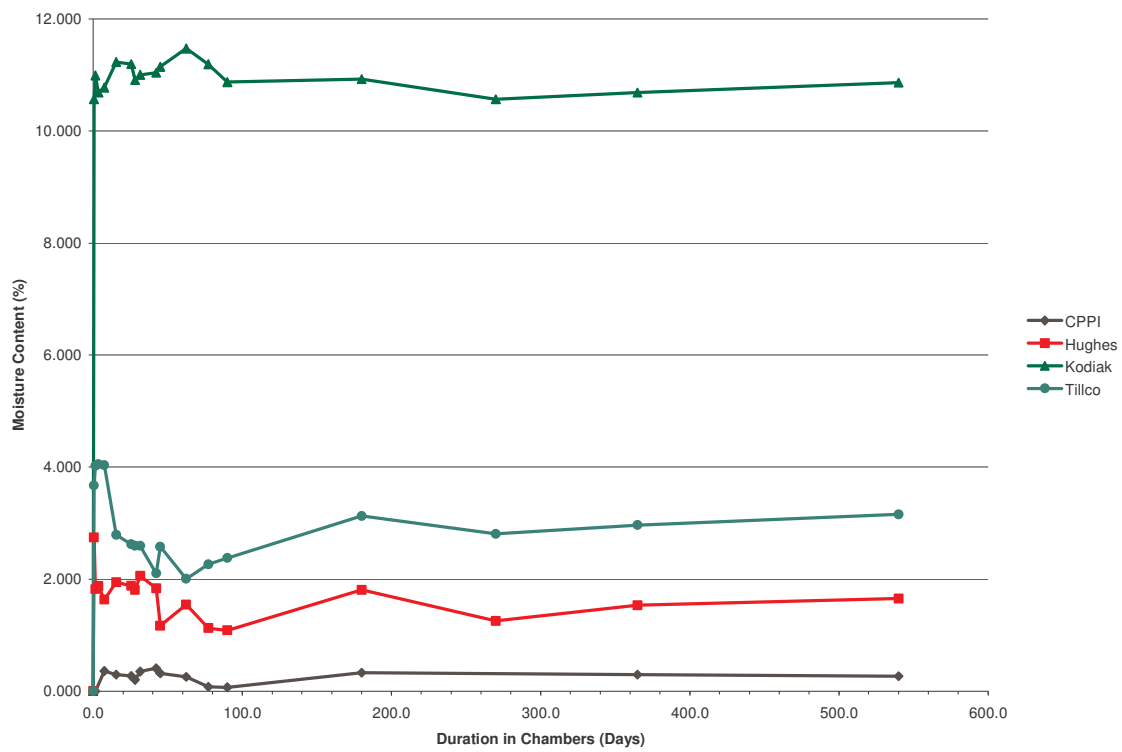
Figure 7.8 Weight-Based Effects Due to Moisture Uptake of Unscathed Specimens at Room Temperature

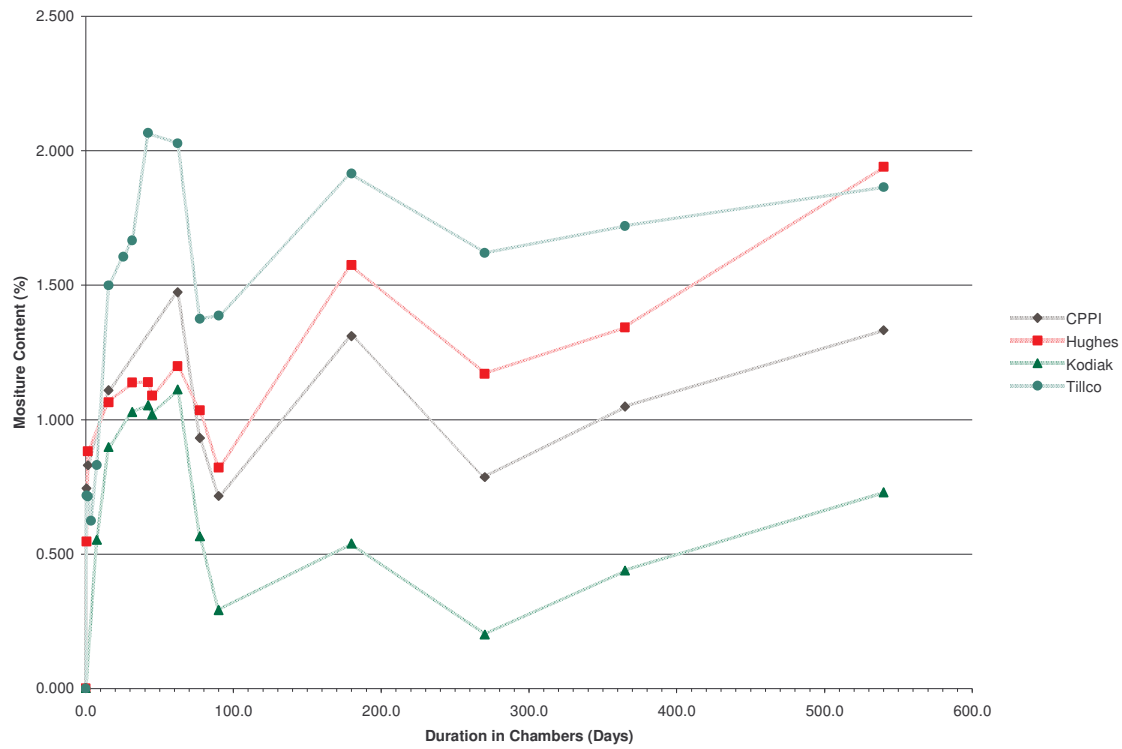
Figure 7.9 Weight-Based Effects Due to Moisture Uptake of Nicked Specimens at Room Temperature

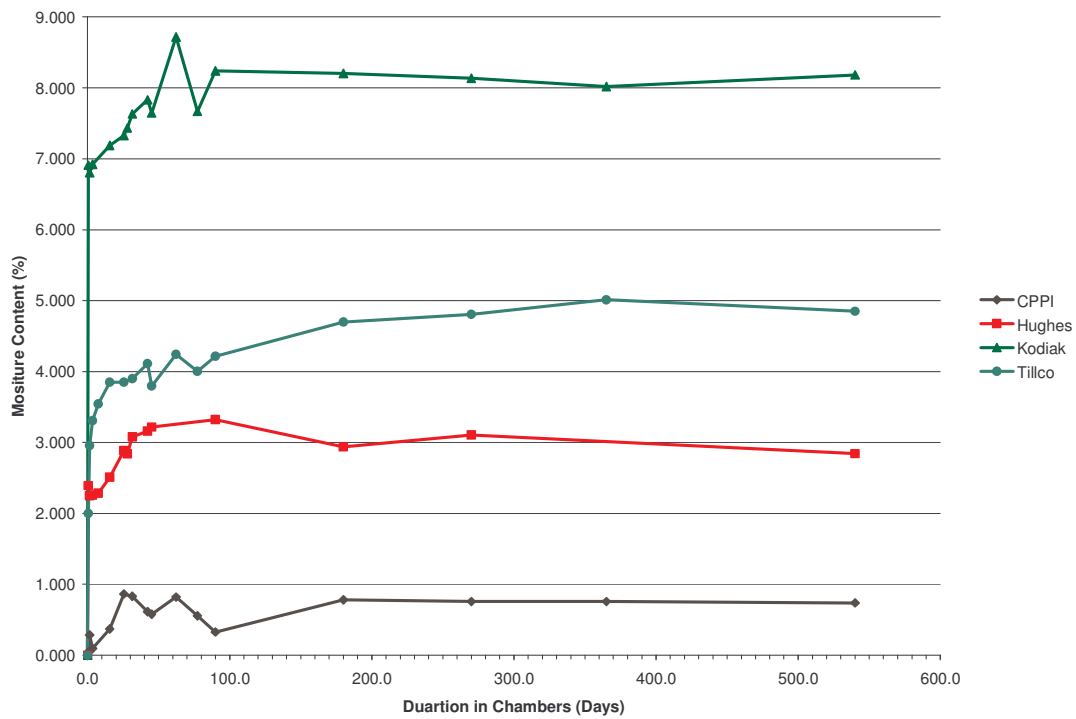
Figure 7.10 Weight-Based Effects Due to Moisture Uptake of Unscathed Specimens at 100°F

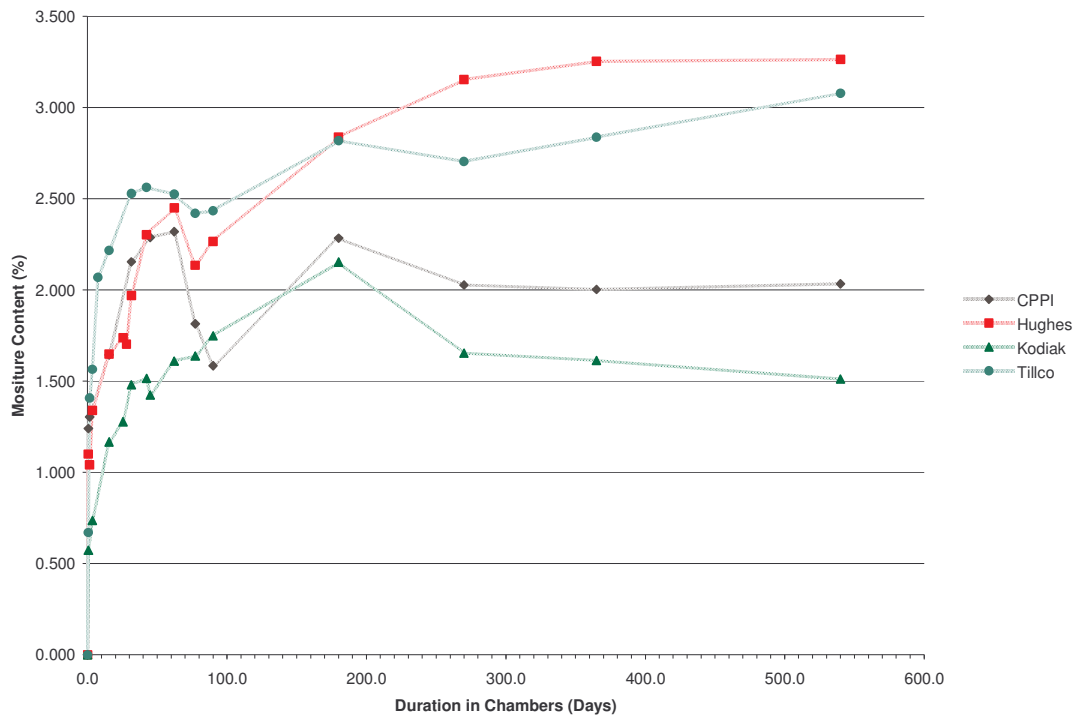
Figure 7.11 Weight-Based Effects Due to Moisture Uptake of Nicked Specimens at 100°F
