**Final Report**

**North Carolina Department of Transportation**

**Research project No. HWY-2005-22**

***Analysis and Testing of a Bridge Deck Reinforced  
With GFRP Rebars***

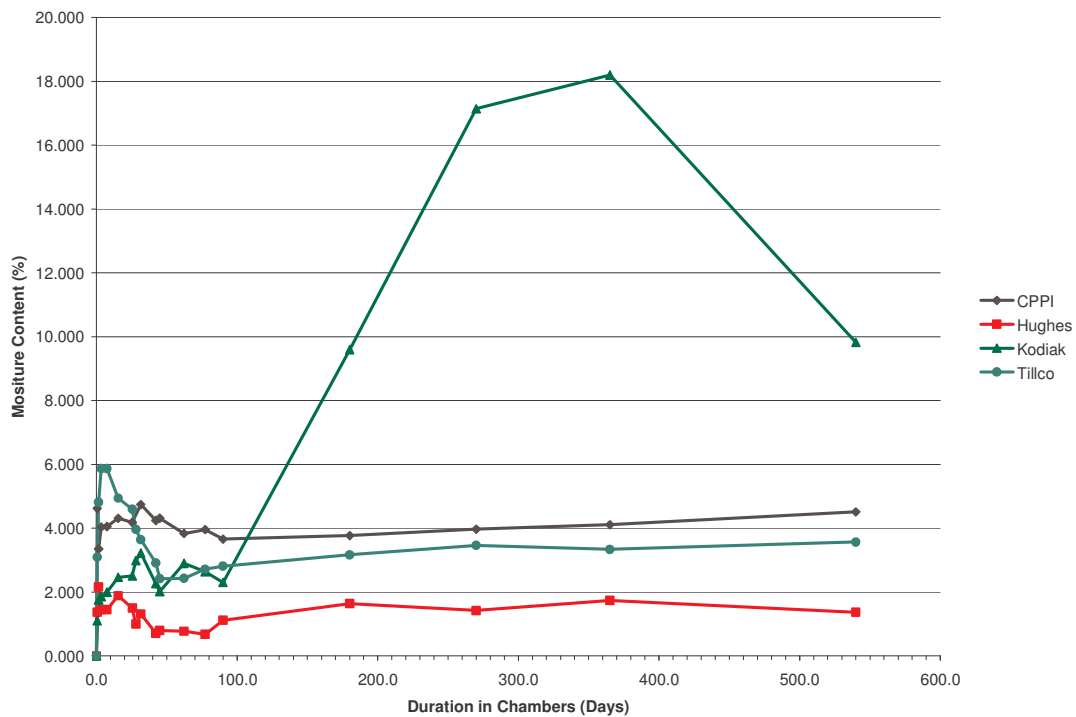
Figure 7.12 Weight-Based Effects Due to Moisture Uptake of Unscathed Specimens at 130°F

In Figures 7.12 and 7.13, there is a dramatic increase in moisture absorption after the 90 day duration period. From observations at the 90 day duration, the Kodiak glass fibers were found to have debonded from the resin matrix allowing moisture to be absorbed in the exposed pores. The change in diameters is also accounted for because of the separation of the fibers from the resin, as compared to the dry samples. This observation is seen in Figure 7.7 correspondingly, as longitudinal cracks and failure of the helical wrap within the Kodiak specimen together with fiber debonding at the specimen ends.

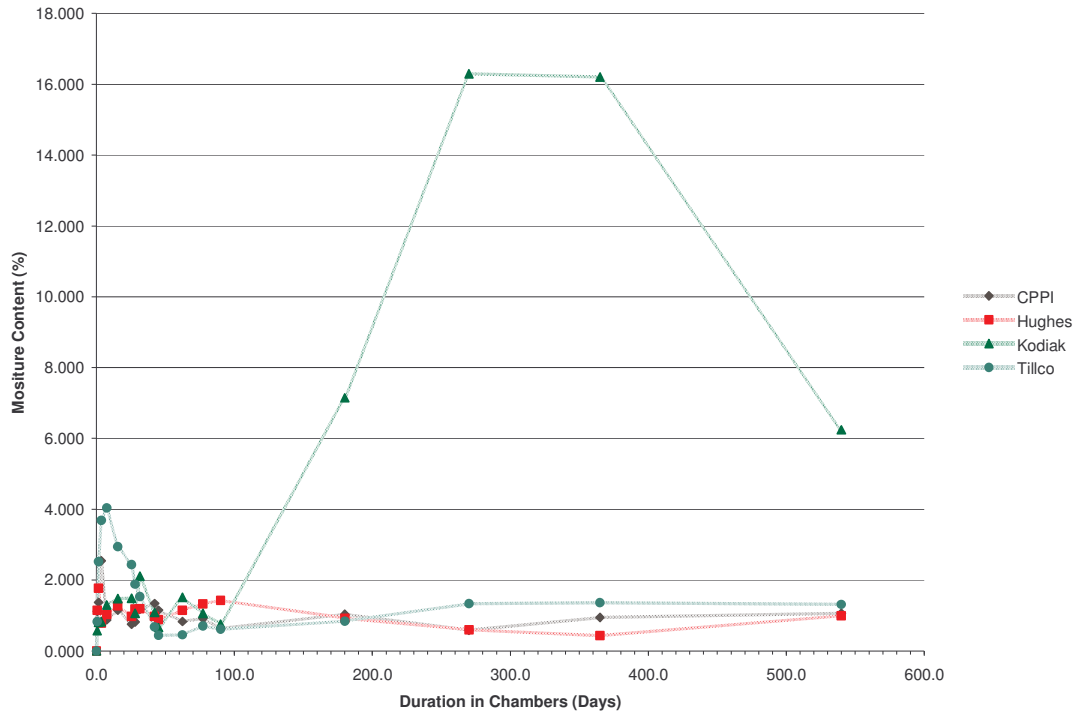
Figure 7.13 Weight-Based Effects Due to Moisture Uptake of Nicked Specimens at 130°F

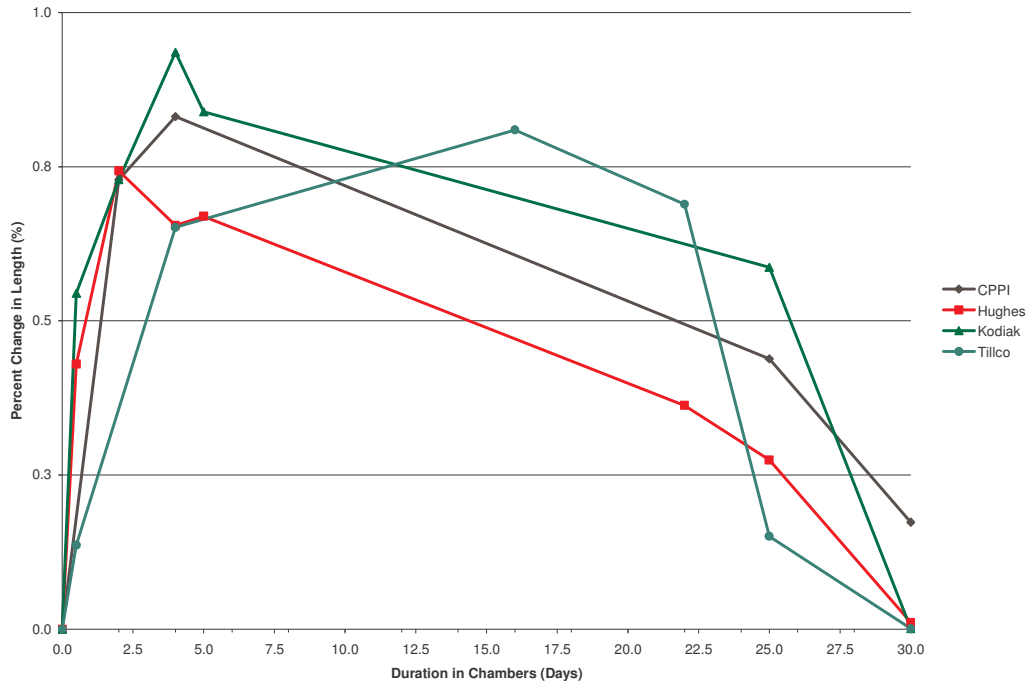
Figure 7.14 Extensional Effects Due to Moisture Uptake of Unscathed Specimens at Room Temperature

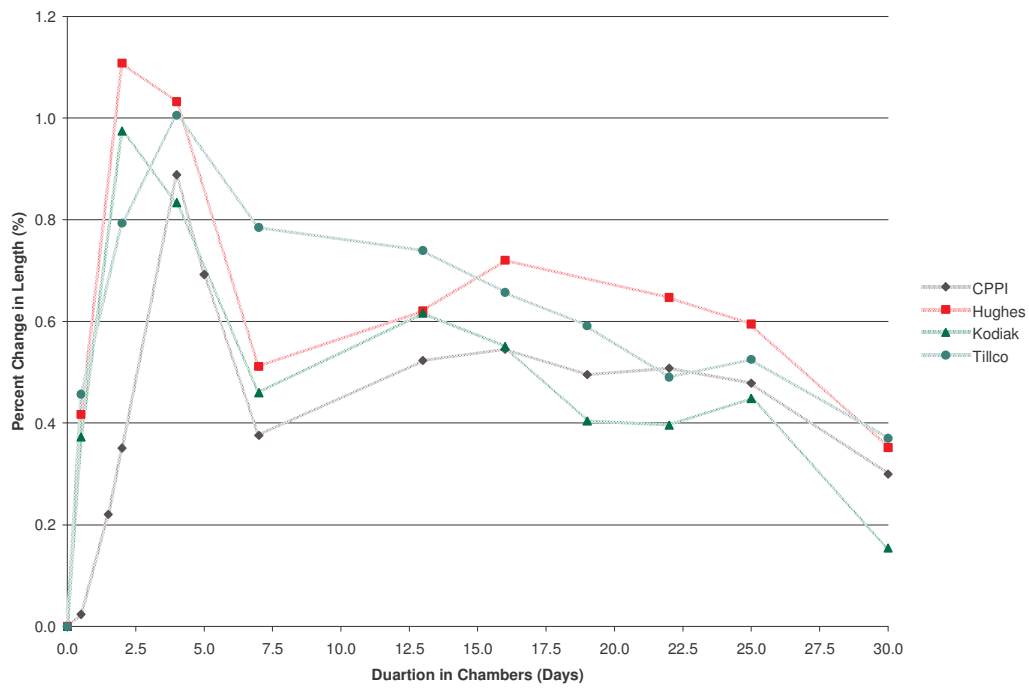
Figure 7.15 Extensional Effects Due to Moisture Uptake of Nicked Specimens at Room Temperature

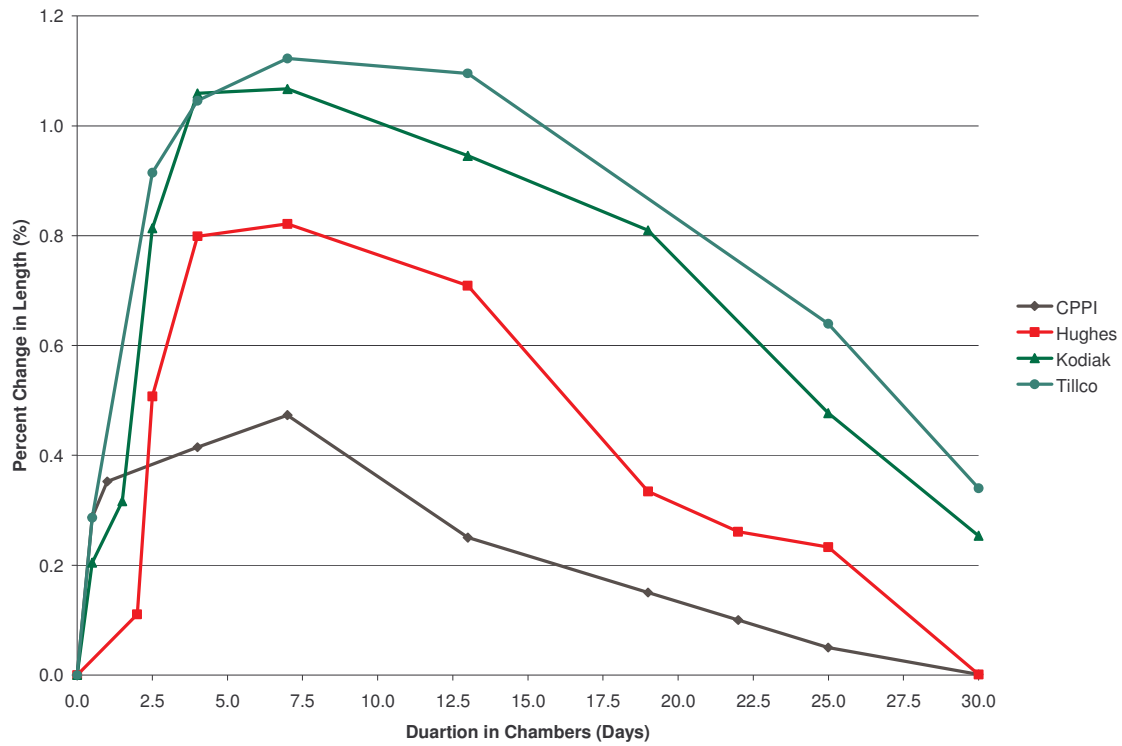
Figure 7.16 Extensional Effects Due to Moisture Uptake of Unscathed Specimens at 100°F

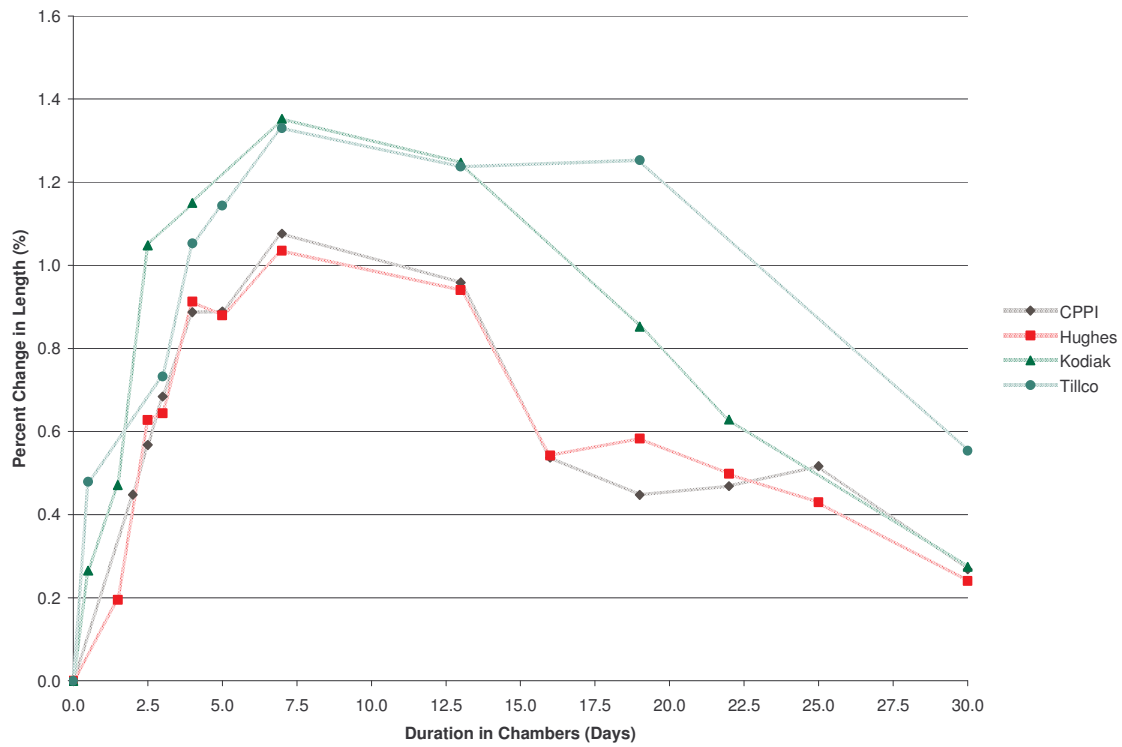
Figure 7.17 Extensional Effects Due to Moisture Uptake of Nicked Specimens at 100°F

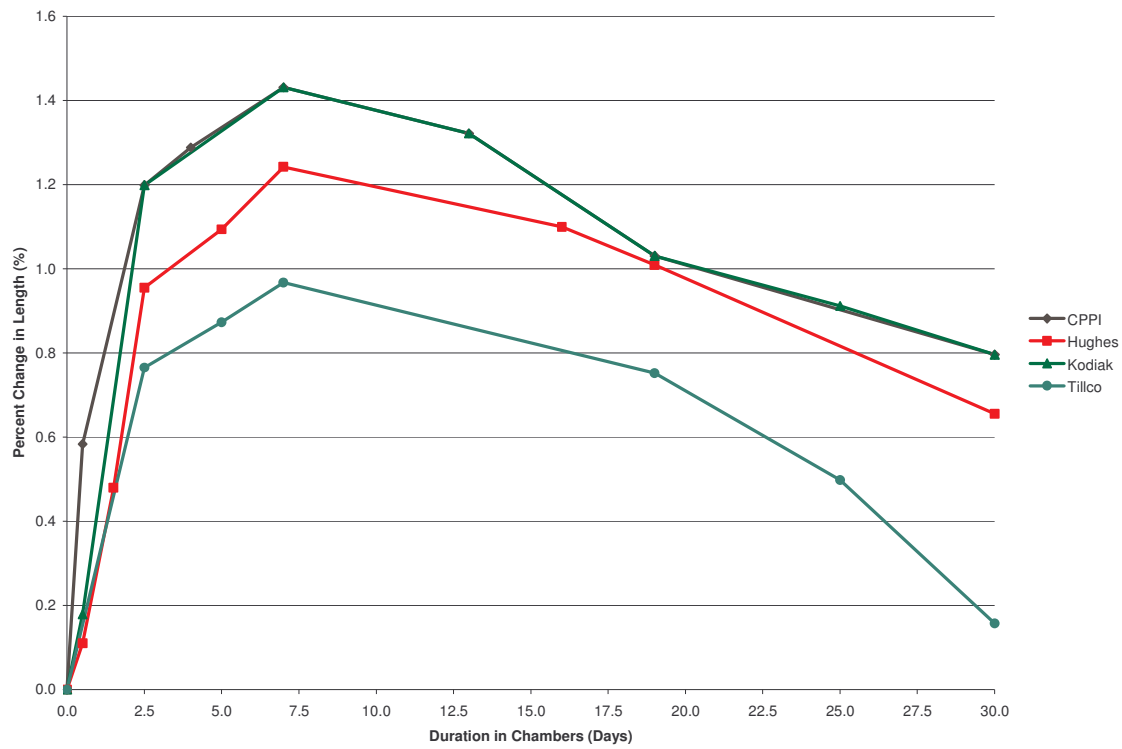
Figure 7.18 Extensional Effects Due to Moisture Uptake of Unscathed Specimens at 130°F

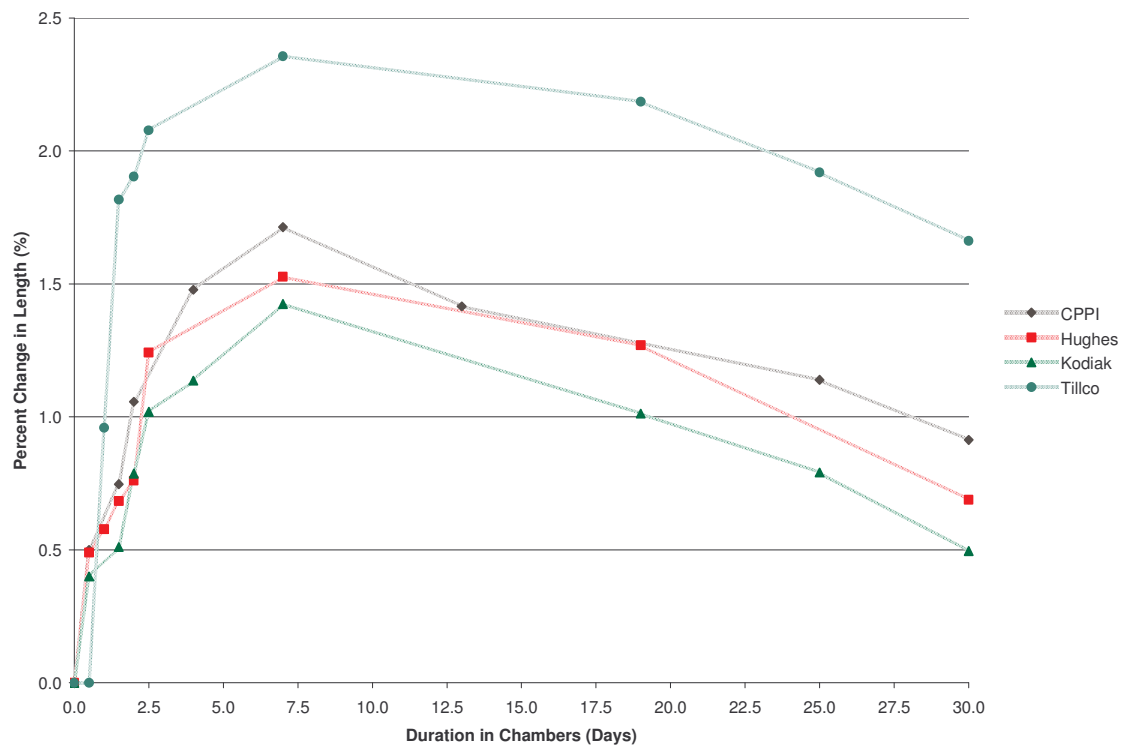
Figure 7.19 Extensional Effects Due to Moisture Uptake of Nicked Specimens at 130°F

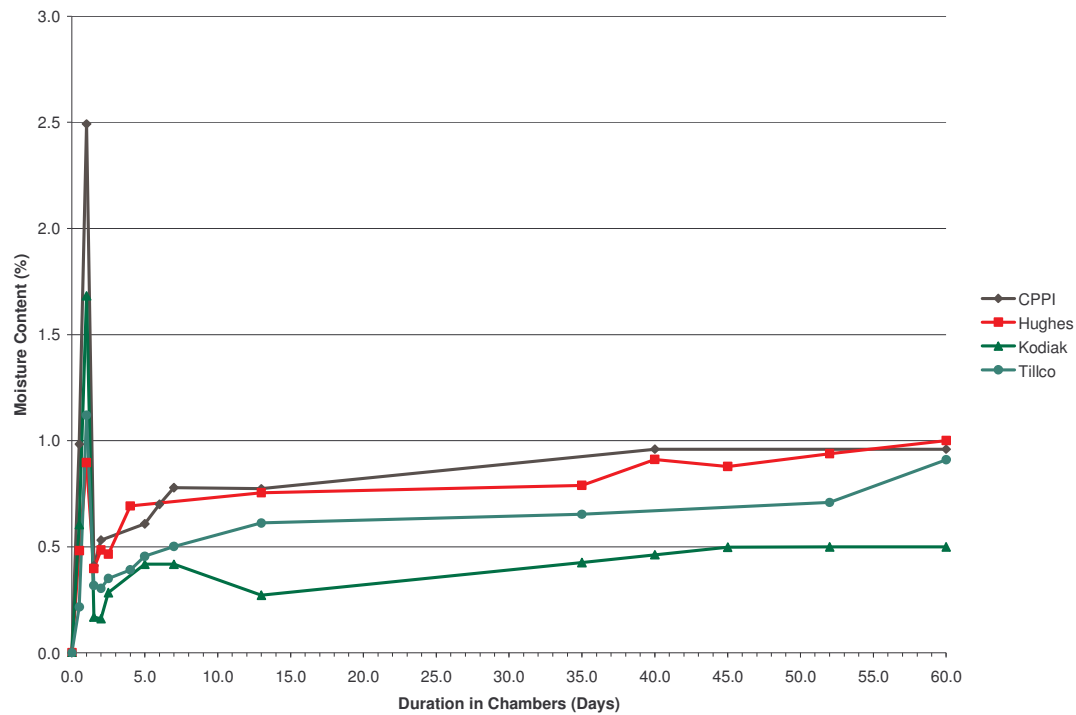
Figure 7.20 Weight-Based Effects Due to Moisture Uptake of Unscathed Specimens at Room Temperature

There is a dramatic increase in weight observed at the first day for the unscathed specimens, whereas the nicked samples experienced changes more uniformly. This spike in moisture uptake was also observed during the initial findings. The one key observation is that after the campus-wide power outage (see Section 7.2), the specimens experienced an increase in absorption at 13 days. From the figures, the trend appears to be that after the first stages of being exposed to the alkaline solution, there is a dramatic spike in moisture uptake. During the next 20 to 30 days, there is a stabilization observed at around 0.50%. After a duration of 30 days, there is a slight increase to about 0.70% and again stabilizes for period of 30 days. An explanation for the spike at the first day is likely due to the specimens having adapted to the new environment. This could also explain why there is a slight increase at 13 days due to the power being turned on and off.

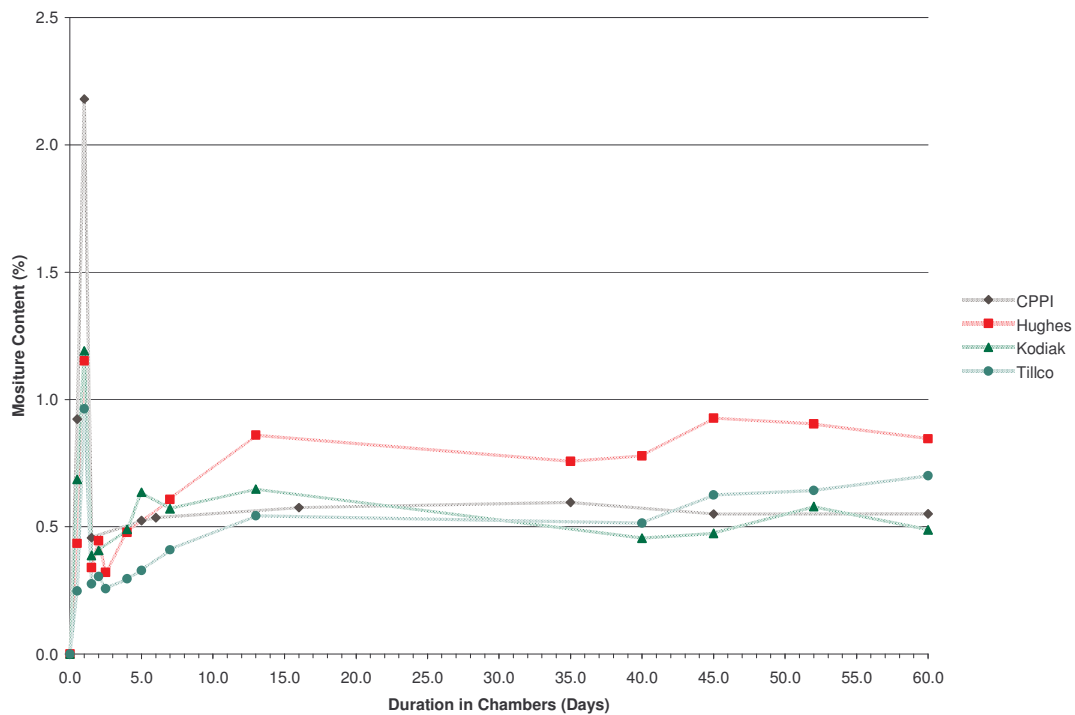
Figure 7.21 Weight-Based Effects Due to Moisture Uptake of Nicked Specimens at Room Temperature

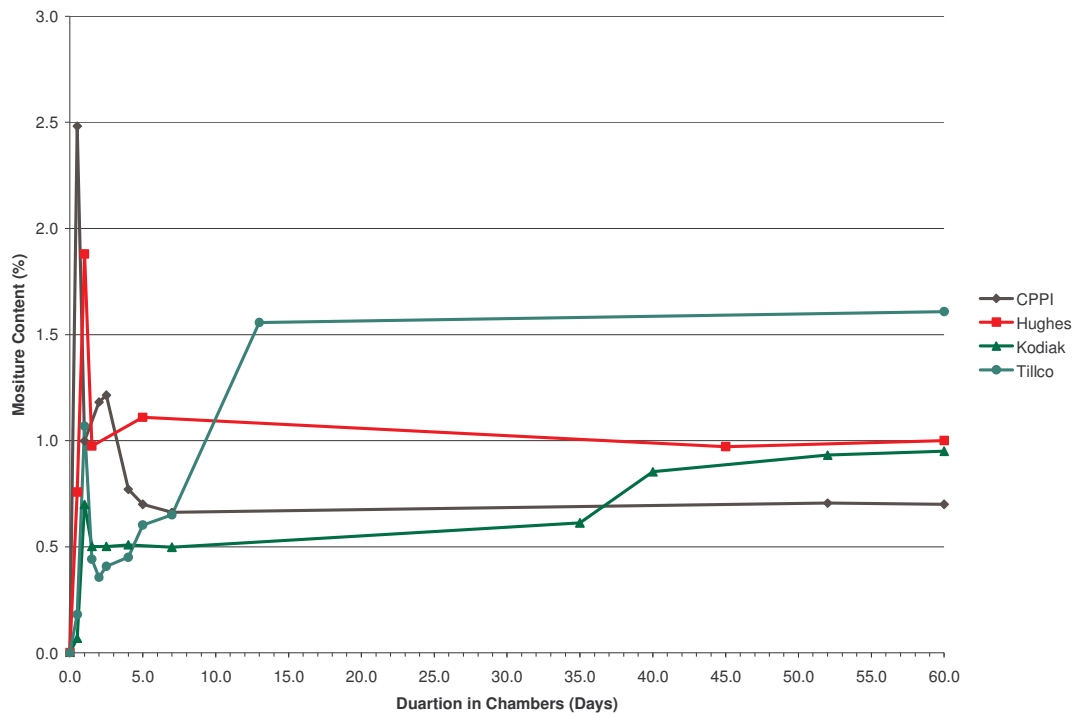
Figure 7.22 Weight-Based Effects Due to Moisture Uptake of Unscathed Specimens at 100°F

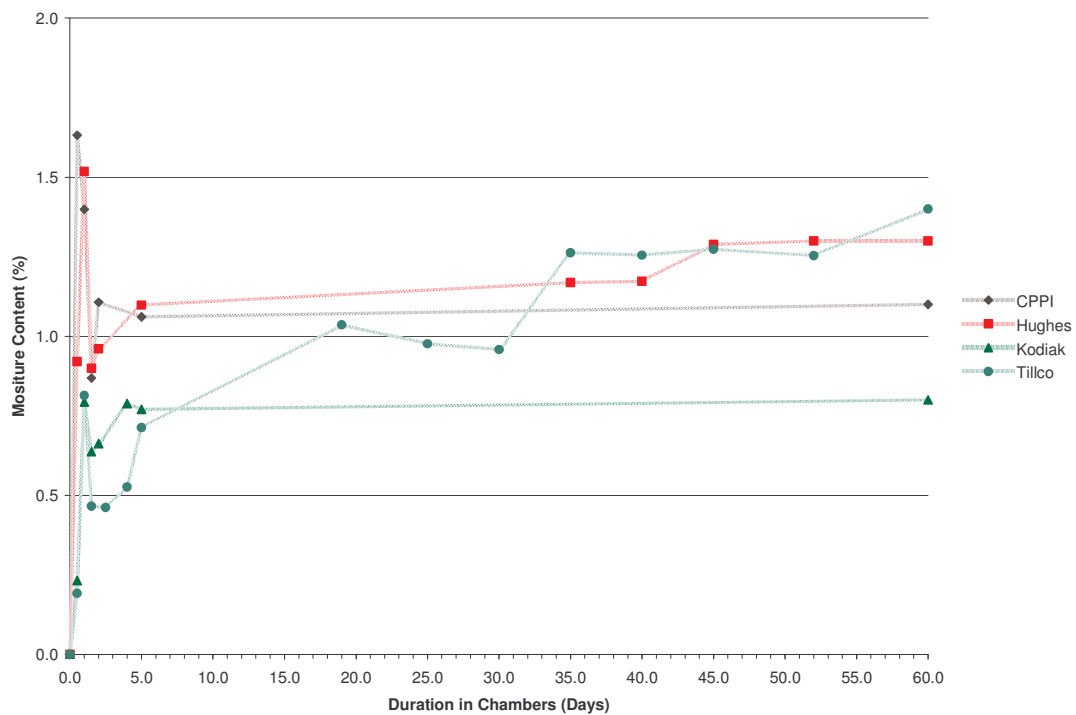
Figure 7.23 Weight-Based Effects Due to Moisture Uptake of Nicked Specimens at 100°F

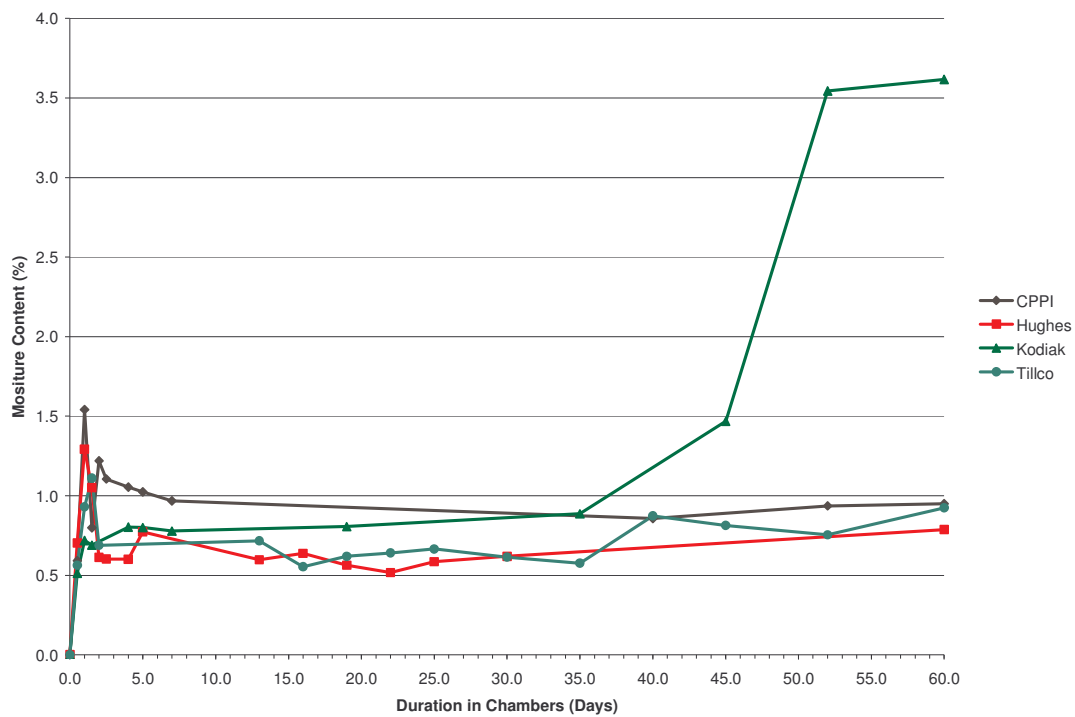
Figure 7.24 Weight-Based Effects Due to Moisture Uptake of Unscathed Specimens at 130°F

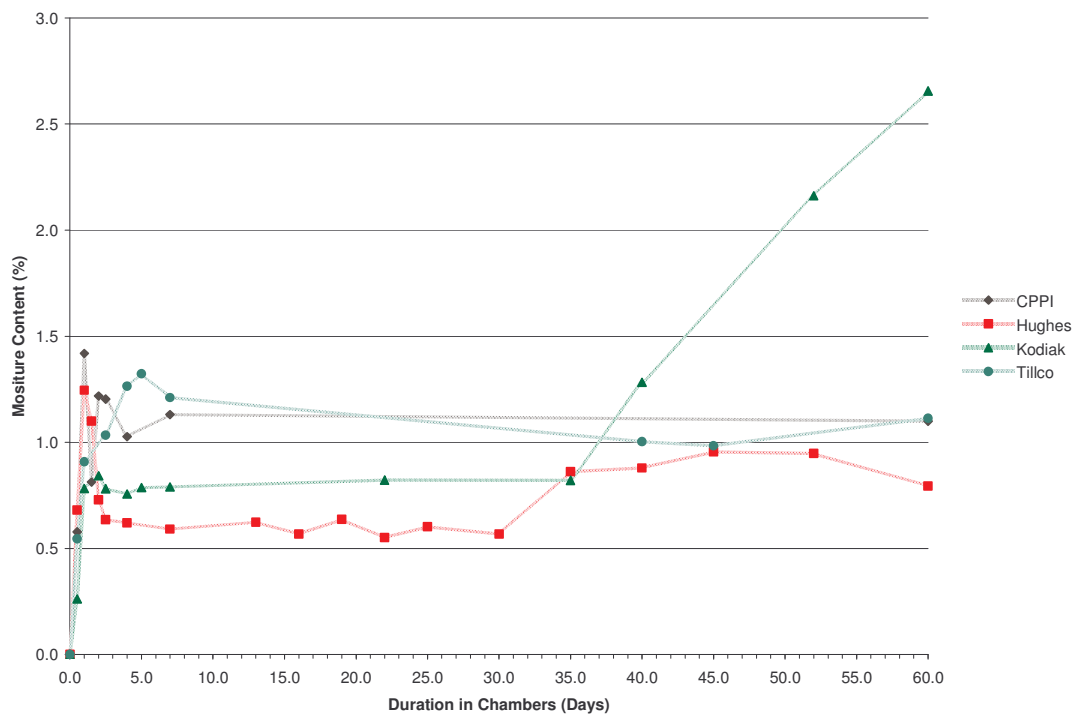
Figure 7.25 Weight-Based Effects Due to Moisture Uptake of Nicked Specimens at 130°F

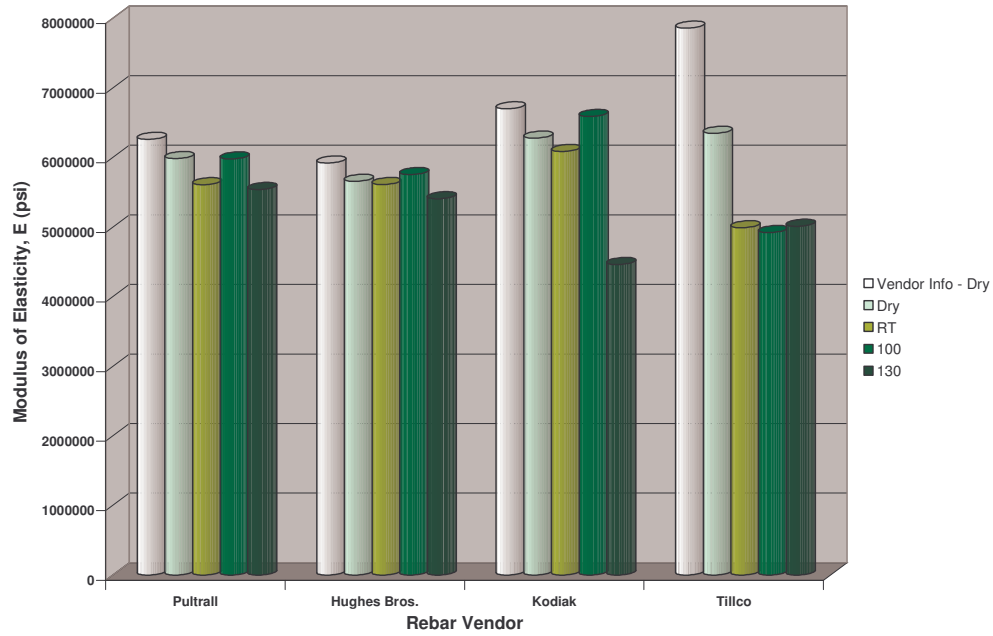
Figure 7.34 Average Modulus of Elasticity for Unscathed at 3 Months

The following figures show of the effects on the modulus of elasticity for the unscathed and nicked specimens for 3, 6, and 18 months. It should be noted that the results for the 12 month duration are not shown due to inaccurate readings from the extensometer during testing, and stress versus strain relationships are shown in Appendix H.

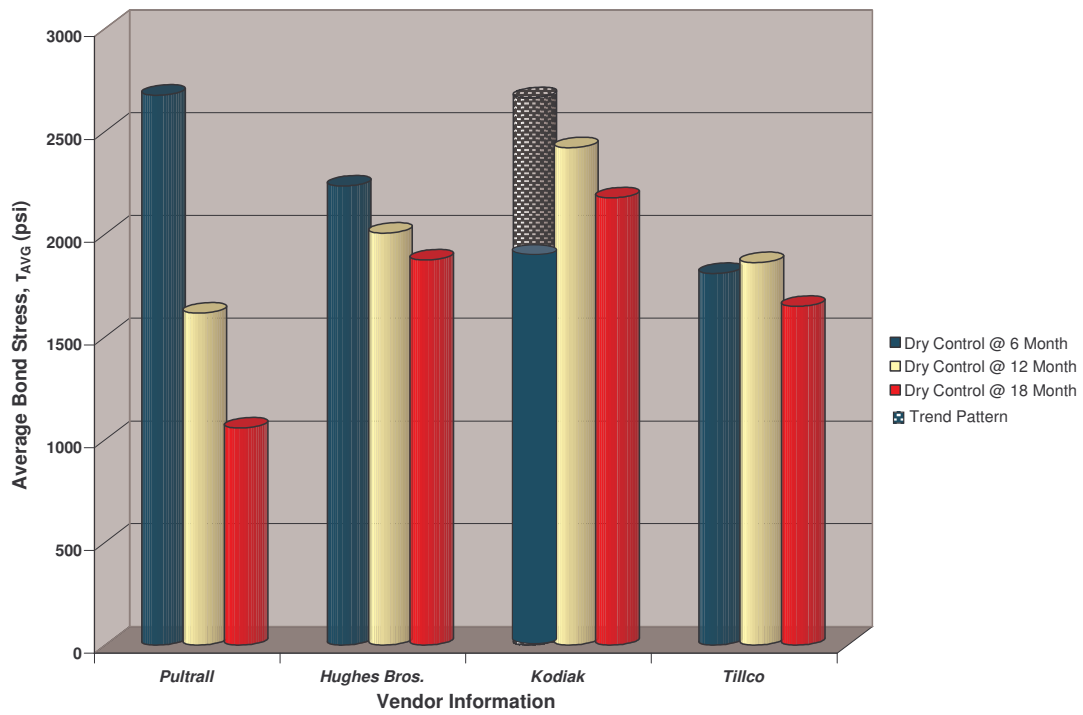
Figure 7.40 Average Bond Stress for  $5\phi_b$  for Dry Conditions

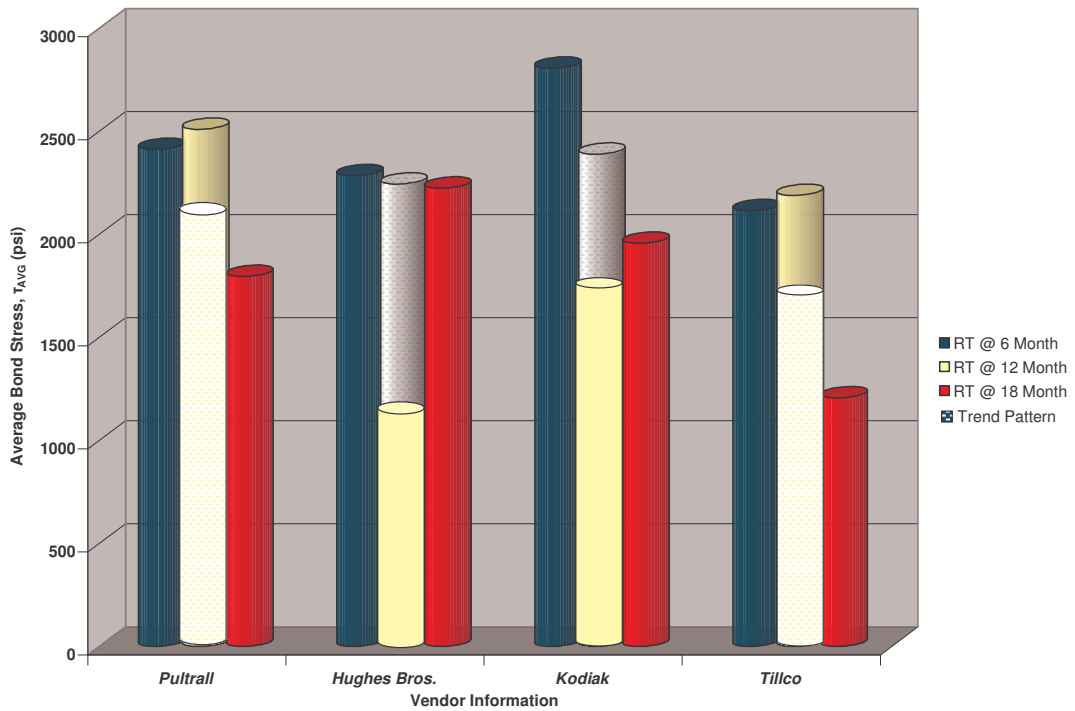
Figure 7.41 Bond Stress for  $5\phi_b$  for Room Temperature

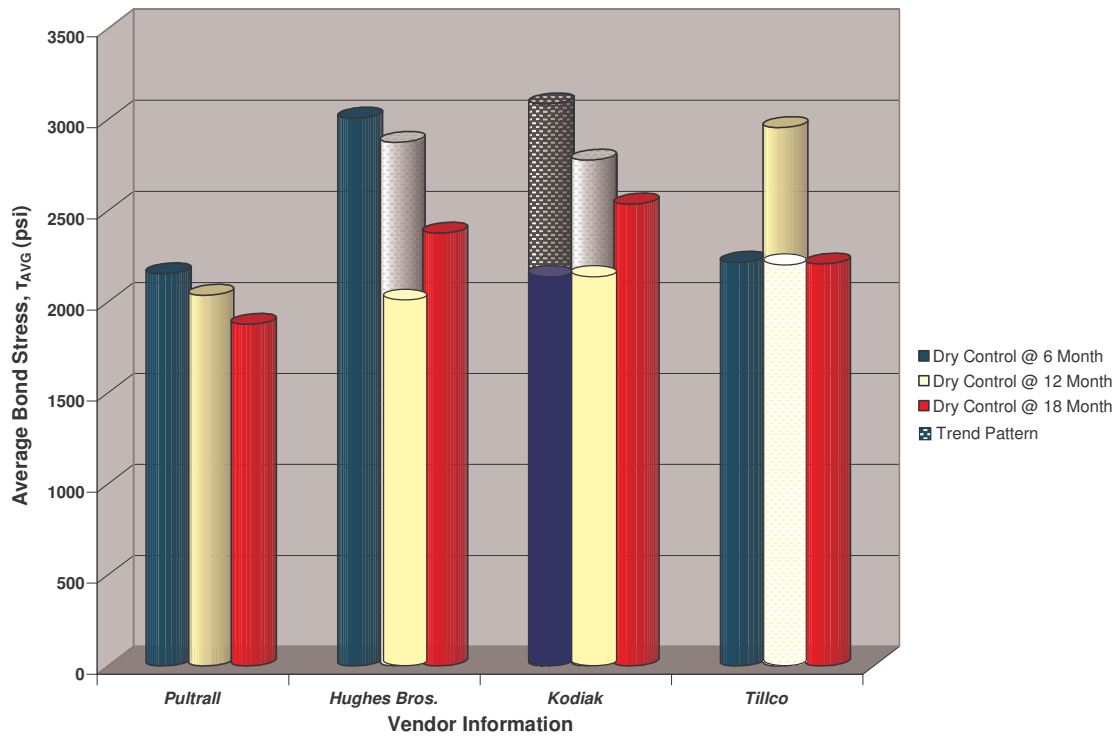
Figure 7.47 Average Bond Stress for 8Ø<sub>b</sub> for Dry Conditions

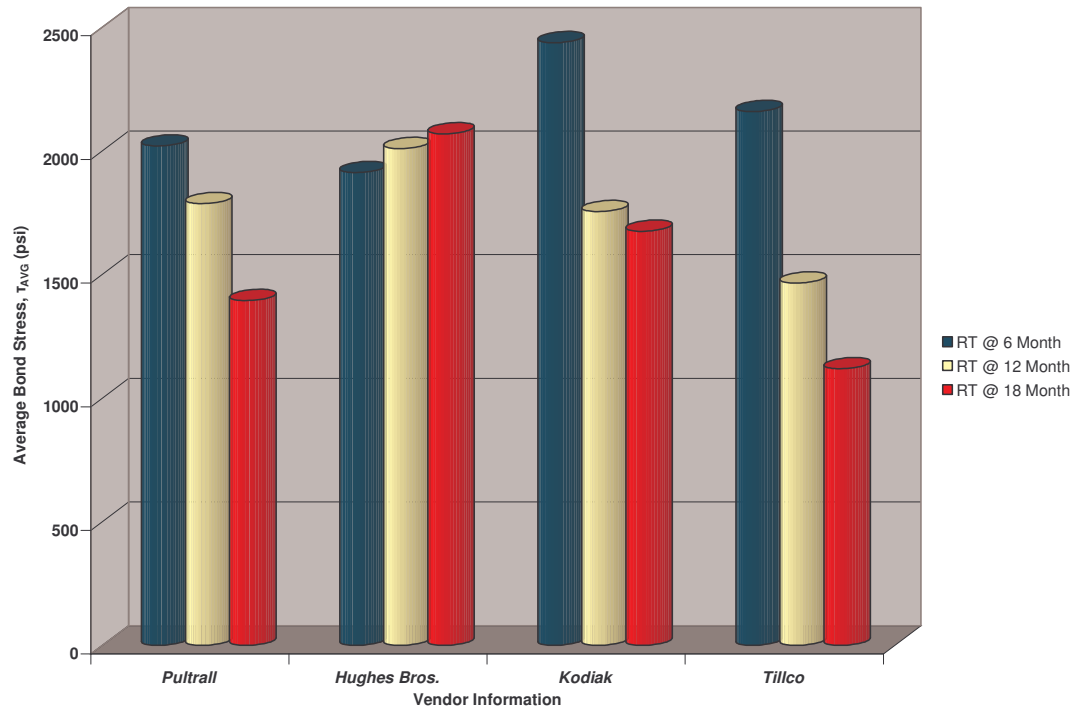
Figure 7.48 Bond Stress for  $8\phi_b$  for Room Temperature

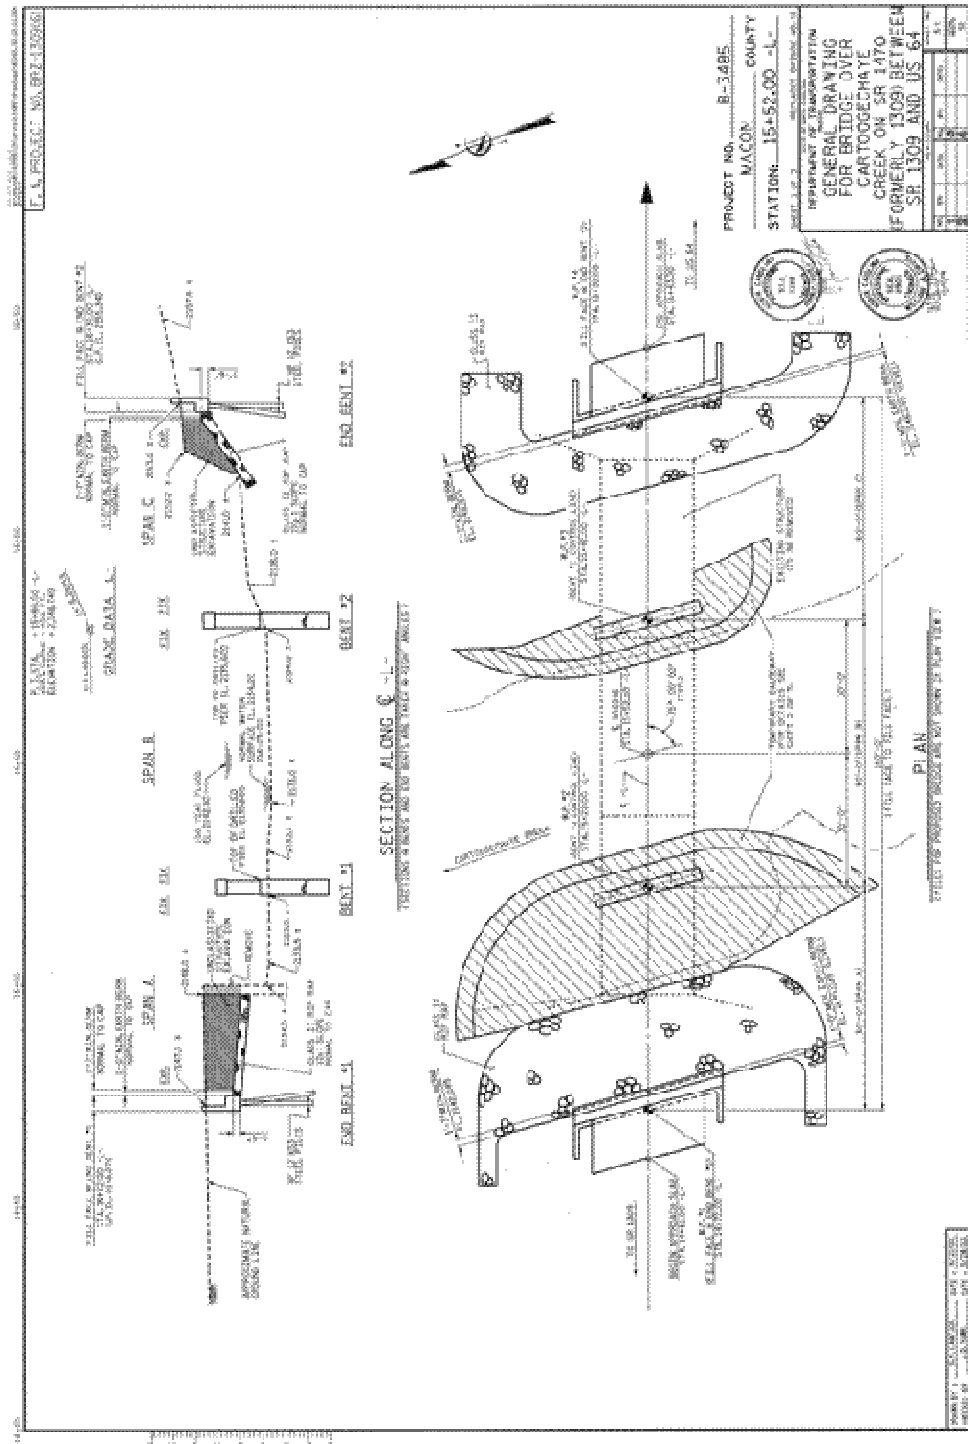
Figure C.3 General drawing of bridge replacement project

Figure C.3 shows the layout of the new bridge and the existing structure (project drawings have been obtained from NCDOT's web page – public domain). As the new structure's length and width was significantly increased, new abutments and approach slabs were required, and the connecting pavement has been widened as well. In addition, to allow the construction of the two intermediate bents, a temporary causeway was built (see Figure C.4), which was completely removed before the end of the project. Figure C.5 shows the two completed reinforced concrete bents built on drilled piers.

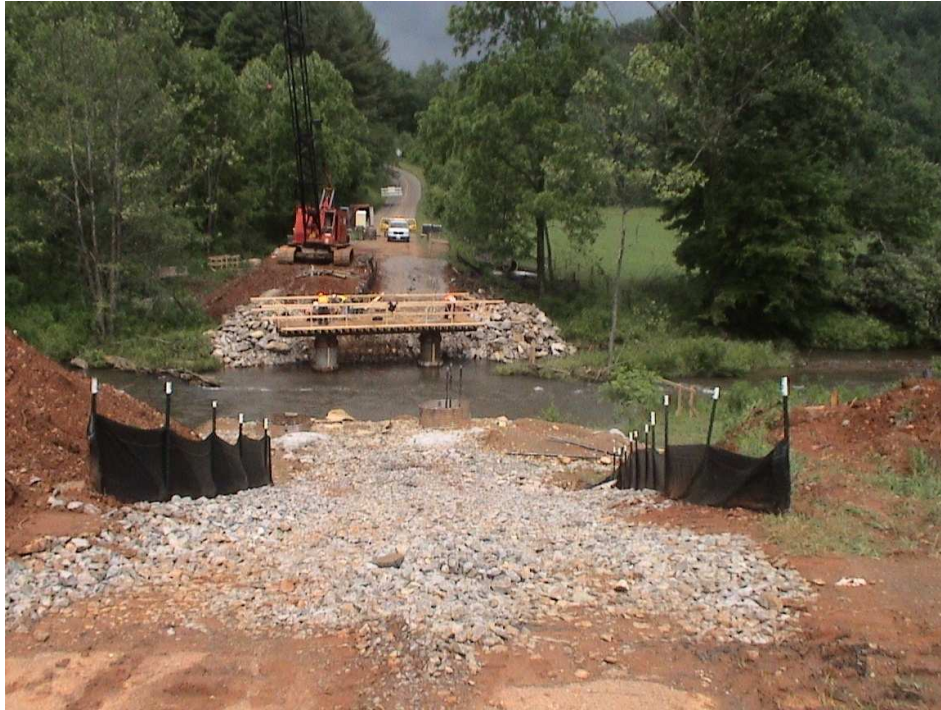
Figure C.4 Temporary causeway and site preparation

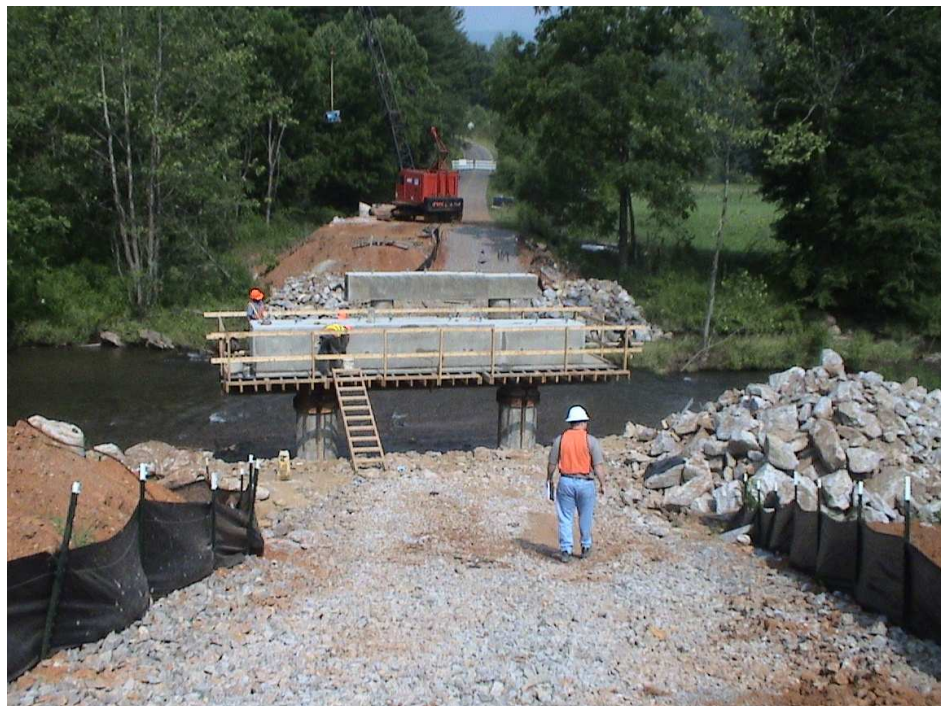
Figure C.5 Reinforced concrete bent construction

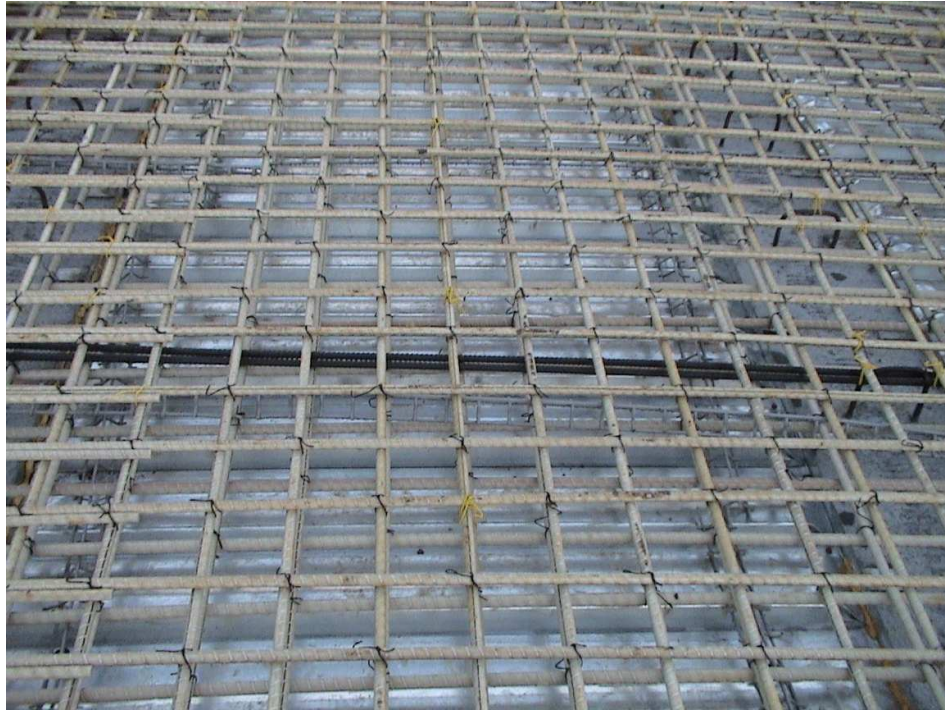
Figure C.11 Composite deck reinforcement

GFRP composite reinforcement placement requires special attention, with somewhat similar measures to epoxy coated rebar construction. Therefore, the general contractor closely followed the rebar manufacturer's specifications with respect to storage, handling and placement of rebars. Prior to placement, the rebars were stored covered to avoid excessive sunlight and moisture exposure. Only plastic chairs and spacers were used to place the rebar mats at the proper height. It is also clear from Figures C.11 and C.12 that the rebars were tied at every other bar intersection with plastic covered wires, avoiding contact with steel and other metal parts of the formwork.

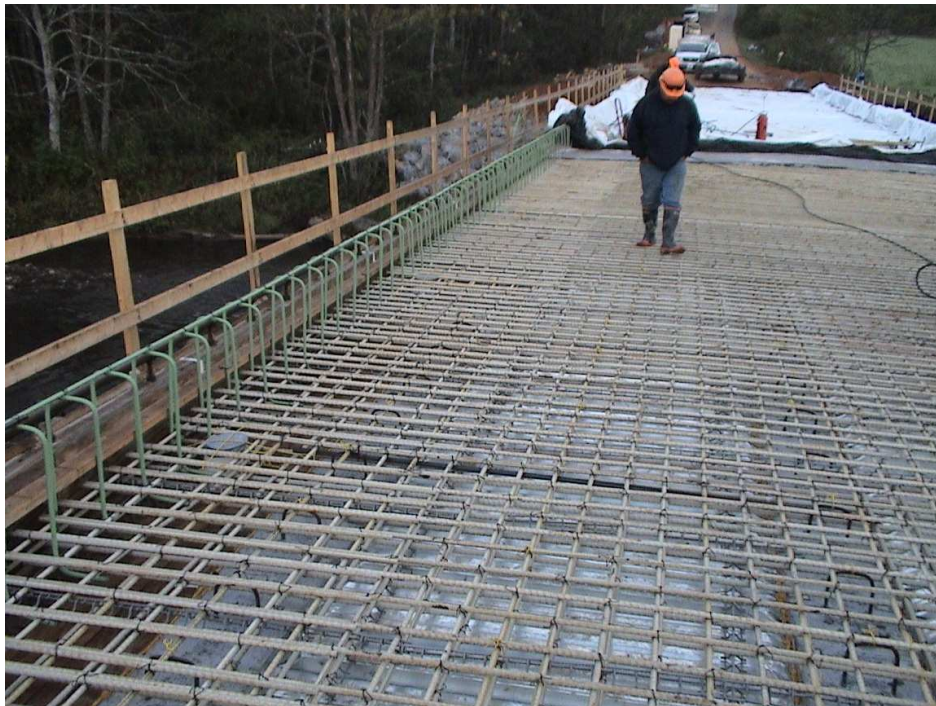
Figure C.13 Completed deck reinforcement

Figure C.13 shows the completed deck reinforcement, with the epoxy coated rebars used as reinforcement for the bridge rail. In the background, concrete was already placed in portions of the deck (using the equipment shown in Figure C.14), and covered to provide adequate protection from below-freezing temperatures and moisture evaporation. Class AA concrete was specified for the bridge deck, containing either fly ash or ground granulated blast furnace slag. Finally, Figure C.15 shows the construction of the reinforced concrete parapet using a sliding formwork.

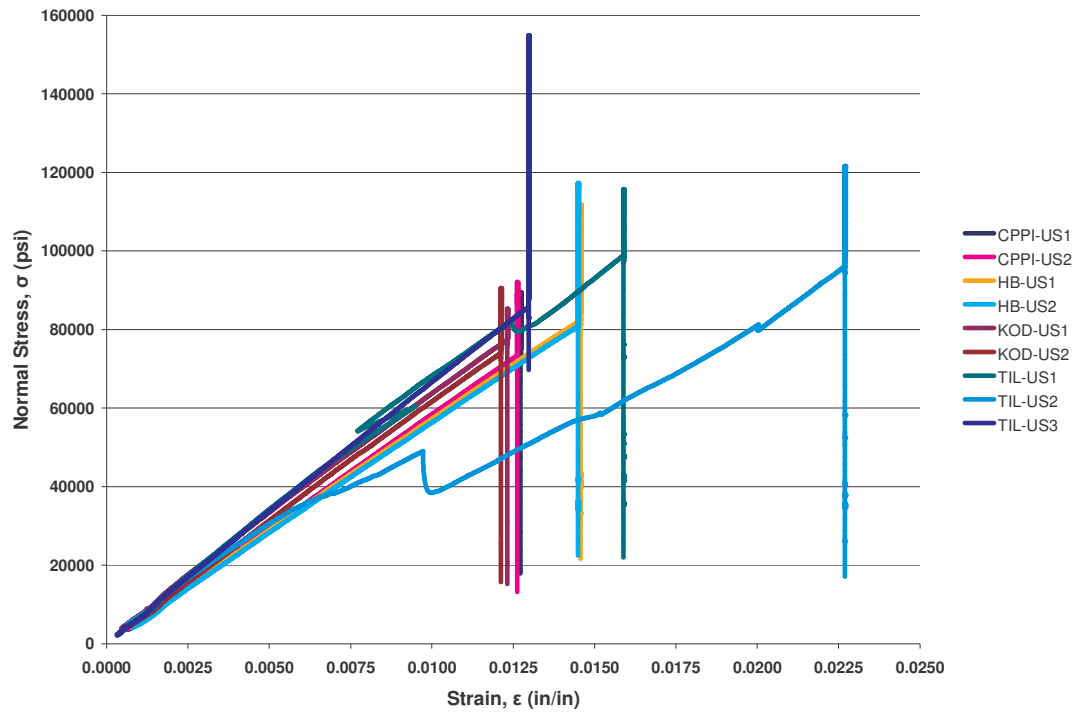
Figure H.1 Tensile Stress vs. Strain for Unscathed at Dry Conditions for 3 Months

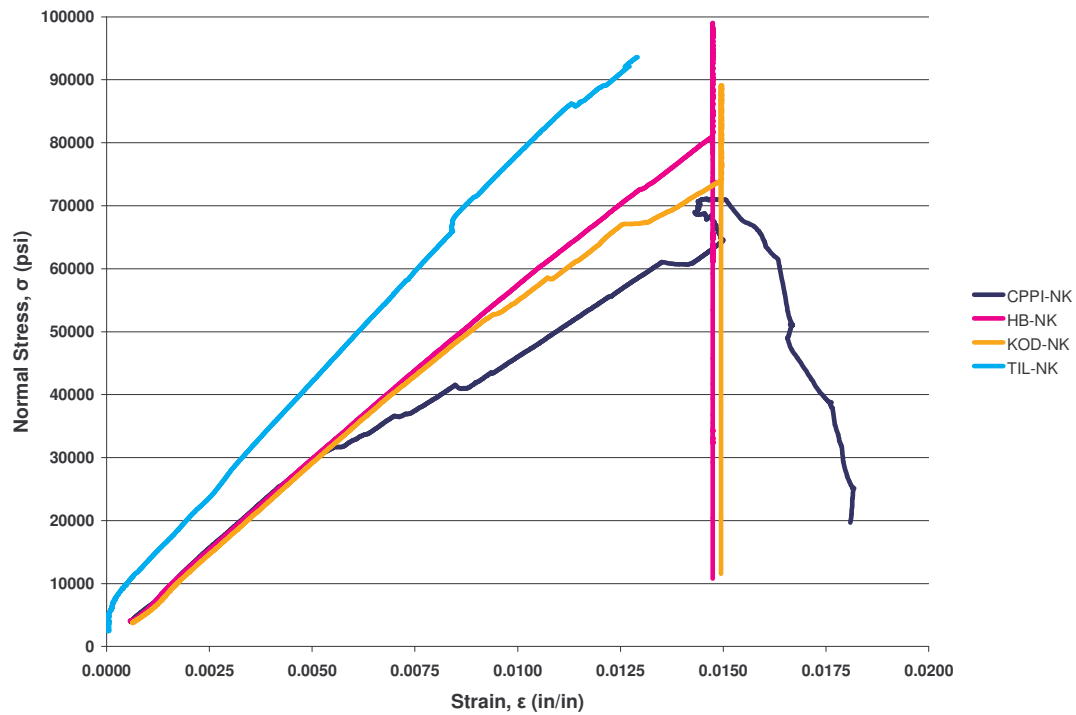
Figure H.2 Tensile Stress vs. Strain for Nicked at Dry Conditions for 3 Months

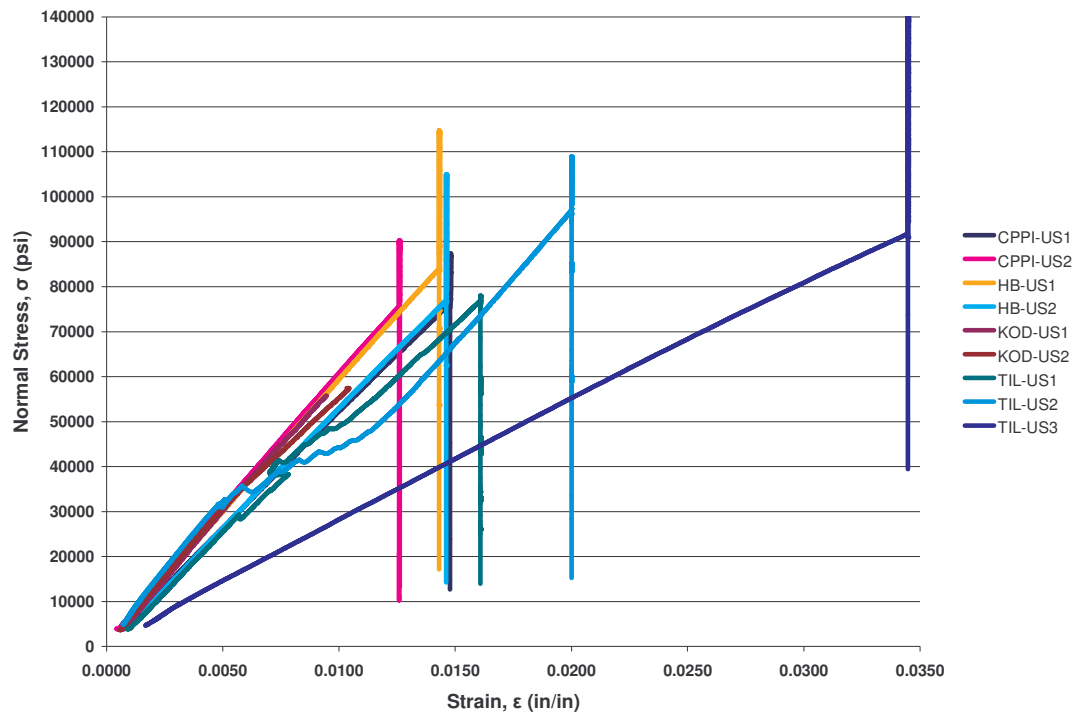
Figure H.3 Tensile Stress vs. Strain for Unscathed at Room Temperature for 3 Months
