**Final Report**

**North Carolina Department of Transportation**

**Research project No. HWY-2005-22**

***Analysis and Testing of a Bridge Deck Reinforced  
With GFRP Rebars***

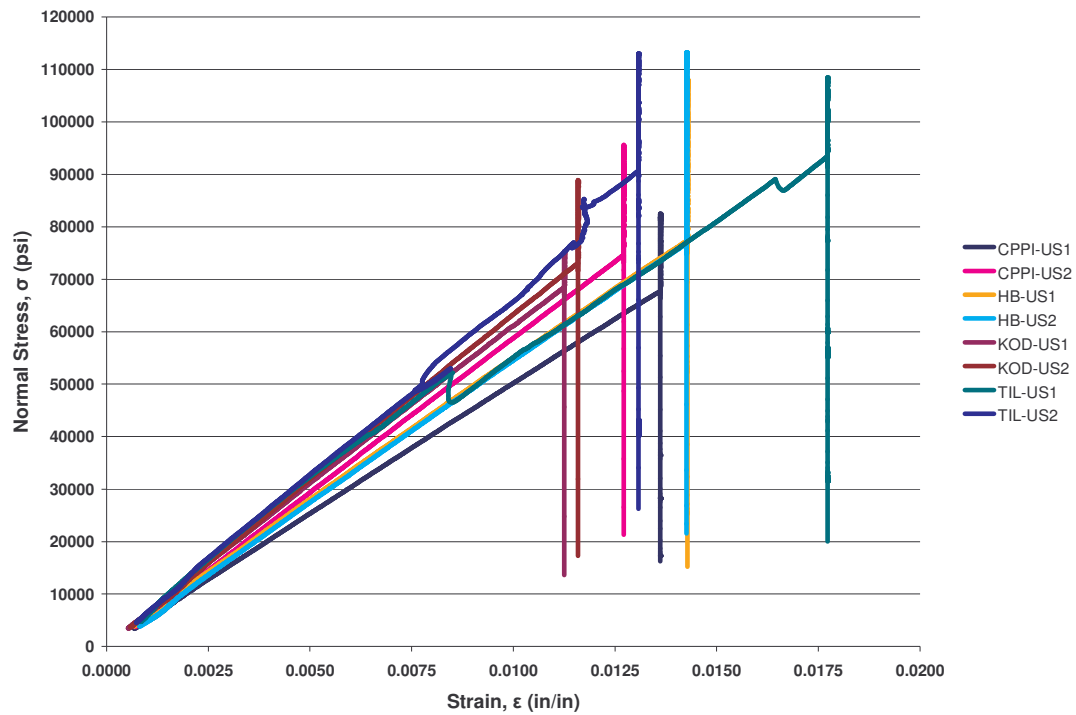
Figure H.9 Tensile Stress vs. Strain for Unscathed at Dry Conditions for 6 Months

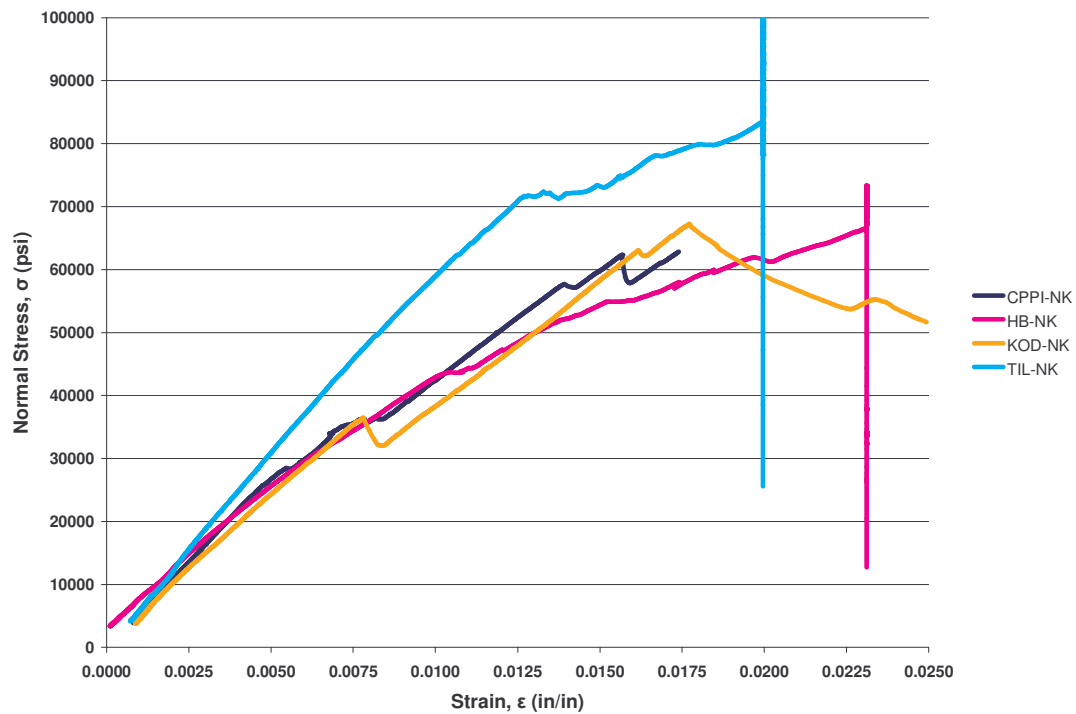
Figure H.10 Tensile Stress vs. Strain for Nicked at Dry Conditions for 6 Months

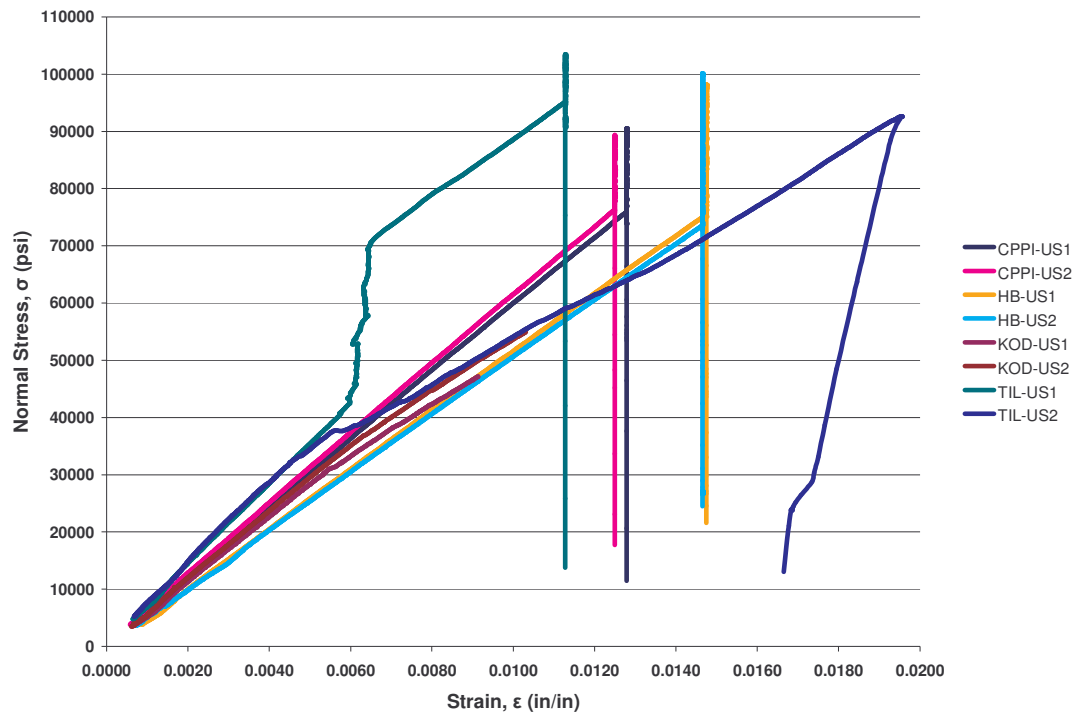
Figure H.11 Tensile Stress vs. Strain for Unscathed at Room Temperature at 6 Months

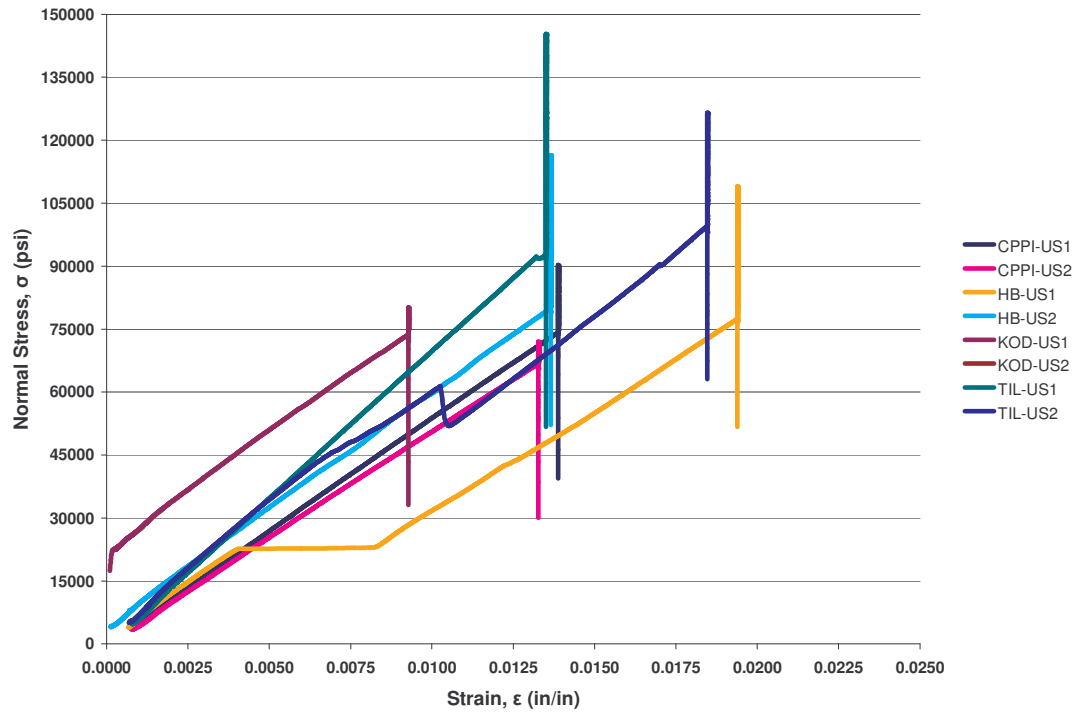
Figure H.18 Tensile Stress vs. Strain for Unscathed at Dry Conditions for 18 Months

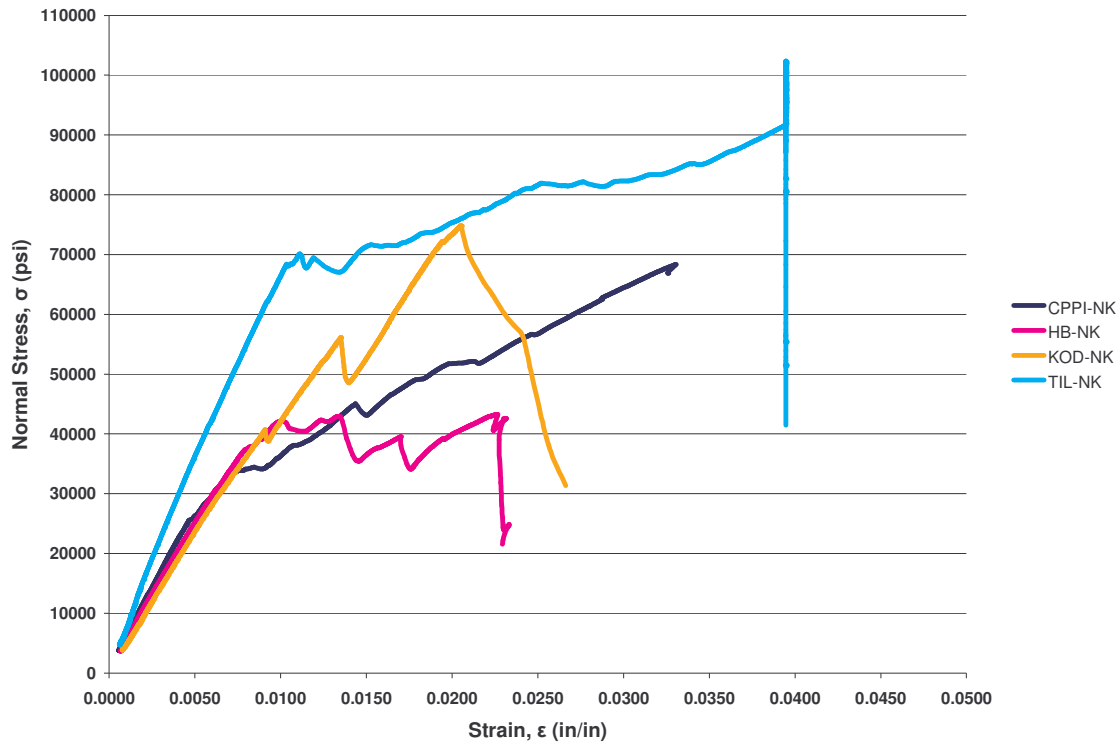
Figure H.19 Tensile Stress vs. Strain for Nicked at Dry Conditions for 18 Months

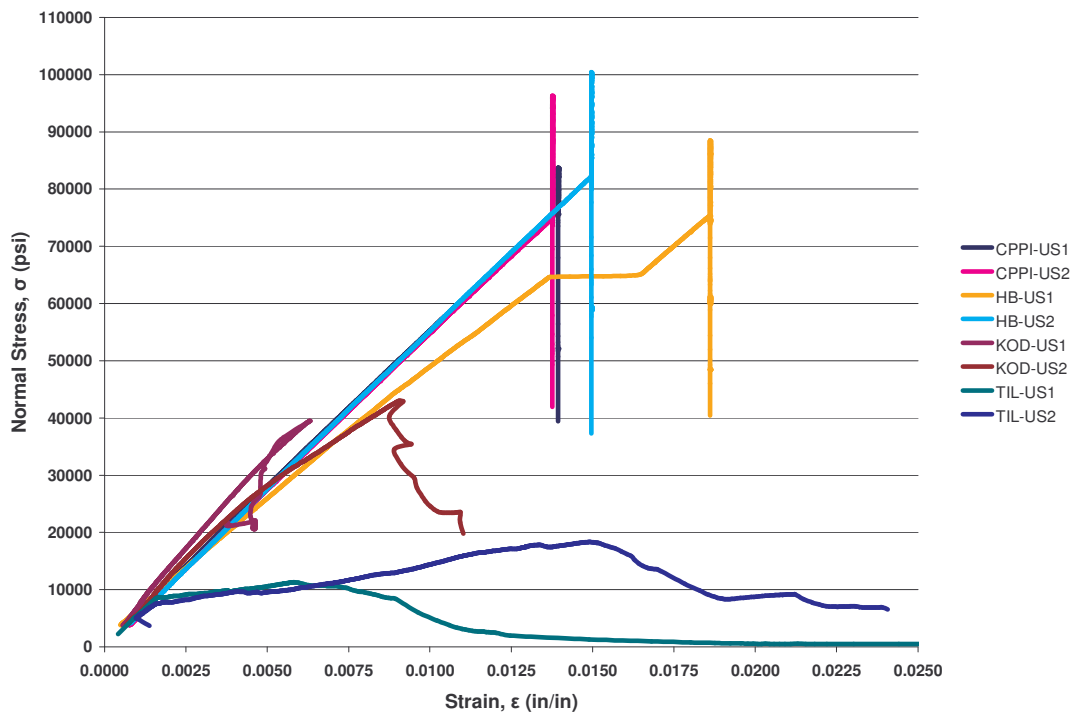
Figure H.20 Tensile Stress vs. Strain for Unscathed at Room Temperature for 18 Months

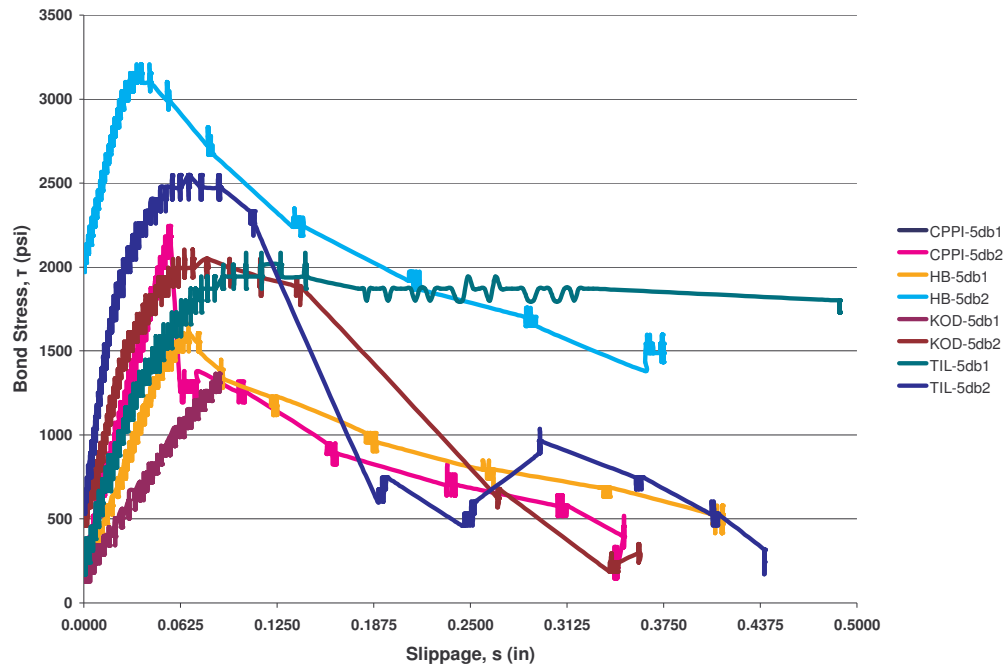
Figure I.1 Bond Stress vs. Slippage Displacement for  $5\phi_b$  at Dry Conditions for 6 Months

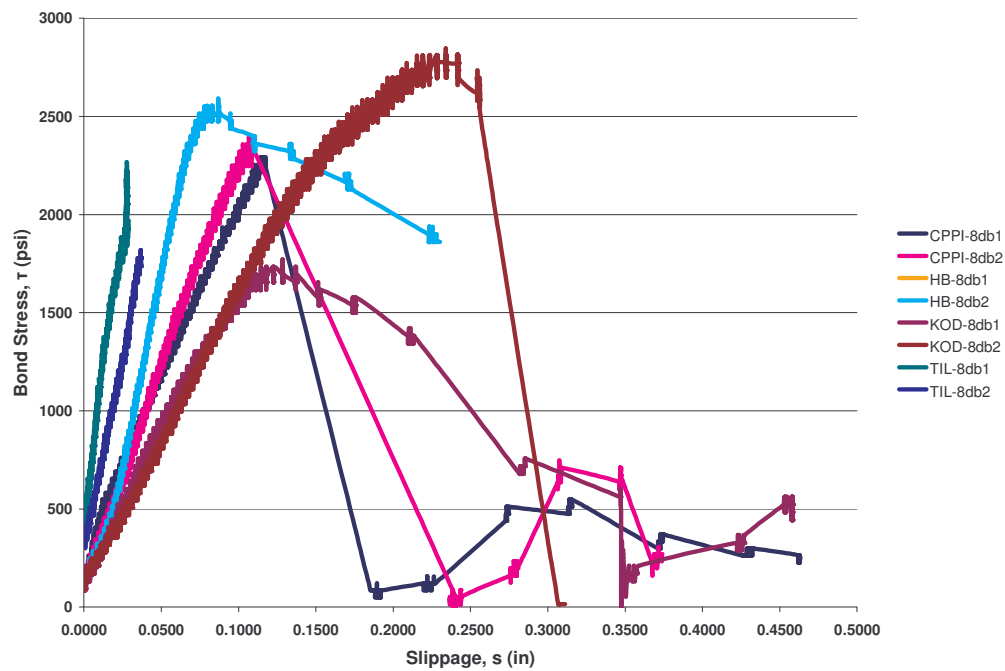
Figure I.2 Bond Stress vs. Slippage Displacement for  $8\phi_b$  at Dry Conditions for 6 Months

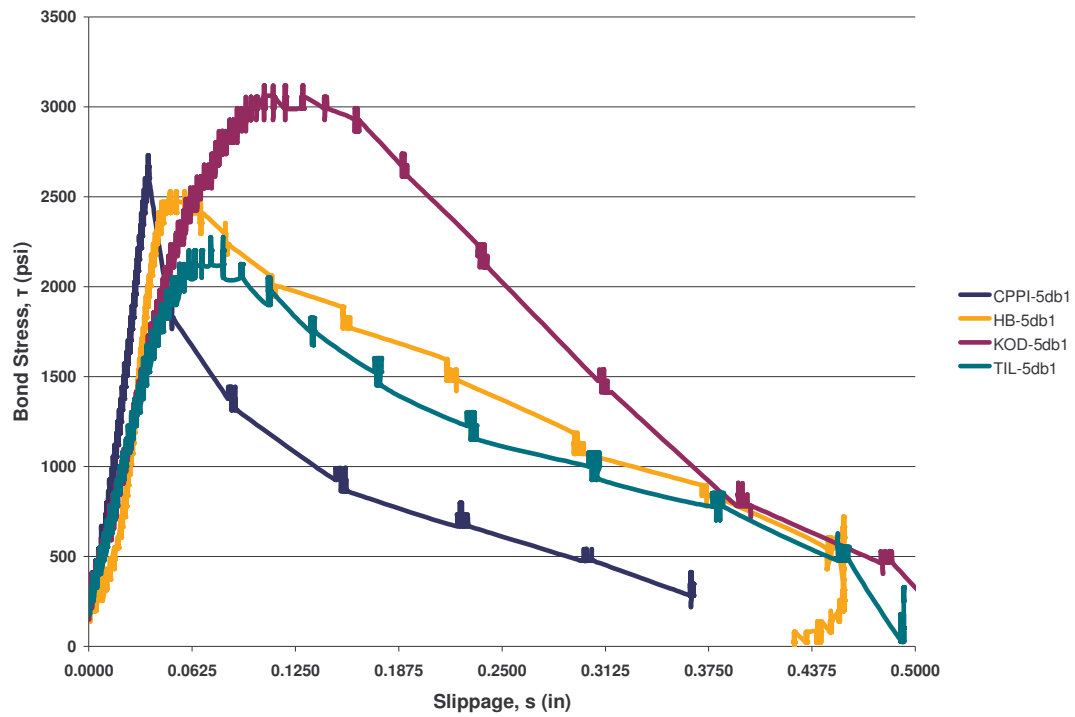
Figure I.3 Bond Stress vs. Slippage Displacement for  $5\phi_b$  at Room Temperature for 6 Months

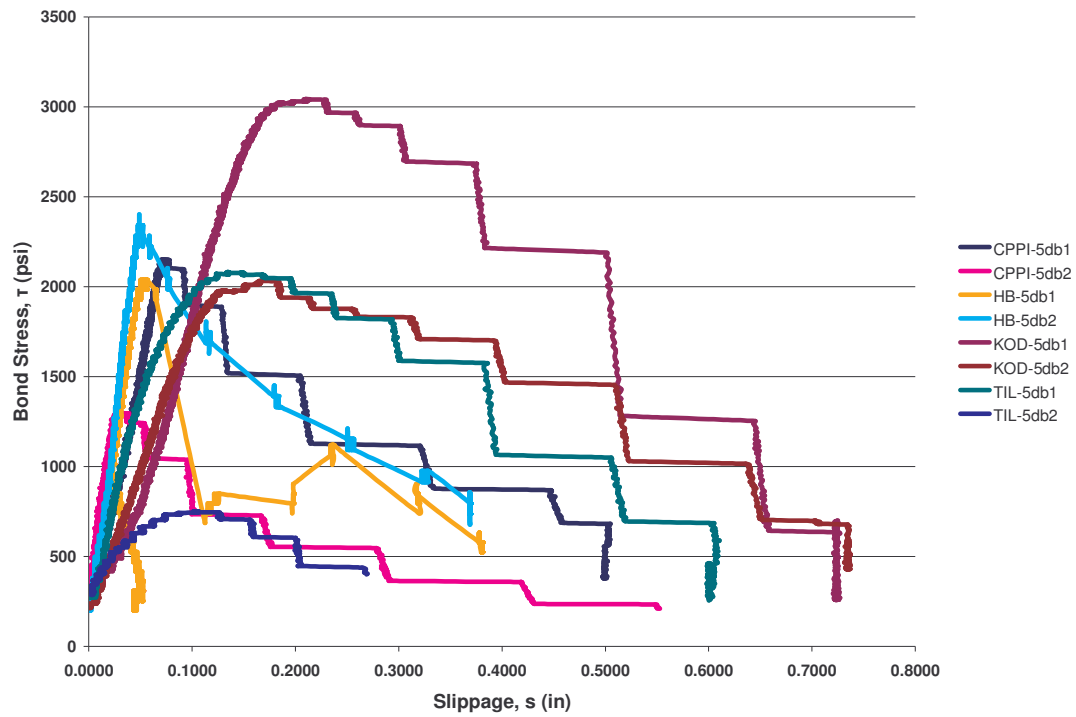
Figure I.9 Bond Stress vs. Slippage Displacement for  $5\phi_b$  at Dry Conditions for 12 Months

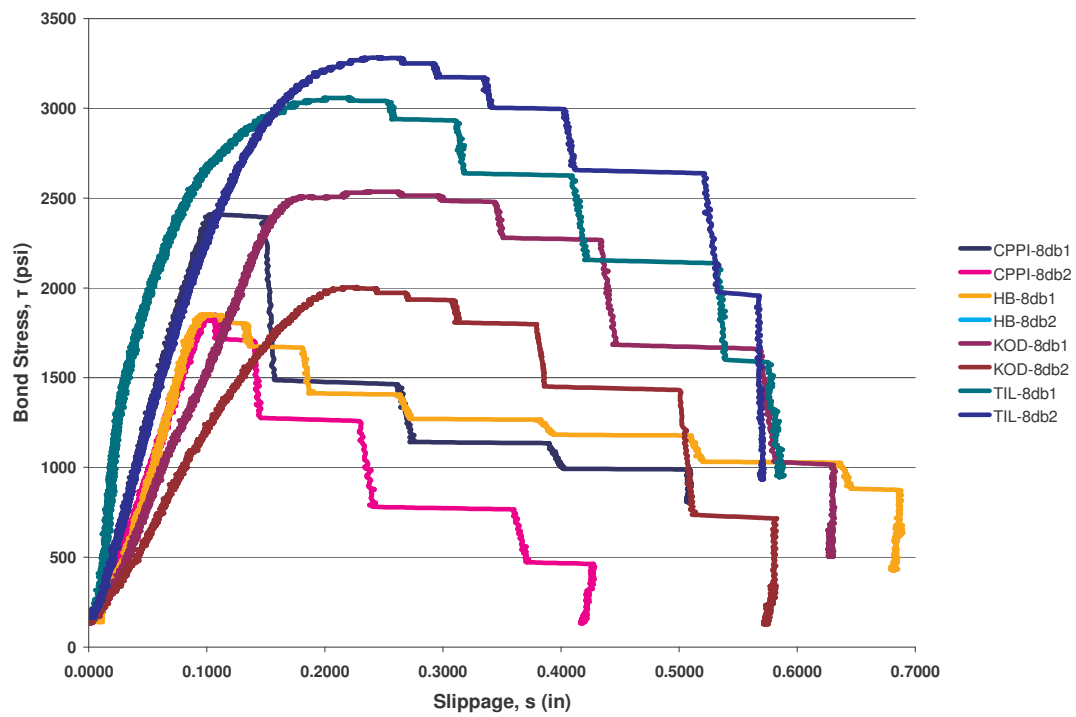
Figure I.10 Bond Stress vs. Slippage Displacement for  $8\phi_b$  at Dry Conditions for 12 Months

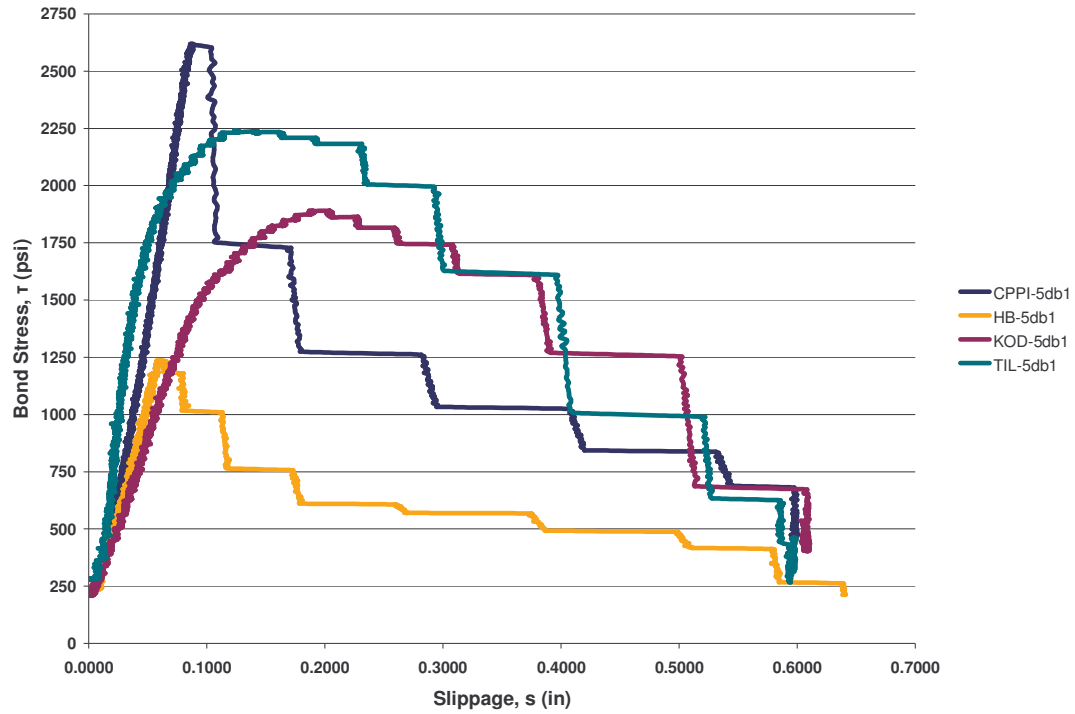
Figure I.11 Bond Stress vs. Slippage Displacement for 5Ø<sub>b</sub> at Room Temperature for 12 Months

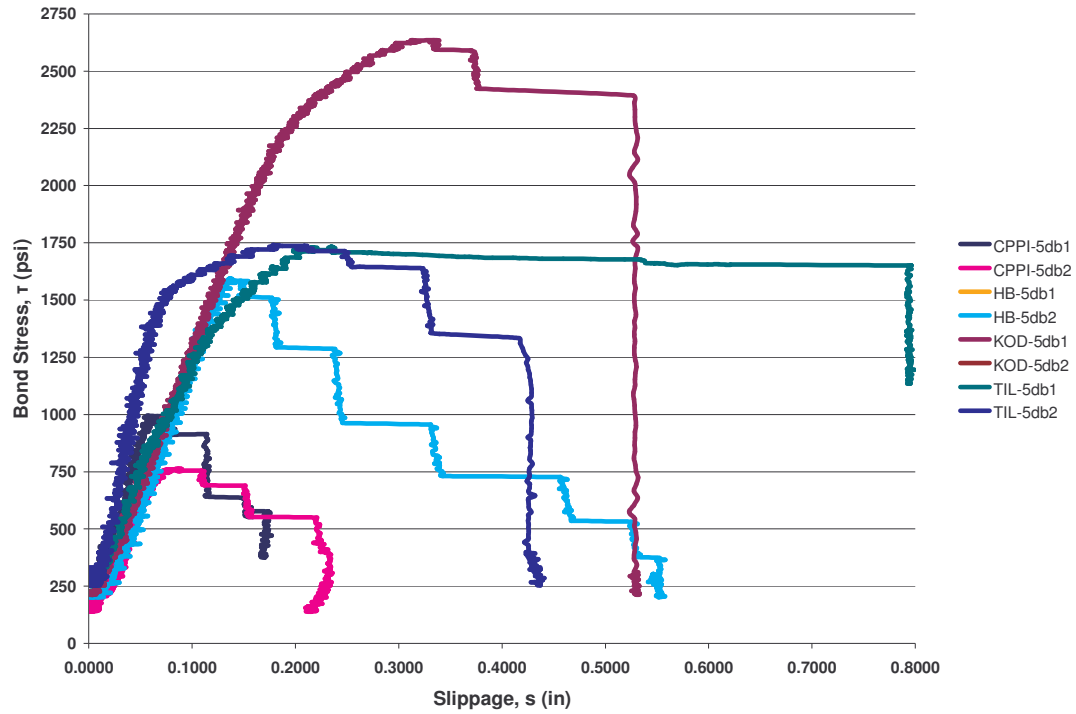
Figure I.17 Bond Stress vs. Slippage Displacement for  $5\phi_b$  at Dry Conditions for 18 Months

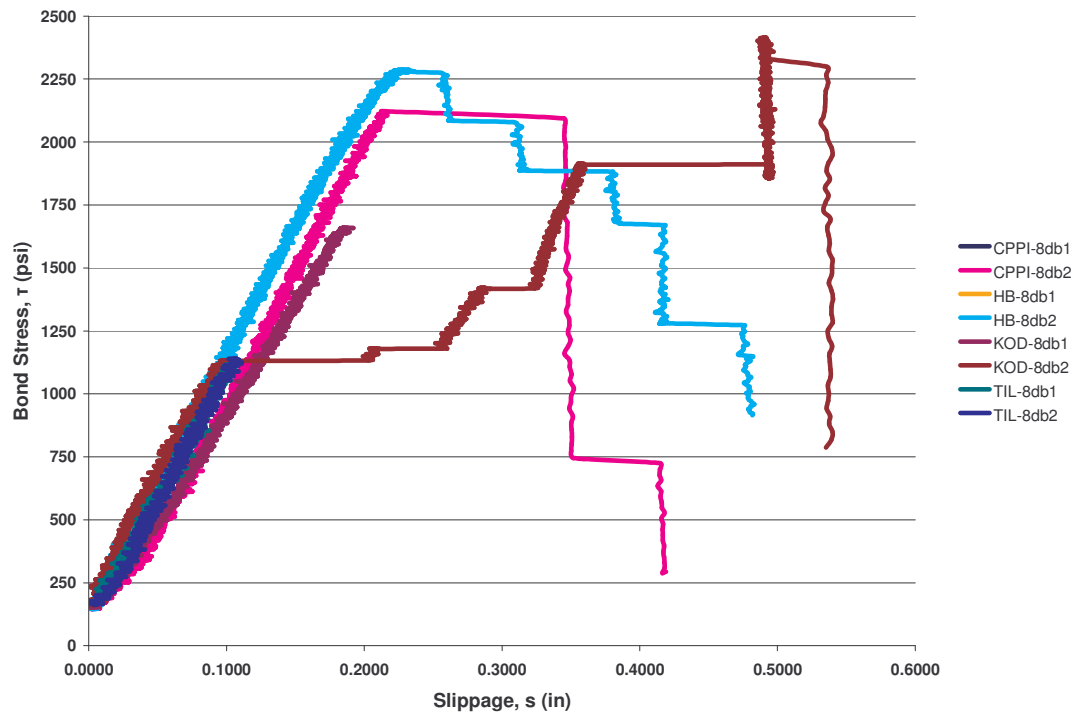
Figure I.18 Bond Stress vs. Slippage Displacement for  $8\phi_b$  at Dry Conditions for 18 Months

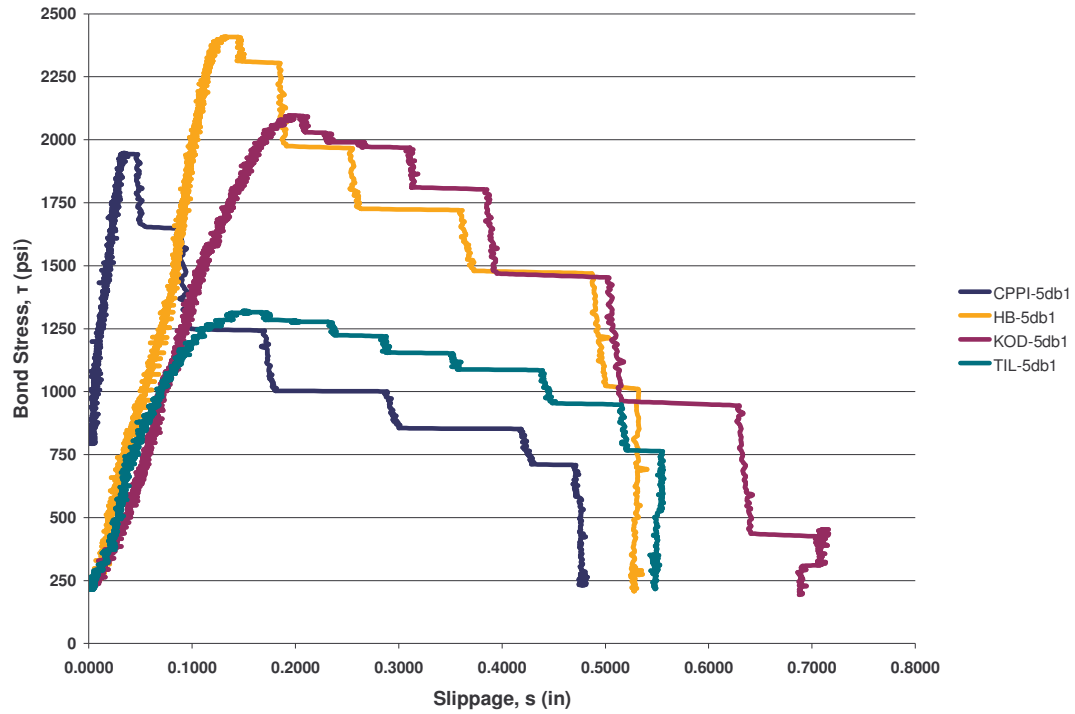
Figure I.19 Bond Stress vs. Slippage Displacement for  $5\phi_b$  at Room Temperature for 18 Months
