**ASR/DEF-DAMAGED BENT CAPS:
SHEAR TESTS AND FIELD IMPLICATIONS**

Technical Report No. 12-8XXIA006
summarizing work conducted for the
Texas Department of Transportation

FERGUSON STRUCTURAL ENGINEERING LABORATORY
THE UNIVERSITY OF TEXAS AT AUSTIN

August 2009

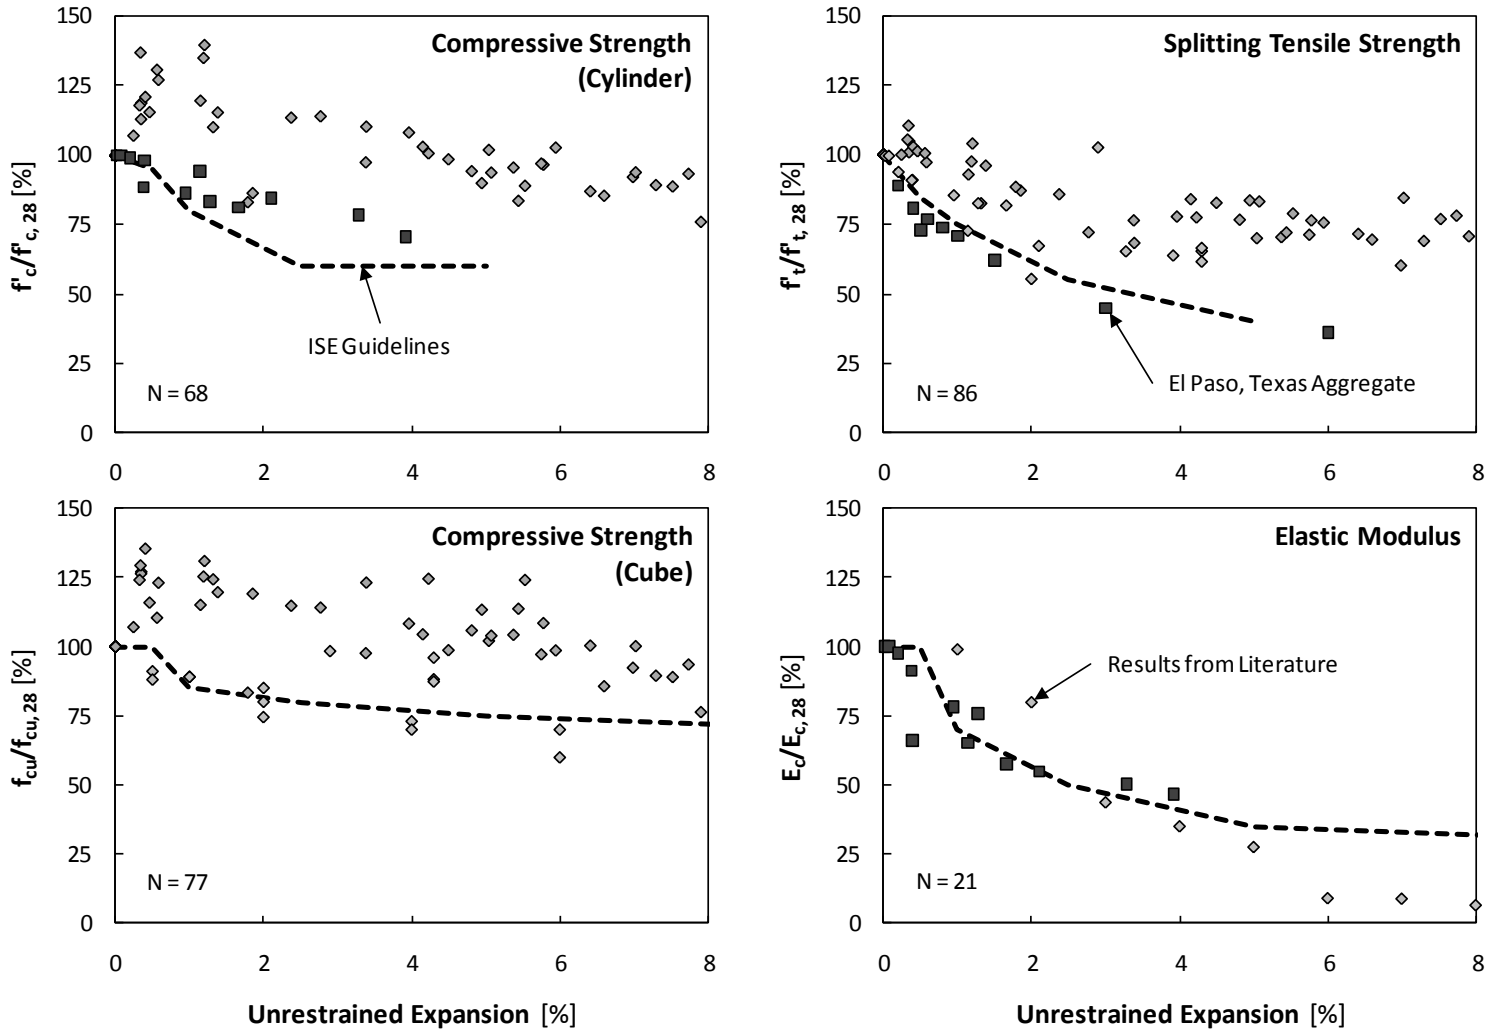
Figure 2-6: Impact of ASR on the Engineering Properties of Concrete

While all of the engineering properties displayed in Figure 2-6 are influenced by exceedingly high levels of PCD-related expansion, only the splitting tensile strength and elastic modulus are sensitive to the levels of expansion commonly observed in the field (up to two percent). In fact, the loss of splitting tensile strength and elastic modulus is commonly attributed to the development of microcracking, which may occur well before significant expansion is measured. The relationship between concrete expansion and microcracking is different for each combination of materials, mixture characteristics and environment. While testing a combination of Texas concrete materials, Smaoui recorded a thirty-four percent loss of elastic modulus at 0.04 percent expansion. It should be noted that testing results from the El Paso aggregate frequently exceeded the lower bound losses recommended by ISE. Quarries within the El Paso area have been identified as sources of *extremely reactive* aggregates in the literature.

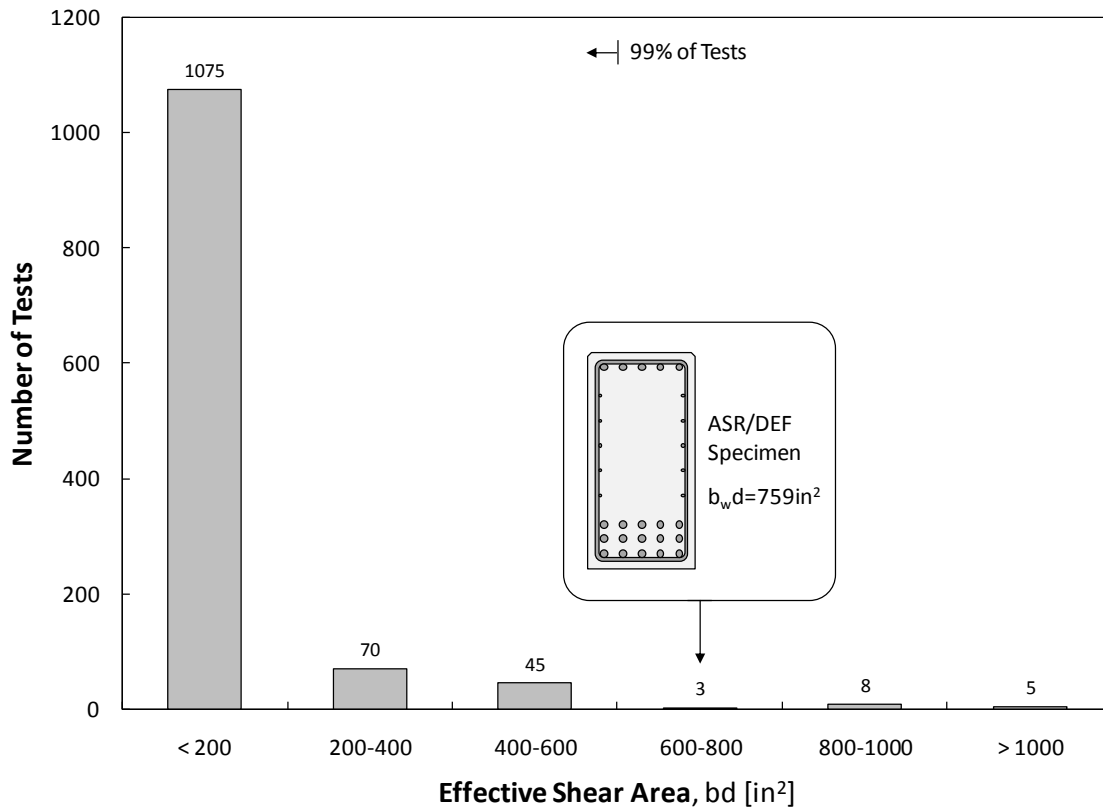
Figure 3-2: TxDOT Project 0-4371 Shear Database – Effective Shear Area

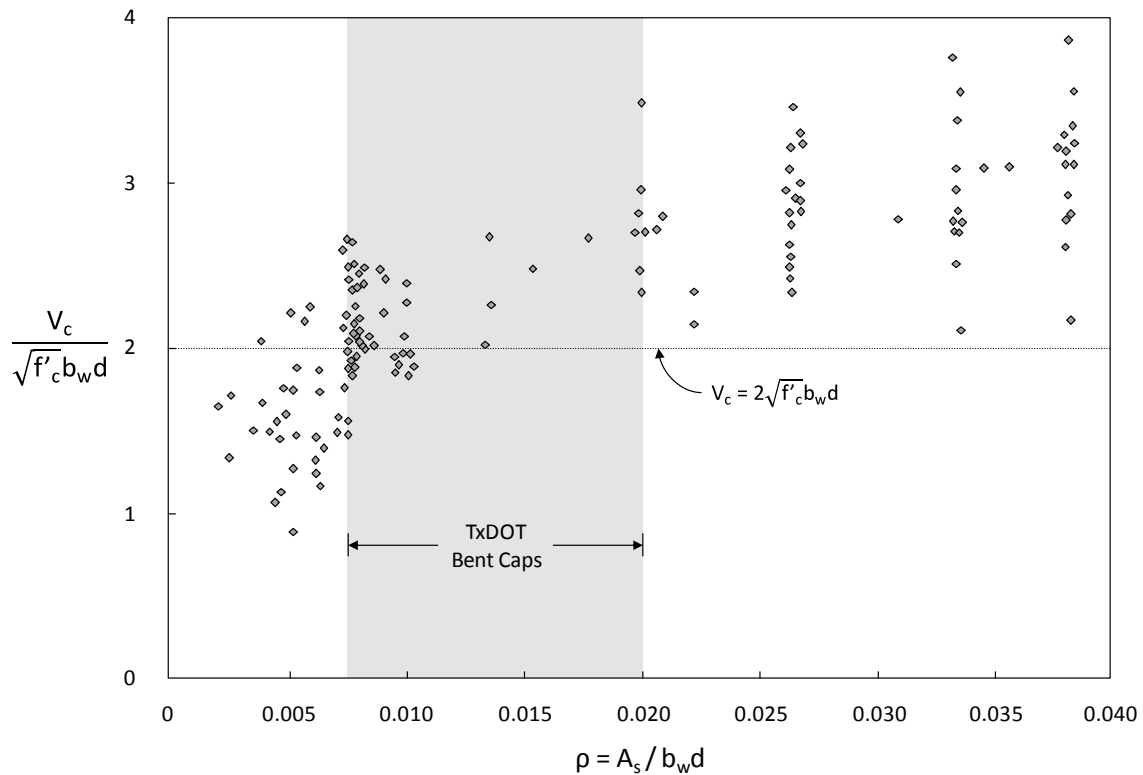
**Figure 3-6: Effect of Longitudinal Reinforcement Ratio on Concrete Shear Capacity
(Adapted from MacGregor and Wight 2005)**

To address alternate concerns regarding the impact of heavy longitudinal reinforcement on ultimate shear strength, historical test data was again examined within the context of the current study. Please note that the following discussion only applies to sectional shear failure; deep beam *failure* is generally not influenced by the primary longitudinal reinforcement. Figure 3-6 was obtained from MacGregor and Wight's *Reinforced Concrete: Mechanics and Design* to show the relationship between the concrete contribution to shear strength and the longitudinal reinforcement ratio.

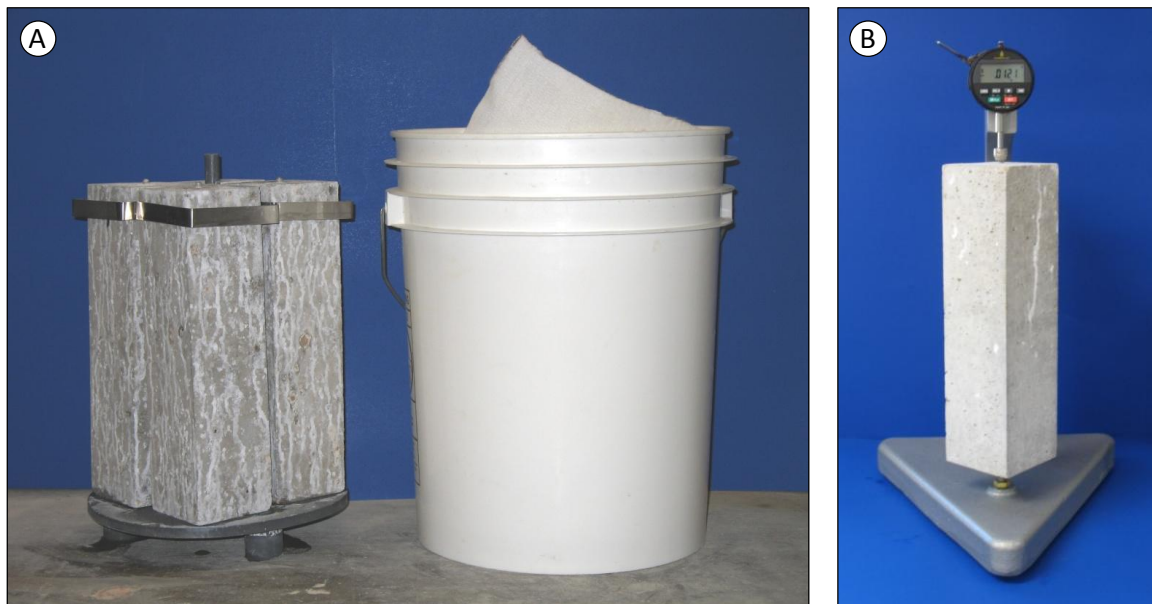
Figure 3-25: Free Expansion Potential (A) Elevated Prisms Set in Felt-Lined Bucket (B) Periodic Measurement of Length Change with Digital Comparator

ASTM C1293 is intended to evaluate the potential of a concrete mixture to expand deleteriously through alkali-silica reactivity. Concrete prisms containing potentially expansive coarse or fine aggregates are subjected to controlled laboratory curing conditions. Following twenty-four hours of in a moist room, each prism is measured and then placed within a sealed storage container above water (Figure 3-25A). The container of prisms is stored within an environmental chamber calibrated to 100°F (38°C). Subsequent length change of each prism is periodically measured with a comparator (Figure 3-25B) over a period of one to two years. Pre-established criteria are then used to determine the severity of the resulting expansions. If the average expansion of the prisms exceeds 0.04 percent in one year, the concrete mixture (and constituent aggregate) will be classified as deleteriously reactive.

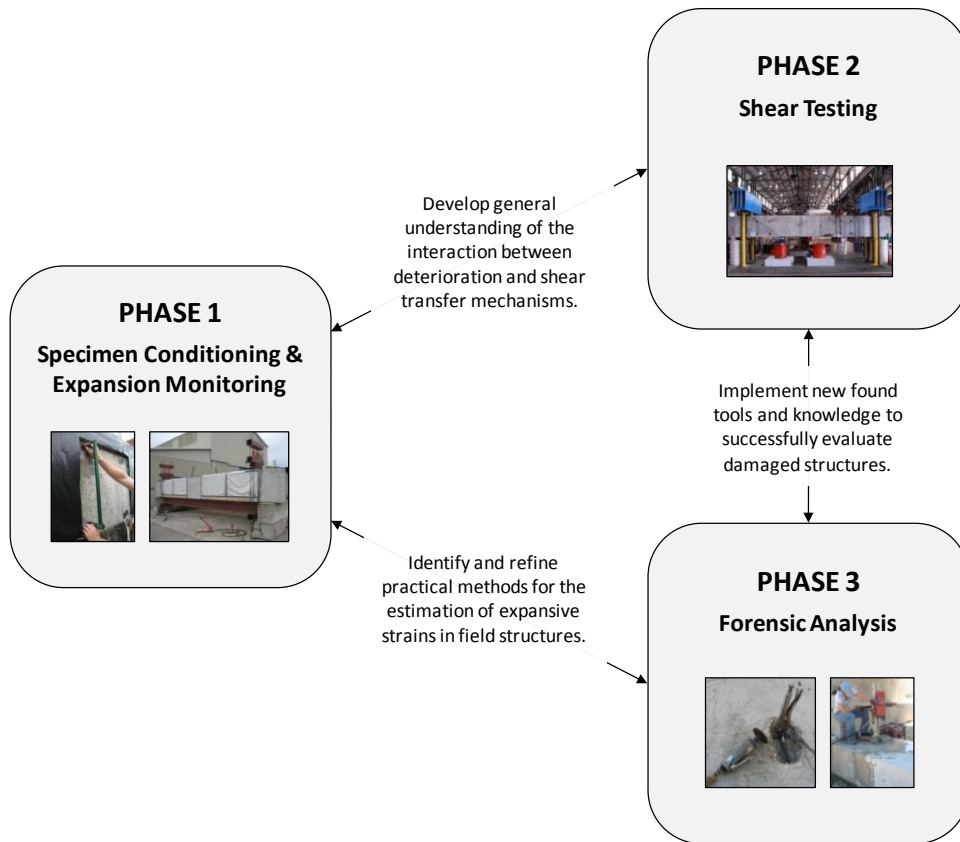
Figure 4-1: Three-Phase Experimental Program

In-house fabrication of the near full-scale bent caps (described in Chapter 3) presented the unique opportunity to thoroughly document the time-dependent effects of ASR/DEF on both service load and ultimate strength behavior. The experimental work was divided into a three-phase study, outlined in Figure 4-1 and detailed below. The results from each phase (presented in Chapter 5) provided much needed insight into the performance and evaluation of ASR/DEF damaged bent structures.

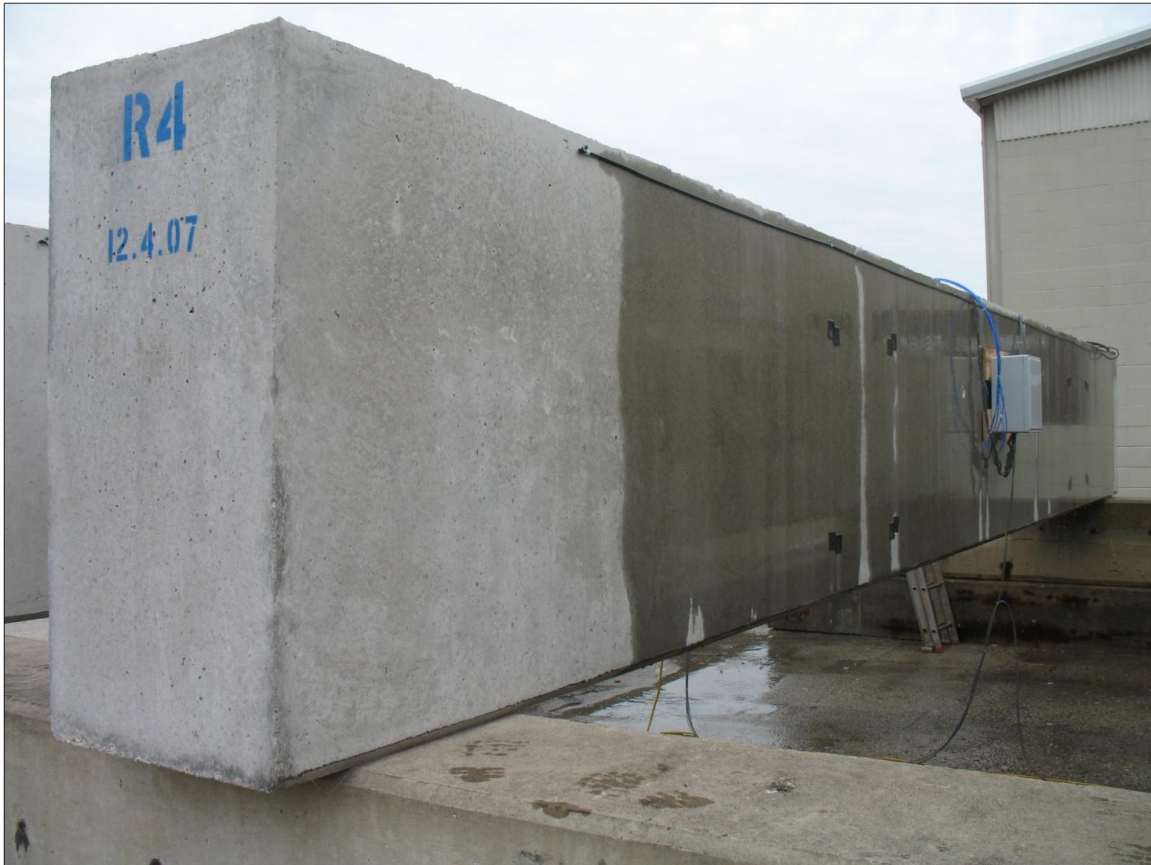
Figure 4-5: Demonstration of Watering System

To replicate the severe conditions described above, a watering system was installed at the exposure site. Three irrigation lines ran the length of each beam. Regularly spaced emitters ensured even water coverage over the top and sides of each shear span (see Figure 4-5). Moisture conditioning of the end regions was not necessary and the irrigation lines were therefore terminated to maximize efficiency. Poly-coated burlap was eventually applied to trap water at the end of each cycle; rapid drying of the specimen was thereby limited.

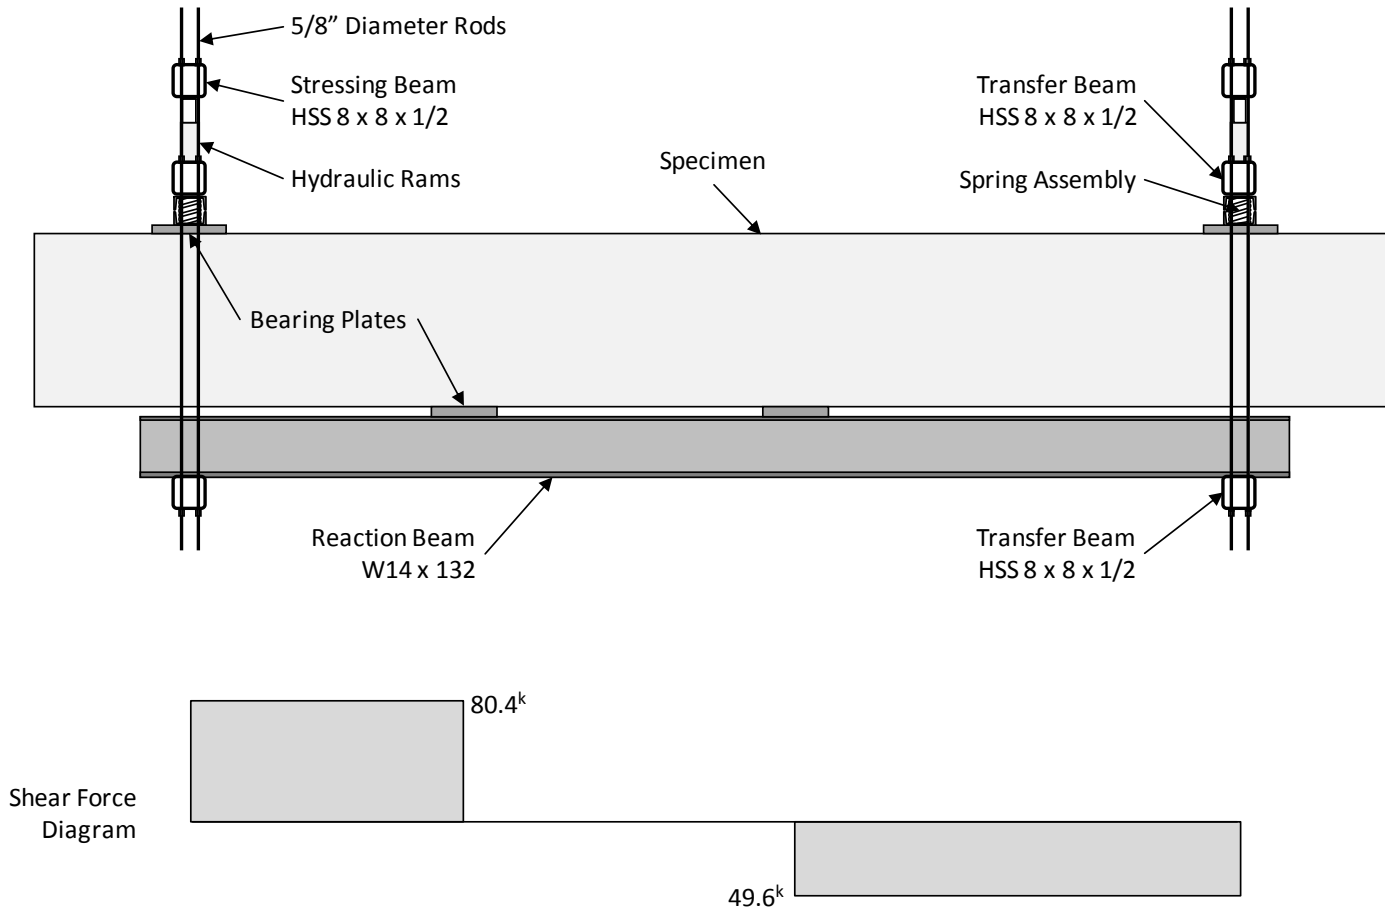
Figure 4-7: Sustained Loading Setup with Superimposed Shear Force

Due to the high longitudinal reinforcement ratio ($\rho = 3.1\%$) of the ASR/DEF specimen, a disproportionate amount of force would be required to produce 22 ksi of stress in the outermost layer of reinforcement. At the stress limit, a typical field structure (conservatively reinforced with $\rho = 1.3\%$) would be subjected to less than fifty percent of the shear required for the current specimen. To ensure that the conditioning load was equivalent to dead load forces found in the field, the reinforcement stress requirement was factored. A ratio of 1.3 : 3.1 ($\rho_{\text{specimen}} : \rho_{\text{typical}}$) produced an effective stress limit of about 9 ksi. The targeted twenty-eight day concrete strength of 5 ksi was then used to calculate the necessary moment and shear for each test region. The respective shear stress levels were fourteen and eighteen percent of the deep beam and sectional capacities measured during the pilot tests (see Chapter 3, Section 3). The desired superimposed shear force diagram is shown alongside the conditioning load setup in Figure 4-7.

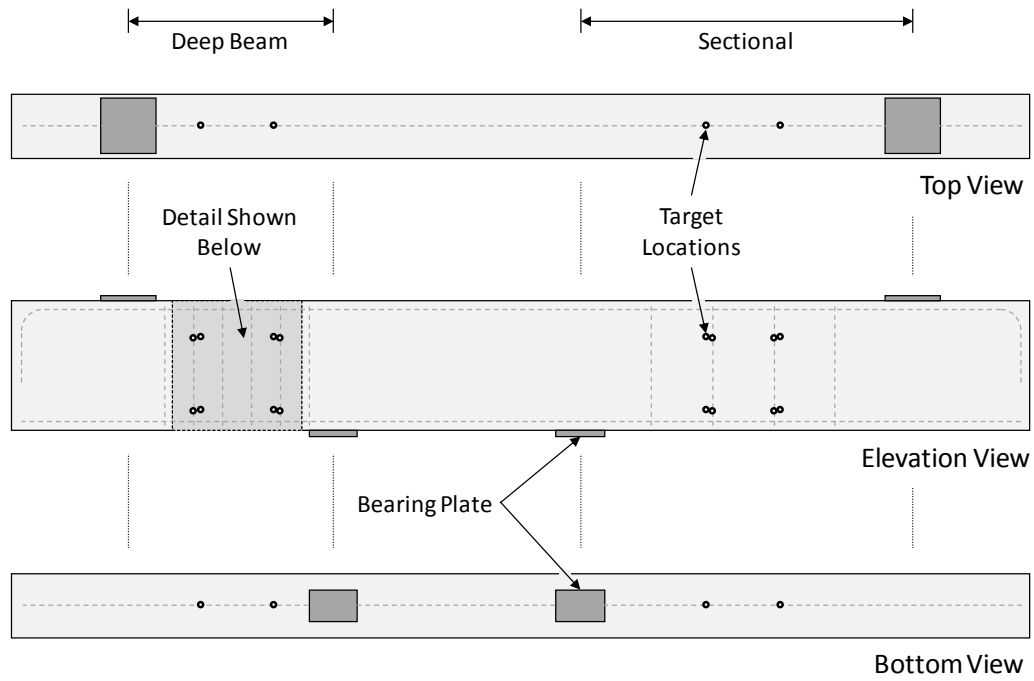
Figure 4-9: Layout of Targets for Expansion Measurement

To eliminate the abovementioned problems, use of surface targets was abandoned. In fact, the influence of cover expansions was eliminated from the measurement process altogether. A unique approach to mechanical strain measurement allowed expansions of the concrete core and strains in the confining reinforcement to be measured directly. Following a discussion of the instrumentation layout (shown in Figure 4-9), production and installation of the targets will be discussed. Hardware and electronics used to measure the time-dependent expansions will then be revealed.

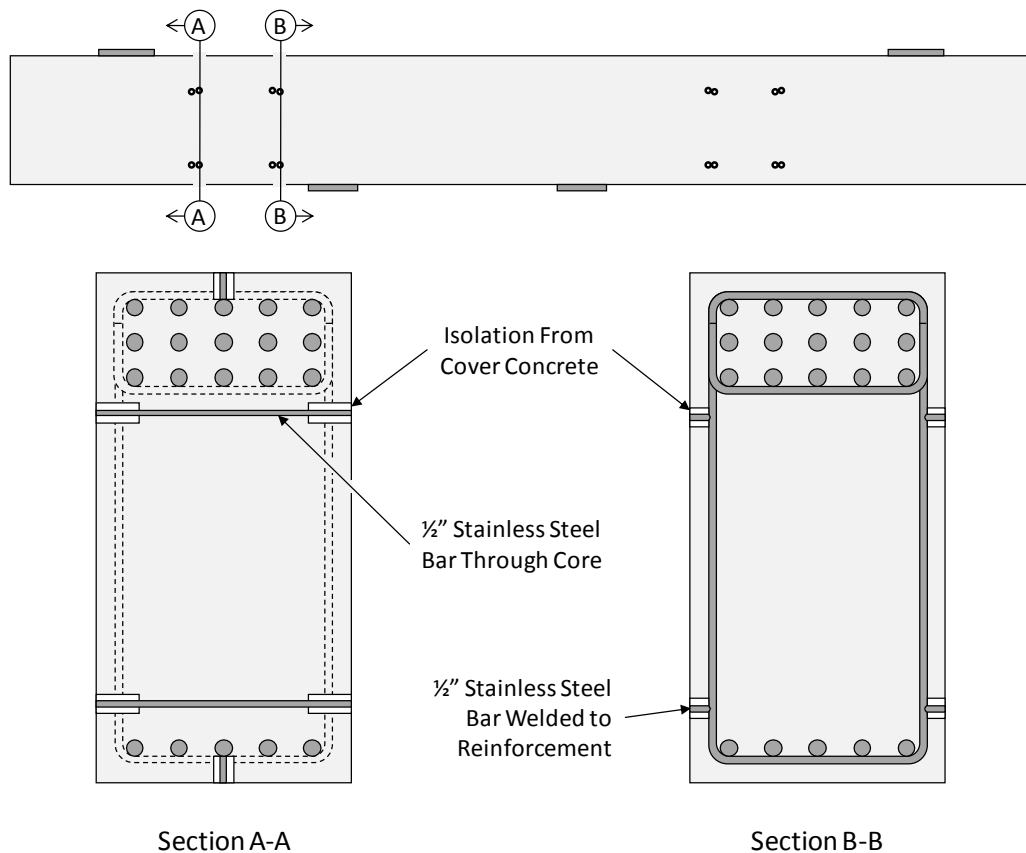
Figure 4-10: Concrete Core and Mild Reinforcement Measurements

The results of past research (see Chapter 2) suggested that the interplay between the expansive concrete core and surrounding reinforcement is critical to the behavior of an ASR/DEF affected concrete member. As a result, instrumentation was placed to efficiently quantify both concrete and steel strains at a number of sections (horizontal and vertical) throughout each bent cap specimen. Figure 4-9 (previous page) serves as an excellent reference for the discussion which follows. Longitudinal (horizontal) and transverse (vertical) concrete core expansions were measured via a twenty-four inch grid of targets placed at the center of the test regions. Each target was machined into the square face of a stainless steel rod. The finished rods were then *suspended* within the concrete core. The position of the rods within the cross-section can be seen in Figure 4-10 (Section A-A). The grid of targets resulted in eight individual measurements of the concrete core expansion (two longitudinal and two transverse per test region elevation). Complementary strains in the longitudinal and transverse reinforcement were measured in a similar manner. Matching targets were first machined into short stainless steel studs. Pairs of studs were then welded to the desired segment of reinforcement at the common spacing (gage length) of twenty-four inches. Figure 4-10 shows the location of longitudinal steel (Section A-A) and transverse steel (Section B-B) stud pairs. In the end, twenty-eight gage lengths (individual measurements) were formed by the strategic placement of only forty targets. Efficiency of the layout should not be undervalued. The design, production, and installation of the instrumentation were highly demanding tasks.

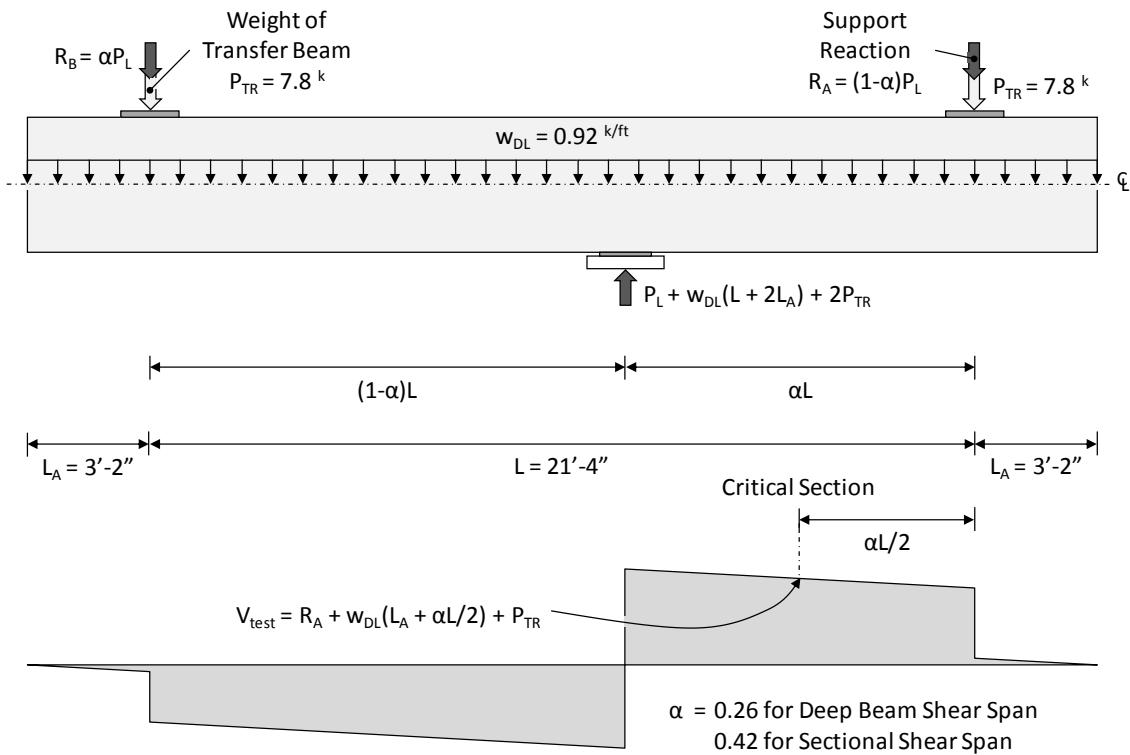
Figure 4-21: Shear Force Diagram for a Typical Beam Test

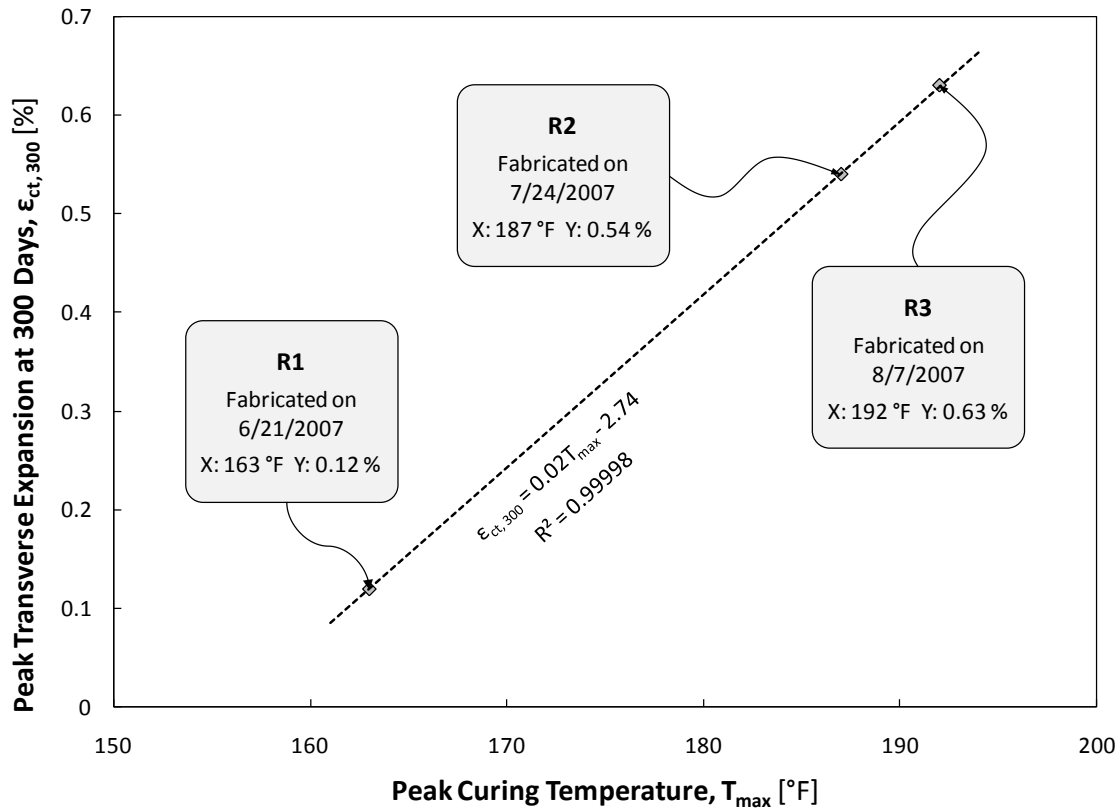
Figure 5-4: Correlation between Peak Curing Temperature and ASR-Induced Expansion

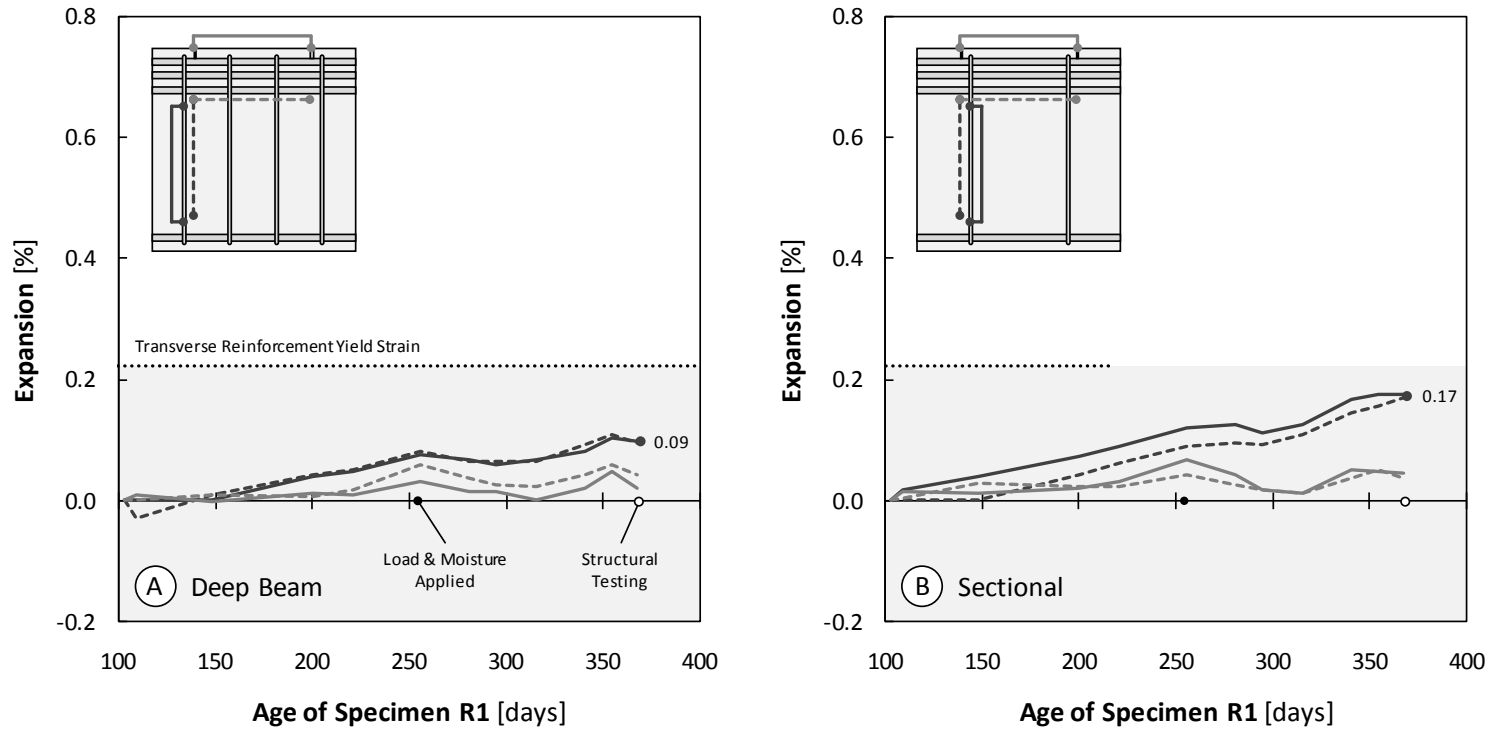
Figure 5-6: Specimen R1 Test Region Expansions (A) Deep Beam (B) Sectional

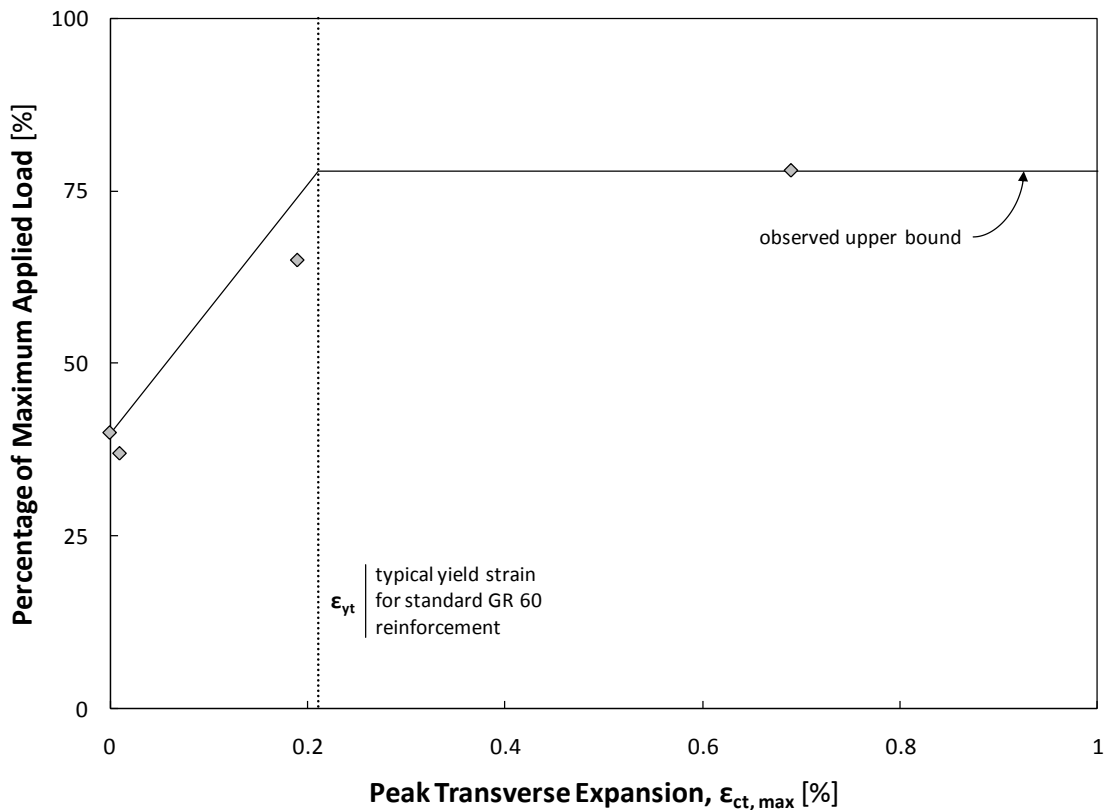
Figure 5-19: ASR/DEF Suppression of Diagonal Cracking in Sectional Shear Spans

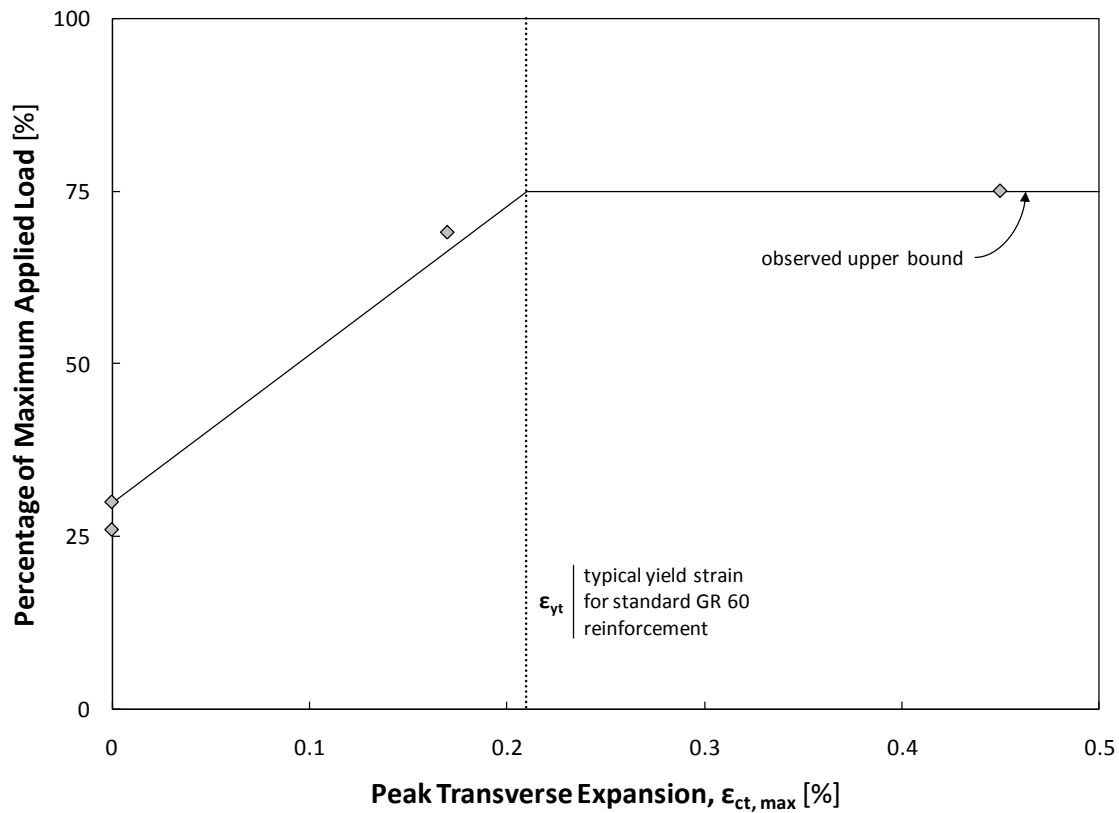
Figure 5-25: ASR/DEF Suppression of Diagonal Cracking in Deep Beam Shear Spans
