FINAL REPORT

DYNAMIC EVALUATION OF A PINNED ANCHORING SYSTEM FOR NEW YORK STATE'S TEMPORARY CONCRETE BARRIERS

MIDWEST ROADSIDE SAFETY FACILITY

MwRSF Research Report No. TRP-03-216-09

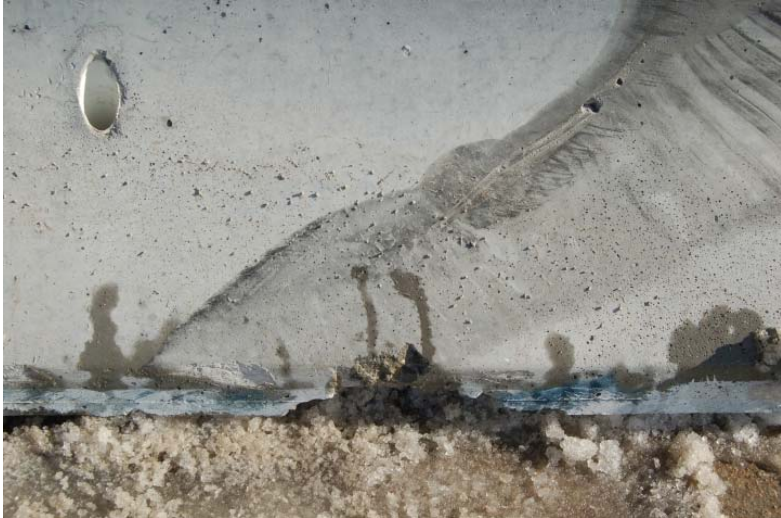
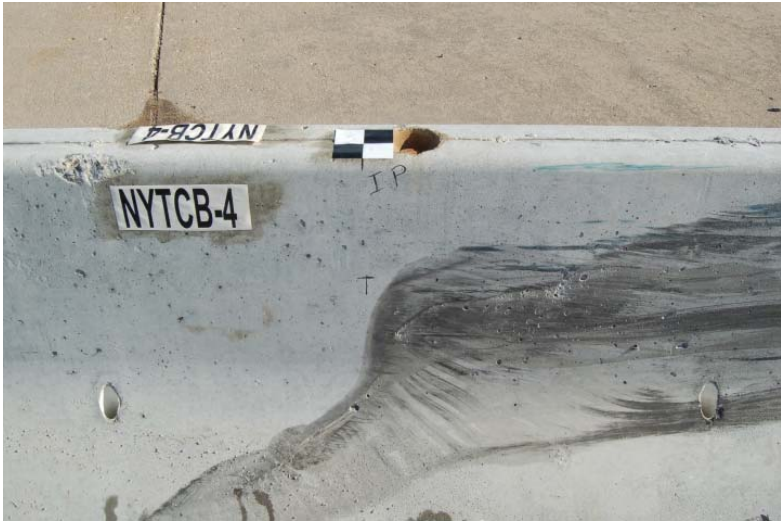
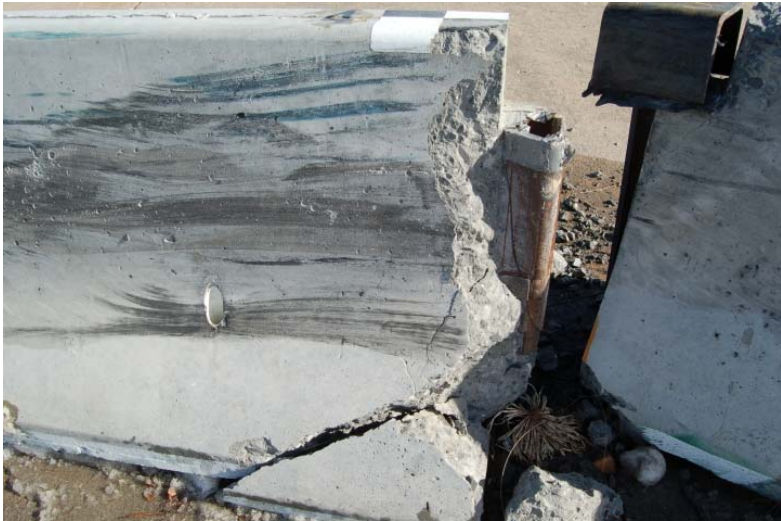
Figure 26. Barrier No. 4 Damage, Test NYTCB-4

The lower-back corner on the downstream end of barrier no. 3 experienced concrete spalling. The lower-back corners on the upstream and downstream ends of barrier no. 4 experienced concrete spalling, as well as the lower-front corner on the downstream end of the barrier. The lower-back corners on the upstream and downstream ends of barrier no. 5 experienced concrete spalling. Concrete spalling also occurred on the upstream end of barrier no. 5 on both the upper- and lower-front corners. A large piece of concrete was removed from the upper-back side of the upstream end of barrier no. 5 near the connection key. The lower-back face of barrier no. 5 experienced major concrete spalling. Concrete spalling occurred on the lower-back corner of the upstream end of barrier no. 6.

Damage to the barrier was moderate, as shown in Figures 25 through 33. Barrier damage consisted of contact and gouge marks, concrete barrier cracking, and spalling, and joint failure. The length of the vehicle contact along the system was approximately 26.0 ft (7.93 m), which spanned from 72 3/16 in. (1.83 m) upstream from the downstream end of barrier no. 4 through the joint between barrier nos. 5 and 6.

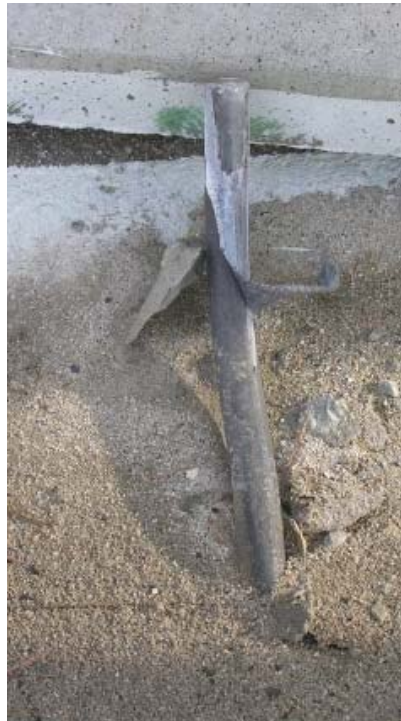
Figure 28. Barrier No. 5 Anchor Rod Damage, Test NYTCB-4

The connection key between barrier nos. 4 and 5 fractured and bent toward the traffic side of the barrier. The connection key connecting barrier nos. 4 and 5 disengaged from barrier no. 4 but remained attached to barrier no. 5. Barrier no. 5 disengaged from the anchor rods. The deformed anchor rods remained embedded in the rigid concrete surface.

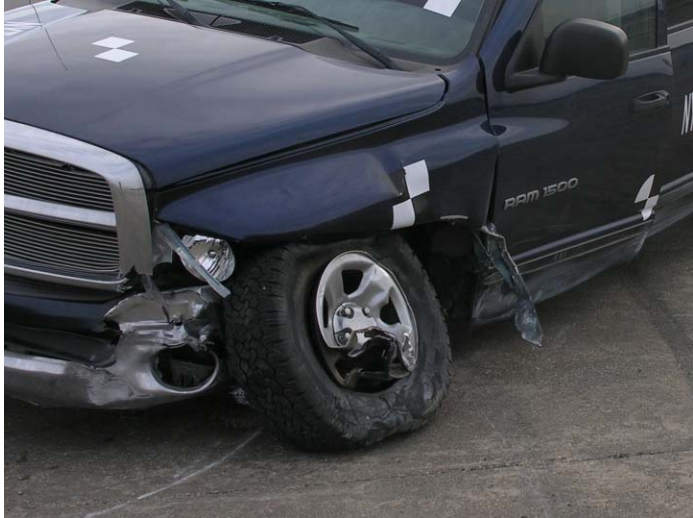
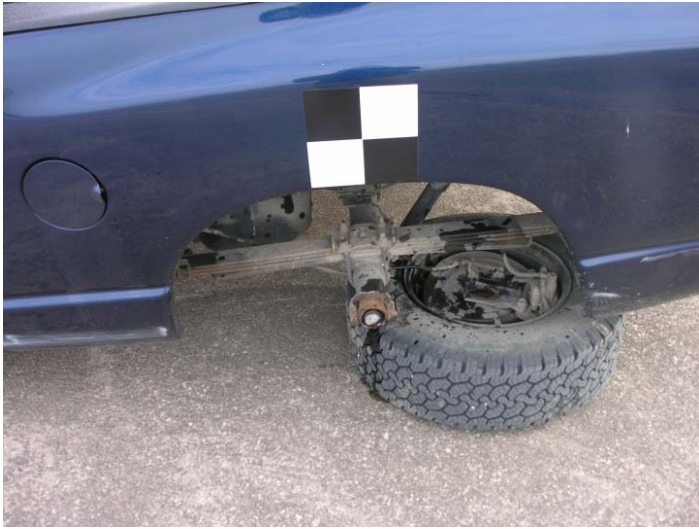
Figure 34. Vehicle Damage, Test NYTCB-4

Damage was concentrated on the left-front corner and left side of the vehicle. The left-front quarter panel deformed inward toward the engine compartment. The left-front wheel and brake line disengaged from the vehicle. The left-rear axle and brake line sheared, and the wheel assembly only remained attached to the vehicle by the emergency brake line. The left-front steel rim was deformed, and the tire bead broke. Scrapes and contact marks were found along the lower portion of the entire left side. The grill was detached and fractured. The hood shifted toward the left. The left headlight assembly and left corner of the front bumper were deformed inward. The left-front corner of the floorboard tore away at the side seam, as shown in Figure 37. The right side of the windshield was cracked. The left-front upper and lower control arm connections were fractured. The left-front vertical stabilizer bar link was bent, and the tie rod end disengaged. The left-rear rotor carrier brackets broke. The rear, roof, and right side of the vehicle as well as all other window glass remained undamaged.

The damage to the vehicle was moderate, as shown in Figures 34 through 37. Occupant compartment deformations to the left side and center of the floorboard were judged insufficient to cause serious injury to the vehicle occupants, as shown in Figure 37. Maximum longitudinal deflections of 5½ in. (140 mm) were located near the left-front region of the driver's-side floor
